A Watching Brief at

**St Mary's Arts Centre
Church Street, Colchester**

CAT Report No. 35
June 1999

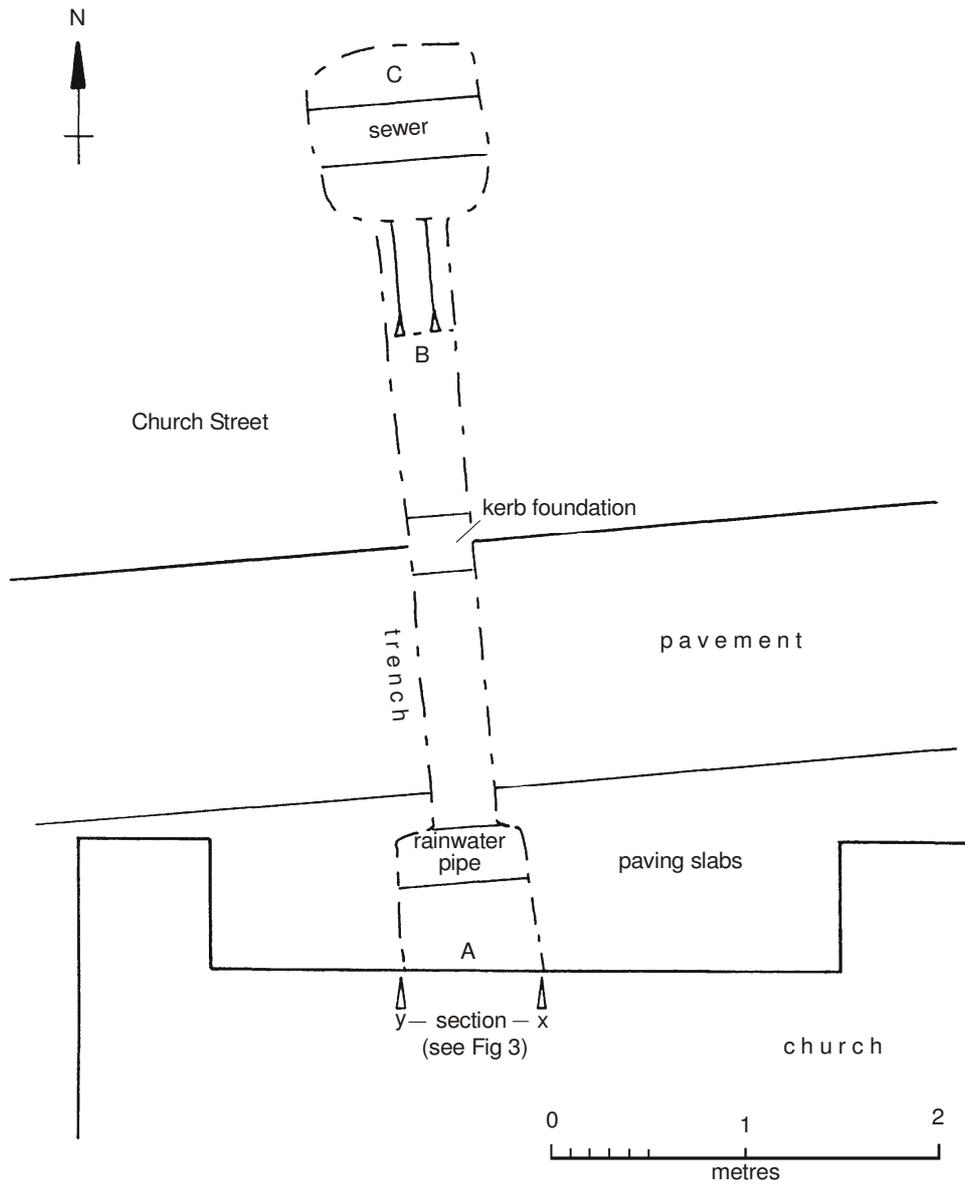
Fig 2 St Mary's Arts Centre, Church Street, Colchester - north drain: trench plan

Figure 1 shows the link from new toilets in the north aisle of the nave to the main sewer in the centre of Church street. The trench (detailed in Fig.2) was dug to a depth of 40cm between points "A" and "B", falling to 80cm at point "C". The trench stratigraphy to either side of the street kerb line differed, and was as follows:

The 40cm deep section between the kerb and "B" was entirely modern, consisting of paving brick above successive layers of sand, tarmac, coarse concrete and brick hardcore. The deeper part of the trench, from "B" to the sewer at "C", revealed an underlying deposit of very mixed reddish brown sand and brown sandy loam, which was cut by the trench for a sewer laid in 1979. Too little of this deeper material was exposed to permit firm interpretation, although its mixed nature suggests that it is possibly the backfill of a pre-1979 trench, perhaps associated with an earlier sewer.

In the stretch between the kerb and the south wall of the church, paving slabs on a light mortar bed occupied the uppermost 15cm, sealing a modern deposit of dark greyish brown sandy loam which extended to the bottom of the trench. There were indications of a soil change at that point: although identical in colour and texture to the sandy loam above, the material partly revealed in the trench bottom was harder and was felt to be compacted to a greater extent than might be expected from trample resulting from the current work. Several large oyster shell fragments were also present in this soil, but not in the overlying sandy loam.

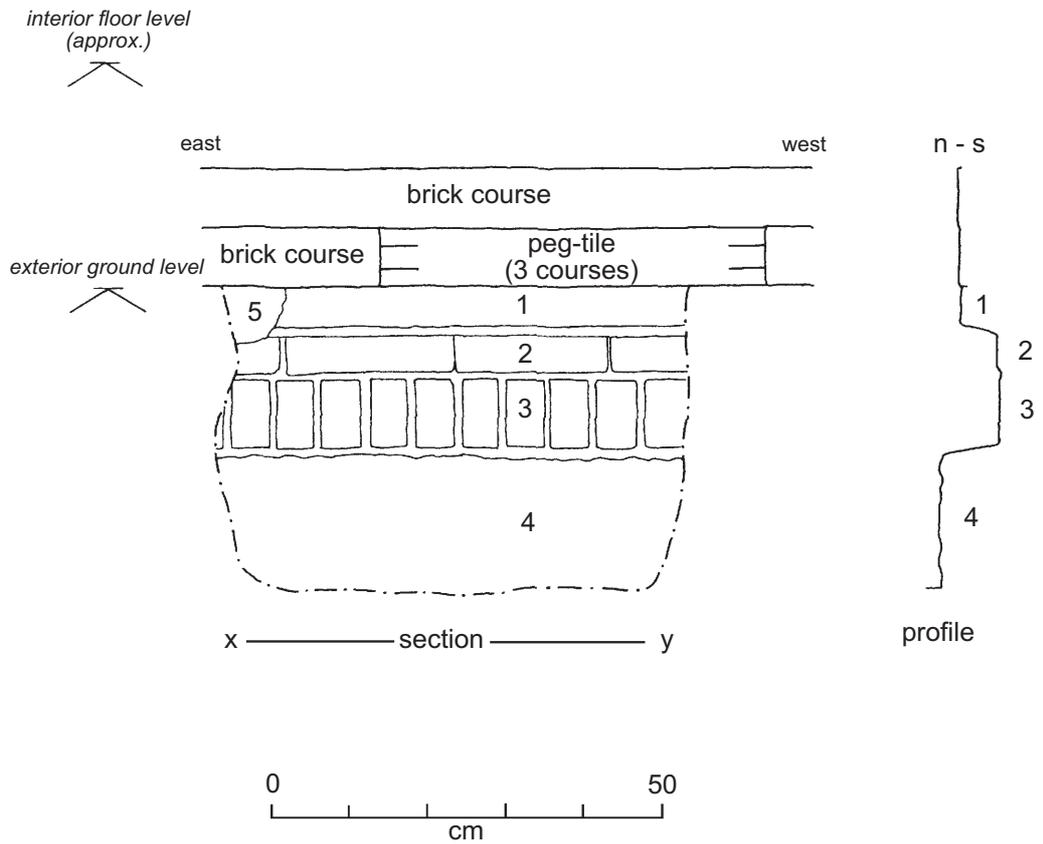
Fig 3 St Mary's Arts Centre, Church Street, Colchester - north wall: section and profile

Trenching exposed the uppermost 40cm of foundation for the north wall of the church. Illustrated in Figure 3 (section x-y), the foundation was composed of the following (numbered from ground level):

- (1) Stone slab
- (2) Red brick, 205mm long, exact height uncertain, width unknown, laid as stretchers.
- (3) Red brick, 90-95mm wide, 45mm high, laid on their sides as headers.
- (4) A rubble foundation of mortar with septaria, kentish ragstone, red brick and peg-tile fragments, also including Roman tile and occasional small shell fragments.
- (5) Mortar. Part of the modern mortar bed for paving slabs.

The stone slab (1) was flush with the exposed brick courses above ground level, while the lowest brick courses, (2) and (3), were recessed 5cm from the standing face of the wall. The rubble foundation, L4, projected about 8cm beyond L2 and L3 (Fig.3, profile).

Although no complete set of brick dimensions could be retrieved from the brick courses below the exterior ground level, their available measurements, colour and general form seem to be consistent with the early 18th century rebuilding of the church. The underlying rubble foundation, with its peg-tile inclusions, is probably also associated with this phase in the church's history.

The position of the stone slab (1) shown in profile in Figure 3 suggests that it is contemporary with the standing brickwork, which belongs to a further major rebuild finished in 1872.
