**An archaeological evaluation at  
St Nicholas' Church, Copt Hall Lane,  
Little Wigborough, Essex  
November 2005**

**report prepared by  
Kate Orr and Howard Brooks**

**CAT Report 350**  
April 2006

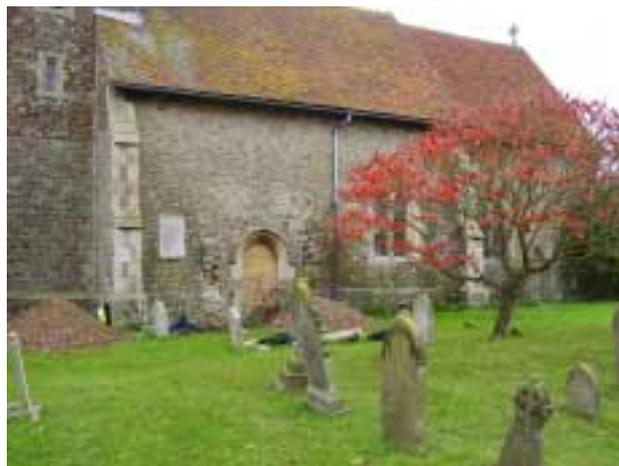
TP1 was located in the angle between the south tower wall and the west nave wall, and was dug to between 1.35m and 1.5m depth. Five phases of activity were evident, as follows.

TP2 was located on the south side of the nave, west of the blocked-in south door, and was dug to 1.35m depth.

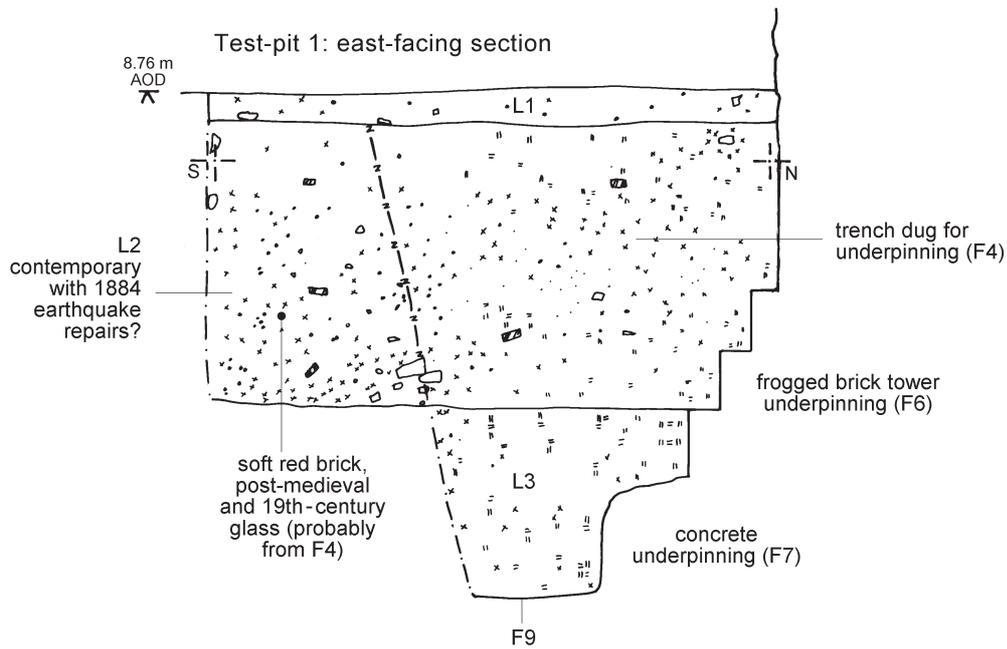
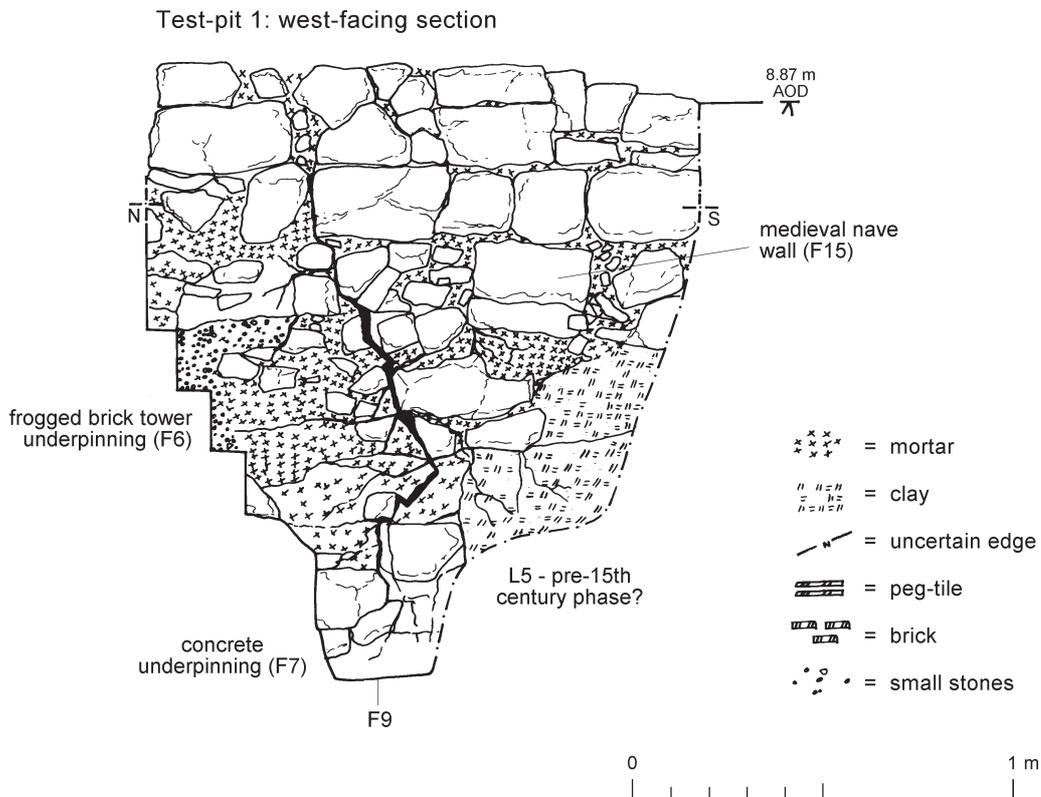
Fig 2 Test-pit 1: east-facing section (top), and west-facing section (bottom).

The second phase is marked by the west nave wall (Feature or F15) cutting L5. The nave wall had 1.35m-deep foundations of Kentish Ragstone and lime mortar.

Unlike the foundations in TP3 and TP4, these were not stepped out, and appear to be the original 15th-century footings. There is some undercutting at the base, and a crack runs from this undercut to the top of the foundations. Thick tree roots were growing out of the crack.

The fourth phase of activity is the underpinning of the tower foundations, with the original stone being replaced by frogged bricks foundations (F6) underpinned by concrete (F7). These foundations were 1.2m deep and stepped out, so that they projected 450mm from the wall. A trench (F4) cutting through the earlier L2 is assumed to be the trench dug during the underpinning work. The bottom fill of F4 is L3, which abutted and sealed the concrete foundations. This redeposited clay layer, which contained common mortar flecks, peg-tile, post-medieval brick and Kentish Ragstone fragments, was also seen abutting foundations in TP3 and TP4. There are perhaps two explanations for this layer; either it is simply a dumped clay layer, or else it is the material used to backfill 19th-century trenches dug to underpin the foundations. At the base of the test-pit and associated with the underpinning was an impenetrably hard concrete layer with a mortar surface (F9). This is likely to be modern.

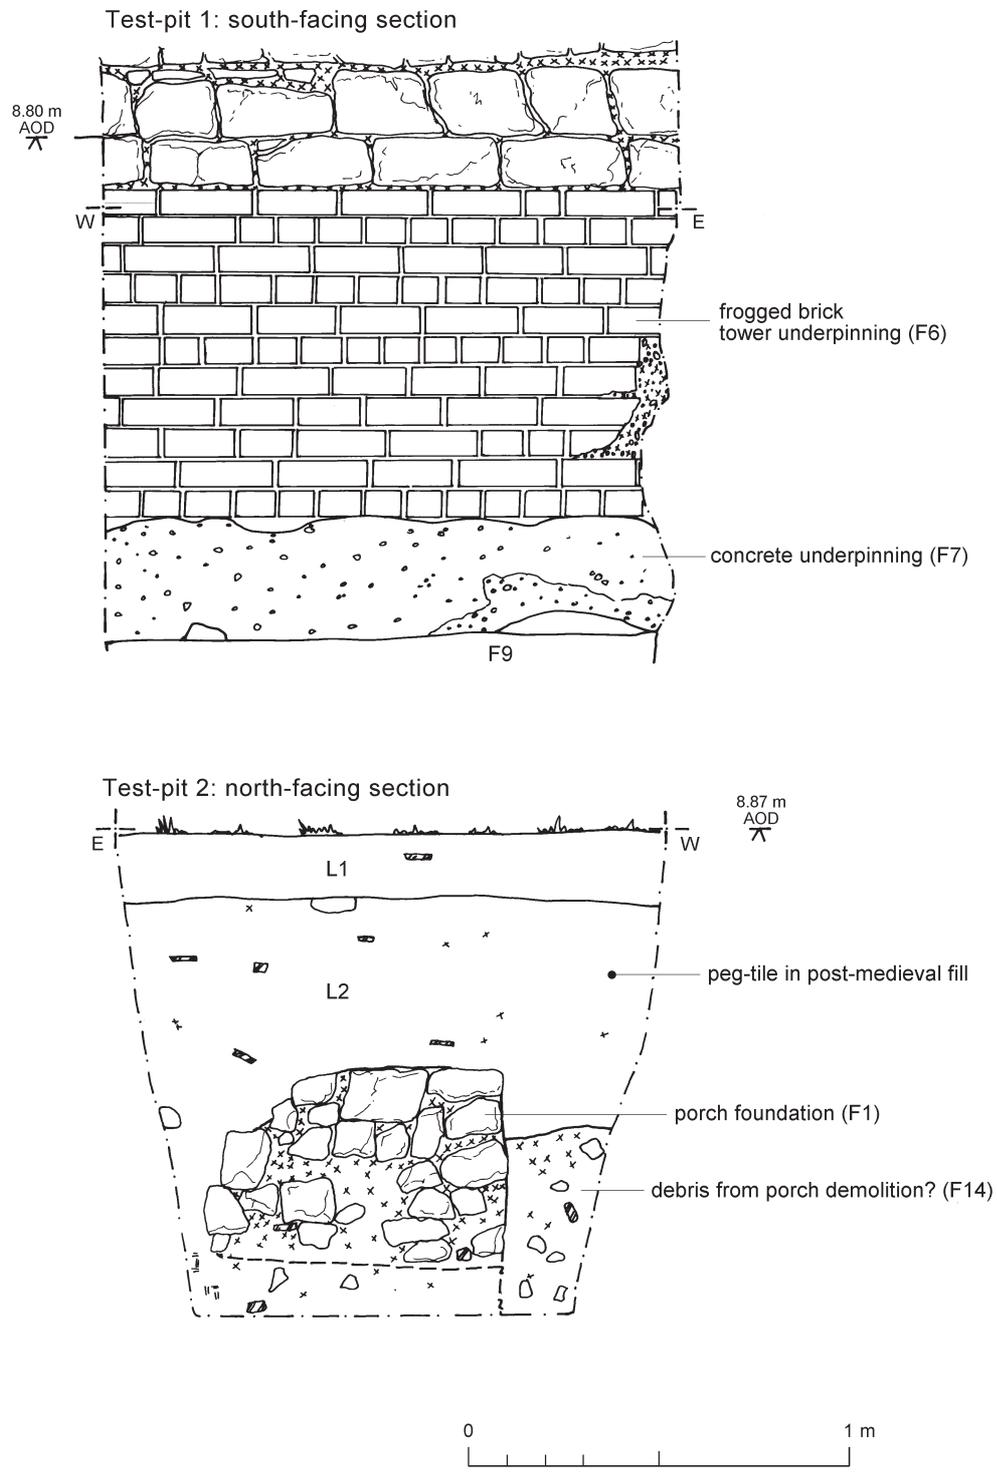
Fig 3 Test-pit 1: south-facing section (top), and Test-pit 2: north-facing section (bottom).

The earliest phase of activity is represented by the stone foundations of the nave wall (F8), found at 320mm below ground-level and supporting the main body of the nave wall. These were constructed of Kentish Ragstone blocks 200-500mm wide, with some smaller septaria blocks which were set in with lime mortar. Unlike the northern side of the church, the foundations were only offset once, projecting 300mm from the wall. They were substantial, and 1m deep. A layer of peg-tile could be seen above the foundations, at the bottom of the nave wall, which may have had a levelling function. These foundations were not underpinned with concrete and appear to be the original 15th-century footings.

The second phase of activity consisted of the foundation of a demolished south porch, whose outline can be clearly made out on the exterior nave wall. TP2 was dug directly below this point. The porch may have been contemporary with the original 15th-century church, or a slightly later addition, but it must have been built before the 18th century because its demolished remains were cut by two late 18th-century graves (below). The foundation of the demolished porch (F1) was found 620mm below ground-level in the southern part of the test-pit. It was 780mm wide and 500mm deep, and was constructed of lime-mortared septaria and Kentish Ragstone, with occasional peg-tile.

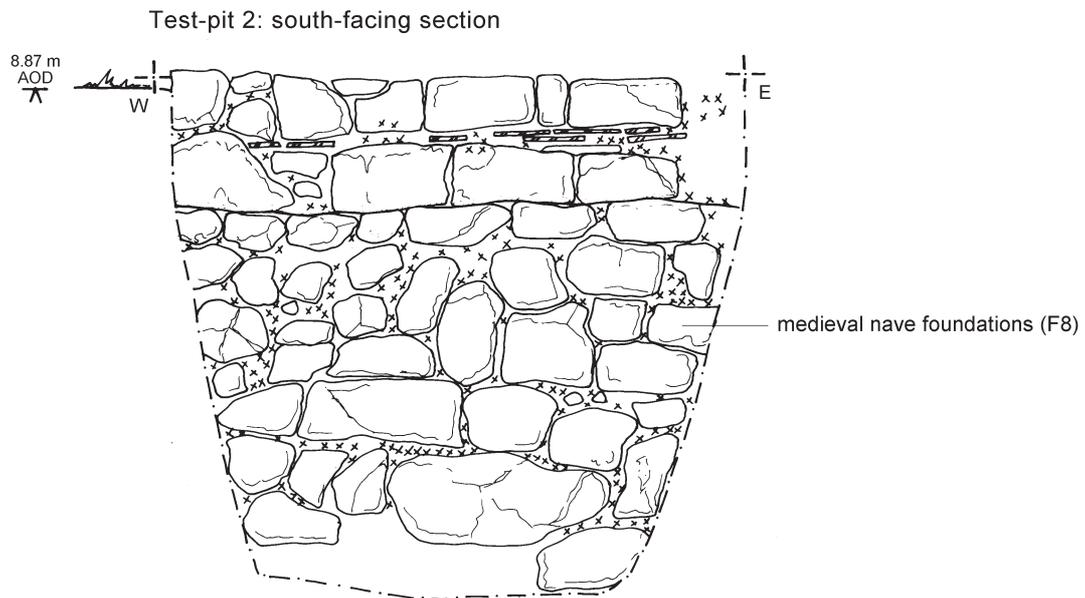
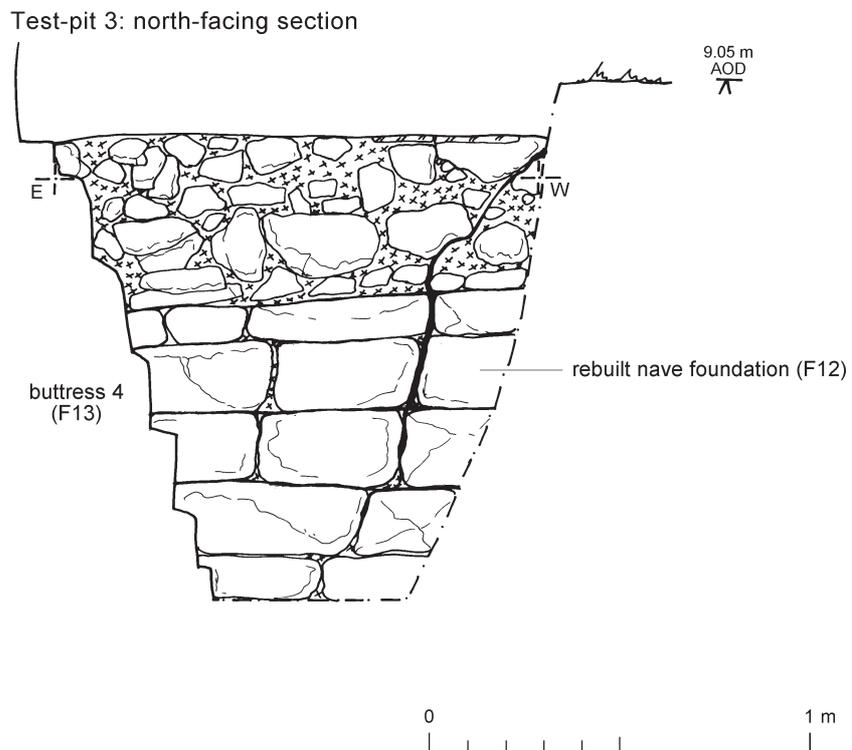
Fig 4 Test-pit 2: south-facing section (top), and Test-pit 3: north-facing section (bottom).

The third phase is represented by was an area of yellowish mortar, some loose lumps of septaria and chalk (F14) lying to the west of foundation F1. This is interpreted as debris from the demolition of the porch. This demolition must necessarily pre-date the late 18th century, because two graves cut through the line of the demolished porch wall.

The first skull (F3) was 1.08m below ground-level and lay under the projected line of the porch foundation F1. A human humerus (either from an adult or adolescent), part of a rib and fragments of skull had been found in L2 above, and may form part of this burial. The skull was incomplete, without the lower jaw, but appeared to be of an adult or of a young person. There was no sign of a grave cut. The second skull (F5) was on the eastern side of the test-pit at 1.3m below ground-level. The rest of the body may have continued under the baulk, but there was no sign of a grave cut. This skull was small and appeared to belong to a child. It was left *in situ*.

The earliest phase of activity is represented by the foundations of the chancel and one of the buttresses. The upper 400-450mm of the nave foundations (F12) were constructed of irregularly-shaped Kentish Ragstone and septaria blocks pointed with lime mortar. These projected 100mm from the chancel wall. The foundations below this were constructed of large Kentish Ragstone blocks pointed with cement mortar. These formed three further steps so that the total projection of the foundations from the wall was 450mm. A crack in the foundations continued up the nave wall. The trench could not be dug any deeper due to space restrictions, and therefore the bottom of the wall foundations were not reached. They must be at least 1.2m deep.

The foundations to the buttress (F13) were stepped out six times so that the base projected by 500mm. They were similar to those of the nave, having an upper course of irregularly-shaped mortared Kentish Ragstone, sitting above courses of long Kentish Ragstone blocks all pointed with cement mortar. The lowest step of the buttress foundation was formed of concrete, which is presumed to be modern underpinning (there was no sign of an underpinning cut like the one in TP1).

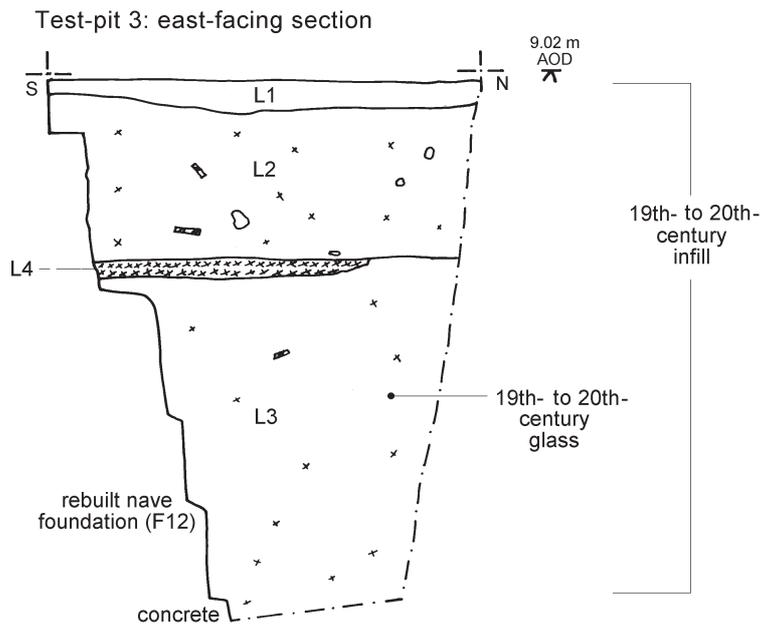
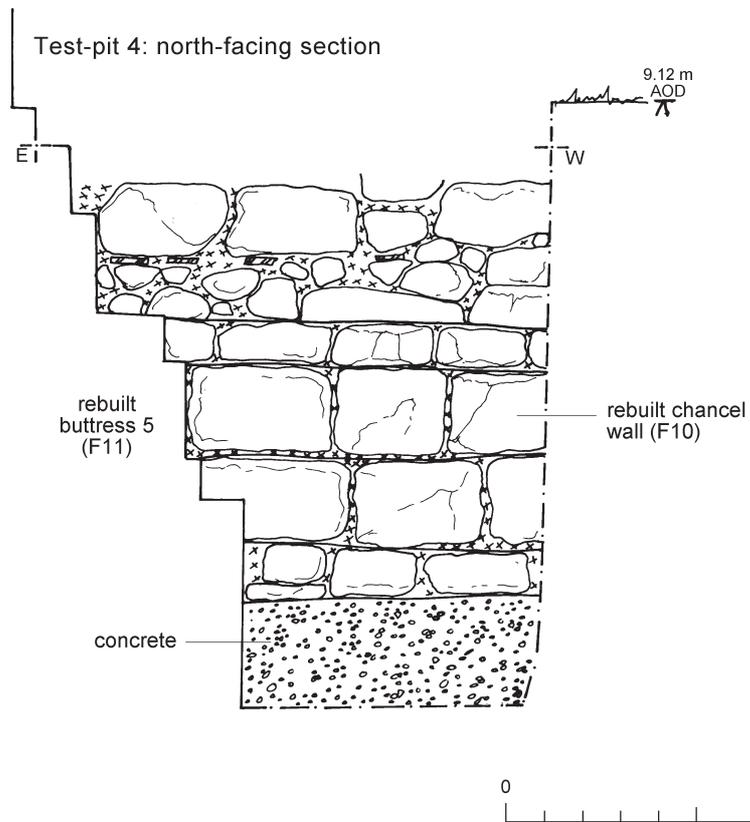
Fig 5 Test-pit 3: east-facing section (top), and Test-pit 4: north-facing section (bottom).

The earliest phase is the foundations of the buttress (F11) and chancel (F10). These were very similar to those in TP3, the only difference being that in TP4 the nave foundation had a layer of peg-tiles set between the Kentish Ragstone, at just over 400mm below ground-level. The test-pit was dug deep enough to expose the bottom of the buttress and chancel foundations, both of which were 1.4m deep and had been underpinned with concrete. The cut for the underpinning could not be seen. This implies a 19th- or 20th-century date for the exposed foundations, and for everything above them.
