Report on a watching brief: CAT Report 410

Site address: St Giles' Church, Great Maplestead, Essex
Date of fieldwork: 1st November 2006 to 28th February 2007

CAT project code: 06/11b HEM site code: GMSG 07

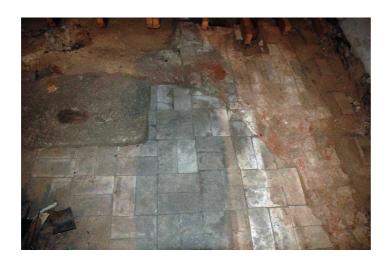
The first visit was made after the wooden floor and the organ in the tower had been removed. This exposed an area of white flooring bricks (pavers) in the tower, near the entrance. These bricks are 18th/early 19th century in date (Andrews 1993, 98). The white flooring bricks had been cut to form a curved edge as if they had butted up against some fitting or furnishing. To the north-west of the white flooring bricks and on the same level was another patch of flooring bricks. The bricks were the same size and shape as the white ones but redder in colour and clearly not contemporary with them (Plate 1). The red bricks were slightly more fragmented than the white bricks. The rest of the floor was a beaten clay floor made of locally produced clay with chalk nodules. It would appear that the fitting or furnishing that the white bricks were laid up against had been removed. After its removal the red bricks and the beaten clay floor had then perhaps been used to patch this exposed area. Just west of centre in the tower floor was a slab of Purbeck marble which is likely to have been a base for something, perhaps the font. The font is currently positioned in the south nave, near the entrance.

Plate 1: the flooring bricks and Purbeck marble slab, view west.

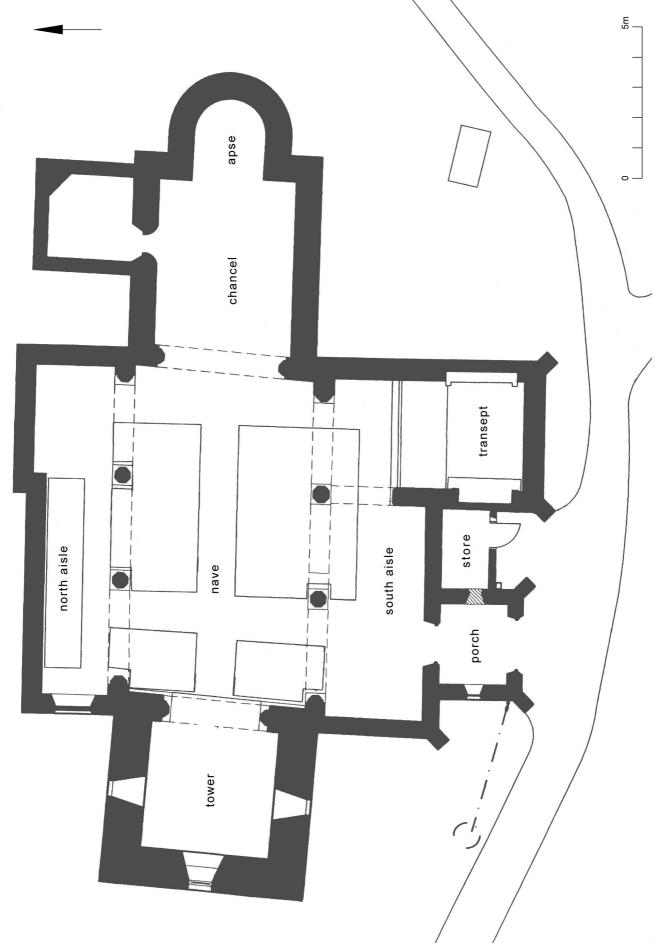
Fig 1 Floor plan of St Giles' Church prior to internal re-ordering (source: David Whymark Building Design and Conservation).

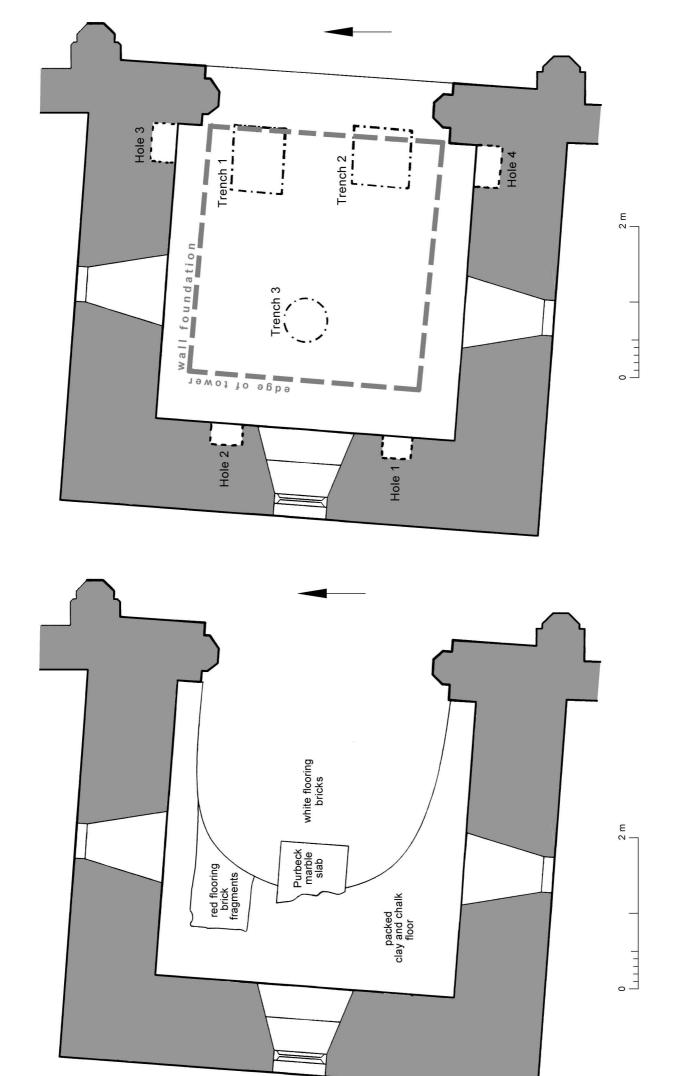
The second visit was made after the brick and clay floors had been removed and two holes for foundation pads had been made in the floor of the tower (Trenches 1 and 2). An extra hole was also dug in the centre of the tower floor to investigate a void there (Trench 3). Trenches 1 and 2 were both 900mm deep. Both exposed a flint wall foundation running north-south and dividing the nave from the tower. To the west of this foundation, the holes had been dug through a loose mid brown silt with flint fragments. Natural sand was encountered at 850mm below ground-level. Trench 3 was circular and 850mm deep. It was dug through the loose silt with flint fragments only.

The fourth visit was made after the tower floor had been reduced by a further 100mm-120mm. This further reduction was due to an alteration in the design of the planned tower supports. The north-south aligned flint wall foundation observed in Trench 1 and Trench 2 was fully exposed. The ground reduction had also exposed a continuation of this flint wall foundation extending the whole way around the interior of the tower. This foundation appeared to be the foundation for the current tower wall and not an earlier foundation, as it was made of the same mortar and flint as the wall and exactly followed its course. The foundation protruded between 450mm and 600mm from the wall face. The top of this foundation was 250mm below the floor-level of the nave. The fact that the north-south flint wall foundation dividing the nave and tower was seen to be a continuation of the tower wall foundation is interesting as it shows that the tower and nave were one build. During this

Fig 2 Plan of tower after removal of wooden floor (source: David Whymark Building Design and Conservation).

Fig 2a Plan of tower after removal of brick floor and clay floor, showing excavations (source: David Whymark Building Design and Conservation).
