**A historic building survey at  
High House Farm, Woodham Road,  
Battlesbridge,  
Chelmsford, Essex**

**report prepared by  
Leigh Alston**

**on behalf of  
Churchgate Project Management Ltd**

**CAT Report 470**  
April 2008

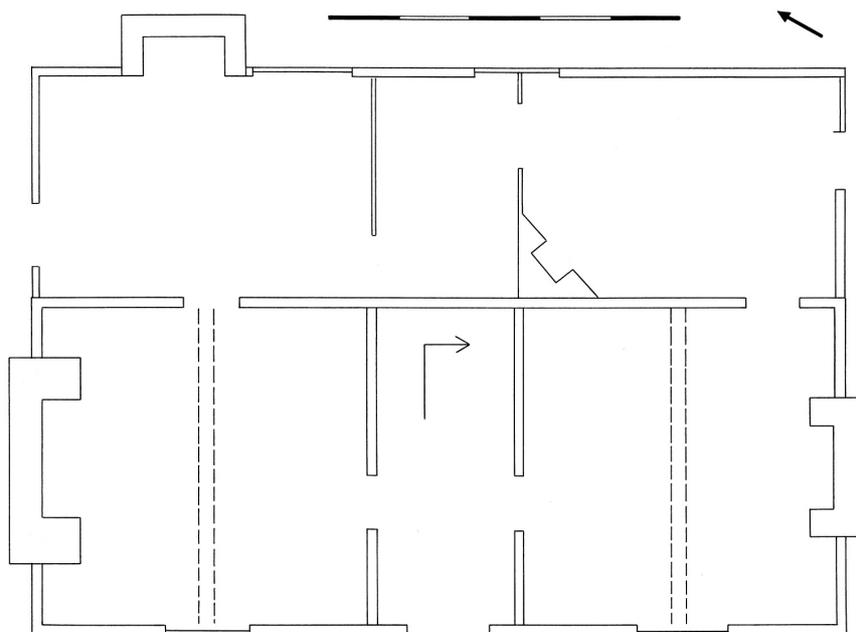
The grade II-listed farmhouse is a timber-framed structure clad in white-painted weatherboarding in the tradition of coastal Essex, and was listed chiefly on the basis of its external appearance. The building extends to 11.6 m in length by 8.2 m in overall width, including its rear lean-to, and contains a central stair lobby between principal rooms heated by gable chimneys in the fashion of the 18th and 19th centuries.

The house was extensively refurbished in the 1970s and stripped of any historic fixtures and fittings, although part of an 18th-century fire surround survives in the northern room behind a blocked Art Deco surround of the 1930s (photo. A2.3). The Mansard roof and the framing of the southern half of the structure date only from the 19th century, as indicated by the poor quality of the framing visible where the weatherboarding has been removed. The fabric of the northern half appears to date from the late 17th or early 18th century; its framing contains more substantial timbers but incorporates primary diagonal bracing and re-used 16th-century material in a manner not found at earlier periods. The fireplaces elsewhere in the house, which probably dated from the 19th century, are missing and appear to have been stolen. More evidence of the building's origin and development may be revealed during forthcoming alterations. The rear lean-to is of mid 19th-century origin as it appears on the Ordnance Survey of 1875 but not the tithe map of 1838 (Figs 4 and 3 respectively). The depiction of the house with a central chimney in 1778 (Fig 2) may reflect a genuine alteration of the late 18th or early 19th centuries, but may not have been accurately observed.

Fig 7 The farmhouse. Ground-plan showing positions of chimneys, windows and doors, together with the central stair opposite the entrance lobby.

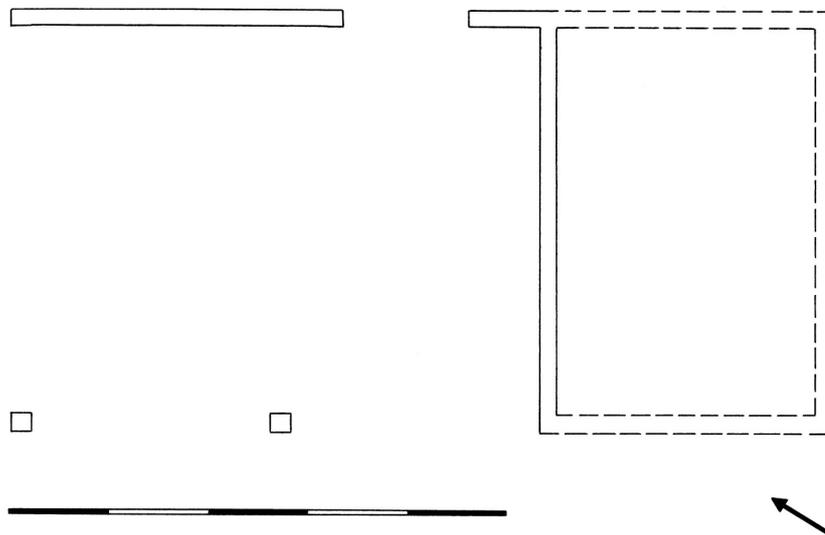
Building 2 in Figure 1 is a north-south aligned timber-framed structure of three bays which extends to 8.2 m in length by 3 m in overall width (27 feet by 14) and rises to 2.1 m at its eaves (7 feet). It dates from the mid 19th century, and is shown on the Ordnance Survey of 1875 but not the tithe map of 1838. The building was converted for domestic purposes in the 1970s or 1980s, rendering precise interpretation of its original appearance impossible at the time of inspection. The northern gable was open framed with massive knee-braces between its corner posts and tie-beam, and a similar brace remains visible at the northern end of the western elevation. The southern bay was divided from the others by a missing lateral partition (indicated by empty mortises in the tie-beam), but it is not clear whether this area was enclosed or open. There is evidence of two horizontal rails in the eastern elevation, as shown by notches in the corner posts, but it is unclear whether these were original or later insertions. The structure is shown as a free-standing structure at the entrance to the farmyard on the Ordnance Survey of 1875 and was probably designed as a cart lodge, but may have been subsequently converted into a shelter shed for cattle. This building contains no historic fixtures or fittings and its historic integrity was lost during its recent domestic conversion.

Fig 8 The cart lodge. Ground-plan showing the open arcade to north and west, and the partition which divided the southern bay from the rest. The original structure of the walls indicated by broken lines was lacking or obscured at the time of inspection.

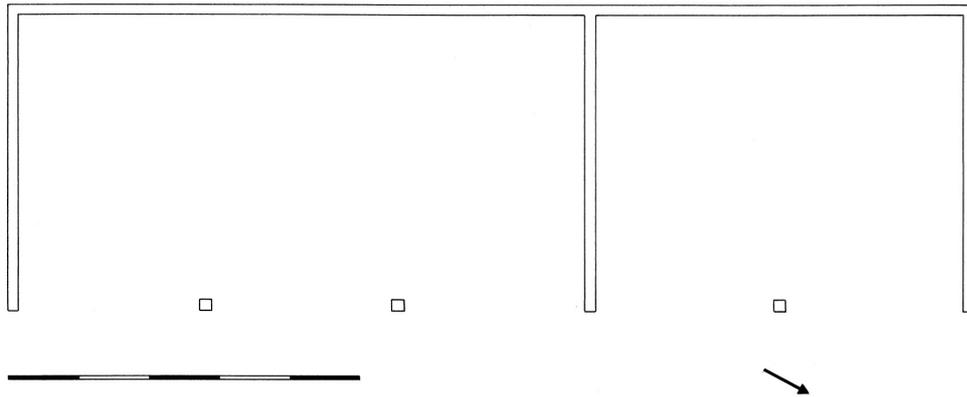
Building 3 lies to the west of the farmyard and consists of a timber-framed structure of five bays on a north-south axis which extends to 13.7 m in length by 4 m in overall width (45 feet by 13.5) and rises to 2.1 m at its eaves (7 feet). Its eastern elevation was open along its entire length, with posts rising to short horizontal rails beneath the roof-plates (and lacking braces), but the two northern bays were divided from the rest by a missing lateral partition (indicated by empty mortises in the tie-beam). The western elevation and gables formed solid walls, but, as with building 2 above, precise analysis is hampered by the building's conversion for domestic purposes in the late 20th century. It contains no historic fixtures or fittings.

The building evidently formed a shelter shed adjoining a probable cattle yard to the south of the barn, and dates from the mid 19th-century refurbishment of the site; it is shown on the Ordnance Survey of 1875 but its position was occupied in 1838 by two smaller buildings on the same alignment. Its internal partition would have related to a dividing fence in the yard which is not shown on the Ordnance Surveys. The historic integrity of this building was lost during its domestic conversion, although it remains of historic interest, along with building 2, insofar as it illustrates the diversification of local farming from arable to mixed dairy production during the mid 19th century.

Fig 9 The shelter shed. Ground-plan showing the open arcade to the east and the internal partition dividing the two northern bays from the rest.

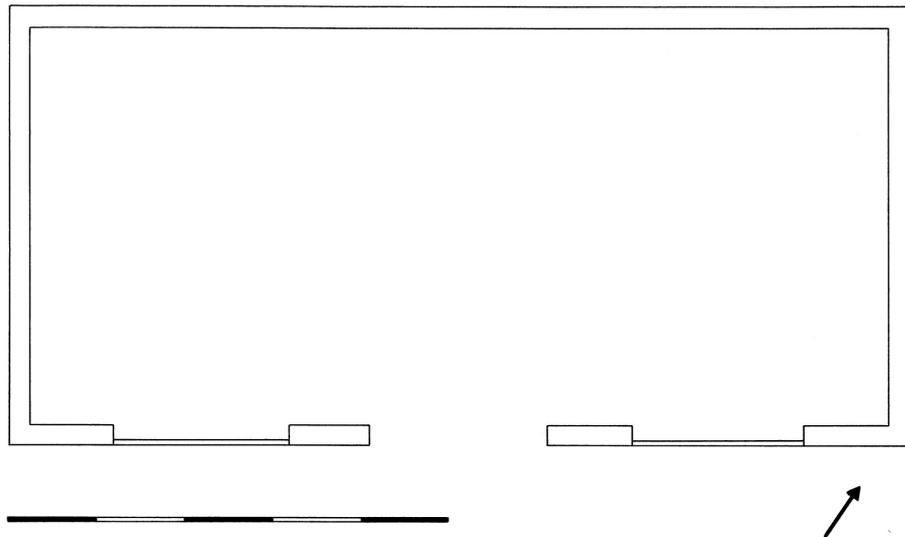
Building 4 is a white brick structure which forms the southern side of the cattle yard but faces south on an east-west axis and is adjoined by a modern lean-to shed to the north. It extends to 10 m in length by 5.2 m in overall width (33.5 feet by 17) and rises to 3.3 m (11 feet) at its eaves. The building is shown on the New Series Ordnance Survey of 1922 but not the Second Edition of 1897, and dates from the early 20th century. It originally contained a full-height central entrance and was lit by a large full-height window on both sides, together with small lights in the upper gables. These windows have since been reduced to more normal proportions. This unusual building now operates as a workshop, and may well have been designed as such given its exceptionally large windows of industrial scale. It may also have operated as a machine shed, but contains no relevant fixtures or fittings. It remains of some historic interest as an example of the increasingly mechanised nature of local agriculture during the early 20th century.

Fig 10 The workshop. Ground-plan showing the central southern entrance flanked by exceptionally tall windows on each side.

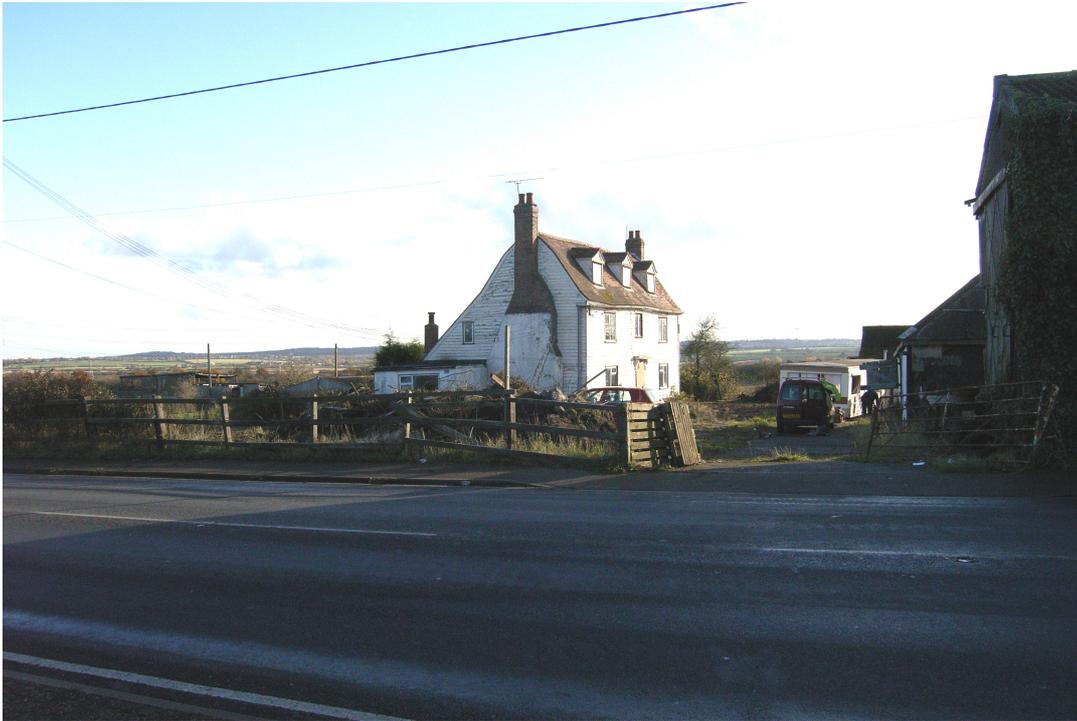
A2.1 General view of site from Woodham Road to north-west, showing farmhouse with 20th-century roadside barn (5) to right. Note commanding view of valley to south.

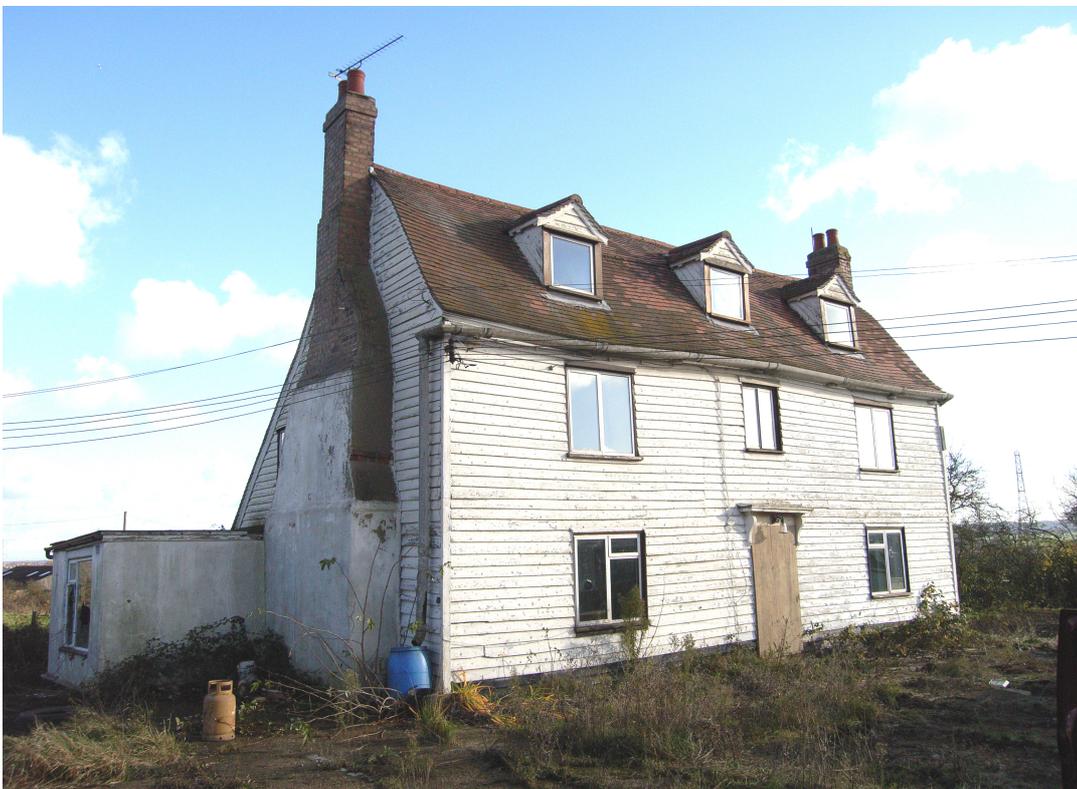
A2.2 Farmhouse. Exterior from north-west, showing central entrance with probable 18th-century section to left and 19th-century section to right.

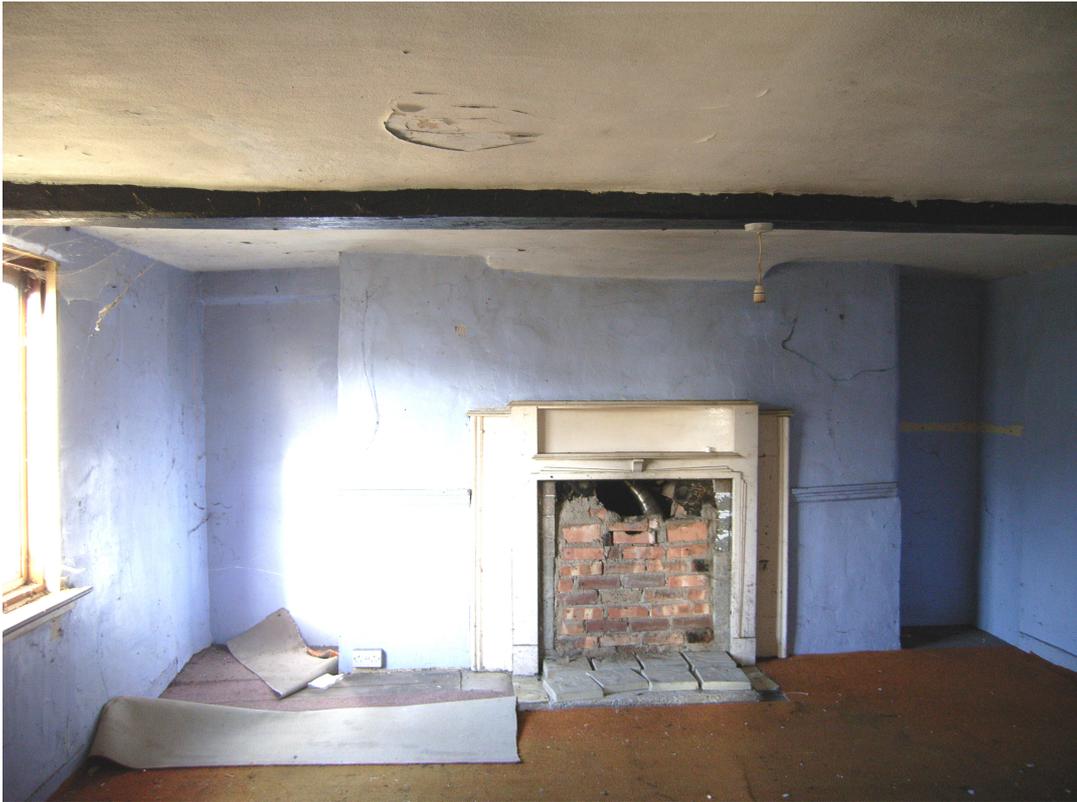
A2.3 Farmhouse. Internal northern gable, showing altered 18th-century fireplace on ground floor.

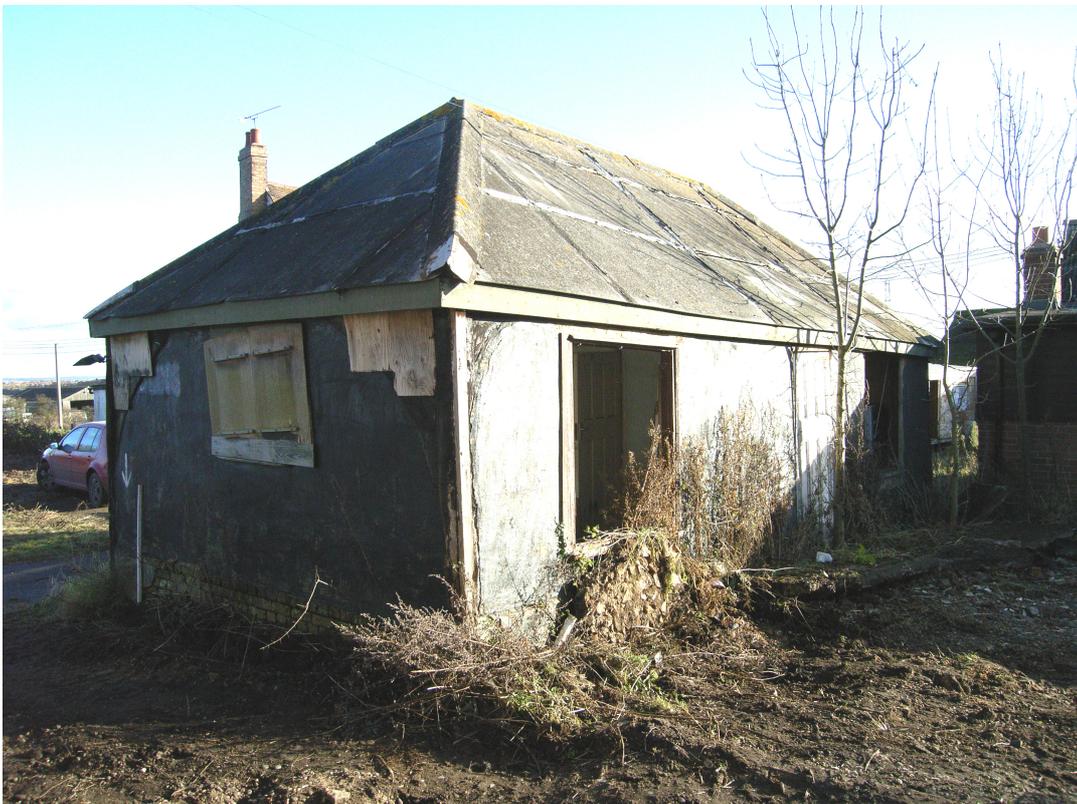
A2.4 Cart lodge. Exterior from north-west, showing massive brackets to western elevation and (left) to northern gable.

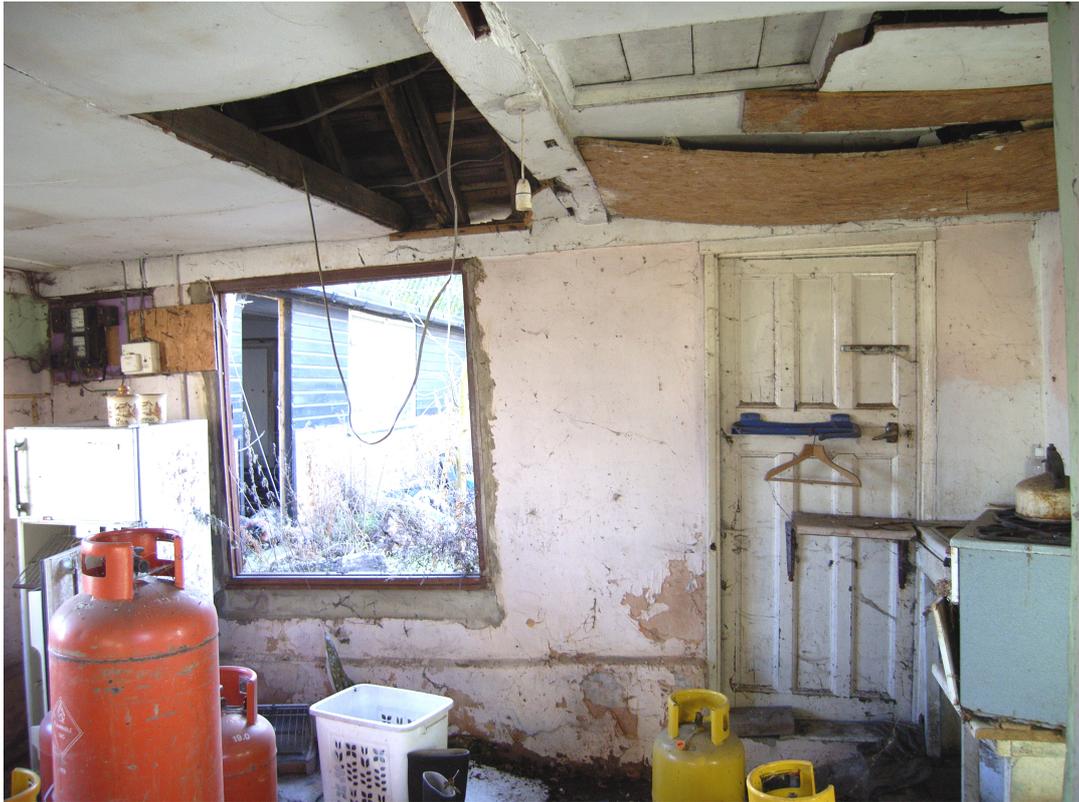
A2.5 Cart lodge. Interior of southern room, showing western elevation with empty partition mortises in tie-beam above.

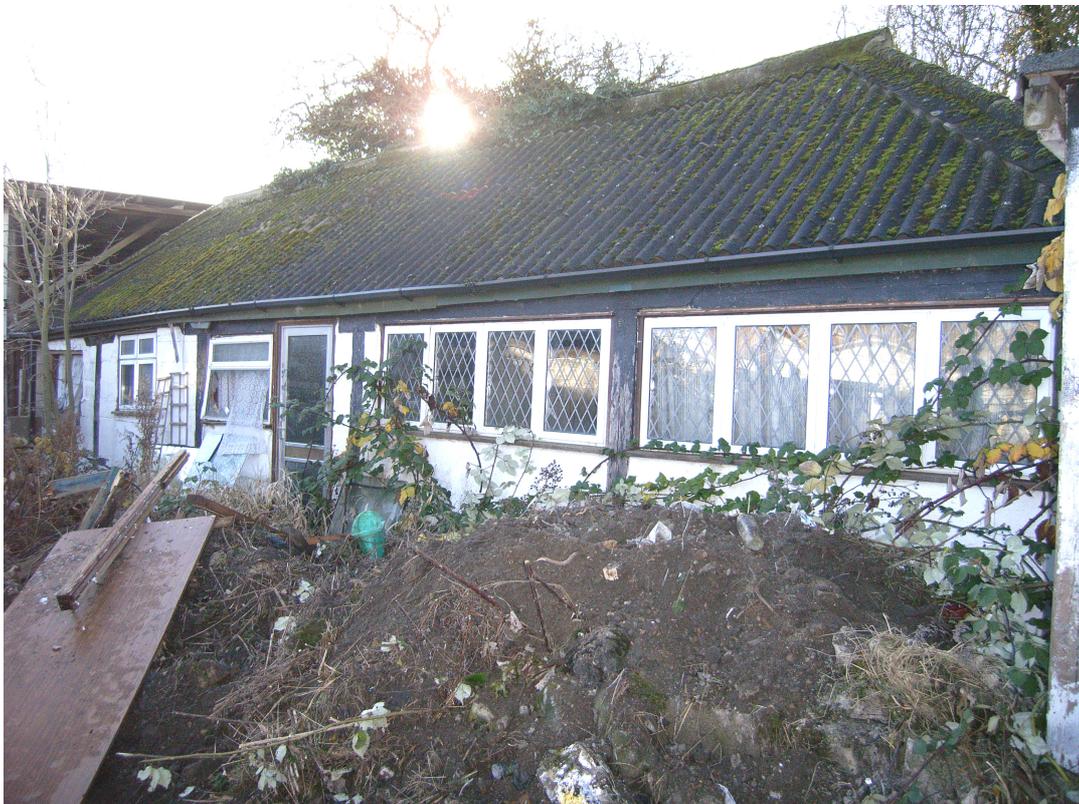
A2.6 Shelter shed. Exterior, showing former open arcade of eastern elevation.

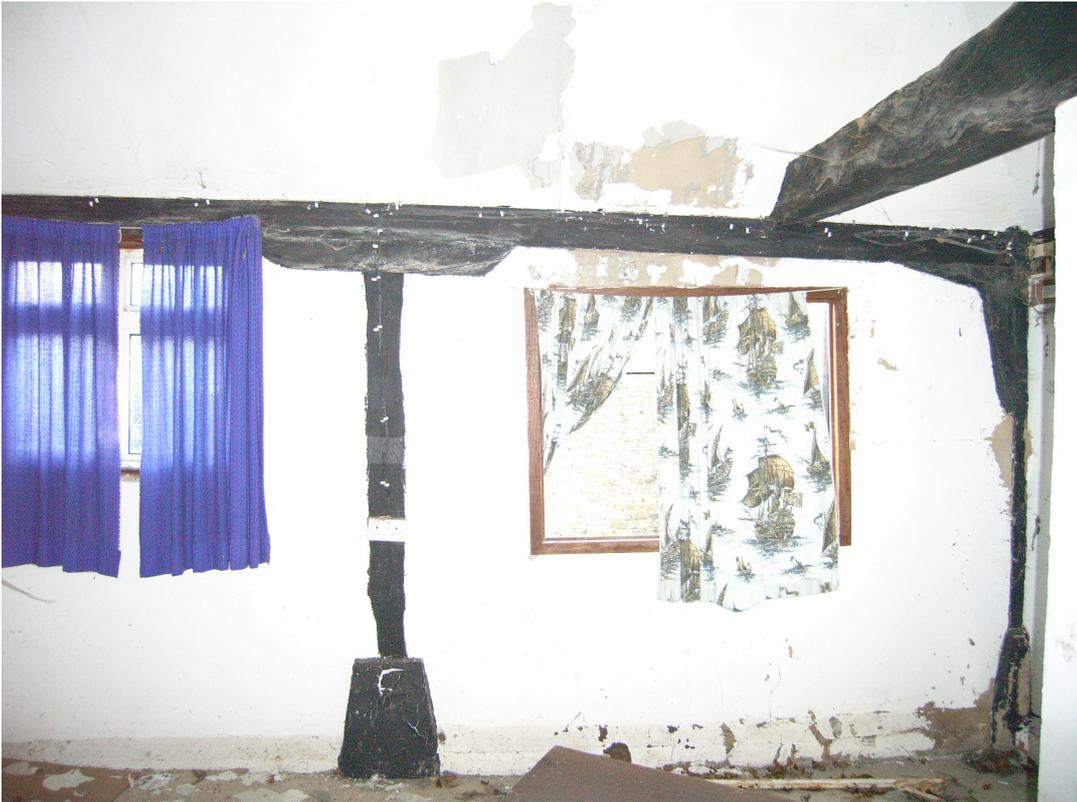
A2.7 Shelter shed. Interior, showing southernmost post of open arcade to left with southern gable to right.

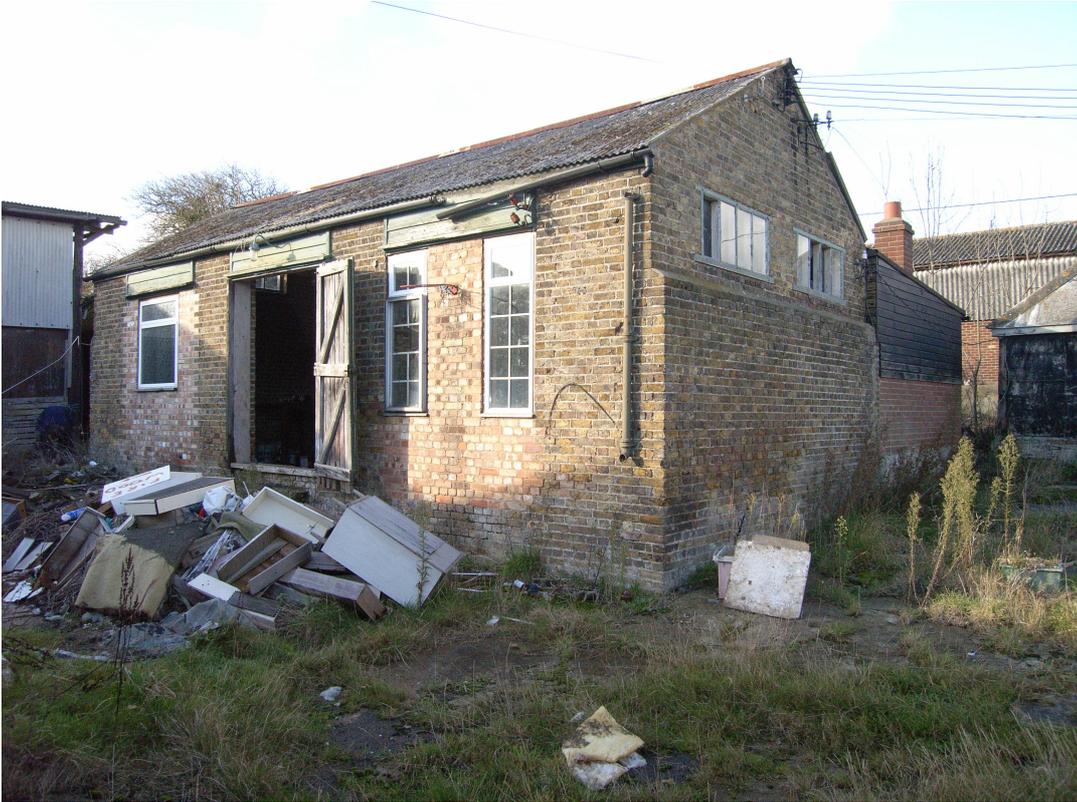
A2.8 Workshop. Exterior from south-east, showing blocked tall windows to right and left of central entrance.

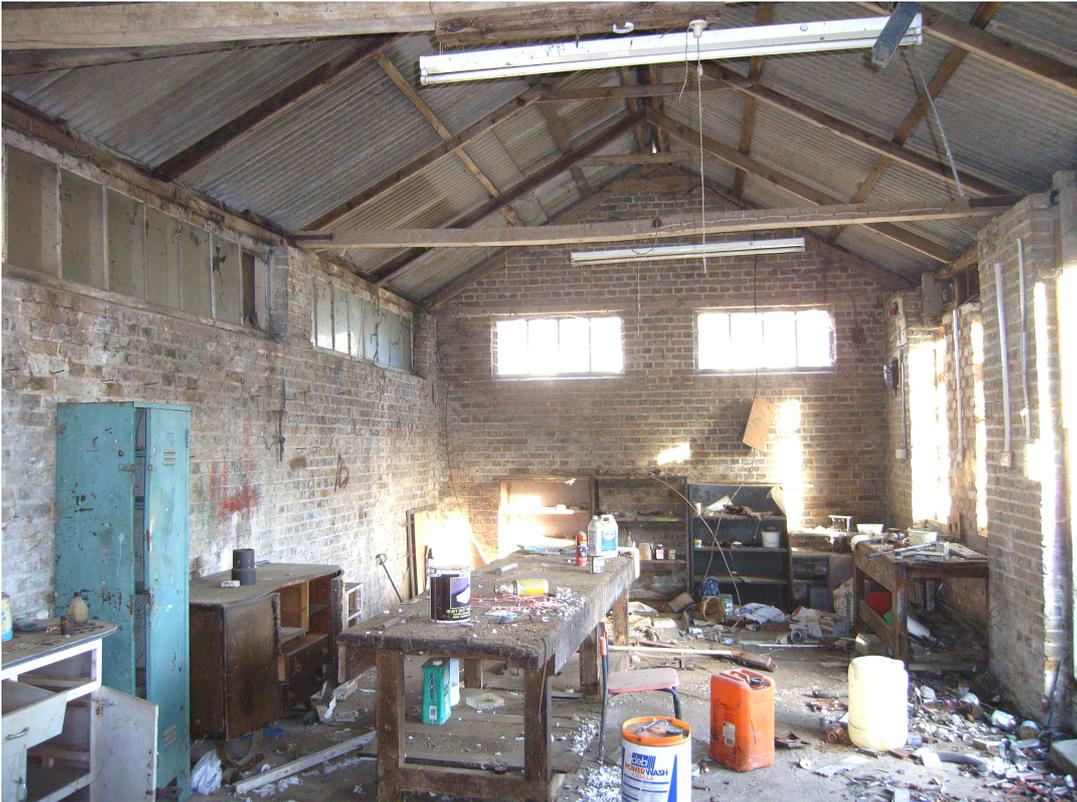
A2.9 Workshop. Interior from west, showing entrance to right.

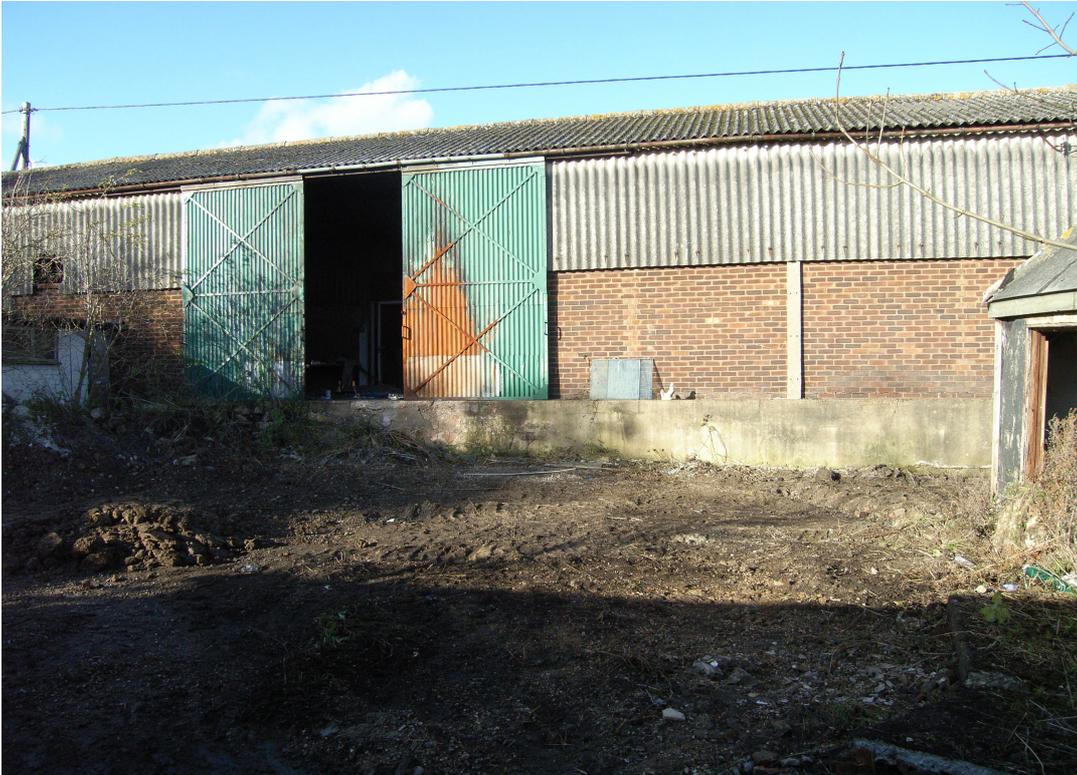
A2.10 Barn. Exterior from yard to south, showing corner of cart lodge to right.

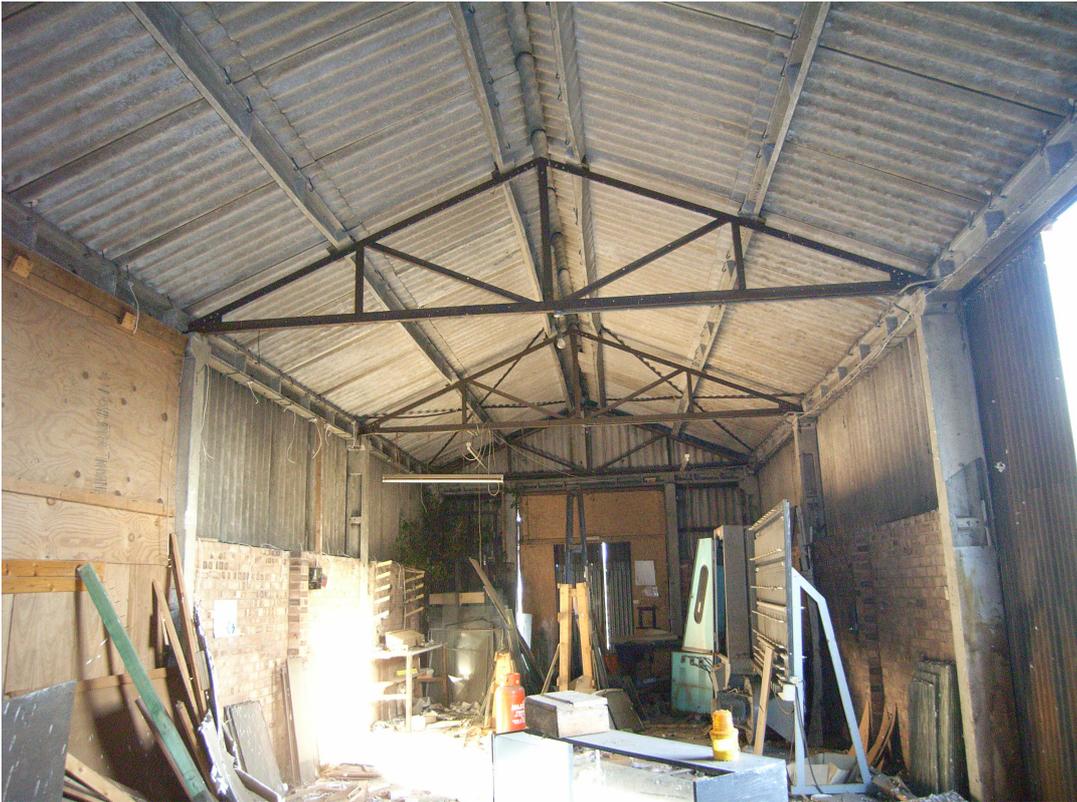
A2.11 Barn. Interior from west, showing mid 20th-century construction.

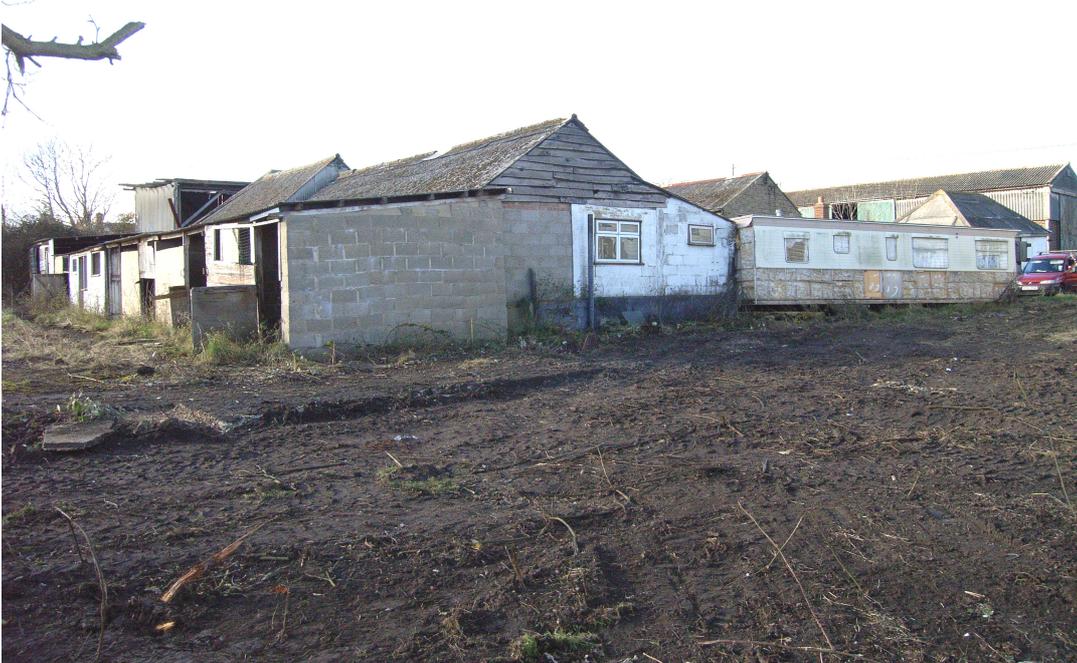
A2.12 20th-century complex of block-work animal sheds to south of site viewed from south-east, with barn to right.
