Historic building recording at Rectory Cottage, Rectory Road, Tolleshunt Knights, Essex

October 2013

CAT Report 734 October 2013

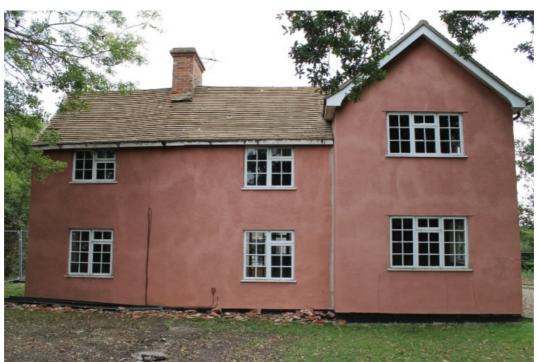
The original structure is rectangular in plan, aligned roughly north-south, measuring 7.5m x 3.65m, and comprises two storeys with a gabled roof of plain tiles (Plate 1). Much of the original structure has been obscured by the application of a modern render, painted pink, applied when the Phase 3 extension was built in 1979. Where the original structure is exposed, it can be seen that the building is timber-framed and has two bays. The frame is of hand-sawn oak with the corner posts having flared bases. No trace of a sill beam or plinth was observed due to the presence of a modern concrete floor, but if these elements exist they are below modern ground level.

Plate 1 Rectory Cottage, with the 1979 extension to the right - view east

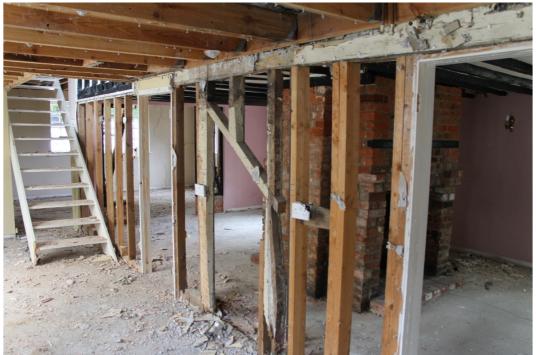
On the ground floor the frame is exposed only on the east wall (Plate 2). The corner posts and a central main post are original timbers and support the original girding beam, or girt, which is single-pegged to the posts (Plate 3). A straight brace falls from the main post and there are the remains of original studs above and below this (Plate 4). There is a chiselled carpenter's mark (II) on the main post at the joint with the south girt (Plate 3) and a scratched (II) where the brace passes through one of the studs (Plate 5). The remaining studs of the frame are modern replacements. The studs of the south wall have been removed entirely to provide access to the 1979 extension. The frame of the north and west walls is obscured by modern plasterboard, but a projection in the west wall suggests there are studs surviving behind. Modern timber casement windows have been inserted into these walls, although it is not possible to say if these are through original openings.

Plate 2 The exposed frame of the east wall, with the surviving girt, main post, studs and brace – view south-west

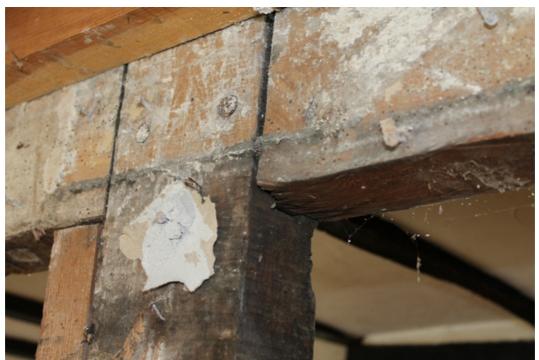
Plate 3 Girding beams single-pegged to main post, with carpenter's mark (II) at the top of the post – view south-west

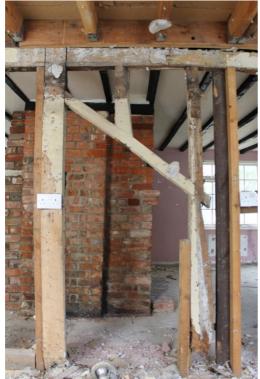
Plate 4 Surviving timbers of the east wall - view west

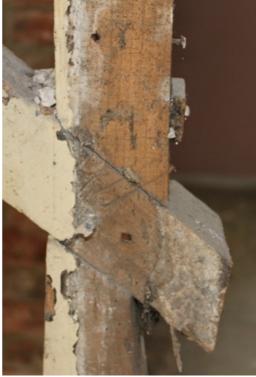
Plate 5 Carpenter's mark (II) on brace and stud – view west

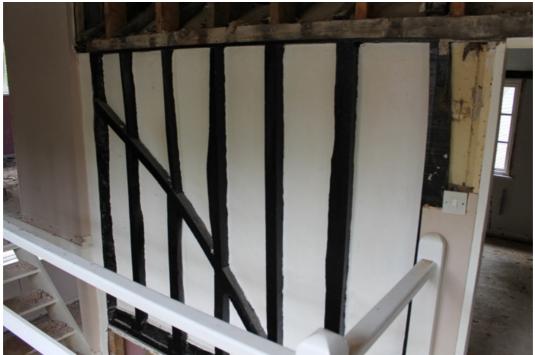
There is greater survival of original timbers in the frame of the first floor. In the east wall, nearly all of the original studs have survived (Plates 6, 7), exceptions being where studs have been removed to create doorways with the Phase 2 extension. Where this has occurred, empty mortices can be seen in the underside of the wall plate (Plate 8). The frame of the east wall of bedroom 3 has a lightly curved brace falling from the corner post and passing through the studs, terminating at the base of the fifth stud from the corner post. The lower end of a second brace survives, rising from the sixth stud to the central main post, although this has been truncated by the inserted doorway to bedroom 3. The studs are nailed to these braces. At the north end of the east wall, there is a straight brace rising from the corner post and terminating at the head of the fifth stud from the corner post. Removal of modern plasterboard in bedroom 3 shows that the frame of the north wall has been rebuilt below the wall plate. However, above the wall plate the gable has an original collar beam with studs above and below. The exterior of the gable is clad in lath and plaster (Plate 9). Exposure of the roof space also shows the survival of the original rafters, carried on clasped purlins supported by collars. The bases of the rafters have firring pieces nailed to them to lessen the slope of the eaves (Plate 10). Bedroom 3 has a tie beam spanning the structure (Plate 11). This is not part of a truss; it does not sit above the main posts, nor does it have principal rafters rising from it. Instead it sits on the wall plate in a shallow notch, abutting one of the common rafters (Plate 10). This is a result of the insertion of a chimney stack in the centre of the structure. The tie beam has been moved from its original position, central to the structure, and relocated to the immediate north of the inserted stack. To provide support for the tie beam, re-used timbers (possibly from an original dividing wall) have been inserted between the floor and the underside of the beam. The west wall has few original timbers below the wall plate. One further point of interest is the presence of diagonal wind braces nailed to the underside of the common rafters.

Plate 6 Surviving timbers of the first floor frame - view south-west

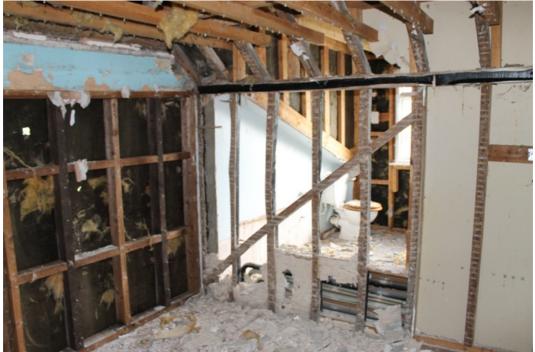
Plate 7 Surviving timbers of the first floor frame, with modern replacements to the left - view north-east

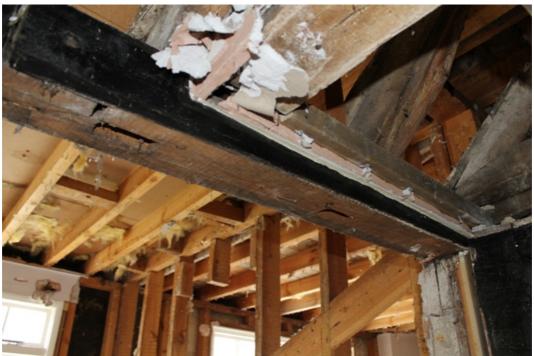
are exposed in the ceiling of the living room, although they have been planed smooth and chamfered. The wall plate of the east wall has a bridled scarf joint located above the entrance to bedroom 4 (Plate 8).

Plate 8 Mortices for removed studs in underside of wall plate with bladed scarf joint to the left – view south-east

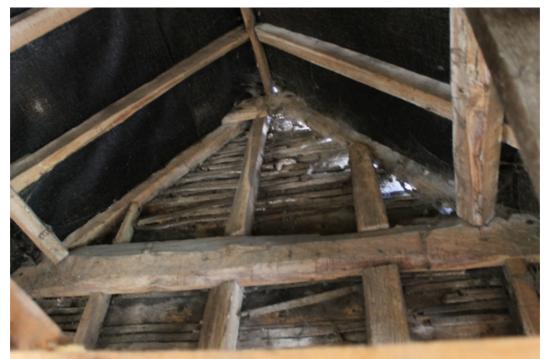
Plate 9 The interior of the north gable with original studs above and below a collar beam and the original purlins and rafters - view north

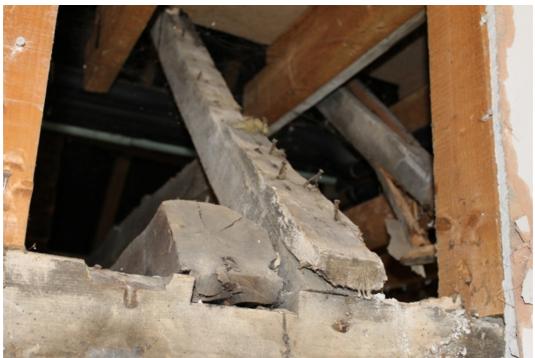
Plate 10 Original rafter with firring piece nailed to it and end of relocated tie beam – view north-west

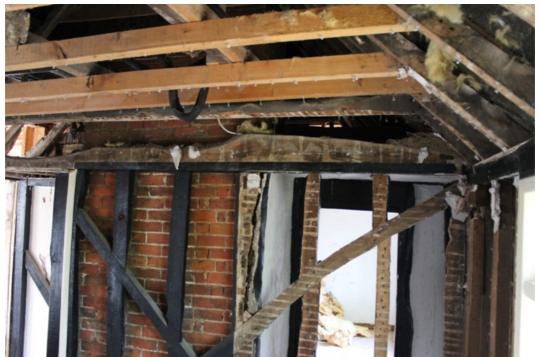
The flooring throughout the first floor of the Phase 1 structure dates to renovations carried out when the 1979 extensions were built but there is small area of flooring in the cupboard of bedroom 3 that is contemporary with the construction of the Phase 2 chimney stack. The construction of this chimney stack necessitated the relocation of the original tie beam.

Plate 11 The relocated tie beam in bedroom 4 - view south

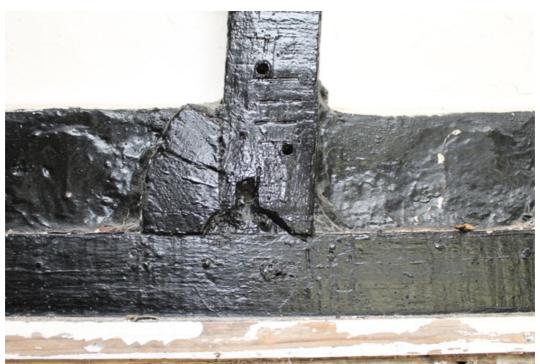
Carpenters' marks are visible on the exterior of the east wall frame to bedroom 3. The bases of five of the studs each have a chiselled mark (I-V) ascending from south to north (Plate 12). There is also a scratched (III) across one of the junctions of the brace and studs. The exposed end of a floor joist abuts the base of each stud (Plate 12). These joists

Plate 12 Example of a carpenter's mark (IIII) on the base of a stud in the east wall of the first floor frame, with the butt end of a floor joist carried on the girt - view west

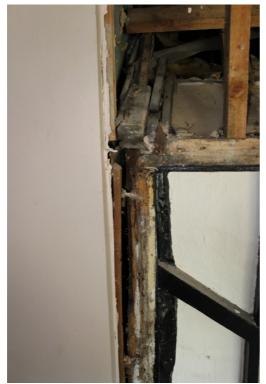
The south gable is preserved where the Phase 3 extension abuts the original structure (Plate 13). This shows that the exterior of the south gable was weatherboarded, although it was not possible to say if this was the original cladding or a later addition.

Plate 13 The south gable with 1979 extension to the left – view west

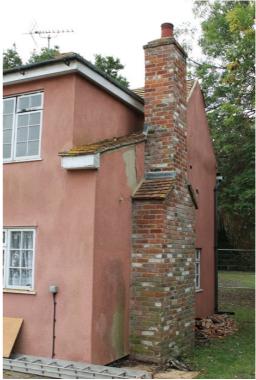
At some point in the 20th century, but prior to 1979, a brick-built single-storey extension was added to the east side of the original structure (Plate 14) and a chimney stack inserted through the centre of the cottage. The extension provided a kitchen to the cottage and included an external chimney stack on the north wall. This extension may have replaced an earlier/original kitchen area as there is no apparent hearth location in the Phase 1 structure.

Plate 14 Phase 2 single-storey extension with the Phase 3 second storey extension above – view southwest

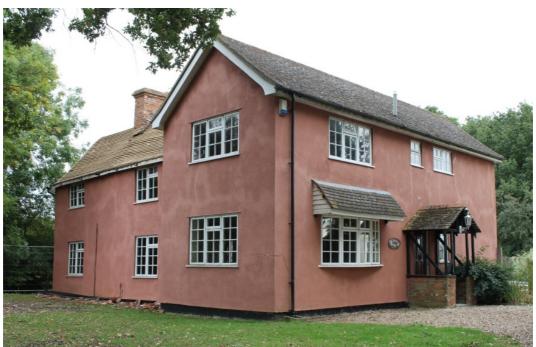
In 1979 a block-built, two-storey extension aligned east-west was built onto the south ends of Phases 1 and 2, along with a timber-framed second floor above the Phase 2 extension (Plates 15, 16). On the ground floor, the extension removed the frame of the south wall of the original Rectory Cottage whilst, on the first floor, the frame and gable were completely obscured. Doorways from the extension above the kitchen cut through the framing of the original cottage's east wall.

Plate 15 Phase 3 extension with the original structure to the rear - view north-east

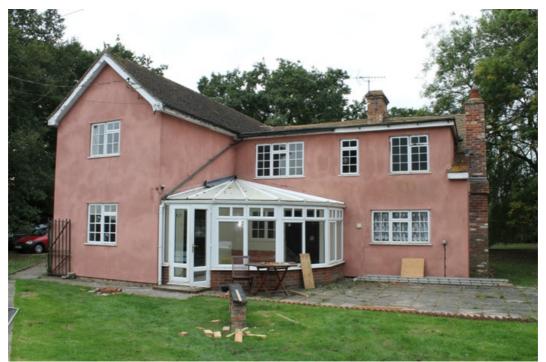
Plate 16 The Phase 3 extensions to the left of and above the Phase 2 extension, with the original structure in the background – view west
