Historic building recording at Cannock Mill, Old Heath Road, Colchester, Essex, CO2 8AA

February 2016

CAT Report 945 May 2016 revised November 2017

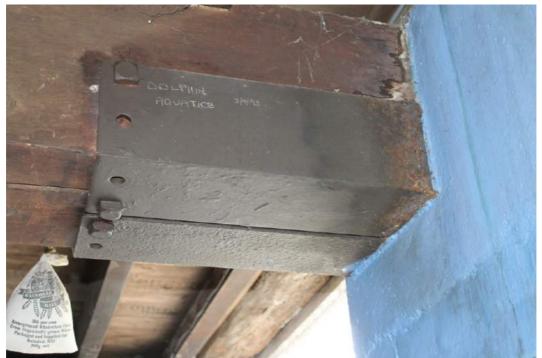
Photograph 5 Chalked date on iron brace at south-west end of bridging beam which suggests a date for the renovation of the mill.

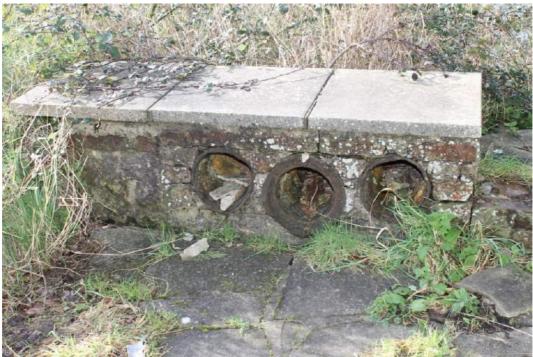
Photograph 6 Detail of iron pipes funnelling water from the mill pond to the overshot wheel - view south-west.

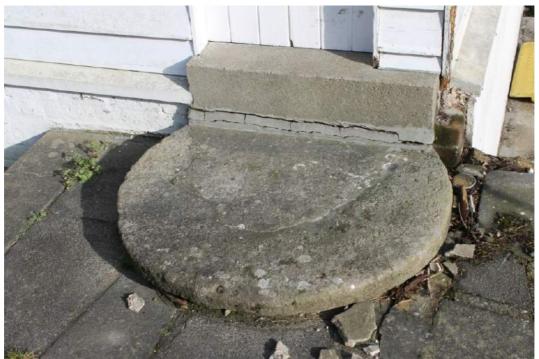
Photograph 7 Mill stone re-used as door step for inserted entrance in first floor of southwest elevation – view north-east.

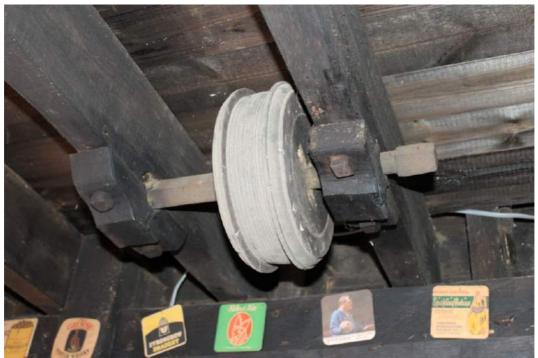
Photograph 9 Original fly wheel from milling apparatus, relocated to underside of the replacement floor joists in the first floor.

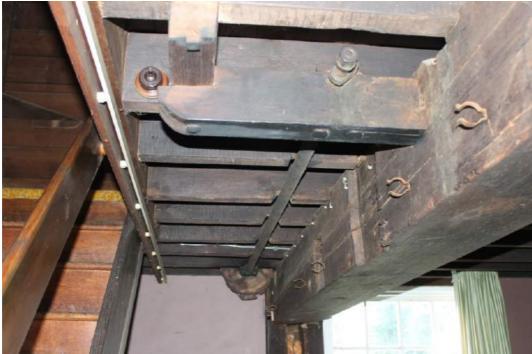
Photograph 11 Original fly wheel and drive shaft, possibly in original location but more likely positioned after 20th-century renovations - view south-west.

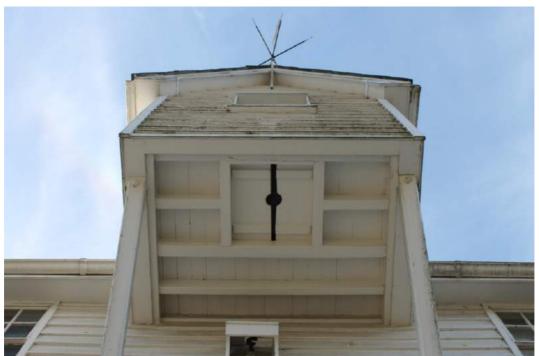
The lucam is the most intact original feature of the entire structure. It retains its original casement window and also the trap doors for hoisting grain sacks through. On one of the posts the words "Rebuilt 1848" have been carved, which rather casts doubt on the historical assertion that the mill was rebuilt in 1845, but may just indicate that the lucam was replaced in this year (Photograph 19). The lucam also contains the surviving hoist mechanism (Photograph 20). Written in ink on the side of this are the words "Charles Witham Re____June 8th 1850", although it is unclear if this is just Victorian graffiti or the name of the hoist manufacturer.

Photograph 15 Underside of the lucam showing the trap doors for the sack hoist.

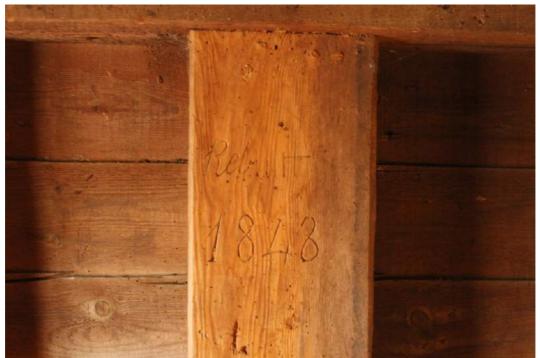
Photograph 19 "Rebuilt 1848" carved into a post of the lucam on the second floor.

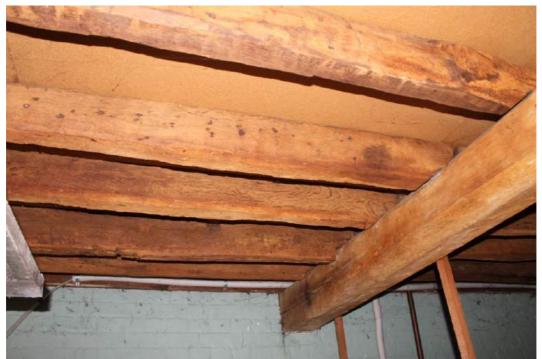
Photograph 21 Re-used timbers supporting the first floor of the 20th-century extension.

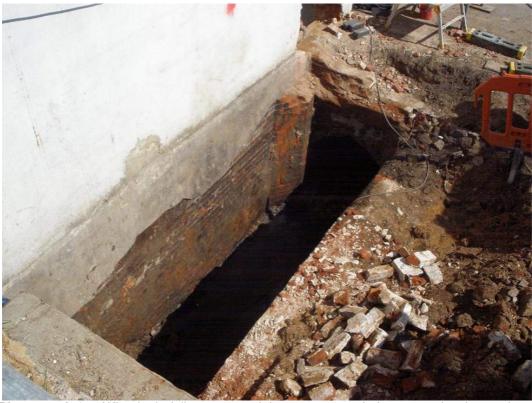
Photograph 27 Wheel pit fully excavated by contractor during groundworks – view north.

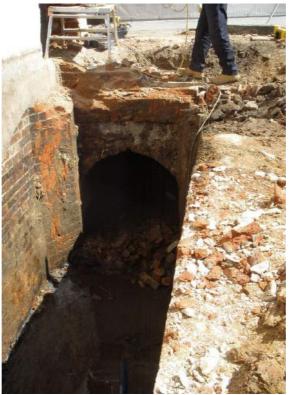
Photograph 28 Wheel pit fully excavated, with culvert taking water below Old Heath Road to Distillery Pond – view north-east.

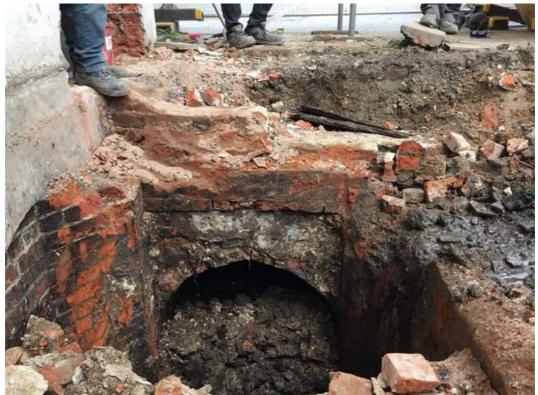
Photograph 29 Wheel pit exposed by contractor during groundworks, showing the culvert taking water below Old heath Road to Distillery Pond – view north-east.

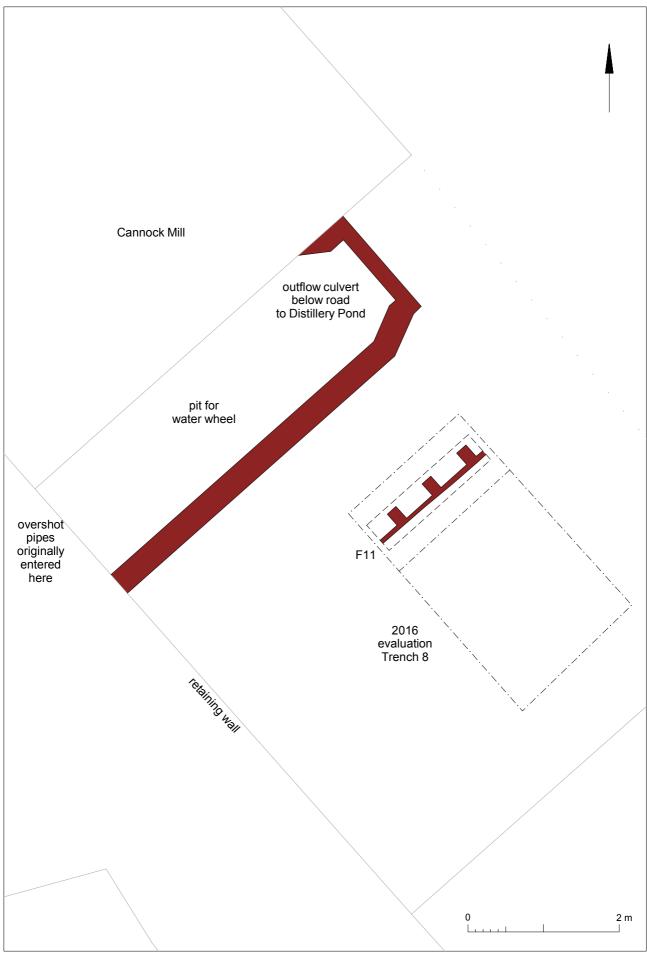
Fig 13 Pit for water wheel uncovered during groundworks in 2017.
