Archaeological evaluation and historic building recording at the garage site adjacent to Bentons Farm, Mollands Lane, South Ockenden, Essex, RM15 6DB

May 2016

CAT Report 953 May 2016

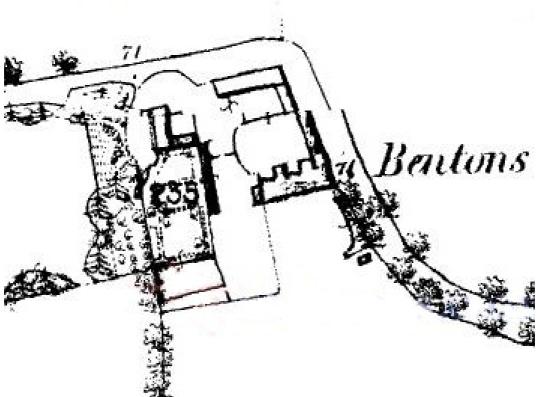
Map 1 1866 25 inch Ordnance Survey map showing building A with the projecting midstreys on its north side.

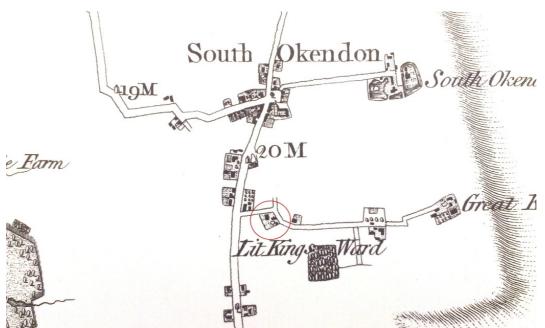
Map 2 Chapman and André survey of Essex from 1777 with Bentons farm circled. The precursor to building A is shown with a single midstrey on its north side.

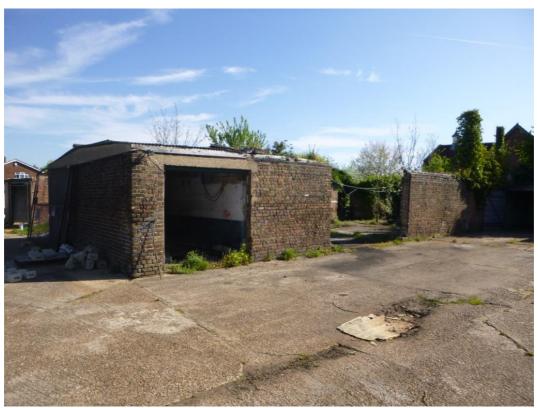
The remains of building A strongly indicate that it was constructed as a threshing barn. with two midstreys on the north side with cart door openings opposite these in the south wall (Photograph 8). Although the brickwork of the walls only stands to single-storey height a pair of surviving door posts in the east cart door opening shows that the structure was originally two storeys in height (Photograph 9). The full height of the building was probably reduced when the other farm yard buildings were demolished in the 1960s by the present owner's father, although it is claimed that the site was cleared completely at this time (Michael Reeves, pers comm). Although the upper part of the building has completely gone, enough of the fabric remains to support the theory that it was constructed as a threshing barn. The midstrey cart door openings have each been infilled with later blocking walls but there are original side doors in the outer walls of each midstrey (Photographs 10, 11) although the doorway in the west midstrey has also been infilled. An original large wrought iron cart door retainer survives attached to the wall in the west midstrey (Photograph 12). The interior of the building is floored with concrete, probably a later coating, but there are large square flagstones in line with the west midstrey that are likely to be the remains of the original threshing floor (Photograph

As well as being reduced in height the building has been subdivided by the insertion of a blockwork wall at the west end. This area has been roofed over and a garage doorshaped opening with a concrete lintel has been inserted into the south wall (Photograph 8). A smaller doorway has been inserted into the east wall of the west midstrey, providing access into a modern lean-to on the north side of the structure between the midstreys.

Photograph 8 Building A, west and south elevations with the inserted garage doorway to the left of the shot – view north-east.

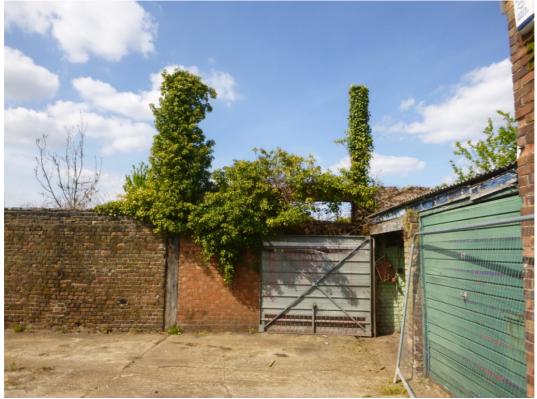
Photograph 9 Infilled cart door opening in south elevation with ivy-covered door posts indicating the original height of the building – view north.

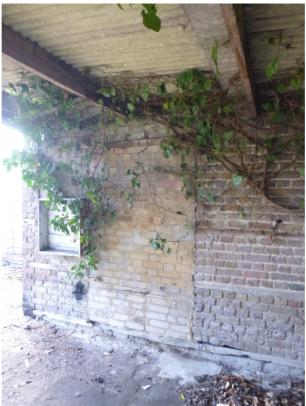
Photograph 11 Infilled original doorway in the west wall of the west midstrey – view south-west.

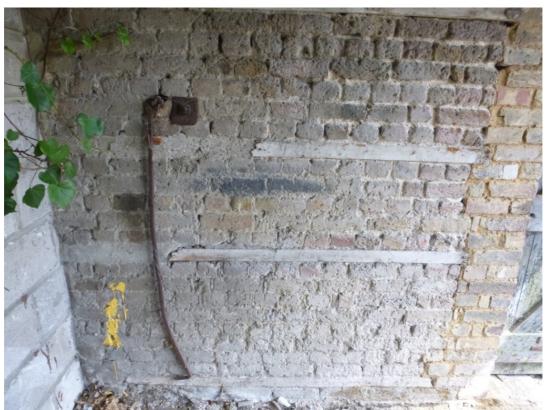
Photograph 12 Original wrought iron cart door retainer mounted on east wall of the west midstrey – view east.

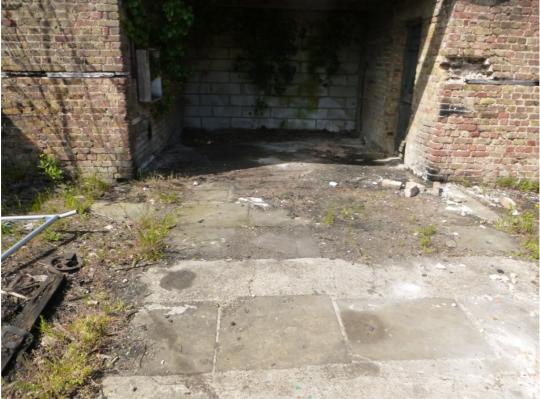
Photograph 13 Probable original flagstones of the threshing floor in front of the west midstrey – view north.

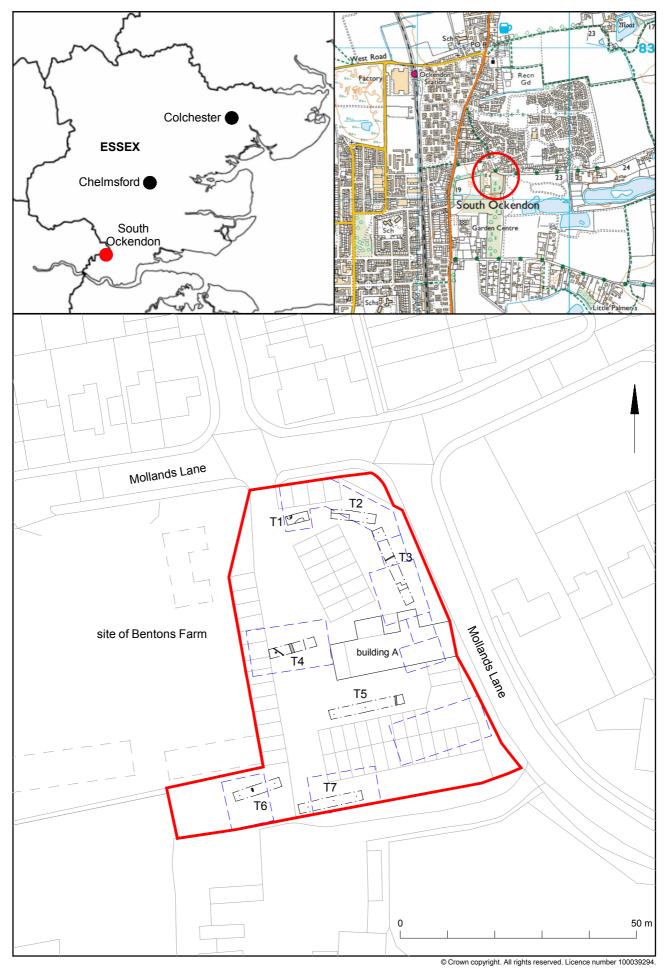
Fig 1 Site location. Proposed buildings are shown as dashed blue lines. Building A, the 19th-century barn, is shown as a black line.

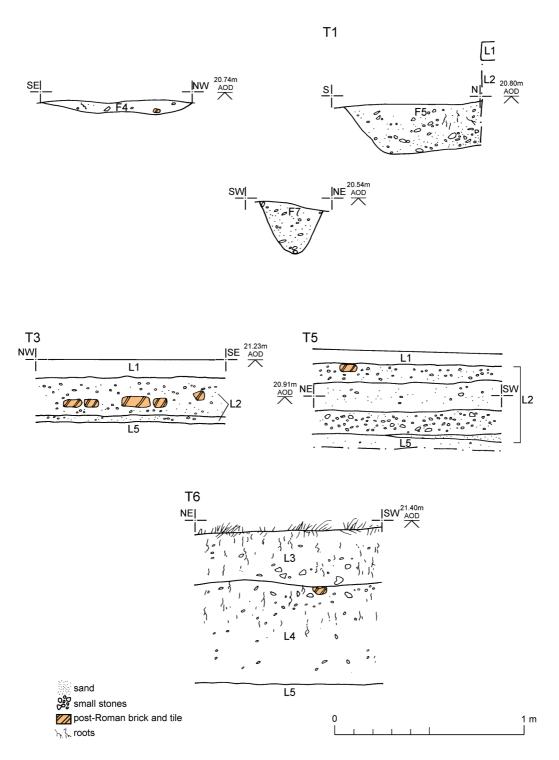
Fig 3 Feature sections (F4, F5 and F7) and representative trench sections (T3 and T5-6)
