**Historic building recording at
50 Silver Street, Buckden, St Neots,
Huntingdonshire, Cambridgeshire, PE19 5TS**

June 2016

**commissioned by
S. Pell Builders Ltd**

CAT Report 976
August 2016

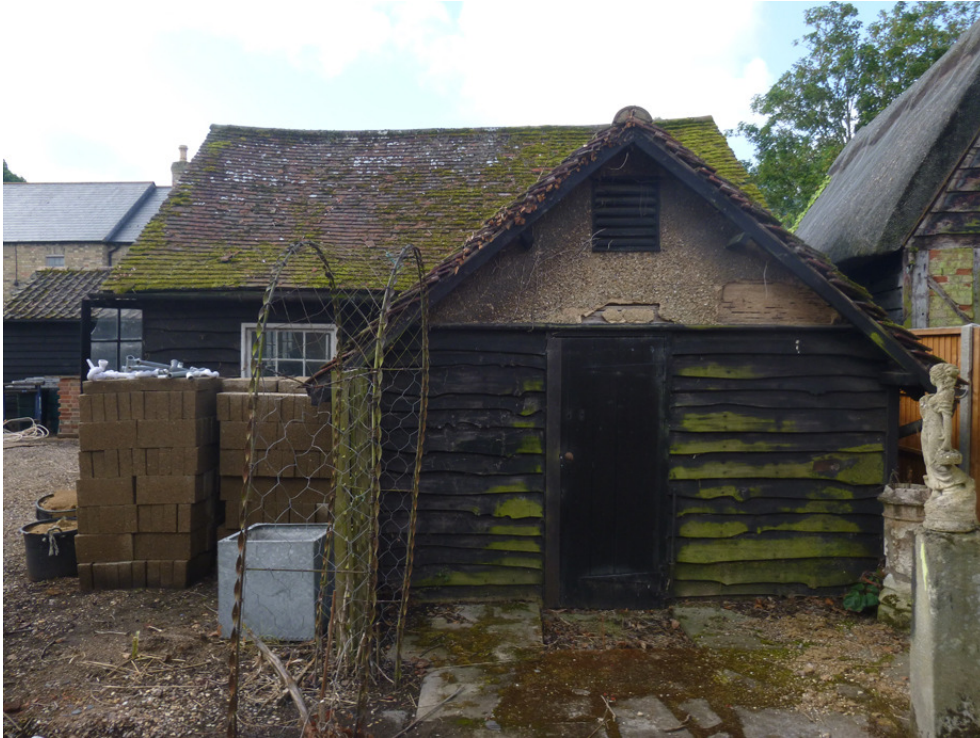
The northern elevation (Fig 2) has a vertical-planked door with three battens and attached with metal hinges below the north wing gable (Photograph 1). The gable itself is covered by pebble-dash render and contains a small wooden louvre. There is six-light fixed window in the wall of the main garage on this elevation.

Photograph 1 North elevation – shot taken facing south.

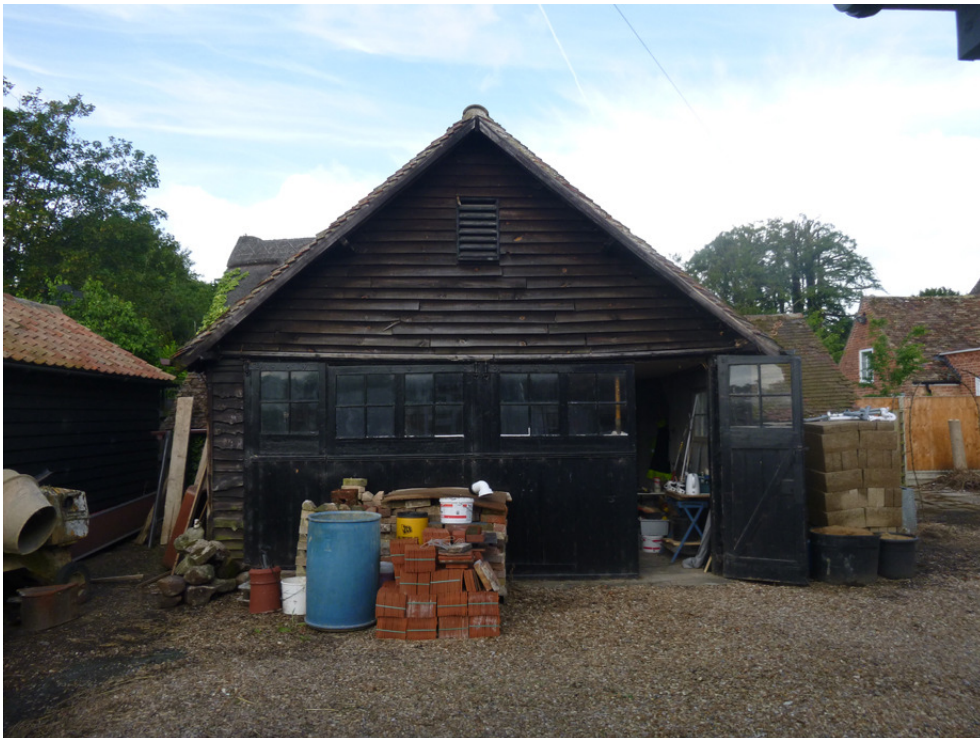
The eastern elevation (Fig 3) has four large half-glazed doors providing access, held in place by large metal hinges (Photograph 2). Two of these doors are double width. These four doors are positioned to create two sets of double doors. These are original to the building and suggest that it was a garage from the outset. The doors have four-lights or eight-lights in the upper panels, depending on width. Also on this elevation on the north wing is an eight-light sliding casement window, with hammered glass.

Photograph 2 East elevation – shot taken facing west.

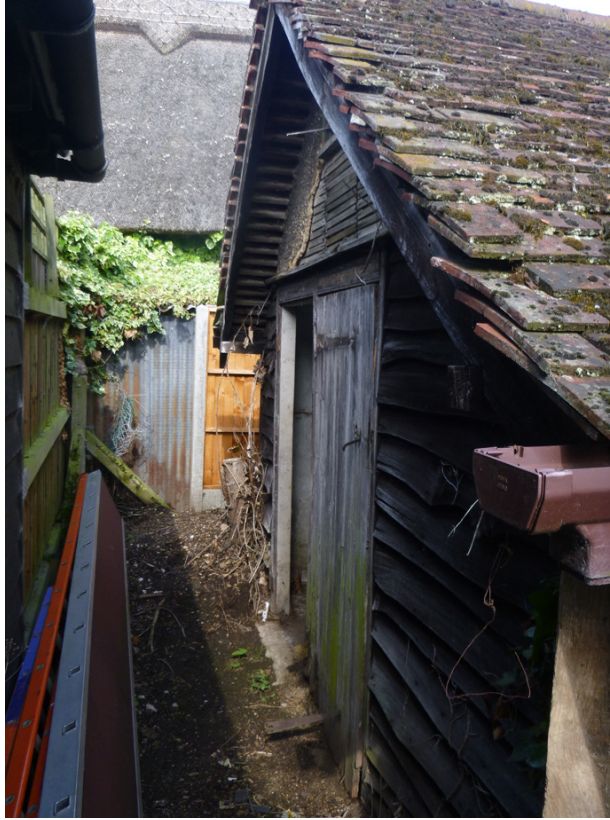
The southern elevation (Fig 4) has two entrances, both on the south wing (Photograph 3). One is into the building proper and has a vertical planked door, and the other has no door and leads into a separate room not accessible from the main structure. This separate room is totally devoid of features and, like the rest of the building, the interior is clad in asbestos panels (Photograph 6). The owner suggested that at some point it was in use as an outside privy (*pers comm*) – although, given the use of the building, it seems more likely to have been a petrol store. Also on the south elevation on the main building is a six-light fixed window, identical to the one on the north elevation (see above). As in the north wing, the south wing gable is covered by pebble-dash render and contains a wooden louvre.

Photograph 3 South elevation – shot taken facing west.

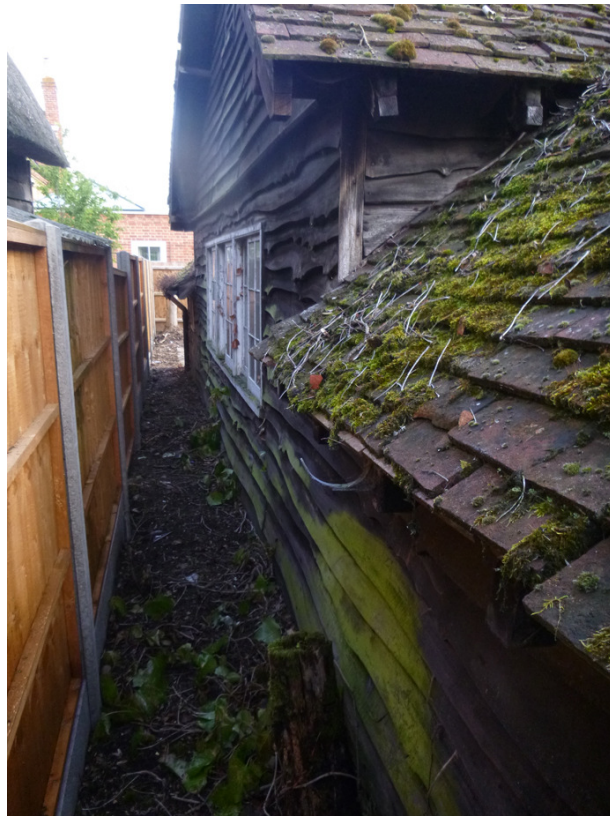
The western elevation (Fig 5) has three twelve-light sliding casement windows centrally positioned on main building (Photograph 4). Like every other elevation, there is a wooden

Photograph 4 West elevation – shot taken facing north.

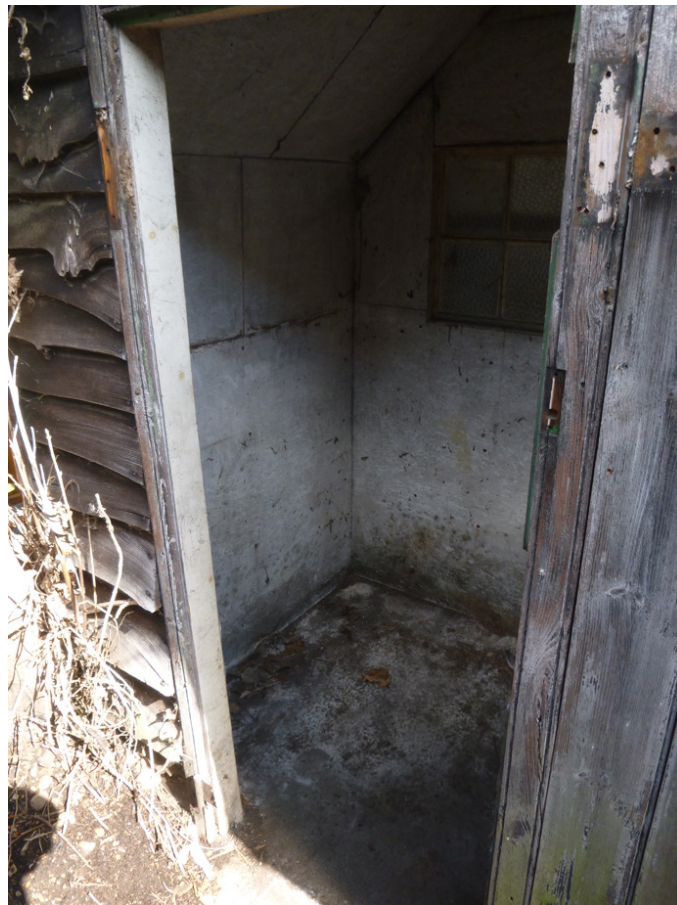
There is an interior four-light fixed window with hammered glass between the main building and the separate room in the south wing (Photograph 6).

Photograph 6 Interior of separate room in south wing – shot taken facing north-west.

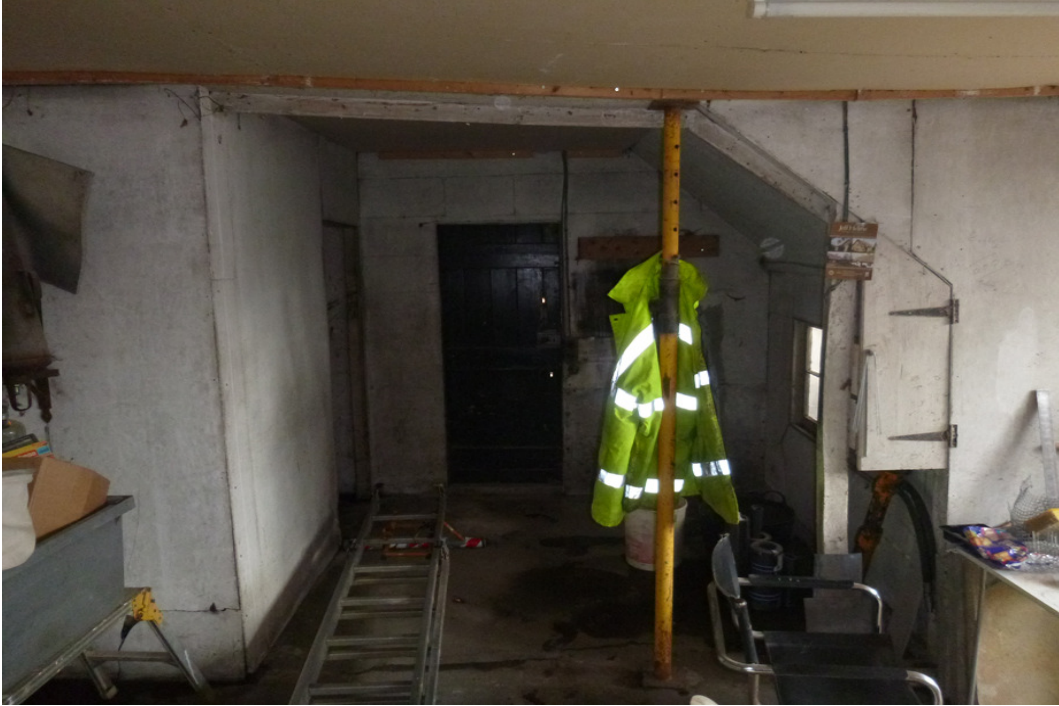
Photograph 9 Interior shot of north wing – shot taken facing north.

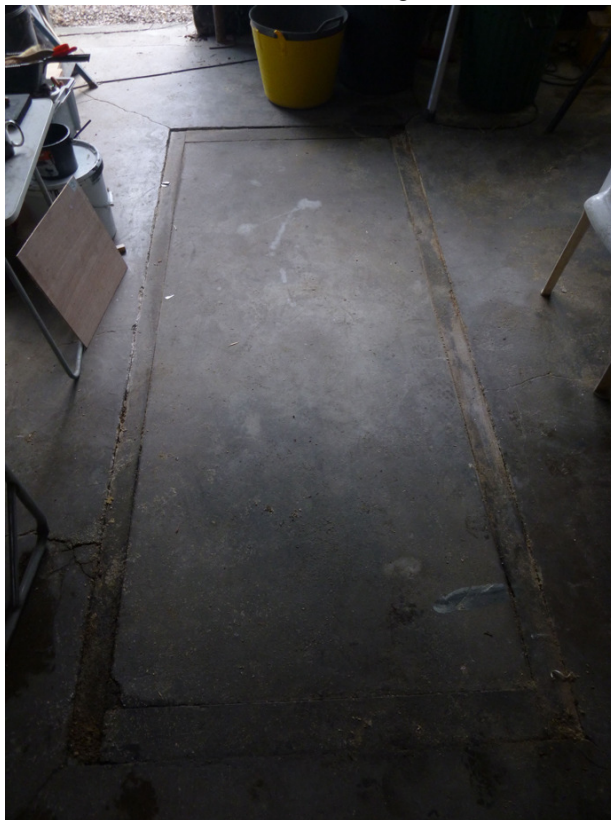
Photograph 12 Backfilled and concreted over inspection pit in main building – shot taken facing east.

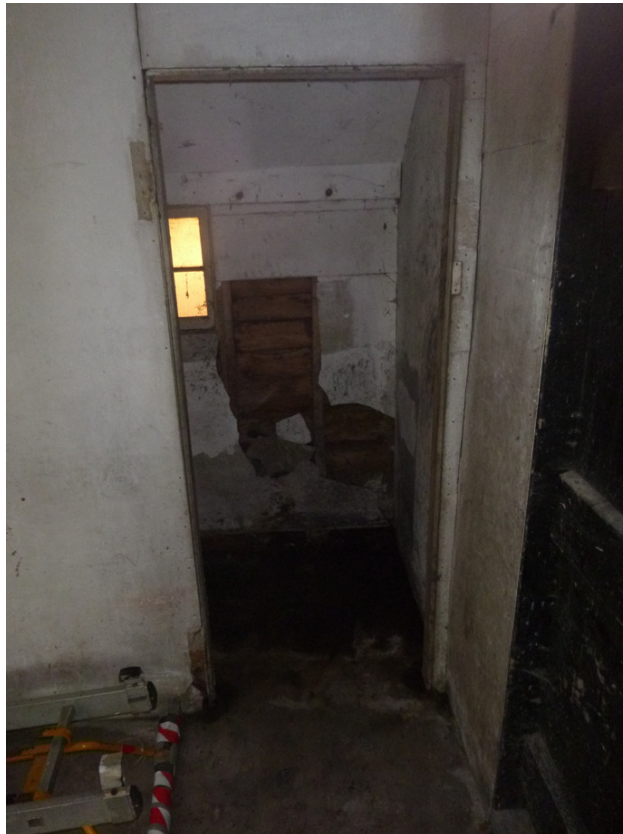
The interior of the building contains very little in the way of features. All the rooms are clad in asbestos panelling and, where this has become damaged or been removed, the machine-cut timbers are visible behind (Photograph 14). The building has been constructed on a single concrete pad and this forms the floor of each room. In the main building is a backfilled and concreted-over inspection pit (Photograph 12).

Photograph 14 Entrance into room in north wing, shot taken facing west
