Historic building recording and test-pit evaluation at Duncan's Gate, Colchester, CO1 1UN

July 2016

CAT Report 1022
November 2016

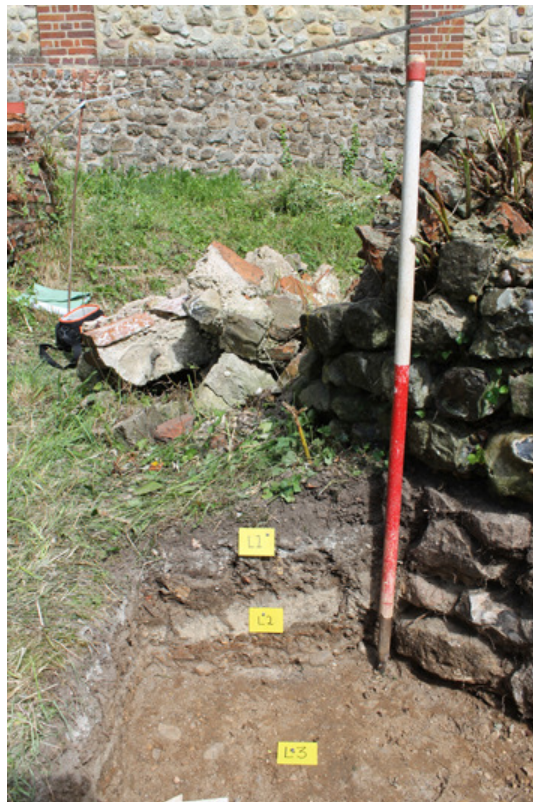
The layers described above butt up against the modern retaining wall to the north of the collapsed masonry (Photograph 5). Below these layers and at the base of the retaining wall is L3 (an orange/brown sandy silt), which has two features (described below) cut into it. The test-pit was stopped at this depth as it seemed that L3 was undisturbed subsoil.

Photograph 5 Section of test-pit, showing layers butting up against the retaining wall. Photograph taken facing west.

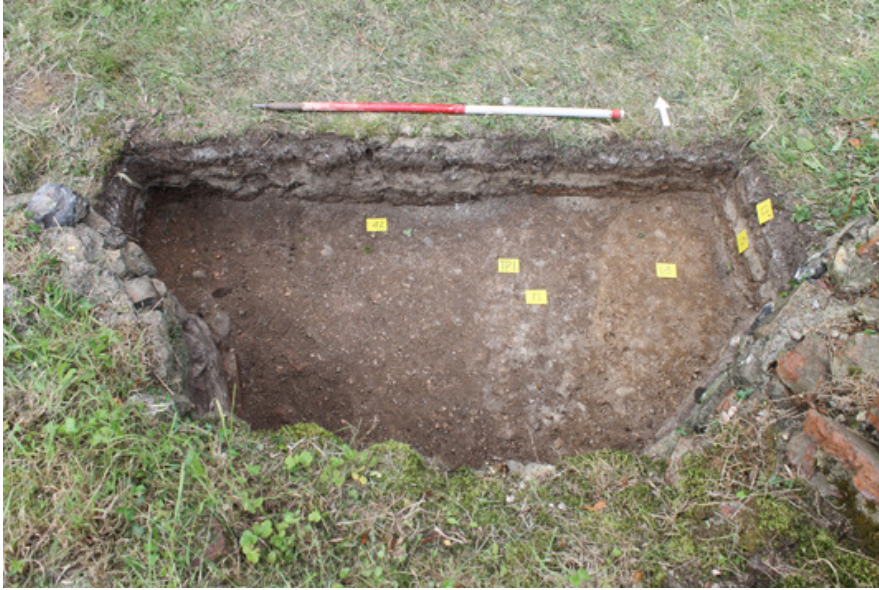
Two features were observed in the test-pit. F1 was the backfilled Roman drain that Duncan discovered in 1853 that services the town and is aligned through the gate to the north. It lined up exactly, both with the still visible grated-over drain to the south, and with the plans from Hull's excavation (Fig 3). The fill of F1 was a dark brown/grey sandy silt and was not excavated, although some Roman pottery and tile was recovered from its surface (see Finds below). Although we can be confident that this cut is for the original Roman drain, the fill of this feature is likely backfill from Duncan's or Hull's excavation.

Photograph 6 Overhead photo of test-pit. F1, F2 and L3 visible.

F2 was only observed at the very north end of the test-pit, and lies within the same cut as F1 (i.e. the Roman drain). The fill was very similar to that of F1, but was clearly darker. Again, this seems likely to be the backfill from one of the two previous archaeological excavations of this feature.

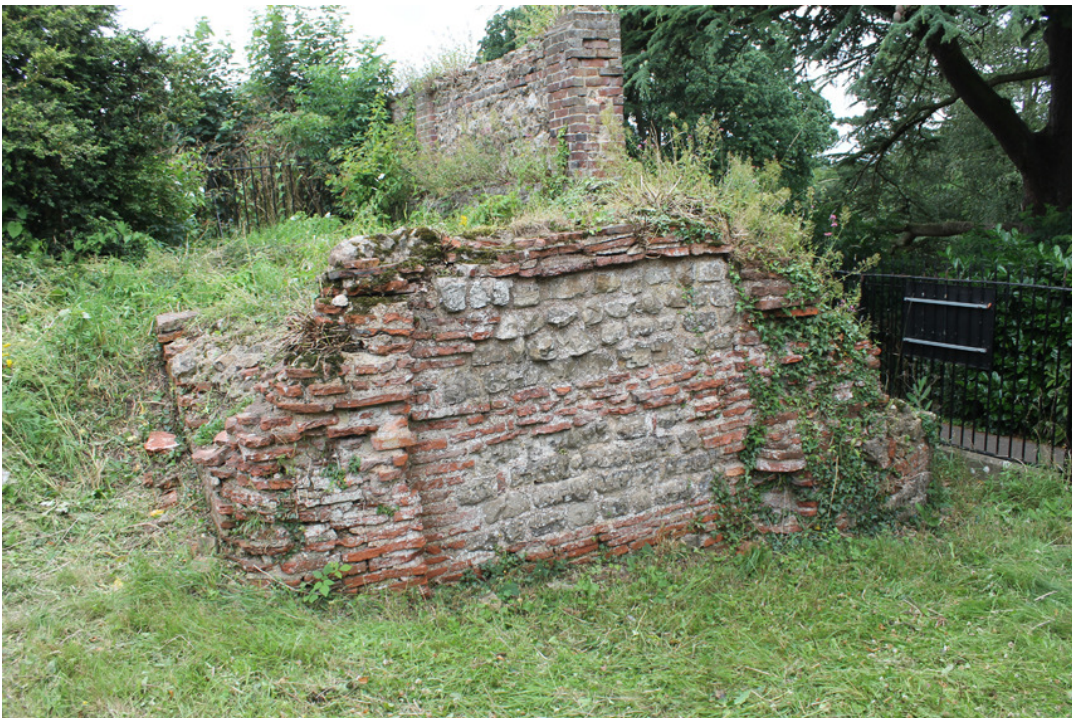
The two sides of the gate vary in preservation, with the western side being in better condition than the eastern – the western side stands 2.4m from the current ground level (Photograph 8), while the eastern side stands 1.7m (Photograph 9). As a result of this height discrepancy, the western side has more courses of brick and septaria remaining (Fig 4). As with the rest of the town wall, neither of the sides stand at their original height at the time of construction (the town wall is thought to have been at least 6m tall – Crummy 1997, 87).

Photograph 8 Western pier of Duncan's Gate Photograph taken facing north-west.

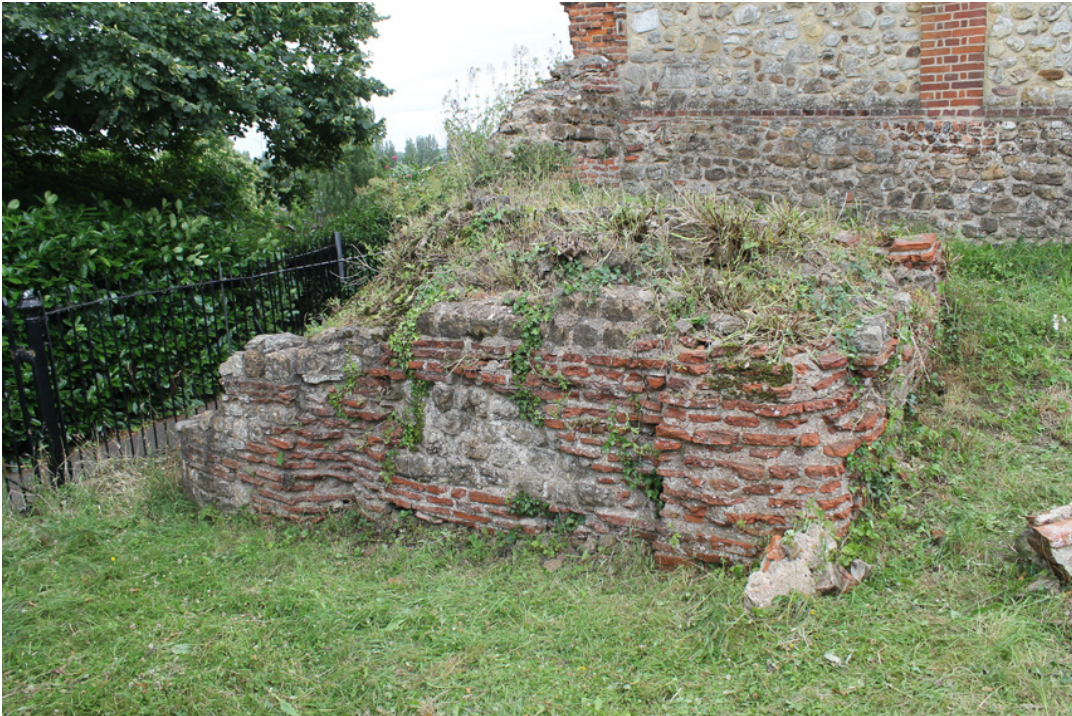
Photograph 9 Eastern pier of Duncan's Gate. Photograph taken facing north-east.

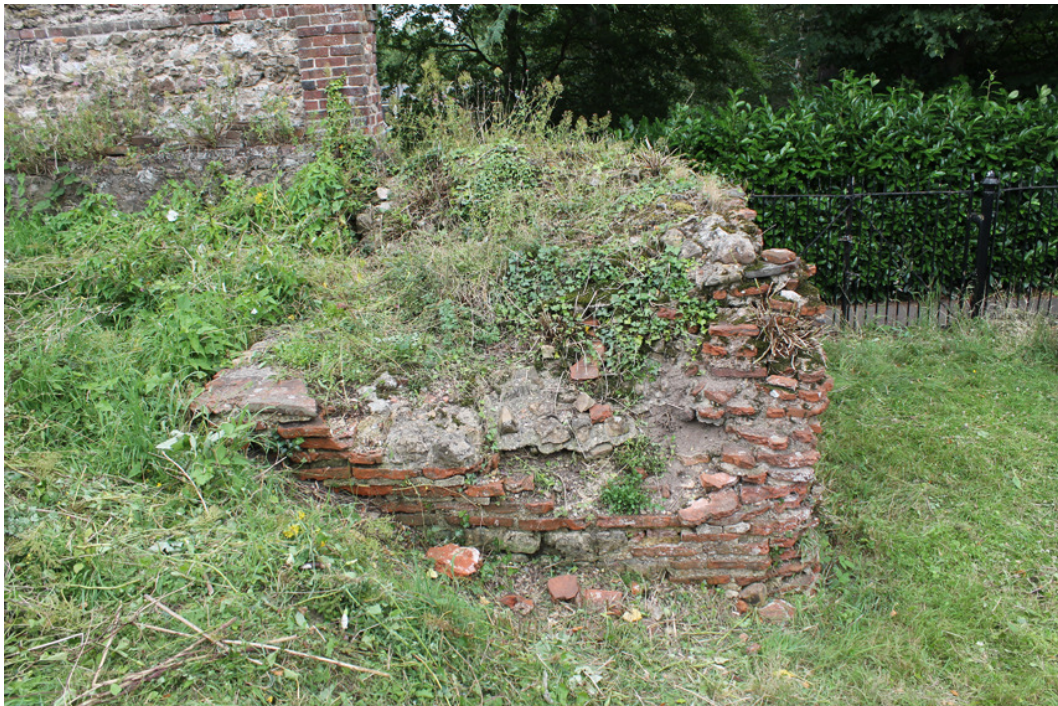
conservation was restricted to the south face of each side (where they are most damaged- Photographs 10 and 11), but part of the west facing elevation of the eastern side was also conserved (Fig 5).

The method of conservation consisted of some areas of the wall/masonry being re-bonded with concrete in an attempt to prevent further collapse. This concrete is very different in appearance from the original Roman lime mortar and so is quite jarring aesthetically (although in some areas the moss and overgrowth make it hard to distinguish between the two). Additionally the concrete itself seems to have decayed significantly since it was laid, in areas re-exposing the original Roman mortar.

Photograph 10 Southern face of western pier. Visible is the decayed concrete used to consolidate the wall in the 1920s. Photograph taken facing north.

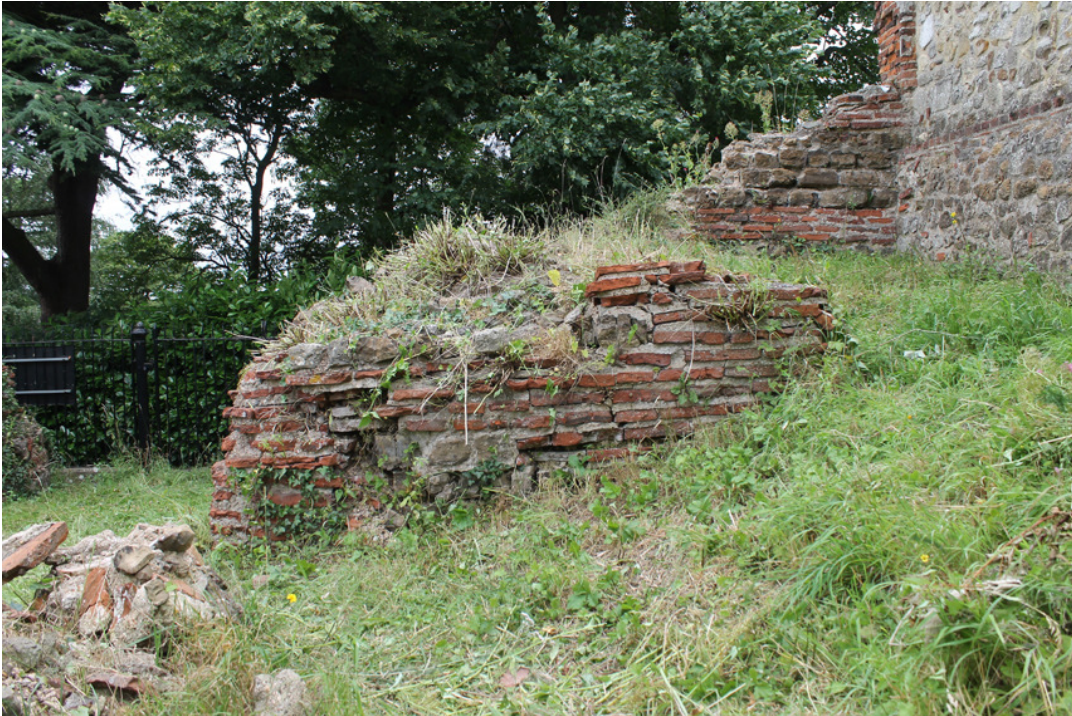
Photograph 11 Southern face of eastern pier. Visible is the decayed concrete used to consolidate the wall in the 1920s. Photograph taken facing north.

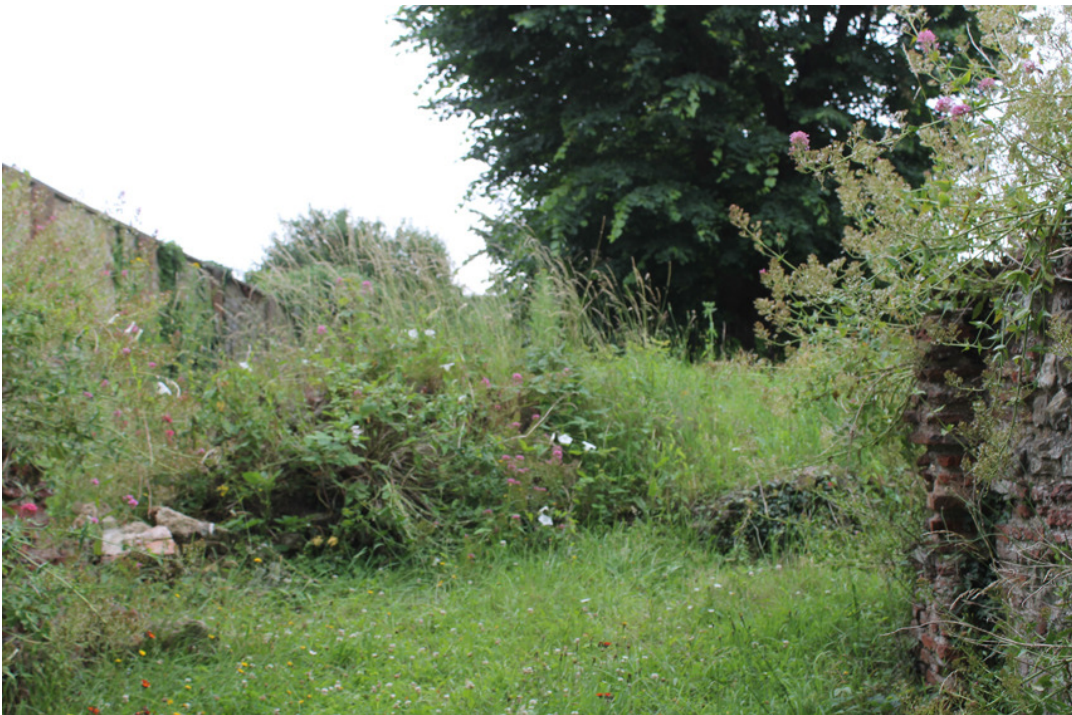
The collapsed masonry lies approximately 1m to the south of Duncan's Gate, and is heavily overgrown (Photograph 12). Even after removal of a substantial amount of overgrowth, the only section identifiable on the surface were the tile courses (with some occasional septaria fragments) defining the windows of the gate tower (Photographs 13, 14 and 19). The entire western half of the collapsed masonry is covered in grass, making any identification impossible. Although the limits of the collapse are difficult to define, the masonry appears to be about 10 square metres in area.

Photograph 12 Collapsed masonry prior to the removal of overgrowth. Photograph taken facing south.

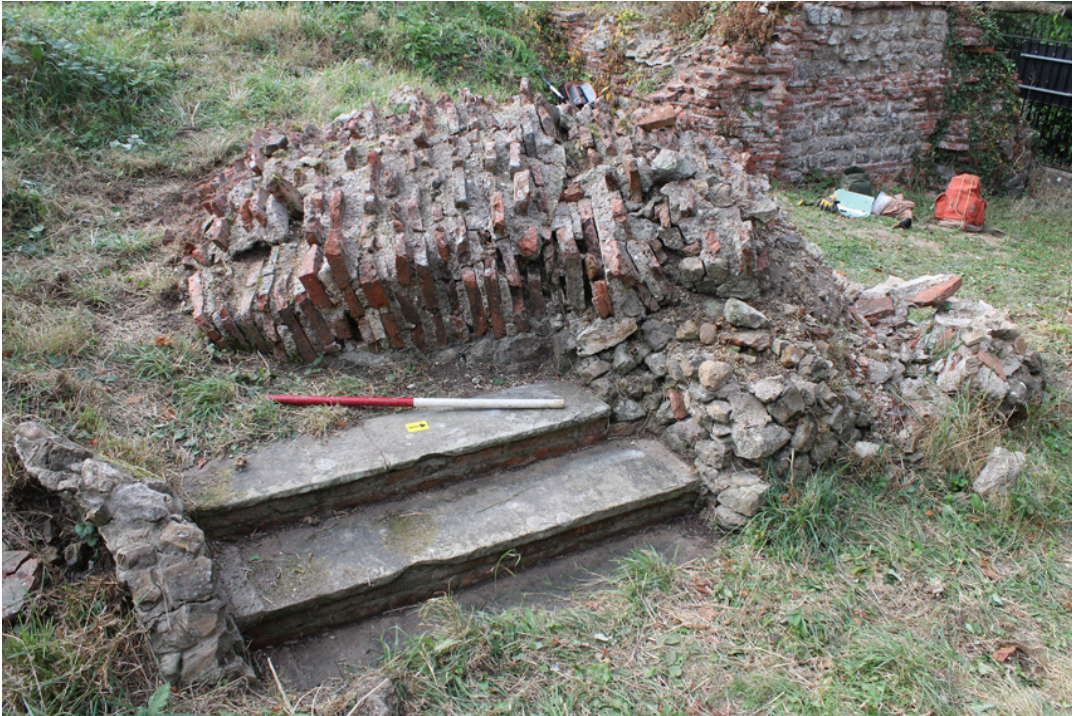
On the south-east side of the masonry, two concrete steps have been added leading up to the collapsed tile courses, probably in an attempt to convert the masonry into a garden feature in the early 20th-century (Photograph 15).

Photograph 15 Collapsed masonry, showing tile courses repaired with modern concrete. Also visible is the modern steps added to the collapse in the early 20th-century. Photograph taken facing north-west.

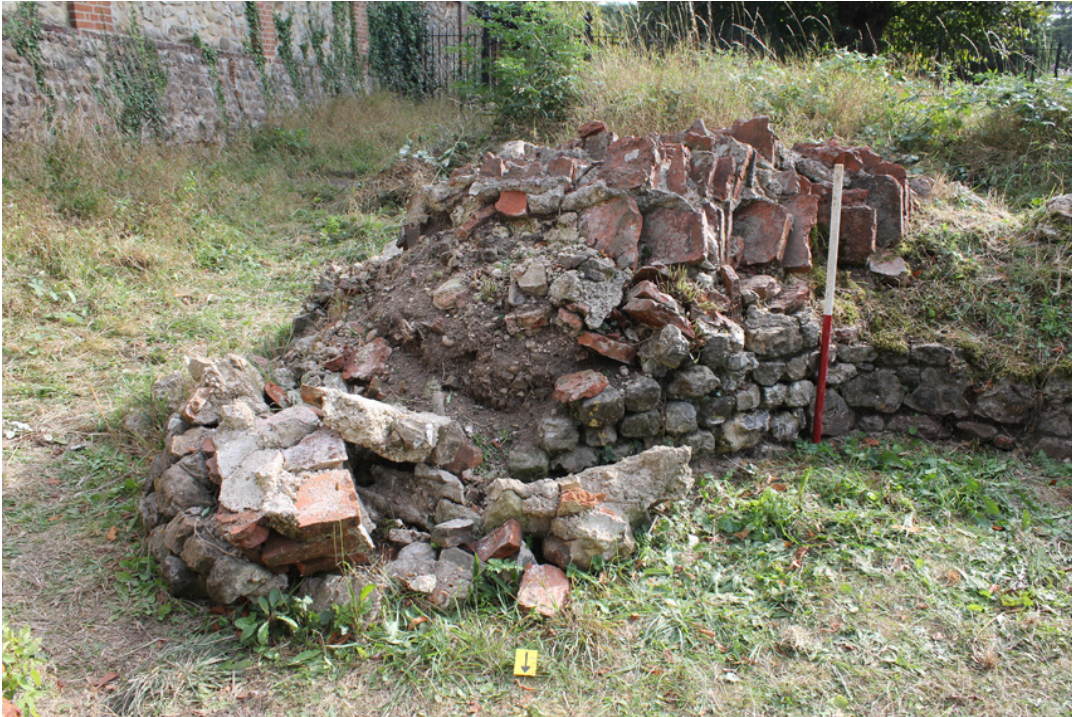
The north-east corner of the masonry has very recently suffered a significant collapse, with the modern concrete render, retaining wall and a course of tiles having fallen, exposing the original lime mortar beneath (Photograph 17).

Photograph 17 Recent collapse to east of masonry. Lime mortar exposed behind concrete render and retaining wall. Photograph taken facing south.

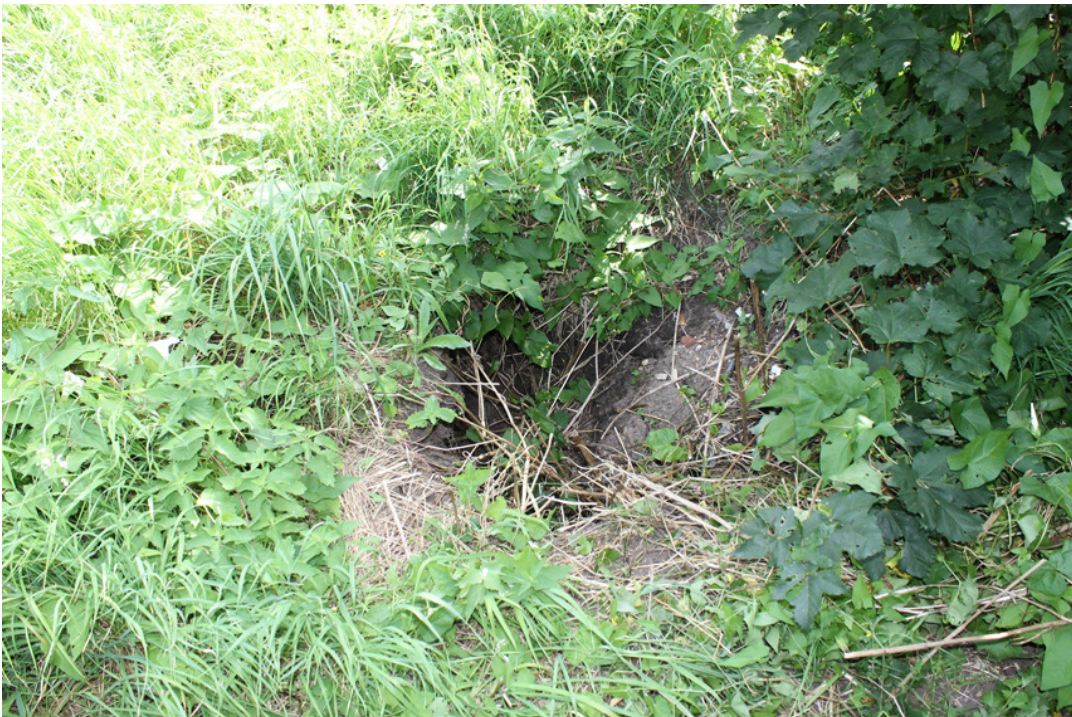
During the course of the work detailed in this report, a section of subsidence was observed to the west of the collapsed masonry (Fig 2). The ground in the area was extremely unstable and seemed to have subsided to a significant depth (Photograph 18). Upon observation down the hole Roman tile was visible. It seems possible that this collapse indicates a previously unknown section of the Roman drainage system – alternatively it may be the result of the Hull's 1920s excavations, as a north-east/south-west aligned trench running from Duncan's Gate is shown in his report (Fig 9). Either way it would be advisable for this area of collapse to be investigated and shored up to prevent further damage.

Photograph 18 Area of collapsed ground to south-west of Duncan's gate. Possibly evidence of a Roman drain run? Photograph taken facing south.

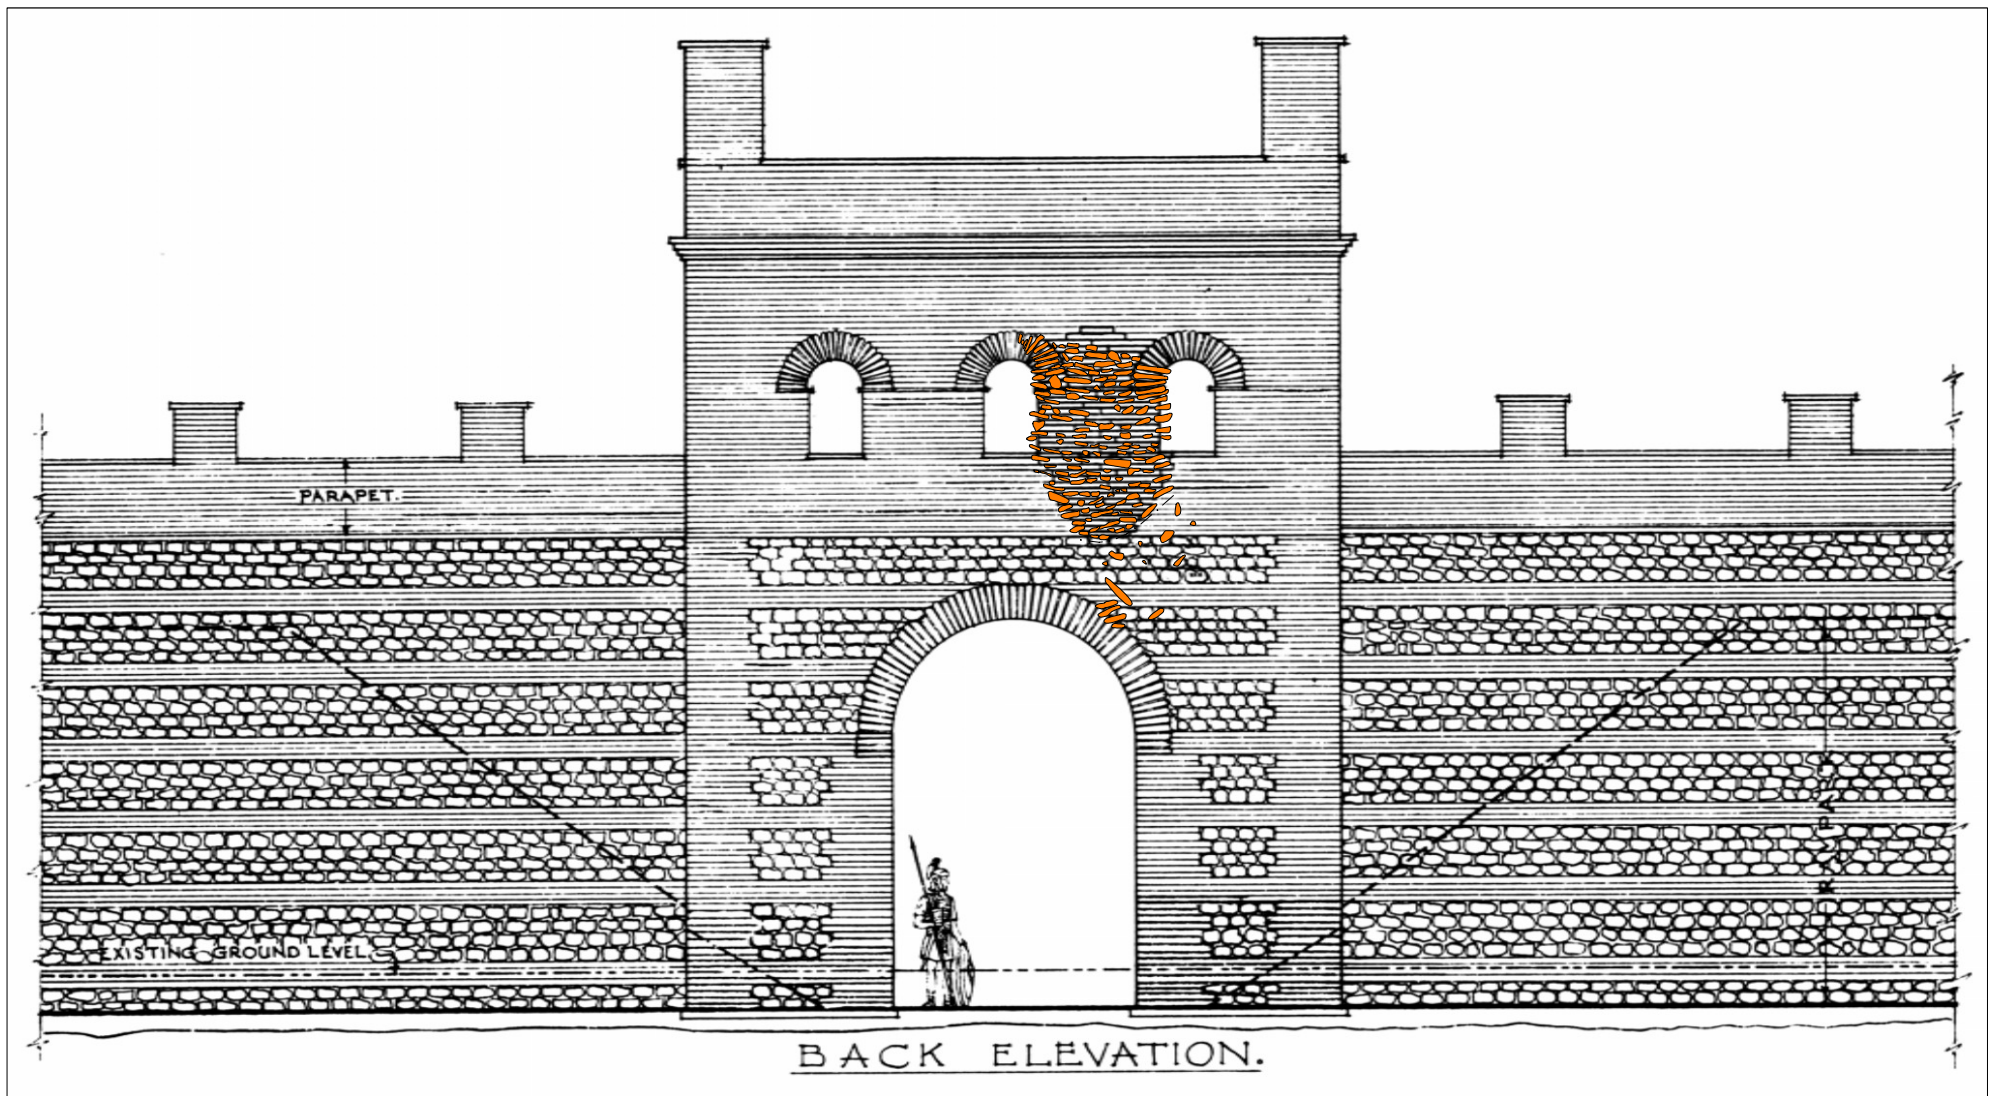
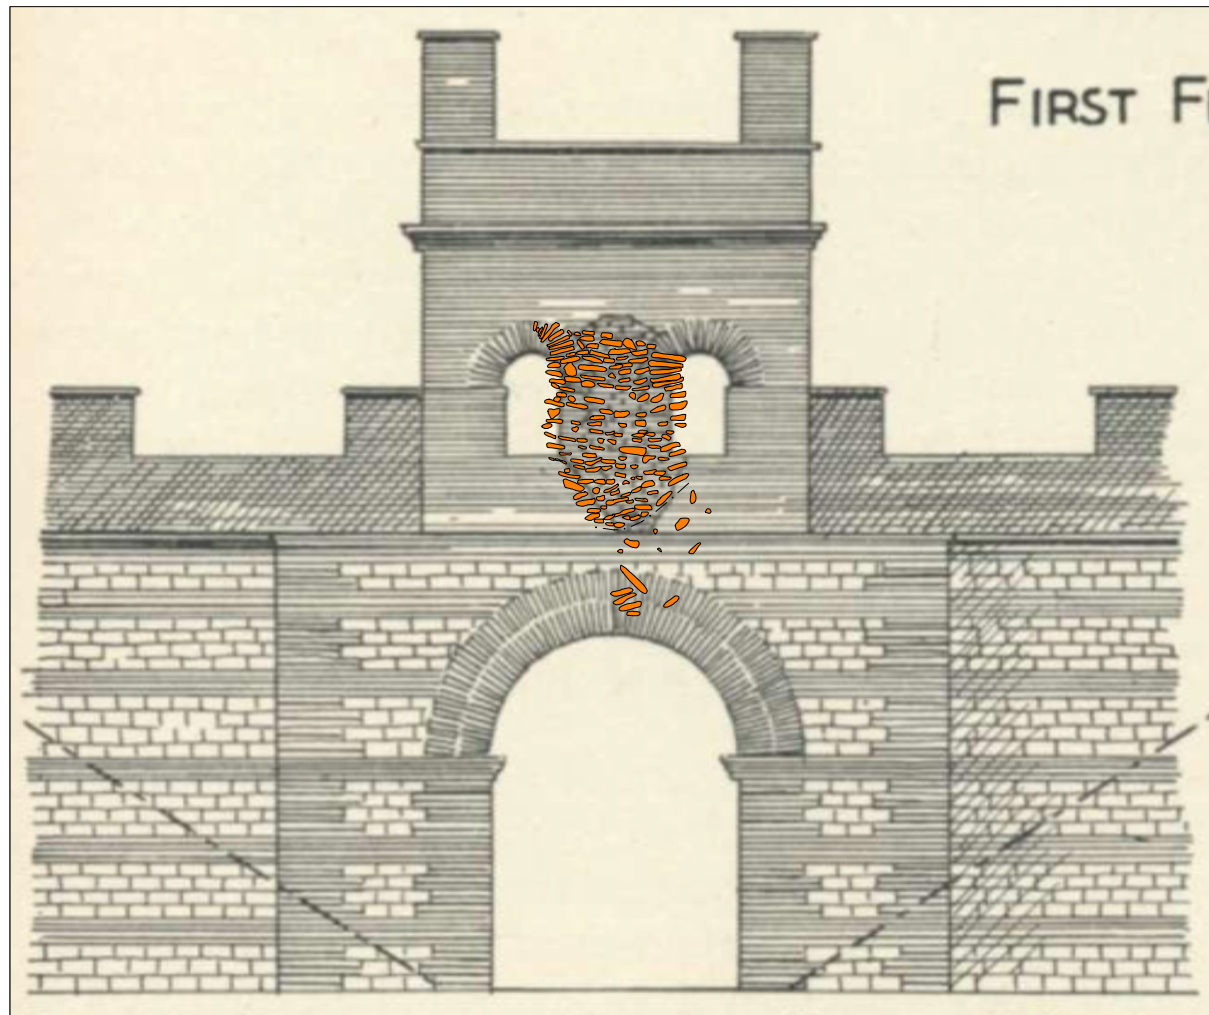
Overlaying the collapsed masonry onto Hulls possible reconstructions of the gate tower (Figs 7 and 8) allows the damage to the masonry since the 1920s to be roughly measured. The masonry overlaps where it is marked on the reconstruction by about 20cm on every side (this is undoubtedly Hull accounting for the 'springing' of the courses of tiles as they fell, as he mentions in his report). The two exceptions to this overlap are at the very top and bottom of the masonry, both of which appear 25cm less than shown on the plan, suggesting some tile courses have been lost in these areas. Although the exact speed of the decay is difficult to measure, continued effects of rain and frost will only result in more deterioration to the gate and masonry's fabric.
