**Historic building recording at
Waples Mill, Ongar Road, Margaret Roding,
Essex, CM6 1QS**

July 2016

CAT Report 1060
January 2017

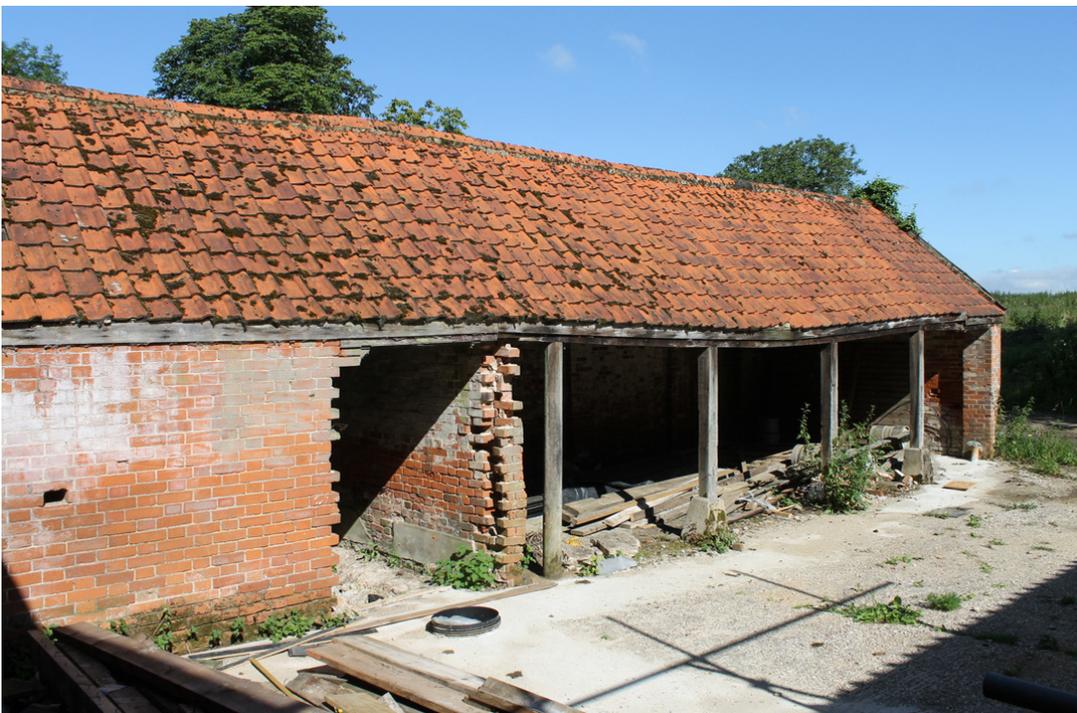
Photograph 2 East elevation of Building A – photograph taken facing north-west.

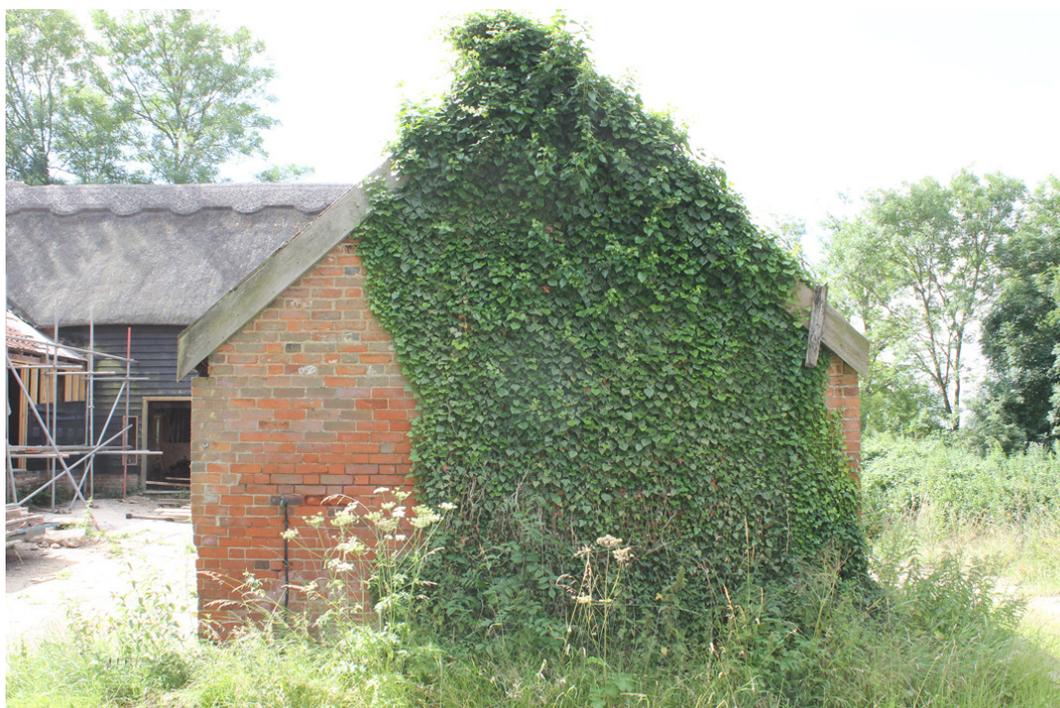
The bricks of the earliest phase of the building are 220mm x 110mm x 65mm in size and laid in Flemish bond. The bricks of the later extension to the north vary in size and are laid in an irregular bond (Photograph 4).

Photograph 4 North elevation of Building A, with changes in brickwork bonding visible – photograph taken facing south.

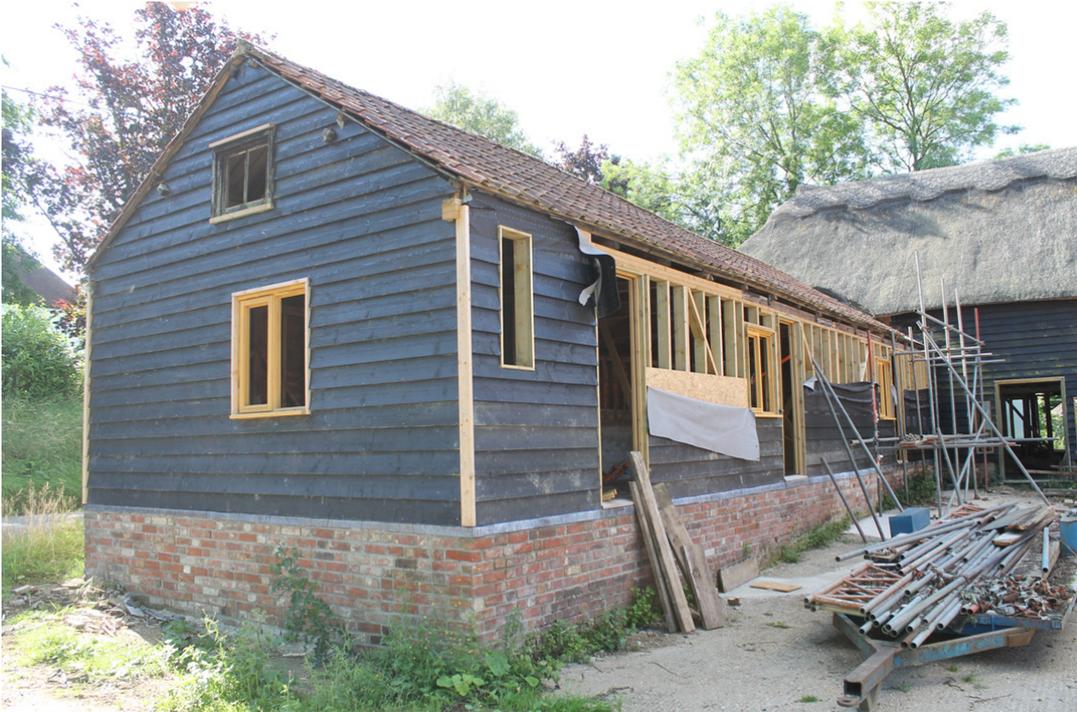
Photograph 5 West elevation of Building B, with multiple modern timbers visible – photograph taken facing south-east.

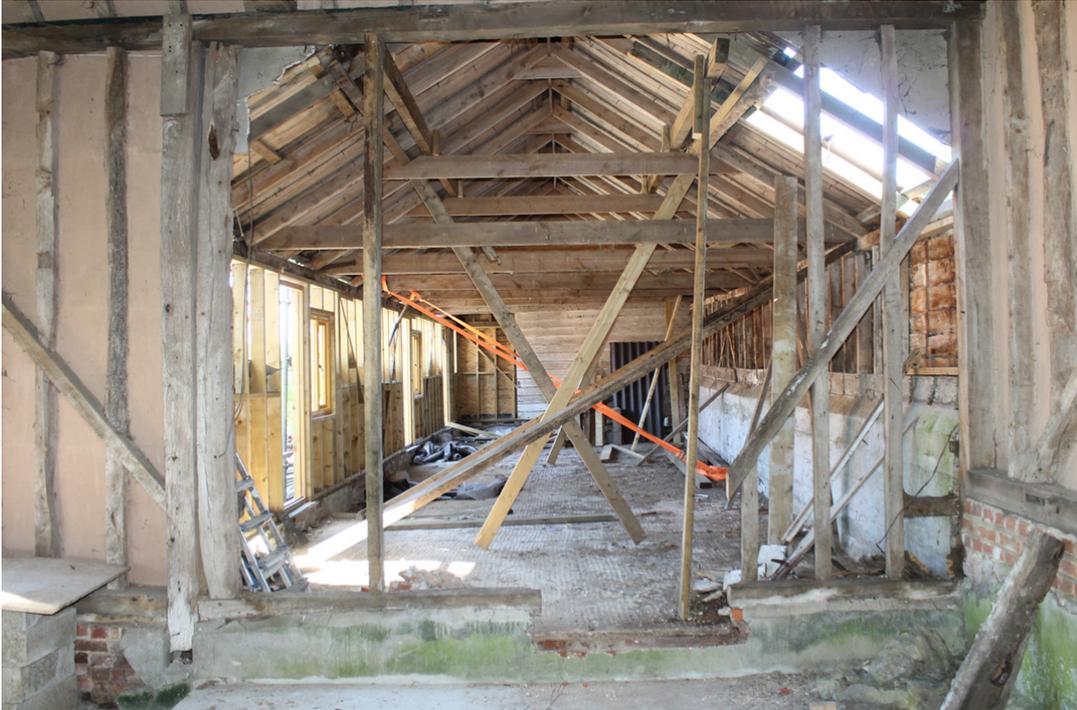
The original timber-frame is in poor repair, with evidence of extensive damage to the studs. This may have necessitated the concrete supports at the base of the frame. Various timbers and straps are supporting the buildings frame while it is under renovation (Photograph 7).

Photograph 7 Interior shot of Building B, showing supporting timbers and straps. In foreground is the northern elevation of Bay 4 (in the barn), with multiple missing studs and modern replacements. Photograph taken facing north.

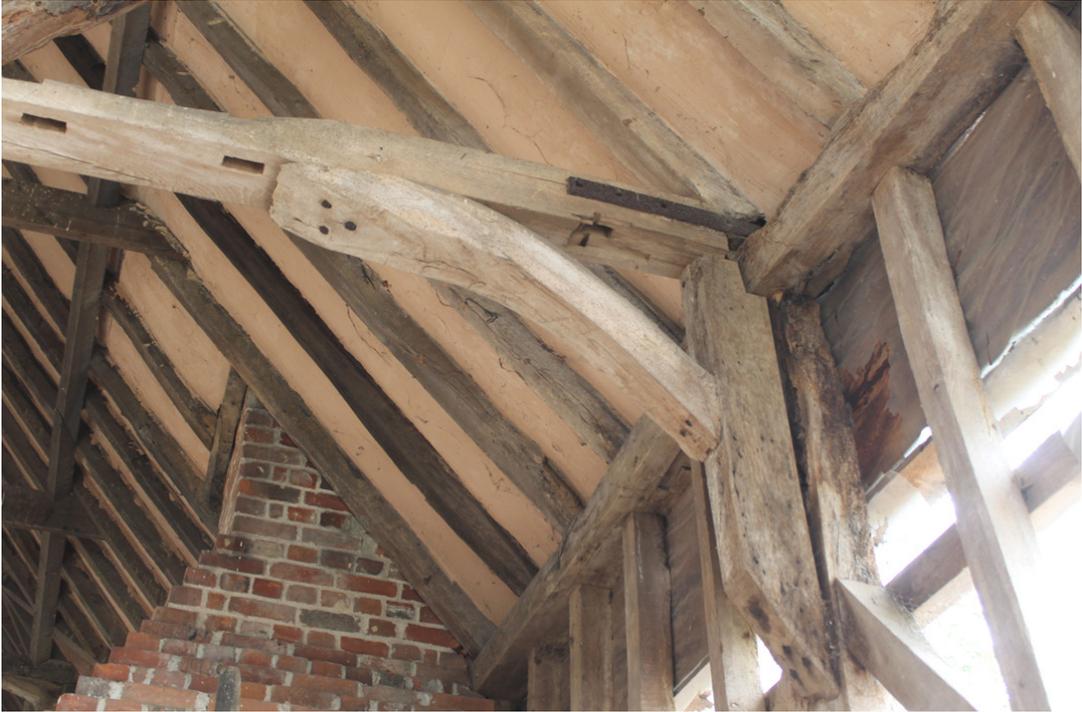
brace is attached to the tie beam and the principal post by three nails (Photograph 15). The southern brace is attached to a piece of timber nailed onto the principal post, providing additional support to the tie beam (Photograph 11). The tie beam is also held in place by metal straps at either end. This beam and its braces have replaced the original tie beam in this location, and were probably added during the partial conversion into a restaurant in order to provide a more 'rustic' aesthetic. Two diagonal struts project from the tie beam and are attached to the side of the common rafters directly above it.

Photograph 11 Southern end of tie beam between Bays 1 and 2, with additional pieces of timber and modern hand-sawn arch brace. Photograph taken facing east.

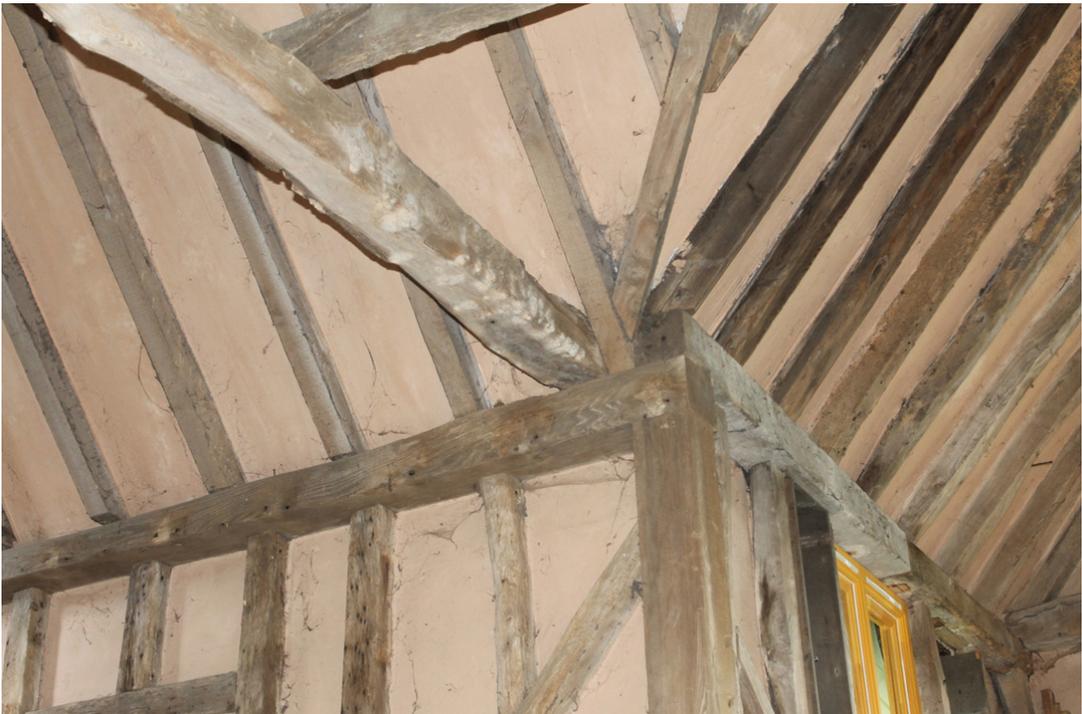
The tie beam between bays 3 and 4 is a modern hand-sawn timber, replacing a tie beam that was damaged in the collapse of the eastern end of the barn (see above). This new tie beam has been moved from the position of the original beam (projecting from the midstrey), and now sits further east on the wall-plate in Bay 4 (Photograph 12). It is not supported by any braces and has no struts that support the rafters. A remnant of a brace that did once support the original tie beam is visible on the old principal post between Bays 3 and 4 on the northern elevation. All the current beam appears to support is the east end of a cross brace that forms the base of an arrangement of timbers at the intersection of the midstrey and main range (see below).

Photograph 12 Modern hand-sawn tie beam between Bays 3 and 4, on the southern elevation. Also visible is the midstrey and modern wall plate joining the original. Photograph taken facing south-east.

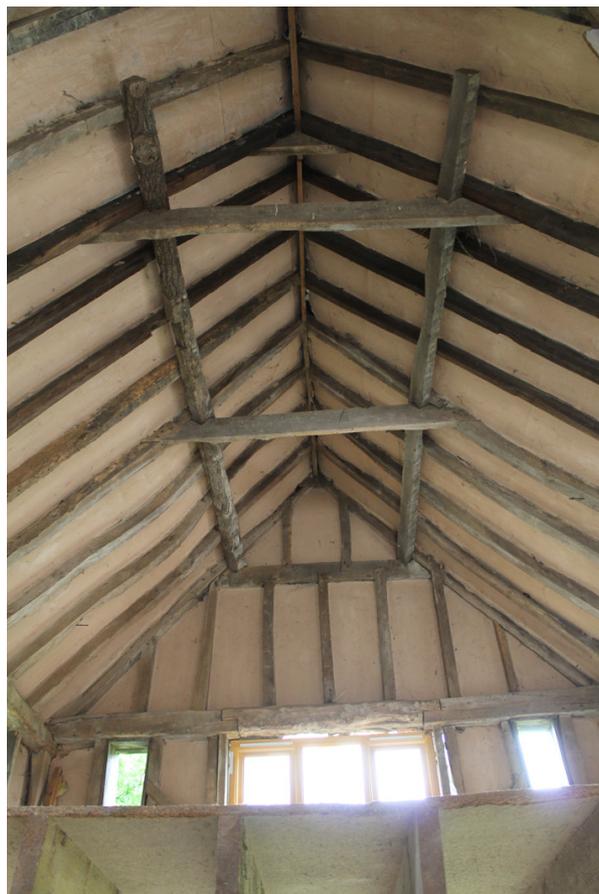
The remaining rafters appear to be largely original hand-sawn timbers, although there are some that may be later replacements. In addition, some rafters appear darker than others, particularly in the midstrey (Photograph 13). This may be as a result of re-use from an older building with a fireplace (the smoke from which would have darkened the timbers). Unfortunately close inspection of the rafters was not possible.

Photograph 13 Detail of midstrey's roof, showing modern purlins and collars as well as ?fire-damaged rafters. Photograph taken facing south.

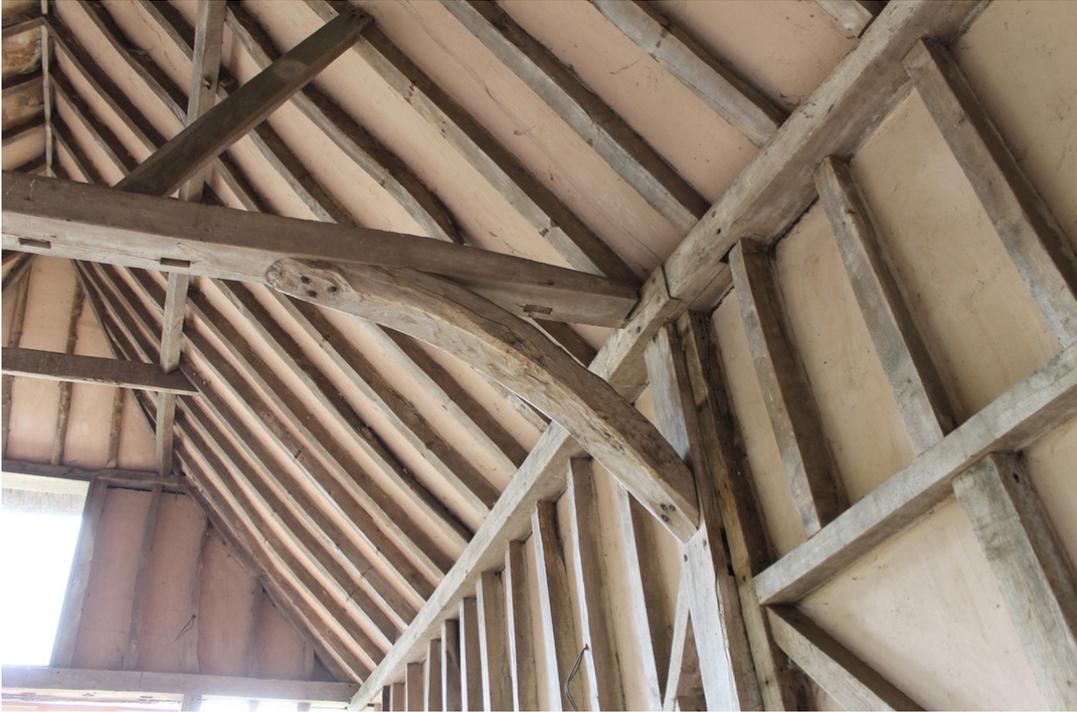
Photograph 15 Northern end of tie beam between Bays 1 and 2. Shows re-used tie beam and modern hand-sawn arch brace. Also visible is the joint between the wall-plates. Photograph taken facing north-west.

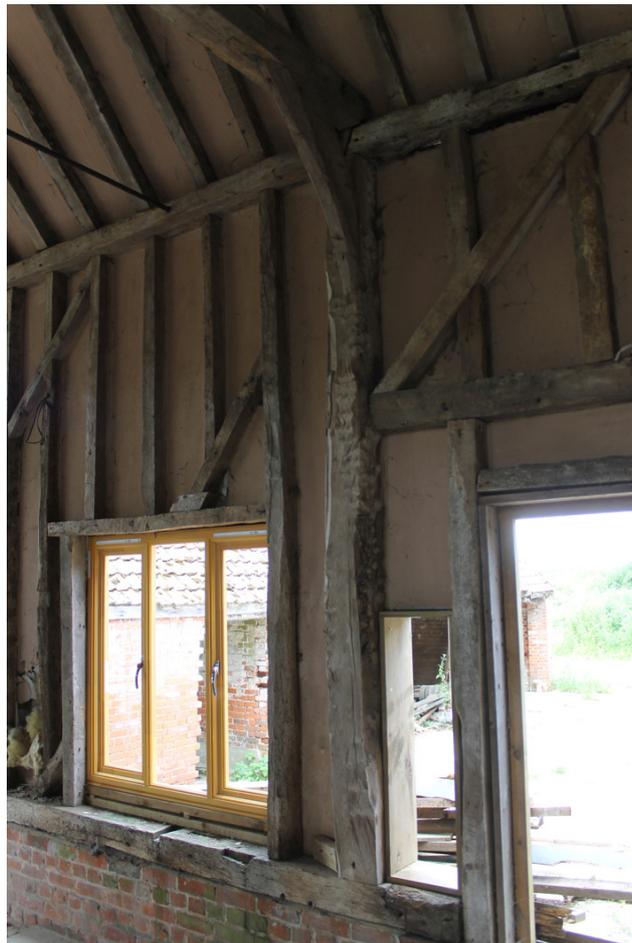
The principal post between Bays 2 and 3 on the northern elevation also appears to be a modern hand-sawn timber replacement, supporting a possibly original tie beam. The bespoke rudimentary joint between this post and the original wall-plate of Bay 3 (Photograph 16) further suggests its modern origin.

Photograph 16 Modern hand-sawn timber forming northern principal post supporting the tie beam between Bays 2 and 3. Photograph taken facing north-west.

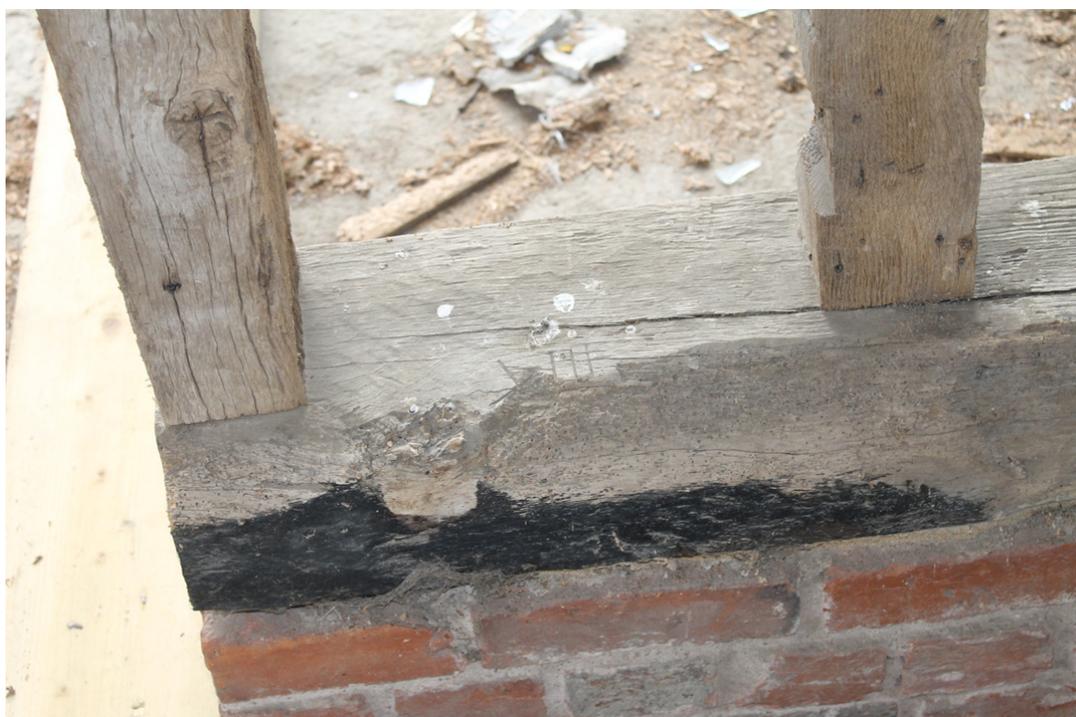
Several carpenter's marks were observed during this investigation, some were visible inside the barn on re-used timbers from elsewhere in the structure (Photograph 18). The only place where in-situ carpenter's marks were observed was where the weatherboarding is not present on the exterior elevations (on the west and part of the southern side) of the

Photograph 18 Possible carpenter's mark out of context on a re-used timber forming part of the first floor addition in Bay 1. Photograph taken facing west.

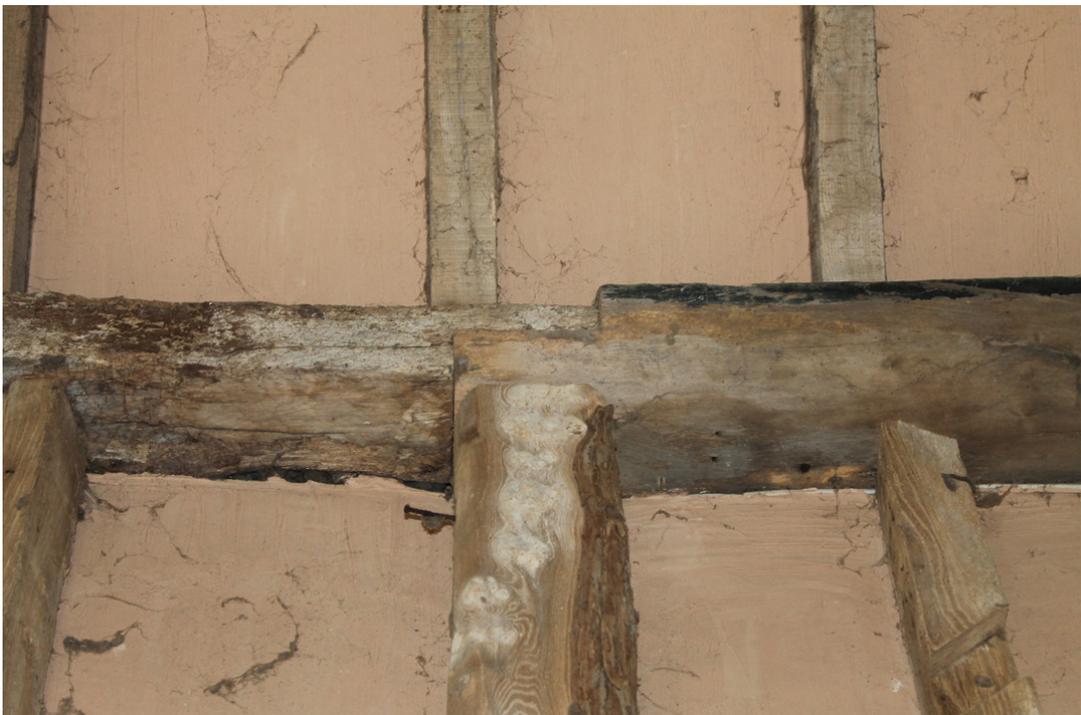
Photograph 20 Modern timber (right) jointed with original wall-plate (left) in bay 3. Modern hand-sawn supporting post visible. Photograph taken facing north.

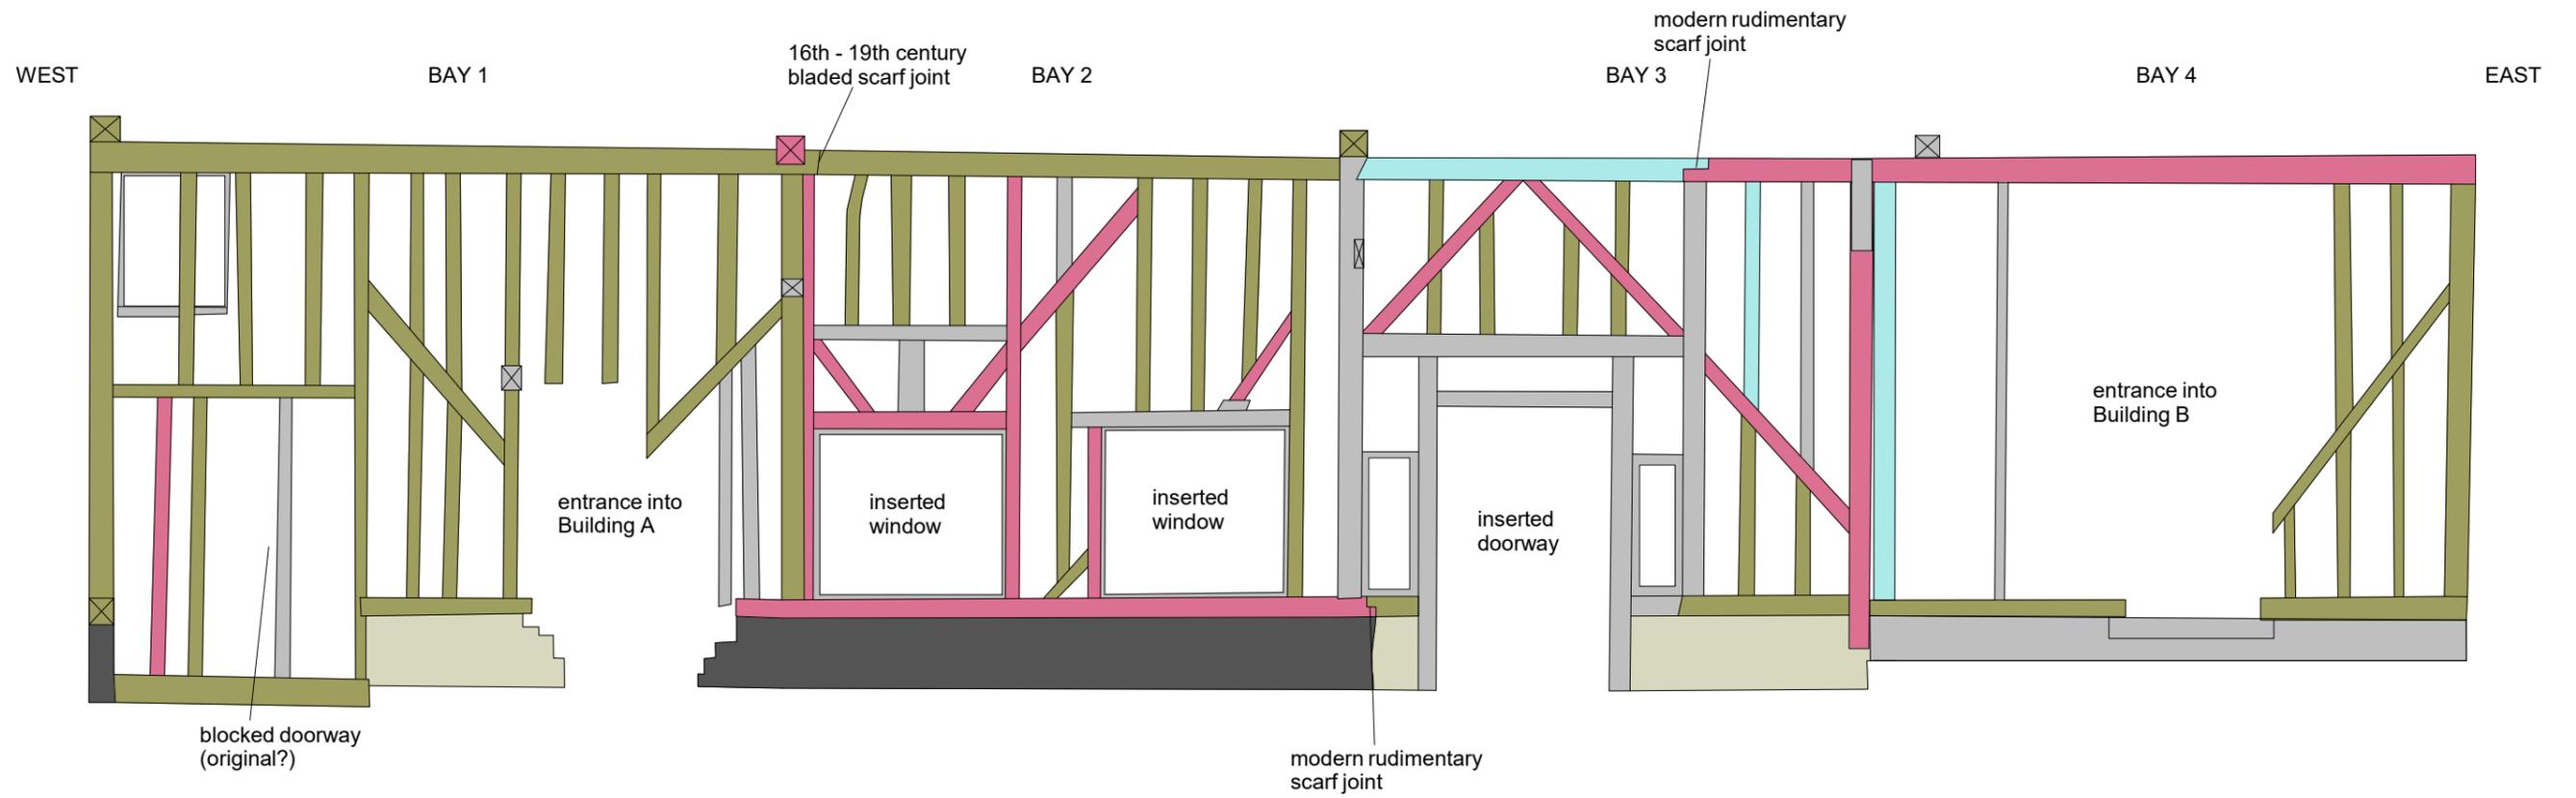
Fig 7 Timber framing on northern side of barn.

The principal post between Bays 3 and 4 on the northern elevation is a modern insertion, re-used from another building. It replaces the original principal post, which is still visible in the frame directly abutting it (Fig 7).
