**Historic building recording
of a barn at Cowlass Hall Farm,
Radwinter End,
Radwinter, Essex,
February 2017**

Planning reference: UTT/2063/15/FUL

CAT Report 1087
July 2017

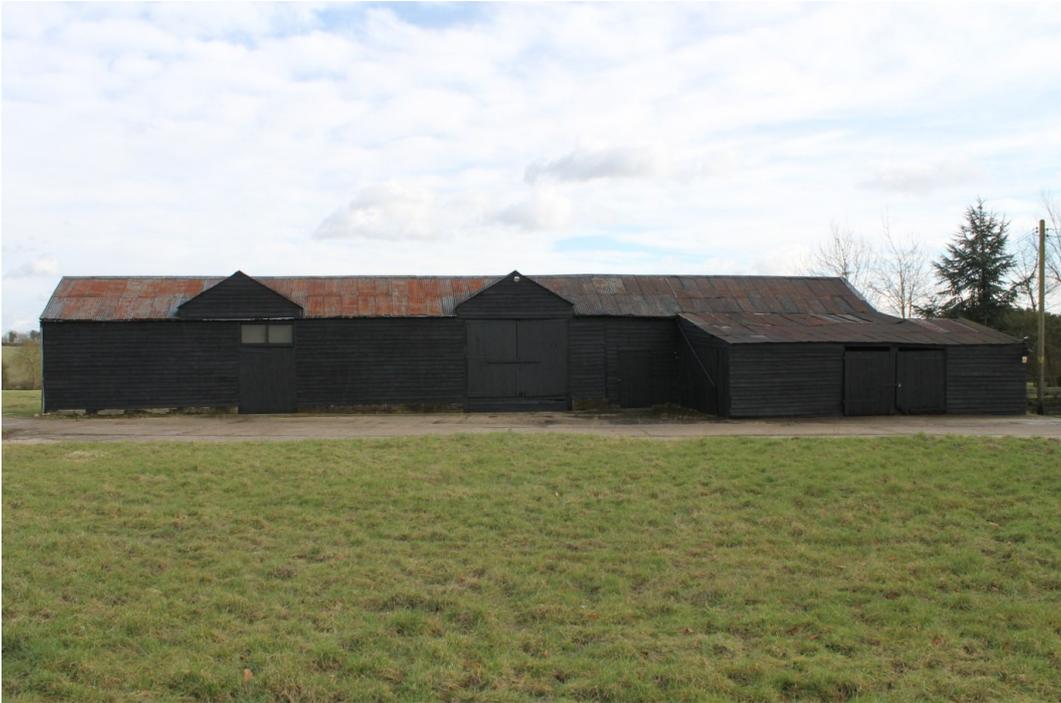
The north-west elevation (Photograph 1, Fig 3) has two non-projecting midstreys at bays 3 and 6, which indicate the barn was used for threshing. These midstreys have gabled pediments rising from the eaves. The opening for the barn doors of the midstrey to bay 3 has been diminished with the northern barn door completely replaced by studwork and the southern door replaced by a smaller door with two lights above it. The opening for the barn doors of the midstrey to bay 6 retains full height cart doors as well as the threshold leap, although these are replacements for the originals. The majority of the north-west frame sits on a plinth of red brick with dimensions of 230 x 120 x 66mm, laid in a rough Flemish bond. The top course of this is chamfered. Approximately 1.5m to the right of the midstrey to bay 6 this plinth stops, with the remainder of the barn to the south (19th-century extensions) carried on a much lower plinth (Photograph 2). A doorway provides access to bay 7 (Photograph 3). A much smaller doorway is located next to this, the purpose of which is unclear but may be linked to machinery located inside. The remainder of the north-west elevation is obscured by OB1 but visual inspection within the lean-to shows that the horizontal weatherboard continues and that there is an entrance to bay 10 with a hatch directly above this (Photograph 4).

Photograph 1 North-west elevation of the barn, with OB1 to the right - view south-east.

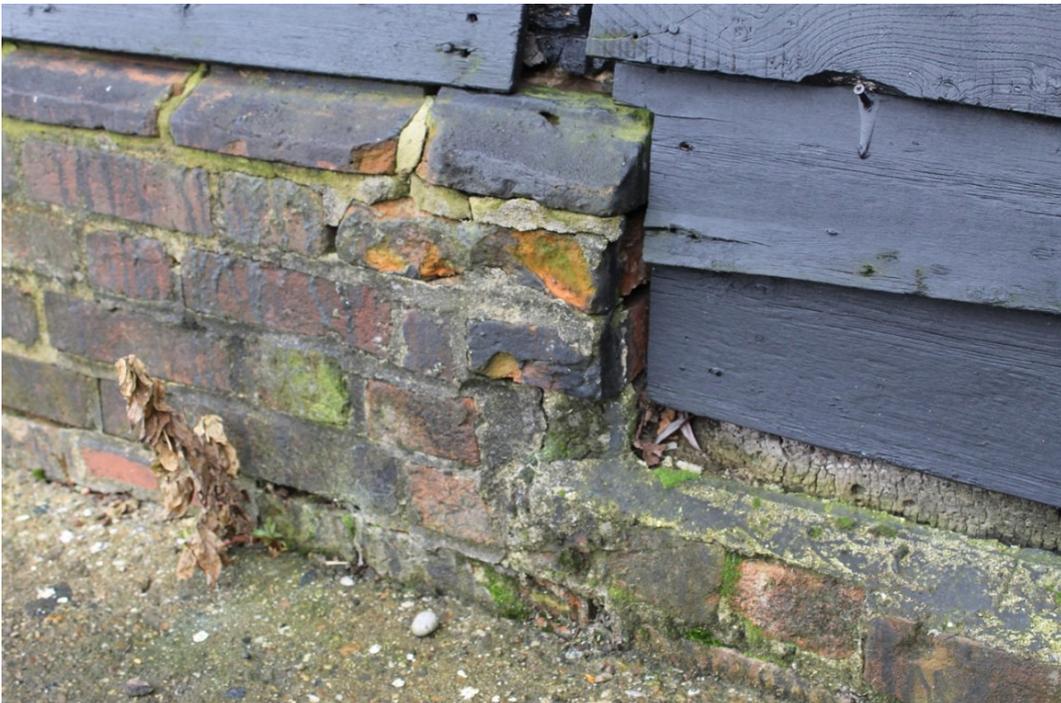
Photograph 2 North-west elevation, showing plinth of main barn to the left with 19th-century extension to the right built on a much shallower plinth - view north-east.

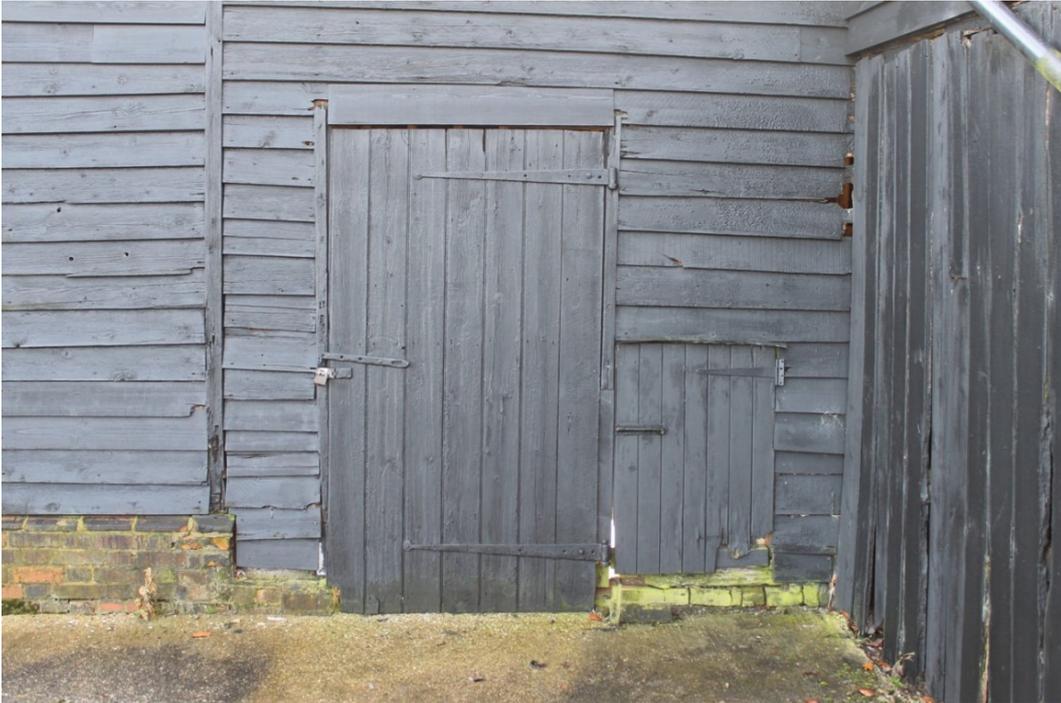
Photograph 3 North-west elevation, door to bay 7 (19th-century extension) with small modern door to the right - view south-east.

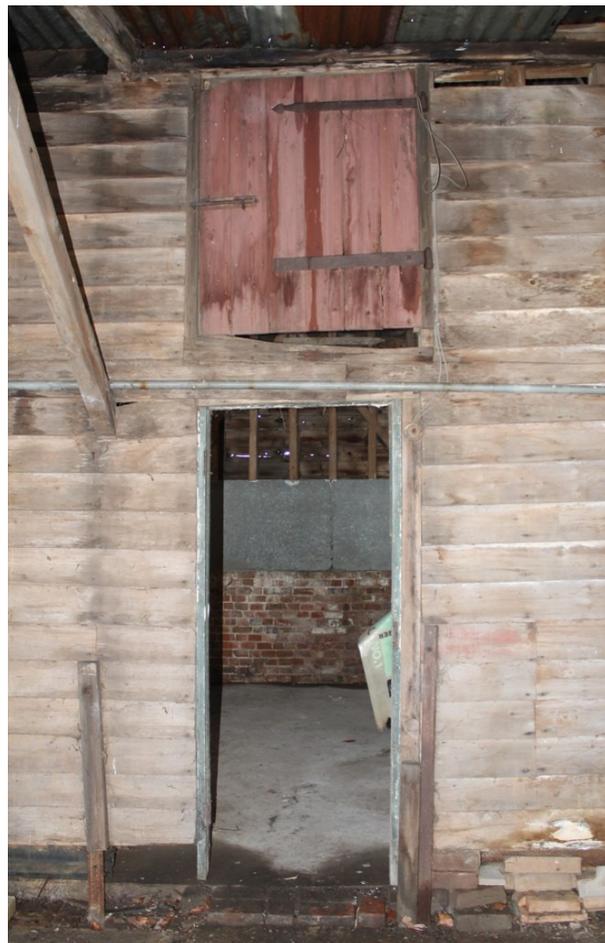
Photograph 4 Entrance to bay 10 in the 19th-century extension to the main barn, with contemporary hatch above - view south-east.

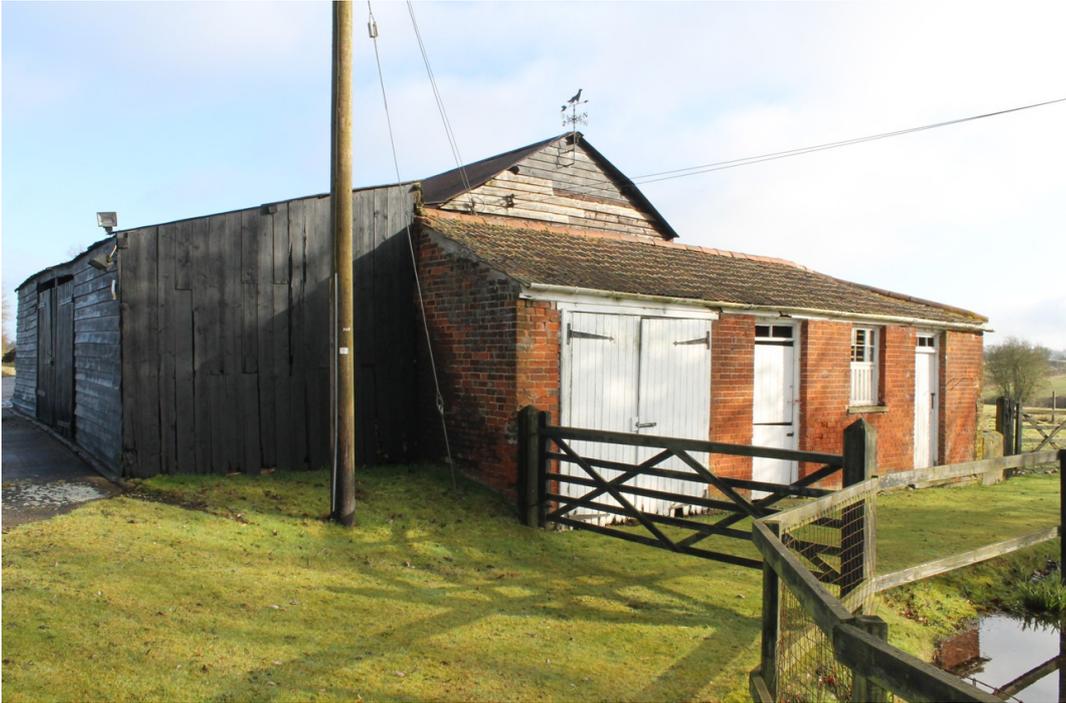
The majority of the south-west elevation of the barn is obscured by the 18th-century brick stable block (Photograph 5, Fig 4). All that is visible is the gable end, clad with horizontal weatherboarding. A weathervane with a canine motif is affixed to the apex of the gable.

Photograph 5 South-west elevation, mainly obscured by the 18th-century brick stable block and with OB1 to the left. The gable of the barn has a weathervane with a canine motif - view north-east.

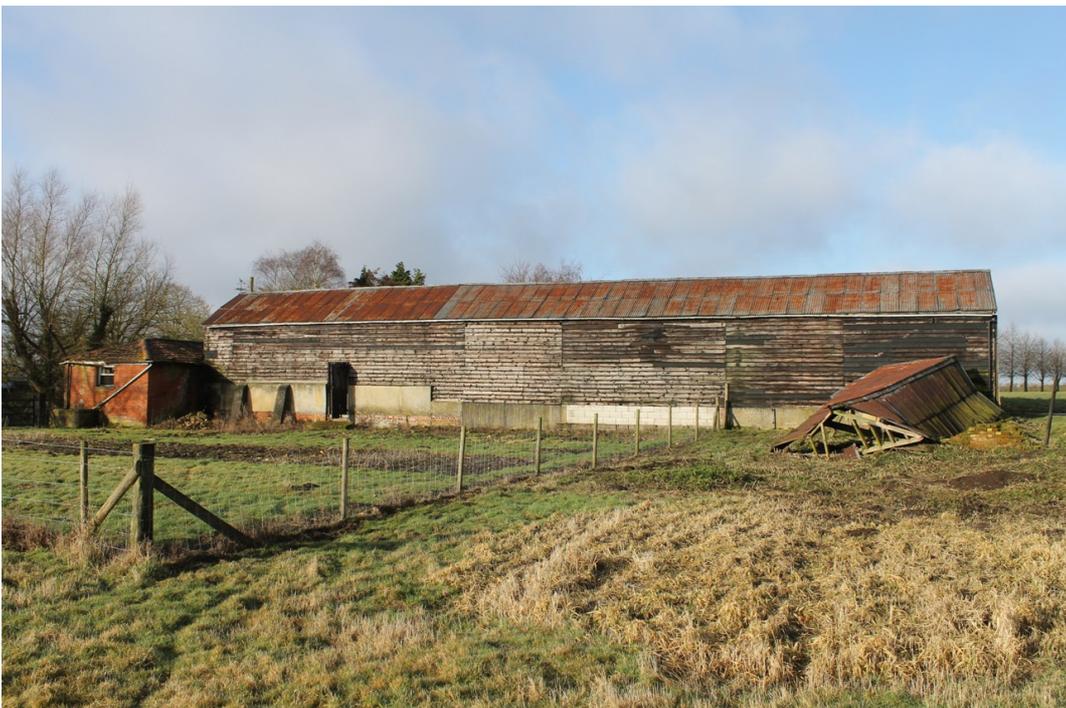
The south-east elevation is plain weatherboard above areas of render and brickwork (Photograph 6, Fig 5). This clearly shows that the plinth walls of the extensions to the south end of the main barn are significantly higher than the plinth wall of the main barn. Two buttresses to the plinth wall of bays 9 and 10 are probably modern additions. An entrance to bay 8 is the only access to the barn on this side. The original cart door entrances on this elevation have been blocked, although it is clear where these were originally located. The north end of this elevation is partially obscured by the ruins of OB2.

Photograph 6 South-east elevation of the barn with the 18th-century brick stable block to the left and the ruins of OB2 to the right - view south-west.

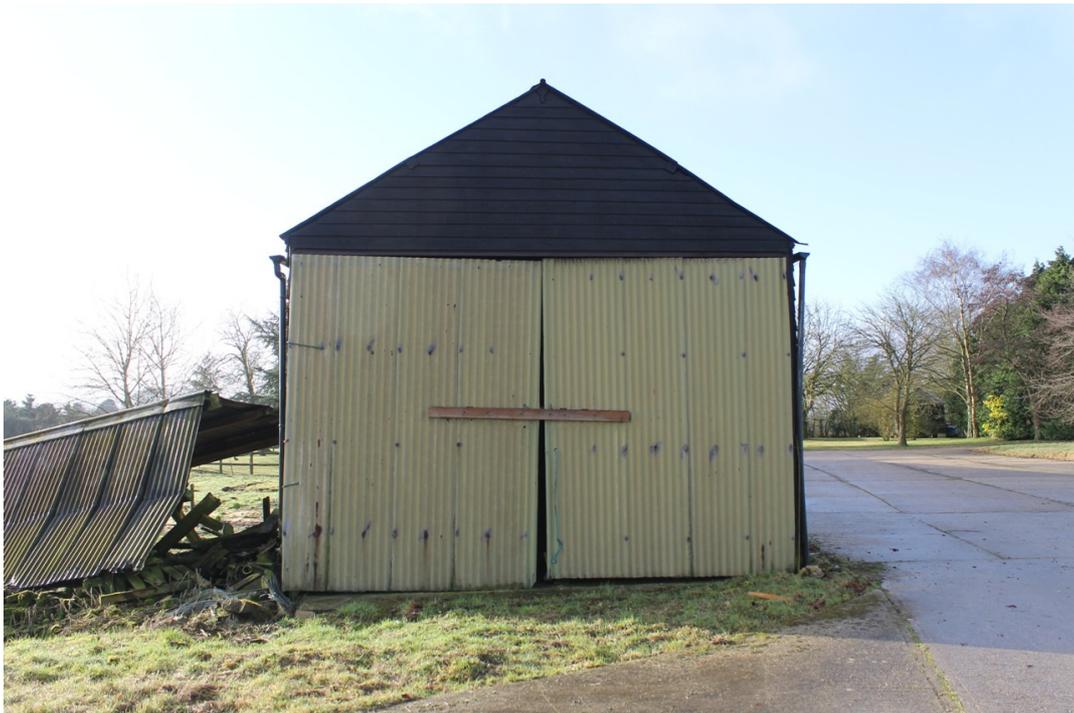
The north-east elevation has been completely converted to accommodate full height doors formed from galvanised sheets on a steel frame (Photograph 7, Fig 6). The gable end above this is horizontal weatherboard and has probably been completely rebuilt.

Photograph 7 North-east elevation of the 18th-century barn with modern full height doors formed from galvanised sheets over steel frames; the ruins of OB2 are on the left - view south-west.

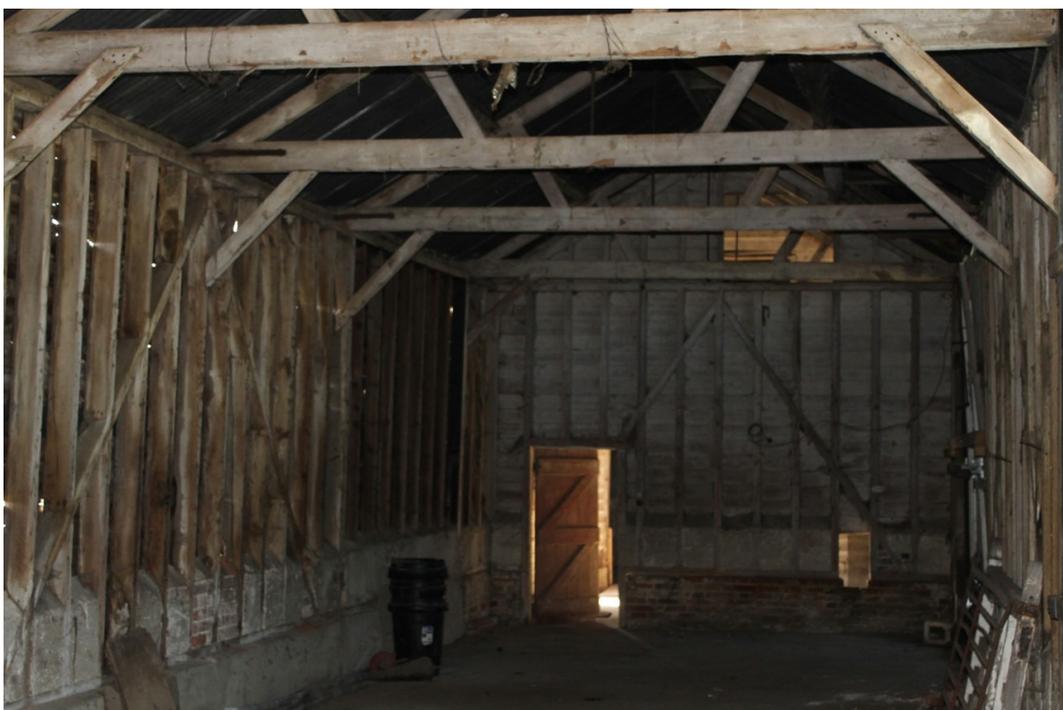
Photograph 8 Interior of the 18th-century barn, with the 19th-century extensions behind the gable frame – view south.

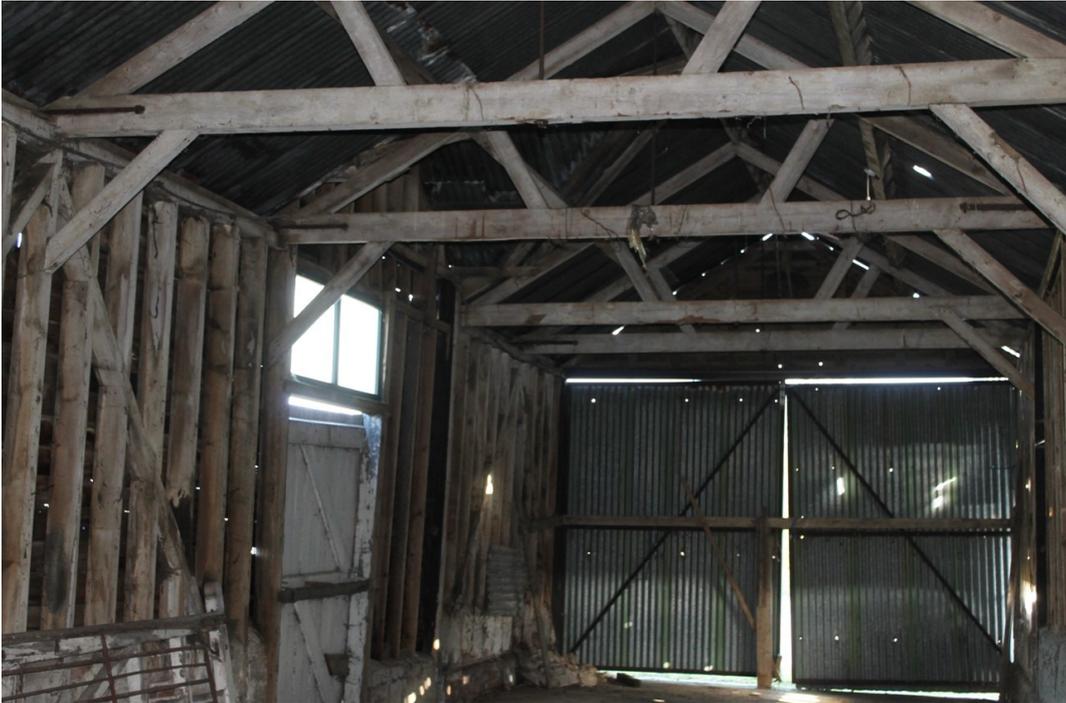
Photograph 9 Interior of the 18th-century barn, with the partially blocked midstrey of bay 3 to the left and the 20th-century doors replacing the north gable frame – view north.

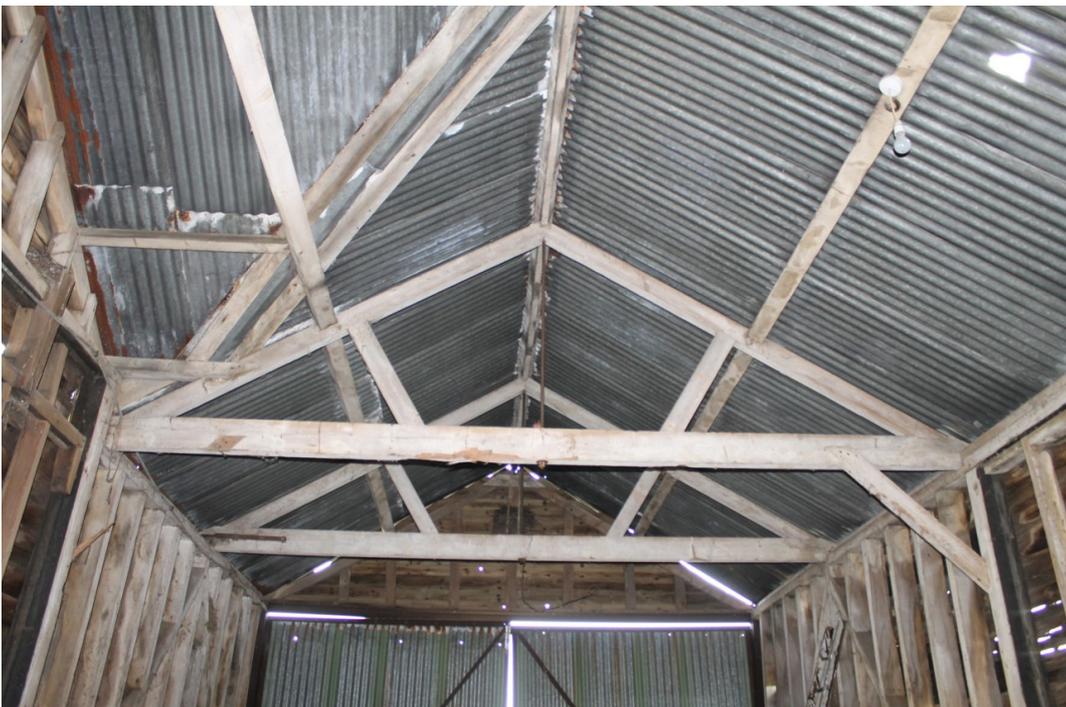
Photograph 10 Replacement roof truss (truss B) of machine-cut timbers in 18th-century barn, with nailed brace and steel king bolt – view north-east.

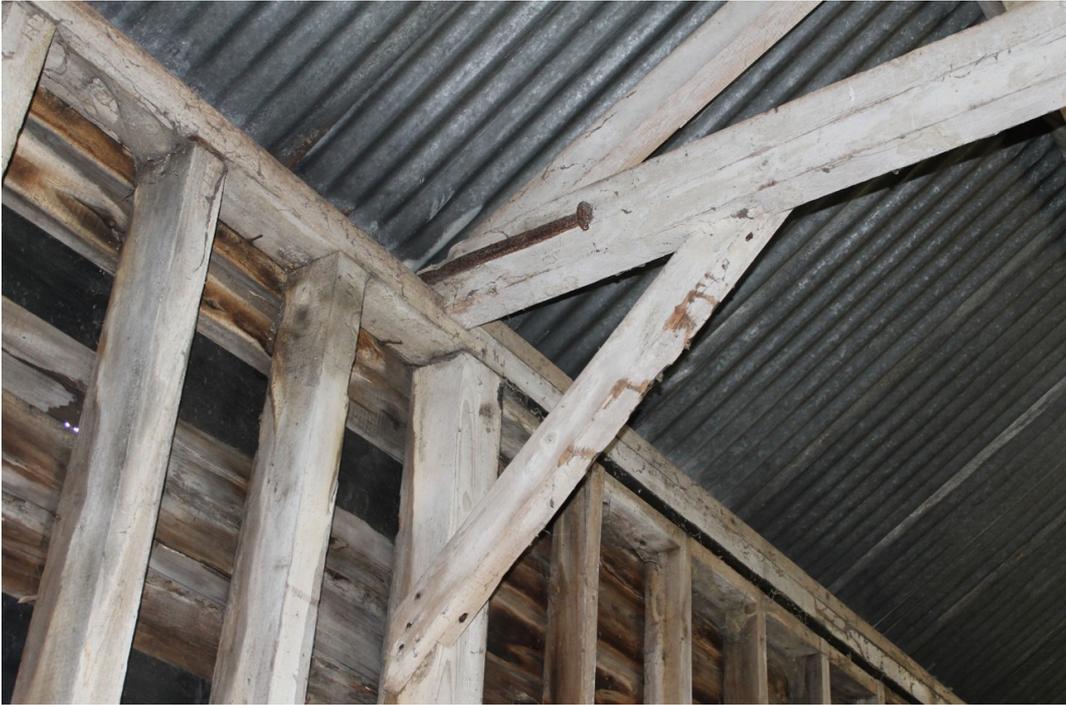
Photograph 11 Nailed brace to south-east post of truss B and iron clamp to later tie beam - view south-east.

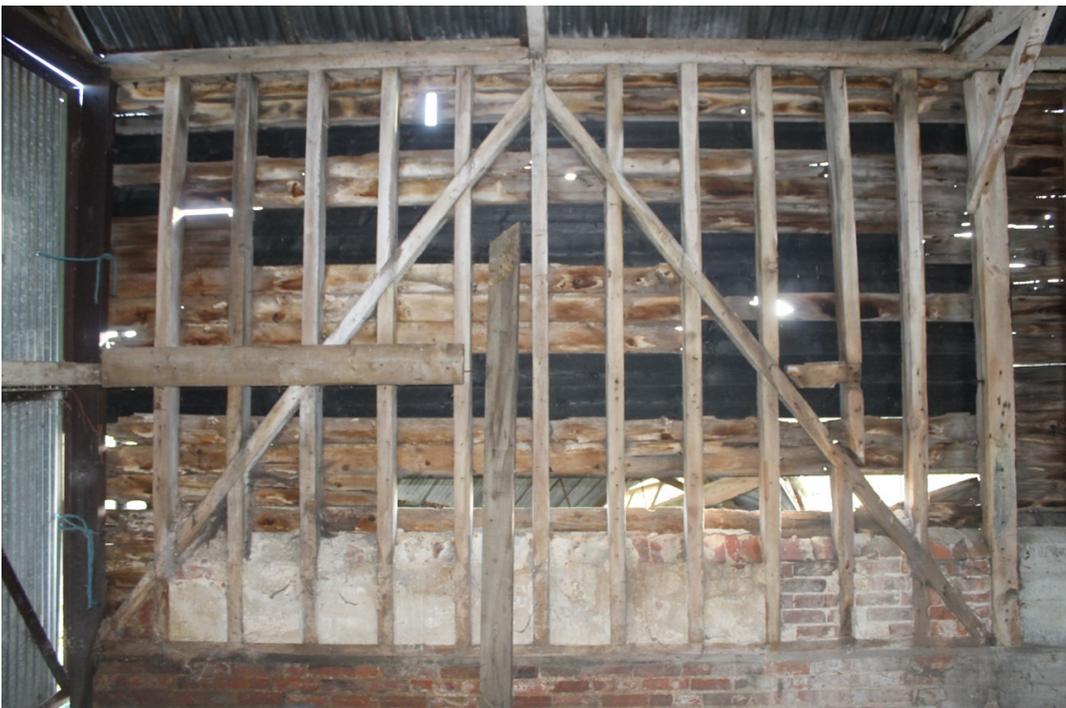
There are chiselled carpenters' marks throughout the barn, on both the original timbers and the modern timbers of the roof trusses. In bays 1 and 2 (Photographs 12, 13) there is a 'I' to the foot of each stud and primary brace and a 'III' to the head of each stud and primary brace on the south-east side. On the north-west side this is a 'I' at the feet and a 'II' at the heads (Photograph 14). Each of the joints to truss A has a 'I' and the braces from the principal posts to the tie beam are missing. The purlins to both pitches are scarfed above bay 2. The timbers of truss B have 'V' and 'VI' marks at the joints.

Photograph 12 South-east framing to bays 1 and 2 - view south-east.

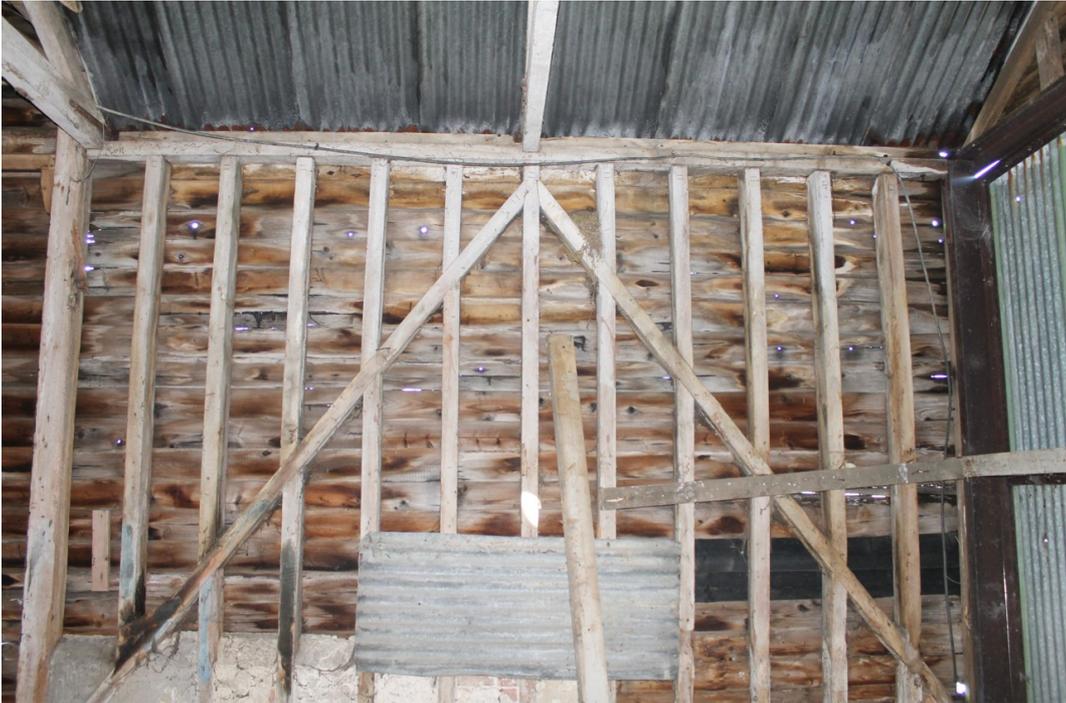
Photograph 13 North-west framing to bays 2 and 1- view north-west.

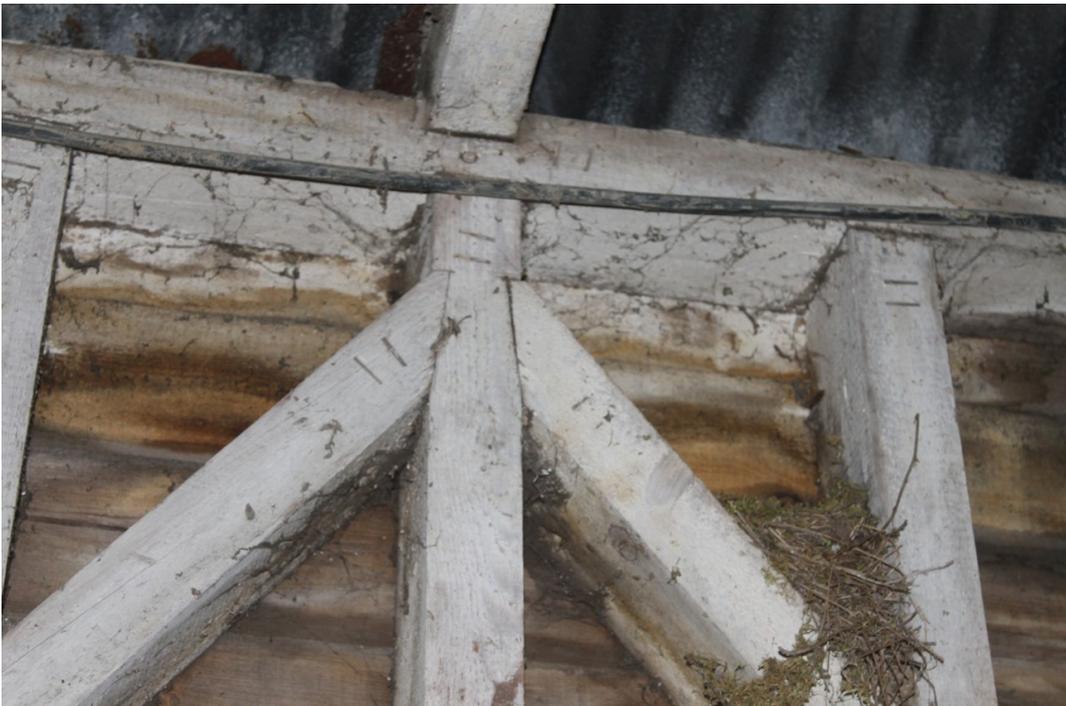
Photograph 14 North-west framing to bays 2 and 1 showing carpenters' marks 'll' on heads of studs and principal post to truss A - view north-west.

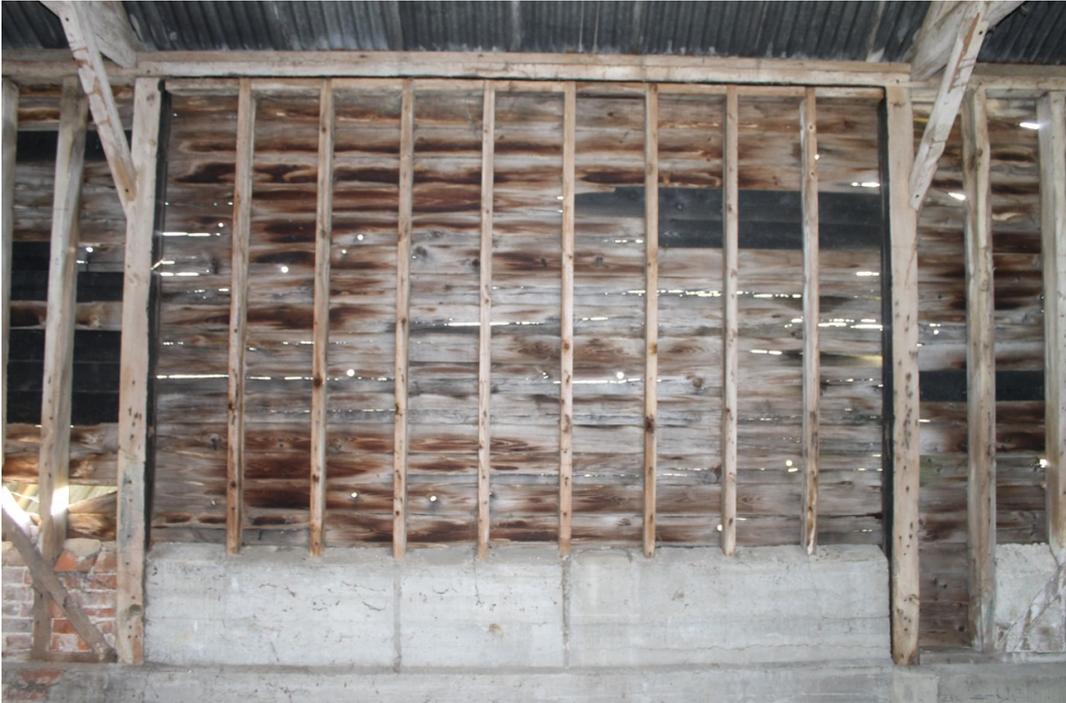
Bay 3 was originally one of the two threshing bays with cart door openings on both sides. These have been substantially altered (Photographs 15, 16). On the south-east side the cart door opening has been infilled by a modern frame with studs of 35mm wide by 105mm deep with block work below to replicate the plinth wall. There is also an edge-halved scarf joint in the wall plate. On the north-west side the cart door opening of the midstreys has been partially infilled and the opening reduced to a narrower doorway with a window above this. There are scarf joints in the purlins above bay 3. The timbers of truss C have 'II' marked on the joints.

Photograph 15 South-east framing to bay 3 replacing original cart door opening - view south-east.

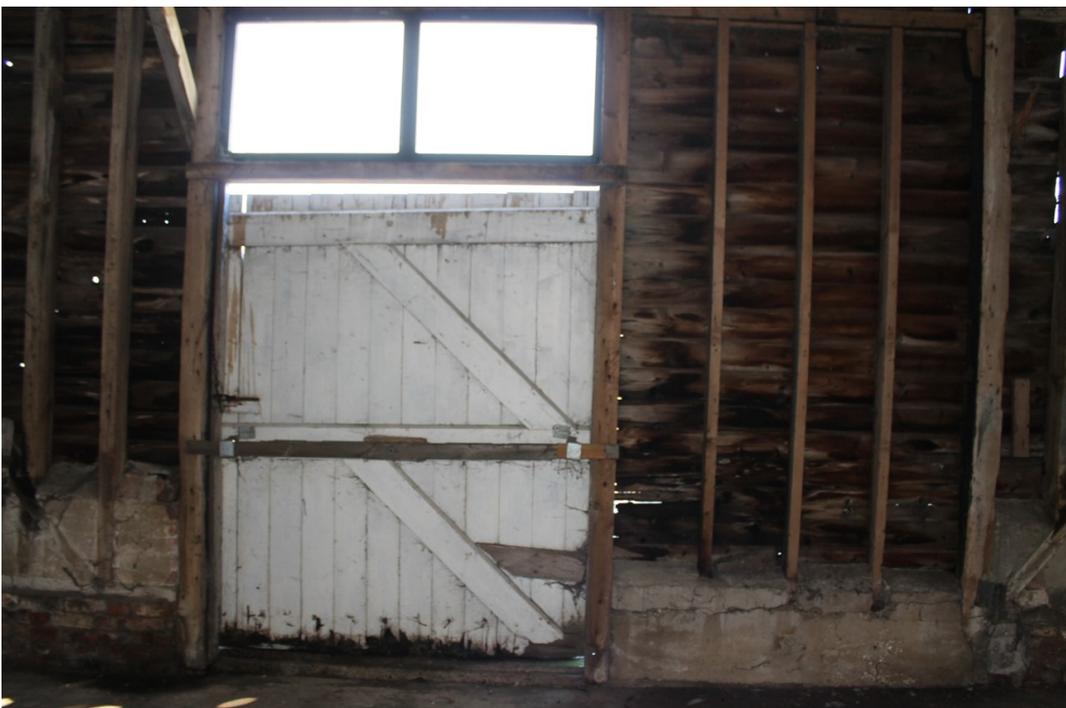
Photograph 16 North-west framing to bay 3 showing partially blocked cart door opening to midstrey and replacement door – view north-west.

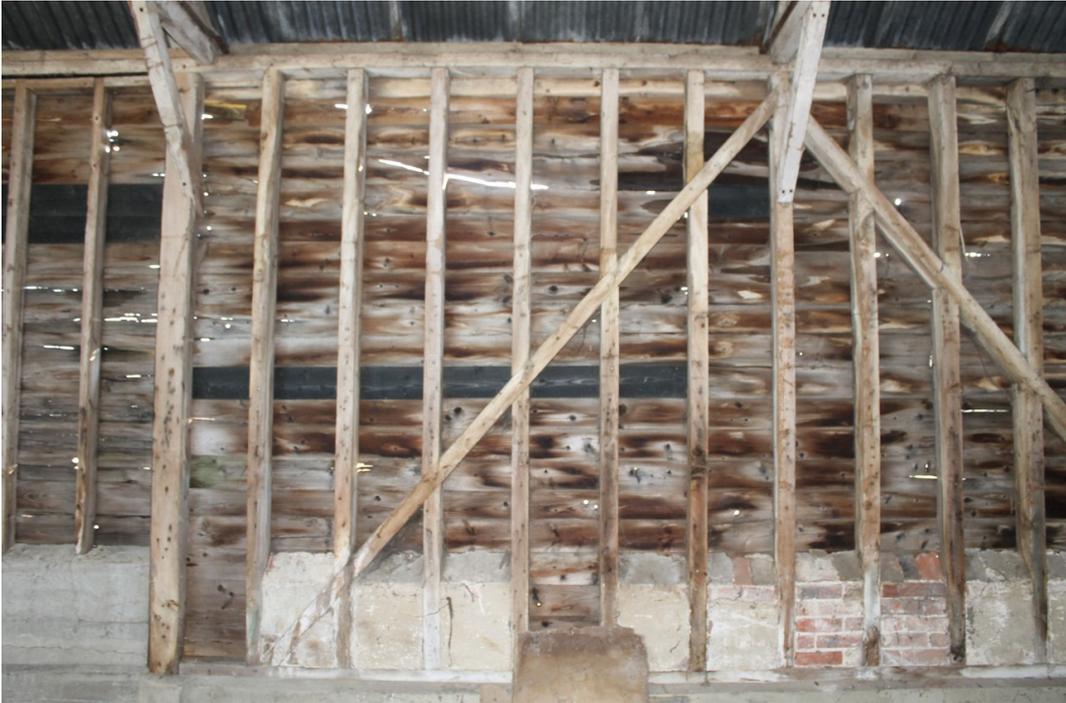
The south-east side of bay 4 (Photograph 17) has 'II' marked on the feet of the studs and bracing with 'IIV' to the heads. The north-west side (Photograph 18) has a combination of 'IIII' and 'IV' to the feet and 'III' to the heads. Truss D has 'IIII' at the joints and 'V' where the tie beam and principal post are braced on the north-west side (Fig 7).

Photograph 17 South-east framing to bay 4 – view south-east.

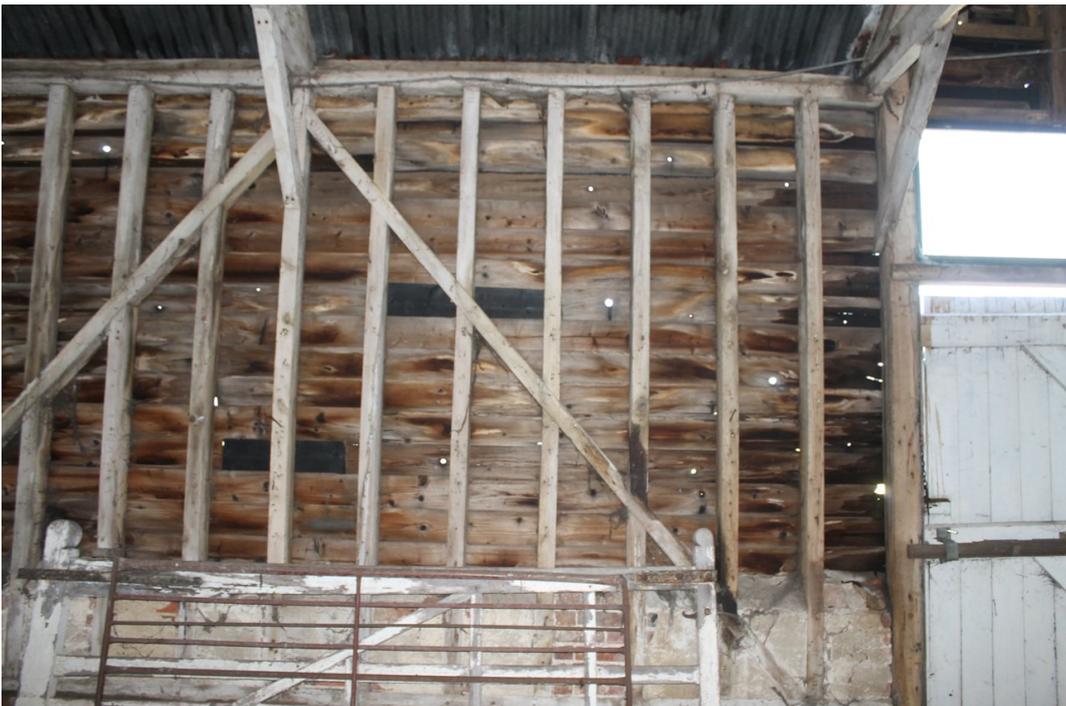
Photograph 18 North-west framing to bay 4 – view north-west.

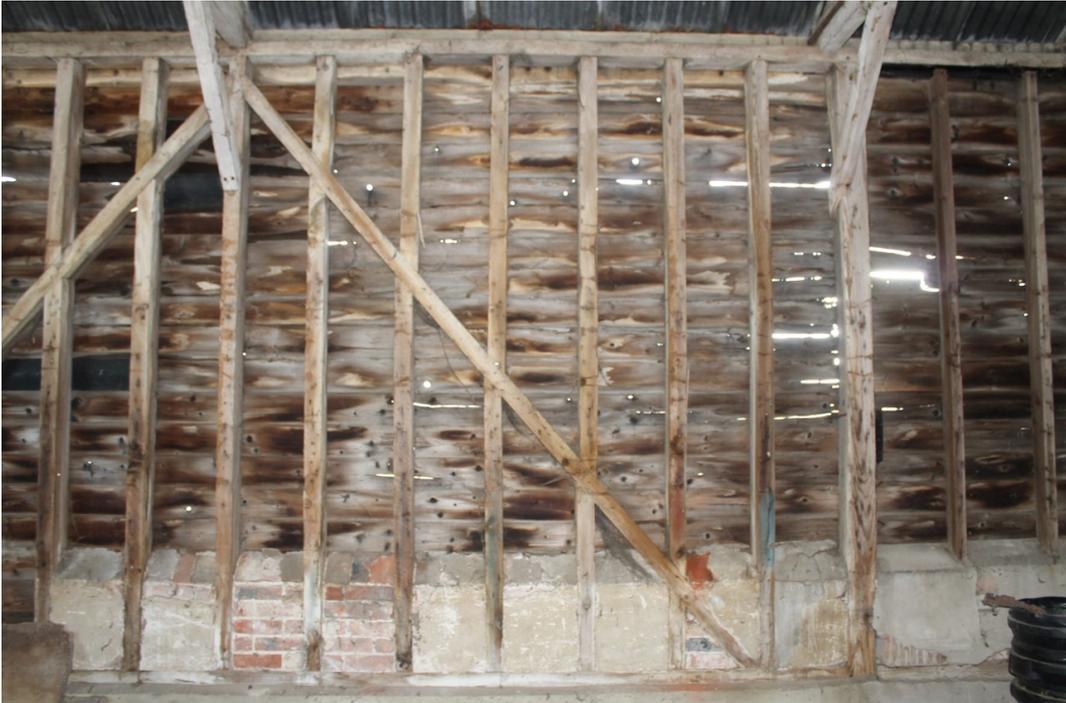
The south-east side of bay 5 has 'V' marks to both feet and heads of the framing timbers (Photograph 19) whilst the north-west side has 'V' marks to the feet and a combination of 'IV' and 'IIII' to the heads (Photograph 20). Truss E has 'IV' marked on the south-east side post and brace and 'V' on the north-west side, although the brace itself is absent. There are no other marks to the remaining joints of the truss. There are scarf joints in the purlins above bay 5.

Photograph 19 South-east framing to bay 5 – view south-east.

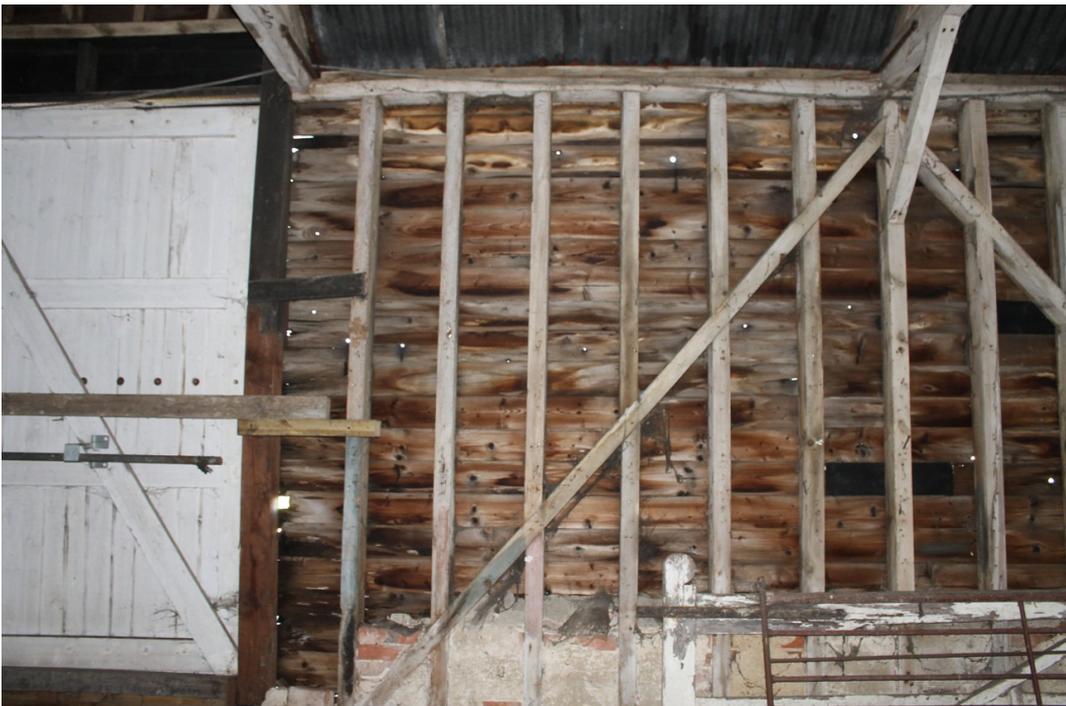
Photograph 20 North-west framing of bay 5 – view north-west.

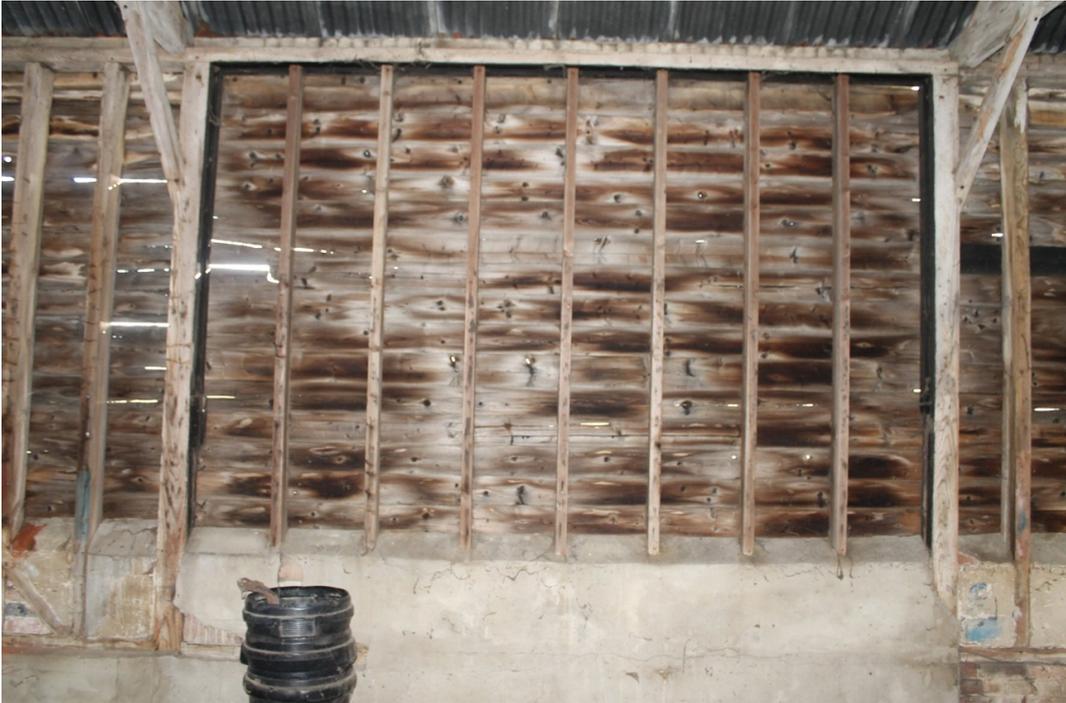
Bay 6 was originally the second threshing floor. The cart door opening in the south-east wall has been infilled in the same manner as bay 3 (Photograph 21) but the opening in the north-west side retains a set of full-height cart doors complete with threshold leap, although these are replacements to the original doors (Photograph 22). Truss F has 'V' marks on the south-east post and brace whilst the brace to the north-west side is absent and there are no apparent carpenters' marks to that side or the remainder of the truss timbers.

Photograph 21 South-east framing of bay 6 replacing original cart door opening – view south-east.

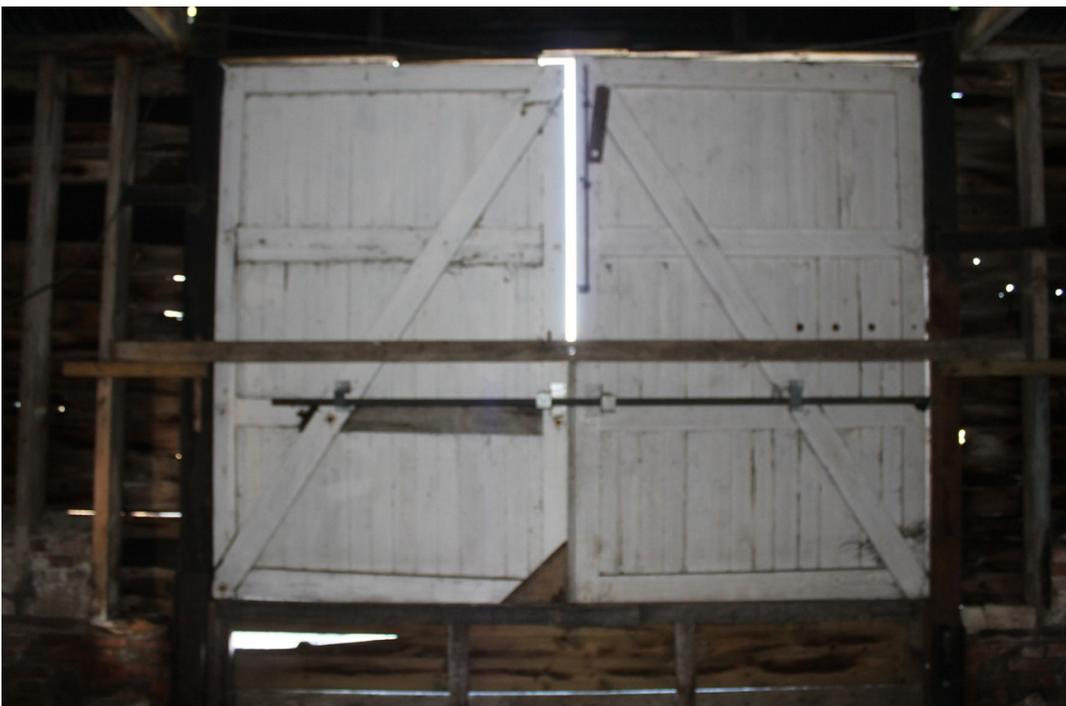
Photograph 22 Replacement cart doors to original midstrey in bay 6 – view north-west.

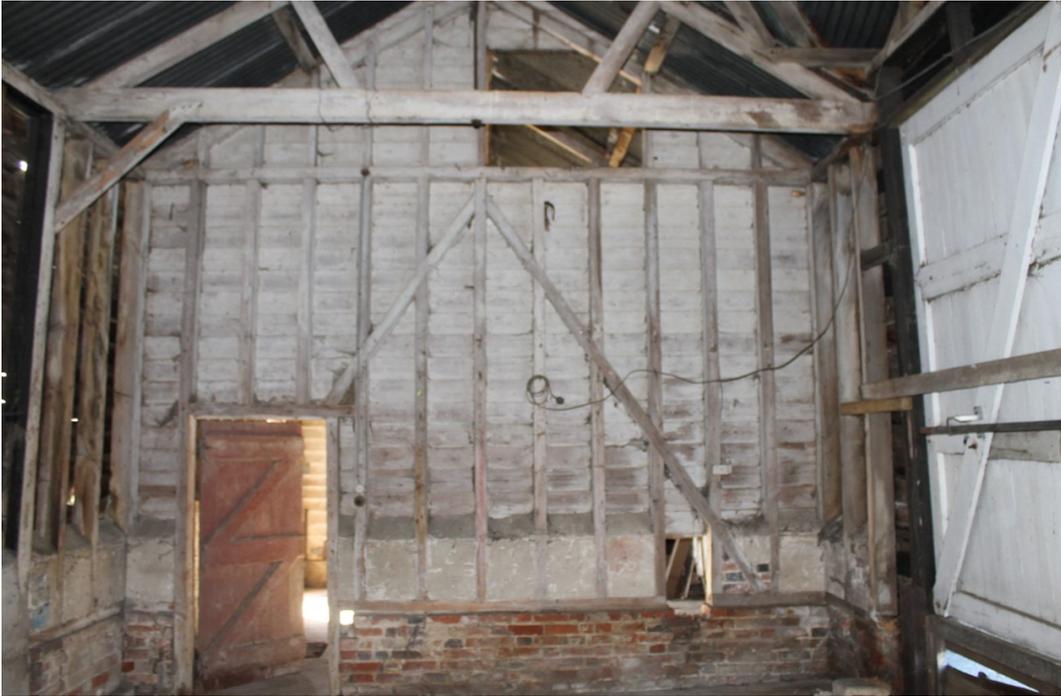
Photograph 23 Gable end framing separated from bay 6 by a narrow bay, with inserted doorway to the 19th-century extensions beyond – view south-west.

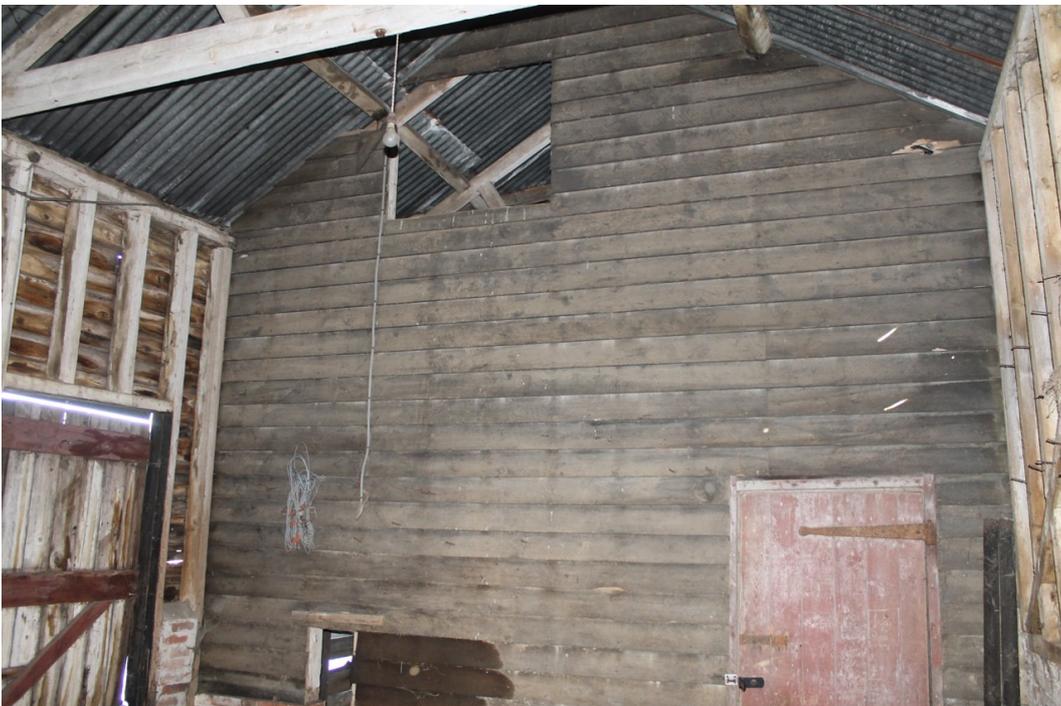
Photograph 24 Weatherboard to exterior face of bay 6, viewed from bay 7, with the frames of the 19th-century extension built up against the main barn and raised on taller brick plinths – view north.

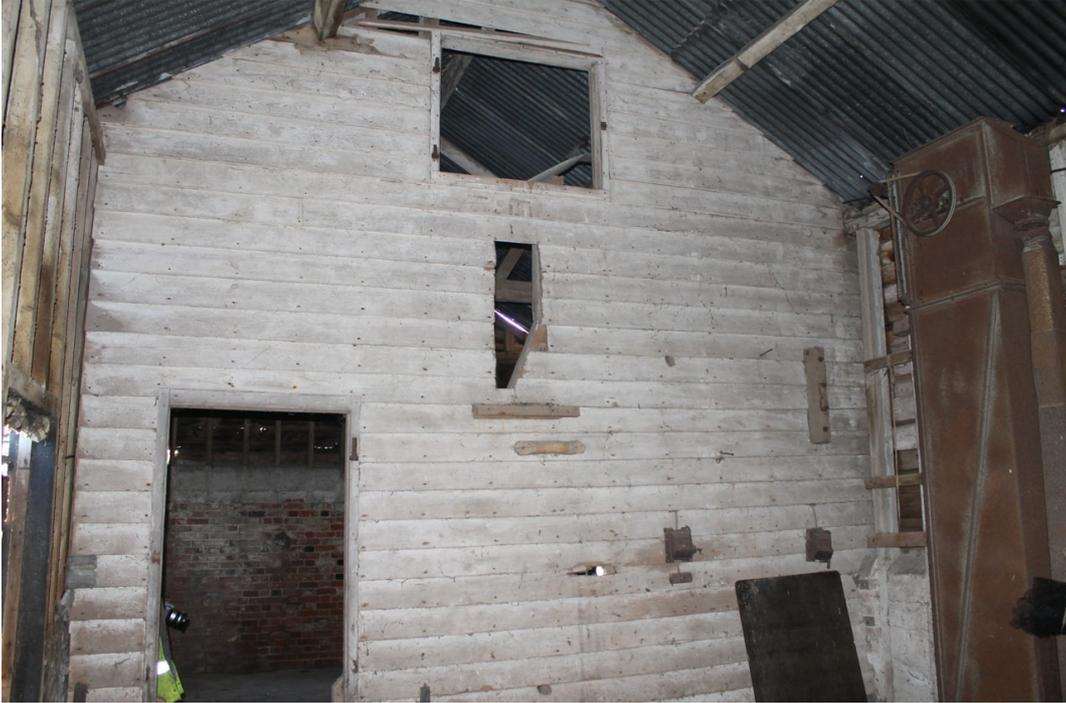
Photograph 25 Weatherboard covering the north-east frame of bays 9 and 10, an earlier structure incorporated into the barn, viewed from bay 8. The frames of bay 7 and 8 are built up against this early 19th-century structure - view south-west.

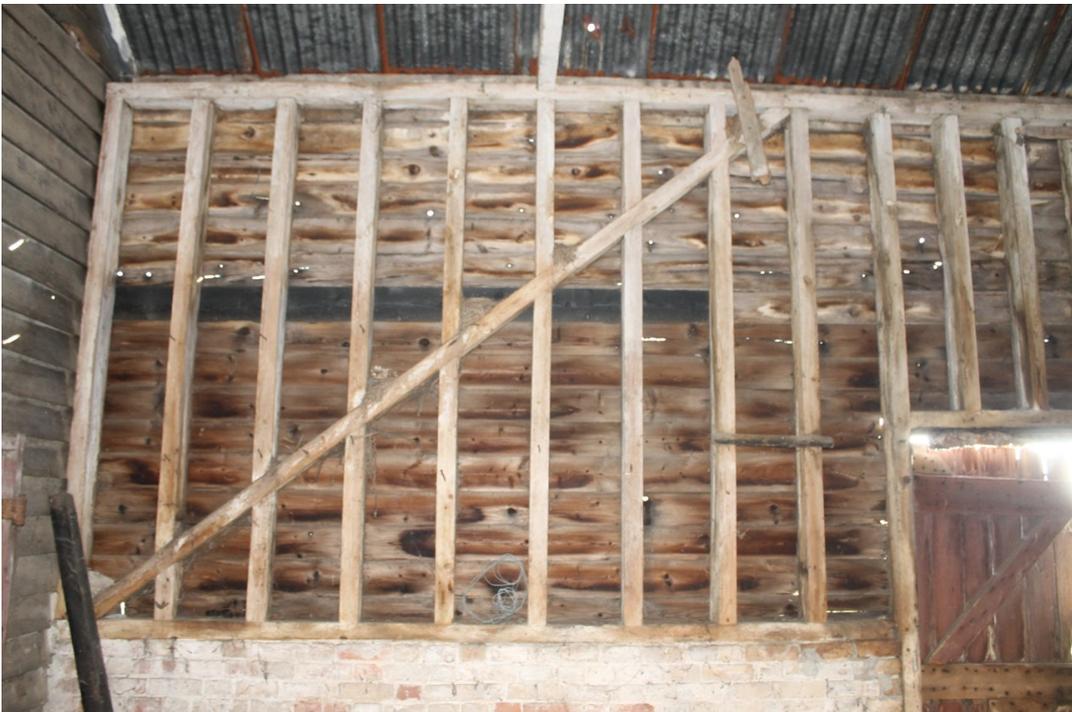
Photograph 26 South-east framing of bays 7 and 8 showing the frame built up against the exterior of the main barn and sitting on a much taller brick plinth, which is probably an earlier farmyard wall. The doorway to the right appears to be an original opening through this wall. The primary bracing crosses both bays – view south-east.

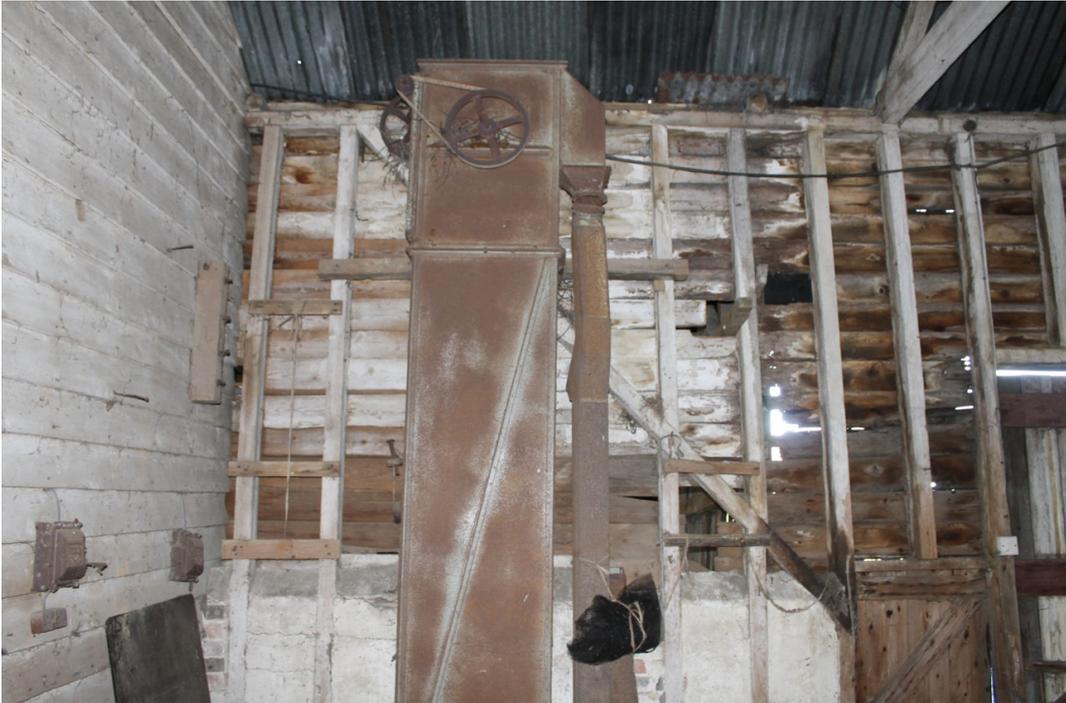
Photograph 27 North-west framing of bays 8 and 7 showing the frame built up against the exterior of bays 9 and 10. The primary bracing crosses both bays. The machinery is a grain hoist and probably dates to the mid 20th century – view west.
