**Historic building recording
of a barn at Cowlass Hall Farm,
Radwinter End,
Radwinter, Essex,
February 2017**

Planning reference: UTT/2063/15/FUL

CAT Report 1087
July 2017

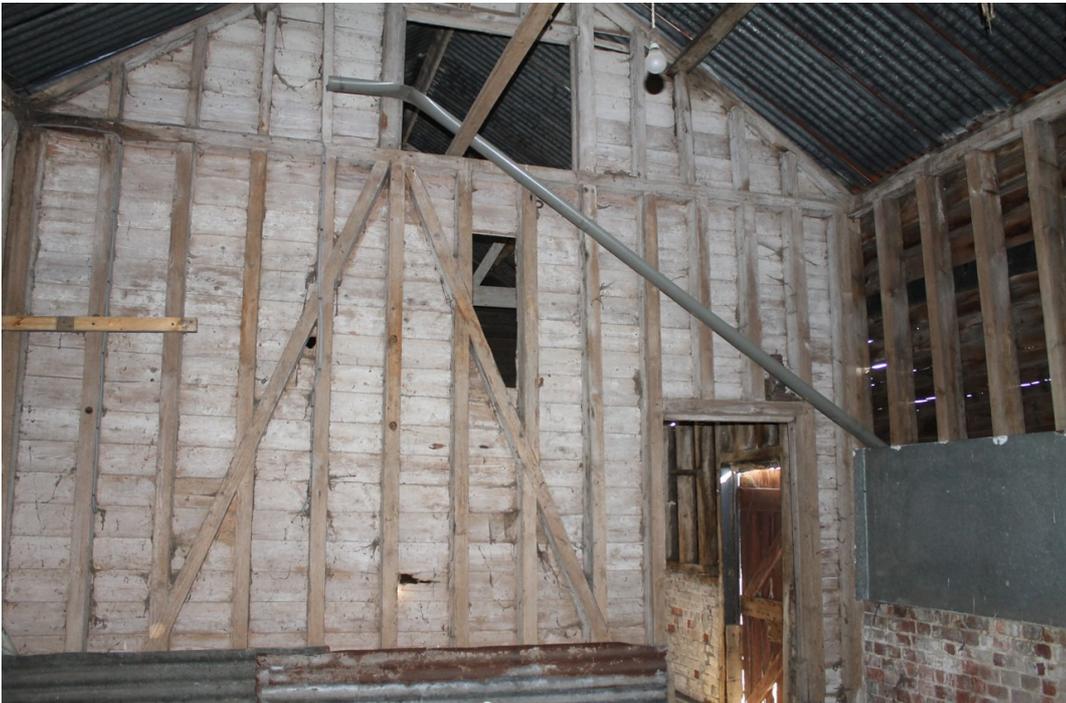
Photograph 28 South-west framing of bay 9, with the locations of the primary bracing indicating that the doorway to the right is an original feature – view north-east.

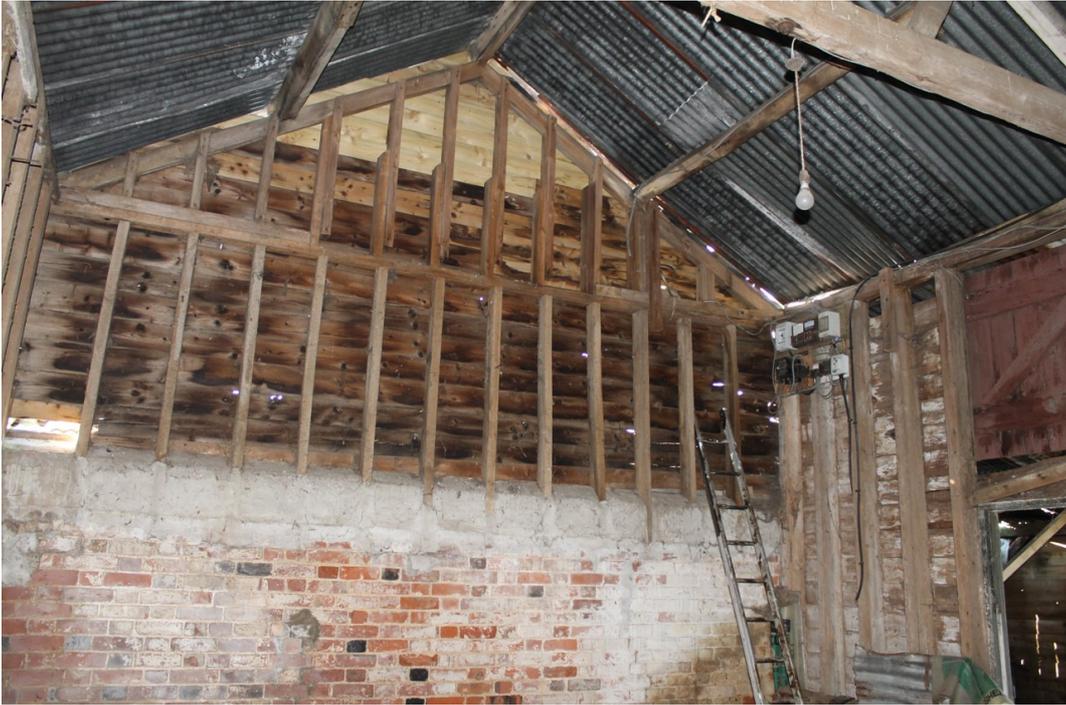
Photograph 29 South-east frame of bay 10, constructed upon the rear wall of the 18th-century brick stable block – view south-west.
