**Historic building recording at
Manor House Farm, Brentwood Road,
Bulphan, Upminster, Essex, RM14 3TJ**

CAT project ref.: 16/02f
NGR: TQ 64515 86120 (centre)
Planning reference: 15/00183/FUL
EHER ref: THMF16
OASIS reference: colchest3-242911

CAT Report 1107
June 2017

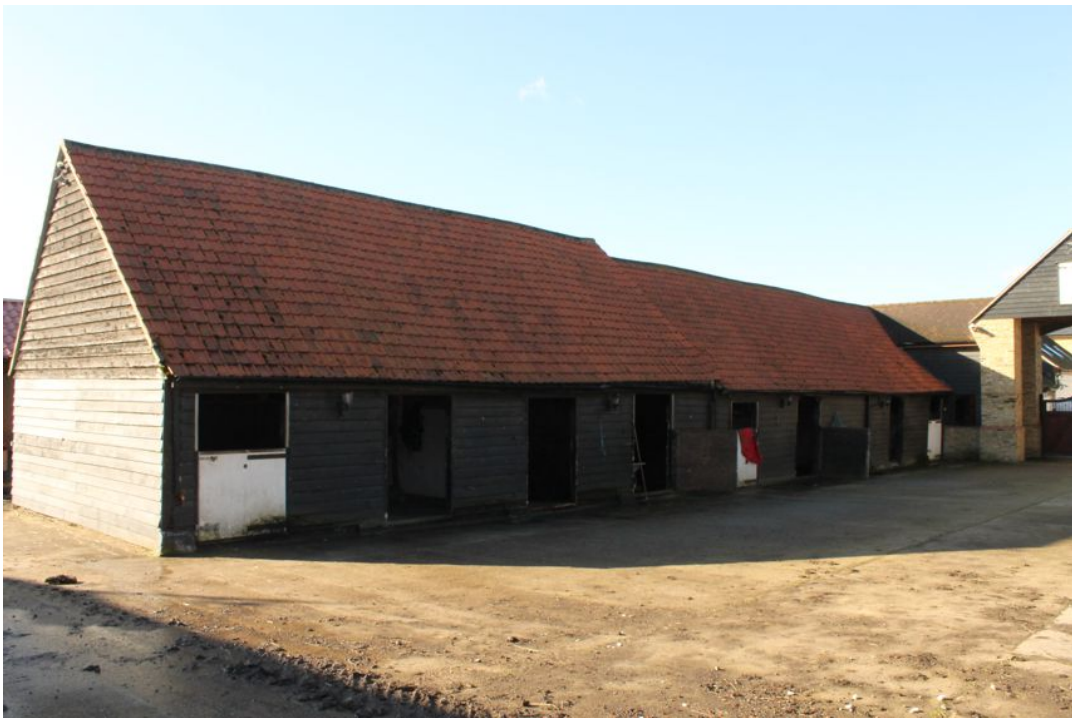
The northern elevation of the building has five vertically planked half-stable doors attached with metal hinges (Photograph 1). Each door leads into a separate stall within the building and has a corresponding electric light adjacent to it. Several hooks and attachments are also present on this elevation, which presumably relates to the building's use as a stable.

Photograph 1 Building A northern elevation. Photograph taken facing south-west.

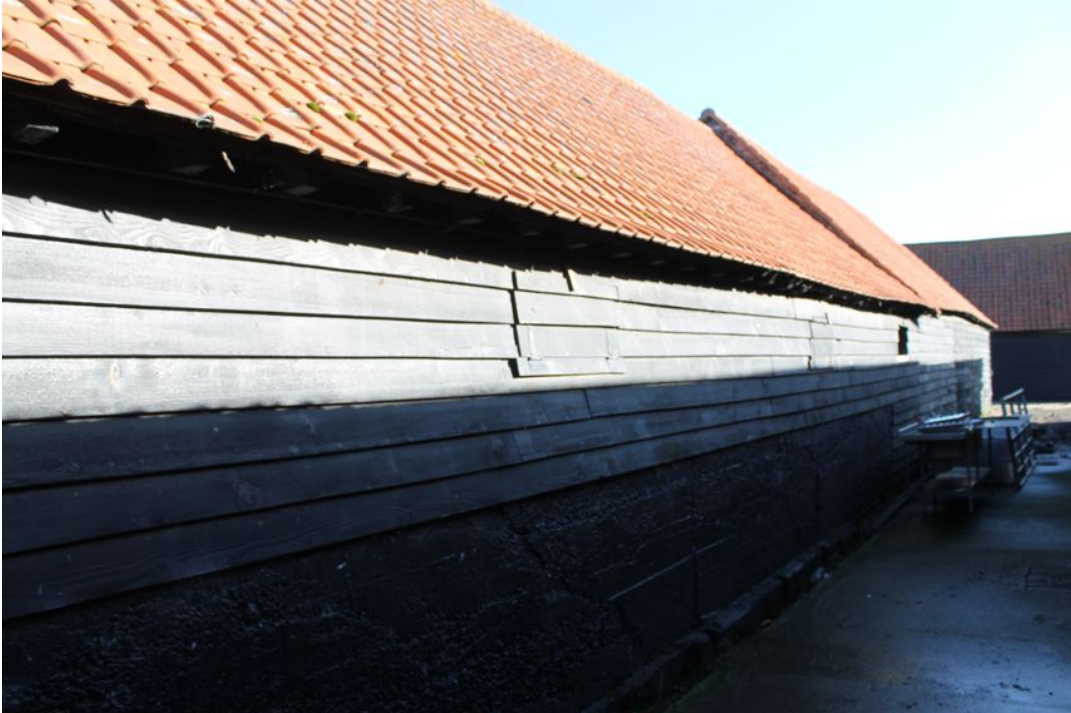
The southern elevation has five small wooden awning shutters for ventilation, one for each stall (Photograph 2).

Photograph 2 Building A southern elevation, showing wooden awning shutters.
Photograph taken facing north-east.

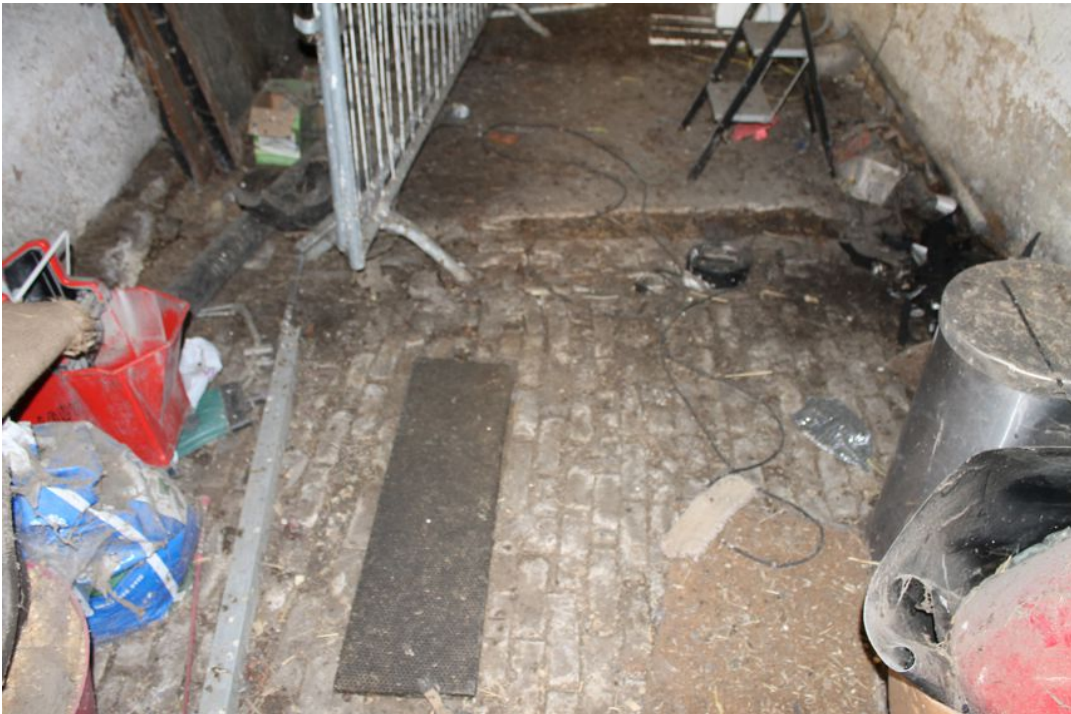
Photograph 3 Building A westernmost stall, showing pavior brick flooring.
Photograph taken facing south.

none due to the lack of tie beams and principal posts). The floor of the building is made of small concrete blocks with channels for water, except in the very westernmost stall, where half of the floor is made of brick paviors (Photograph 3).

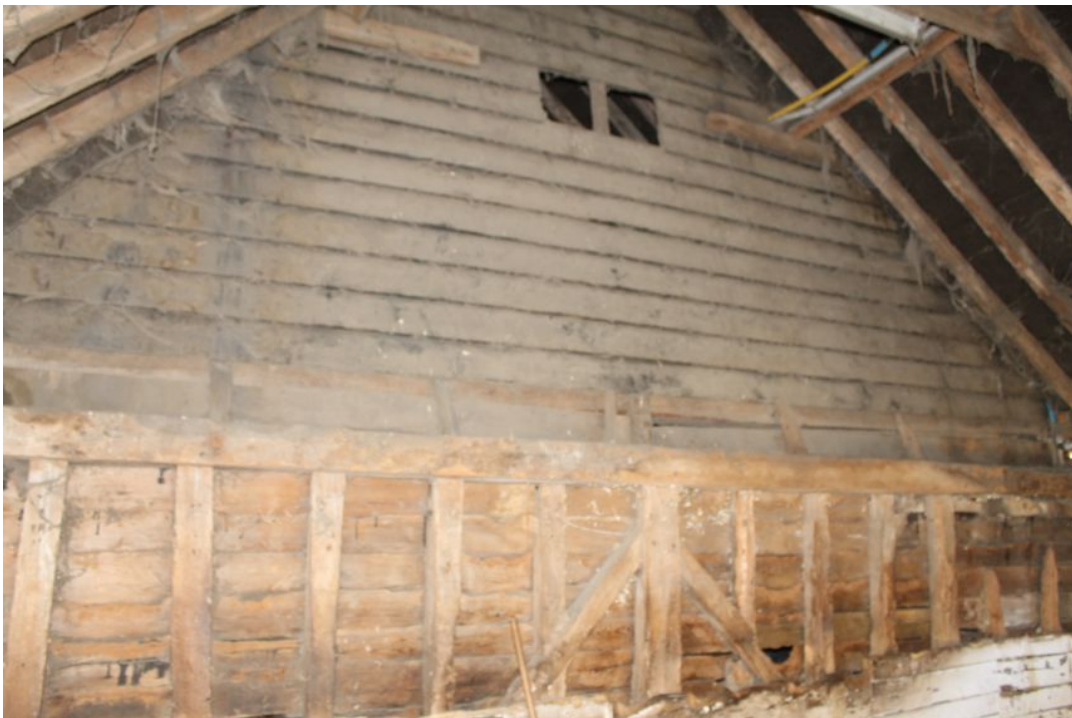
The timber-frames on the east and west ends of the building have two primary braces supporting the central stud. At the western end, the studs are supported in concrete. At the eastern end, of the building the gable has been entirely removed and the roof is supported by timber nailed onto the gable of the adjacent extension (A2) (Photograph 4).

Photograph 4 Original eastern gable end of Building A, showing missing gable and beginning of extension (A2). Photograph taken facing south-east.

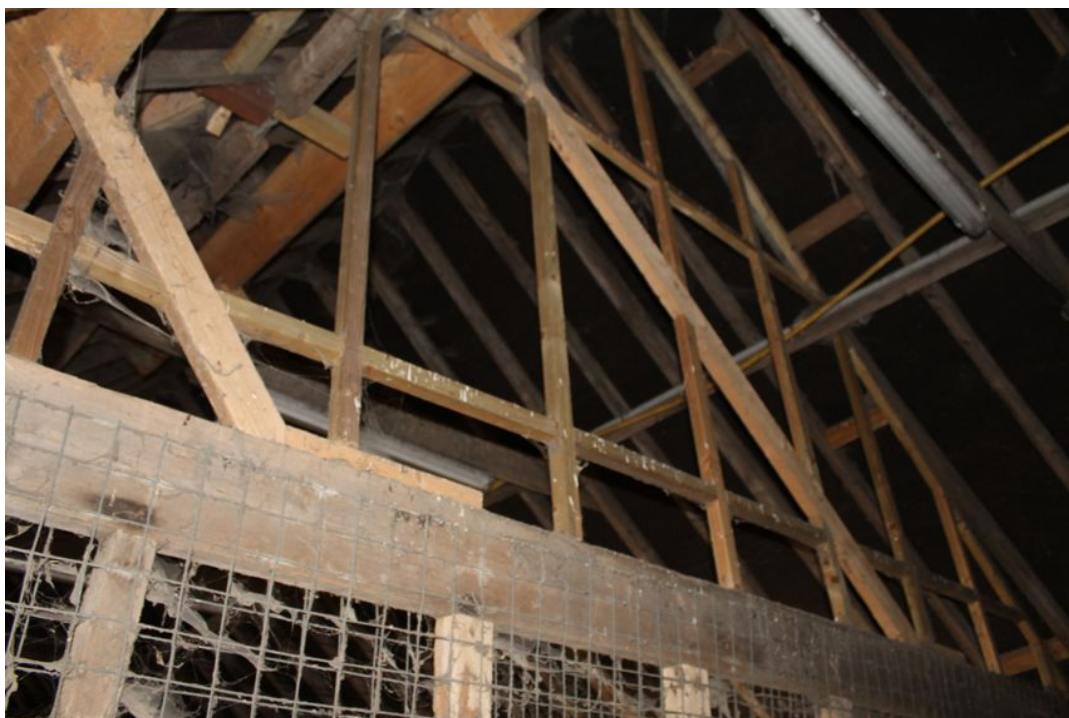
The roof is a collar-rafter roof, supported by one clasped purlin on each pitch, and a series of collars along the length of the building. There are no trusses, and as a result no bays but, at some divisions between the stalls, there are a series of modern timbers providing additional support (Photograph 5).

Photograph 5 Building A, showing modern timbers used to support the roof in the absence of a tie-beam. Photograph taken facing south-east.

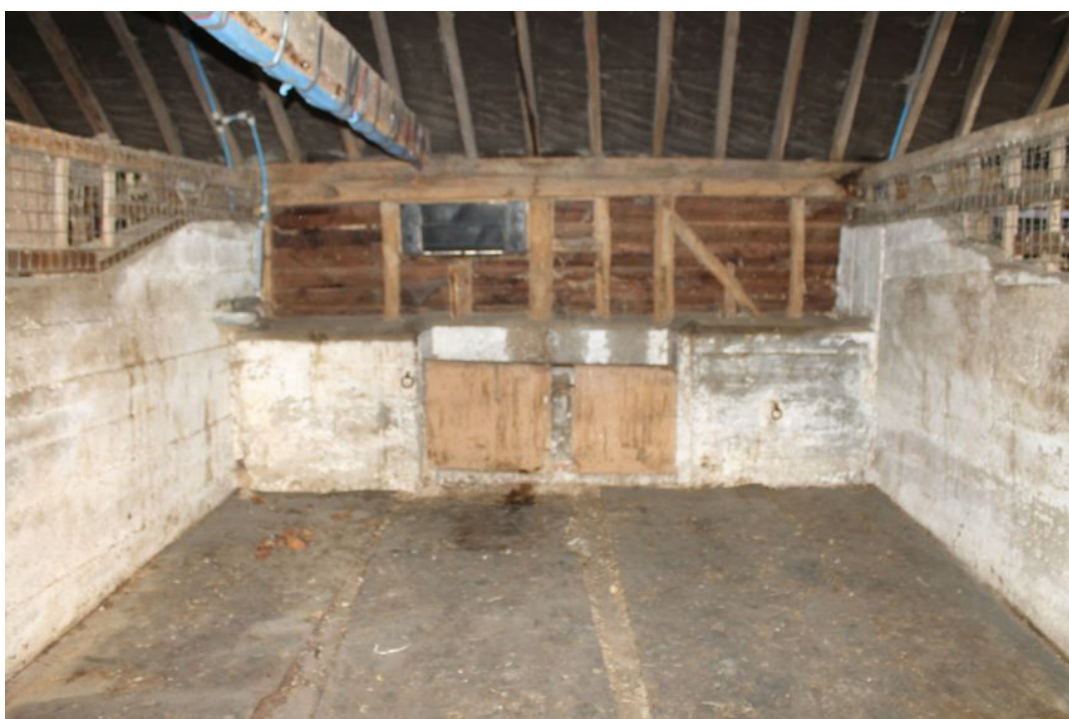
Each stall, except the westernmost one, has a concrete feeding-trough and hay rack on the southern wall (Photograph 6).

Photograph 6 Central stall in Building A, with concrete feeding troughs and hay racks. Photograph taken facing south.

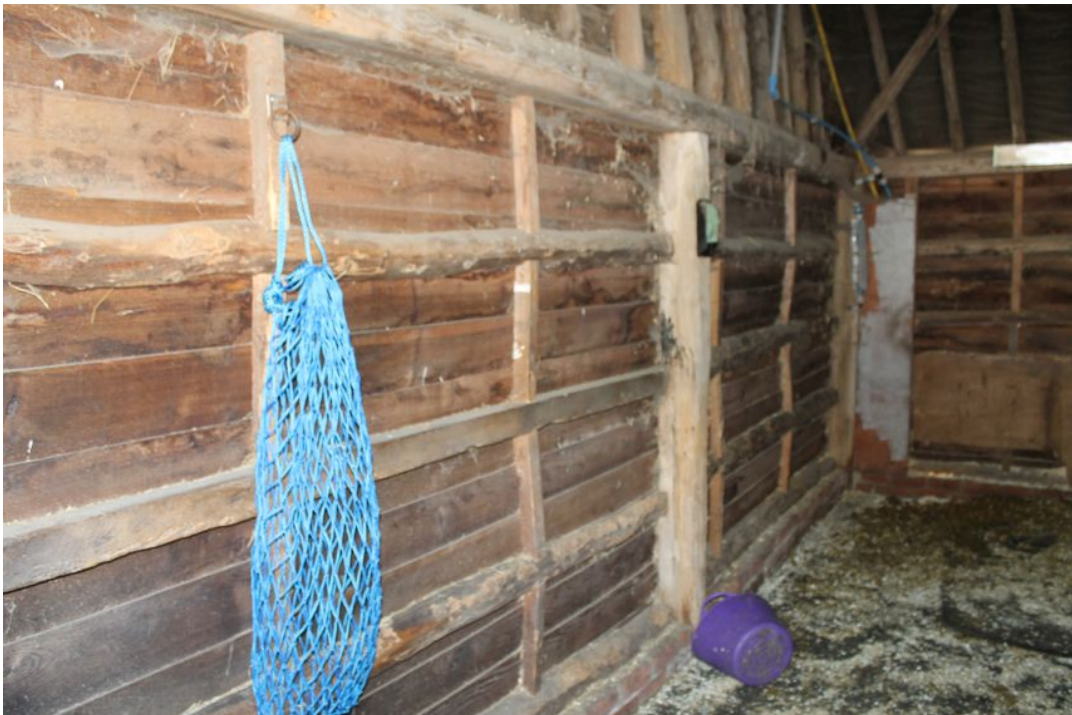
Photograph 7 Detail of wall construction in the extension to Building A, showing rails and separate studs jointed between them. Photograph taken facing south-west.

The timber walls are constructed of rails running between the primary-posts at each bay division, with studs jointed between them (Photograph 7). Some of the rails are hand-sawn whereas all the studs are machine-cut.

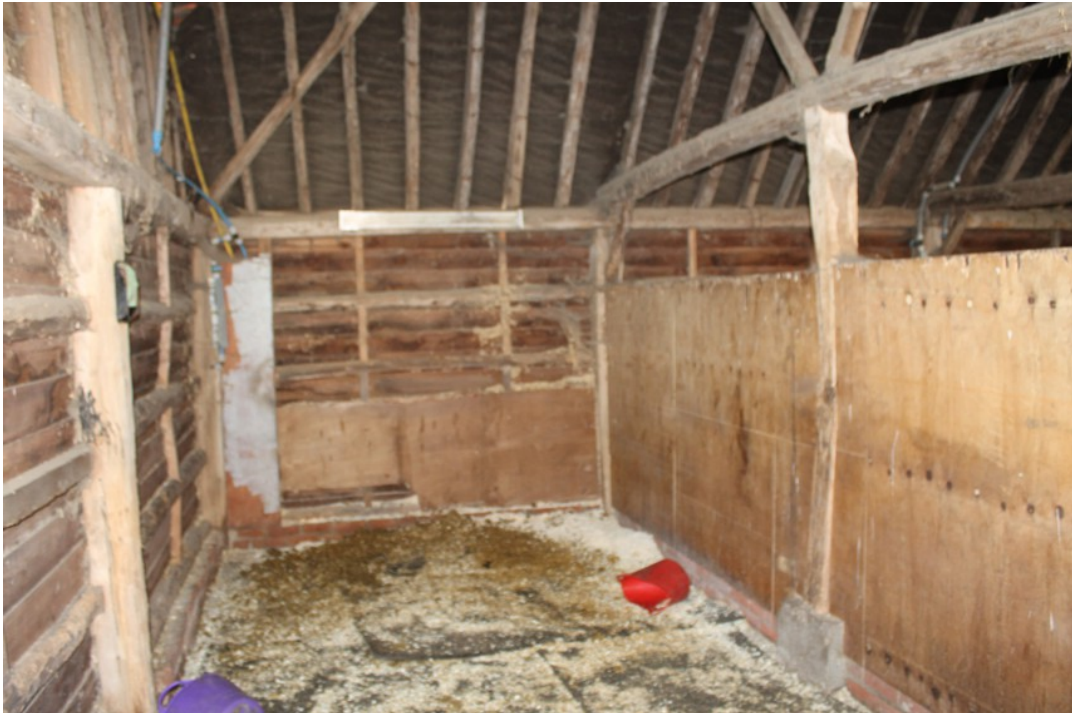
The east and west elevations of the extension have a primary-post in the centre, supporting the wall-plate (Photograph 7). This configuration is mirrored in the trusses between the bays, where there are central-posts, embedded in concrete, supporting the tie-beams (Photograph 8).

Photograph 8 Westernmost stall in the extension to Building A. Photograph taken facing south.

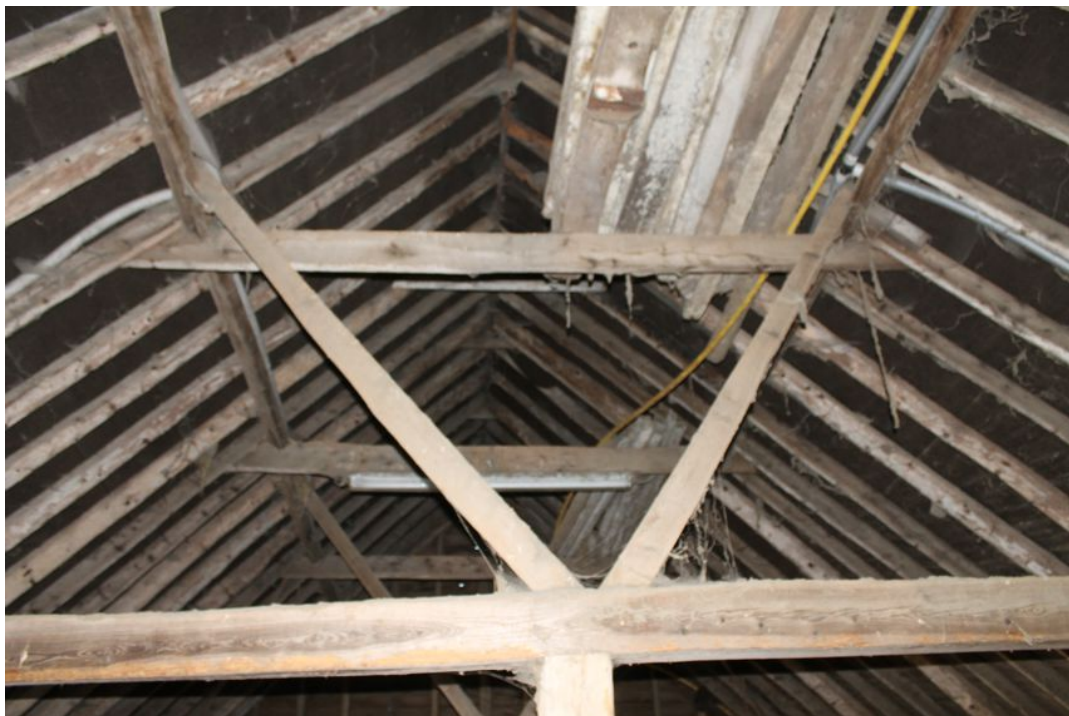
The trusses themselves are of simple construction, with a tie-beam supported on the primary posts and straight braces between bays and a central post beneath (see above). Two inclined braces rise from this tie-beam to the single purlin on each pitch (Photograph 9). Near to each truss there is a collar clasp the purlin, although the inclined braces are not attached to it. As well as the support of the trusses, the roof has wind braces at its eastern end. All the timbers making up the trusses and the roof are machine-cut.

Photograph 9 Truss in extension to Building A. Photograph taken facing east.

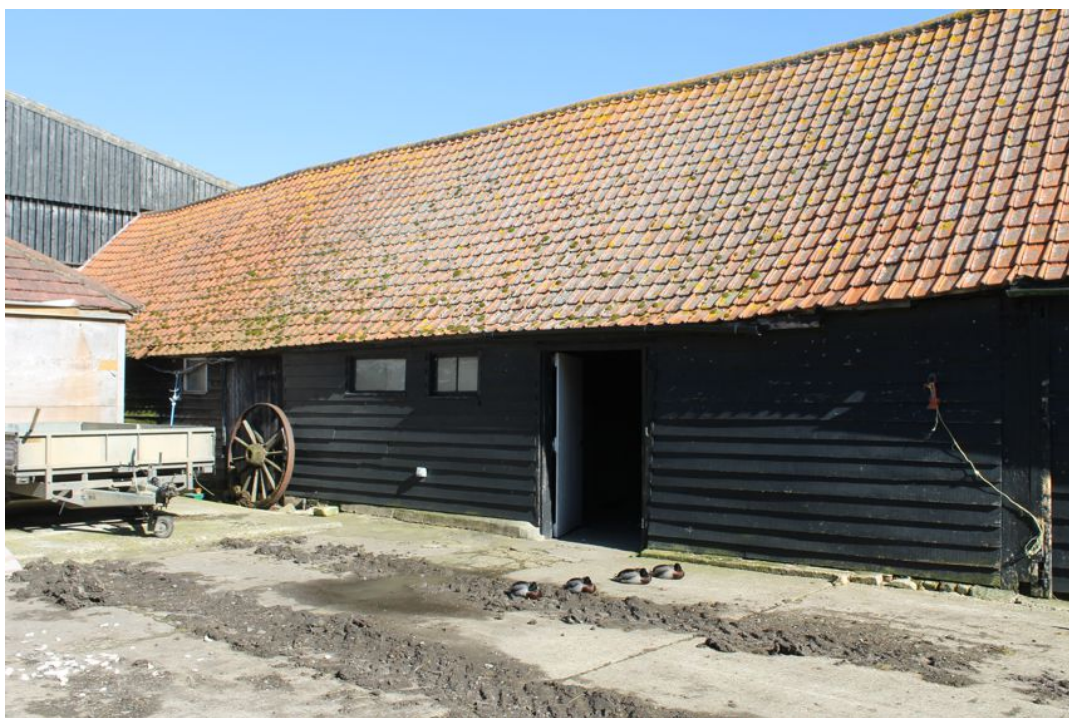
The western elevation of the building has two vertically-planked doors attached with metal hinges. Also on the western elevation are five inserted small wooden-framed awning windows (Photograph 10), the northern two of which are blocked from the inside.

Photograph 10 Western elevation of Building B. Photograph taken facing north-east.

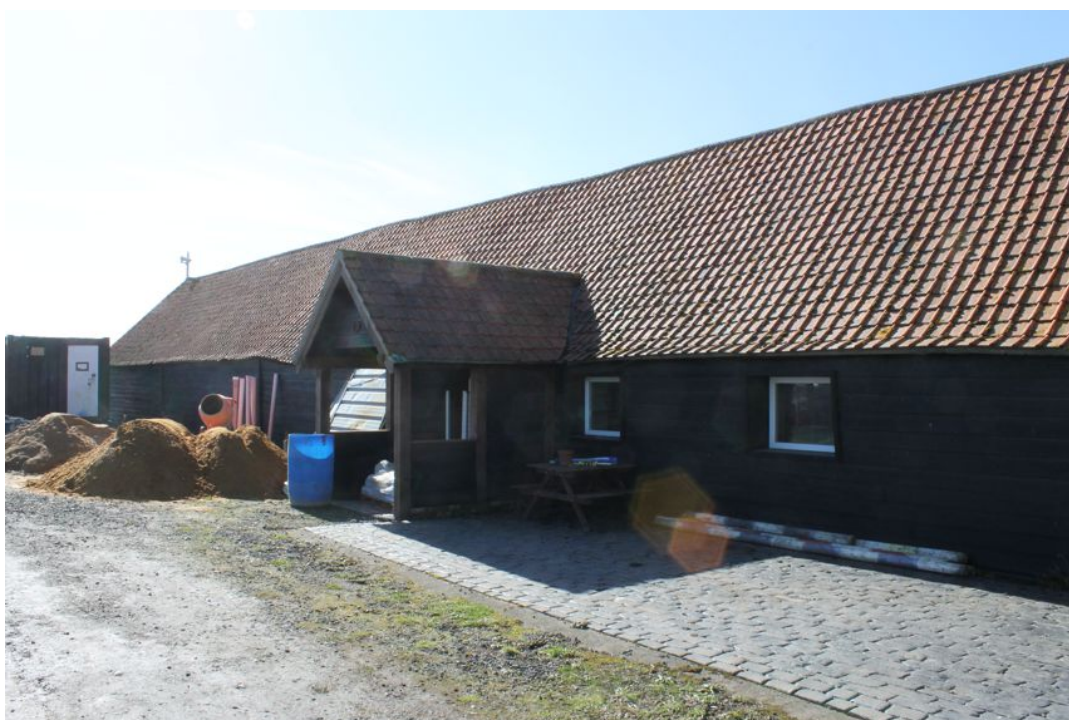
The eastern elevation of the building has three modern plastic-framed windows, and a porch leading to a modern doorway. (Photograph 11).

Photograph 11 Eastern elevation of Building B. Photograph taken facing south-west.

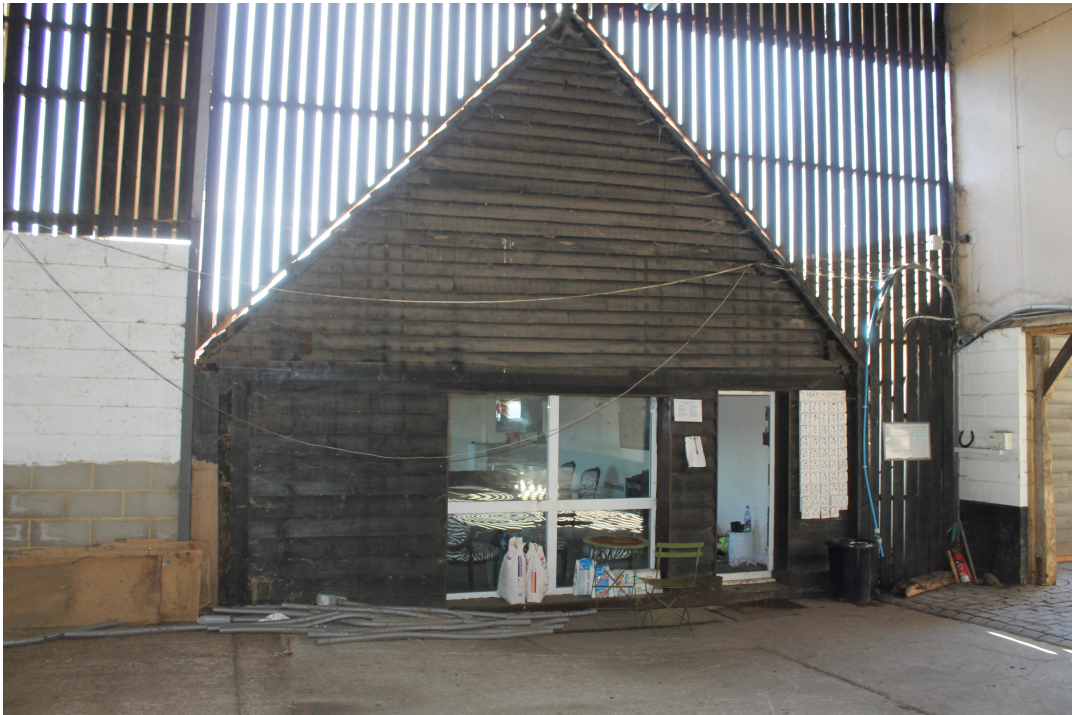
The northern elevation of the building has a large inserted modern plastic-framed window and a similarly modern door inserted into it, but no other features (Photograph 12).

Photograph 12 Northern elevation of Building B. Photograph taken facing south.

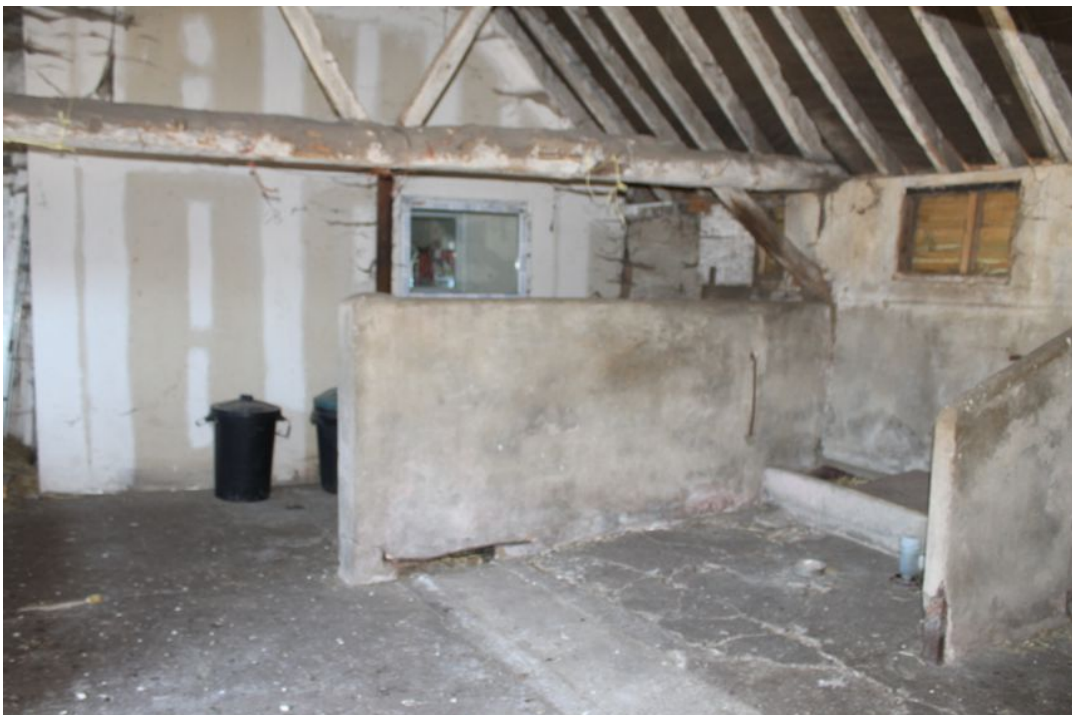
The two doorways on the west elevation lead into what is currently a three-bay storage area (Photograph 13). This area has a concrete floor with drainage grooves cut into it, and

Photograph 13 Building B interior. Photograph taken facing north.

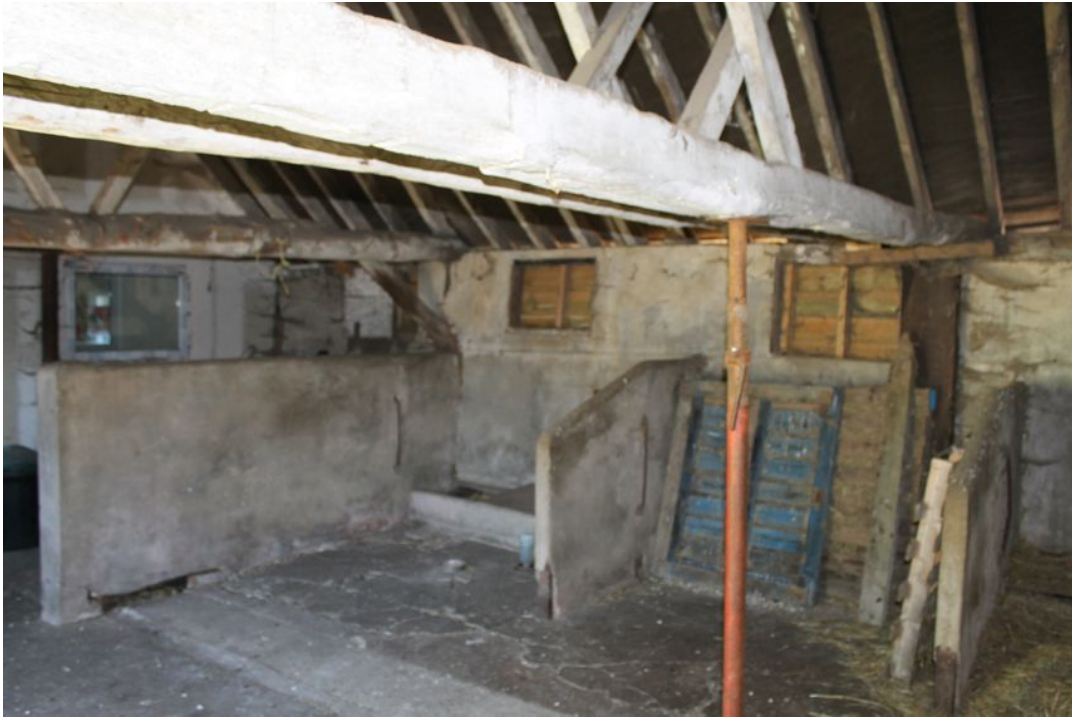
several concrete divisions, feeding troughs and hay racks (similar to Building A) suggesting it was originally used to shelter animals (Photograph 14). There is wooden panelling over much of the timber-frame, with only primary posts left visible. All the primary-posts in the building are machine-cut.

Photograph 14 Building B interior. Photograph taken facing north-east.

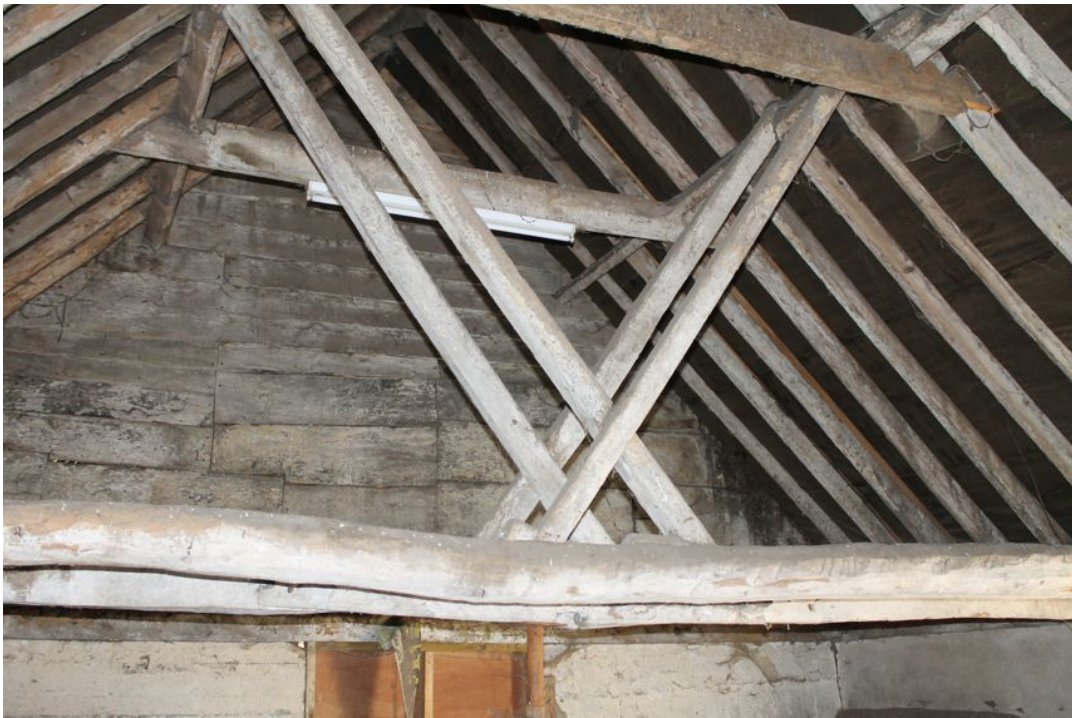
The southernmost tie-beam in the building has been completely removed and replaced with two new tie-beams and scissor braces (Photograph 15). The replacement tie-beams are hand-sawn.

Photograph 15 Replacement scissor brace trusses in Building B. Photograph taken facing south.

It also seems clear that the two buildings and their extensions have been re-roofed and had their weatherboarding re-done at some point in their history, perhaps quite recently. It is possible that this re-roofing also entailed the replacement and rebuilding of several roof trusses in Building B, including the two with scissor bracing (Photograph 15) although this is by no means certain.

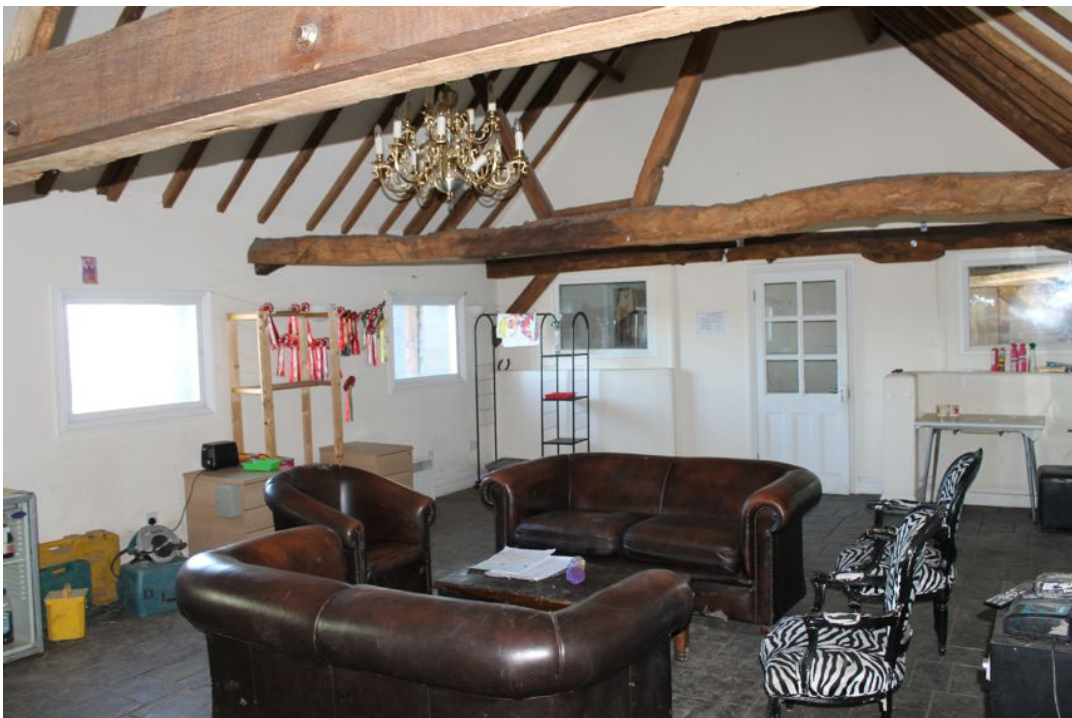
The doorway on the north elevation leads into a recently-renovated three bay living area (Photograph 16), which is divided from the storage area by a chipboard wall. This modern living area has a tiled floor and an inserted chipboard wall and ceiling covering large portions of the timber-frame. This section has three tie-beams, two of which are hand-sawn

Photograph 16 Modern inserted living area in north half of Building B. Photograph taken facing south-east.

Half of the original structure of Building B (B1) has been heavily altered with the insertion of a modern chipboard walled living area (Photograph 16). The concrete-built feeding troughs, stall divisions and hay racks in the other half of the building, however, leave little doubt that it was originally used for sheltering animals.

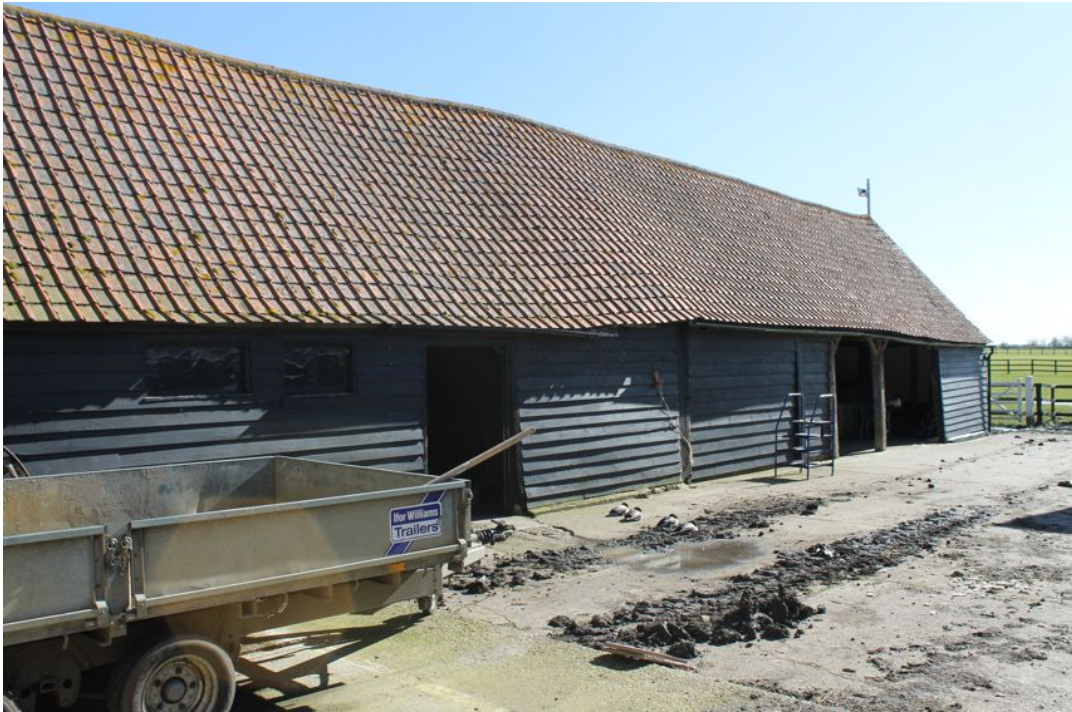
On its western elevation is an opening with no door, spanning one-and-a-half bays (Photograph 17). There are no other features on any of its elevations.

Photograph 17 Western elevation of Building B and its extension. Photograph taken facing south-east.

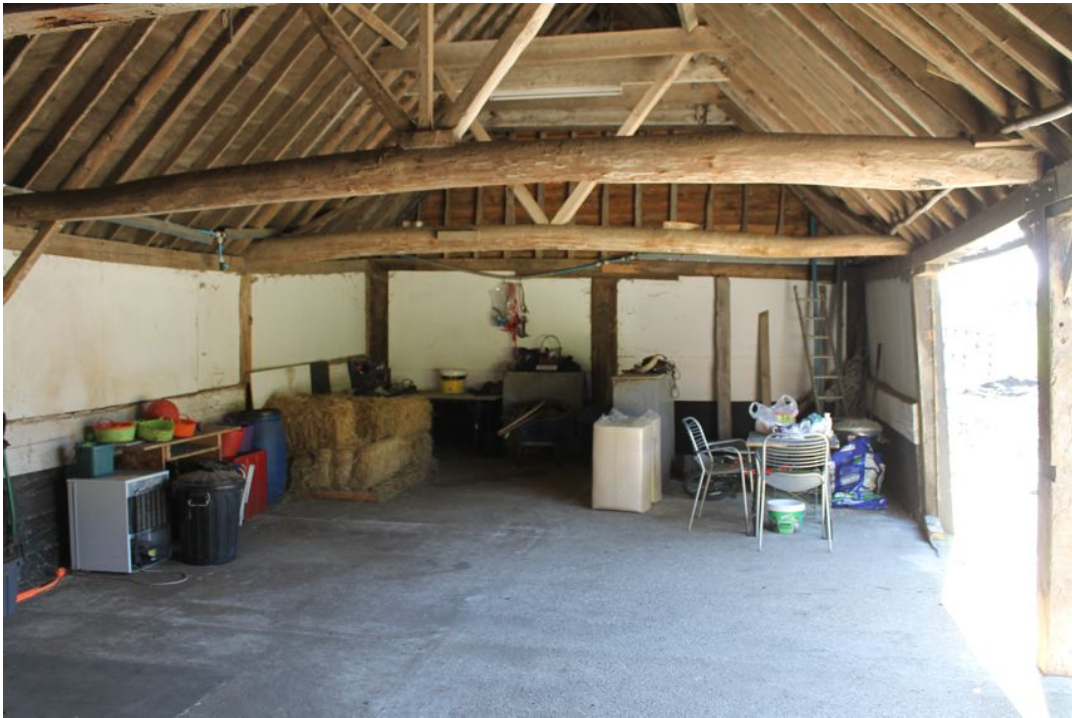
Photograph 18 Interior of extension of Building B. Photograph taken facing south.

As in the original building (see above), there is wooden panelling over much of the timber-frame, leaving only primary posts visible (Photograph 18). The southern elevation of the structure has a primary-post in its centre, supporting the wall-plate above.

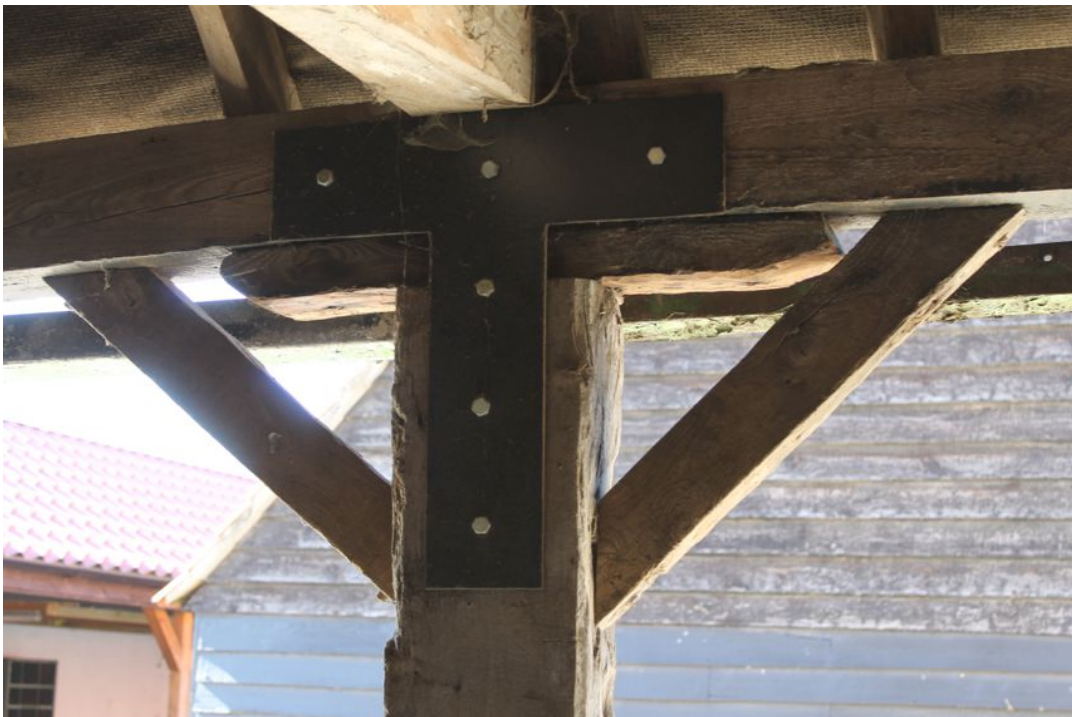
Photograph 19 Steel bracing supporting primary-post in entrance to Building B extension. Photograph taken facing west.

The central primary-post supporting the wall-plate above the large opening in the western elevation has been reinforced with a steel bracket and bolts (Photograph 19).
