**Historic building recording at  
5 and 6 St Nicholas Street (formerly 'Jacks'),  
Colchester  
CO1 1LB**

**September 2017**

CAT project ref.: 17/05i  
NGR: TL 9982 2517 (centre)  
Planning reference: 161296  
CHER event number: ECC4001  
Colchester Museum accession number: COLEM 2017.71  
OASIS reference: colchest3-285635

**CAT Report 1222**  
March 2018

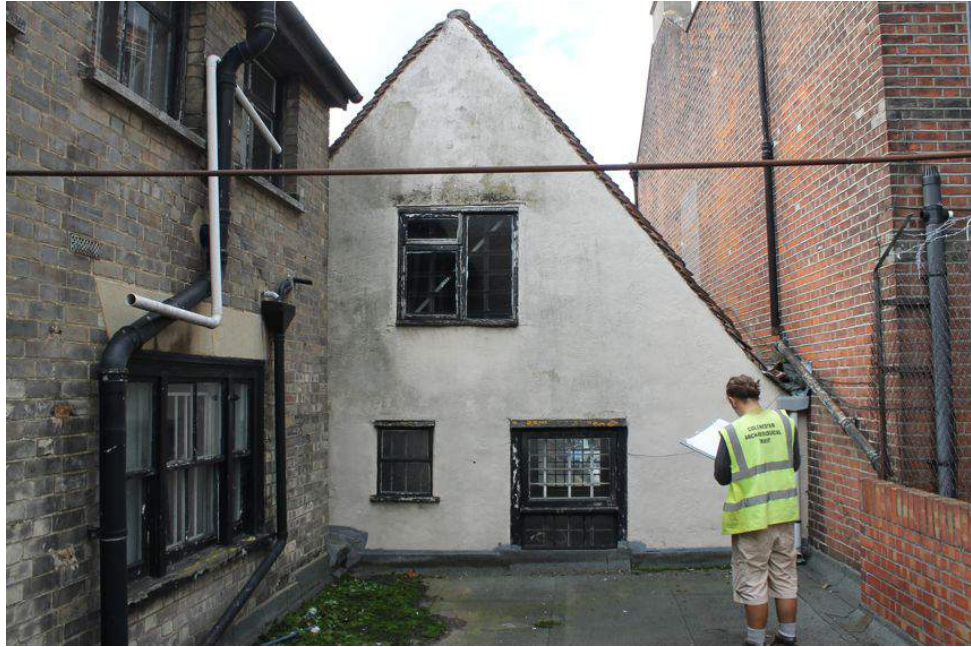
The eastern gable-end of the building is rendered over and contains four inserted wooden-framed windows of varying sizes (Photograph 3). The lowest of these three is partially obscured by the roof of Building E. Within Building E the surviving first-floor eastern elevation of Building A has been stripped, exposing the original timber-frame as well as modern timbers nailed onto it. Nothing remains of the ground-floor elevation.

**Photograph 3** Eastern elevation of Building A. Photograph taken facing west.

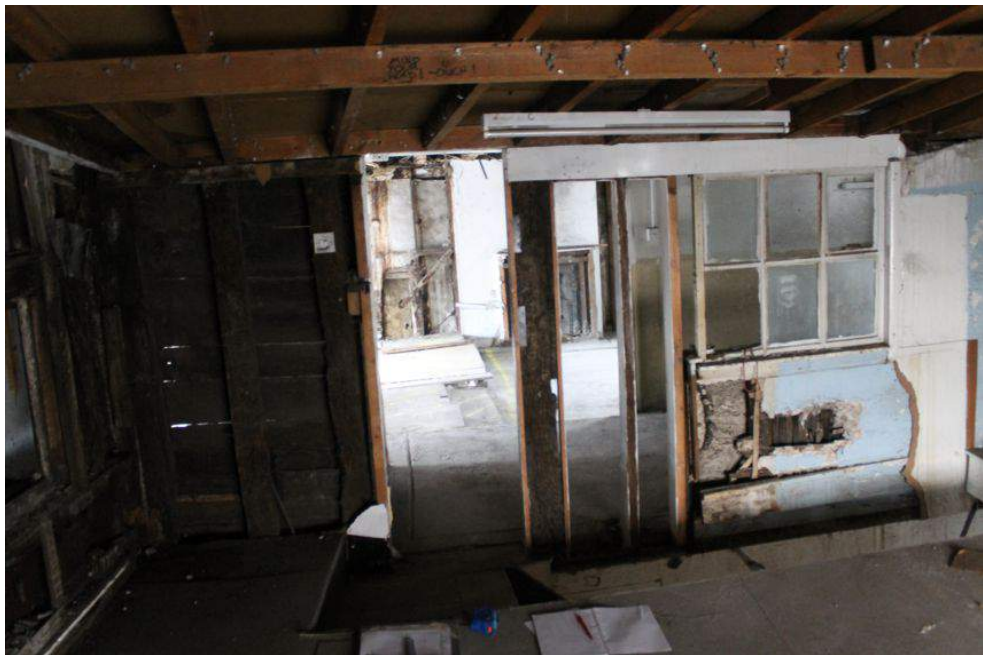
The southern elevation of Building A does not survive at the ground-floor level, but at the first-floor there is an inserted wooden-framed six-light fixed window (Photograph 4). An entrance has also been formed adjacent to this window by removing a stud. Some of the plaster has been removed below the inserted window on this elevation, exposing a section of lath and plaster. Adjacent to Building B on the first-floor, most of the exterior is covered with modern plasterboard, with the exception of a bricked up and plastered over doorway between the two structures (A and B).

**Photograph 4** Southern exterior elevation of the first-floor of Building A, with exposed lath and plaster below inserted window. Photograph taken inside Building C, facing north.

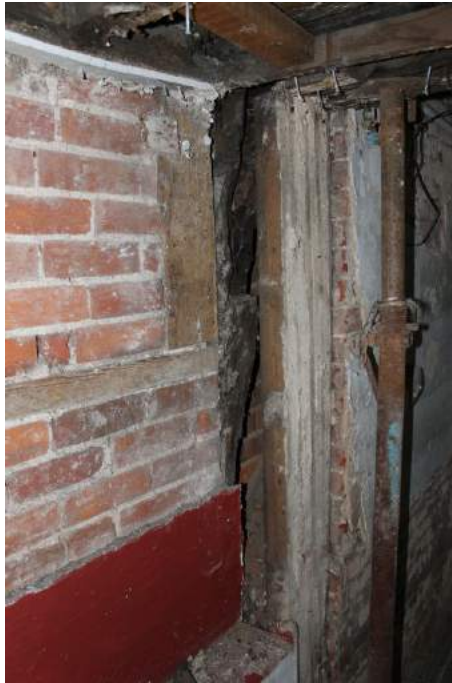
Three of the four corner-posts are still present, but none survive to ground level, either being supported by brickwork, or, in some cases, not being supported at all (Photograph 7 and 8). The corner-post in the south-west corner is not visible, and has probably been replaced by a metal girder (see Building B below). No studs survive. Only one small section of the northern sill-beam survives. Beneath this is a section of brick plinth that may be original to the building: it is in very poor condition, with three courses of indeterminate bonding and bricks measuring 170 x 100 x 60mm (Photograph 9).

**Photograph 7** Remains of north-east corner-post of Building A at the ground floor. Photograph taken facing north-east.

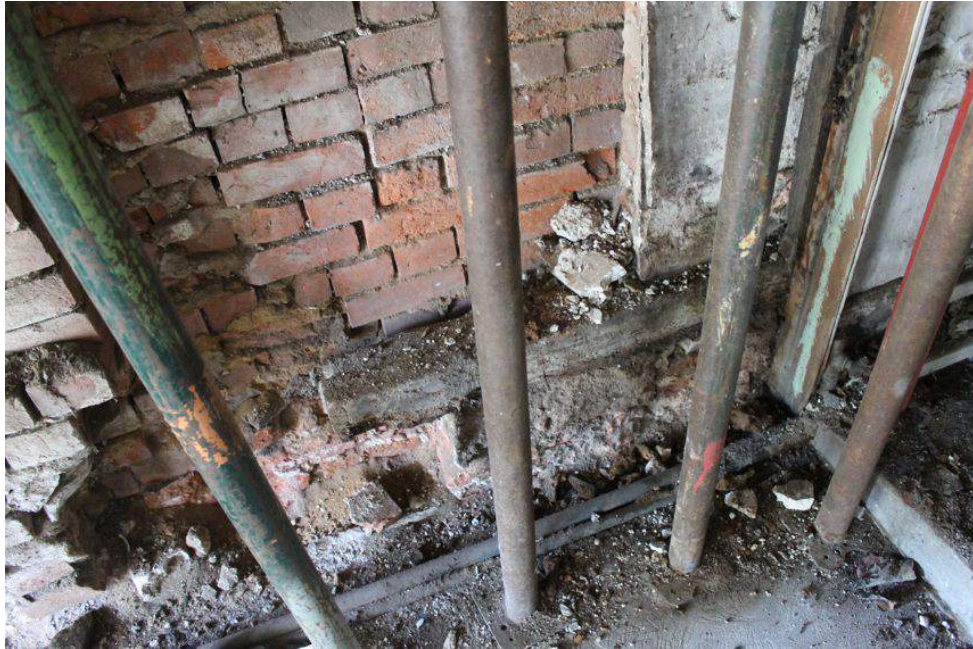
**Photograph 9** Remains of sill-beam and brick plinth on northern elevation of Building A. Photograph taken facing north.

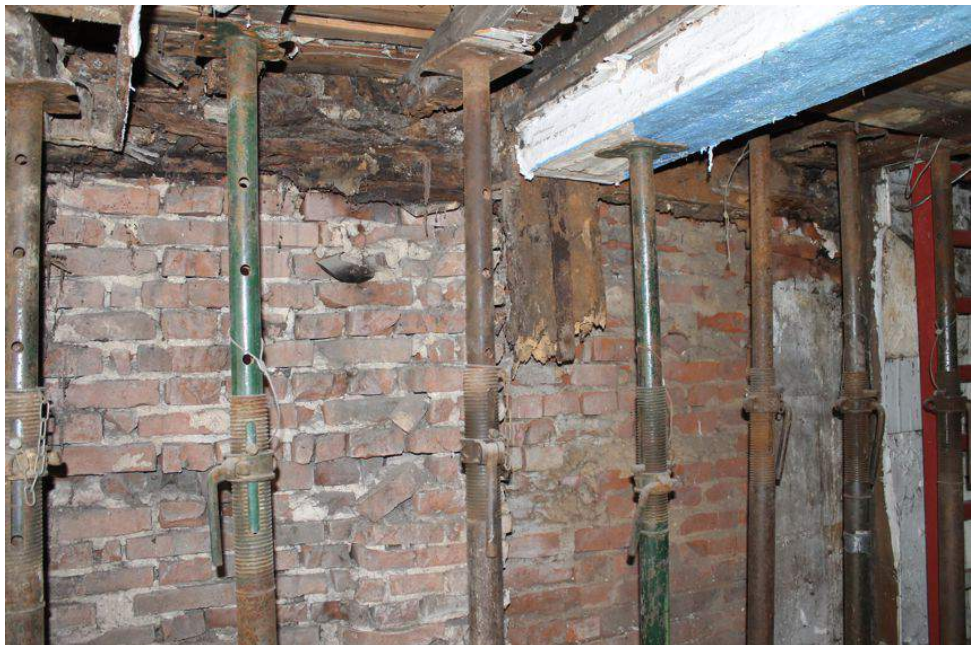
**Photograph 10** Remains of principal-post on ground-floor on the northern elevation of Building A. Underpinning of girding-beam by brickwork also visible. Photograph taken facing north.

Also on the northern elevation is an inserted red brick chimney stack and blocked fireplace. Evidence of this chimney stack is seen again on the first- and second-floors, but its associated chimney is not longer extant. The principal-post on the northern elevation is broken and does not reach ground level (Photograph 10).

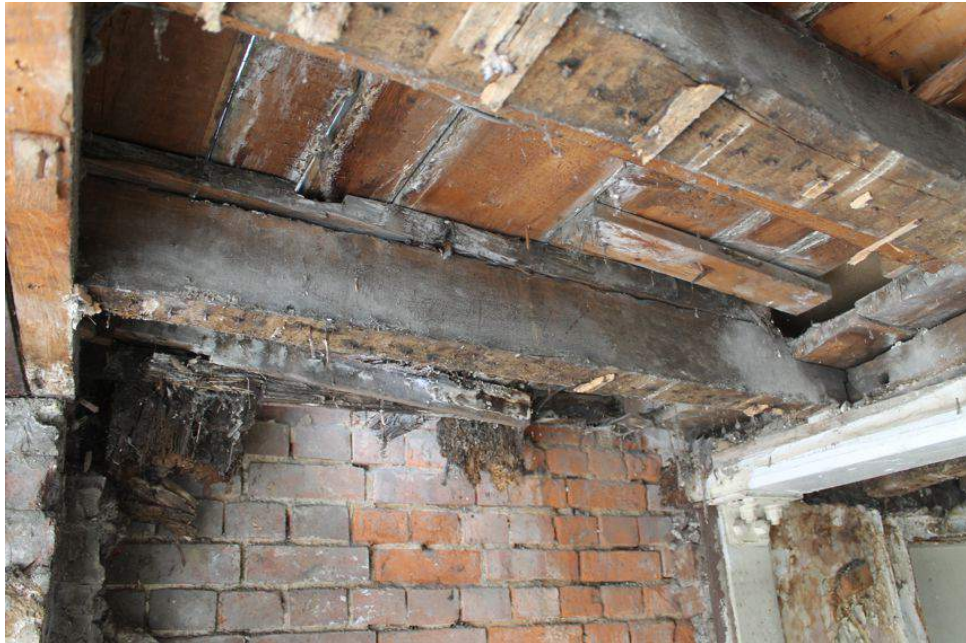
Towards the west of the north elevation, adjacent to the damaged north-west corner-post and in the location of the section of missing girding-beam, a timber is visible projecting from the floor above (Photograph 11).

**Photograph 11** Remains of current corner-post (left) and possible original corner-post projecting from first-floor (centre) on ground-floor on the northern elevation of Building A. Photograph taken facing north.

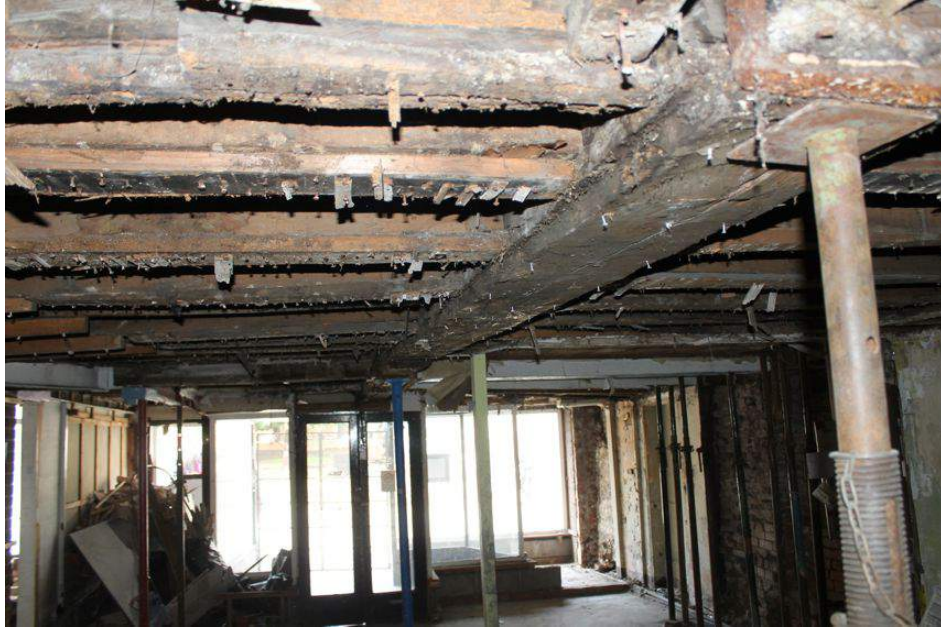
elevations when they were extant (Photograph 14). It is now supported by an iron strap at its eastern, and, presumably, western end, although the modern shop frontage masks any evidence of it on the western elevation. Jointed to the centre of this binding-beam are two more smaller chamfered binding-beams that are jointed to the principal-posts in the north and south elevations. There is a replacement modern post supporting these beams where they meet in the centre of the building.

**Photograph 14** Underside of first-floor in Building A. Chamfered binding-beam and supporting iron strap visible. Photograph taken facing west.

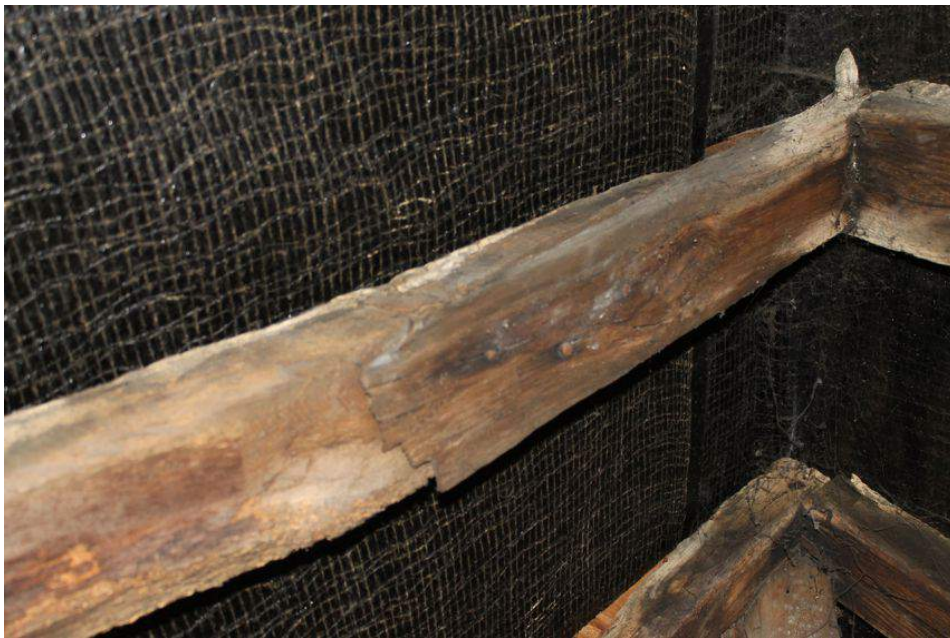
**Photograph 24** Detail of rafters in Building A. Peg at apex visible, along with scarf joint/repair to rafter.

Notably, on rafter pairs that have both sets of carpenter's marks, they don't match (Fig 6). Some rafters have very rudimentary splayed scarf joints, or possibly repairs (Photograph 24).

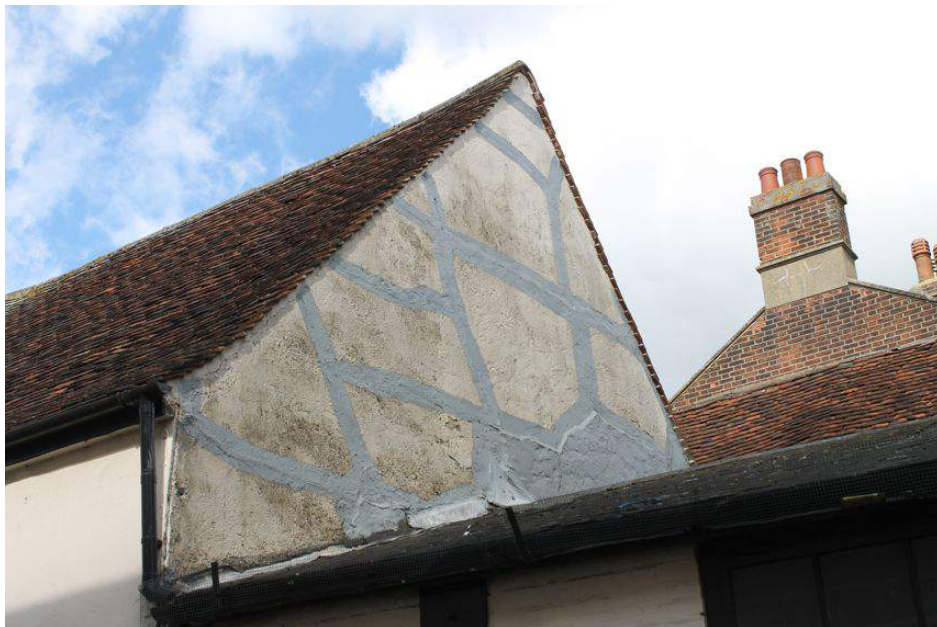
The eastern gable-end of the building is partially obscured by Building C, but what is visible is rendered over and featureless. Cracks in the lath and plaster rendering on this elevation have been repaired by later rendering with grey plaster (Photograph 38). Within Building C the surviving first-floor eastern elevation of Building B has been stripped, exposing the original timber-frame as well as an inserted doorway and wooden-framed window (Photograph 39). The entire first-floor has been raised, and is now supported on a reinforced steel girder, also visible on this elevation.

**Photograph 38** Eastern gable-end of Building B, showing repairs to plaster. Photograph taken facing north-west.

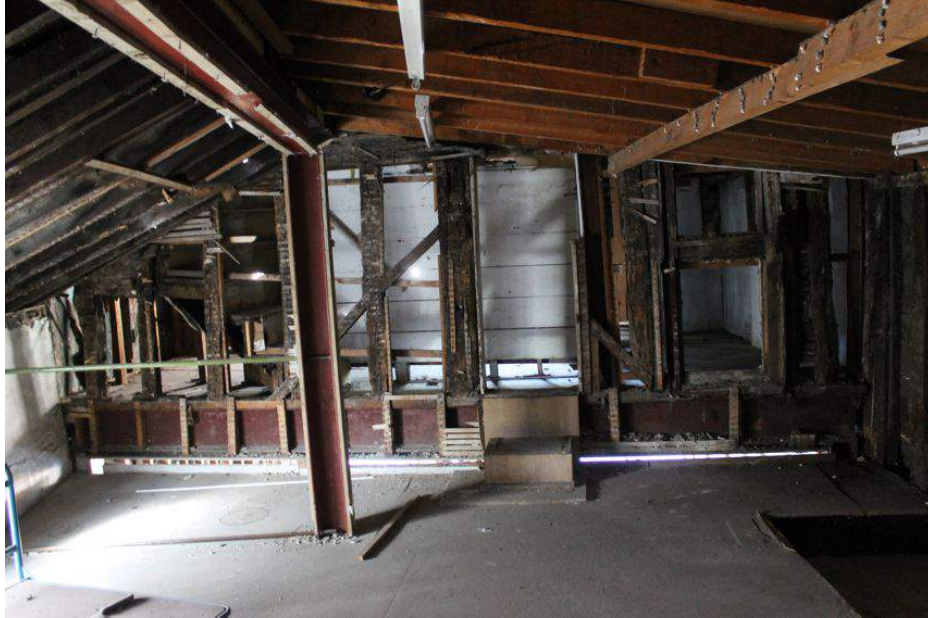
**Photograph 39** Eastern elevation of exterior of first-floor of Building B, showing inserted doorway and window-frame. Also visible is metal beam supporting raised first-floor. Photograph taken facing west.

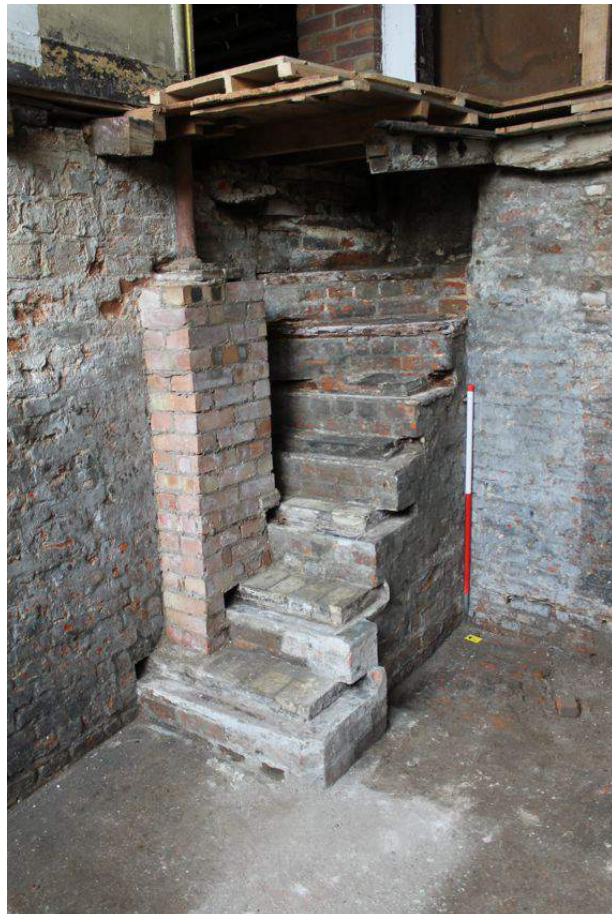
**Photograph 43** Brick stairway into cellar. Also visible is brick pillar added to support metal post. Photograph taken facing north-east.

that they were laid when the cellar was divided. The western half of the northern room has no paving bricks at all; the floor is just soil. A small strip to the west of the southern room is also unpaved (Fig 3). At the foot of the stairs on the northern elevation there is a concrete surface, presumably inserted because of the increased wear in this location (Photograph 43).

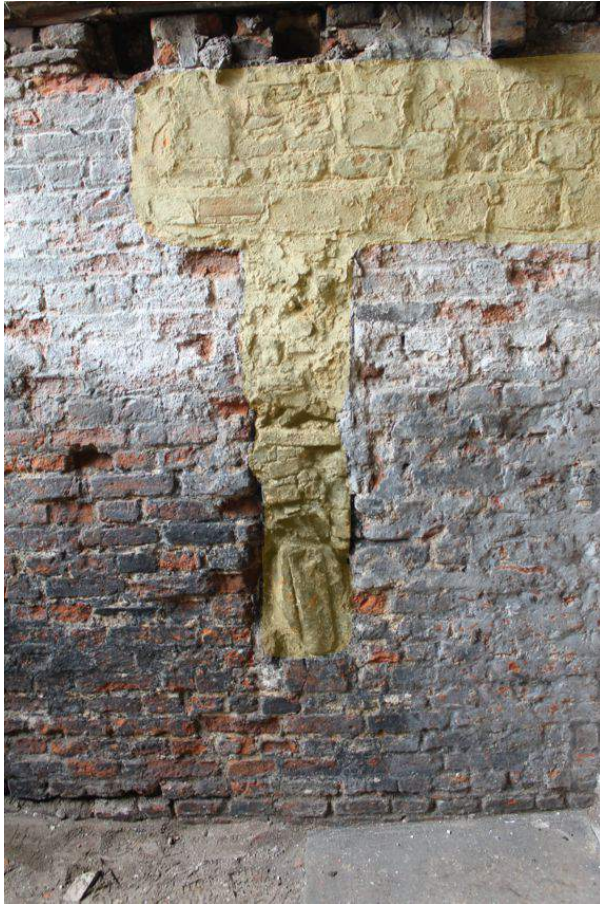
There is also a significant area of infilling within the brick wall on the northern elevation (Photograph 47). As well as more substantial brickwork (230 x 140 x 110mm) and irregular bonding, there is a large piece of worked stone that has been inserted into the wall (Photograph 48). This infilling appears to be where a post was embedded into the brickwork and has since been removed, with associated damage to the top of the wall.

**Photograph 47** Northern elevation of cellar, with repaired section of wall highlighted. Photograph taken facing north.

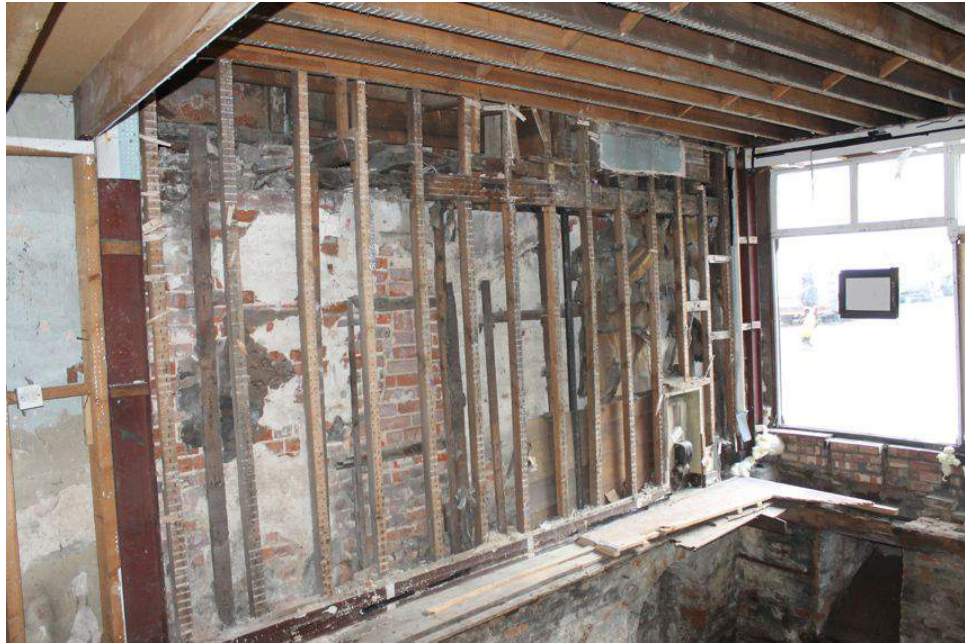
**Photograph 52** Southern elevation of ground-floor of Building B, showing timber-frame partially surviving but obscured by later brickwork. Partially surviving girding-beam visible. Photograph taken facing south-west.

The two southern corner-posts of Building B have been replaced with metal posts, supporting the raised floor (Photograph 52). The north-east corner-post of the building (one of the principal-posts of Building A) is intact within a brick pillar. No stud work survives on any elevation.

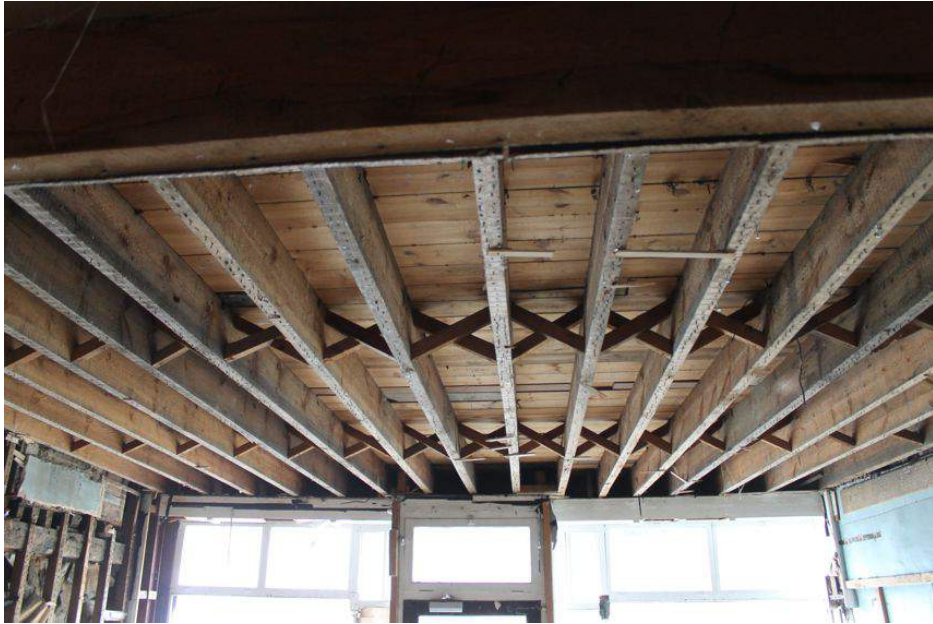
A major reason for this lack of surviving original timber is that the level of first-floor has been raised, with a new floor inserted, the joists of which are reinforced with herringbone strutting (Photograph 53). The raising of the first-floor accounts for the almost complete absence of the girding beam around the structure, and also the replacement of part of the girding-beam in Building A with a metal beam (Building B shares all of its major timbers with Building A on the northern elevation – see Fig 11).

**Photograph 53** Underside of raised first-floor in Building B, showing herringbone strutting supporting joists. Photograph taken facing west.
