**Historic building recording at  
the Rising Sun and Maçonite buildings,  
3 Hythe Station Road,  
Colchester, Essex CO2 8JZ**

**November 2018**

CAT project ref.: 18/10g  
NGR: TM 0155 2474 (c)  
Planning reference: 163196  
CHER number: ECC4271  
Colchester Museum accession code: COLEM 2018.105  
OASIS project id: colchest3-3314814

**CAT Report 1359**  
December 2018

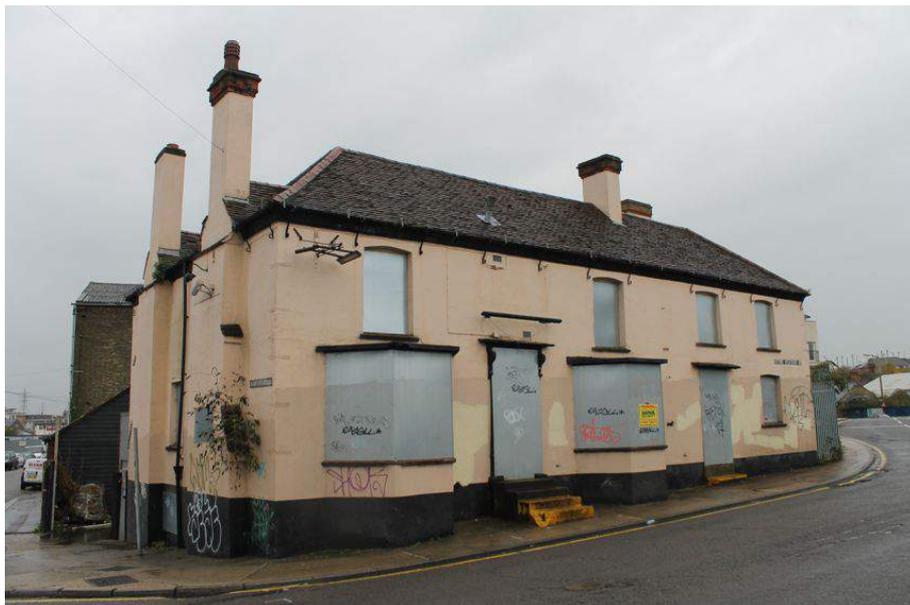
It is a double-ranged building with a double-hipped roof, covered in clay nib-tiles (Photograph 5). The guttering on the Rising Sun (and the house extension) appears to be cast iron, and is supported by metal brackets. These brackets are no visible on the 1925 photograph of the pub (Photograph 2), and so the guttering may have been replaced after that date. Four brick chimney-stacks project from the roof; two on the north-eastern elevation and two on the south-west elevation, between the Rising Sun and its house extension (Structure 2).

**Photograph 5** North-west and north-east elevations of the Rising Sun (left of frame; Structure 1) and the house extension (right of frame; Structure 2). Photograph taken facing south.

The north-west elevation of the Rising Sun (fronting onto Hythe Station Road; Photograph 5) has two projecting canted bay-window openings on the ground-floor. No windows survive today but in 1925 these two openings were each filled with 3 four-light sash windows (Photograph 2). The door on this elevation is heavily damaged but appears to be a four-panel modern replacement. The first-floor on this elevation has two wooden-framed sixteen-light hornless sash windows.

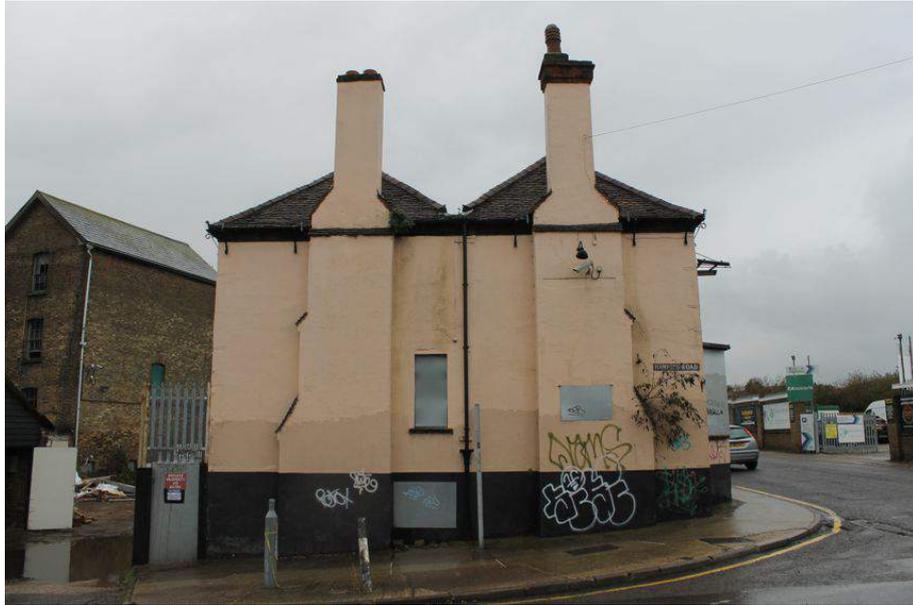
The north-east elevation of the Rising Sun (fronting onto Hawkin's Road; Fig 8 and Photograph 6) is featureless apart from the two projecting chimney-stacks and a single window opening on the ground-floor (that has no surviving window). This window opening is not visible on the photograph from 1925 (Photograph 2) and so is probably a modern insertion.

**Photograph 6** North-east elevation of the Rising Sun (Structure 1).  
Photograph taken facing south-west.

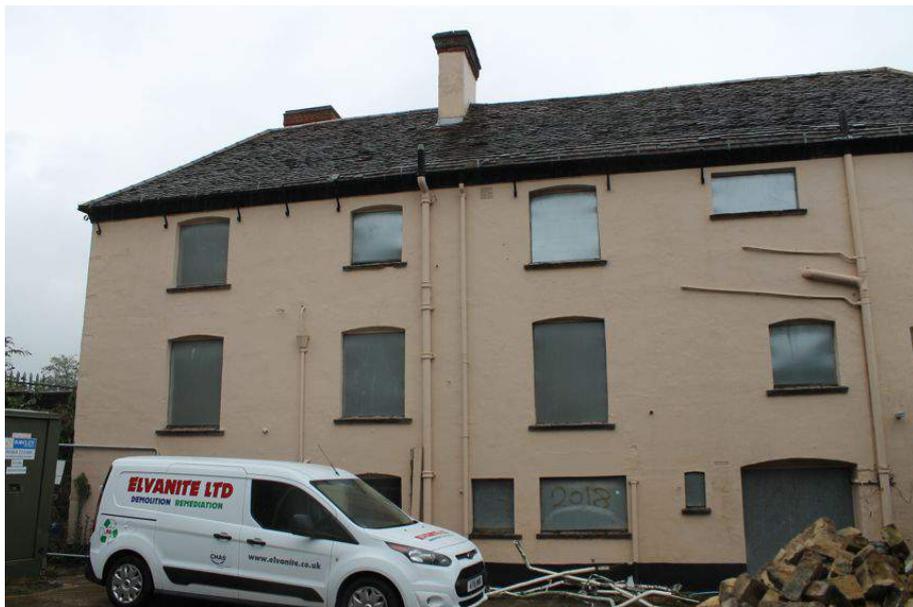
The pub's south-east elevation (fronting onto the yard; Photograph 7) has 11 window openings across the three-storeys (Fig 7). The windows at the basement level are all modern wooden-framed fixed or awning windows, inserted to provide light to the W.C.s on that floor (see interior below). The surviving glass panes on these windows are all hammered. Also at the basement level is a modern half-size half-glazed door (with no surviving glass).

**Photograph 7** South-west elevation of the Rising Sun (right of frame; Structure 1) and the house extension (left of frame; Structure 2). Photograph taken facing north-west.

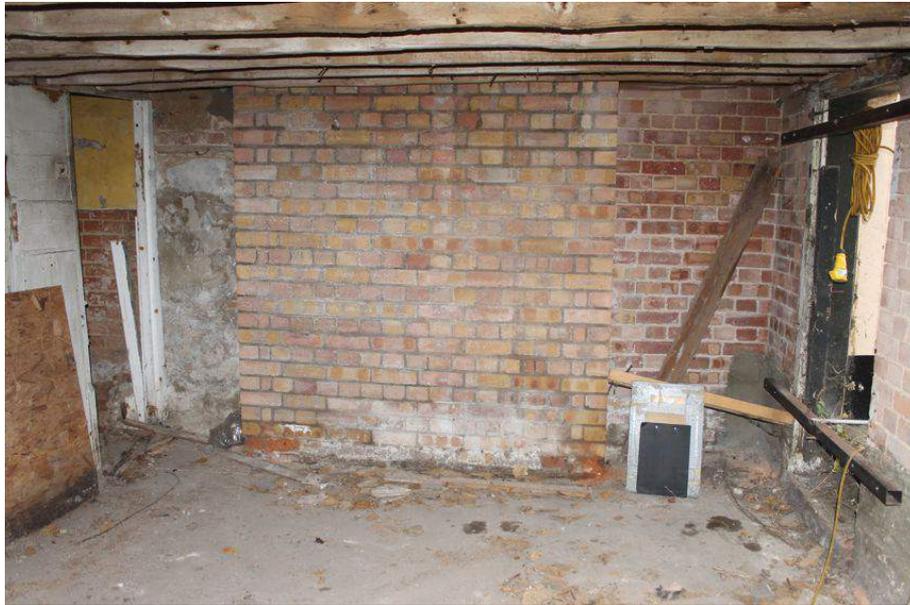
The southern room has a concrete floor. The projecting chimney-stack to the east in this room (from Structure 1) has been rebuilt in modern brick, as has the southern exterior wall on this floor (Photograph 21). Heavily damaged wooden stairs lead up from this room to the ground-floor of the extension (Fig 3).

**Photograph 21** Rebuilt chimney-stack of Rising Sun, visible in basement of Structure 2. Photograph taken facing east.

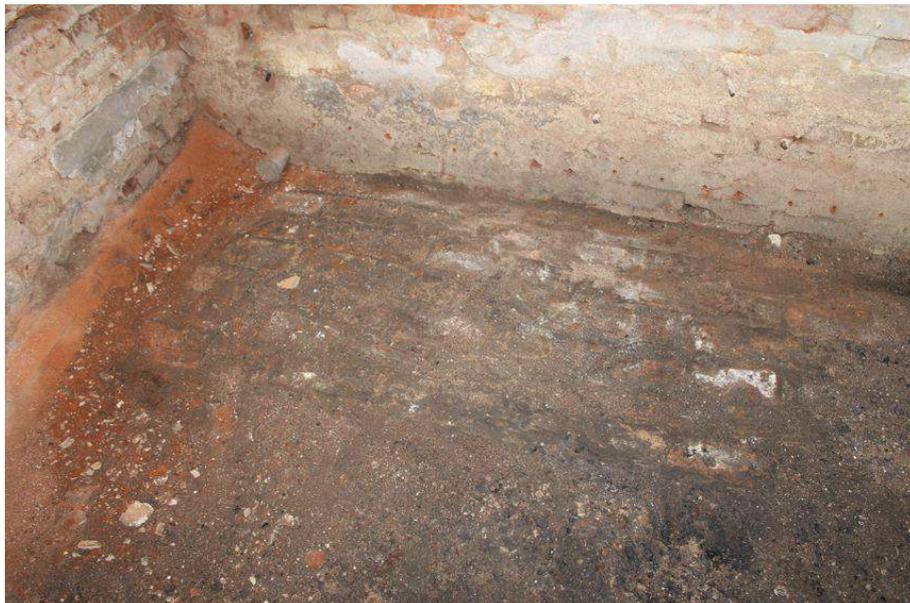
**Photograph 22** Surviving section of pavior-brick floor in northern room of house extension's (Structure 2's) basement. Photograph taken facing south-east.

The northern room of the cellar has the partial remains of a (probably original) pavior-brick floor surviving to the east, with brick dimensions of 230 x 110mm (Photograph 22). Also in this room are several inserted brick pillars, supporting timber-beams that, in turn, support the floor above (Photograph 23). Unlike to the south (see above) the structural brickwork in this room is largely original, although there are still areas of repair and patching. In particular, the chimney-stack in this room is in a very poor state of repair (Photograph 24). There is an opening in the ceiling of this room to the south-east, which presumably would have been the location of a stairway, mirroring the one to the south and leading up to the ground-floor (Photograph 25).

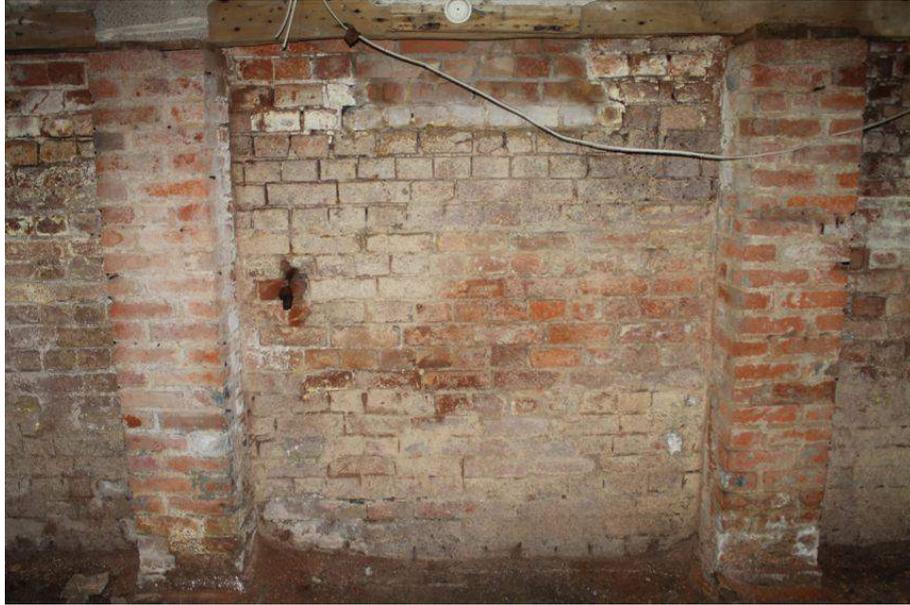
**Photograph 23** Detail of wall in northern room of Structure 2's basement, showing inserted brick pillars. Photograph taken facing north-west.

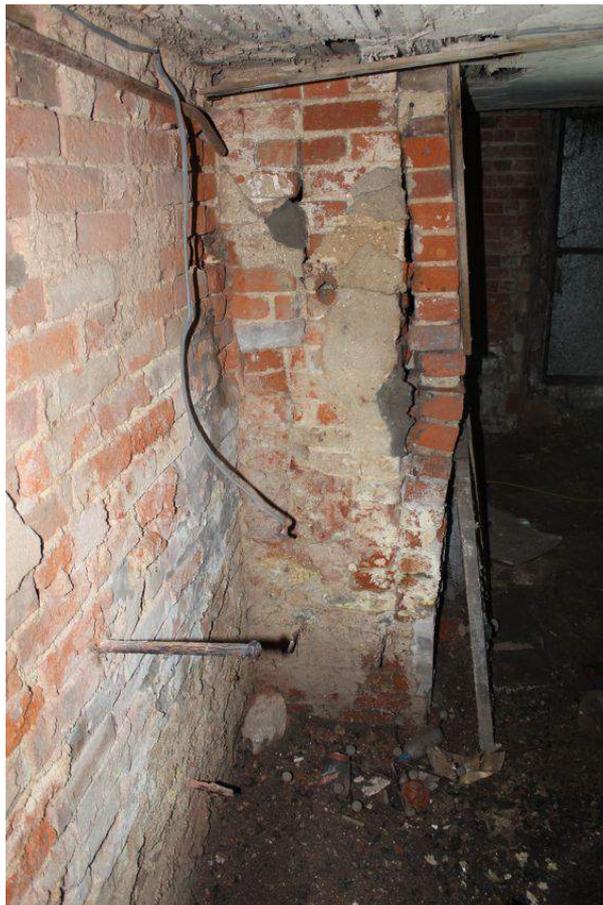
**Photograph 24** Eastern side of fireplace in northern room of house extension, showing damage. Photograph taken facing south-west.

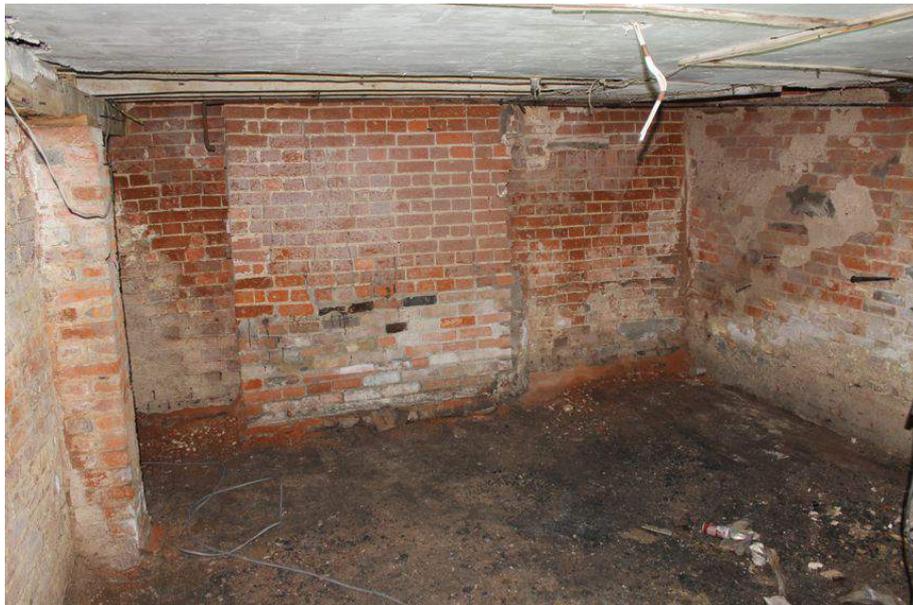
**Photograph 26** Northern room of Structure 2's basement, showing west wall of Rising Sun. Note the central structural wall of the house extension (to right) is not bonded to the pub's walls. Photograph taken facing east.

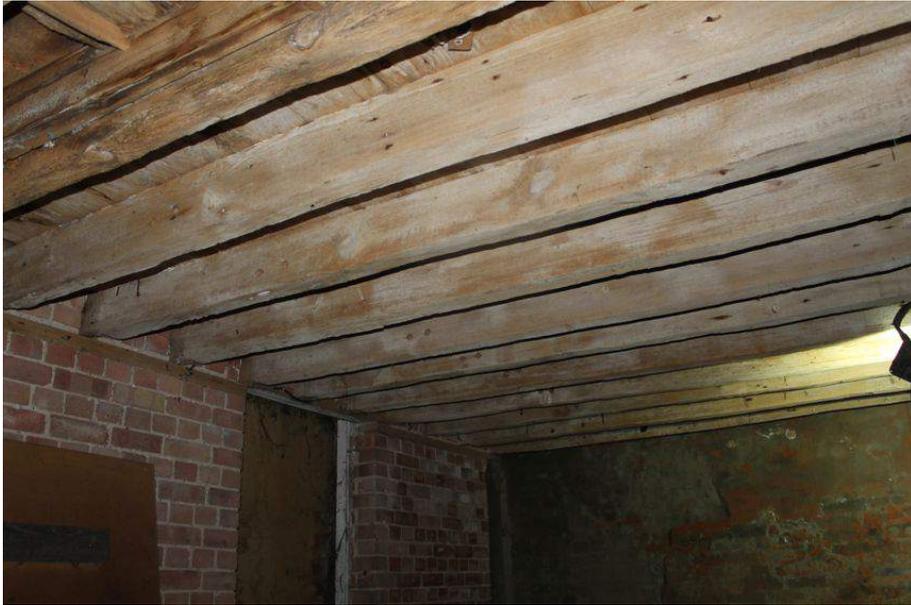
The floor above the basement, where visible, is constructed of machine-cut timber (Photograph 27). In the northern room it appears to be original, but in the southern room it may be a later replacement, perhaps inserted at the same time as the southern structural wall was rebuilt (see above).

**Photograph 27** Joists supporting ground-floor, view from southern room of basement in Structure 2. Photograph taken facing south.

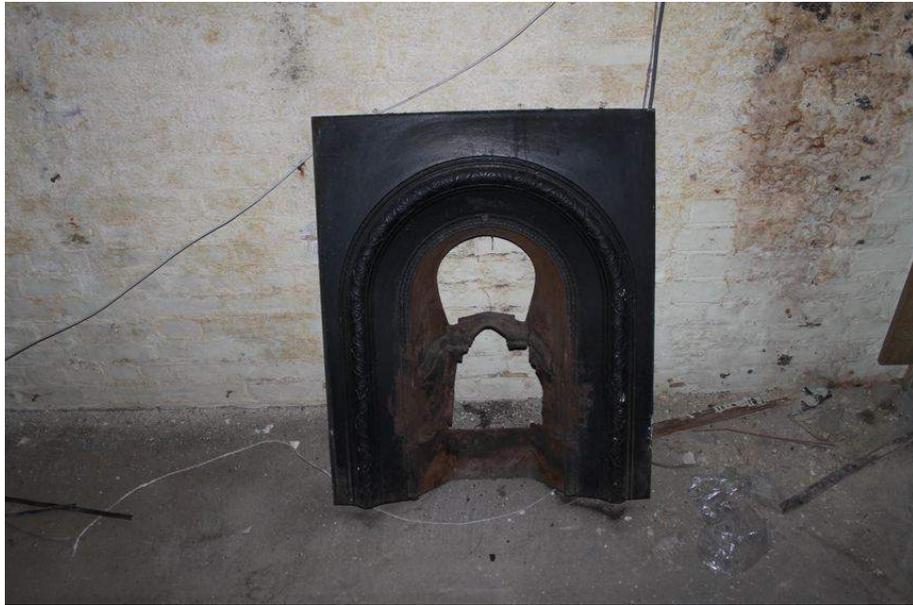
Observed out of situ, but presumably originating from one of the fireplaces on the first-floor of the building, was a metal register grate (Photograph 50). Its concave and arched style suggests it dates from the mid 19th century (Yorke 2012, 53).

**Photograph 50** Metal register grate taken from fireplace on first-floor of Structure 5.

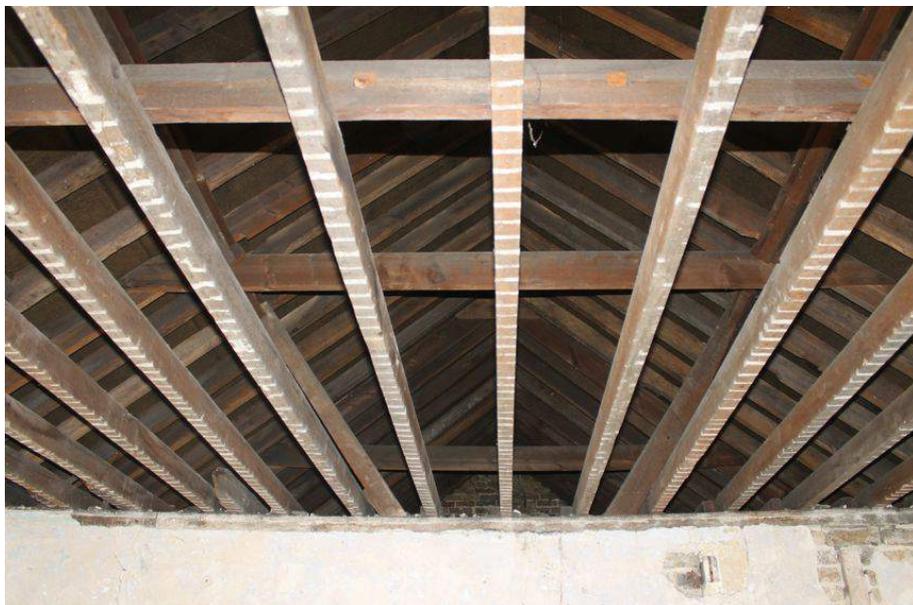
The lath and plaster ceiling of the second-floor had been largely removed at the time of this survey, allowing the roof construction of the building to be observed (Photograph 51). All the timbers in the roof are machine-cut.

**Photograph 51** Timber roof of Structure 5. Photograph taken facing west.

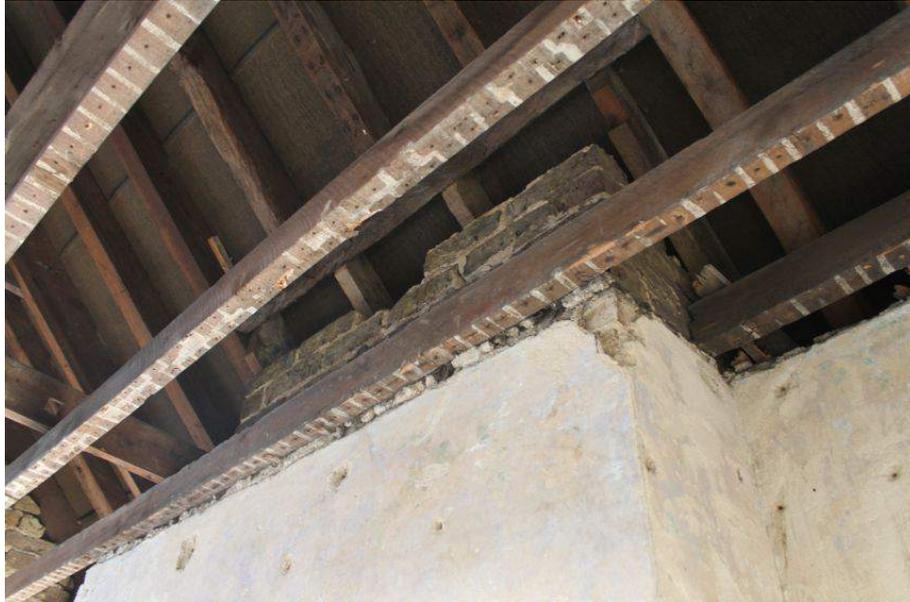
**Photograph 52** Top of chimney-stack in Structure 5, having been removed to below the rafters. Note the modern rafters above it. Photograph taken facing north-west.

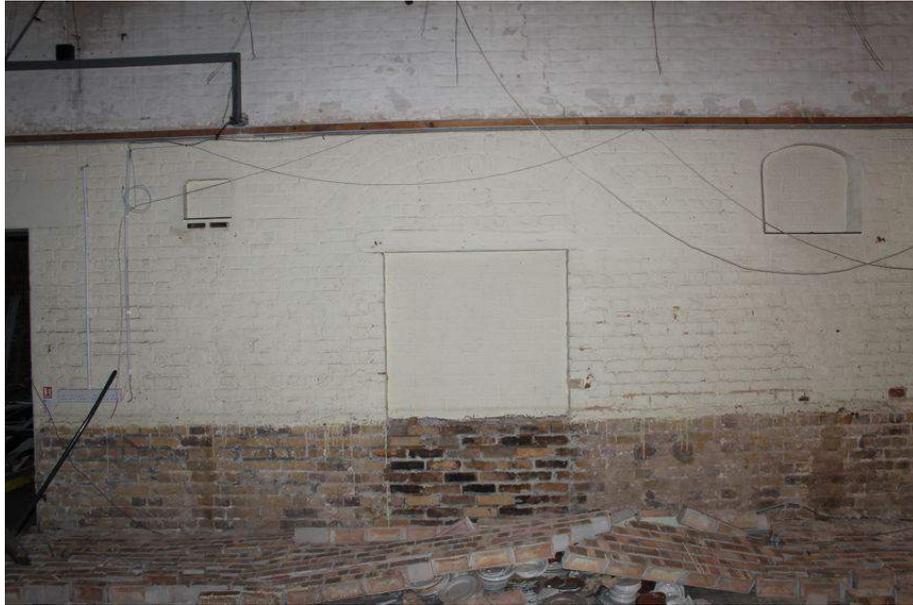
**Photograph 62** Original entrance with arch between Structures 6 and 7 at ground-floor level, now bricked over. Photograph taken facing north.

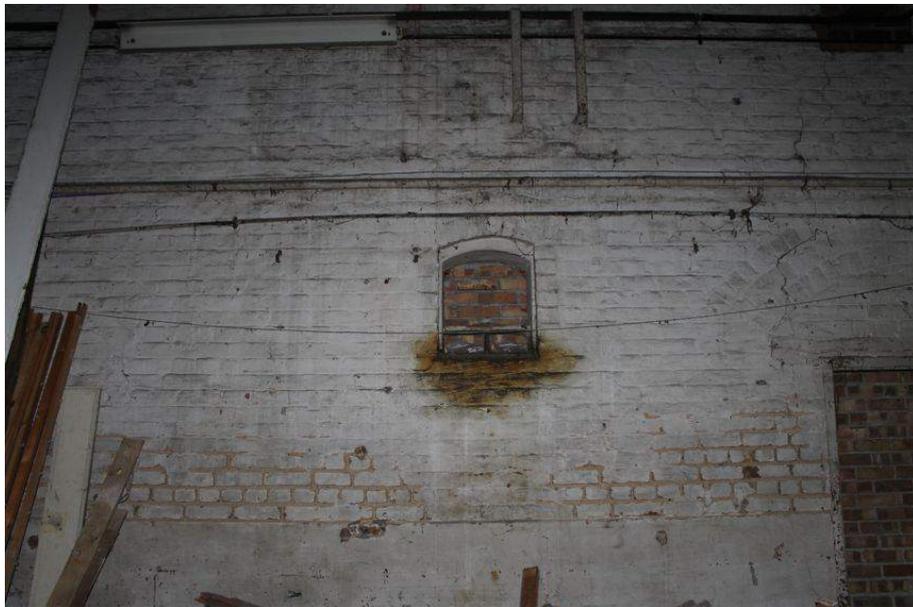
On the southern wall of the ground-floor, to the east of the blocked doorway, is an arched-recess in the brickwork. This recess contains a metal frame subdivided into three chambers (Photograph 63). The purpose of this is uncertain, but given the evidence of fire damage around this recess (and others observed elsewhere in the warehouses; see below) it may have been a housing for a gas light.

**Photograph 63** Possible metal-framed ?gas-light holder in recess in south ground-floor wall of Structure 6. Photograph taken facing south.

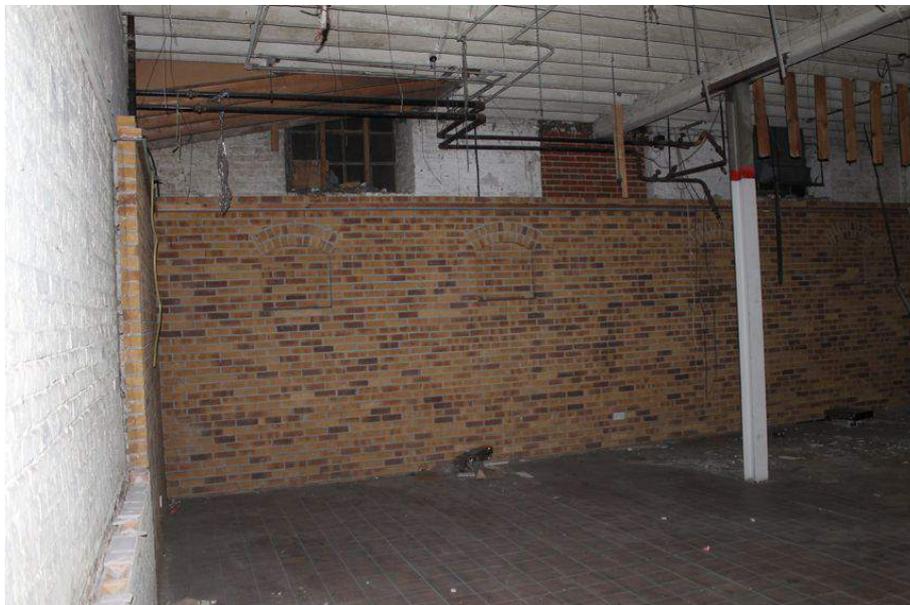
**Photograph 72** Modern skin of bricks over original brickwork in western end of Structure 7. Entrance and windows on western elevation also visible. Photograph taken facing north-west.

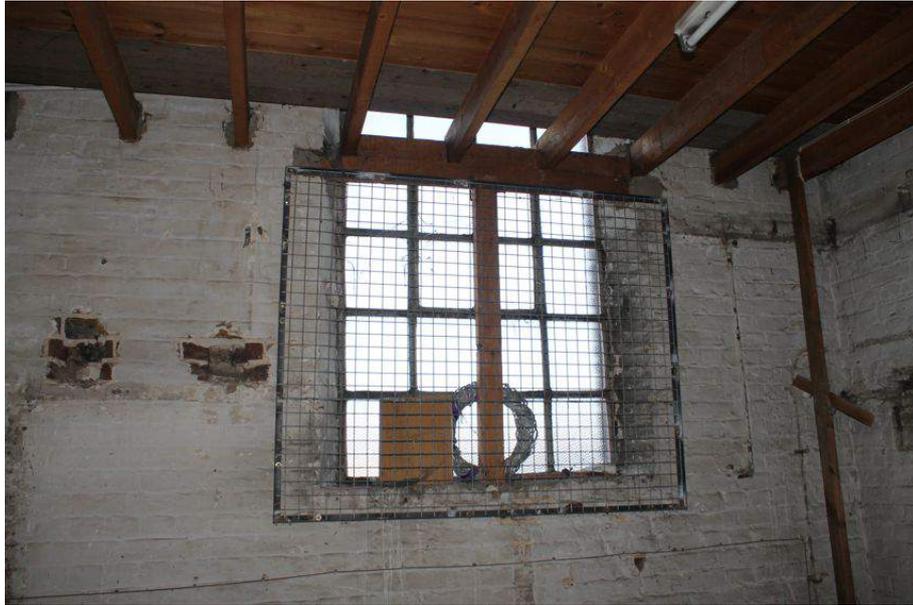
**Photograph 78** Window opening bisected by insertion of second-floor in Structure 7. Photograph taken facing south-east.

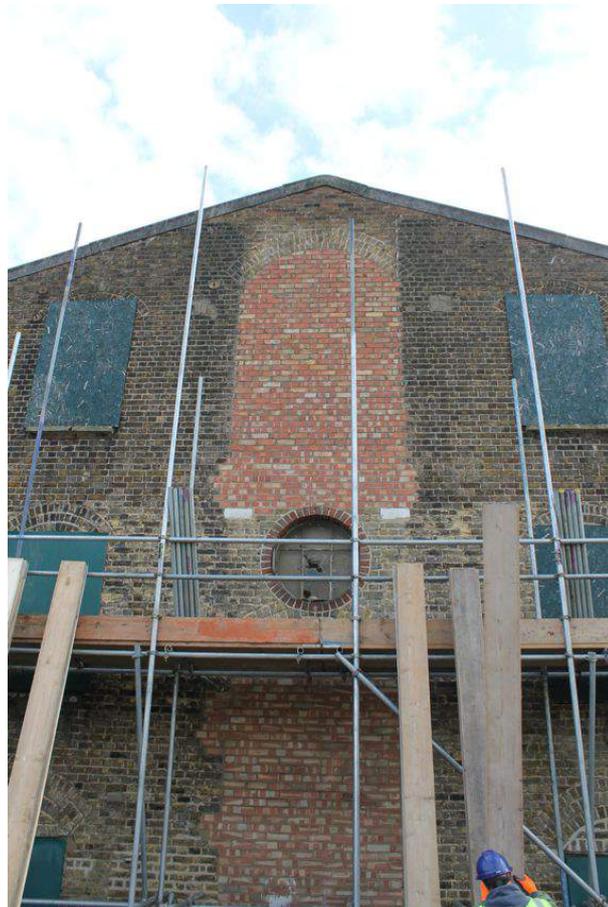
**Photograph 84** Western elevation of Structure 8. Modern brickwork shows location of removed lift and entrance shown in Photograph 4. Photograph taken facing east.

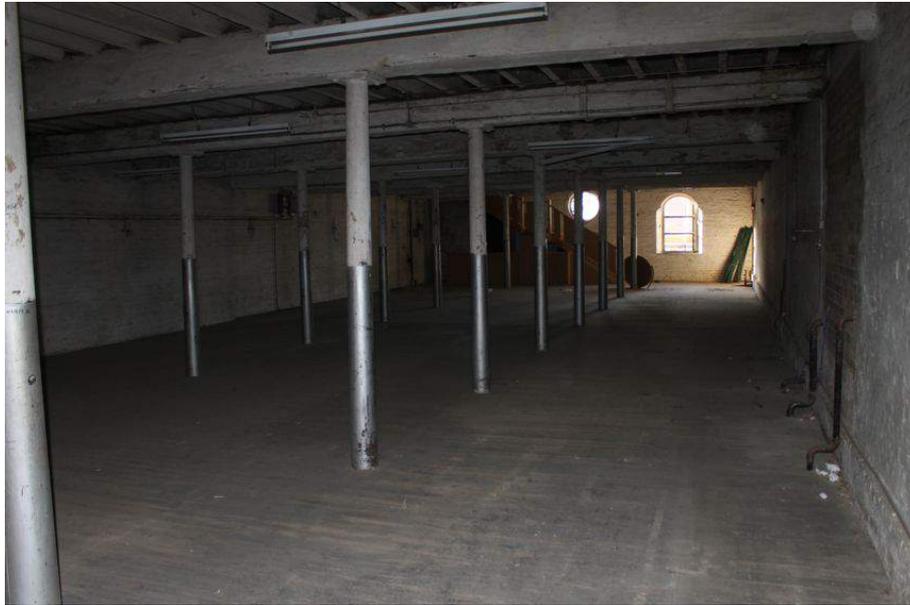
The first-floor itself is constructed of regularly-spaced floorboards, although they vary in width between 110mm and 140mm, perhaps suggesting they have been the subject of repair (Photograph 89).

**Photograph 89** First-floor of Structure 8. Photograph taken facing south-west.
