**Historic building recording at  
Michaelstow Farm,  
Ramsey Road, Ramsey,  
Essex, CO12 5EW**

**November 2018**

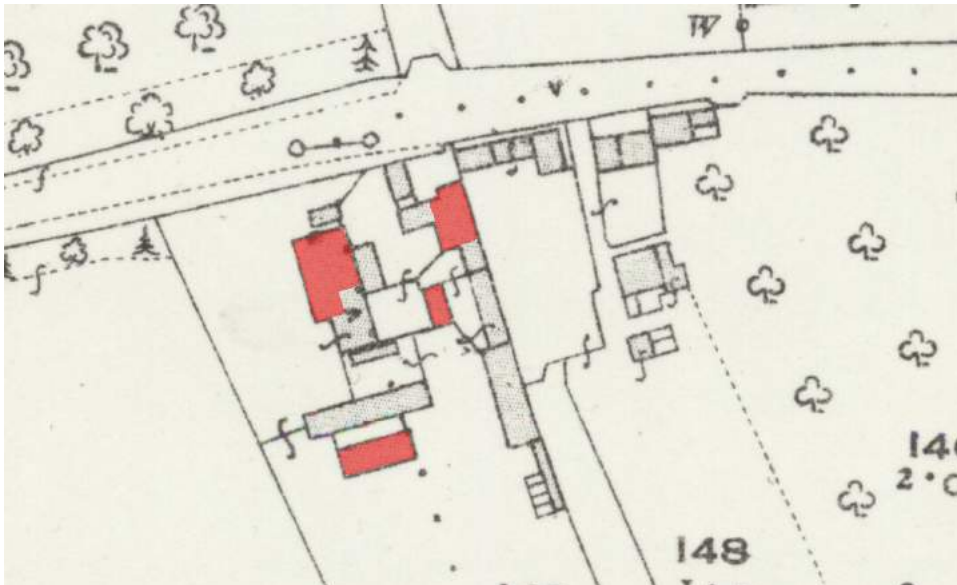
**Map 8** 1922 25-inch OS map. Surviving buildings detailed in this report highlighted in red.

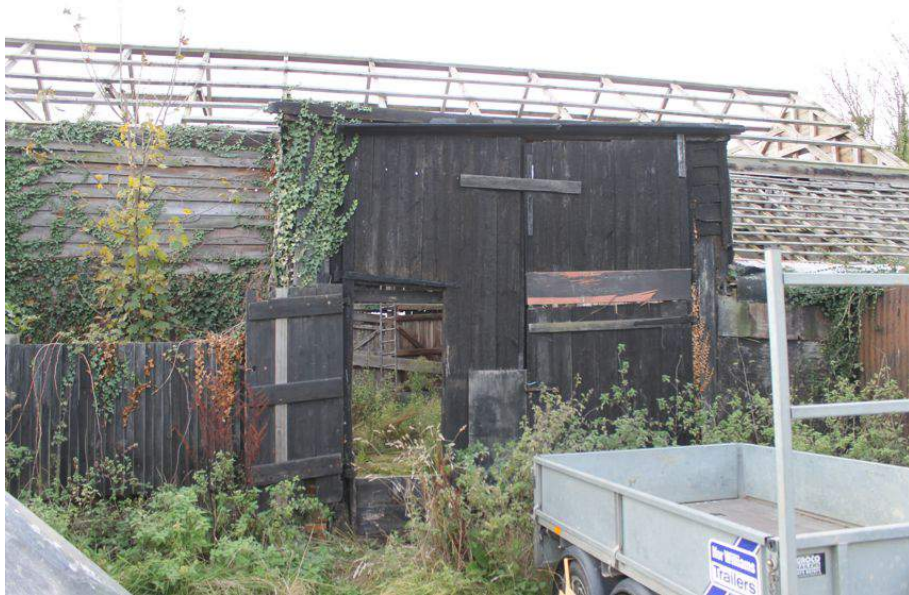
**Photograph 2** Detail of the barn doors on north-east elevation of threshing barn's midstrey. Photograph taken facing west.

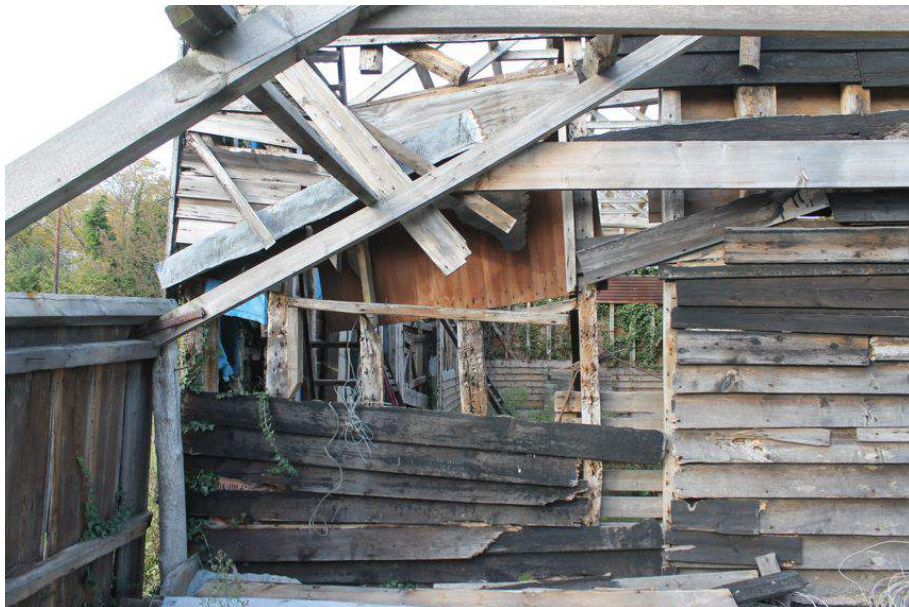
**Photograph 3** Detail of damaged timber-frame and missing weatherboarding on south-east elevation of threshing barn. Photograph taken facing north-west.

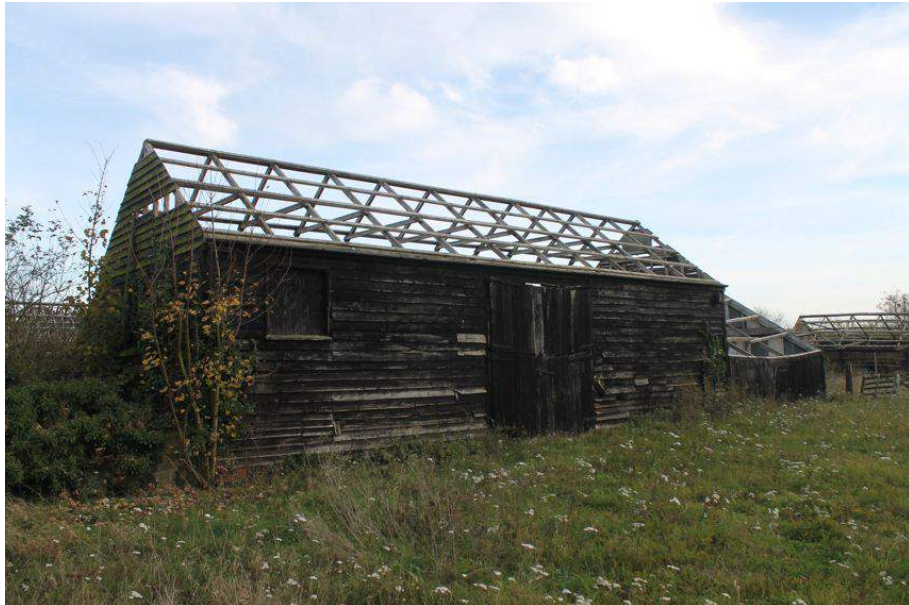
**Photograph 4** South-west elevation of threshing barn and modern extension (to right). Photograph taken facing south-east.

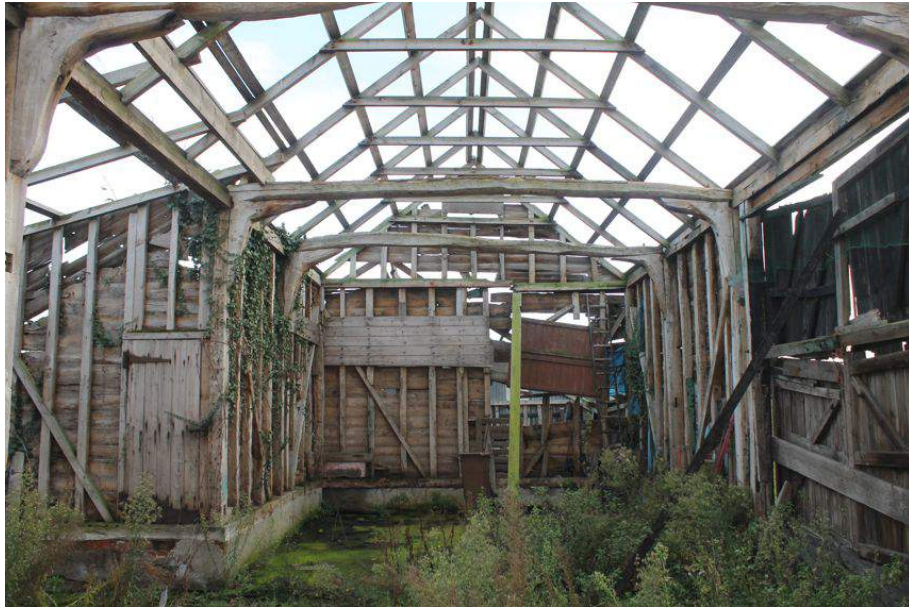
**Photograph 8** Interior shot of threshing barn, showing Bays 1, 2 and 3. Photograph taken from Bay 4 facing south-east.

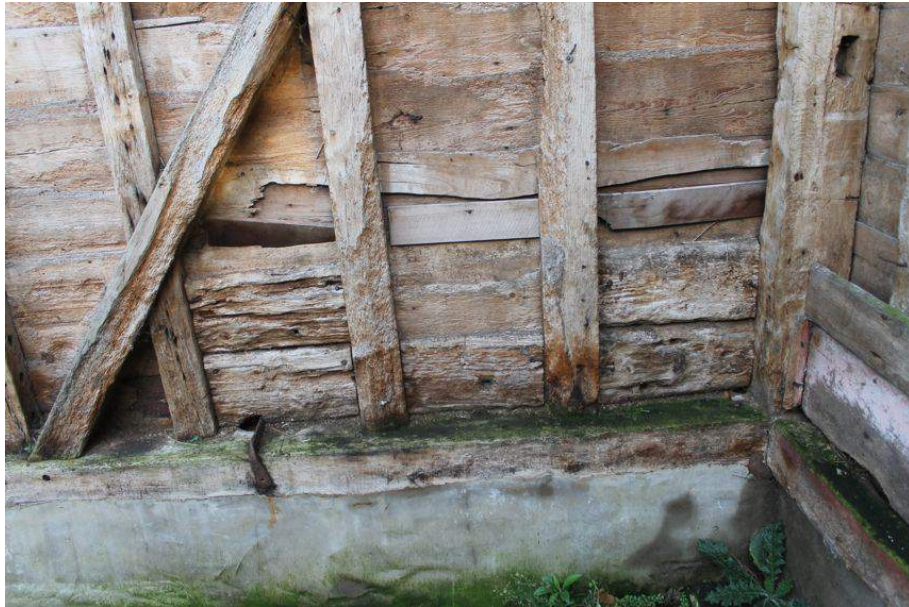
**Photograph 10** Detail of wooden nogging panels on east wall of Bay 1.  
Photograph taken facing north-east.

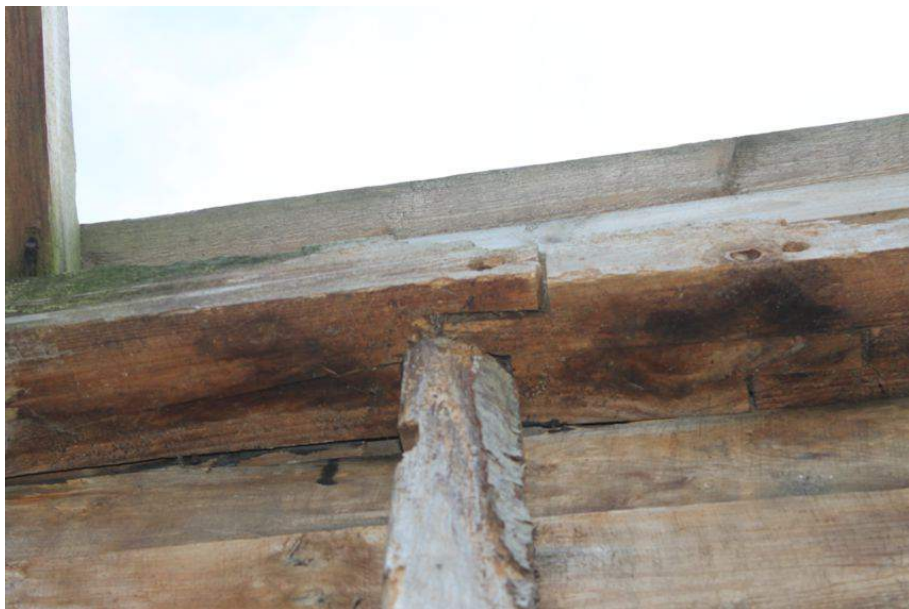
**Photograph 11** Detail of scarf joint on western wall-plate of Bay 2.  
Photograph taken facing west.

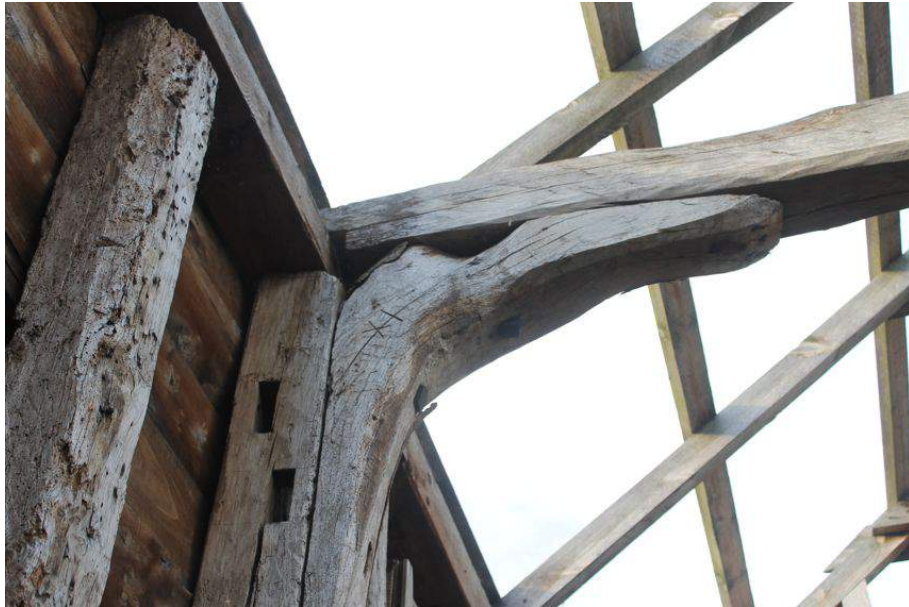
**Photograph 16** Detail of carpenter's mark on western knee brace supporting tie-beam between Bays 4 and 5. Photograph taken facing north.

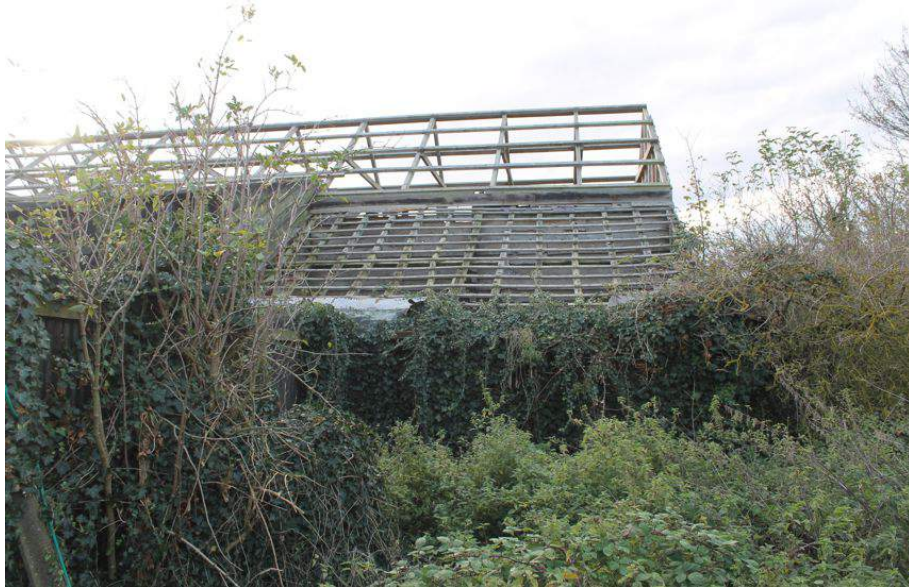
**Photograph 23** North-east elevation of lean-tos, showing large amount of overgrowth. Photograph taken facing south-west.

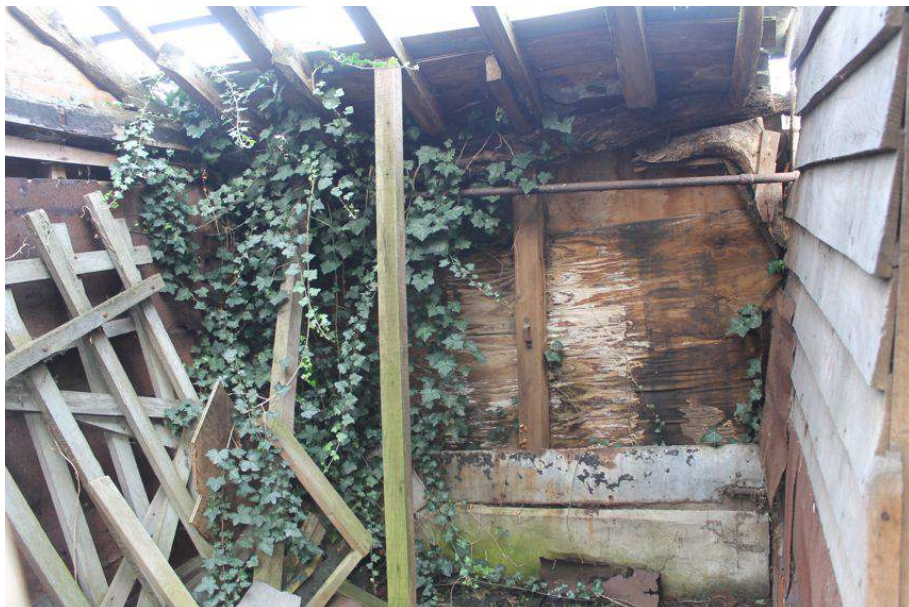
**Photograph 24** Interior of southern lean-to, showing damaged structure, knee brace and inserted concrete plinth. Photograph taken facing north-east.

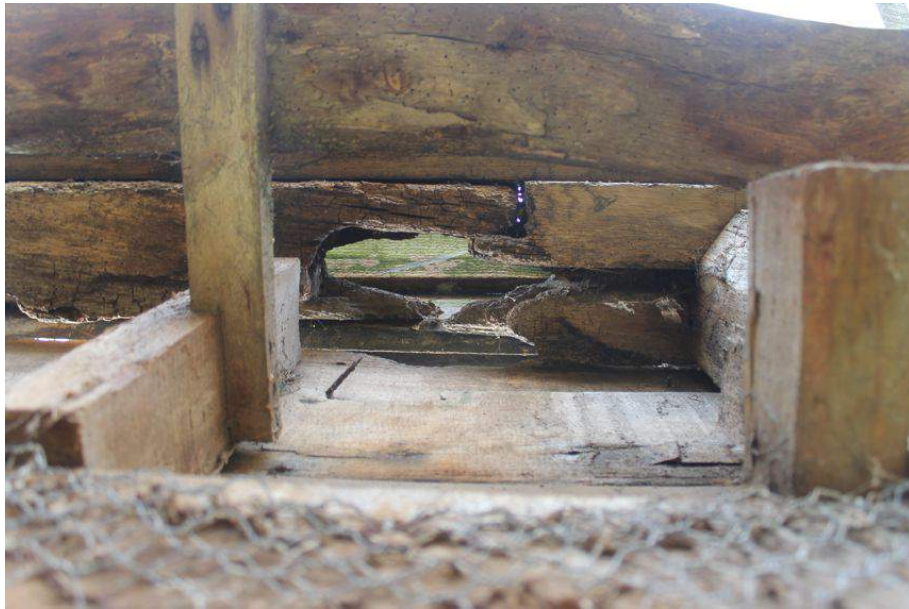
**Photograph 35** Detail of degraded joint on western wall-plate in Bay 2. Photograph taken from below.

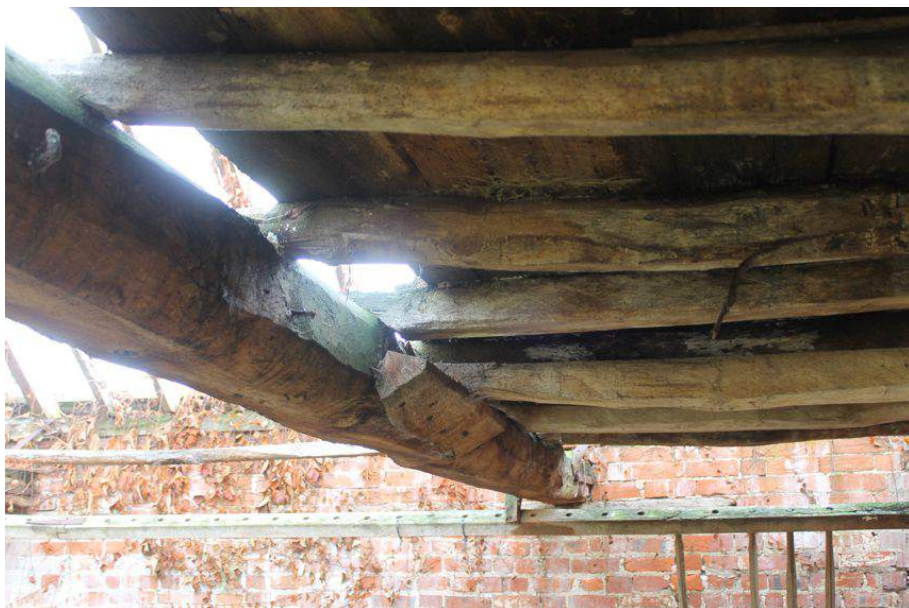
**Photograph 36** Shot showing first-floor joists laying on southern tie-beam. Photograph taken facing north-east.

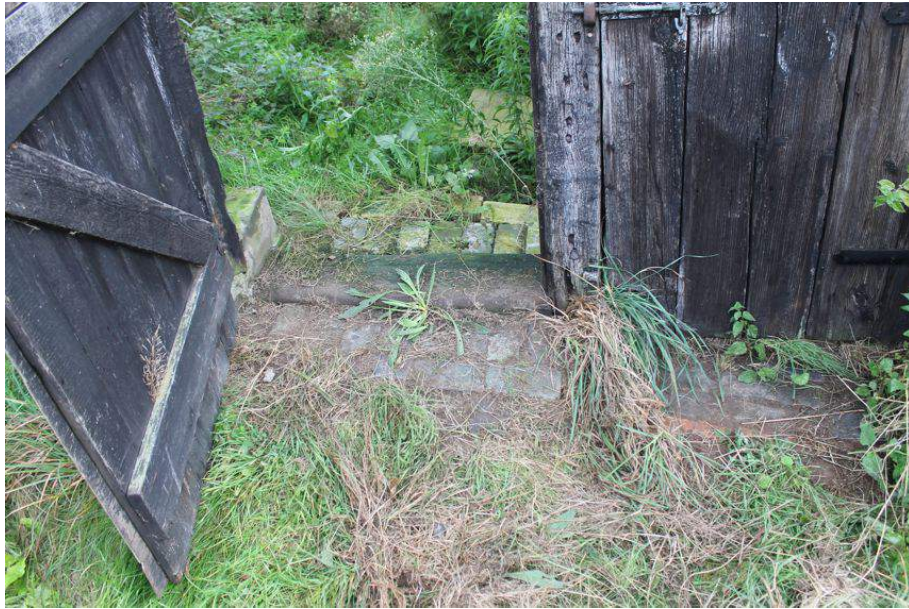
**Photograph 43** Detail of brick floor at entrance to stable. Photograph taken facing north-east.
