**Historic building recording at
79 Magdalen Street,
Colchester, Essex CO1 2LA**

February 2019

CAT Report 1391
March 2019

A programme of historic building recording was carried out by Colchester Archaeological Trust at 79 Magdalen Street, Colchester, Essex in February 2019.

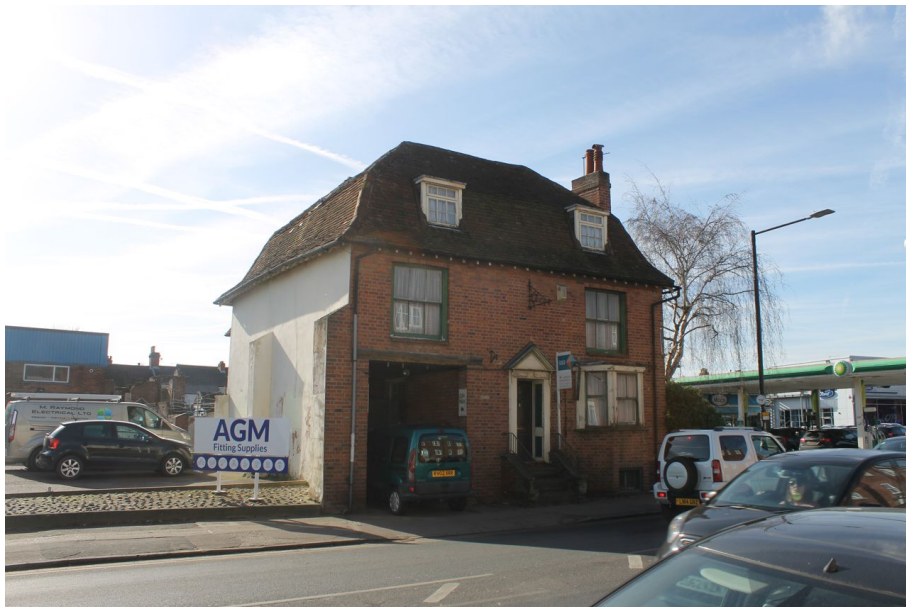
The main range of the building has a double-hipped mansard roof (Photograph 1) and the extension has a hipped mansard roof. Both these roofs are covered in peg-tiles and appear contemporary – it seems likely that the entire roof was redone when the extension was built. There is a cornice around the whole building, beneath the eaves of the mansard roof; the ends of the rafters have been uniformly chamfered and abut against a cement render depicted with angular decoration (Photograph 2).

Photograph 1 North and east elevations of 79 Magdalen Street. Photograph taken facing south-west.

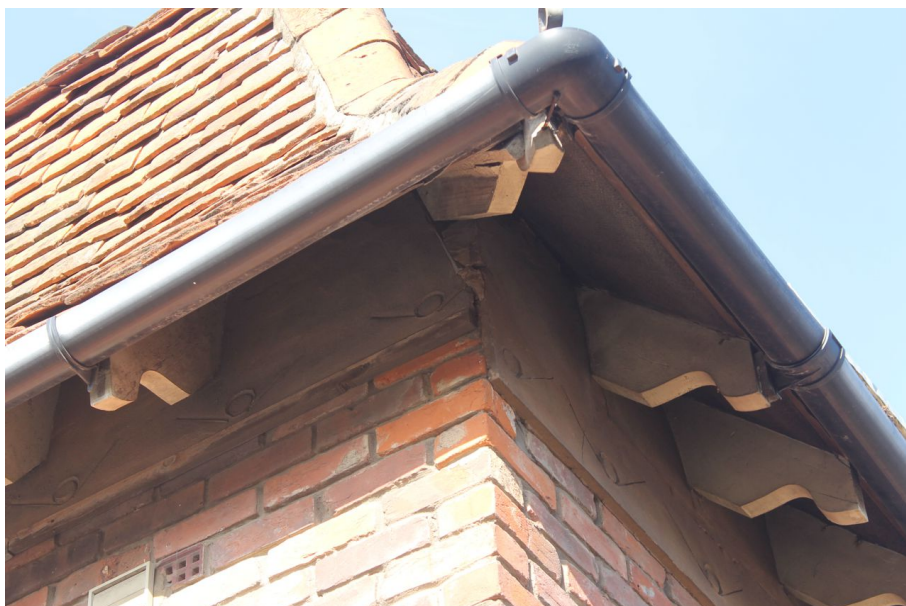
Photograph 2 Detail of cornice around entire building. Chamfered rafter-ends and incised cement shown.

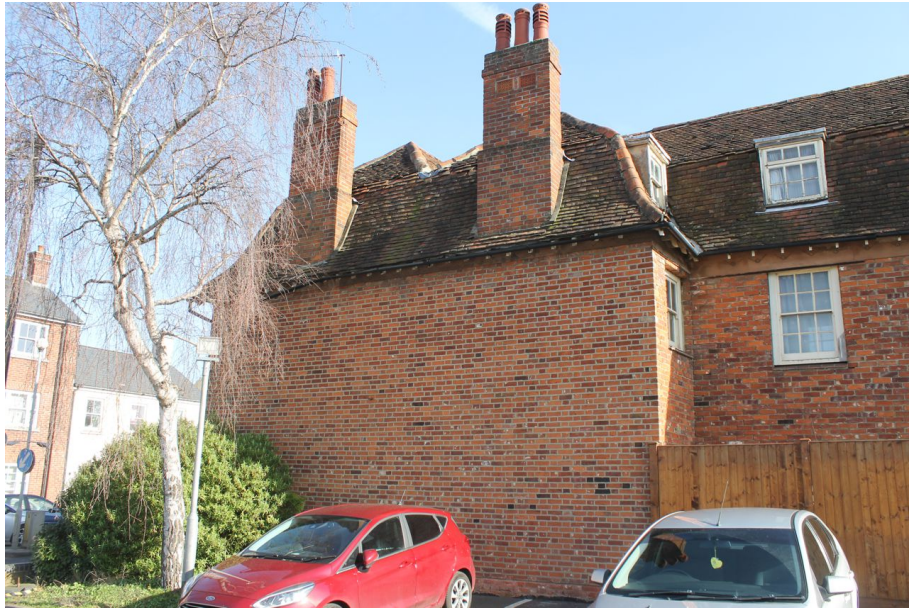
The building has two brick chimney stacks on its western end (Photograph 3). The extension has no chimney.

Photograph 3 Western elevation of 79 Magdalen Street. Two chimney-stacks visible on main range. Photograph taken facing north-east.

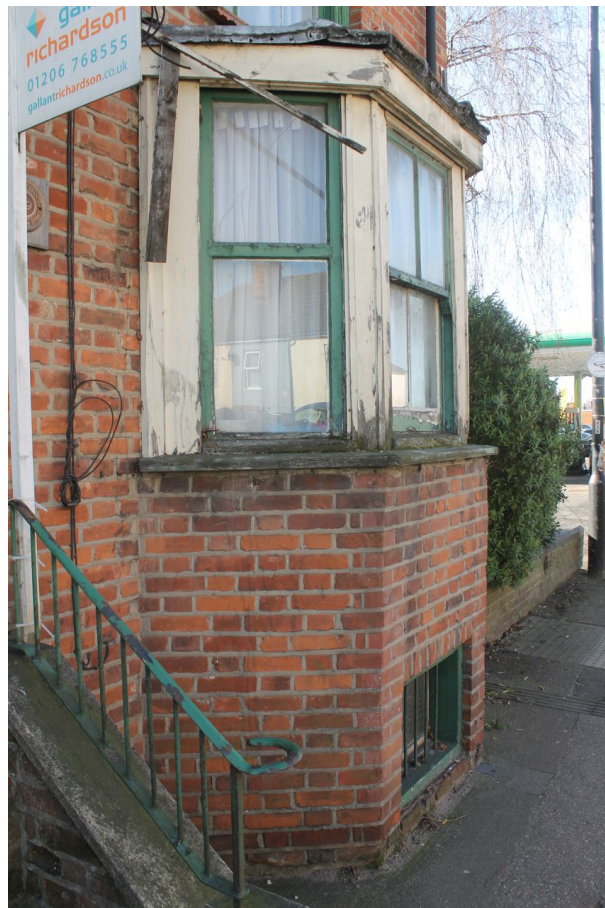
Photograph 4 Bay window on northern elevation of 79 Magdalen Street. Photograph taken facing south-west.

There is a bay window at ground-floor level on this elevation (Photograph 4) containing 2 two-light fixed and one three-light horned sash window. Below this bay window is a small fixed window providing light to the cellar. The main entrance into the building is on this elevation, consisting of a doorway about 1m above ground-level, accessed by a flight of brick-built steps with concrete treads and metal balusters and handrails (Photograph 5). The doorway is heavily recessed into the building and surrounded by a porch-like slight forward projection with a hood above (Fig 7). Within the doorway is a six-panel door that appears to be a modern replacement.

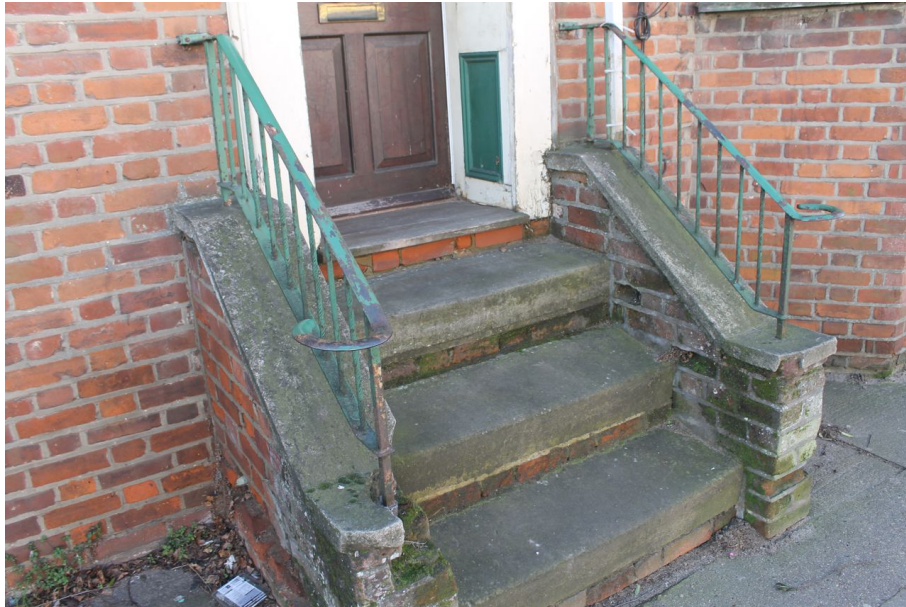
Photograph 5 Detail of steps up to front door on northern elevation of 79 Magdalen Street. Photograph taken facing south-west.

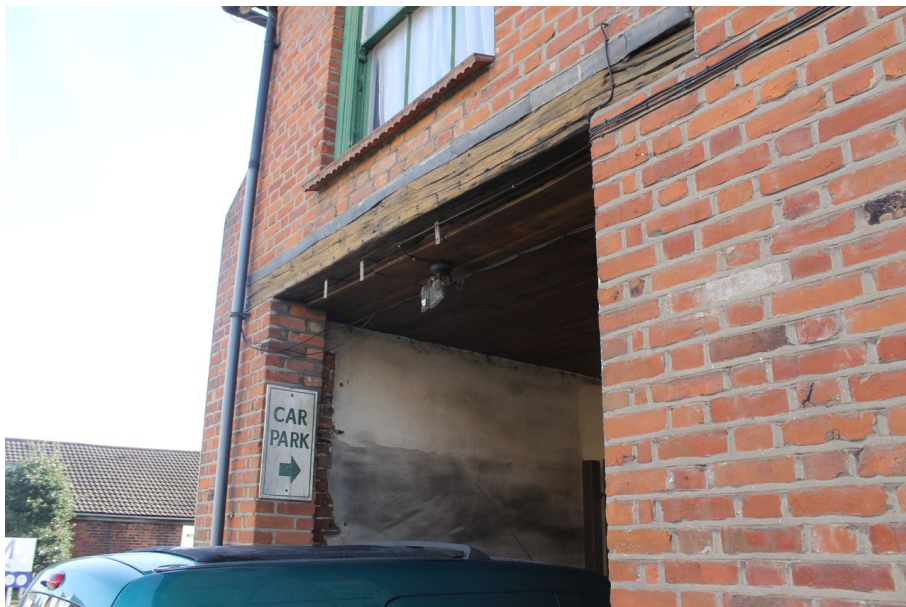
The passageway to the rear of the building has a large timber lintel supporting the opening and the floor of the room above (Photograph 6).

Photograph 6 Entrance into passage leading to rear of building on northern elevation. Substantial timber lintel visible. Photograph taken facing south-east.

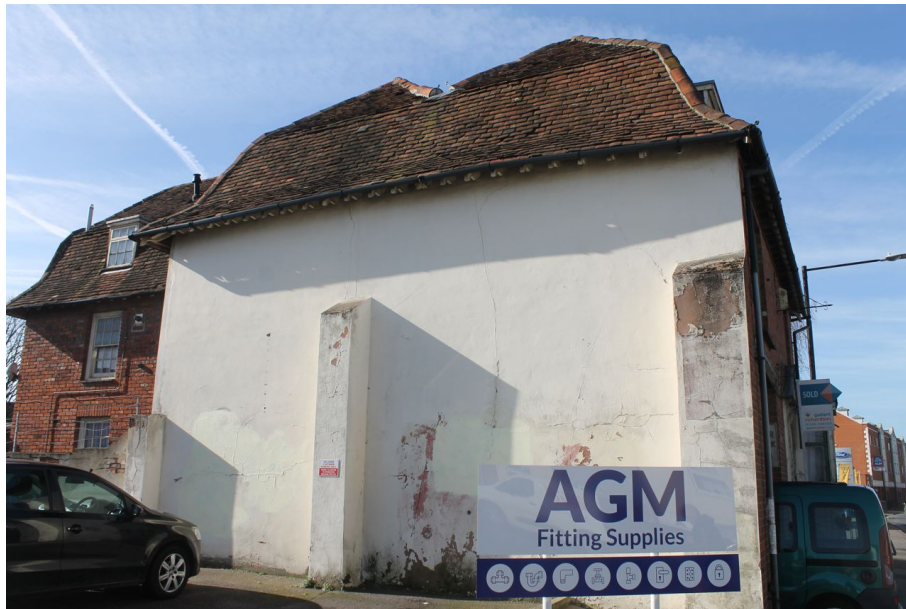
The main range of the building is rendered on this elevation (Photograph 7). It has no windows, but it has three brick buttresses. The extension on this elevation has two twelve-light horned sash windows on the ground-floor, mirrored by two more above on the first-floor (Photograph 8). In the mansard roof above, like on the main range, are two dormers each containing six-light fixed and three-light awning windows.

Photograph 7 East elevation of 79 Magdalen Street. Photograph taken facing south-west.

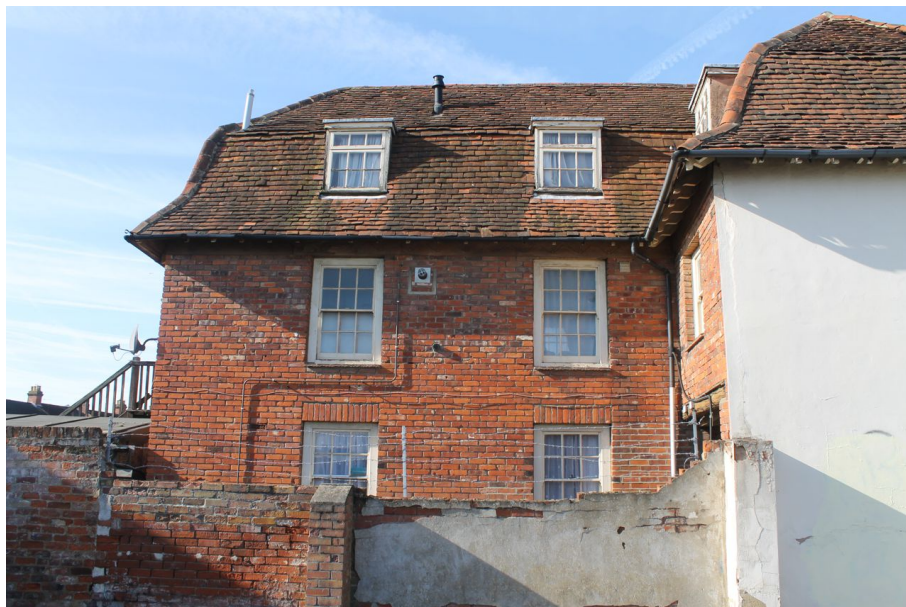
Photograph 8 East elevation of extension. Photograph taken facing west.

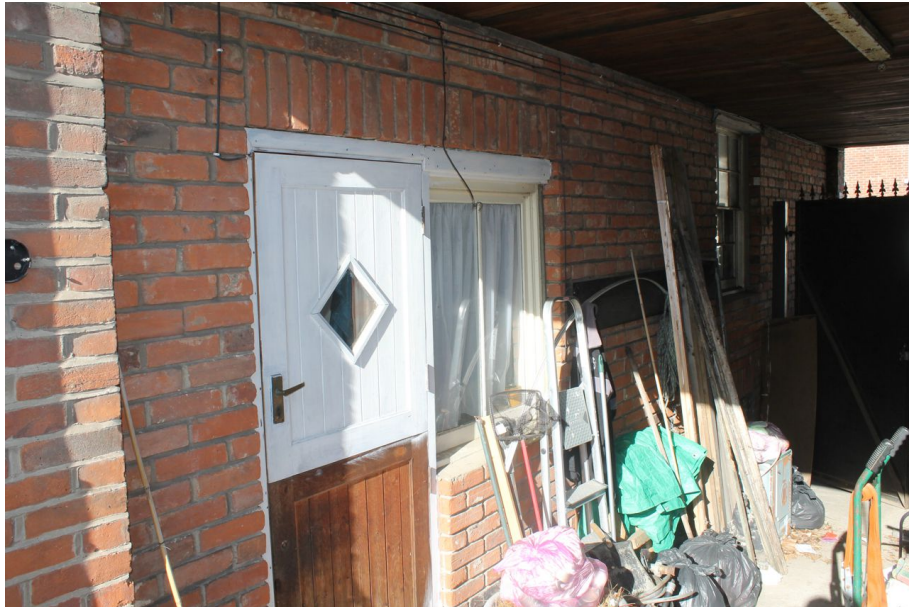
Photograph 9 Western wall of passageway on ground-floor of 79 Magdalen Street, showing rebuilt wall. Photograph taken facing north-west.

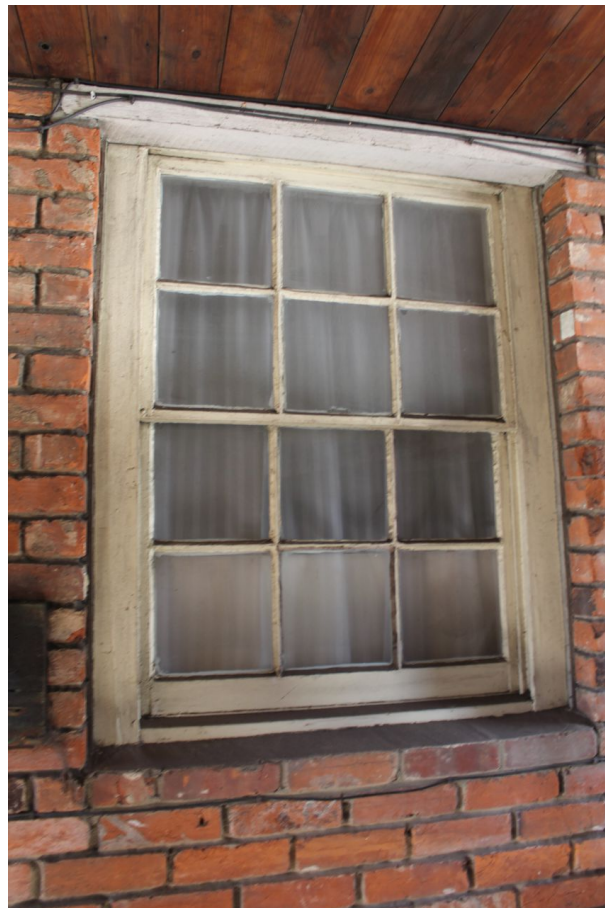
windows providing light to the cellar, as well as a twelve-light hornless sash window (Photograph 10).

Photograph 10 Sash window on west side of passageway on ground-floor. Photograph taken facing west.

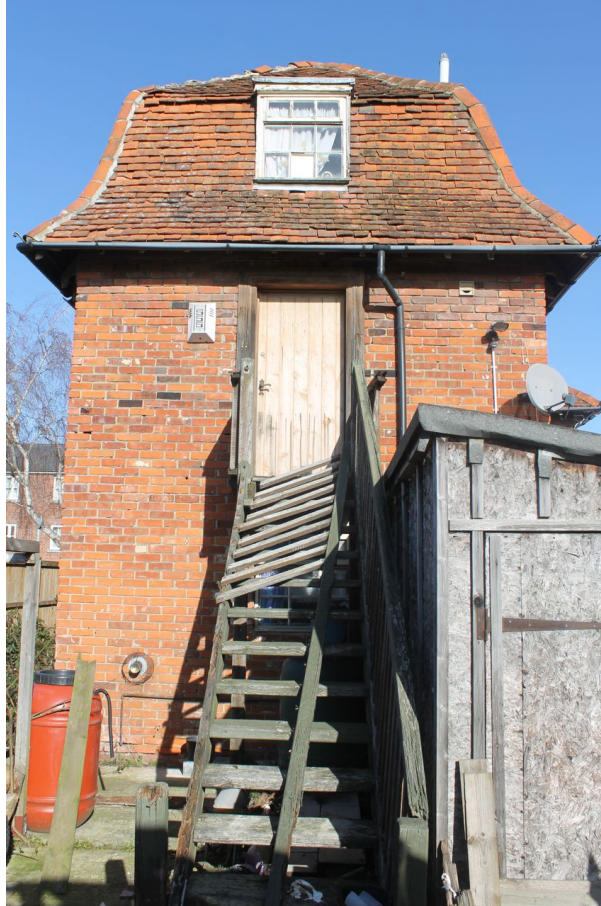
Photograph 11 Southern elevation of extension, showing staircase up to first-floor door. Photograph taken facing north.

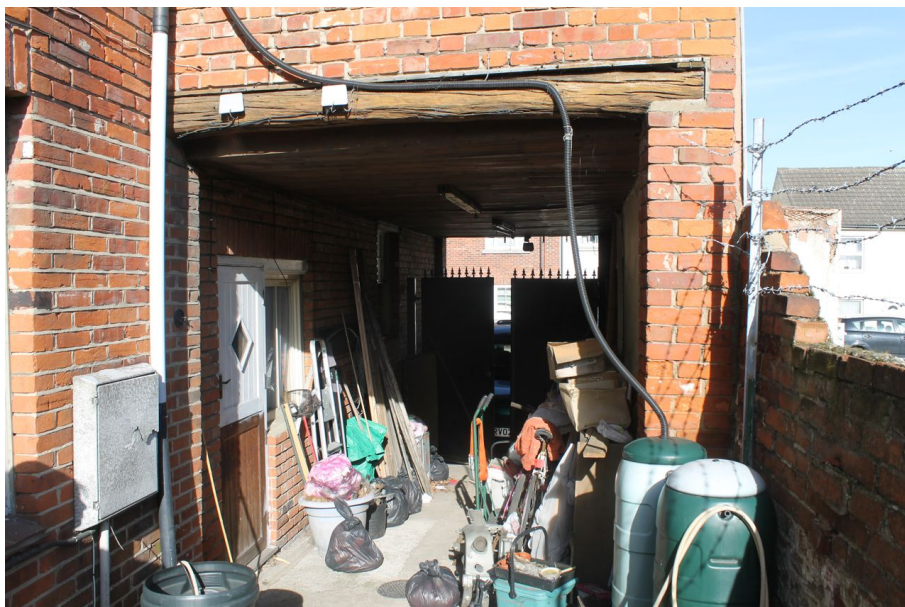
Photograph 12 Passageway on ground-floor on southern elevation. Photograph taken facing north.

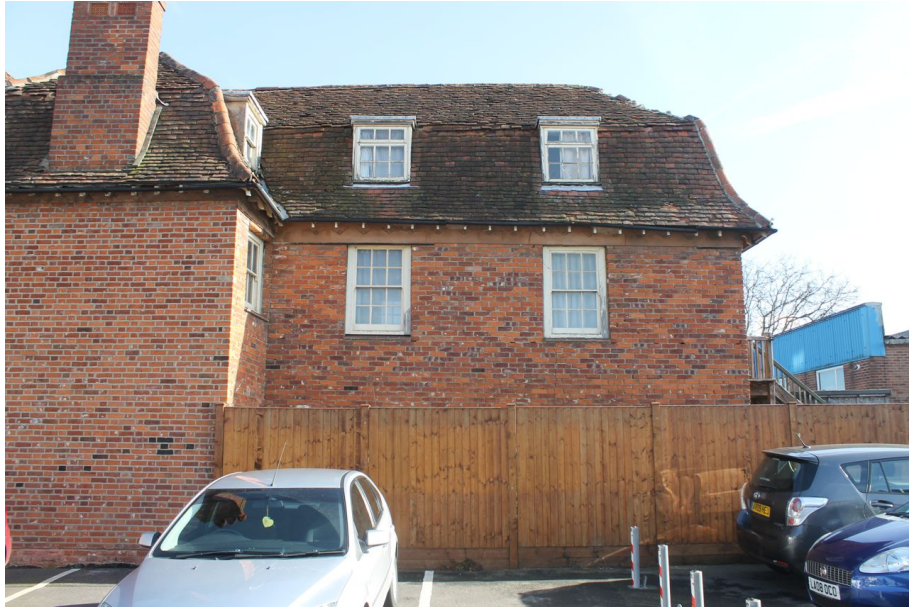
The main range has two chimneys on this elevation, but no other features (Photograph 3). The extension has two six-light horned sash windows on the first-floor, with the usual dormers above, but no windows on the ground-floor (Photograph 13).

Photograph 13 West elevation of extension. Photograph taken facing east.

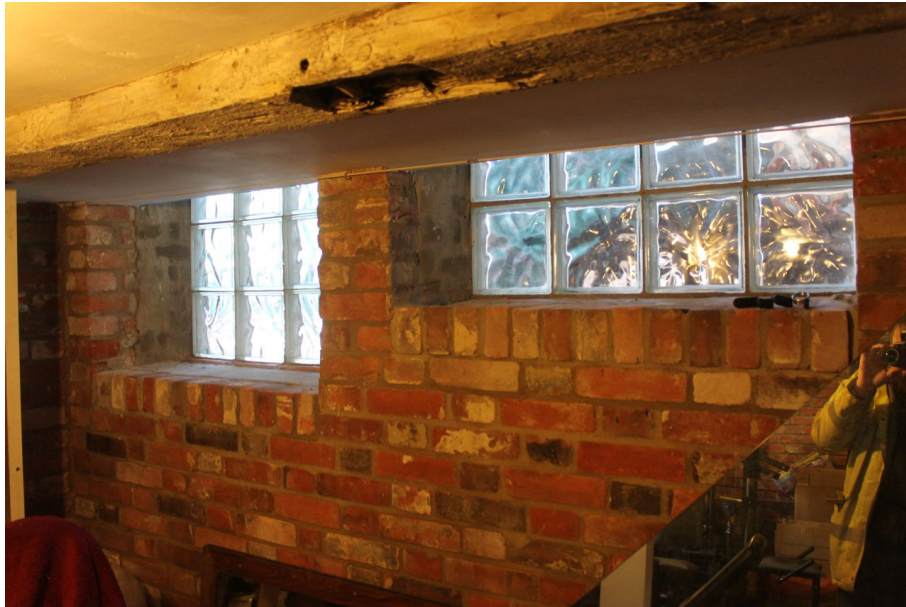
The cellar is only present beneath the north-western quarter of the main range. It is accessed by a concrete staircase on the ground-floor (Fig 3) and has a six-panel modern replacement door. It is constructed of brick laid in Flemish-bond, with bricks measuring 220mm x 100mm x 60mm and bonded with cement. Its eastern wall contains several modern hammered thick-glass windows that are just above ground-level in the passageway to the east (Photograph 14). A small fireplace remains open on its western wall.

Photograph 14 Hammered-glass windows on east side of cellar, looking out onto passageway. Photograph taken facing north-east.

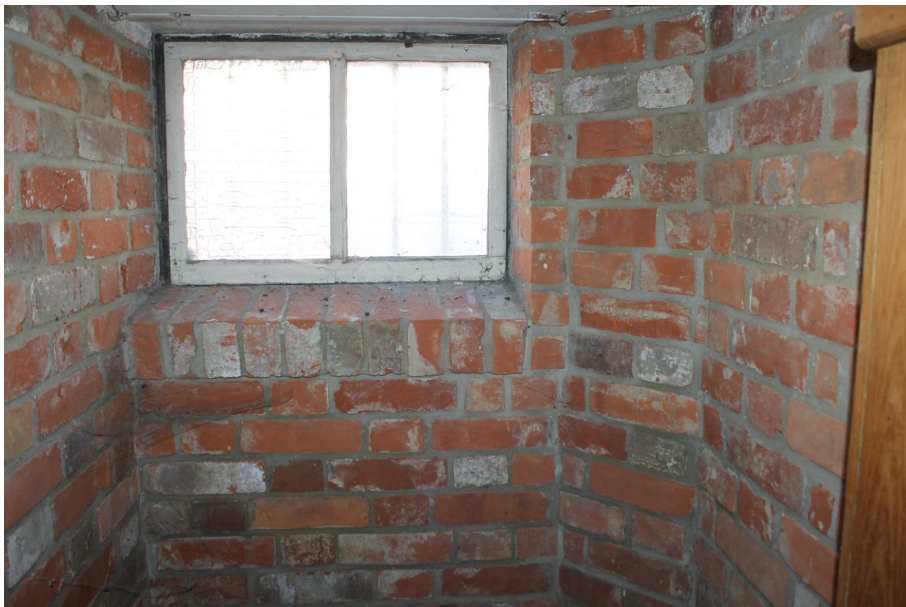
Photograph 15 Fixed window in cellar below bay window on ground-floor. Rebuilt brickwork around. Photograph taken facing north.

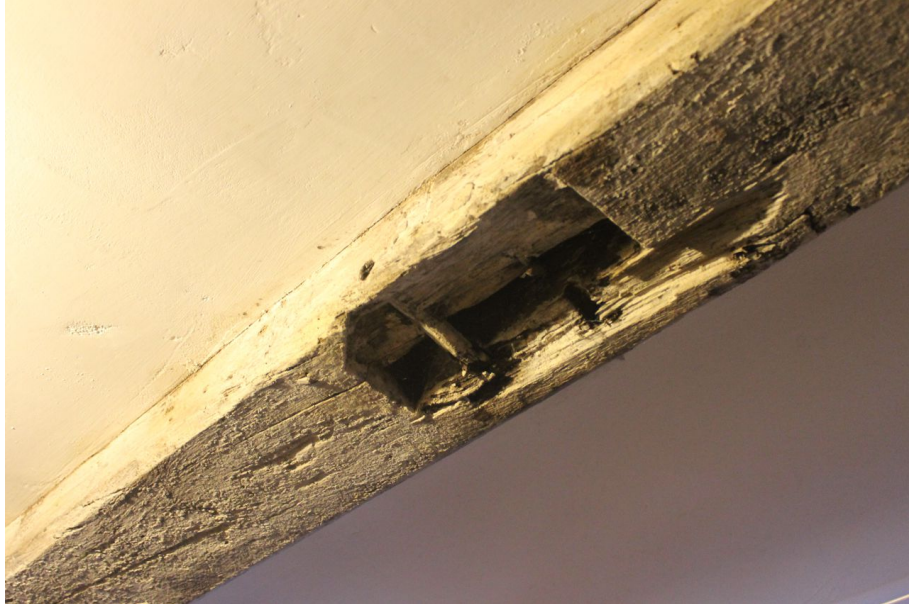
Visible in the cellar, and of some interest, are the joists of the ground-floor above. Seven of the joists, to the west of the cellar, are modern machine-cut timbers measuring 75mm x 70mm. The three joists to the east, however, are much larger hand-sawn timbers, two of which have evidence of re-use in the form of empty mortices (Photograph 16). One of these mortices has an associated carpenter's mark of "IIII" (Photograph 17).

Photograph 16 Detail of empty mortise on joist in cellar. Photograph taken facing north-east.

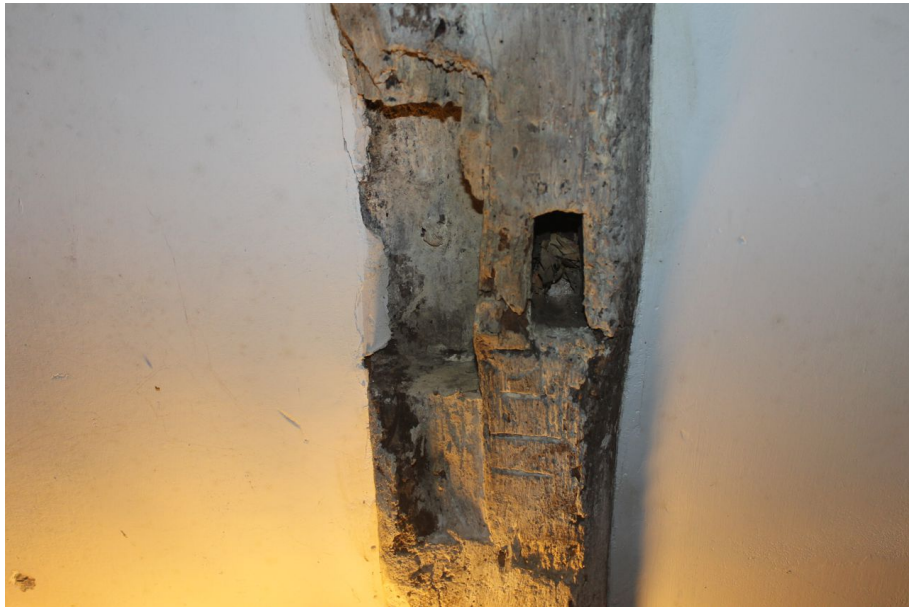
Photograph 17 Detail of empty mortise and carpenter's mark "IIII" on underside of joist in cellar.

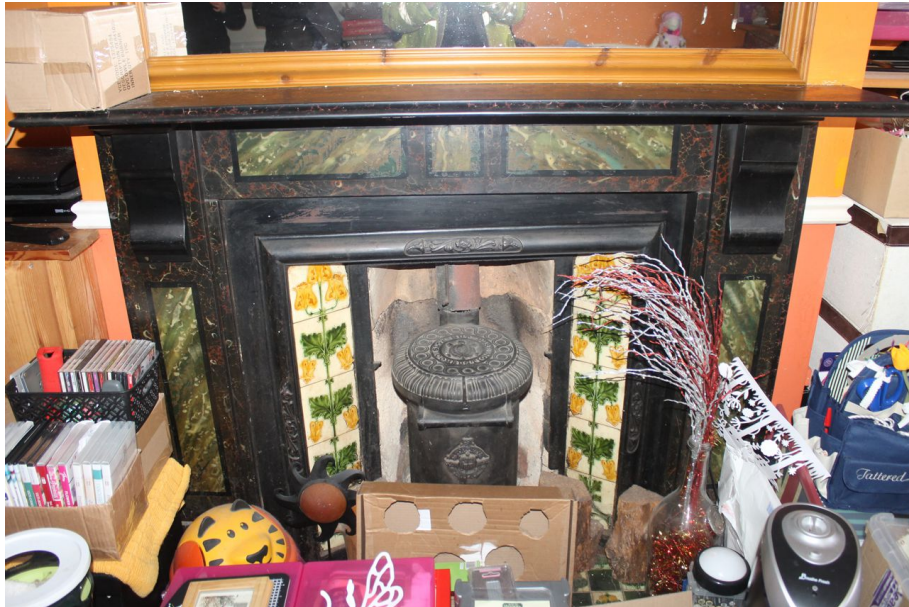
Although there are no original features, some are still of note. Within the northern room on the ground-floor is an example of a late 19th-century fireplace (Yorke 2005, 75). While the cast-iron fireplace has been removed and replaced with a wood burner, the decorative surround, with its tiles and carved brackets, survives (Photograph 18). The fireplace in the southern room has been blocked (Fig 3).

Photograph 18 Tiled fireplace surround in northern room of ground-floor. Wood burner in centre a modern insertion. Photograph taken facing west.

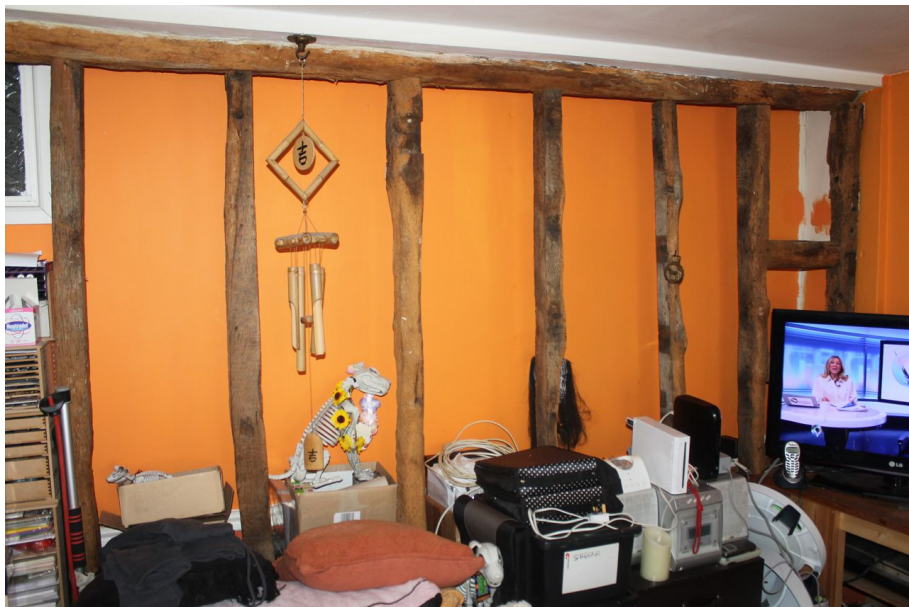
Within the northern room is what appears to be a timber-framed wall, constructed of hand-sawn timber with studs rising to a beam in the ceiling (Photograph 19). Closer inspection, however, reveals that this is an imitation wall and not a legitimate part of the fabric of the building; the studs are not set in mortices and are simply nailed to the upper beam. Behind this timber-framed imitation is the actual interior wall of the building, but as it is rendered it is impossible to tell if it is brick or timber.

Photograph 19 Imitation timber wall in northern-room of ground-floor. Photograph taken facing south-west.

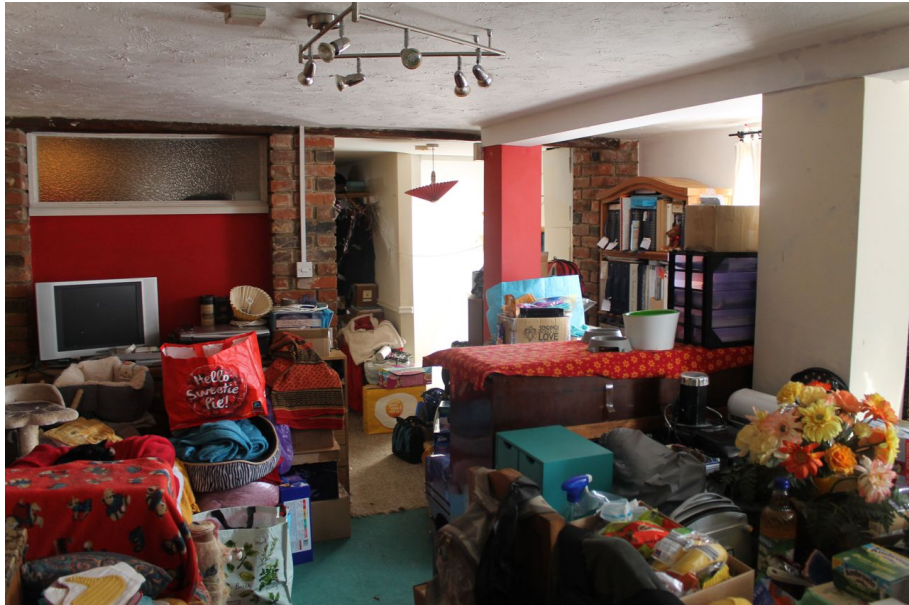
Visible on the ground-floor, and supporting the upper-floors, are several brick-pillars. These all appear to be later additions, presumably added to the building when part of the southern wall of the main range was removed to allow access into the extension. Three of these pillars are supporting an inserted timber beam of the floor above (Photograph 20).

Photograph 20 Ground-floor of extension, showing brick pillars supporting upper floors of main range. Photograph taken facing north.

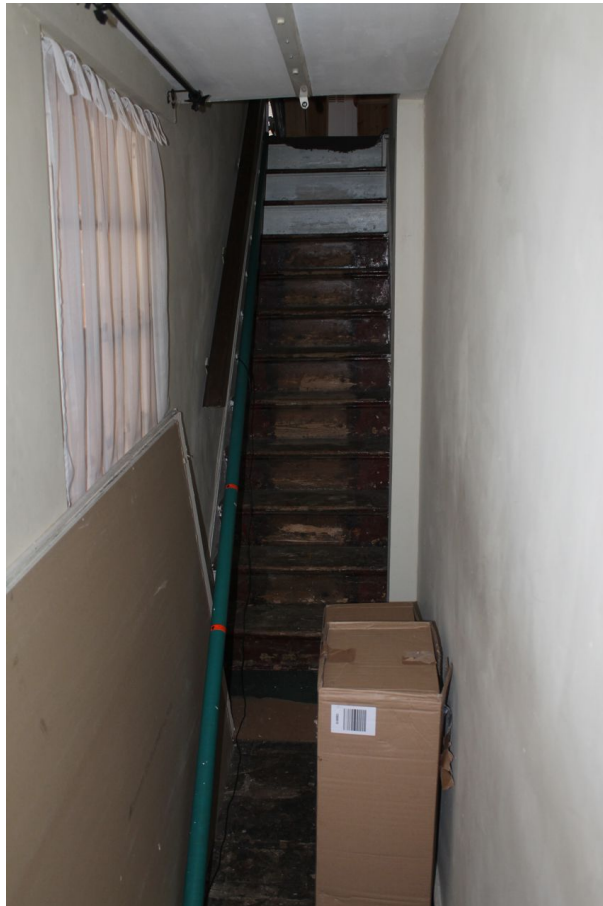
The staircase up to the first-floor is constructed of wooden riser and treads with a modern handrail. Although relatively undiagnostic, there is no reason that this staircase could not be original to the building (Photograph 21).

Photograph 21 Staircase leading up to first-floor. Photograph taken facing south.

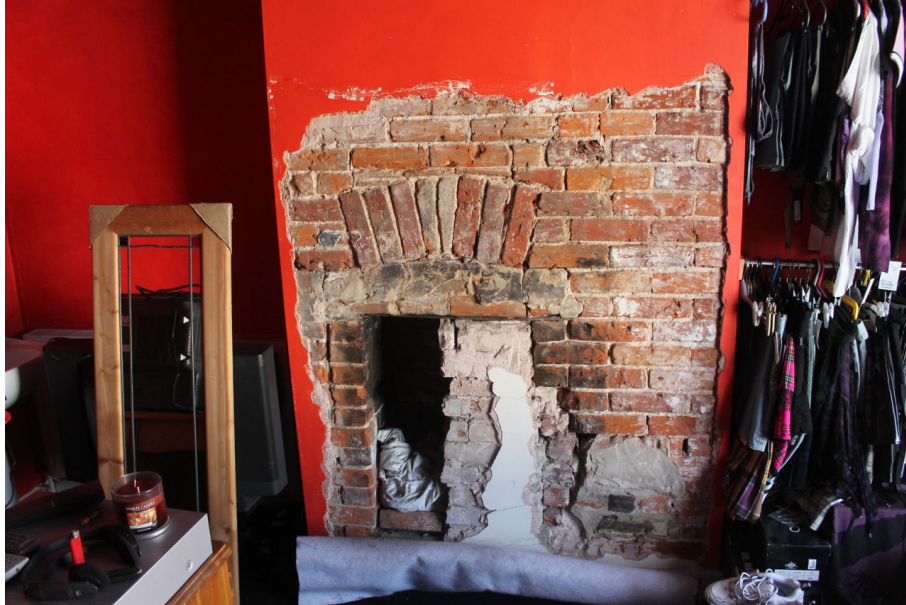
The southern fireplace is blocked on this floor but the northern one has been partially reopened, revealing a segmental brick arch above (Photograph 22). In the same room as this exposed fireplace, a beam is partially visible above the central wall (Photograph 23).

Photograph 22 Blocked then partially reopened northern fireplace on first-floor. Photograph taken facing west.

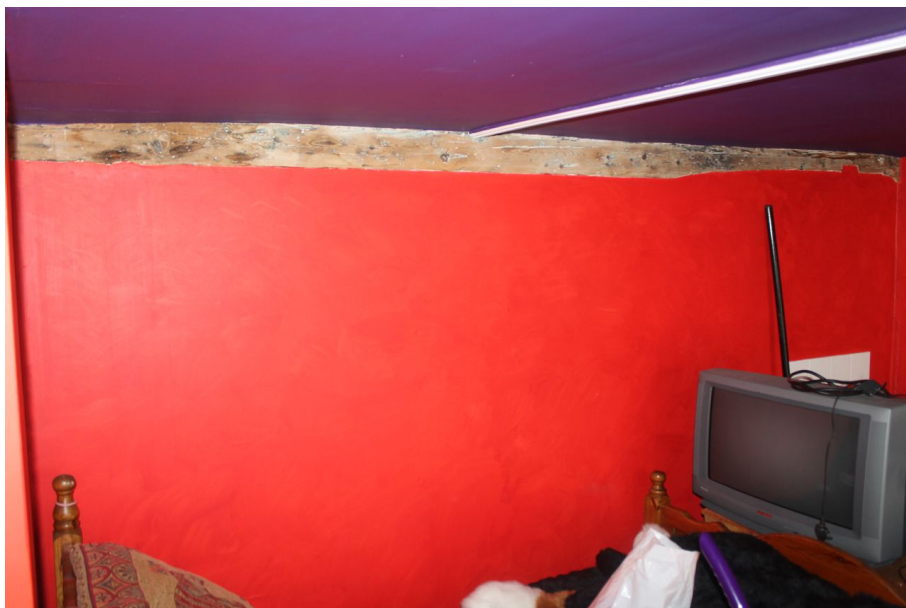
Photograph 23 Visible beam in north-west room on first-floor. Photograph taken facing south.

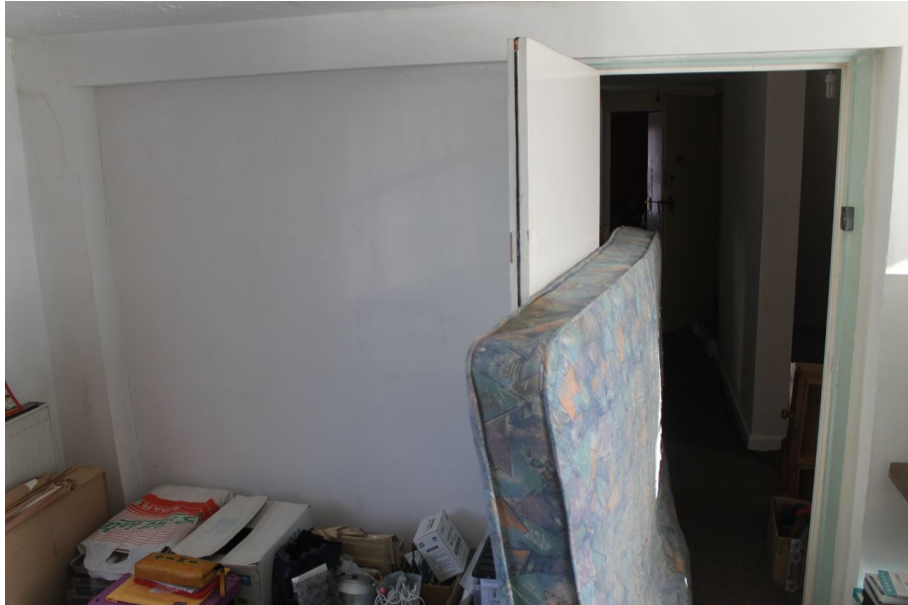
location of a previously removed window originating from before the extensions construction.

Photograph 24 View from extension showing entrance into main range on first-floor, alongside possible blocked entrance or window. Photograph taken facing north.

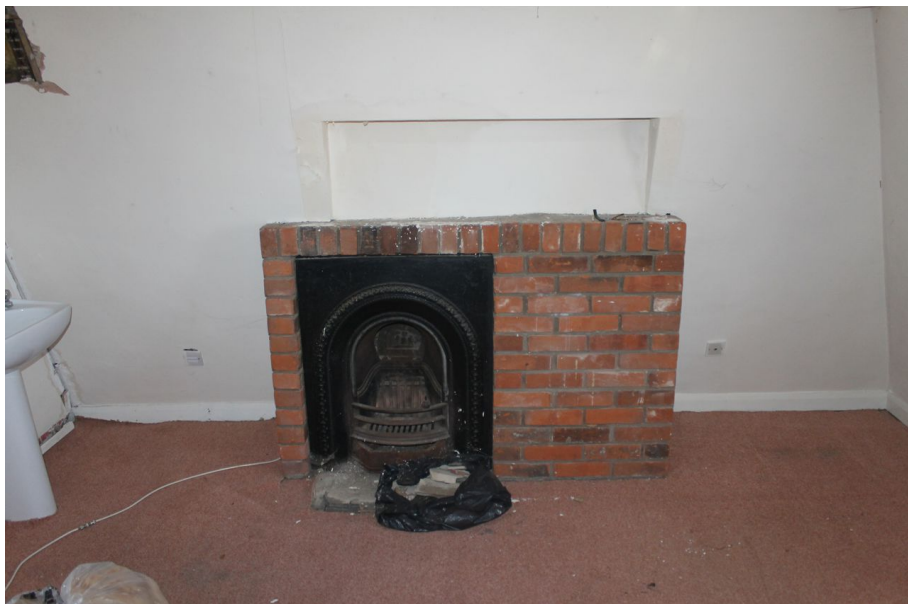
The southern fireplace has been blocked, but the northern has had a new brick surround built and a late 19th-century cast-iron fireplace within it (Photograph 25). The origin of this cast-iron fireplace is unclear, but it may originate from the ground-floor of this building (in the location now occupied by a wood burner; see pg 18).

Photograph 25 Rebuilt northern fireplace surround on second-floor. Photograph taken facing west.

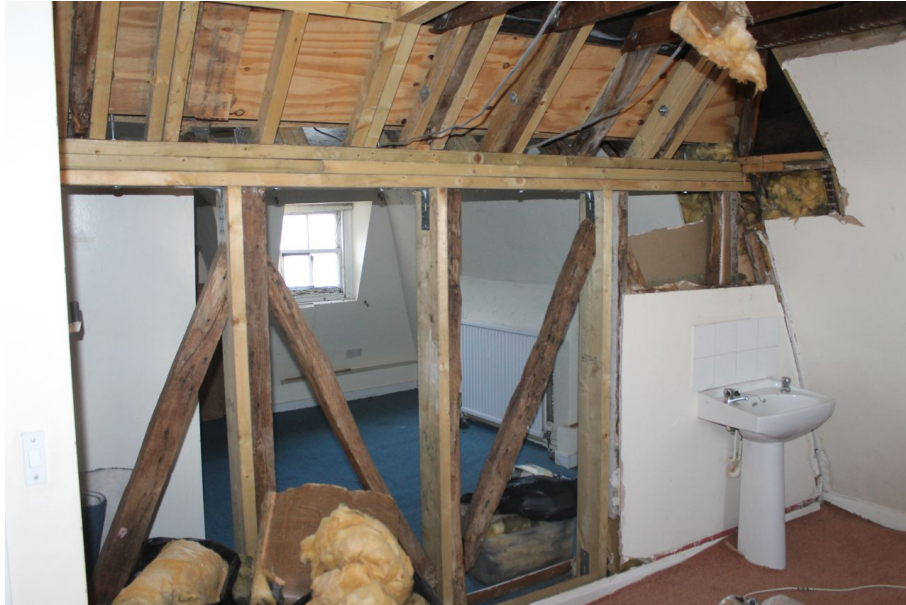
Of note on this floor is that the plasterboard has been removed from one of the interior walls, exposing its fabric which consists of a mix of older hand-sawn and very modern machine-cut timber (Photograph 26). The hand-sawn sections of the wall are studs and diagonal bracing supporting them, all resting on a beam below (as observed on the first-floor; see pg 21). The hand-sawn studs are supported by modern metal braces and machine-cut timbers, and all rise to a very modern wall-plate (Photograph 26). Although these hand-sawn timbers are clearly of some significant age, there can be no doubt that the wall they are currently part of is not. The question becomes where these hand-sawn timbers originate from: were they part of the original fabric of 79 Magdalen Street or are they from an earlier structure? This question is examined in the discussion (pg 25).

Photograph 26 Timber wall between north-west and south-west room in main range on second-floor. Mixture of modern machine-cut and historic hand-sawn timber visible. Photograph taken facing south-west.

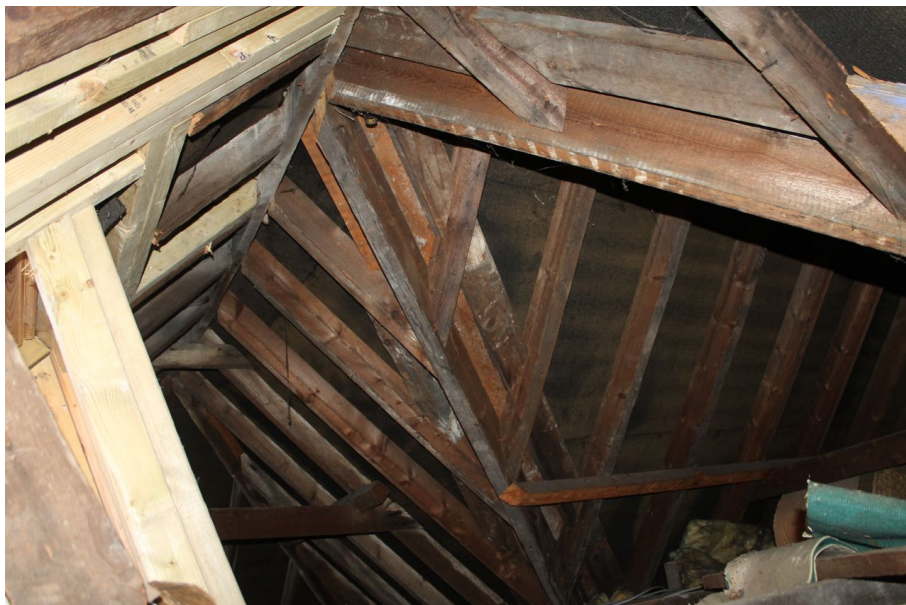
Photograph 27 Roof structure, showing extension's roof to right attaching to main ranges roof. Photograph taken facing east.

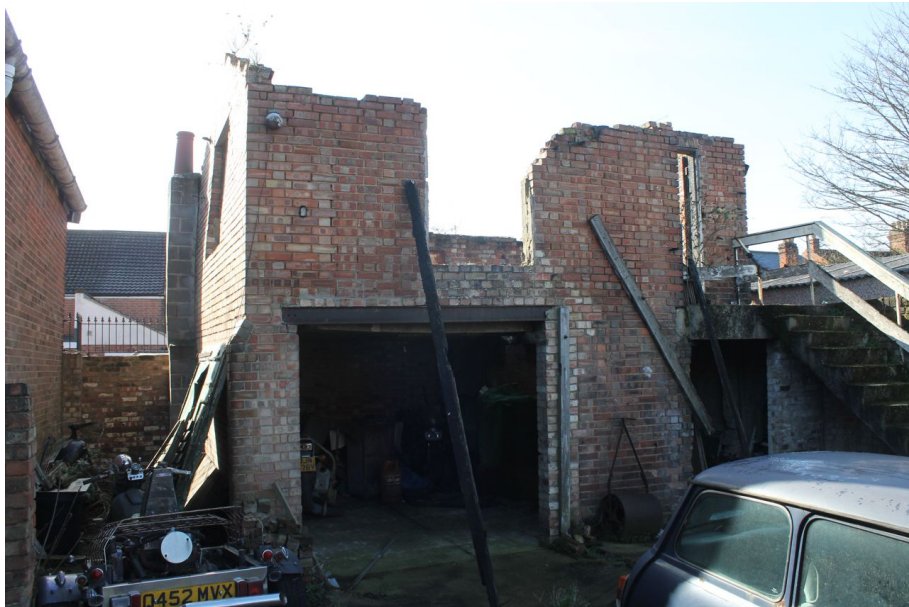
The outbuilding is of very little interest historically. It is constructed of red bricks with a deep frog, laid in Sussex-bond with queen-closers and bonded in cement (Photograph 28). The roof has collapsed and is entirely absent and the remainder of the building is not structurally sound. The double-width garage opening on the ground-floor (Fig 9) appears to be a later insertion judging by the rebuilt brickwork around it (Fig 10). The first-floor is accessed by a set on concrete steps, but could not be examined for safety reasons.

Photograph 28 North elevation of outbuilding. Photograph taken facing south-west.
