**Historic building recording at  
No 10-12 Botany Cottages,  
London Road, Purfleet,  
Essex, RM19 1PS**

**March 2019**

**commissioned by  
Thurrock Council**

**CAT Report 1427**  
May 2019

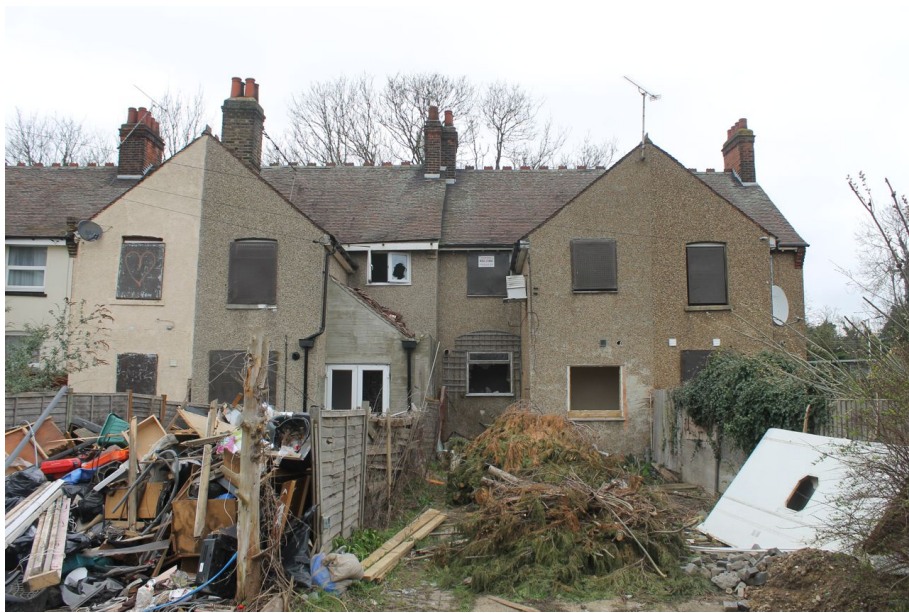
**Photograph 4** South-west elevation of No 10-12. Photograph taken facing north-east.

The south-west elevation of the buildings is covered in pebbledash render, with no visible brickwork (Photograph 4). Each building has four windows on this elevation, two on the main range and two on the south-west wing, split between the ground and first-floors (Photograph 4). The vast majority of these are modern plastic-framed awning and casement windows, although the two on the main range of No 11 are both modern wooden-framed awnings (Fig 5). The windows vary in size significantly, and on the ground-floor of No 11 no window remains at all on the ground-floor of the south-west range (Photograph 4).

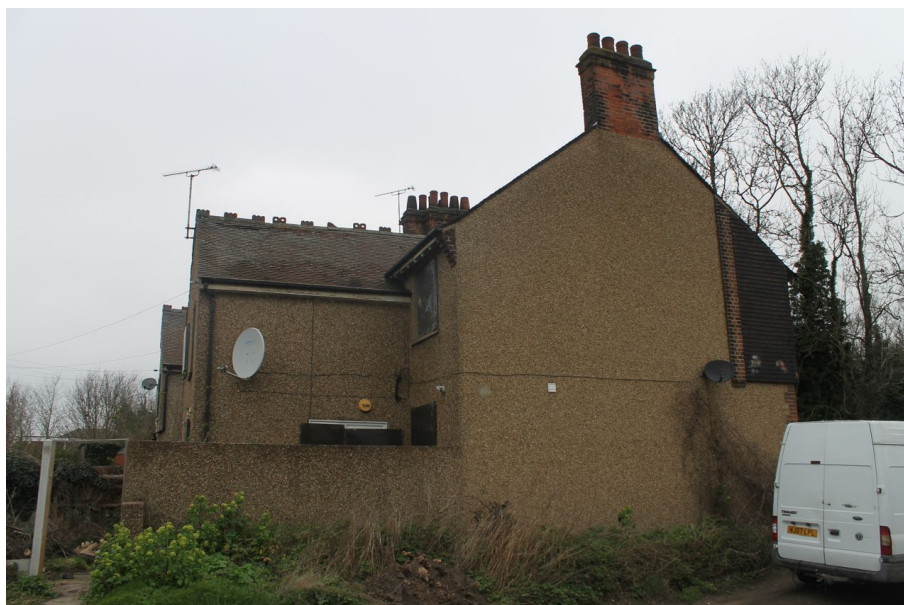
Only No 12 has a south-east elevation. It is featureless and covered with pebbledash render, with a small section of hanging tiles and brickwork to the north (Photograph 5).

**Photograph 5** South-east elevation of No 12. Photograph taken facing north-west.

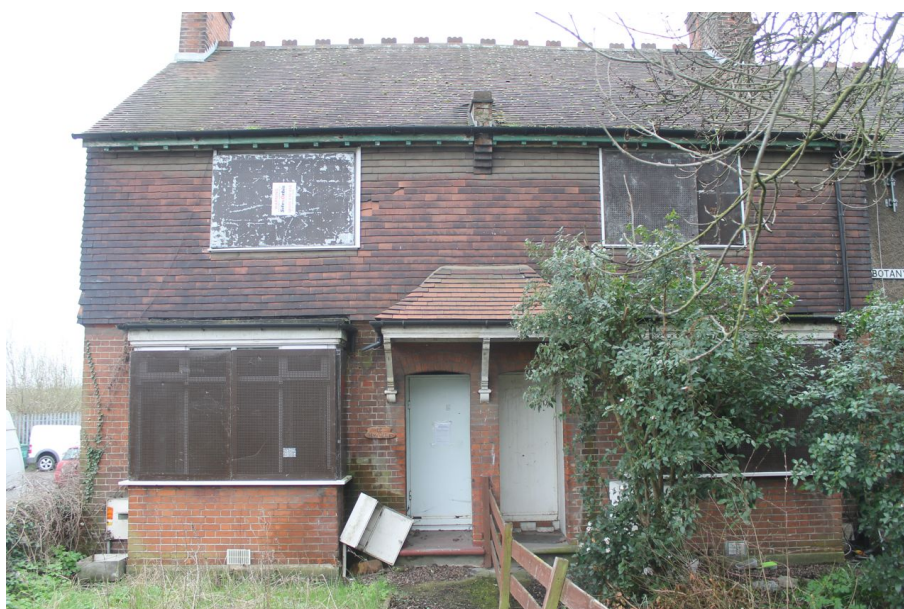
**Photograph 6** North-east elevation of Nos 11 and 12. Photograph taken facing south-west.

The main entrances into the buildings are on this elevation, with each pair of houses having doorways side by side (Photograph 6). Above the doorways is a timber-framed hood, covered in plain tiles (Photograph 7). The doors into the buildings are modern replacements.

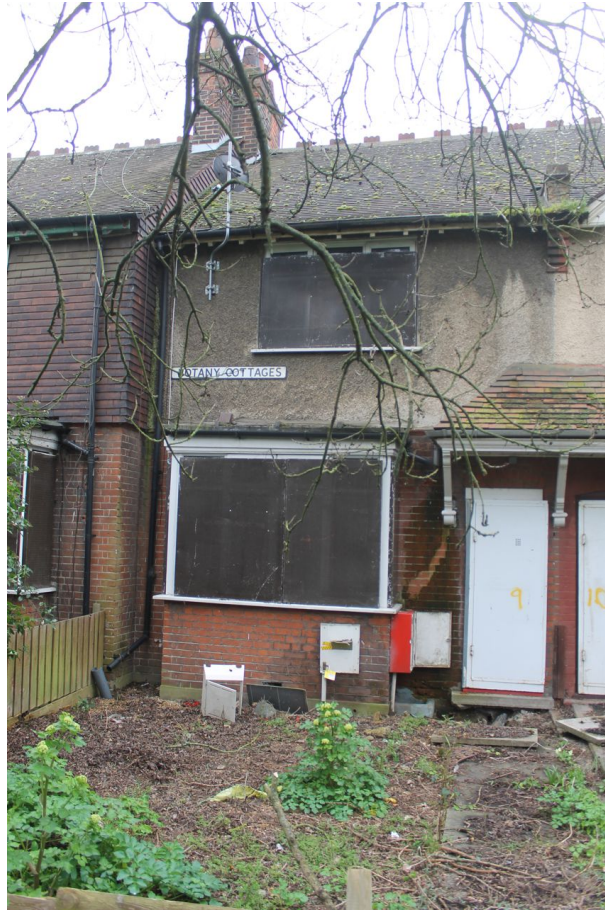
**Photograph 7** North-east elevation of No 10.  
Photograph taken facing south-west.

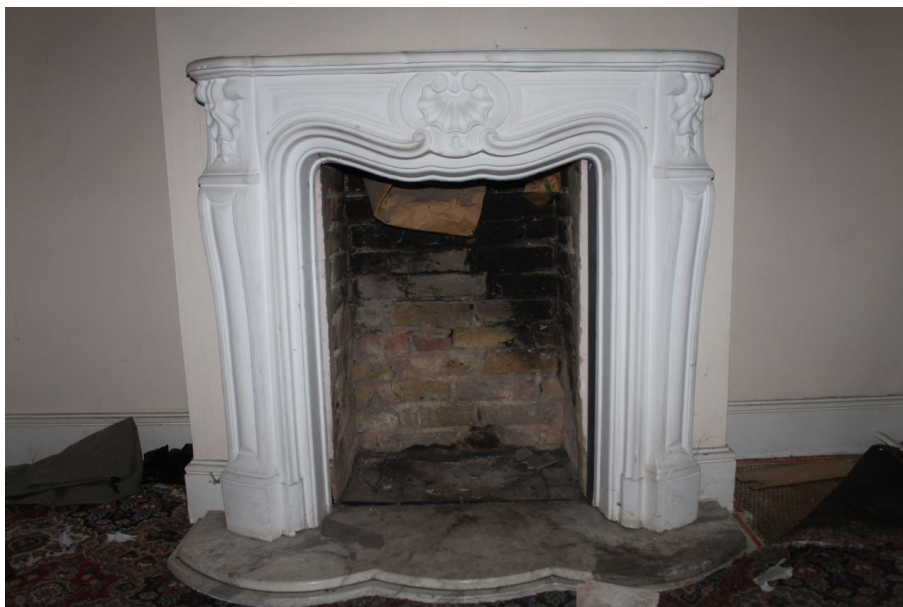
The fireplaces in the living-rooms are all still open on the ground-floor, although none of them have their original surrounds: No 11 has a moulded plaster surround, No 12 a tiled surround and in No 10 no surround survives at all (Photographs 8-9).

**Photograph 8** Modern plaster fireplace surround in living-room on ground-floor of No 11. Photograph taken facing north-west.

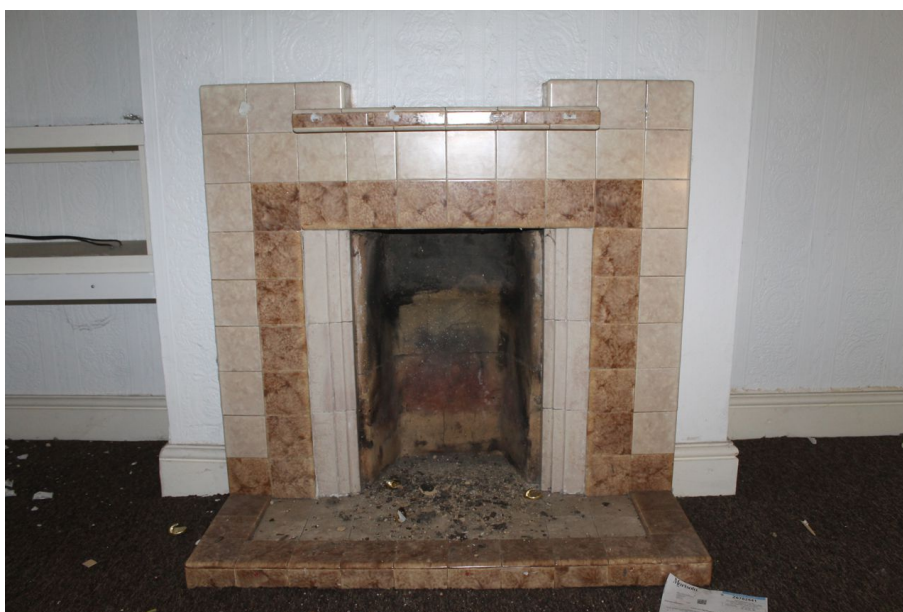
**Photograph 9** 1930s tiled fireplace surround in living-room on ground-floor of No 12. Photograph taken facing south-east.

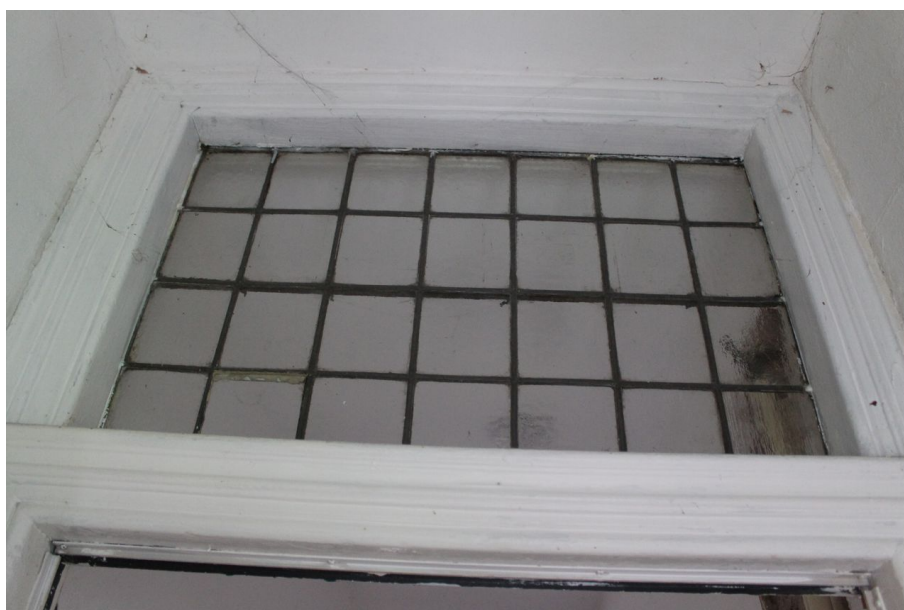
In the entrance hall of each property is a doorway with a window opening above (Fig 2). A fixed 28-light leaded window survives in this location in No 10, and is probably original (Photograph 10). The other two cottages have a modern plastic-framed window in this location (Photograph 11).

**Photograph 10** Detail of original leaded light in entranceway of No 10 on ground-floor. Photograph taken facing north-east.

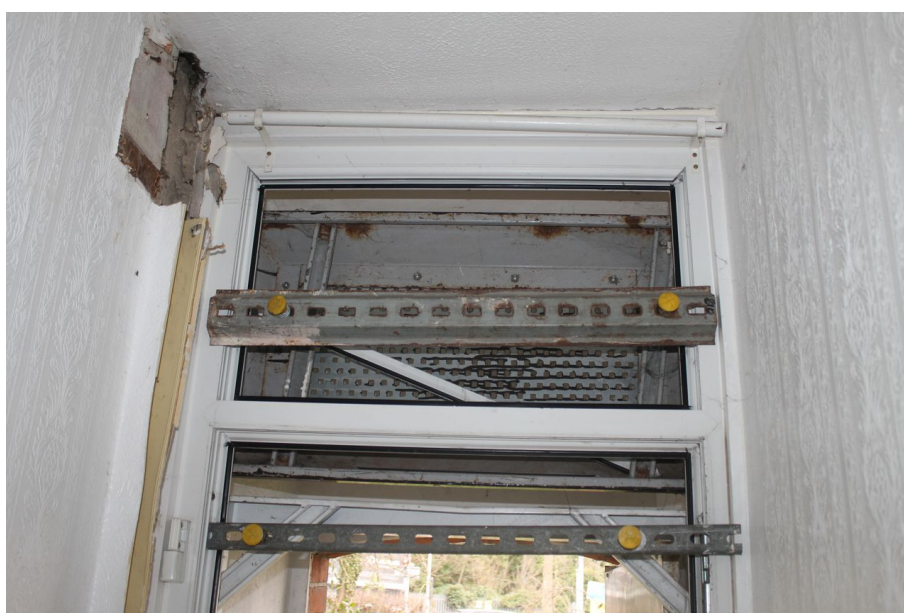
**Photograph 11** Plastic-framed window above entranceway on ground-floor of No 12. Photograph taken facing north-east.

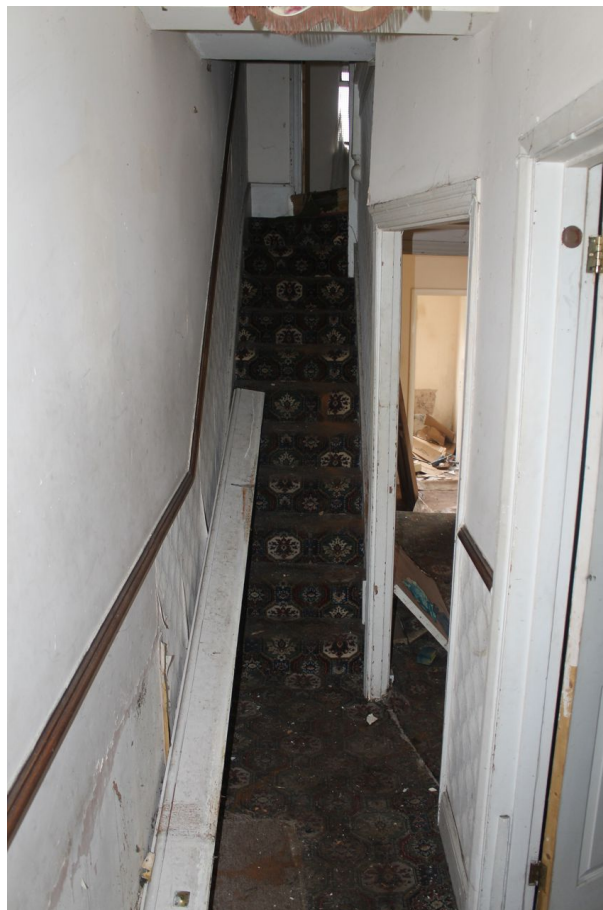
No 11 has a surviving dado rail on the both the ground, stairs and first-floor (Photograph 12).

**Photograph 12** Ground-floor of No 11, showing dado rail to left of frame. Photograph taken facing south-west.

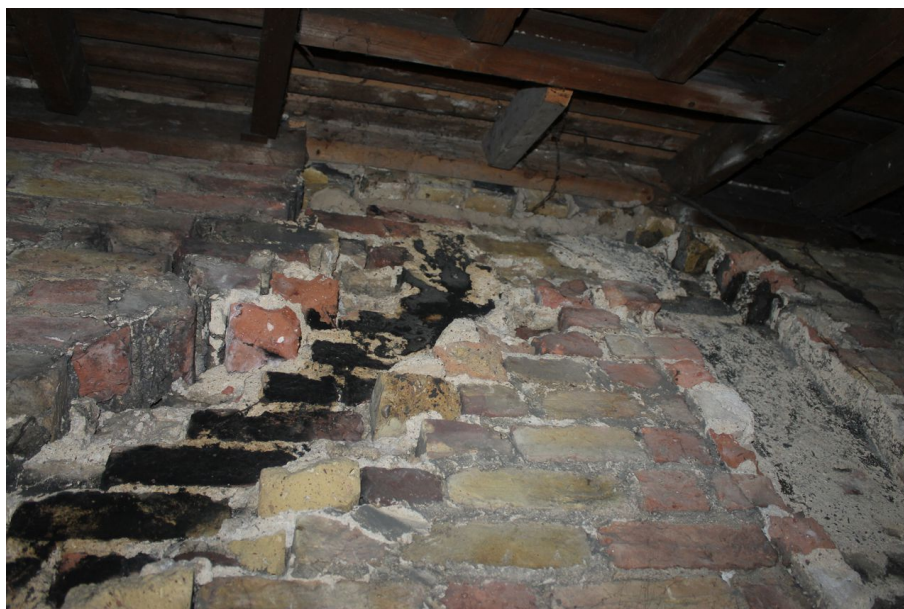
**Photograph 13** Remains of chimney in the attic space of No 11's south-west wing. Photograph taken facing south-east.

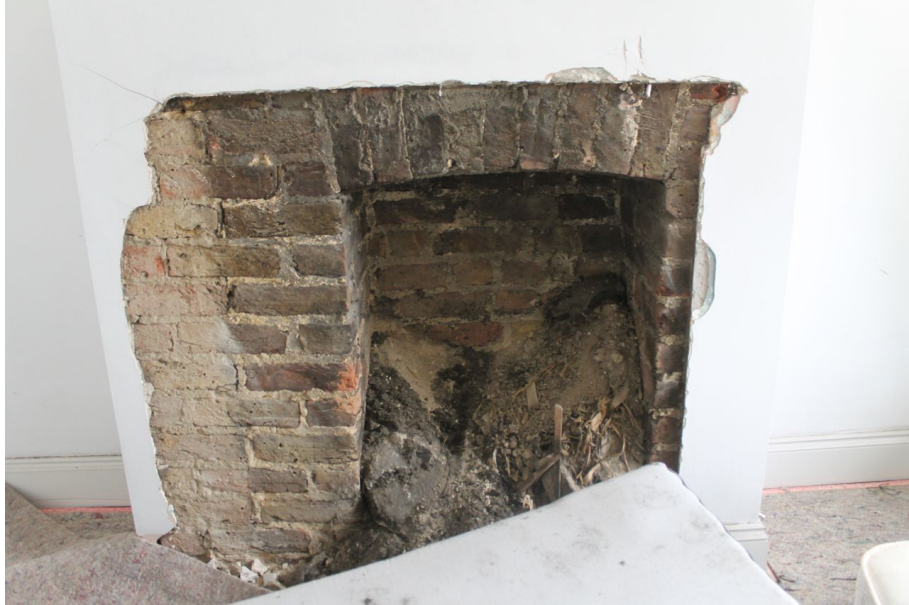
**Photograph 14** Exposed fireplace in southern room of main range on first-floor of No 10. Photograph taken facing south-east.  
An original cupboard survives on the first-floor landing of No 12 (Photograph 15). Although the interior shelves appear to be more recent replacements, the cupboard's four-panelled door is probably original.

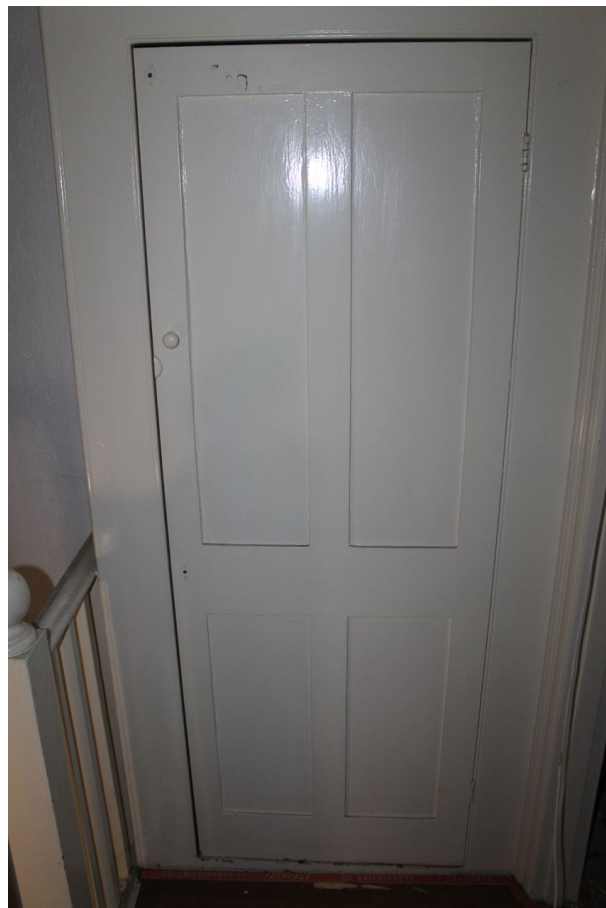
**Photograph 15** Original cupboard on first-floor landing of No 12. Photograph taken facing north-west.

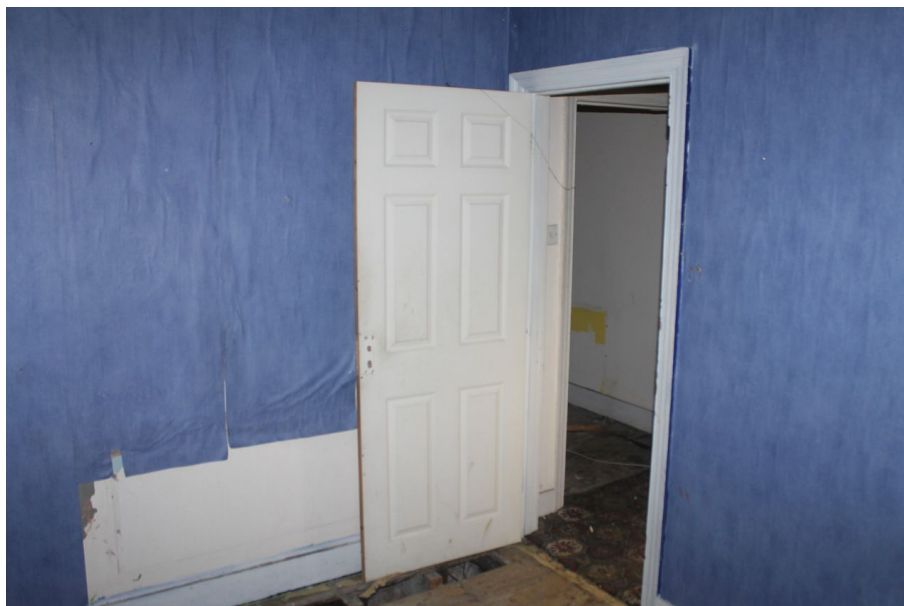
Very few doors survive on the interior of the buildings, and most of ones that do are all modern replacements (Photograph 16). The only exceptions to this are two vertical-planked doors leading into the cupboards under the stairs on the ground-floors of Nos 10 and 11, which are probably original (Photograph 17).

**Photograph 16** Modern door leading into southern room on first-floor of No 11. Photograph taken facing north-east.

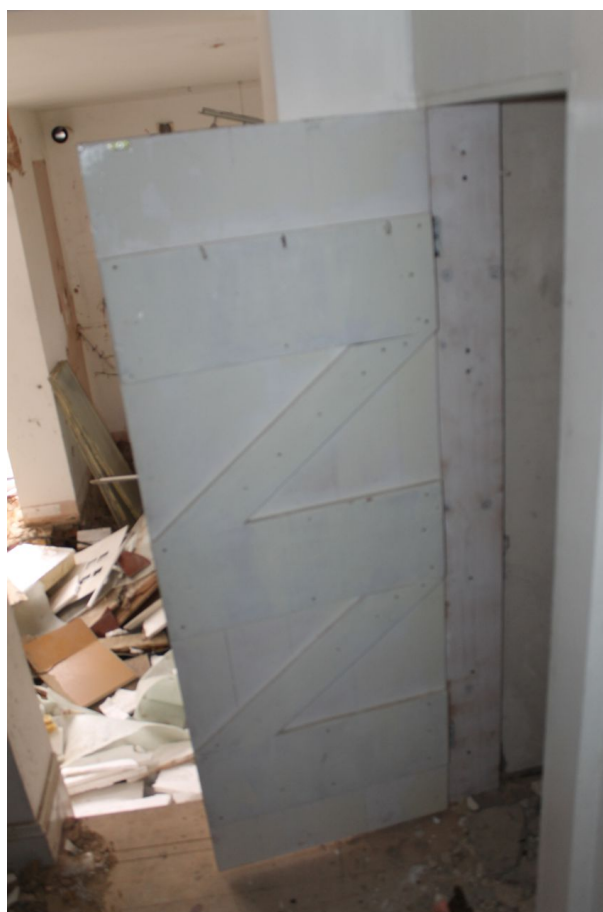
**Photograph 17** Surviving vertical-planked door on ground-floor of No 10 leading into cupboard under stairs.

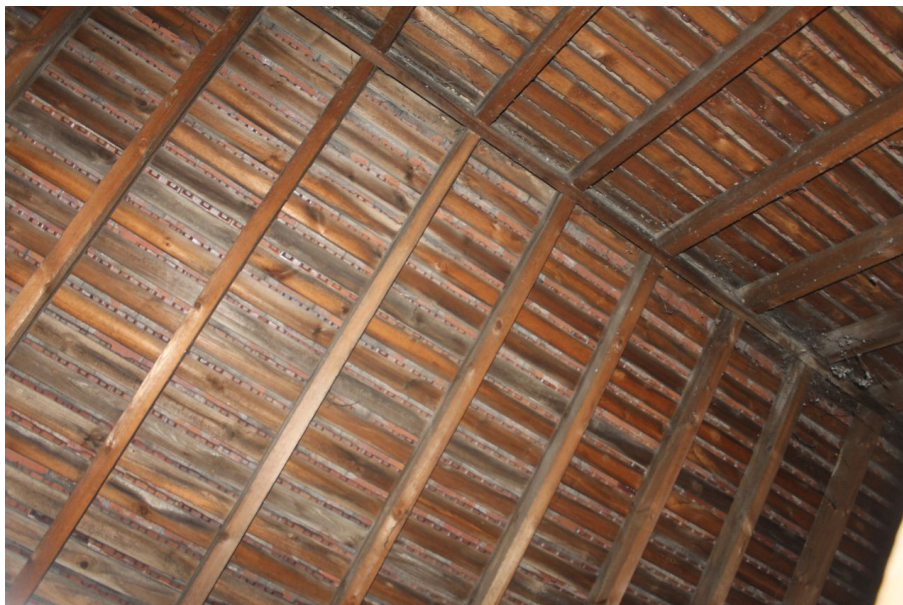
The building's roofs are partially visible through loft hatches, and are constructed of machine-cut rafters rising to a ridgeboard. They have no collars, but each roof is supported by inclined struts rising from the tie-beams.

**Photograph 18** Detail of roof structure in No 10, showing rafter pairs rising to a ridgeboard with no collar support.
