Historic building recording at the former Great Wigborough Village Hall, School Lane, Great Wigborough, Essex CO5 7RJ

June 2020

CAT Report 1594
September 2020

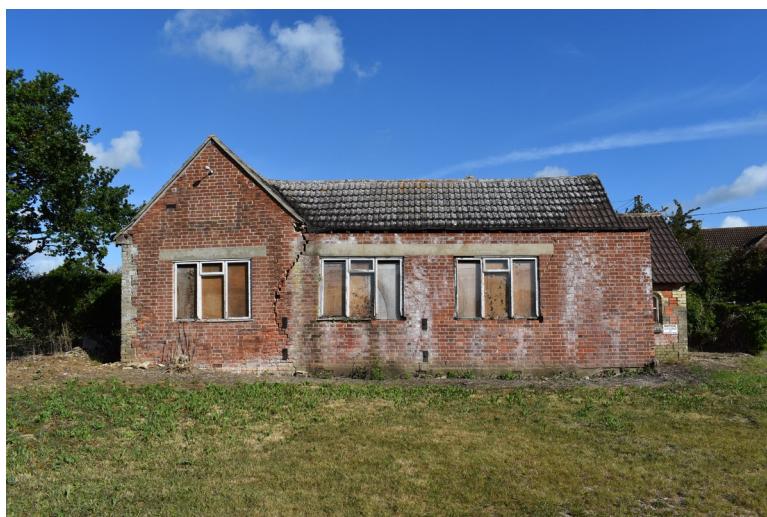
Photograph 8 South-east elevation of building. Note structural damage and modern windows with substantial concrete lintels.
Photograph taken facing north-west.

The south-east elevation of the building has three identical casement/awning windows, with substantial concrete lintels (Photograph 8). Four small tie-plates are present on this elevation, and are presumably the result of repair work. They have been limited in their effectiveness, however, as a substantial crack in the brickwork of this elevation is visible in the join between the flat-roofed extension and the gable-end (Photograph 8).

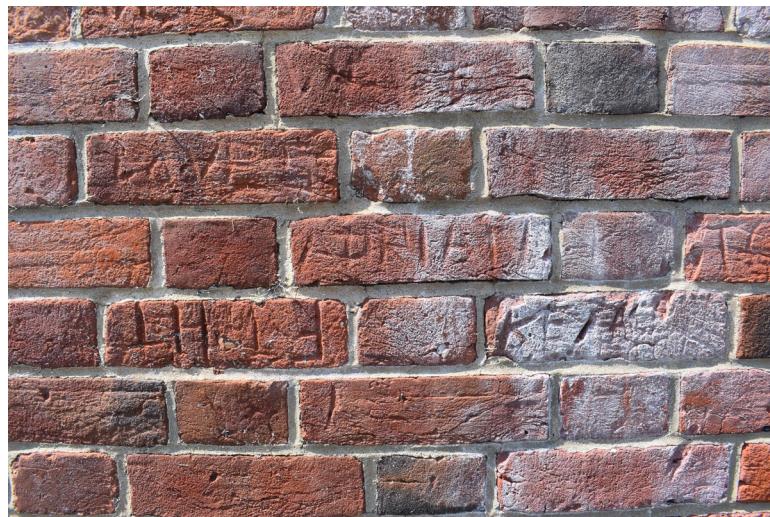
Photograph 9 Example of graffiti on south-east elevation of building. Photograph taken facing north-west.

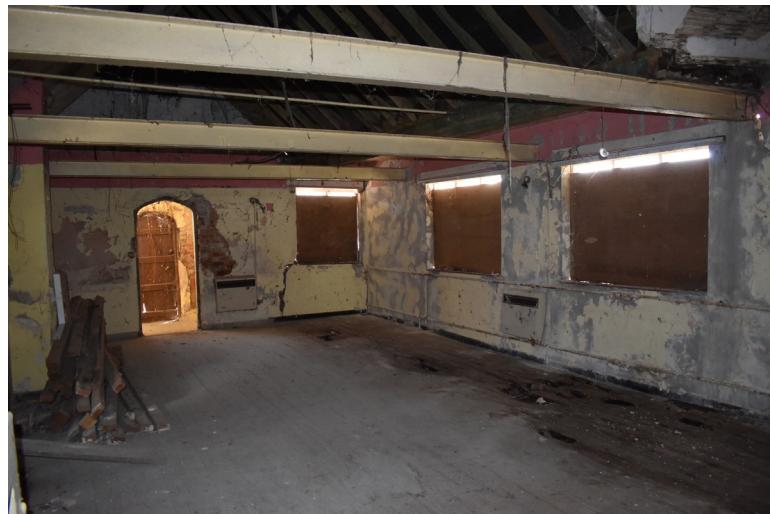
Photograph 16 Southern room of building, showing metal beams and damaged floorboards. Photograph taken facing east.

There are three inserted metal beams serving as tie-beams in this room, all of which project from the top of the south-eastern wall of the flat-roofed extension (Photograph 16). There is also a tie-rod joining each pitch of the cross-wings roof (Photograph 21). Both of these are clearly later additions to the structure, presumably added when the flat-roofed extension was constructed.

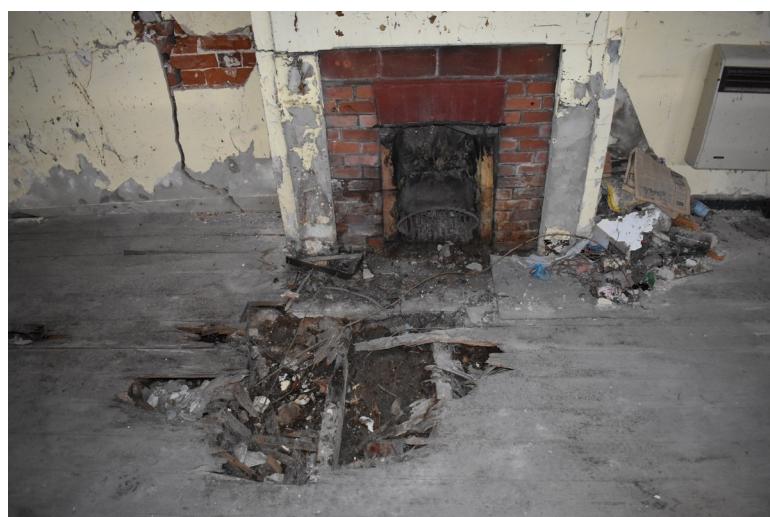
Photograph 17 Detail of inserted fireplace in western chimney-breast of southern room. Damaged section of floor visible in front. Photograph taken facing north-west.

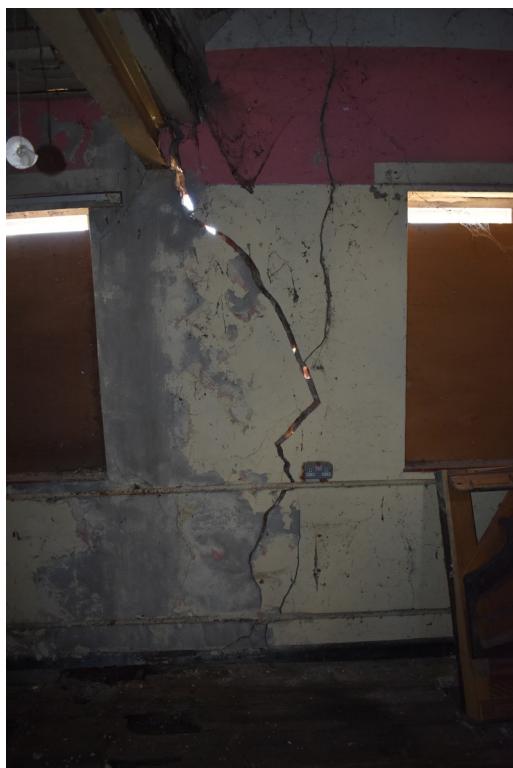
This room, and indeed the building as a whole, has some serious structural issues. Most notably, there are several very substantial cracks in the brickwork on multiple elevations in this room (Photographs 19-20).

Photograph 19 Serious structural problems evident on south-east elevation of southern room. Photograph taken facing south-east.

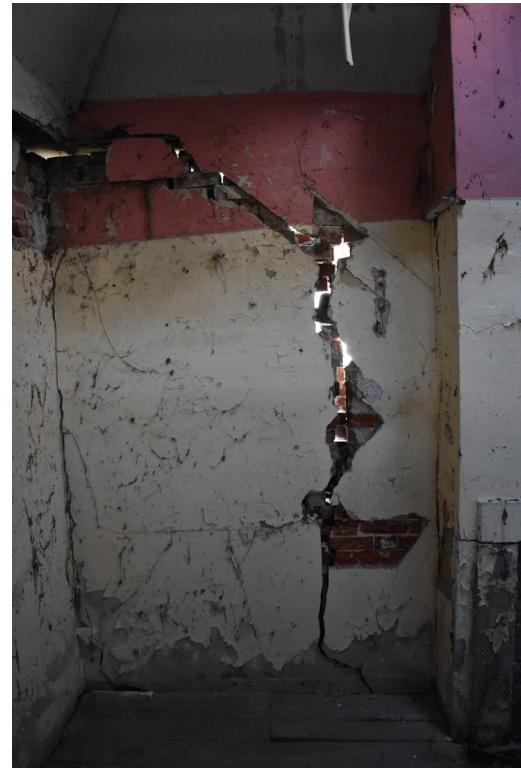
Photograph 20 Structural problems adjacent to western chimney-breast on north-west elevation of southern room. Photograph taken facing north-west.

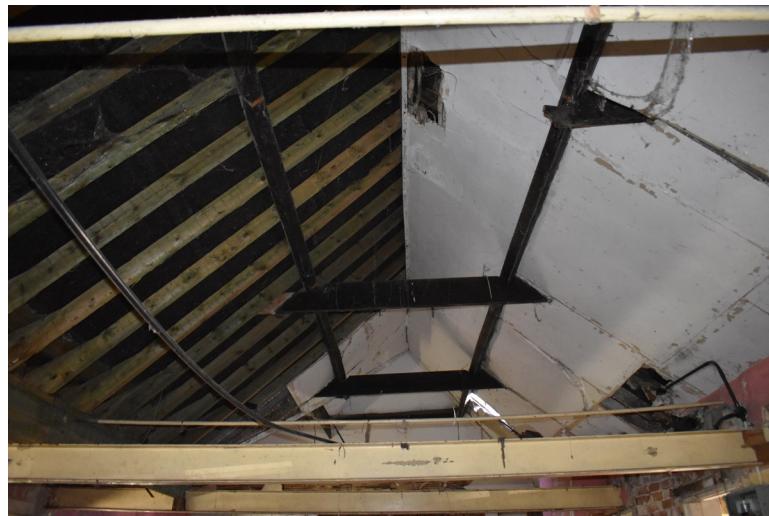
Photograph 21 Detail of roof structure above cross-wing.
Rafters on left side are replacement timbers. Photograph taken facing north-west.

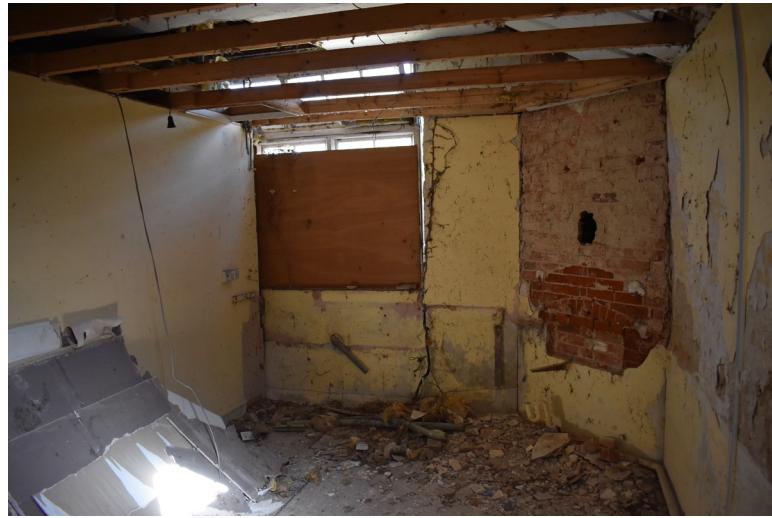
Like the southern room, the structure of this room has been severely compromised. In particular, the brickwork around the window opening on the rooms north-west elevation is cracking quite severely (Photograph 25).

Photograph 25 Northern room of building, showing structural damage evident to room's north-west elevation. Photograph taken facing north-west.

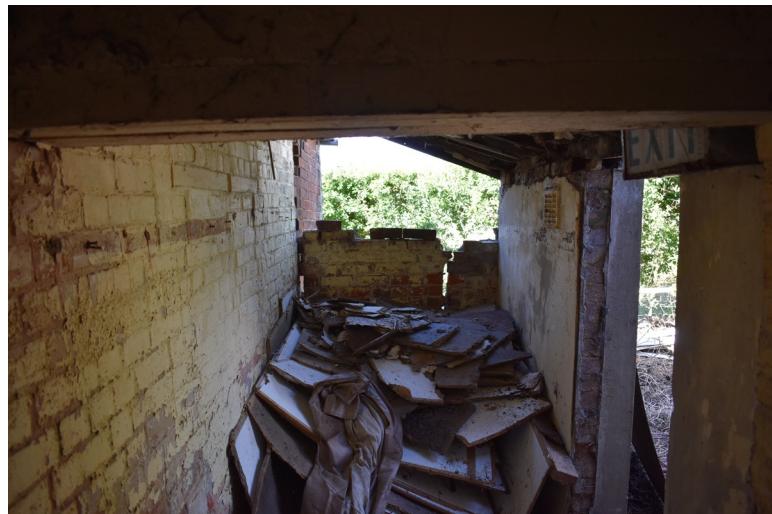
Photograph 26 Interior of western extension, showing damaged north-west elevation. Photograph taken facing north-west.

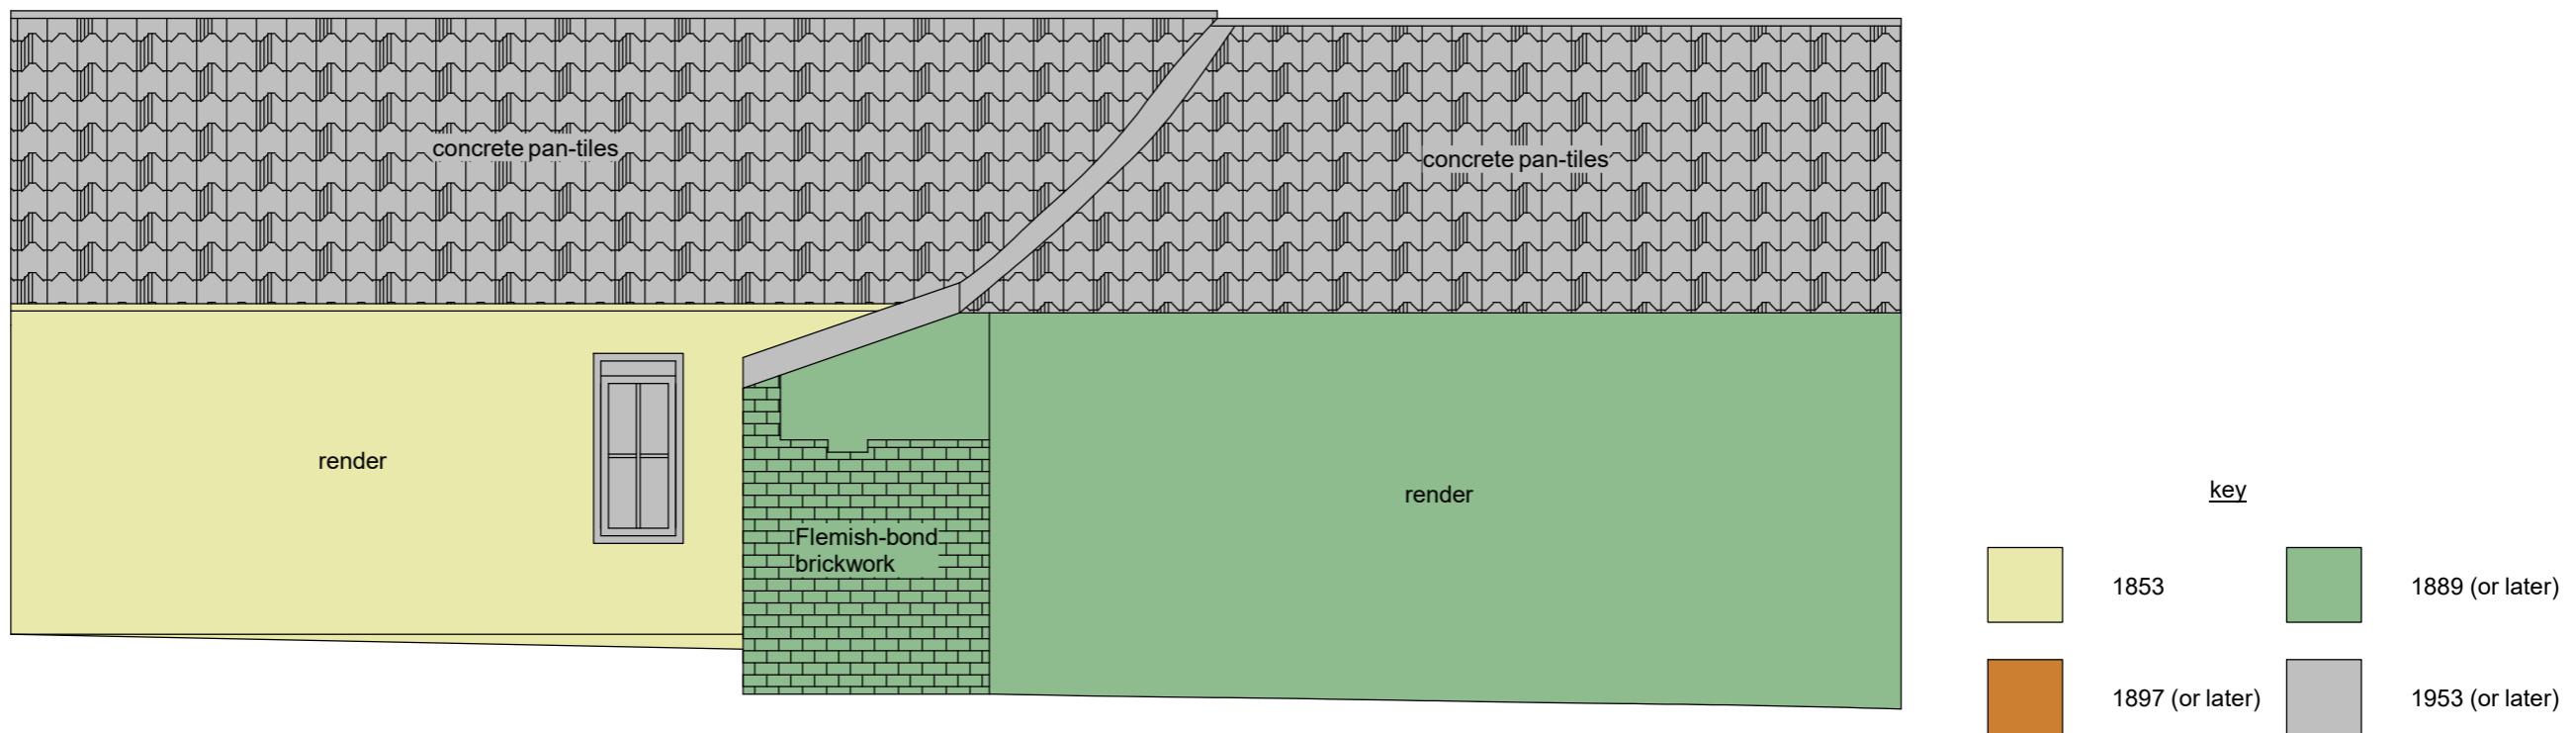
SOUTH-WEST ELEVATION

The south-west elevation of the building is largely featureless apart from a single four-light fixed window on the northern range (Fig 4). In addition, the small western extension has a substantial amount of its brickwork missing from this elevation (Fig 4).
