**Historic building recording
of the former Fleece public house,
27 West Street, Coggeshall,
Essex, CO6 1NS**

August 2020

CAT project ref.: 2020/07g
NGR: TL 84772 22503 (c)
Planning reference: 13/01071/FUL
ECC code: CG24
OASIS project id: colchest3-400127

CAT Report 1595
September 2020

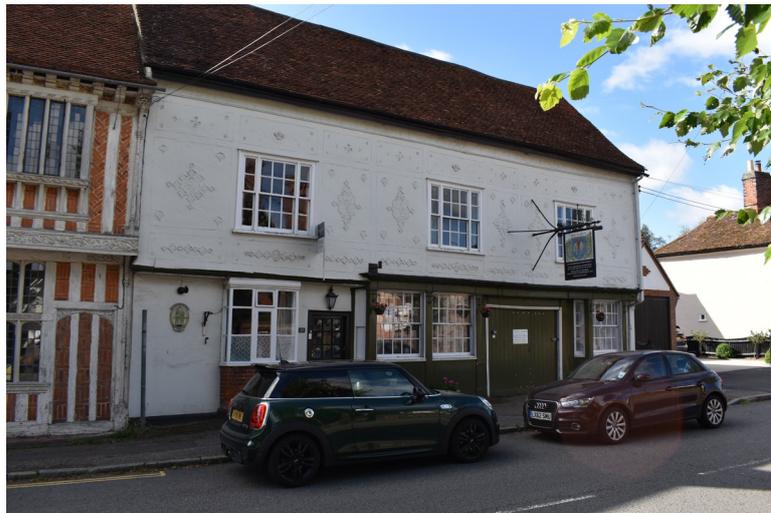
Photograph 6 North-west elevation of building. Photograph taken facing south.

The north-west elevation of the building fronts onto West Street and is decorated with ornate pargetting, including the date 1505 at the top of the elevation (Photograph 6). As this pargetting was added to the building in the later 20th century (see historical background above), this date is of little merit (and is described as such in the listing entry). A wide doorway on this elevation enters into the passage leading to the rear yard (Photograph 6). The main door into the property is also on this elevation, filled with a half-glazed (with crown glass) doorway. This entire first-floor is jettied and has three tripartite wooden-framed 20-light sash windows with no horns. The ground-floor has several bay windows projecting from the wall, infilling space beneath the jetty. The easternmost window is a wooden-framed 15-light casement window, supported on exposed brickwork. The two other windows on the ground-floor are splayed wooden-framed sash windows, one of 48 and one of 28-lights.

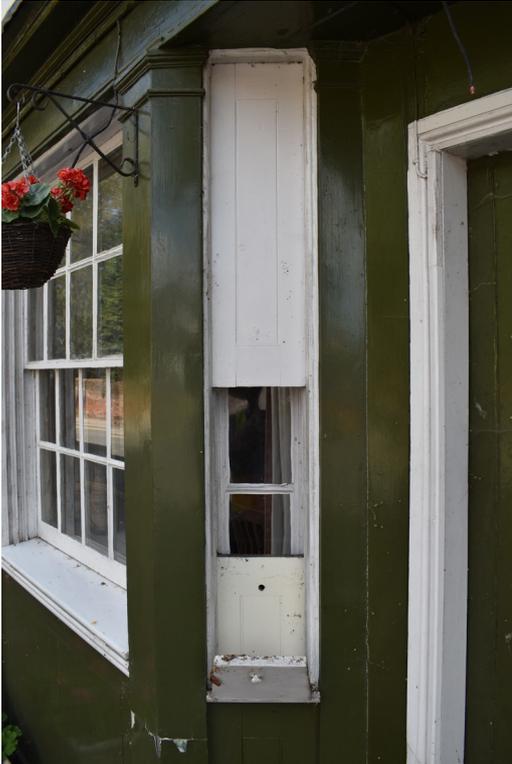
Photograph 7 Detail of sash-shutters on bay windows. Lid into recess in sill visible below window. Photograph taken facing east.

During the conversion work carried out on the building it was discovered that these splayed sash-windows have external sash shutters, housed in the sill below the windows (Photographs 7 and 8). These sash shutters are early 19th century in their design (Hall 2005, 96) and are unquestionably original to the windows. They were, however, obscured by modern additions and paintwork during the building's use as a pub, and as a result are not mentioned in the listing entry (see above).

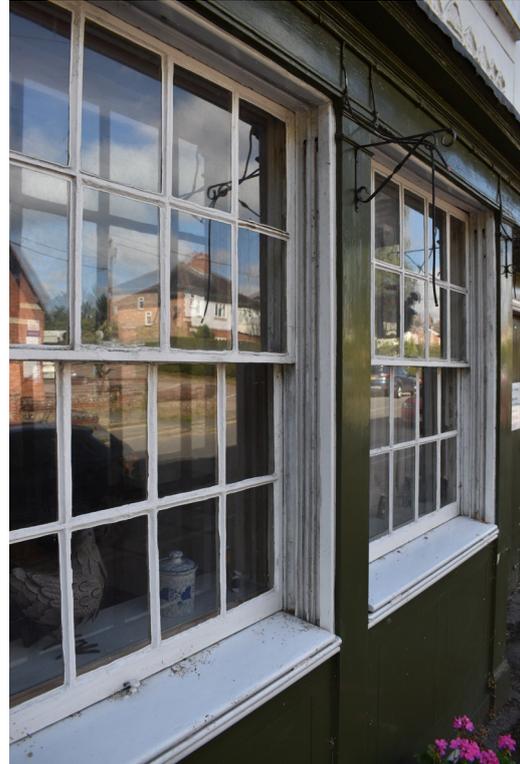
Photograph 8 Detail of windows showing sash for pulling up shutters. Lid into recess in sill visible below windows. Photograph taken facing south.

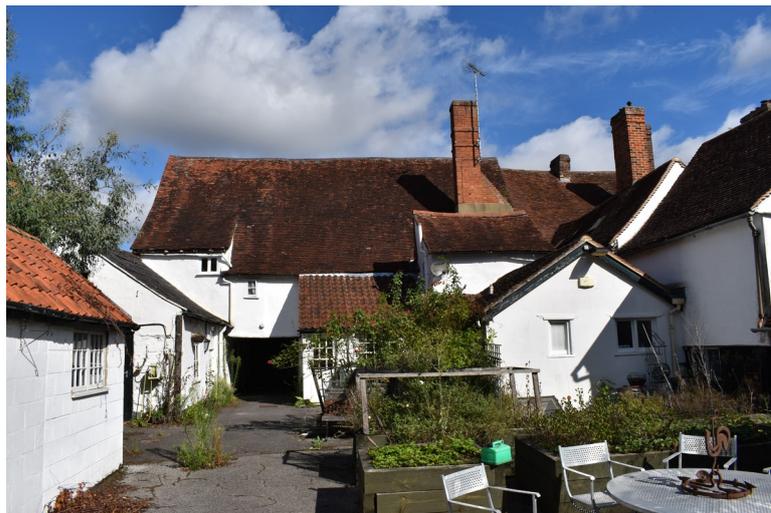
Photograph 9 South-east (rear) elevation of the building, showing multiple ranges and ridge-lines. Photograph taken facing north-west.

The rear south-east elevation of the building is a much more complex scene than on the street frontage, with the many extensions and varying roof pitches (Photograph 9). The windows at the rear of the building are many and varied, and include multiple 18th-19th-century sash, fixed and casement windows on the western range, along with modern fixed windows on the 20th-century rear extension (Fig 2, Photographs 10-11). The rear doors into the building are all modern replacements. The first-floor of the western range has a door in the gable-end (Photograph 12) and the first-floor of the main range has two small casement windows (Photograph 9).

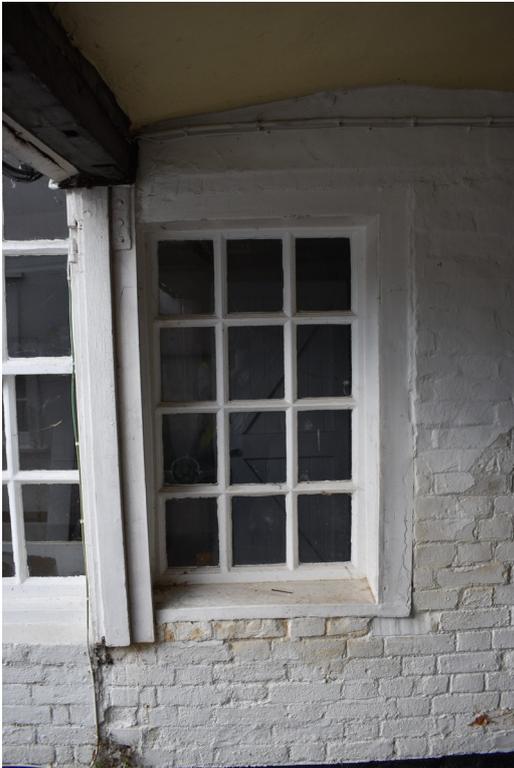
Photograph 10 Mid 18th-century fixed 12-light window on western range with surviving crown-glass pane. Photograph taken facing south-west.

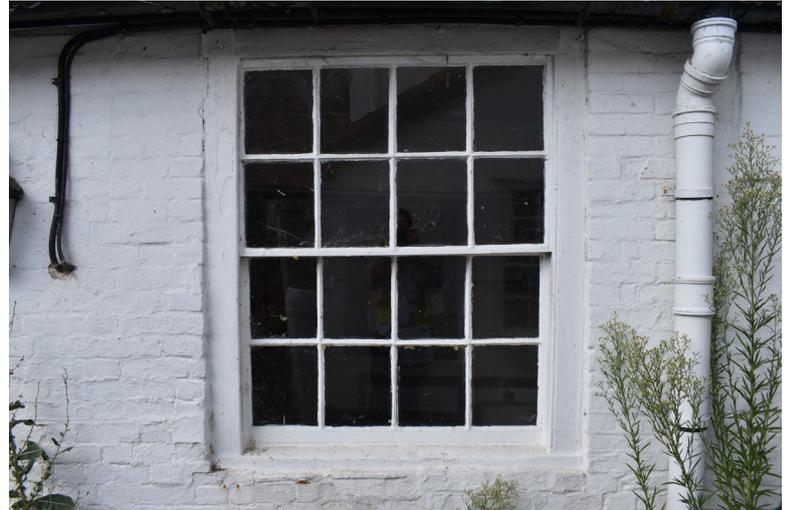
Photograph 11 Early 19th-century 16-light sash window on western range. Photograph taken facing south-west.

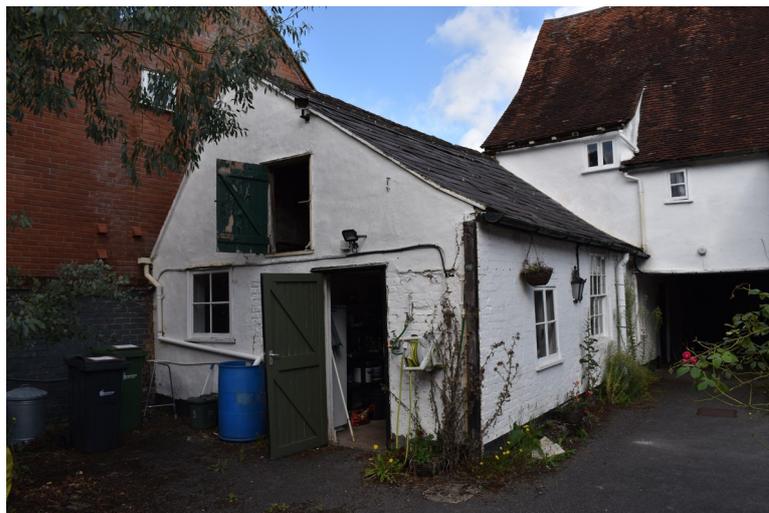
Photograph 12 South-east elevation of western range, showing door in gable. Photograph taken facing west.

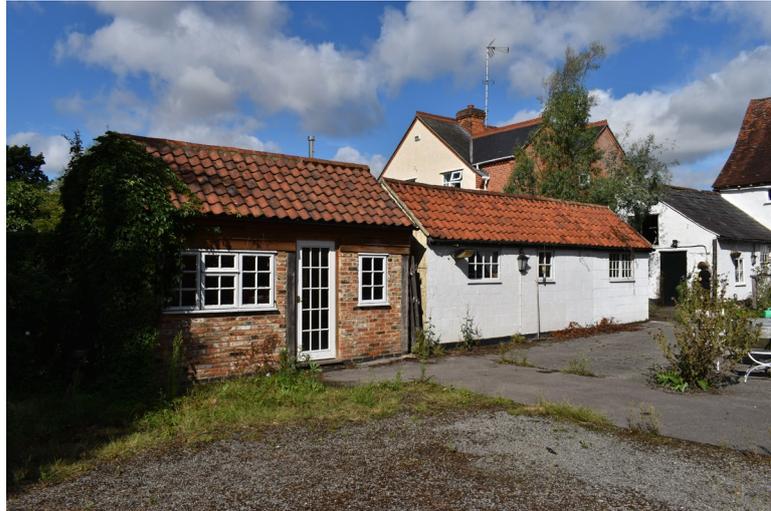
There are two outbuildings in the yard to the rear of the pub, both of which appear to be very modern in origin (Photograph 13). The northernmost outbuilding is constructed entirely of concrete blocks, has a pantile roof and several modern casement windows (Photograph 13). The southernmost outbuilding is constructed of regular brickwork laid in stretcher-bond, again with a pantile roof and modern casement windows. Both outbuildings are accessed via modern doors, with the southernmost one being entirely glazed (Photograph 13). Only the interior of the southern outbuilding was accessible, but was very clearly modern in origin, with machine-cut panelling and imitation timber-framing.

Photograph 13 Modern outbuildings in rear yard. Photograph taken facing west.

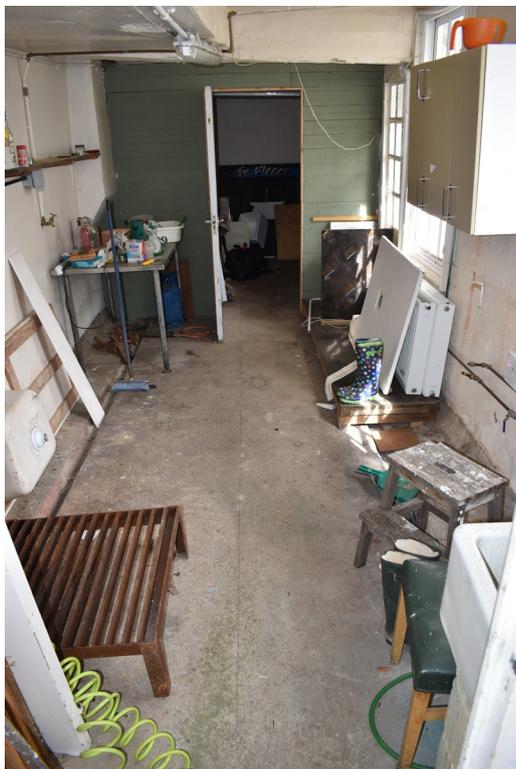
Photograph 14 Largest room in western range, showing concrete floor with drainage channels for storage of kegs. Varying ceiling heights also visible. Photograph taken facing north-west.

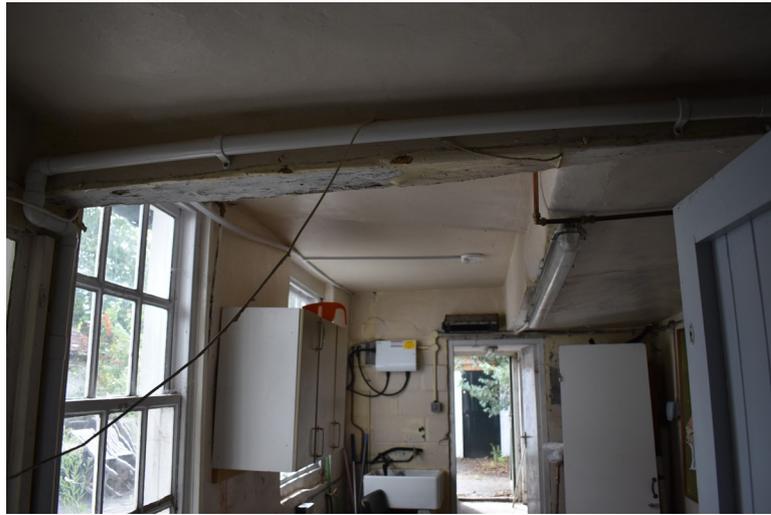
The rooms to the west of the passage to the rear yard (within the area of the 15th-century cross-wing) appear largely unchanged from when the building was a public-house. They are all storage rooms with concrete floors, and the largest central room has several drainage chutes on the floor, suggesting it was previously used for storage of kegs (Photograph 14). The northernmost room of this range is a converted office space containing an inserted, and later blocked, fireplace (Fig 2). Hand-sawn chamfered binding-beams are visible in the northern rooms of this range, and there are varying ceiling heights, all of which are presumably associated with what remains of the 15th-century cross-wing and the 17th-century full length extension (Photograph 15, Fig 2). The attic-space of this range was not

Photograph 15 Interior of western range, showing varying ceiling heights related to 15th-century phase. Wall to left is brick-built, wall to right is timber. Photograph taken facing south-east.

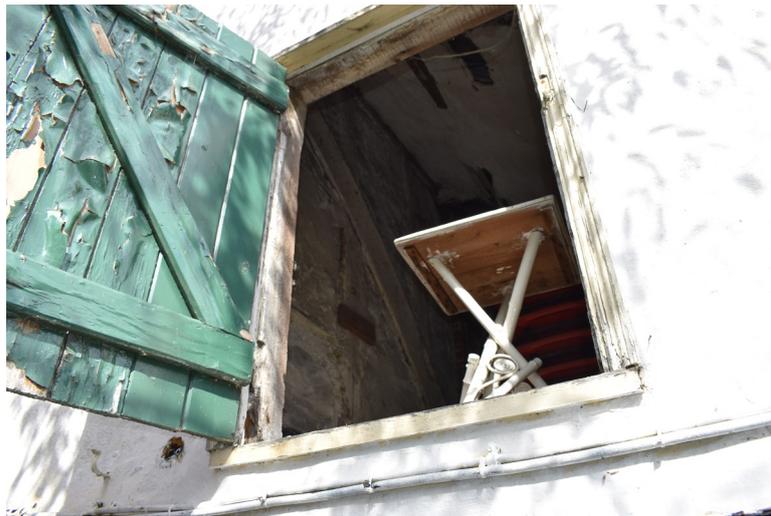
accessible, but visible through the door in the gable-end were several apparently hand-sawn timbers (Photograph 16).

Photograph 16 View of attic space above western range through door in gabled end. Timbers visible. Photograph taken facing west.

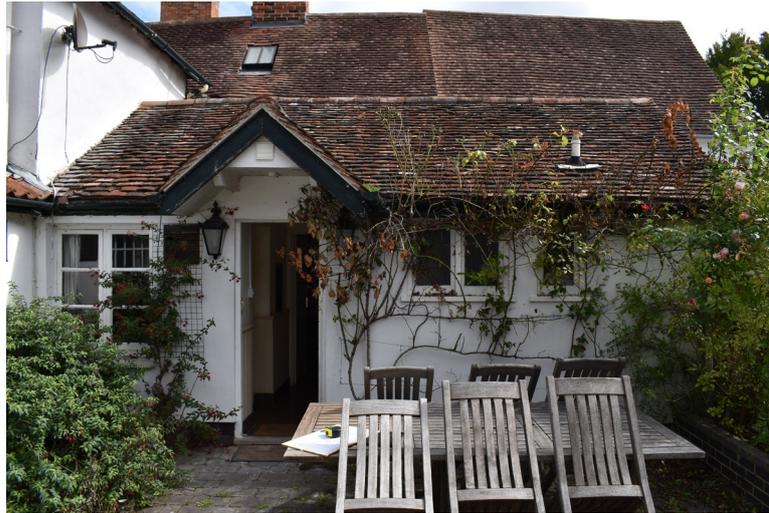
The 20th-century extension at the south end of the east range was the pub's toilet block, but was converted into a toilet/washroom when the property was converted into a dwelling in 2013 (Photograph 17). Some of the interior walls have been removed and the layout partially altered, but given the extensions modern origin, this is of little interest historically (Fig 2).

Photograph 17 South-west elevation of 20th-century extension (toilet block of pub). Photograph taken facing north-east.

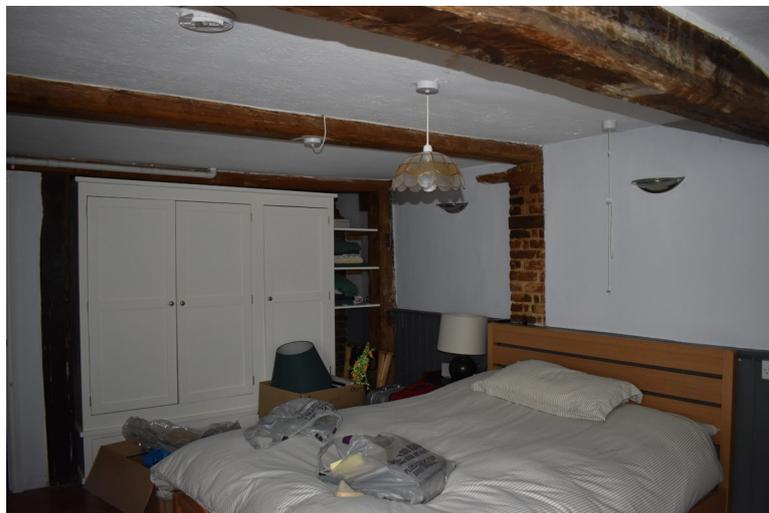
Immediately to the north of the 20th-century extension is the 18th-century two-storey extension (as noted in the listing entry). The ground-floor of this extension was labelled on plans of the pub as a "Dining Room", but has been converted into a bedroom (Photograph 18). There appears to have been no structural change to the fabric of this room, although the rear of the 17th-century fireplace to the north is partially obscured by a wardrobe (Photograph 18).

Photograph 18 Ground-floor of 18th-century extension. Chamfered binding-beam visible in foreground, rear of 17th-century fireplace behind cupboard. Photograph taken facing north.

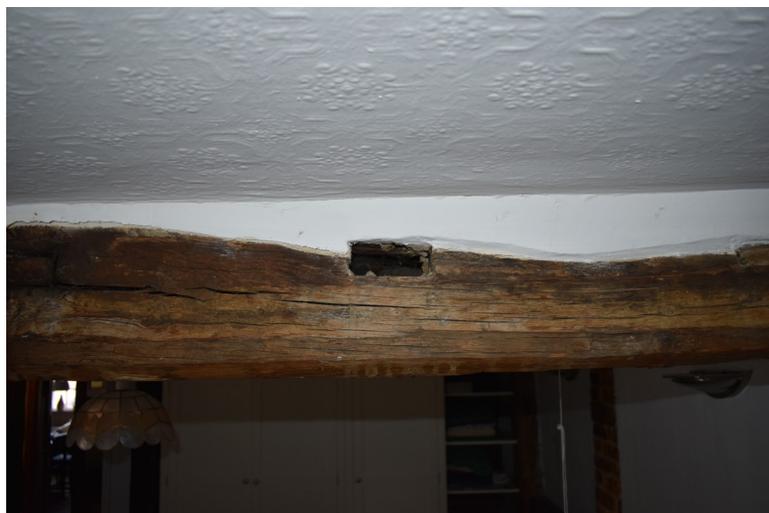
Photograph 19 Detail of empty mortice on binding-beam in 18th-century extension. Photograph taken facing north-west.

The ceiling in this room has two north-east/south-west binding-beams; the northern one is machine-cut and clearly a modern replacement, but the southern one is hand-sawn, chamfered, and appears to be the original southern end of this extension (Fig 2). It has empty mortices on its side, suggesting that at some point the ceiling of this room has been raised and that the joists now sit on-top of the binding-beam (Photograph 19). The floor of this room is tiled.

The ground-floor of the 18th-century two-storey range has been converted into a bedroom, but none of the building's fabric appears to have been altered. The raised ceiling level and replacement binding-beam observed in this room were probably alterations carried out sometime in the 19th-century.

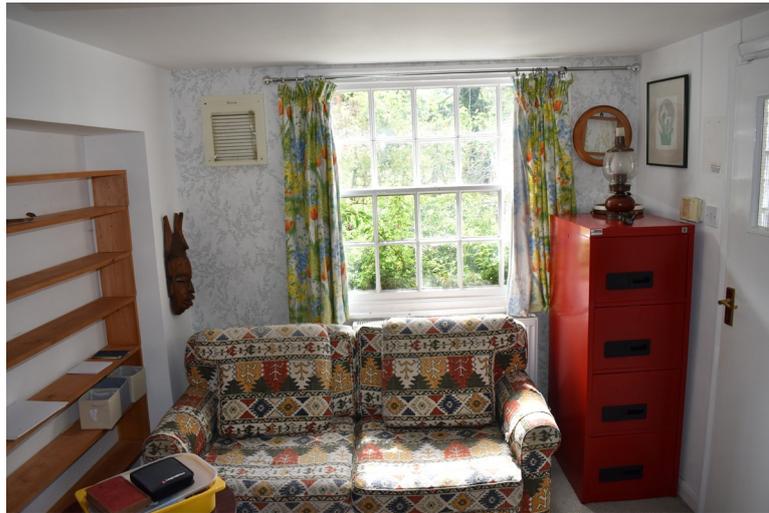
The 19th-century single-storey lean-to to the west of the 18th-century two-storey extension is labelled as a “Kitchen” on plans of the pub, but has since been converted into a lounge area (Photograph 20). The staircase up to the first-floor is also in this extension.

Photograph 20 Interior of 19th-century lean-to extension. Photograph taken facing south-east.

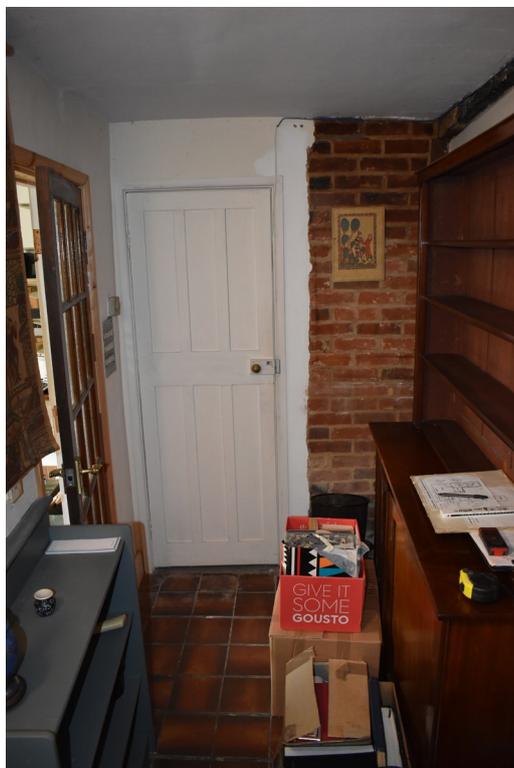
Photograph 21 Interior of 17th-century full length extension, showing six-panel door at western end led to cupboard. Photograph taken facing south-west.

The two-storey full-length 17th-century extension is probably where the bar would have been located during the building’s use as a pub, although it may also have extended into the 17th-century main range. No evidence of the bar was observed during the survey. It is unlikely, however, that the bar would have taken up the whole of this extension, as access for customers into the dining room area (the 18th-century extension, see above) would be required. At the western end of the 17th-century extension is a small cupboard below the stairway, accessed by a six-panel 18th or early 19th-century door, with an original lock case (Photograph 21).

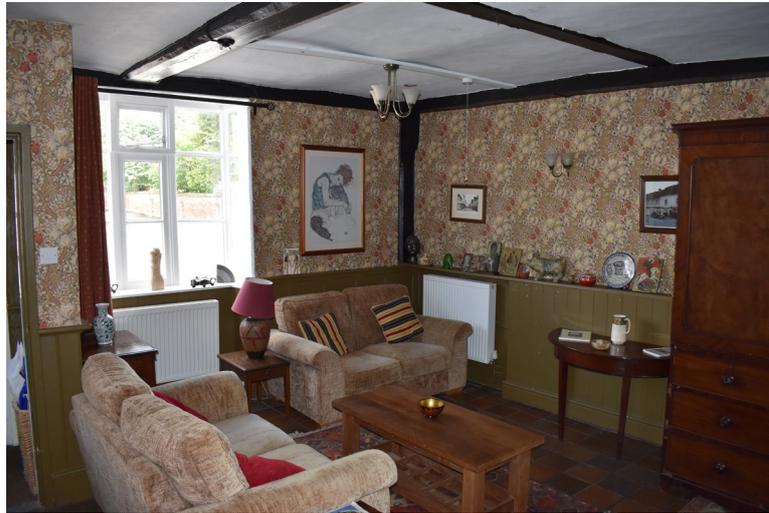
Photograph 22 Interior of 17th-century main range, showing bays 3 and 4. Photograph taken facing north.

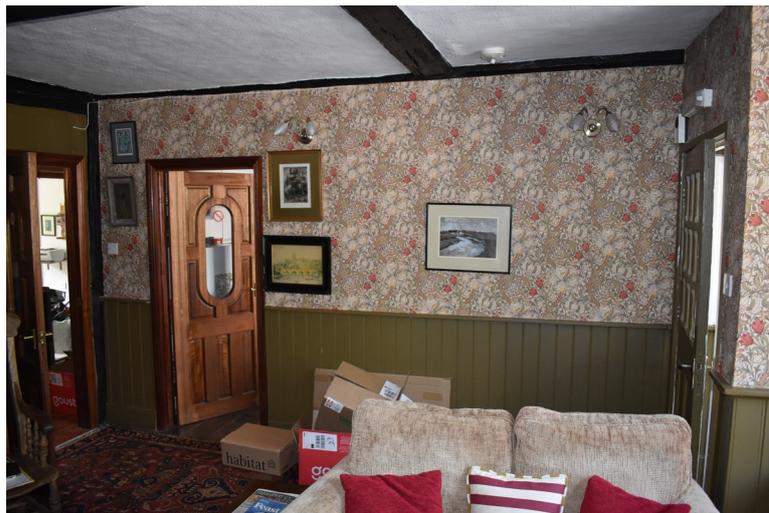
The ground-floor of the main four-bay 17th-century range (whose bays have been numbered 1-4 for ease of description; see Fig 2) has been the most altered by the conversion of the building. Most prominently, a stud wall has been inserted between bays 2 and 3, subdividing an area that during the building’s use as a

pub would have been open plan (Photograph 23). Examination of the hand-sawn binding-beam above this stud wall shows several pegs and empty mortices, indicating that it would have originally been the location of a timber division within the building during its original tenure as a house.

Photograph 23 Interior of 17th-century main range, showing inserted stud wall between bays 2 and 3. The binding-beam above wall has several original pegs. Photograph taken facing west.

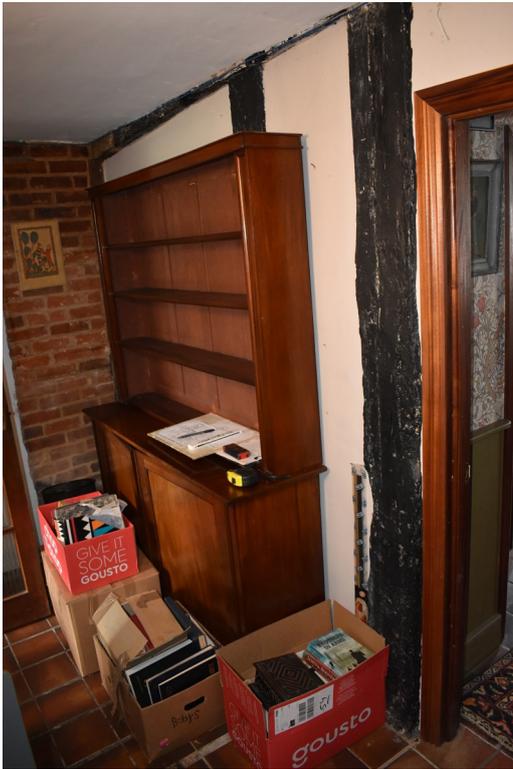
The wall dividing the four-bay range from the 17th-century full-length extension also appears to have been added during the conversion work (although, again, in the location of an original division). Although the timbers forming the studs are all hand-sawn and quite substantial, they all fail to align with pegs visible on the beam above, suggesting that they are a later addition to this division (Photograph 24). In addition, the easternmost timber has empty mortices for lap-joints on its side, suggesting it has been originally a wall-plate or girding-beam and has been reused, either from elsewhere in the building or from another structure entirely (Photograph 25). There is the possibility that these timbers may have been present prior to the conversion work and formed part of the fabric of the bar in some capacity.

Photograph 24 Inserted wall between 17th-century extension and main range, with large re-used studs added. Photograph taken facing west.

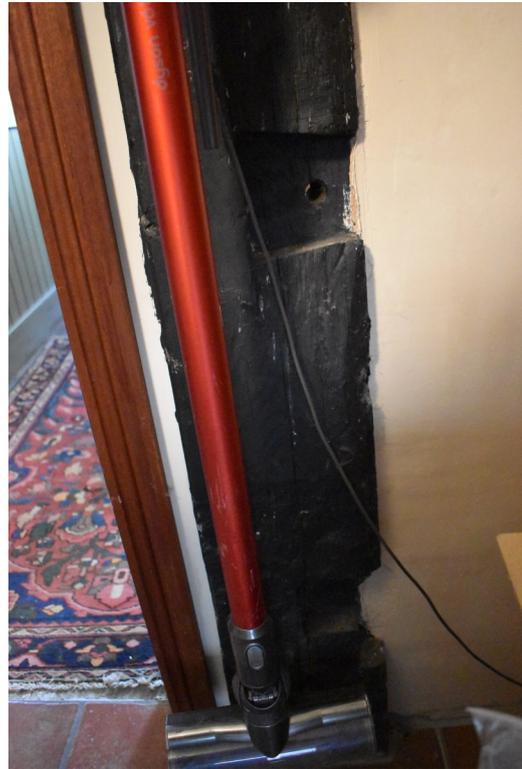
Photograph 25 Detail of reused timber with lap joints forming part of division between 17th-century extension and main range. Photograph taken facing north-west.

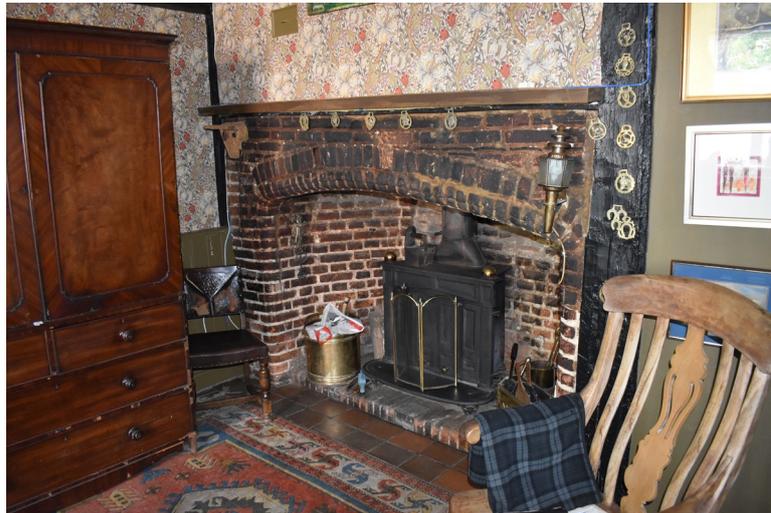
Also visible on the ground-floor of this range is the brick fireplace on the southern elevation of bay 4 (Photograph 26), as well as the ornately carved north corner-post (Photograph 27), both of which are described in the listing entry (see above).

Photograph 26 17th-century fireplace in south wall of bay 4. Photograph taken facing east.

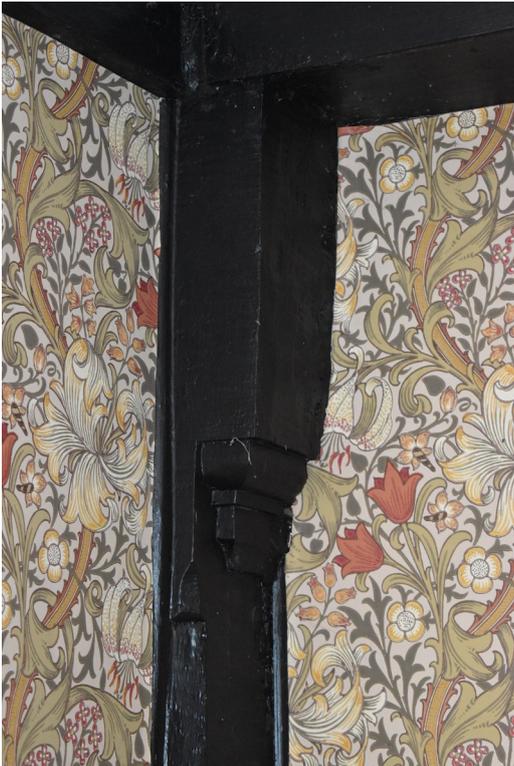
Photograph 27 Detail of decorated north corner-post in main 17th-century range. Photograph taken facing north.

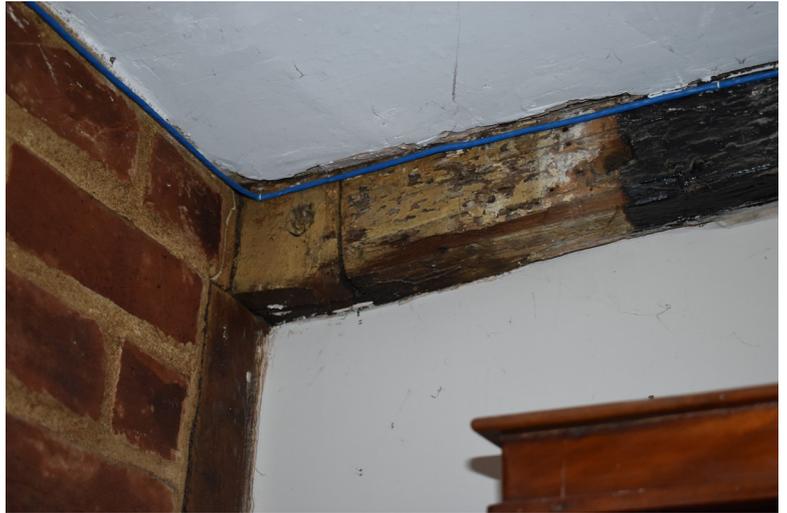
A single scarf joint was observed during the survey on the southern girding-beam between bays 1 and 2 in the main range. Although it is clearly a face-halved scarf, its exact form could not be identified (Photograph 28).

Photograph 28 Detail of face-halved scarf joint on girding-beam between bays 1 and 2 of 17th-century main range. Photograph taken from 17th-century extension, facing west.
