**Historic building recording
of a gateway at
Gatehouse Farm,
Thorrington,
Essex, CO7 8JL**

October 2020

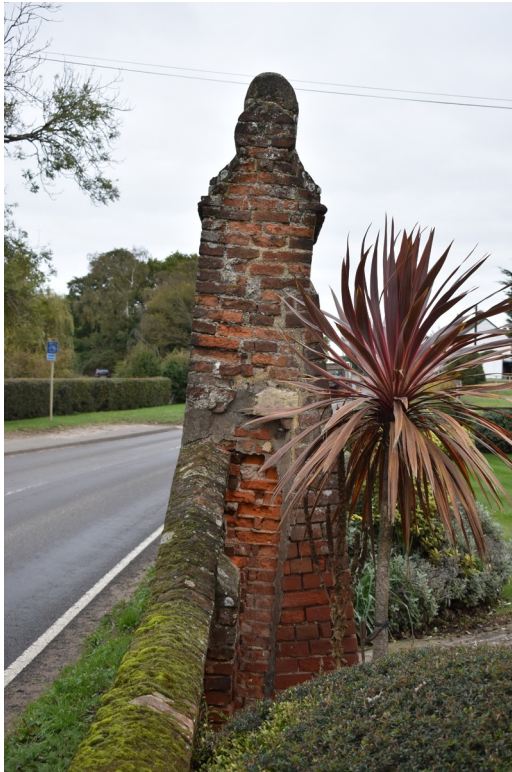
Photograph 3 South-west elevation of gateway. Damage to brickwork visible. Photograph taken facing north-east.

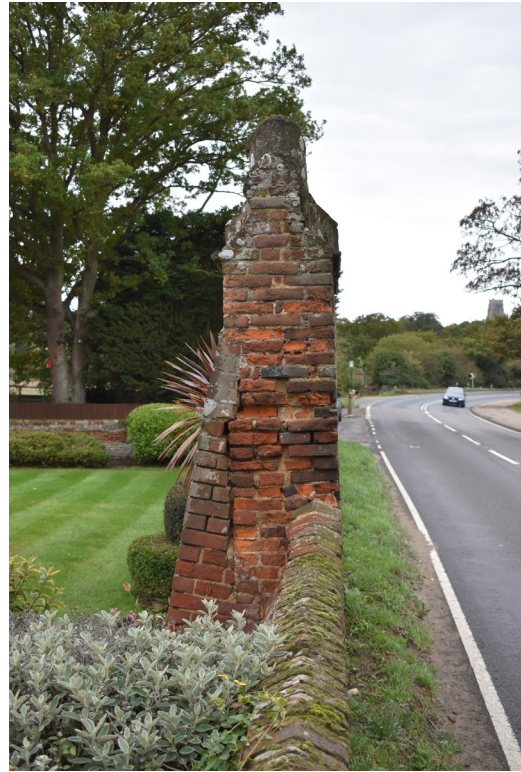
Photograph 4 North-east elevation of gateway. Photograph taken facing south-west.

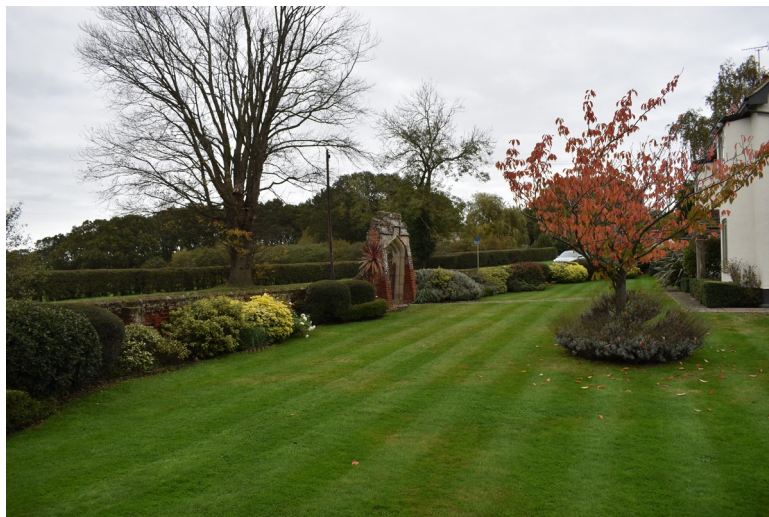
Photograph 5 Garden of farmhouse, showing gateway in context. Photograph taken facing north.

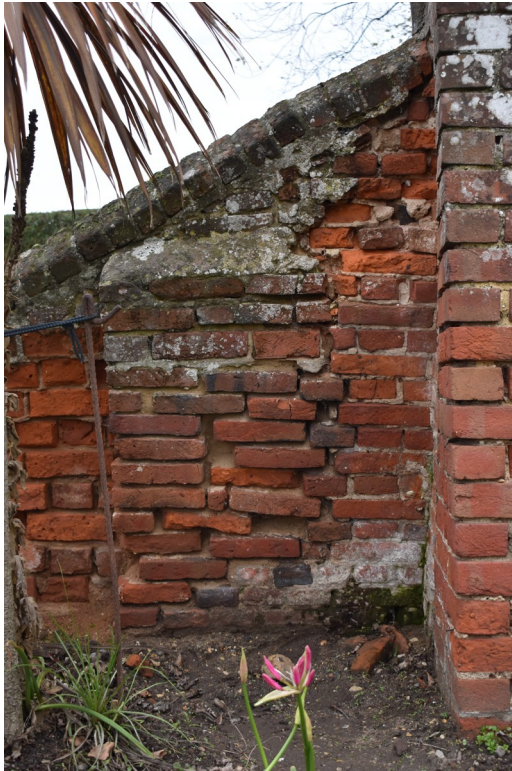
Photograph 6 Detail of section of wall immediately to south of gateway, showing 16th-century brickwork in front of later, thicker, brickwork. Also visible is significant damage in top right of frame. Photograph taken facing north-west.

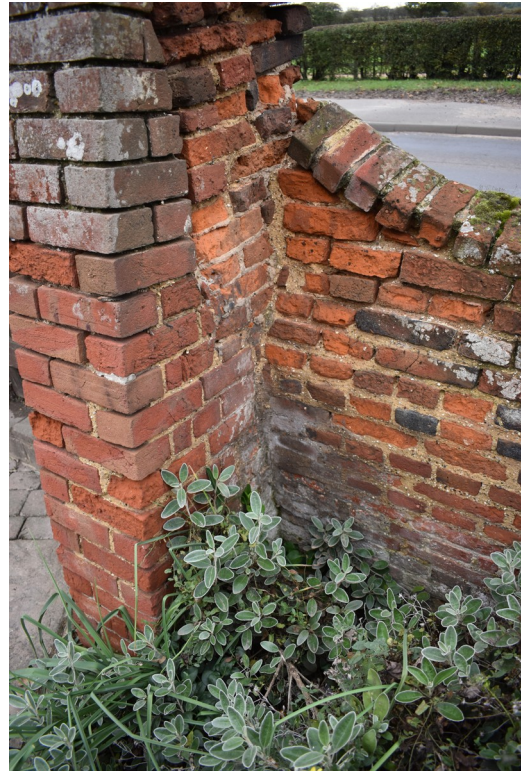
Photograph 7 Detail of north-eastern elevation of gateway, showing join with garden wall and varied brickwork. Photograph taken facing west.

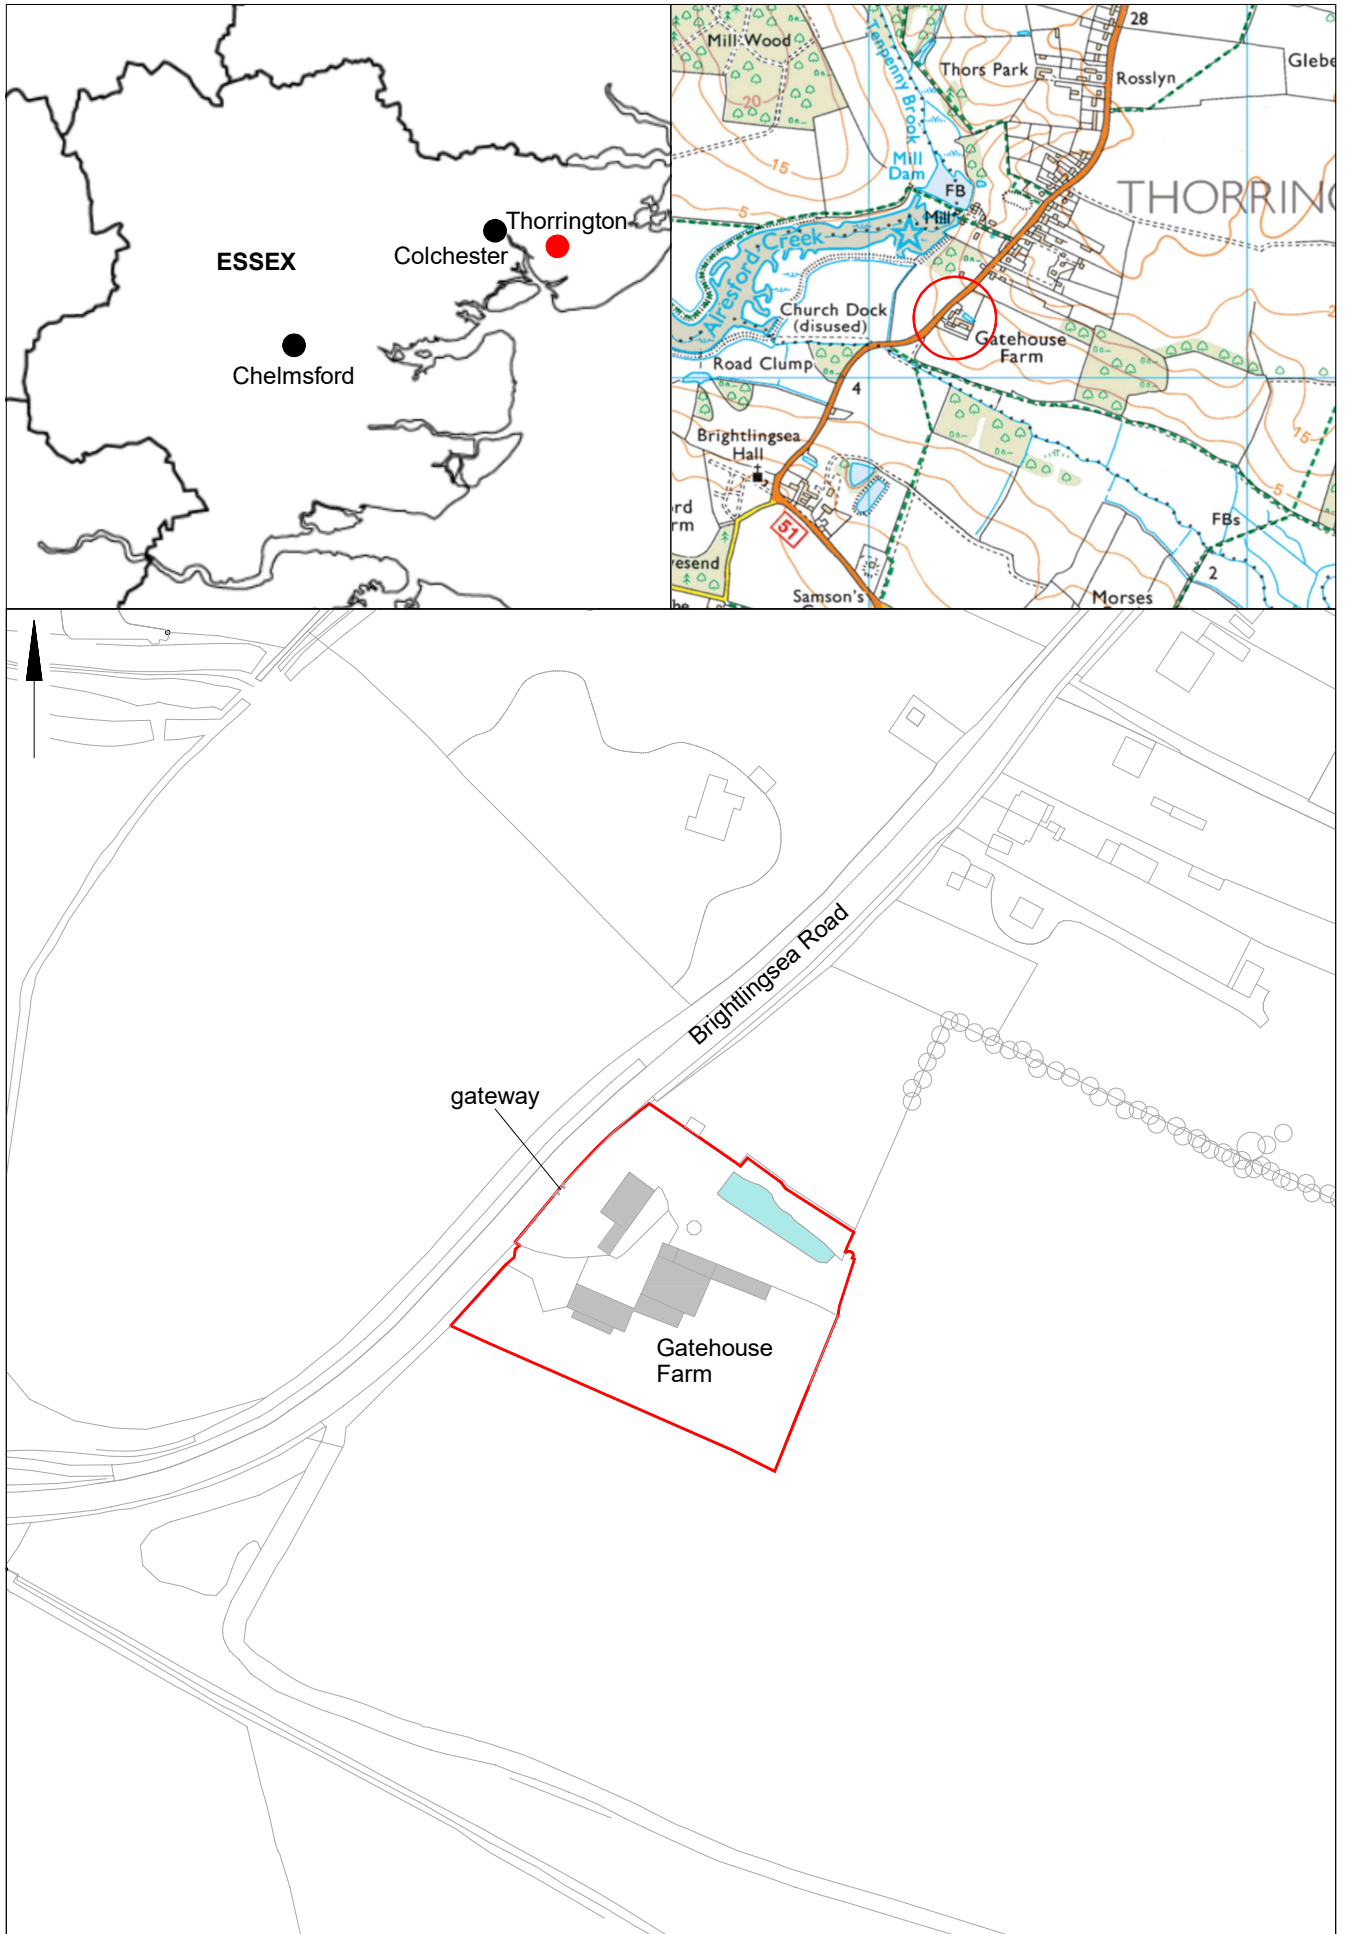
Fig 1 Site location.
