**Historic building recording  
of The Forge,  
The Street, Bradwell,  
Essex, CM77 8EG**

**October 2020**

**CAT Report 1615**  
November 2020

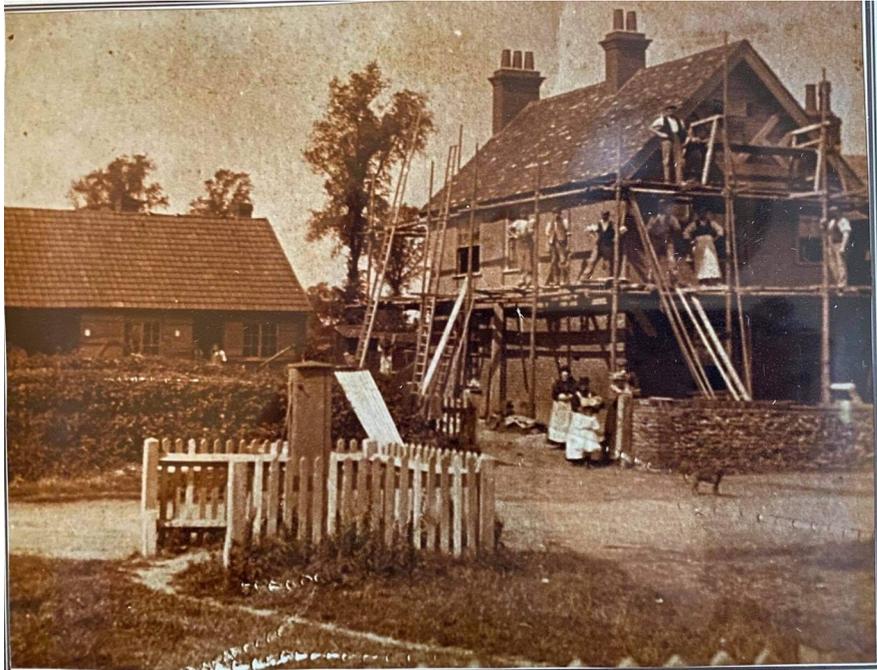
A photograph from 1903 shows the smithy during the construction of the adjacent Forge House (Photograph 1). Visible in this photograph are the original windows on the south-east elevation, the tile roof-covering and a chimney projecting at the north-eastern end (none of which survive today).

**Photograph 1** 1903 photograph showing Forge House under construction, with the forge visible to left of frame. Photograph taken facing north-west. Photograph courtesy of residents of Forge House.

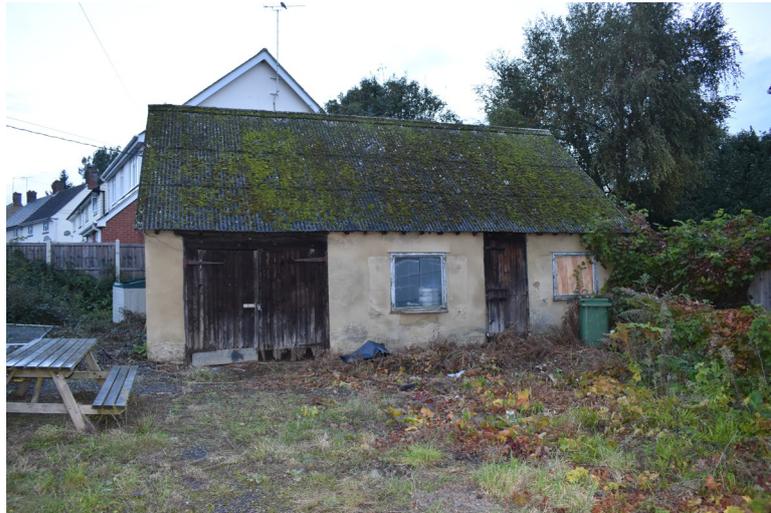
**Photograph 2** South-east elevation of the building. Photograph taken facing north-west.

The south-east elevation of the building (Fig 3) has two replacement entrances, one stable door and one large double-width door (Photograph 2). Both these doors are vertically-planked and constructed of machine-cut timber. Also on this elevation are two replacement wooden-framed single-light awning windows (Photograph 2). The brickwork on this elevation is covered in render.

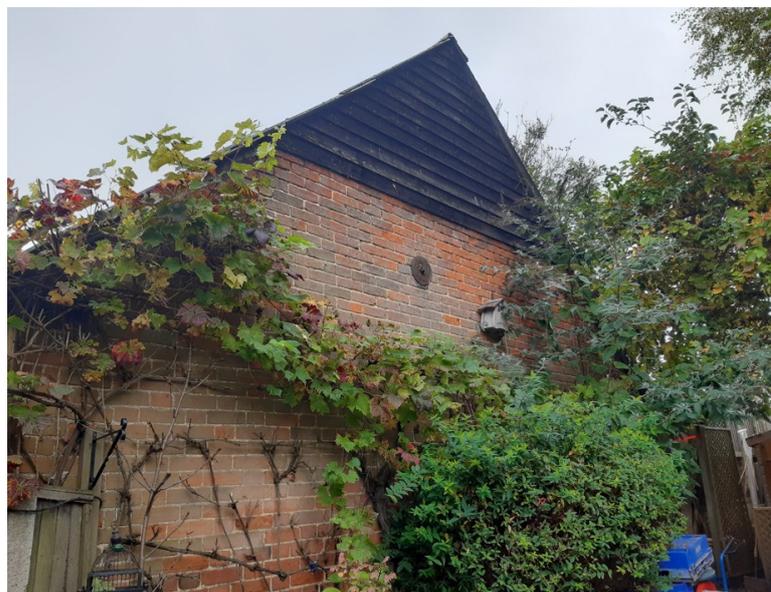
**Photograph 3** North-east elevation of building, showing weatherboarding on gable. Photograph taken facing west.

The north-east elevation (Fig 5) has no features, but on this elevation the brickwork is exposed and the top of the gable is covered in weatherboarding (Photograph 3).

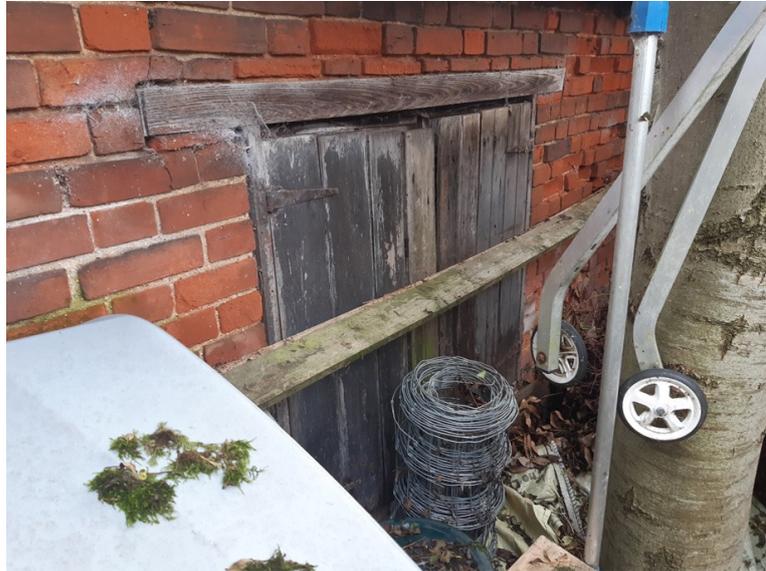
The north-west elevation (Fig 4) also has exposed brickwork and contains an original wooden-framed 12-light casement window with external shutters (Photograph 4).

**Photograph 4** Detail of shutters of original window on north-west elevation. Photograph taken facing south.

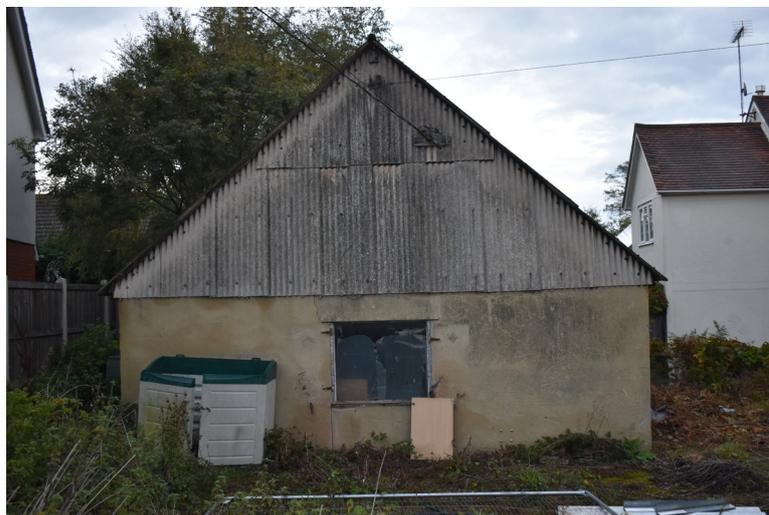
The south-west elevation of the building (Fig 5) contains a central wooden-framed single-light fixed window, and the gable is covered in corrugated asbestos panels, identical to the ones on the roof (Photograph 5).

**Photograph 5** South-west elevation of building. Photograph taken facing north-east.

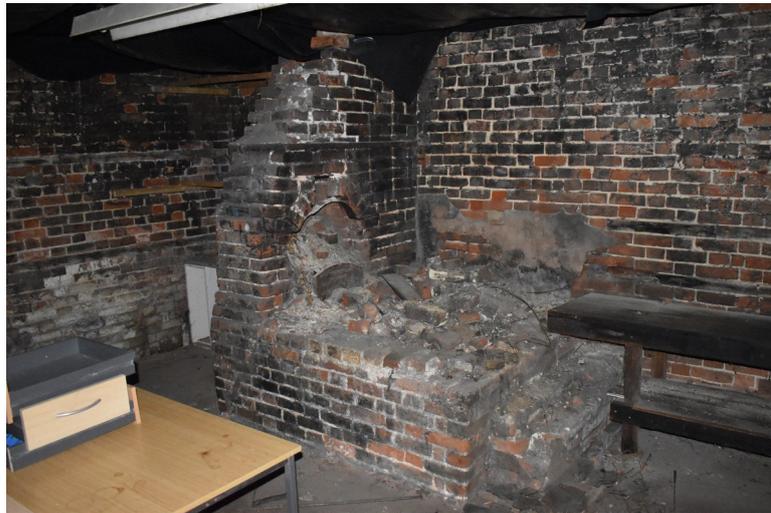
The floor of the building is entirely concrete, and the interior walls are all unrendered. At the north-eastern end of the building, built into the wall of the structure, is the forge itself (Photograph 6). The interior brickwork of the building, particularly at its northern end, is smoke and soot blackened.

**Photograph 6** Detail of forge within the building. Soot blackening visible on walls. Photograph taken facing north.

The forge appears largely intact and contains much ash and debris, presumably from its last firing. Like the rest of the building, its brickwork is bonded in lime mortar. The forge's chimney rises from its western side and has only a small opening (Photograph 8), containing a surviving cast iron firefront inscribed with "A. J. Pledger & Co Stamford". The chimney contains a section of brick repair bonded in cement mortar (Photograph 7). This repair must have been in place for some time, however, as the bricks are suitably soot blackened on their eastern side (Photograph 6). The eastern end of the forge has two tiers of steps (Photograph 6).

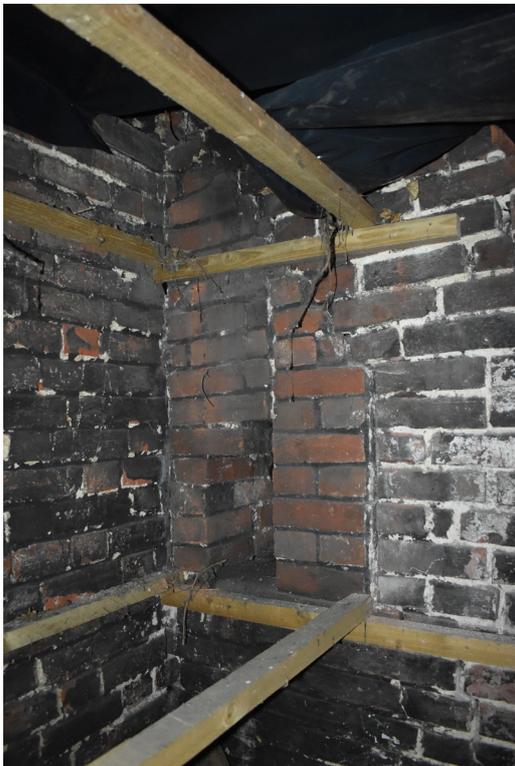
**Photograph 7** North-west side of forge, showing more recent bricks bonded in cement mortar. Photograph taken facing east.

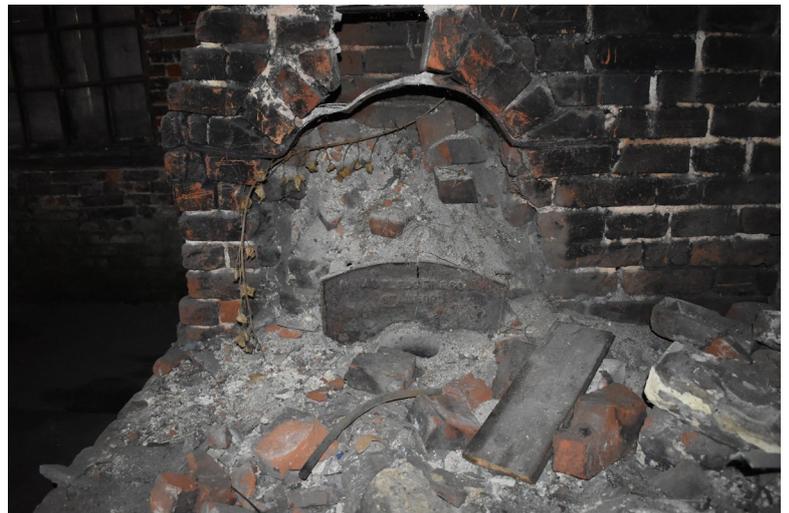
**Photograph 8** Detail of opening in chimney of forge, showing firefront. Photograph taken facing north-west.

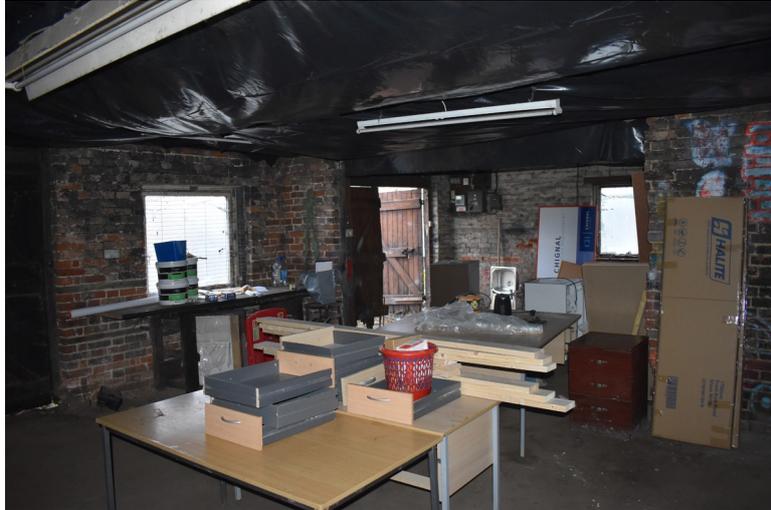
The interior of the building is a single room, although originally it appears to have been subdivided into two (Fig 2). Two internal walls project from the south-east and north-west elevations, but the north-western one has been cut short and a door jamb survives on the south-eastern wall, suggesting they originally formed a doorway (Fig 2, Photograph 9).

**Photograph 9** Interior of building showing modern additions and furniture. Photograph taken facing south.

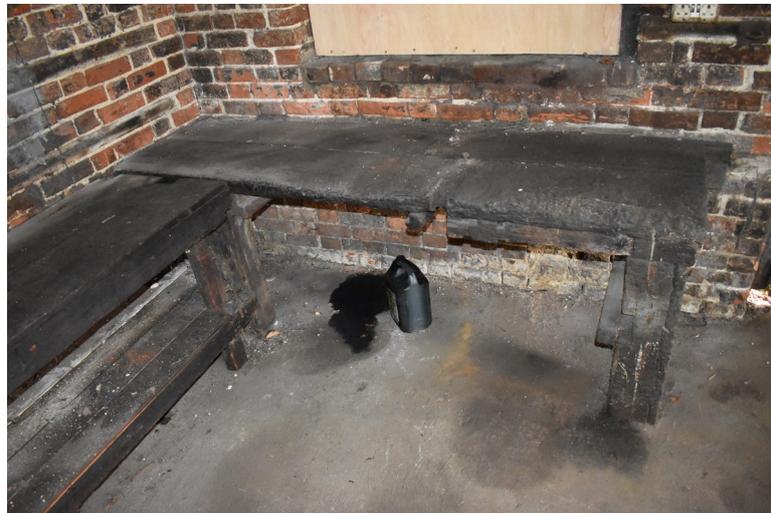
**Photograph 10** Detail of hardwood table in north corner of building. Photograph taken facing north.

The building contains much in the way of modern furniture and fittings (Photograph 9), but in the eastern corner and along the southern eastern wall are two large hardwood tables (Photograph 10). These tables are heavily worn and appear partially built into and supported by the structure's brickwork, suggesting they are original.

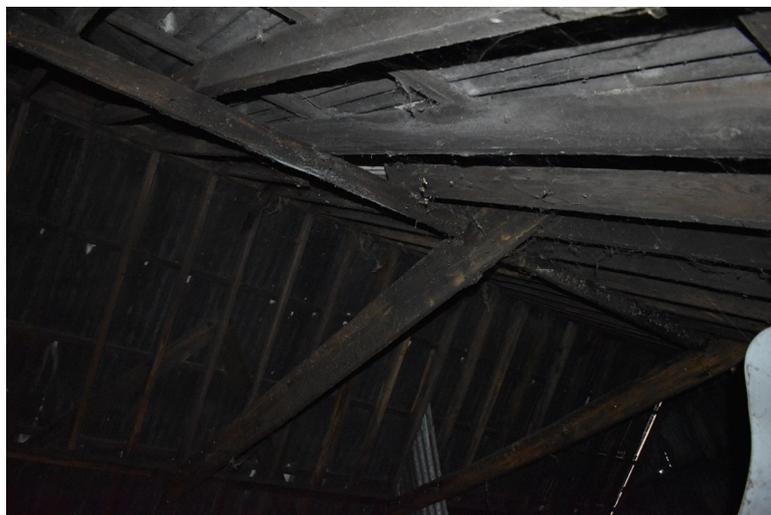
**Photograph 11** Detail of roof structure. Photograph taken facing south.

The roof of the building is obscured by plastic covers (on account of the asbestos panelling), but it was possible to observe part of the roof through a gap in the plastic (Photograph 11). This showed the roof to be constructed entirely of machine-cut timbers, supported by clasped-collars and a single purlin on each pitch.

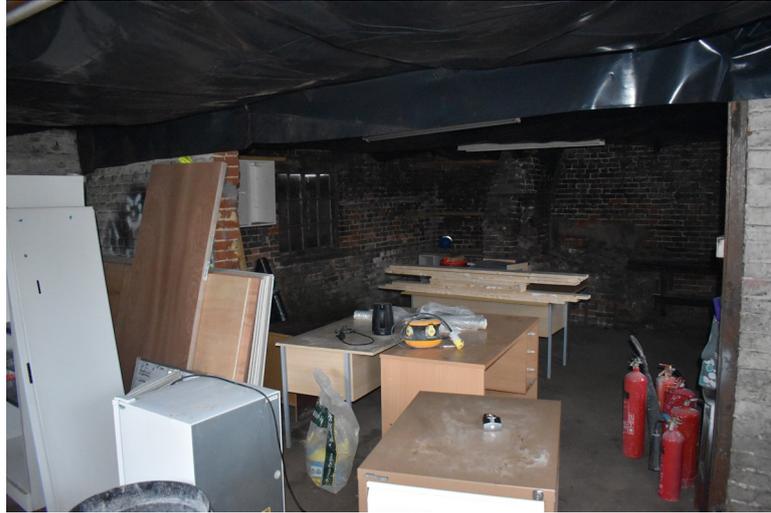
**Photograph 12** Interior shot of building. Photograph taken facing north.

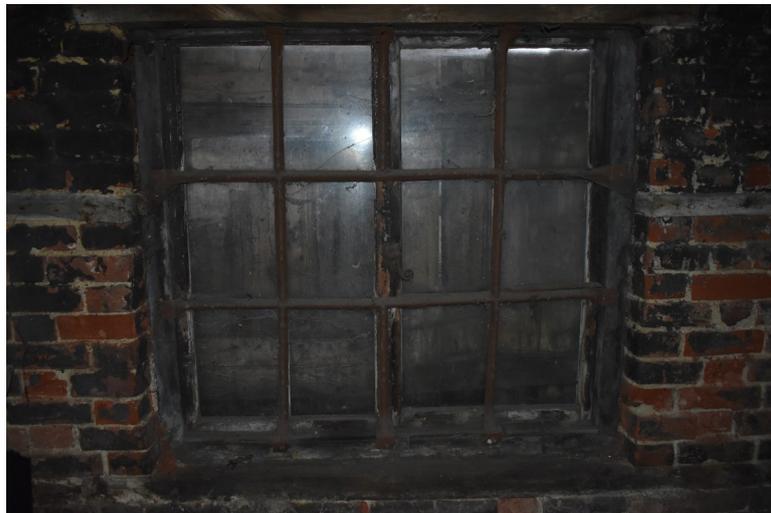
The original casement window on the north-west elevation has had several iron straps added to its frame on the interior, presumably for the purposes of security (Photograph 13).

**Photograph 13** Original 12-light casement window on north-west elevation, viewed from interior. Iron straps on frame shown. Photograph taken facing north-west.
