**Historic building recording
of Maldon Wycke Barn,
Spital Road, Maldon,
Essex, CM9 6SQ**

April 2021

CAT Report 1675
May 2021

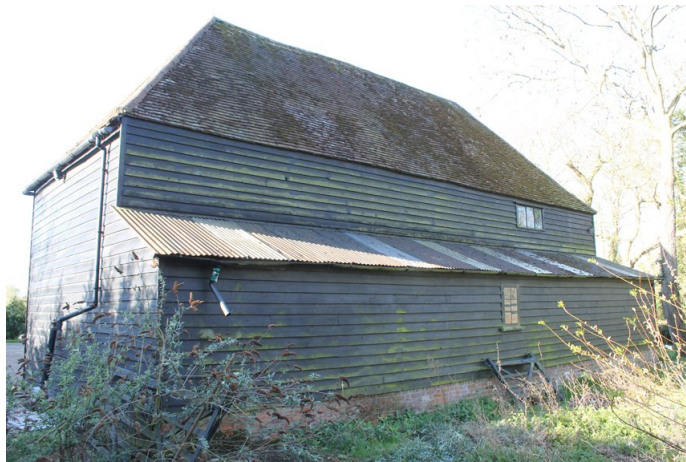
The northern elevation has a modern six-light fixed window on the ground-floor lean-to, and a modern three-light fixed window on the first-floor (Photograph 4). The brick plinth on this elevation consists of six courses, laid in Flemish bond and with brick measurements of 225 x 105 x 65mm (Photograph 4).

Photograph 4 Northern elevation of building, show lean-to supported on brick plinth. Photograph taken facing south-west.

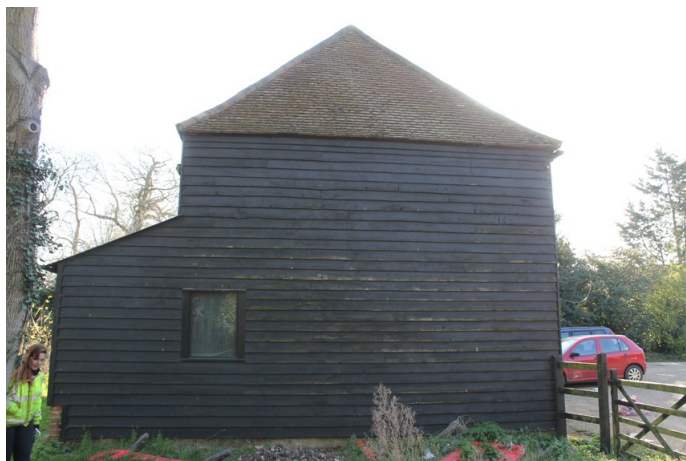
The western elevation contains a blocked modern fixed single-light window (Photograph 5).

Photograph 5 Western elevation of building. Photograph taken facing east.

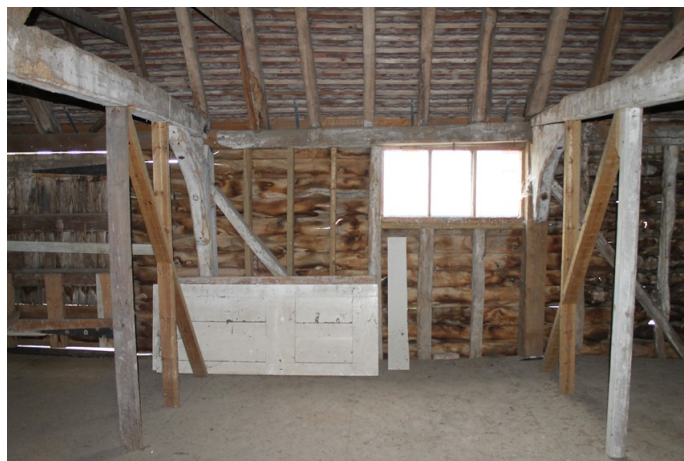
The southern wall-plate of bay 2 contains a rudimentary edge-halved scarf joint (Photograph 17) joining it to the modern replacement southern wall-plate of bay 3 (see below). Additionally, the purlin on the northern roof pitch in this elevation contains a splayed scarf joint.

Photograph 17 Southern elevation of bay 2 on first-floor, showing modern studs, window and scarf joint. Photograph taken facing south.

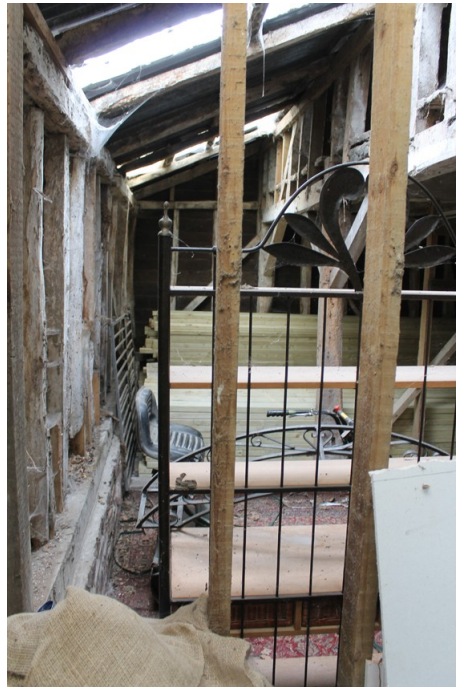
The lean-to projecting from the north of the building has a roof entirely constructed of machine-cut modern timber (Photograph 30). The eastern and western ends of the lean-to are similarly constructed. The northern elevation, however, although containing some machine-cut timber, is largely constructed of hand-sawn timbers, nailed together and with little in the way of jointing (Photograph 30). These hand-sawn timbers have several empty mortices and are clearly re-used, possibly from an earlier phase of the building.

Photograph 30 Interior of lean-to, with re-used hand-sawn studs to left of frame. Photograph taken facing east.
