Historic building recording of a barn north of Cooper's Farm House, Whatfield Road, Nedging- with-Naughton, IP7 7BS

November 2021

CAT Report 1744
May 2022

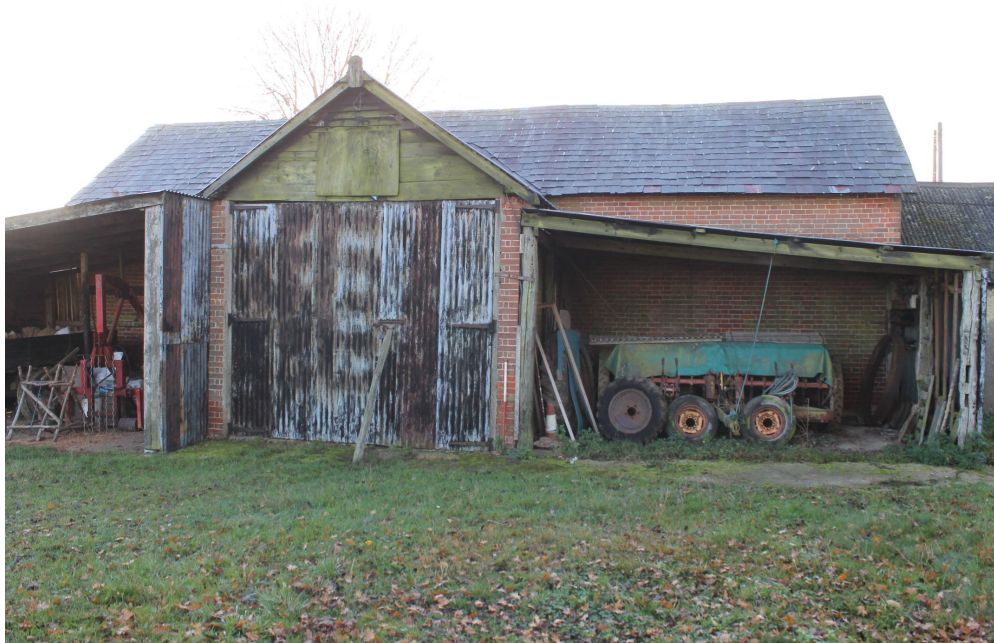
The north-west elevation of the barn contains the centrally-located midstrey. The north-west elevation of the midstrey is dominated by a full-height double doorway. The original cart doors have been replaced with a modern replacement constructed from timber and corrugated metal. Above these the gable-end is clad in timber boarding.

Photograph 1 North-western elevation. Photograph taken facing south-east.

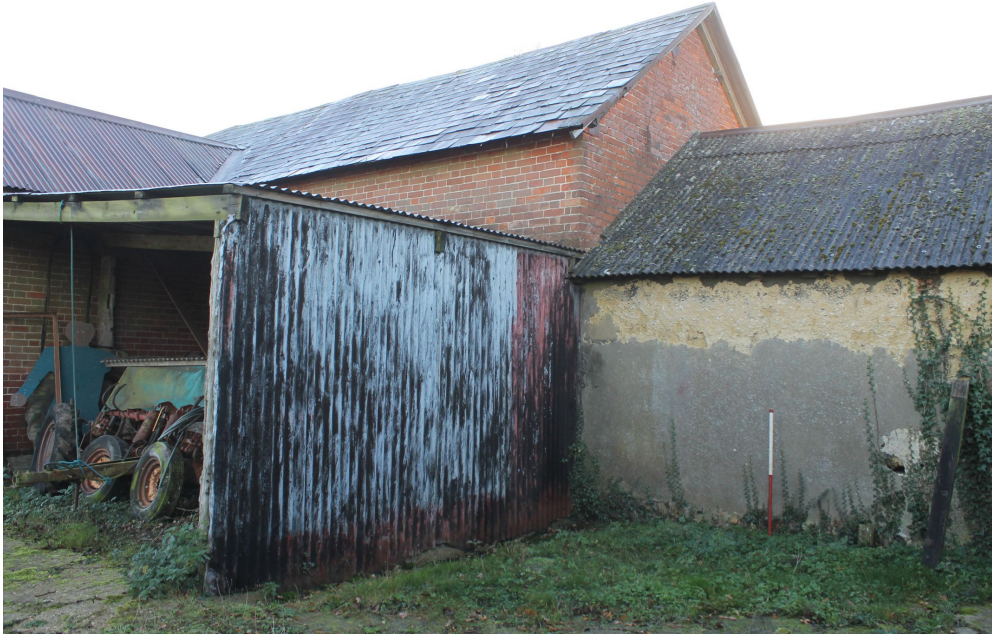
Photograph 2 North-western elevation. Photograph taken facing east.

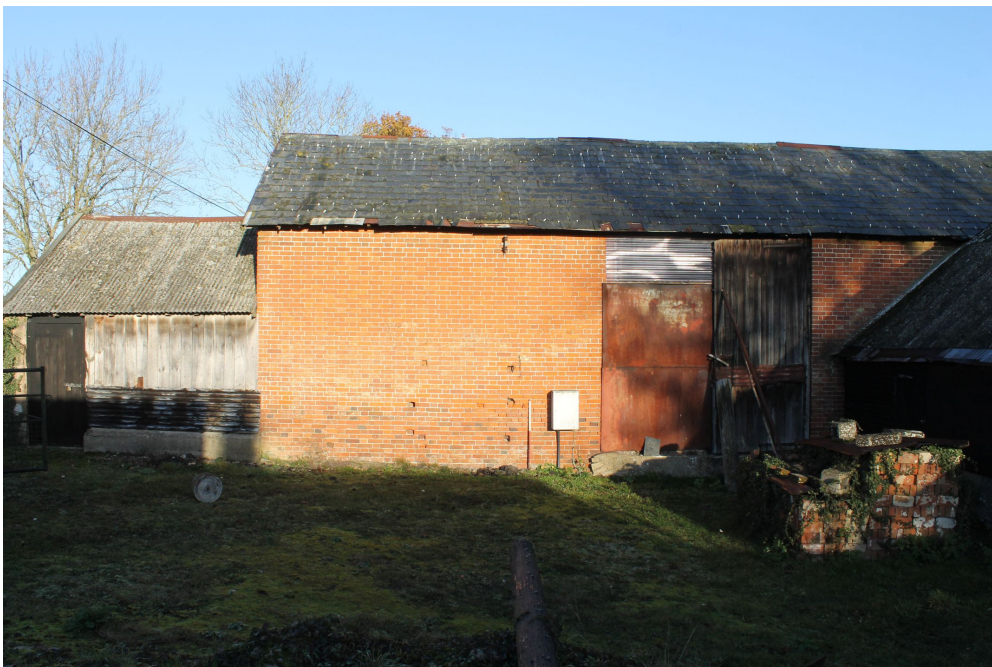
In the centre of the south-east elevation is a full-height opening with a single original vertically-planked cart door and a lower threshold leap door. This door has an original iron latch, iron strap hinges and pintles. The other-half of the door way is boarded up with metal sheets and corrugated plastic. Below the door is a large concrete step. This was likely once a ramp that has since been removed. To the south-west of the opening are six recesses in the brickwork indicating a small structure may have once been attached to the barn here. The rest of the barn's elevations are plain brickwork.

Photograph 3 South-eastern elevation. Photograph taken facing north-west.

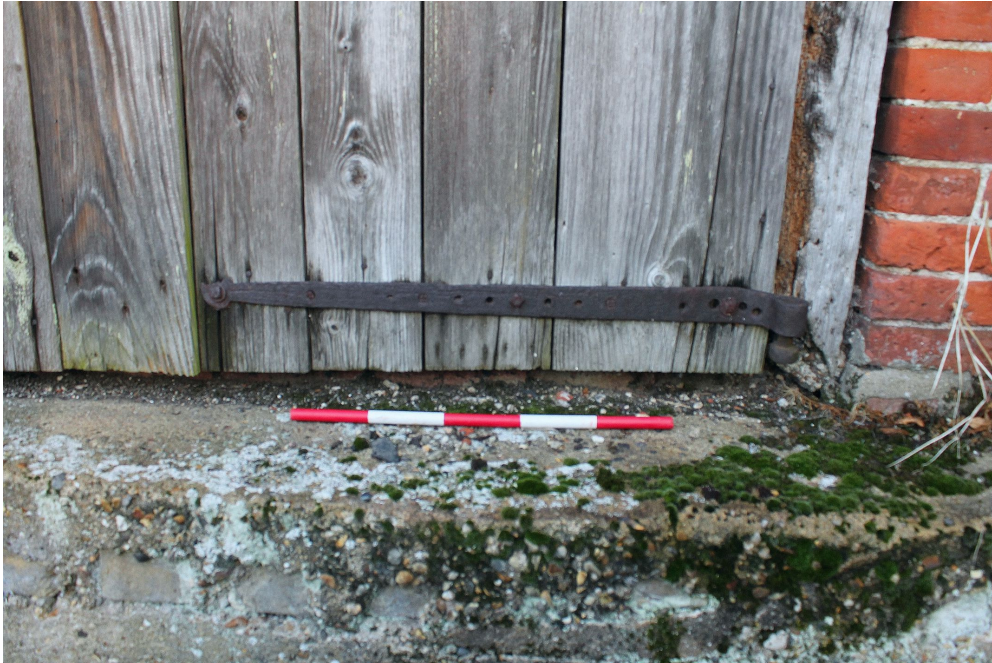
Photograph 4 Detail of original hinge and pintles. Photograph taken facing north-west.

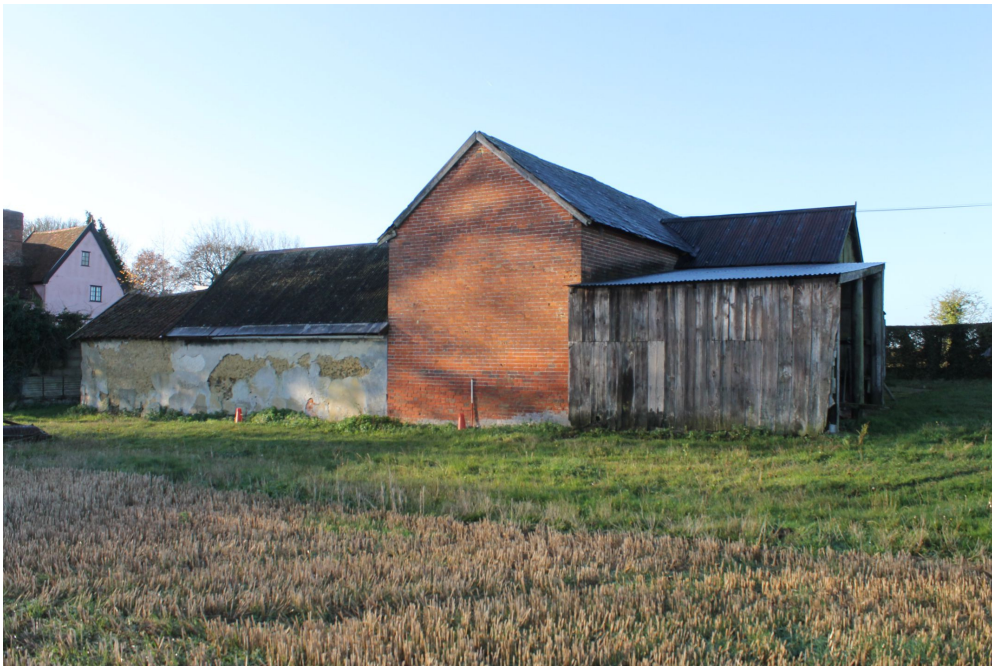
Photograph 5 North-eastern elevation. Photograph taken facing west.

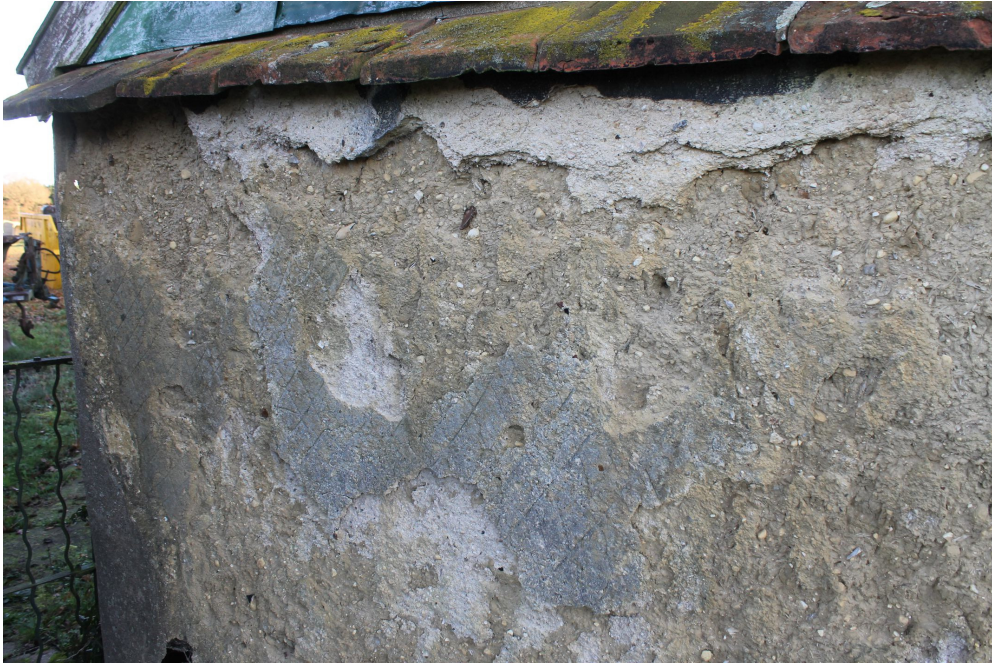
Outbuilding 1 is located on the south-west elevation of the threshing barn. This outbuilding is a later addition to the farmstead which incorporates two original clay yard walls into its construction. Both clay walls are in poor condition, with the south-west elevation having large areas repaired with brick and concrete. The walls were originally plastered with lime horse-hair plaster, which is still visible in places, but has more recently been skimmed with concrete. Laid on top of the south-west clay wall is a row of triangular terracotta coping tiles.

Photograph 6 Detail of surviving keyed horsehair plaster on clay wall of western elevation. Photograph taken facing north-east.

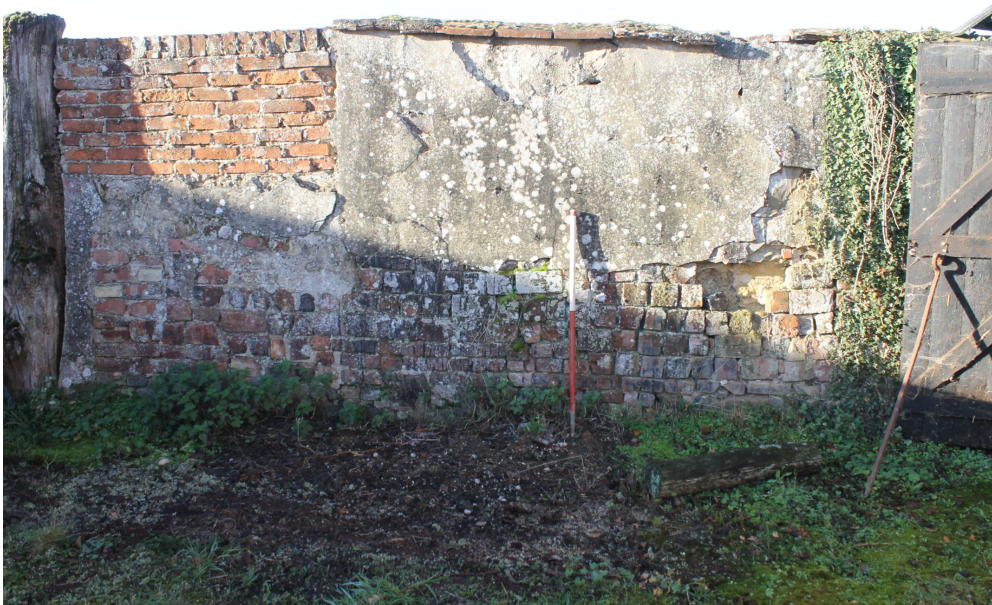
The south-west clay wall of outbuilding 1 also forms part of the boundary wall. The interior southern end of the wall appears to be clad in a hodgepodge of early shallow-frogged red bricks in an attempt to repair the wall. At the southern end of the wall, the outer side has been completely rebuilt in red brick. A gate-post has been formed from a tree-trunk to the south-east of the wall.

Photograph 7 Detail of boundary wall. Photograph taken facing south-west.

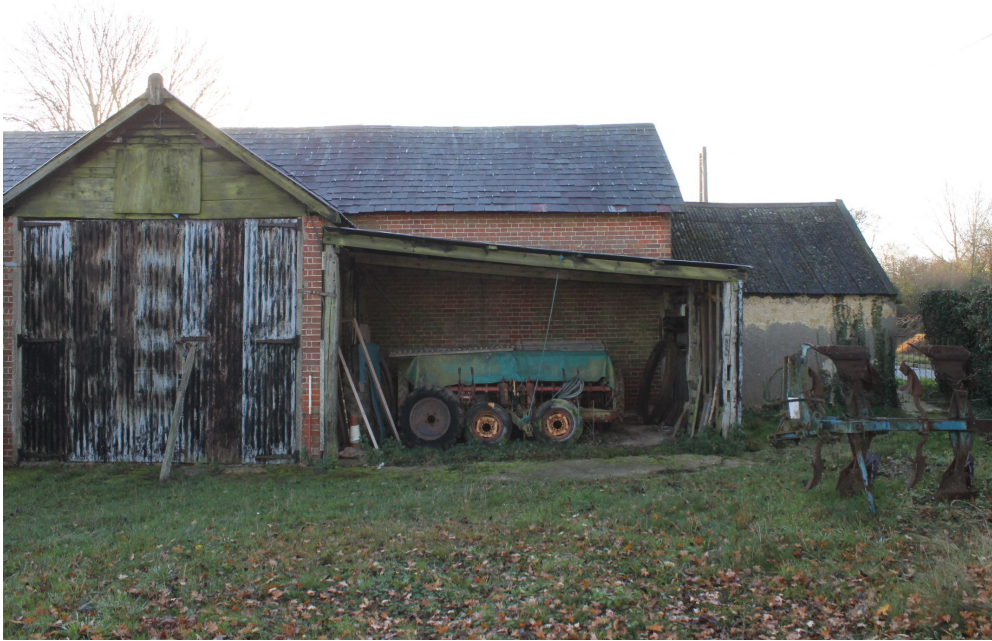
Both outbuildings are open on the north-west elevation. Outbuilding 2 has an outer wall clad in corrugated metal sheets while outbuilding 3 is clad in horizontal timber planks.

Photograph 8 Outbuilding 2 on north-western elevation. Photograph taken facing south-east.

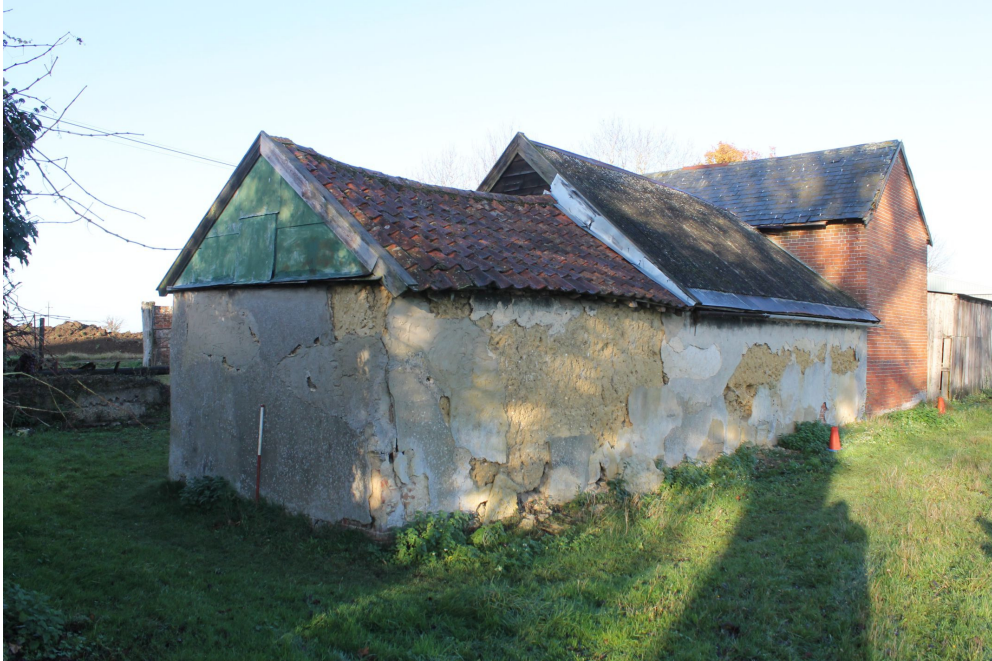
The rear wall of outbuilding 4 is of clay construction. Similarly to outbuilding 1, the clay has a lime horse-hair plaster render covered by a modern concrete skim and areas repaired with red-brick. This clay wall was also likely an original yard wall that has later been incorporated in the outbuilding. The south-east elevation has a gable-end clad in black weather-boarding while the rest of this elevation is clad in black horizontal timber-planks. The south-west elevation has two single vertically-planked timber doors with modern strap hinges. This elevation is clad in a combination of horizontal black timber-planks and corrugated metal. A poured-concrete plinth is also present on the south-west elevation, although is not the full length of the building. The roof of outbuilding 4 is covered in corrugated asbestos panels with metal ridge coping tiles and a metal sheet overhang.

Photograph 9 Detail of clay wall on north-eastern and south-eastern elevations. Photograph taken facing north-west.

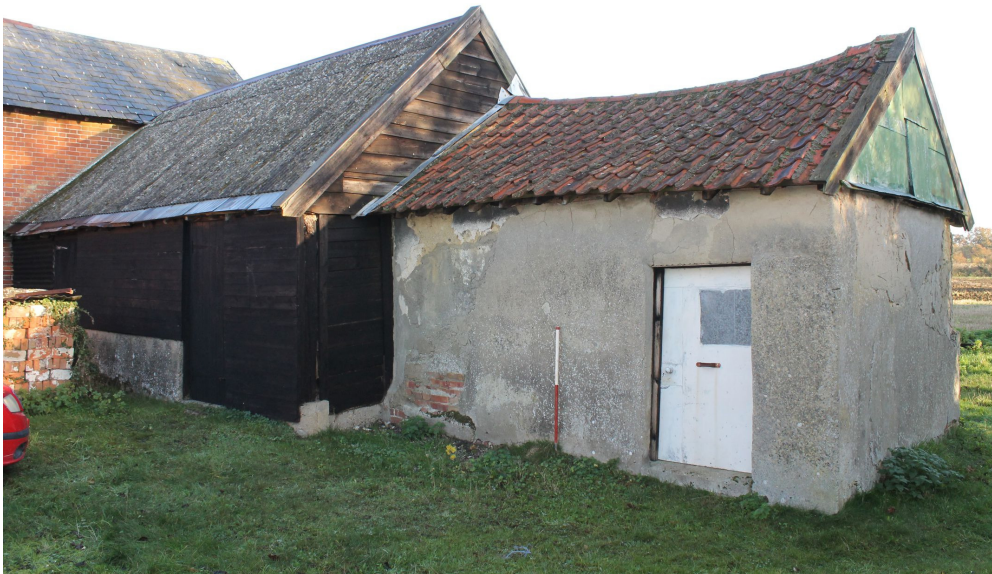
All four walls of outbuilding 5 are of clay construction, indicating that it is probably an original outbuilding. Again, the clay walls have an original lime horse-hair plaster render covered by a modern concrete skim. The clay walls are in poor condition and have small areas that have been repaired with red brick. On the south-west elevation is a small wooden door that has metal sheeting nailed to it. The roof is gabled and covered in clay pantiles. The south-east gable-end is clad in metal sheets painted green.

Photograph 10 South-western elevation of outbuilding 5. Photograph taken facing north.

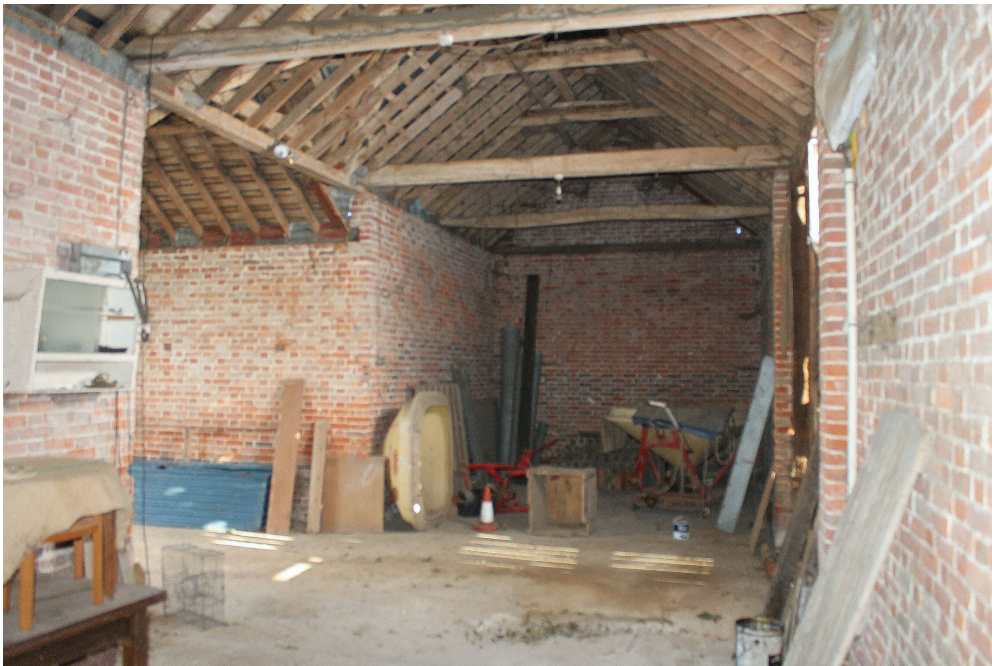
The roof of the barn is gabled at both ends as is the midstrey. The roof consists of pairs of rafters that rise from the wall-plate and meet at a ridge-board. The rafters have two collars, the lower of which supports one through purlin on each roof pitch. The rafters are covered by sarking-boards, some of which are missing. The collars and purlins are mainly hand-sawn or re-used timbers while the rafters are machine-cut. Each bay is separated by a hand-sawn tie-beam which is supported by the wall-plate. The existing roof has been constructed without trusses, suggesting the roof timbers may have been replaced at some point.

Photograph 11 Interior of threshing barn. Photograph taken facing north-east.

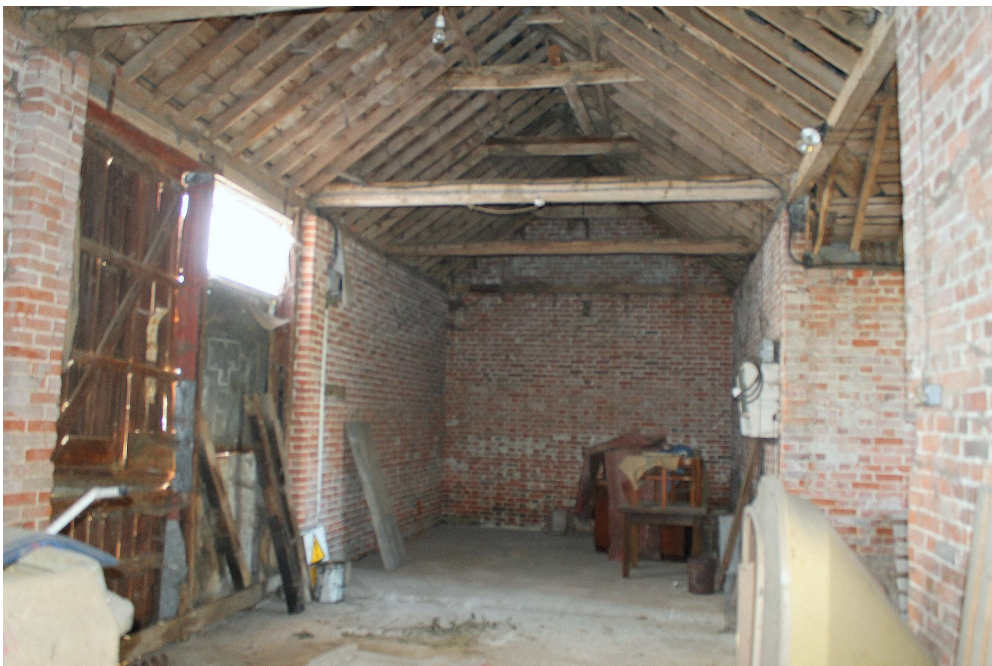
Photograph 12 Interior of threshing barn. Photograph taken facing south-west.

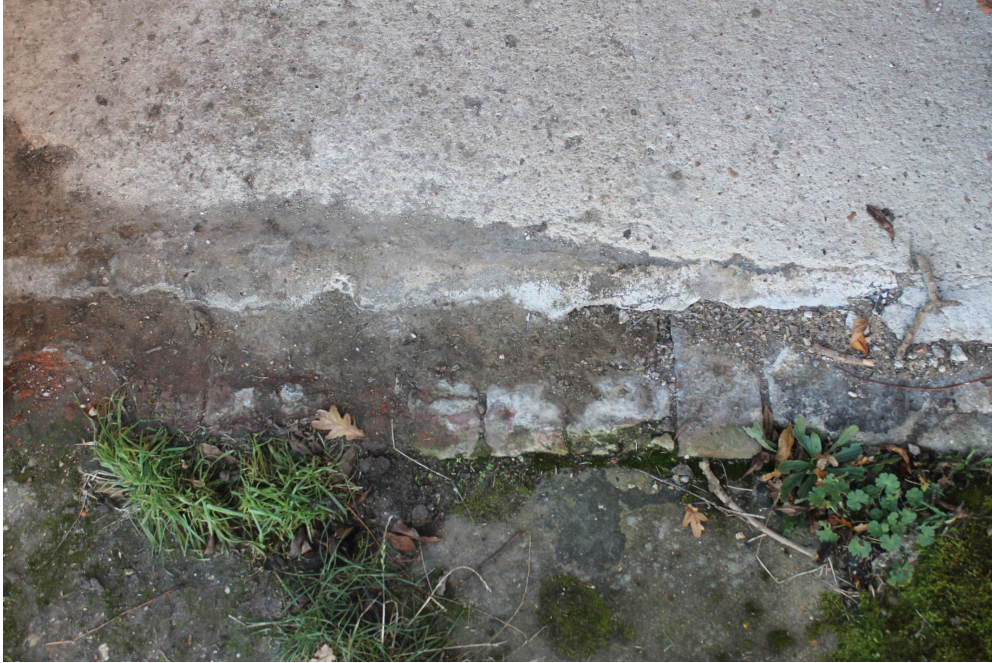
Bay 3 is the central and largest of the bays. The midstrey projects from the north-west of this bay. The north-west wall is dominated by a pair of replacement timber doors. A small amount of the original brick threshing floor is still visible in the doorway.

Photograph 13 Detail of original brick flooring covered with concrete. Photograph taken facing south-east.

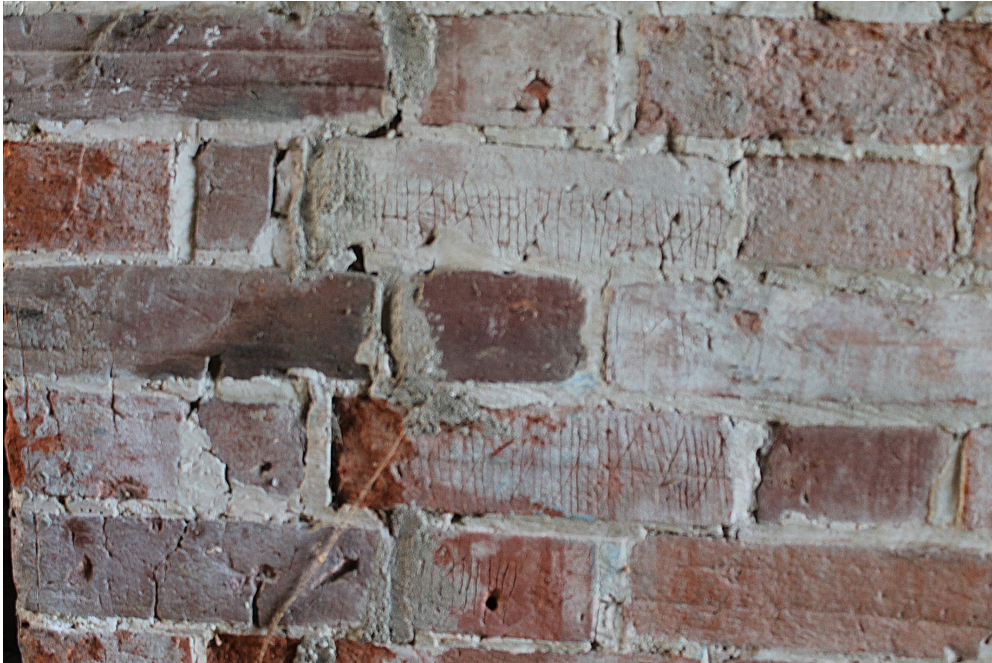
Graffiti is present on the north-east and south-west walls of the midstrey. On the north-east wall a series of names and initials have been carved into the brickwork and on the south-west wall are a series of tally-marks, possibly relating to the barns use for grain processing.

Photograph 14 Detail of tally-mark graffiti. Photograph taken facing south-west.

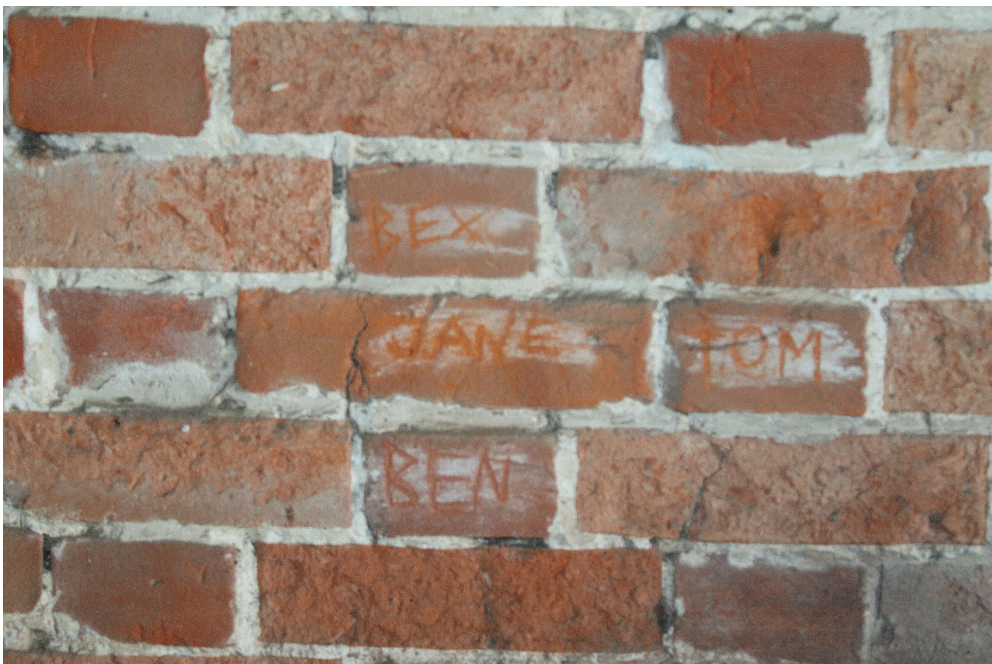
Photograph 15 Detail of carved name graffiti. Photograph taken facing north-east.

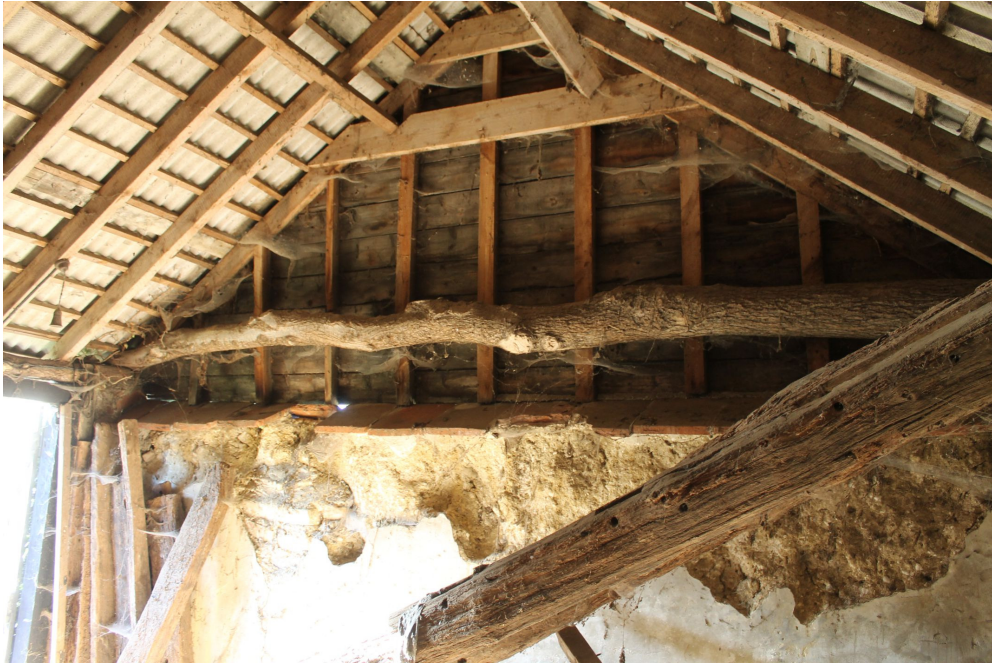
The roof of the outbuilding is gabled and is constructed from pairs of rafters that rise from the wall-plate and meet at a ridge-board. These are supported by two collars, the lower of which supports one through purlin on each roof pitch. The roof has been constructed using a mixture of machine-cut and unprocessed timber. The floor is concrete.

Photograph 16 Interior of outbuilding 1 showing detail of timber structure. Photograph taken facing south-west.

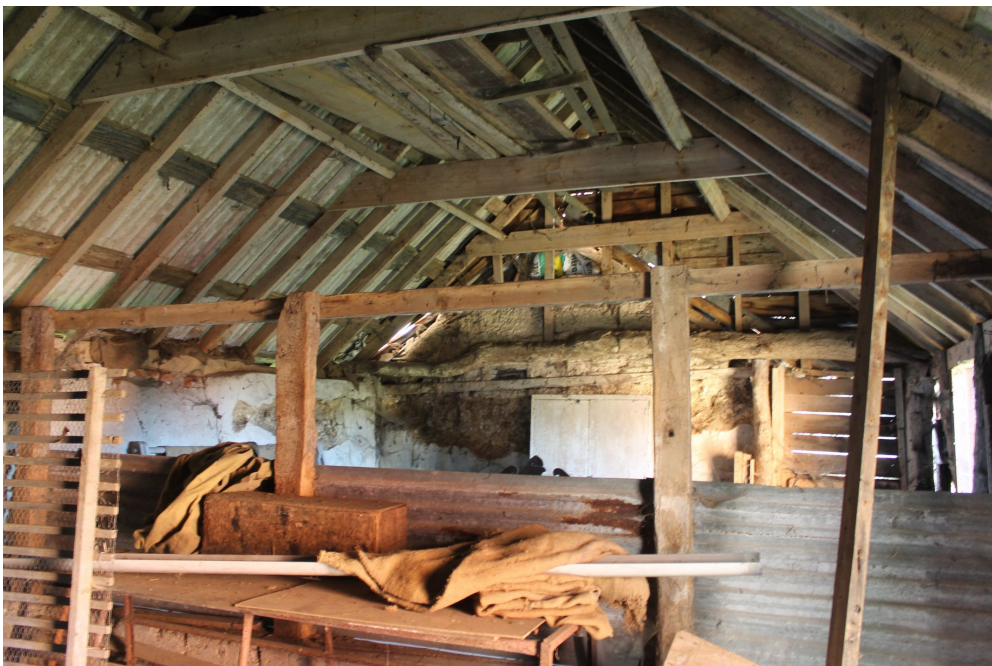
The roof of outbuilding 4 consists of pairs of rafters rising from the wall-plate and meeting at a ridge board. These are supported by a single collar, which also supports a single through purlin on each roof pitch. The timber used in the roof of outbuilding 4 is all machine-cut.

Photograph 17 Interior of outbuilding 4. Photograph taken facing south-east.

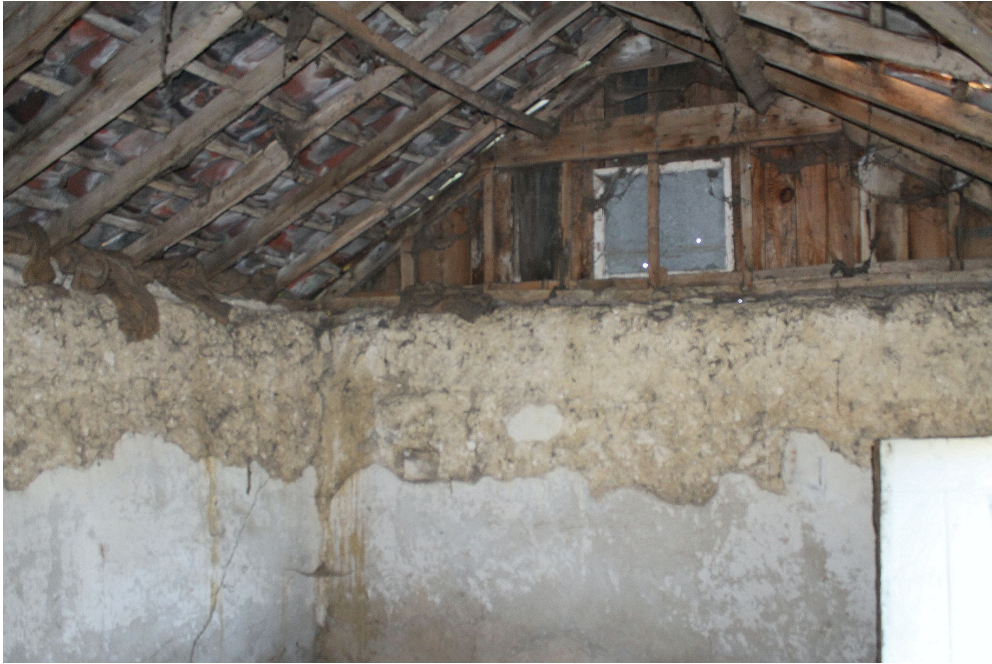
The roof of outbuilding 5 has pairs of rafters rising from the wall-plate supported by a single purlin on each pitch. A single collar joins the purlins at the south-east wall. Below this collar is the opening for a window which has been boarded-up from the outside. The timber used in the roof is a combination of hand-sawn and machine-cut. The floor is concrete.

Photograph 18 Interior of outbuilding 5. Photograph taken facing south-east.
