CAT Report 1898 issued February 2023

Historic building recording at Boxted Methodist Chapel, Chapel Road, Boxted, CO4 5RP

January 2023

CAT project ref.: 2022/11i CAT Report 1898

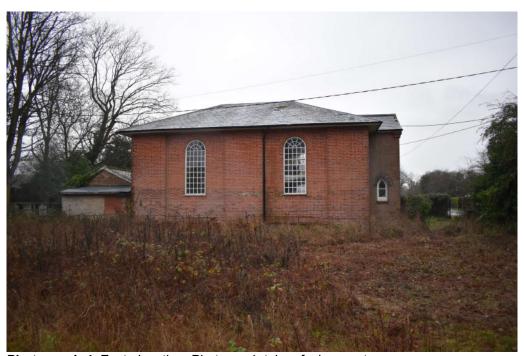
On the eastern elevation, the chapel has two large 51-light round-headed windows, both with an arched brick lintel. These windows are set into an area of recessed brickwork. There is a single two-light fixed pointed-arch window located at ground-floor level on the porch that has a yellow and dark-red brick lintel. The lean-to is partially rendered with concrete.

Photograph 4 East elevation. Photograph taken facing west.

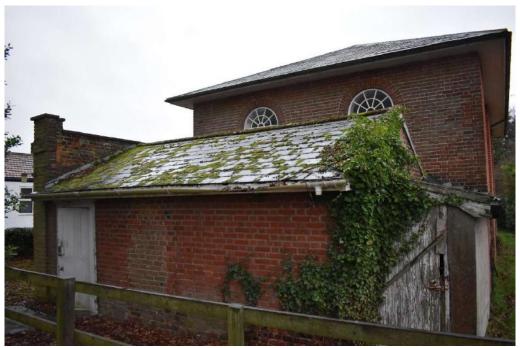
There are two timber doors on the southern elevation – one that leads into the vestry and one that leads into the lean-to. The door to the vestry is inserted, probably at the

same time the lean-to was constructed. Two 36-light round-headed fixed windows are present on the chapel. Both have a brick arch lintel.

Photograph 6 South elevation. Photograph taken facing north-west.

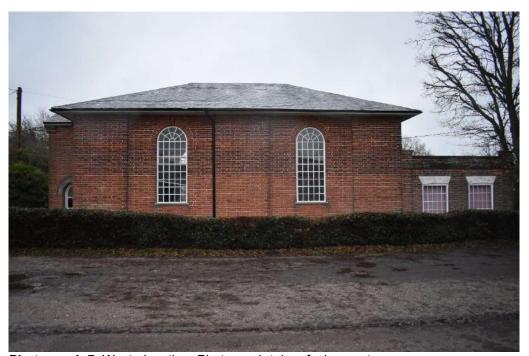
The western elevation has five windows in total. The chapel and porch mirror the eastern elevation with two round-headed windows and a single point-arched window. The vestry has two rectangular windows – both replacement PVC – with a stone lintel. The vestry's parapet has three courses of protruding decorative brickwork and is topped with coping stones. It also has square pilasters on the north and south corner. The letters TD have been gratified on the western elevation of the chapel.

Photograph 7 West elevation. Photograph taken facing east.

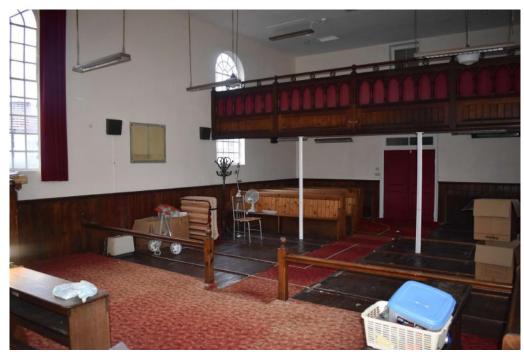
The main hall of the chapel is the largest room and is the original single-celled chapel building. The chancel is located at the southern end and is on a raised platform. The floor of the chancel and the central aisle is carpeted while the nave has varnished floorboards. The walls are plastered and painted white with varnished timber panelling at floor level.

Photograph 10 Internal view of main hall. Photograph taken facing north-west.

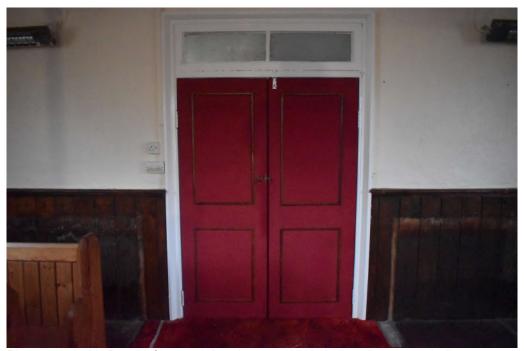
There are two doorways in the main hall: one in the northern wall and one in southern wall. The northern door is a double door, covered in red felt, with a rectangular fanlight. The southern door is single door with a step down into the vestry. The local listing suggests this door is inserted and the original door was located central to the southern wall.

**Photograph 12** Detail of internal door between main hall and entrance hall. Photograph taken facing north.

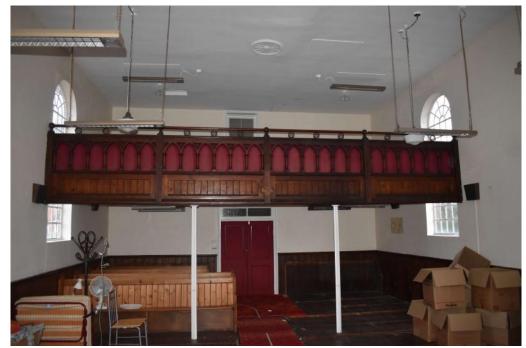
In the southern third of the main hall is an inserted gallery which is accessed via stairs in the porch. It is supported on two cast-iron posts and has a timber balustrade with decorative ironwork and a red felt backing.

**Photograph 15** Detail of gallery and balustrade as viewed from main hall. Photograph taken facing north.

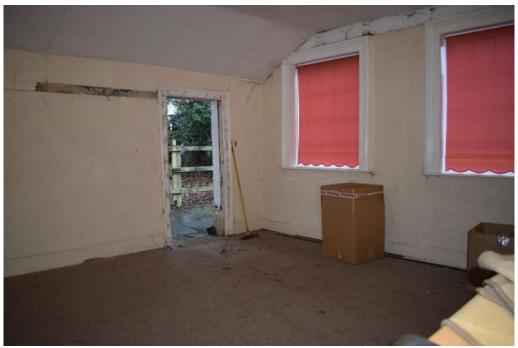
The vestry is in a single-storey extension to the south. The floor is carpeted, and the walls are plastered and painted white. There are two replacement PVC windows on the western wall. Two timber doors are present in the vestry – one in the southern wall and one in the northern wall. Both are inserted. The eastern wall is dominated by a set of modern cupboards.

**Photograph 20** Internal view of vestry. Photograph taken facing south-west.

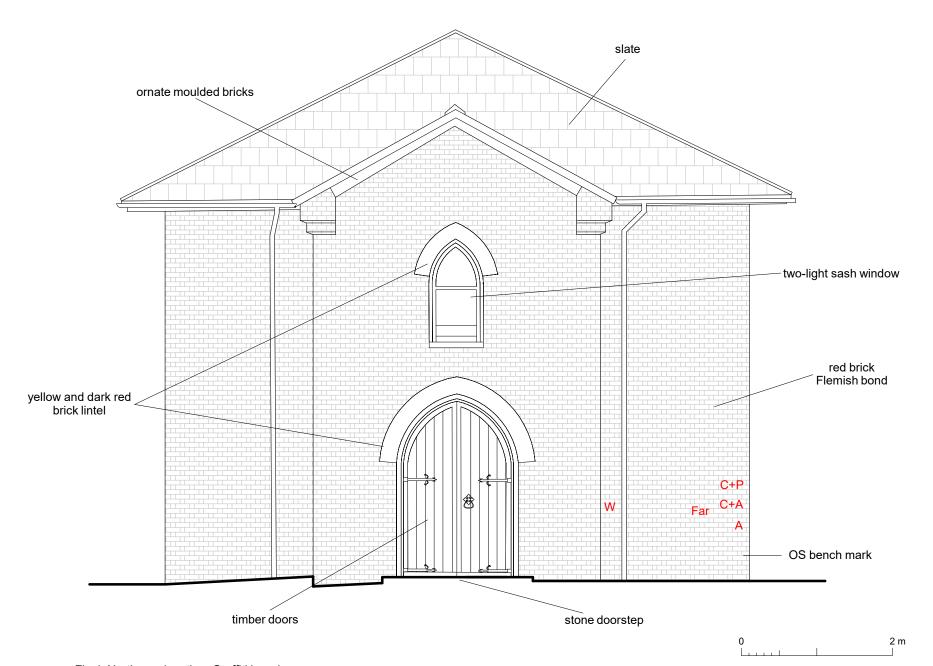
Fig 4 Northern elevation. Graffiti in red.

areas of carved graffiti are present on the main chapel (see Fig 4), along with a chiselled OS benchmark symbol.
