Colchester Archaeological Trust

**CAT Report 1972
issued September 2023**

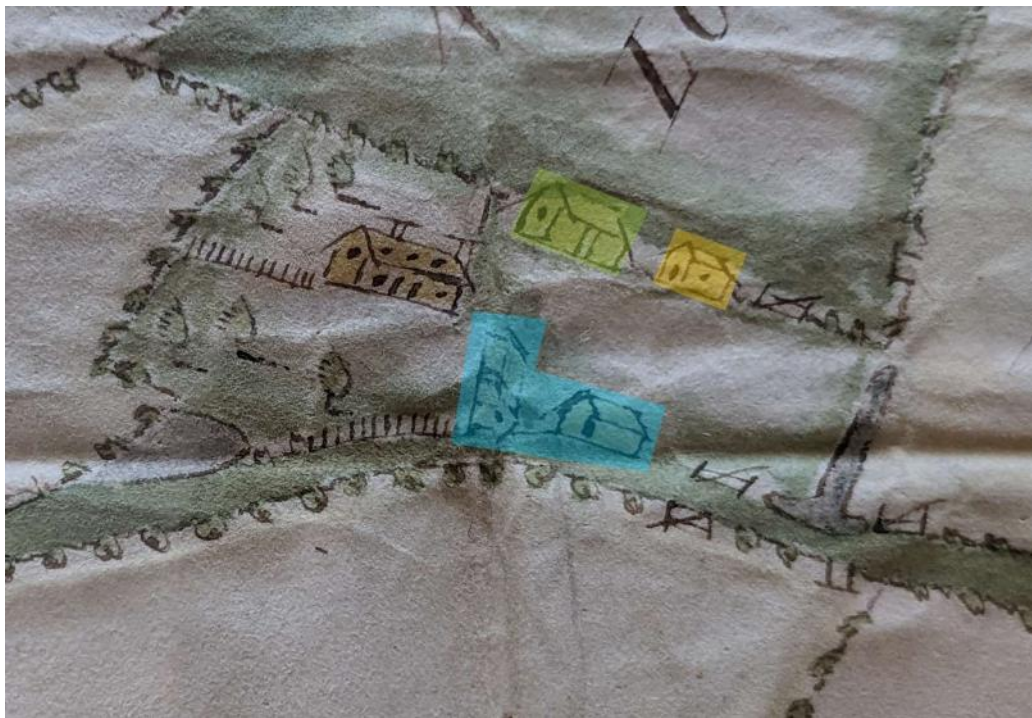
Map 2 Extract of Joseph Dawson's map of Great Leighs (1787, ERO D/DBw P1). The Bailey Barn highlighted in green, the Road barn highlighted blue and the Field Barn highlighted yellow.

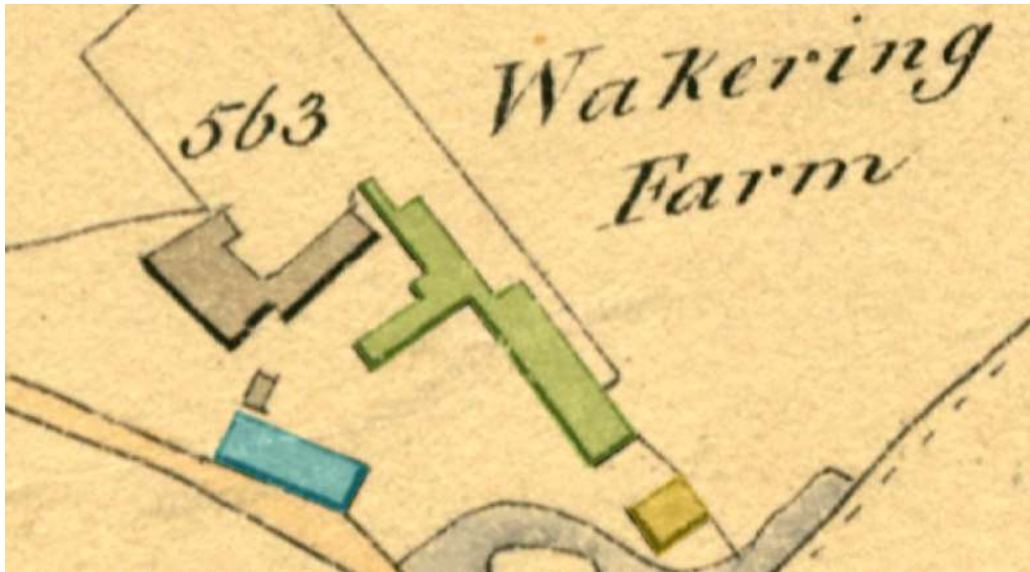
Map 3 Extract of the 1838 tithe map. The Bailey Barn highlighted in green, the Road Barn highlighted blue and the Field Barn highlighted yellow.

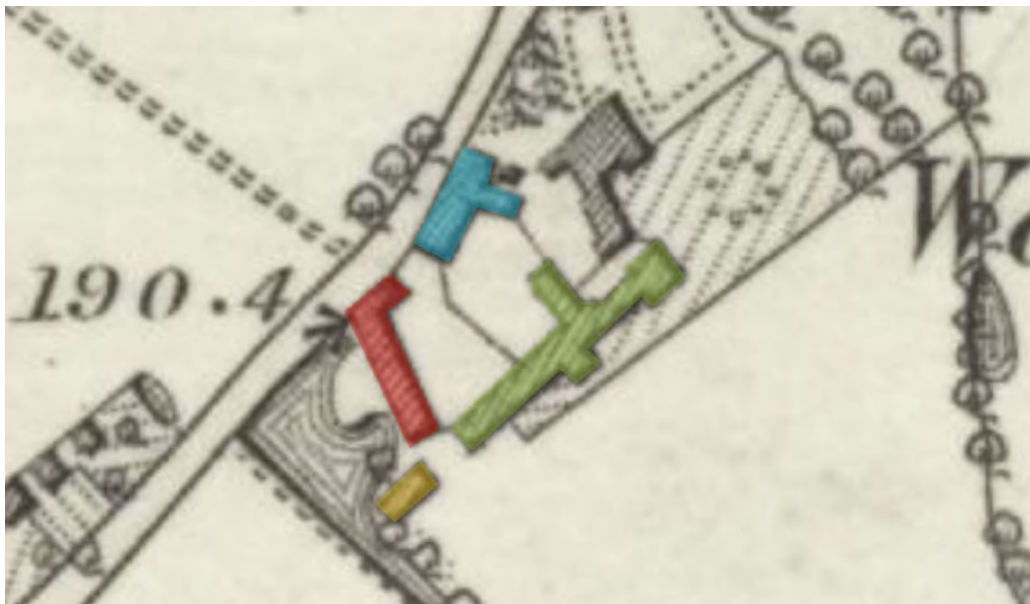
Map 4 Extract of the first edition 6-inch OS map (1874). The Bailey Barn highlighted green, the Road Barn highlighted blue, the Pond Barn highlighted red and the Field Barn highlighted yellow.

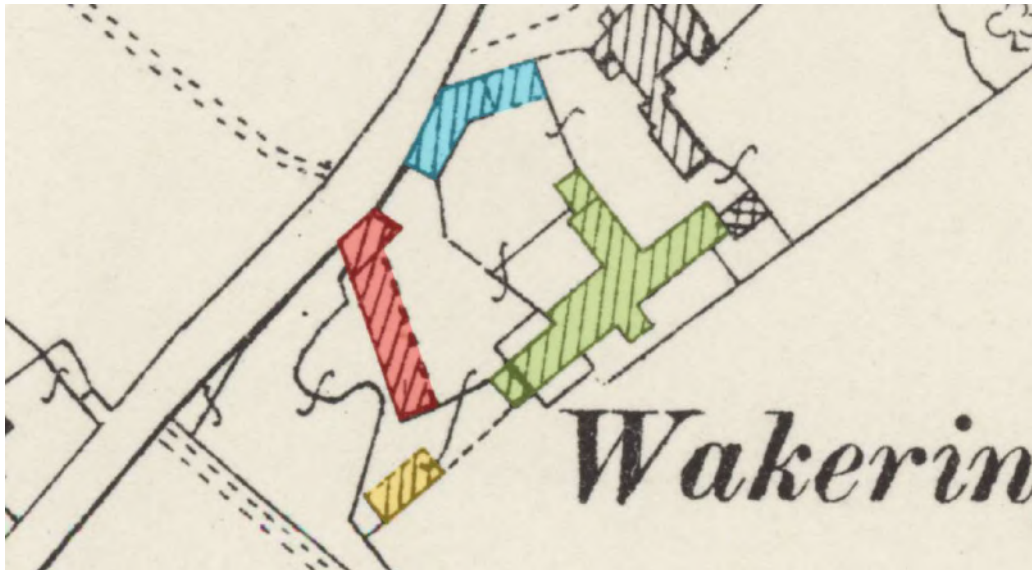
Map 5 Extract of the 1895 25-inch OS map. The Bailey Barn highlighted green, the Road Barn highlighted blue, the Pond Barn highlighted red and the Field Barn highlighted yellow.

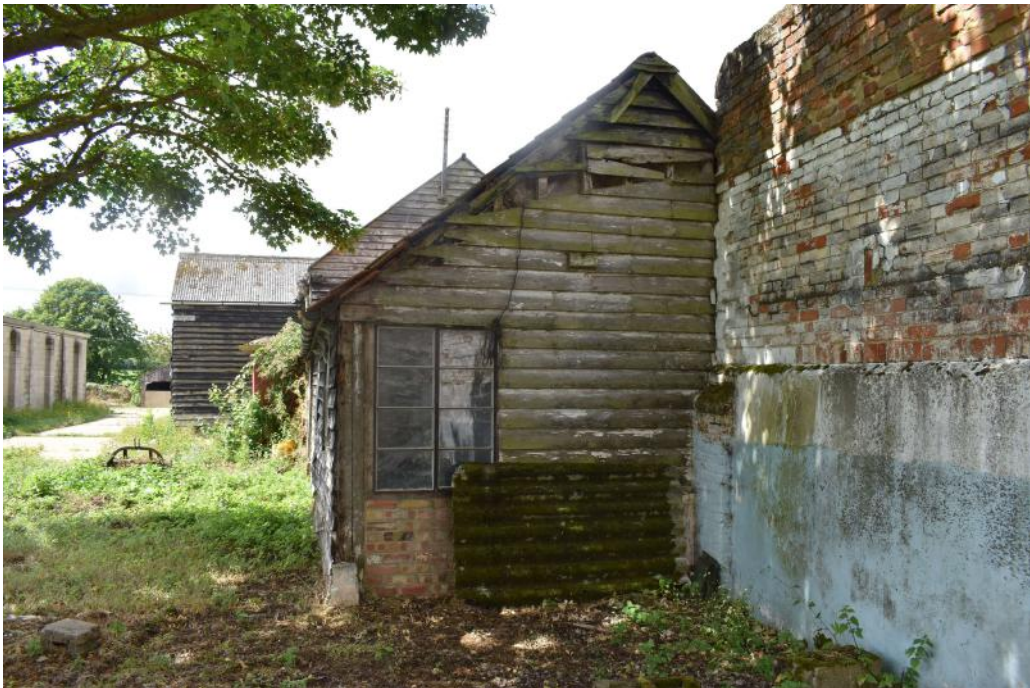
Photograph 3 North-east elevation of Bailey Barn. Photograph taken facing south-west.

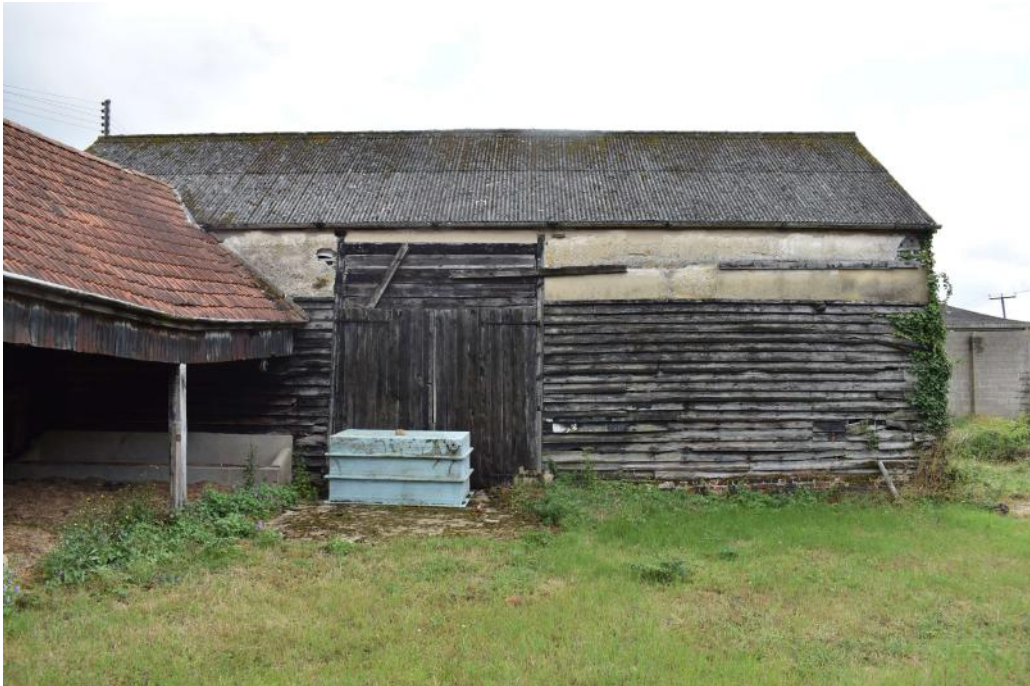
Photograph 4 North-west elevation of Bailey Barn. Photograph taken facing south-east.

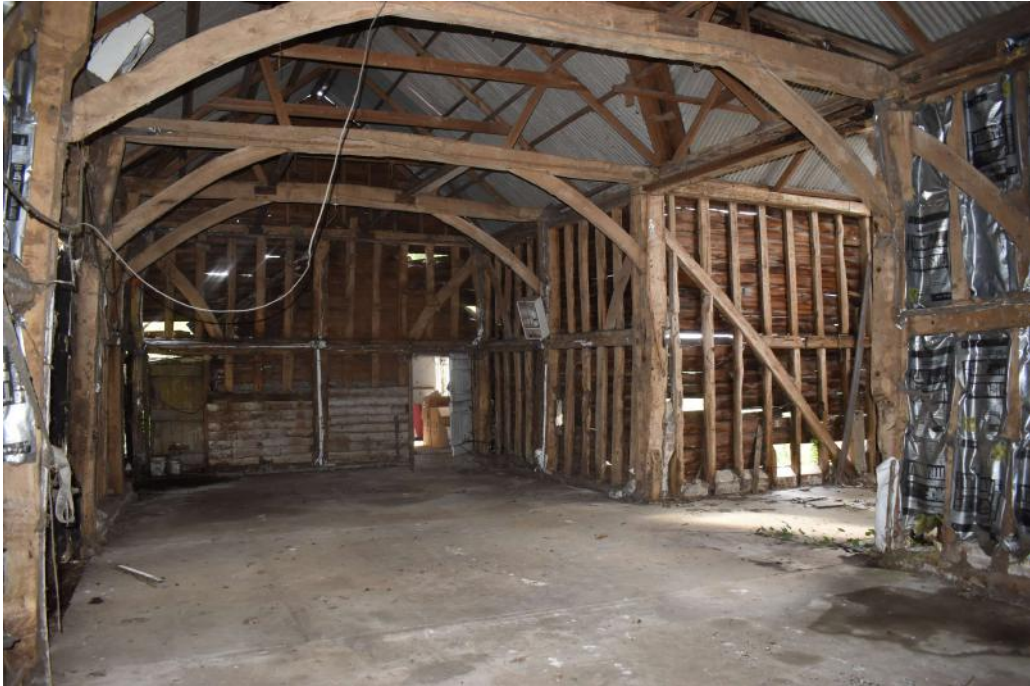
Photograph 6 Interior of Bailey Barn (threshing barn). Photograph taken facing north-east.

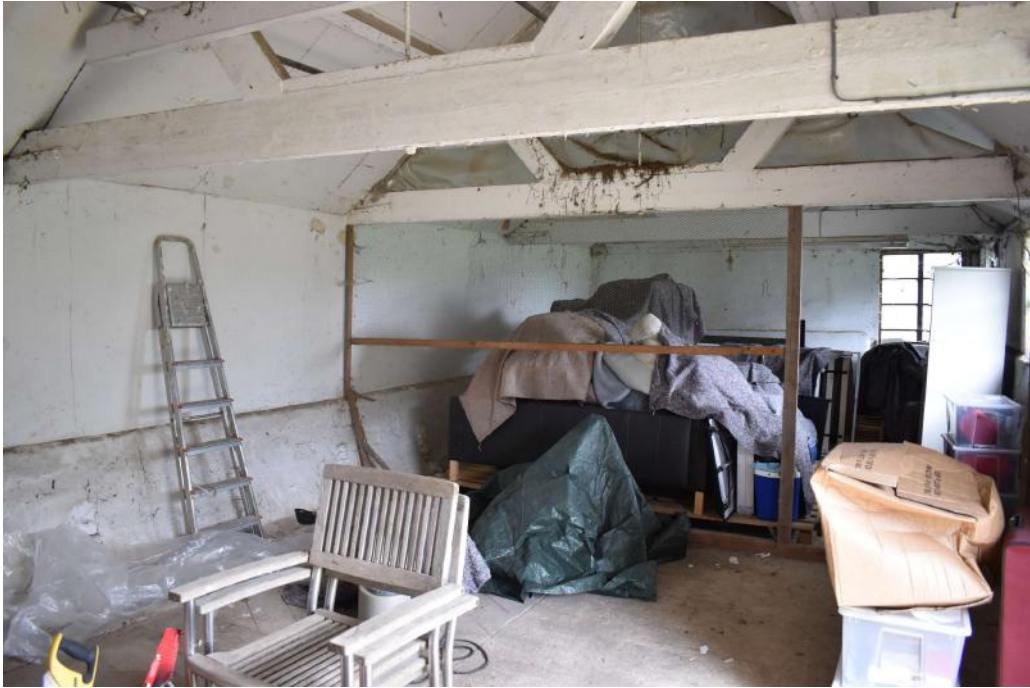
Photograph 17 Interior of Bailey Barn (building 1). Photograph taken facing north.

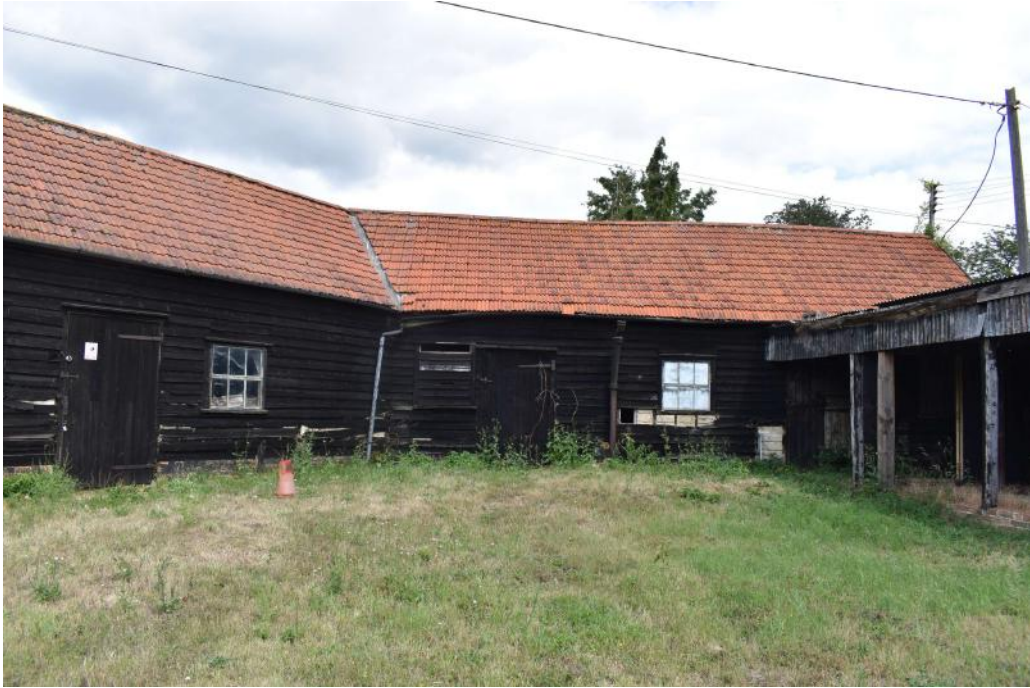
Photograph 20 South-eastern and south south-eastern elevation of Road Barn, Photograph taken facing north.

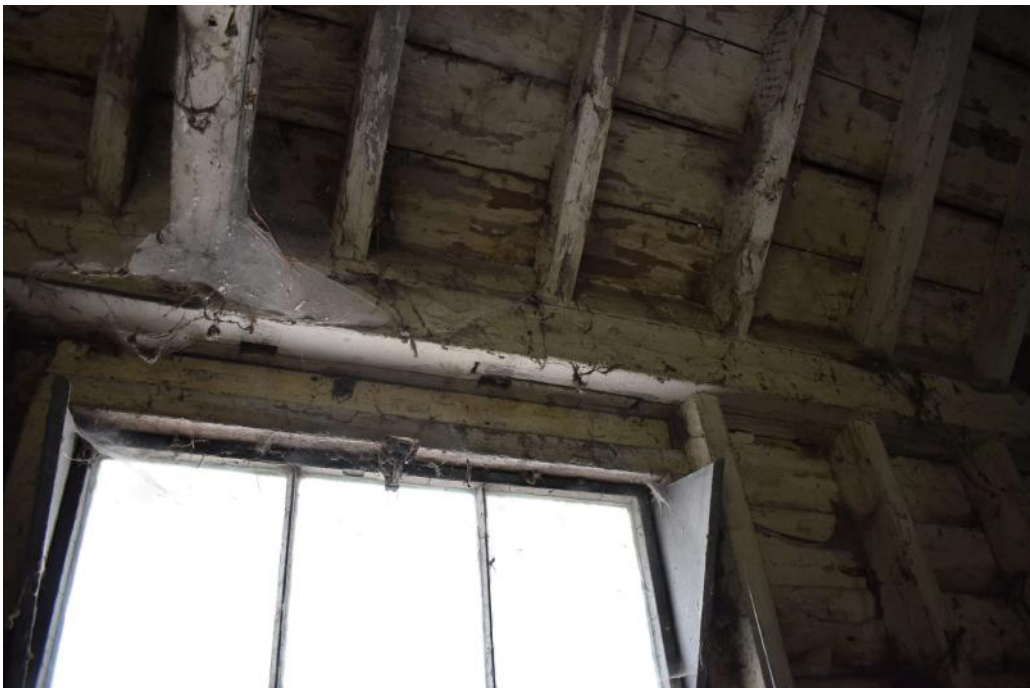
Photograph 25 Interior of Road Barn, detail of side-halved scarf-joint (building 3). Photograph taken facing north north-west.

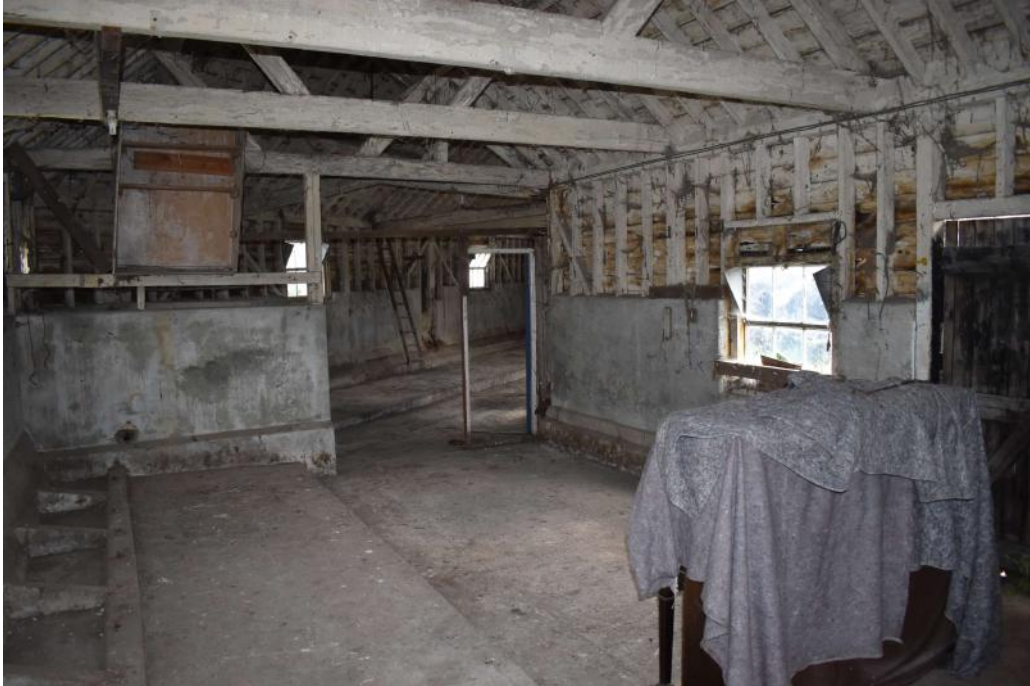
Photograph 26 Interior of Road Barn (building 3). Photograph taken facing north-east.

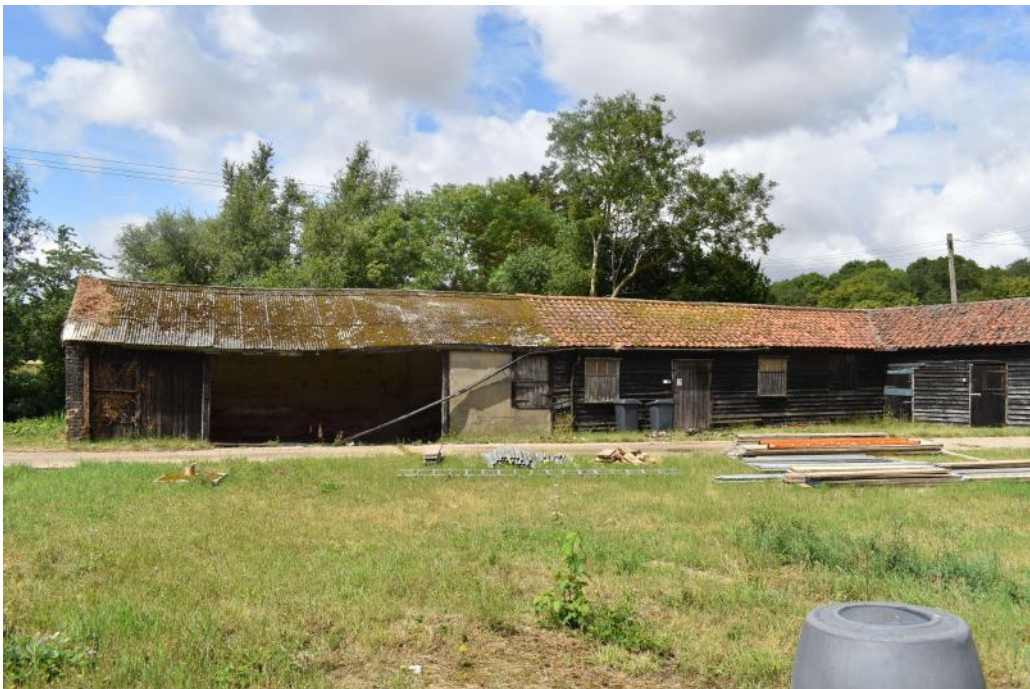
Photograph 29 North-east elevation of Pond Barn. Photograph taken facing south-west.

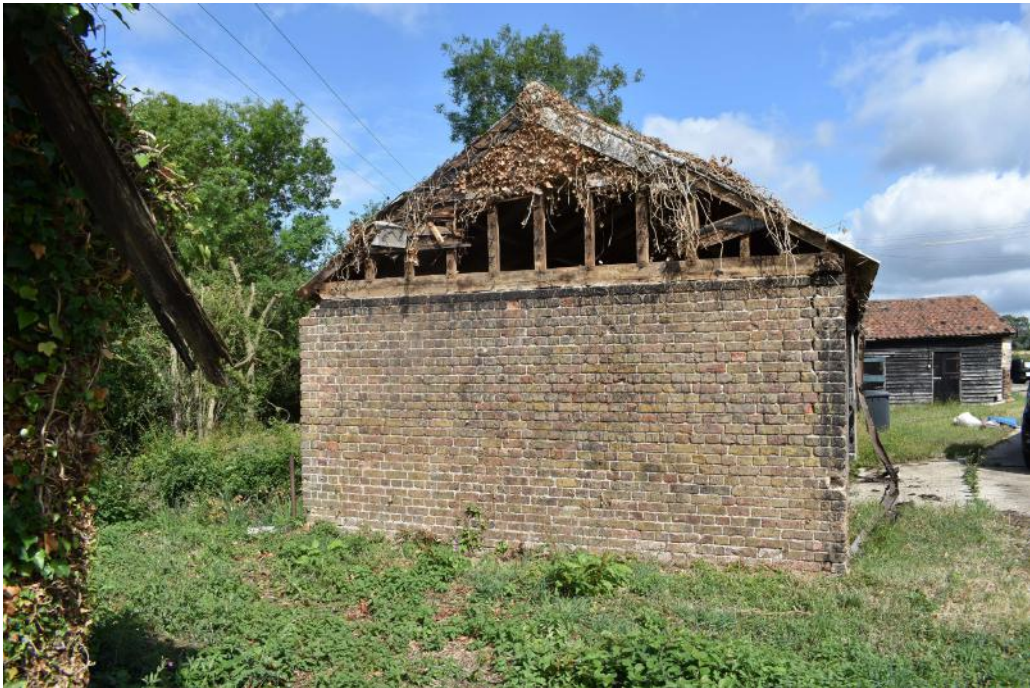
Photograph 30 South-east elevation of Pond Barn. Photograph taken facing north-west.

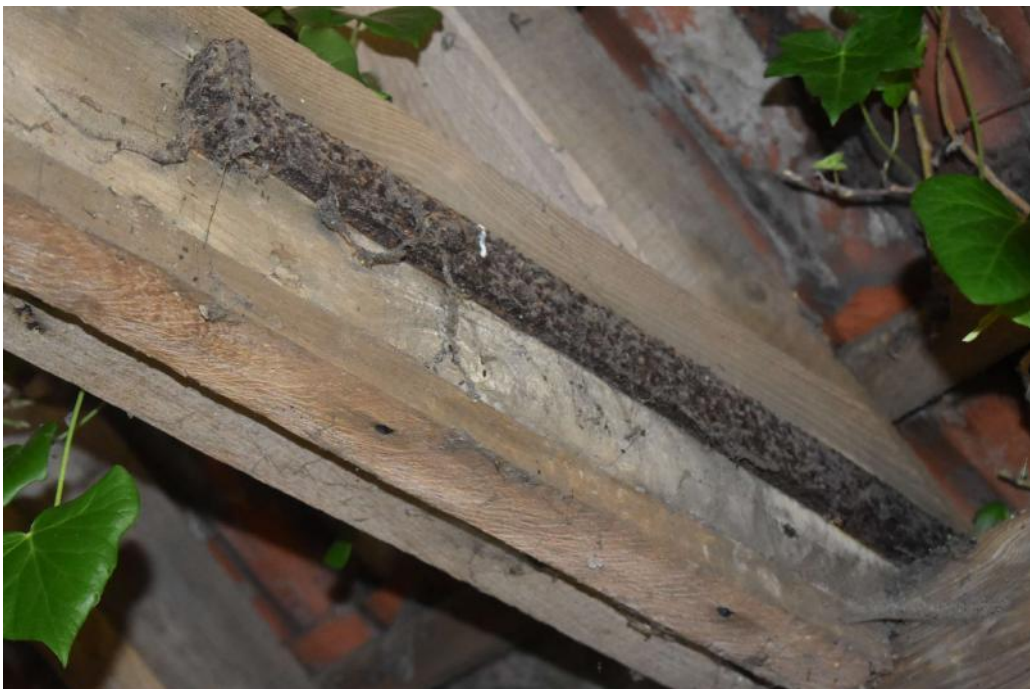
Photograph 45 Interior of Field Barn, detail of iron strap (building 10). Photograph taken facing west.

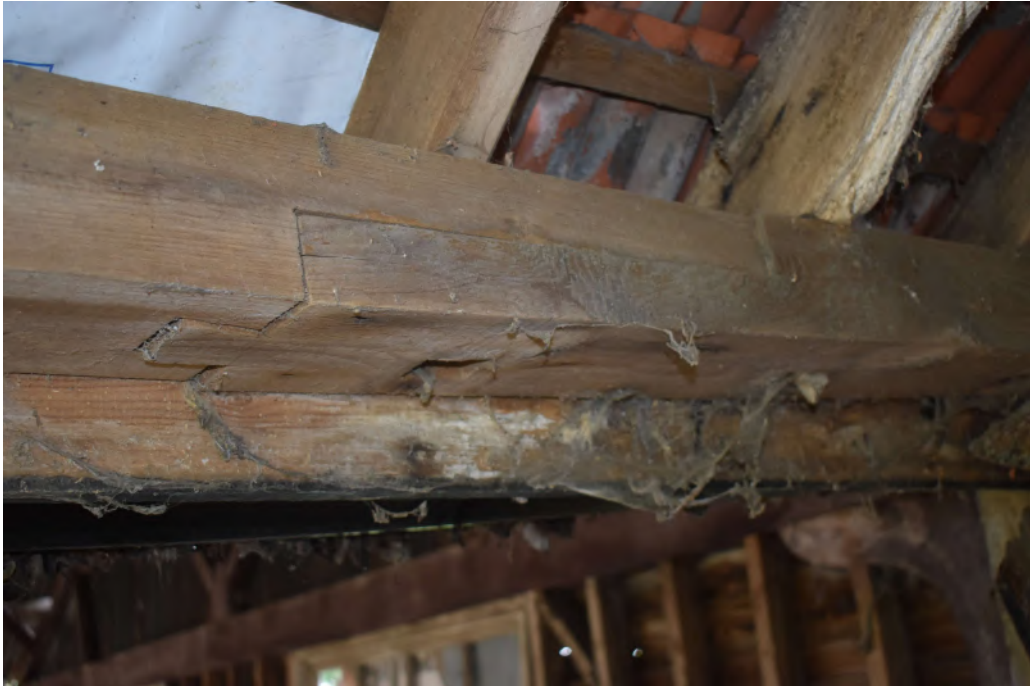
Photograph 46 Interior of Field Barn, detail of scarf-joint on the south-east wall-plate (building 10). Photograph taken facing south-east.
