**CAT Report 2034
issued April 2024**

**Historic building recording of a barn and store
on land at Glebe House, Rectory Road, Stisted,
Essex, CM77 9AL**

**CAT project ref.: 2024/02m
ECC code: SSGH24**

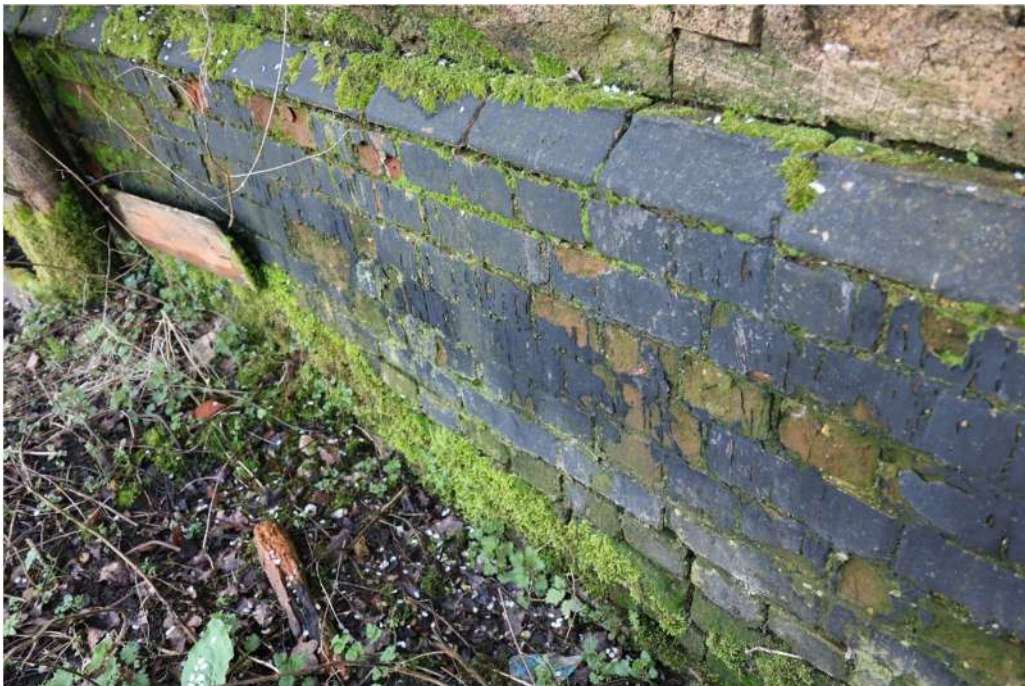
The roofs of the barn and the store are gabled at both ends and clad in asbestos roofing sheets while the exterior of the building is clad with timber weatherboards. The timber-framing is supported on a plinth comprising red bricks (brick dimensions: 225 x 110 x 65mm) laid in English bond, topped with a course of chamfered bricks. Due to differences in the ground level, the plinth on the north-east elevation is more substantial than that of the south-west elevation (Photographs 2 and 3).

Photograph 3 Detail of brick plinth on north-east elevation. Photograph taken facing south.

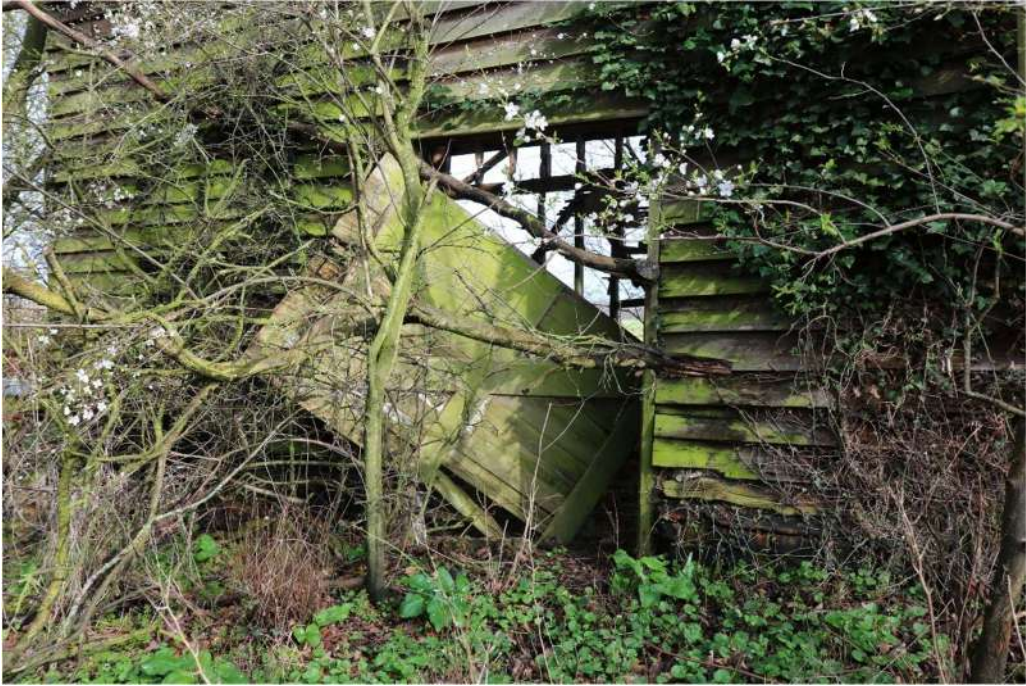
The south-west elevation (Photograph 1) of the barn has a slightly off-centre doorway flanked by two blocked windows (Photograph 4). Above the doorway, a break in the weatherboarding indicates the doorway was originally the full height of the elevation. A replacement door is present but is hanging off the hinges. On this elevation, the store has one blocked window and a double doorway, within which are the partial remains of a single door (Photograph 5).

Photograph 4 Detail of single door on south-west elevation. Photograph taken facing north north-east.

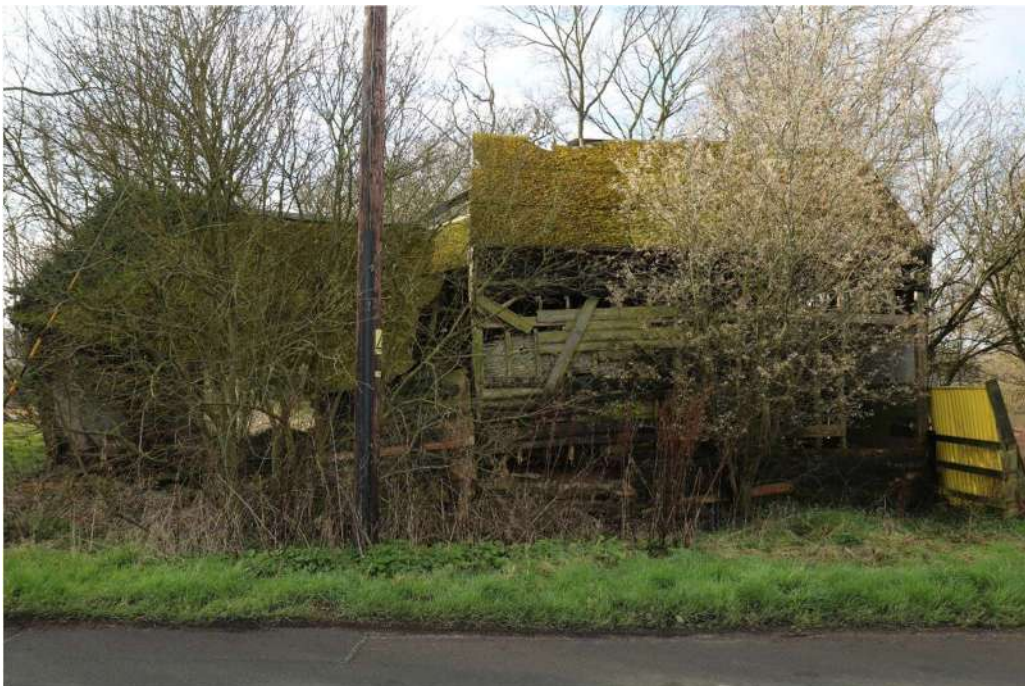
The north-east elevation is severely dilapidated (Photograph 7). The wall of the store has collapsed, which has caused the roof to buckle. From what remains of the store's elevation, it seems to have been largely featureless. The barn's elevation is somewhat more stable, although much of the weatherboard is missing. Damage to south-east end of the barn's plinth has revealed the brick floor inside the barn. A side-halved scarf-joint in the barn's wall-plate has been exposed due to the loss of the weatherboard.

Photograph 7 North-east elevation. Photograph taken facing south-west.

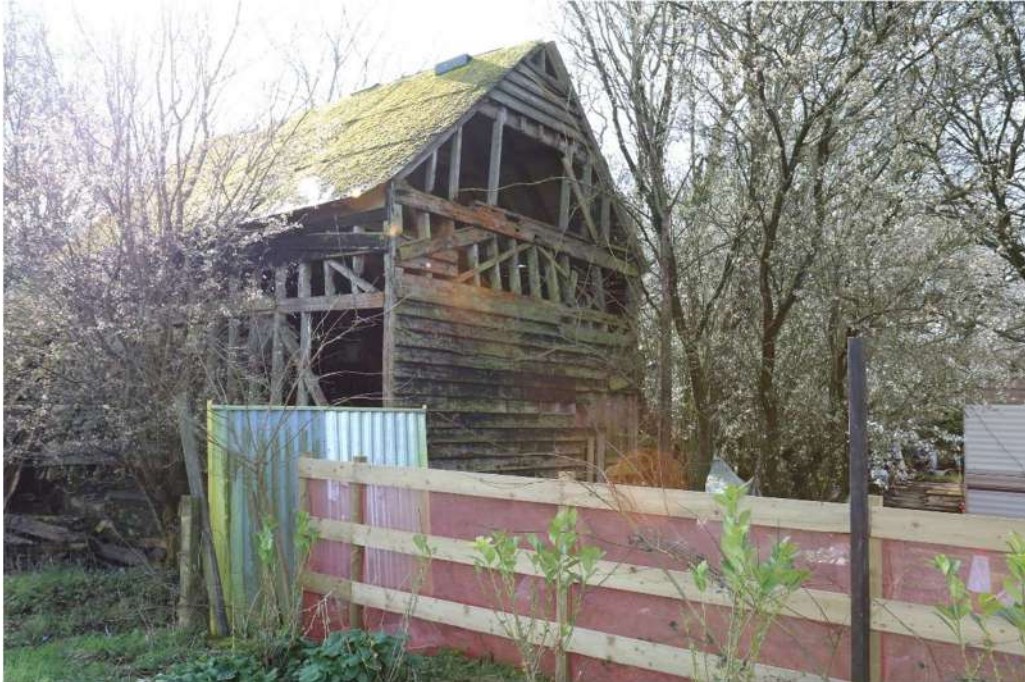
On the north-western elevation (Photograph 8), the barn has an inserted and partially blocked livestock opening (Photograph 11). Much of the weatherboard is missing from the barn's gable on this elevation.

Photograph 8 North-west elevation. Photograph taken facing south-east.

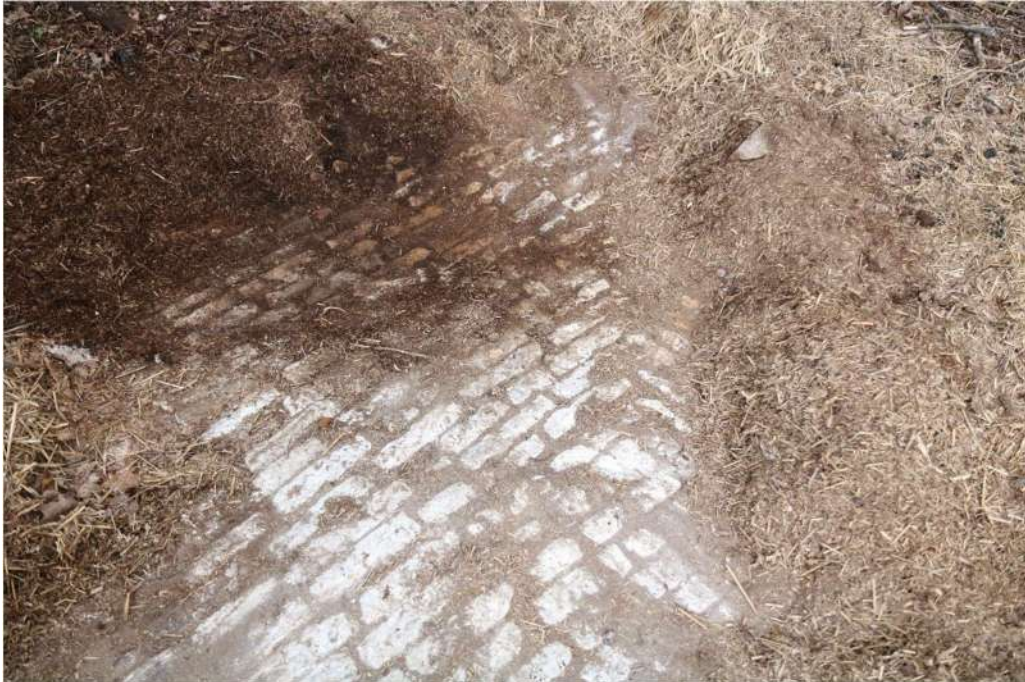
floor of the barn is covered with yellow brick pavers (brick dimensions: 200 x 60 x 45mm) laid on edge (Photograph 10). The brick pavers are likely original to the structure.

Photograph 10 Detail of brick floor of barn. Photograph taken facing south.

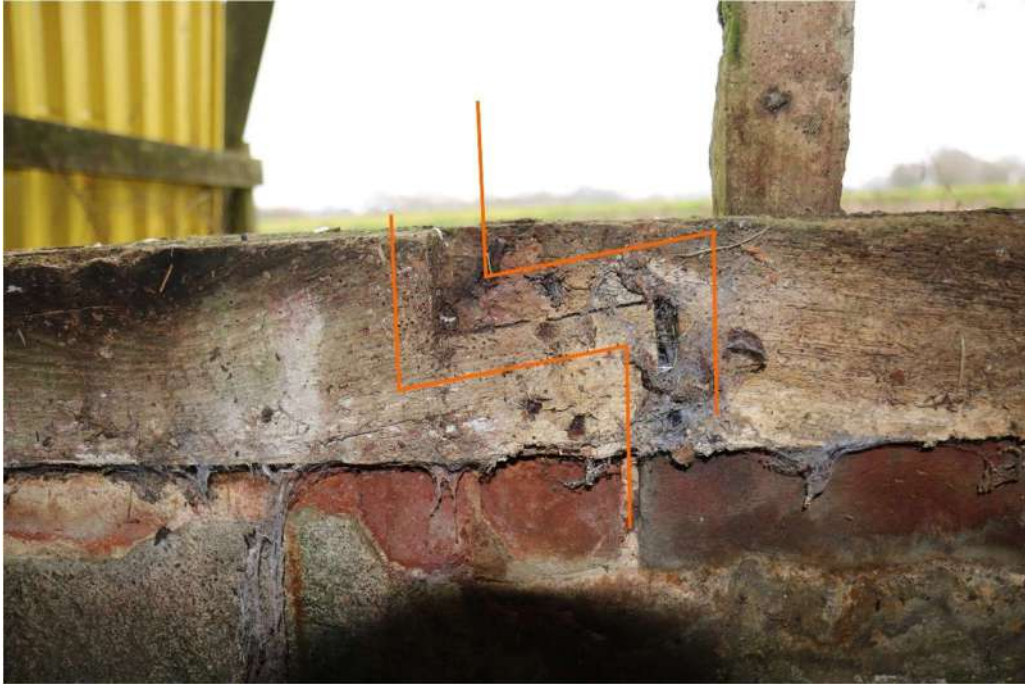
There is a simple side-halved, with squinted abutments, scarf-joint in the sill-beam of both bays, in the north-eastern wall of bay 1 and the south-western wall of bay 2 (photograph 12). Two windows are present in the south-western wall, one in each bay, both are twelve-light casement windows with a timber-frame (photograph 13). Due to the wall coverings, it's not possible to tell if these are replacements or inserted (although most likely later insertions). Both windows have been blocked on the exterior of the barn.

Photograph 12 Detail of scarf-joint in north-east sill-beam of barn. Photograph taken facing north-east.

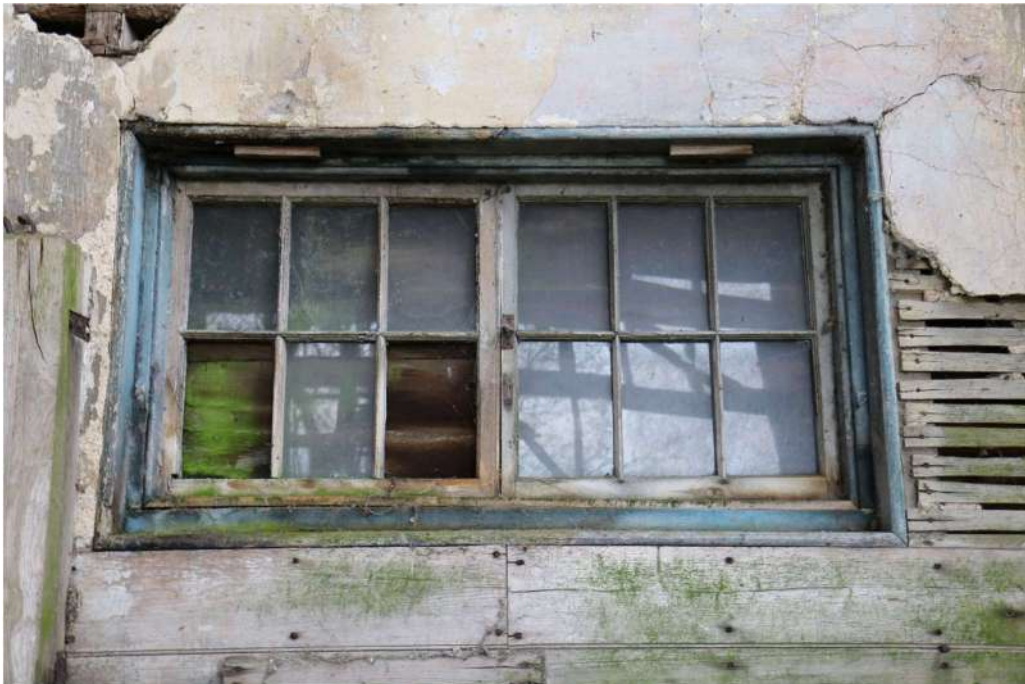
Photograph 13 Detail of window in south-west wall of barn. Photograph taken facing south-west.

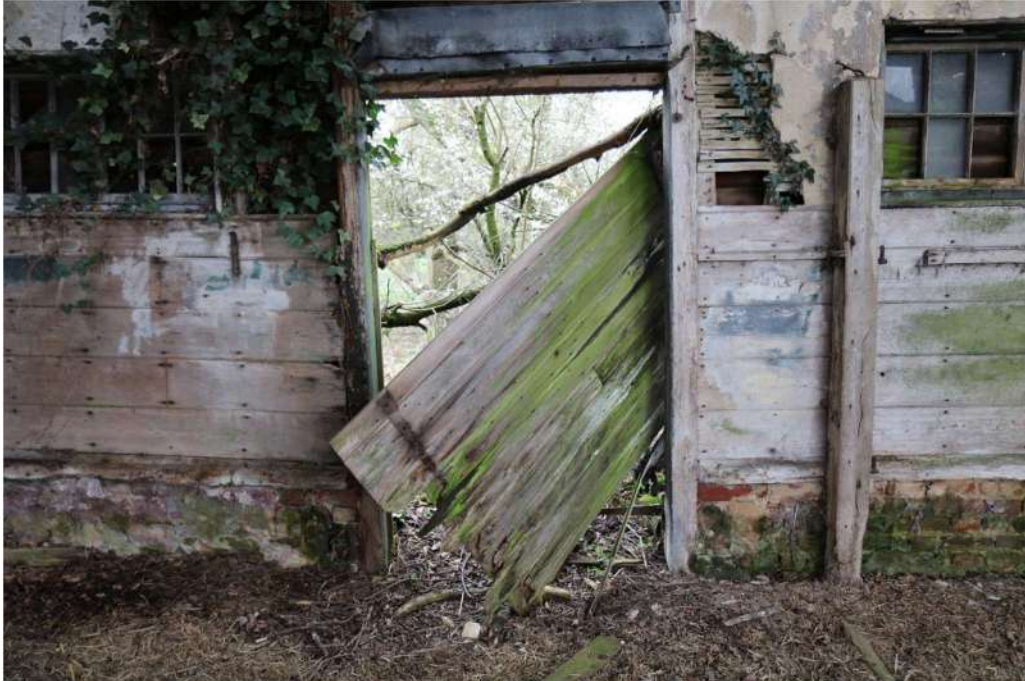
There is a door slightly off-centre in the south-western wall, straddling both bays (Photograph 14). A Baltic timber mark is present near the top of north-eastern door post (Photograph 15). Above the Baltic timber mark is an iron pintle (Photograph 16), further evidence the doorway was originally the full height of the barn. A second door is present in the south-eastern wall of bay 1, whilst the opening is original to the barn the door is a replacement. Where the wall-cladding has come away at the base of the south-east wall, brick infill between the studs has been exposed.

Photograph 14 Detail of door in south-west wall of barn. Photograph taken facing south-west.

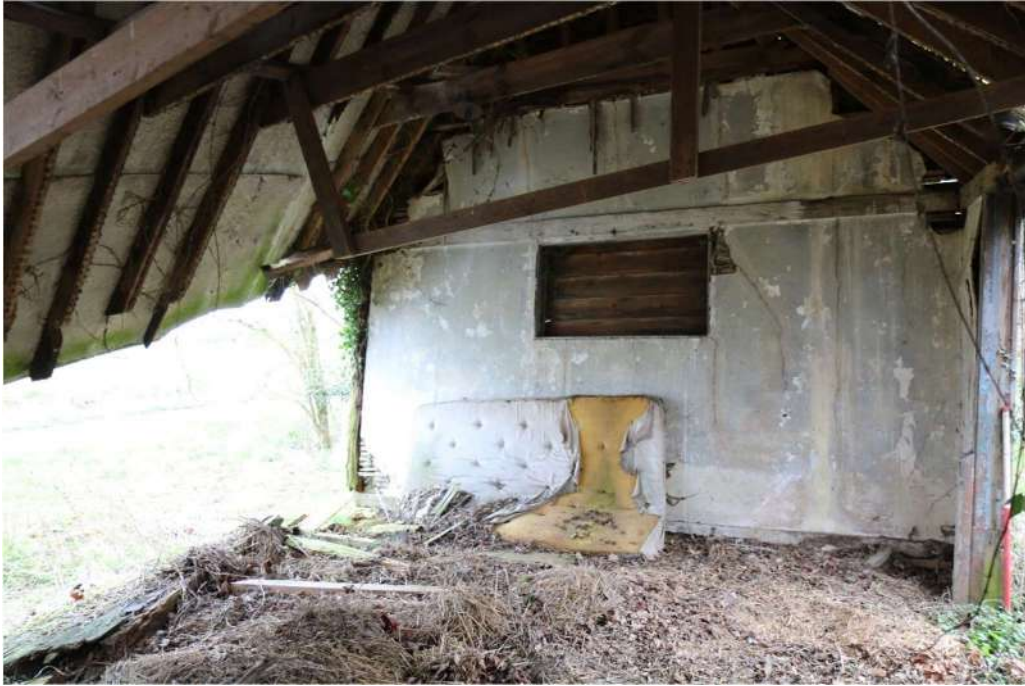
Photograph 18 Interior of store. Photograph taken facing east.

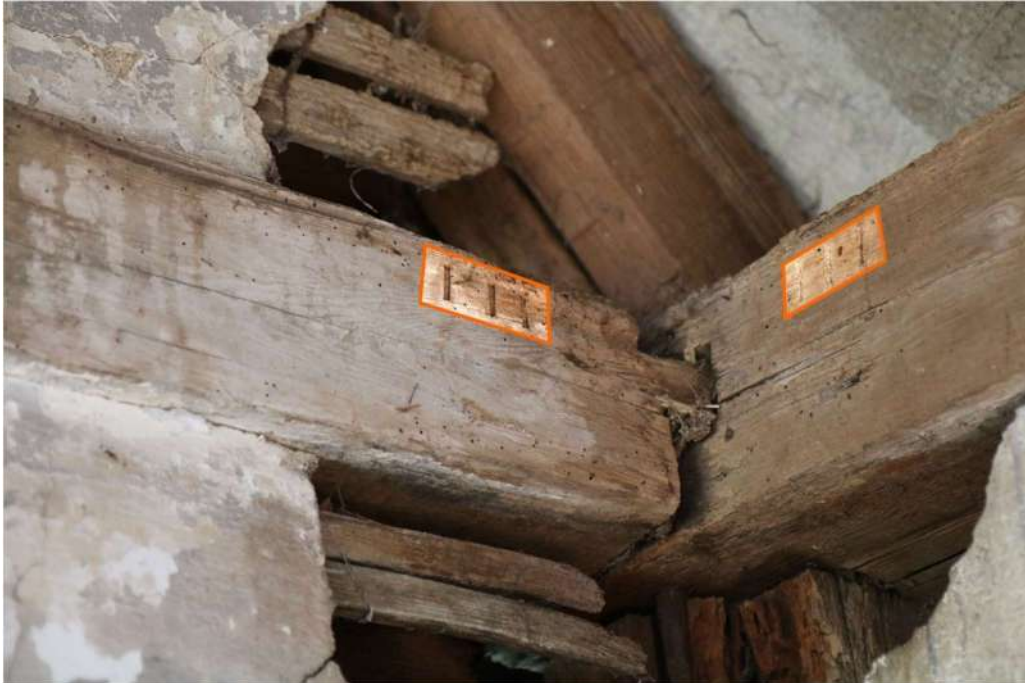
In the southern corner of the store, matching 'III' carpenter's marks have been incised into the wall-plate (Photograph 22). A possible scarf-joint is present in the south-

Photograph 22 Detail of carpenter's marks on wall-plate of store. Photograph taken facing south.

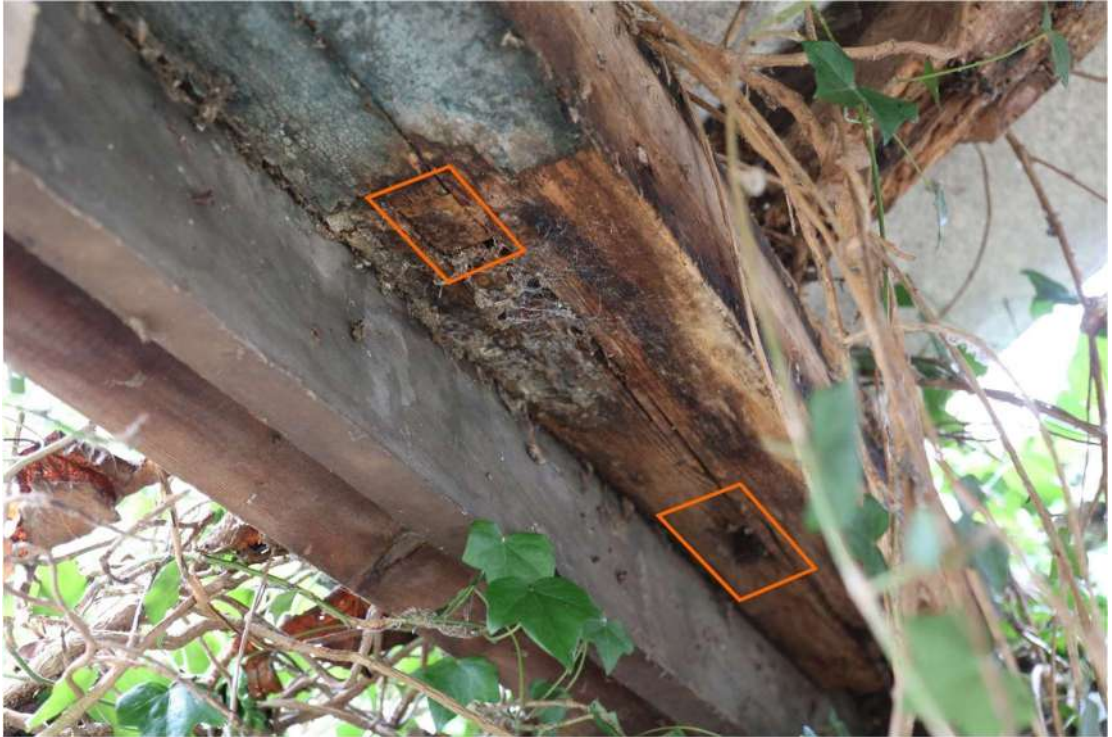
A double doorway is located in the south-western wall. The doorway is original to the building, but empty mortices above a portion of it are evidence it has been widened at some point (Photograph 24).

Photograph 24 Detail of empty mortices in wall-plate above south-western doorway. Photograph taken facing west.

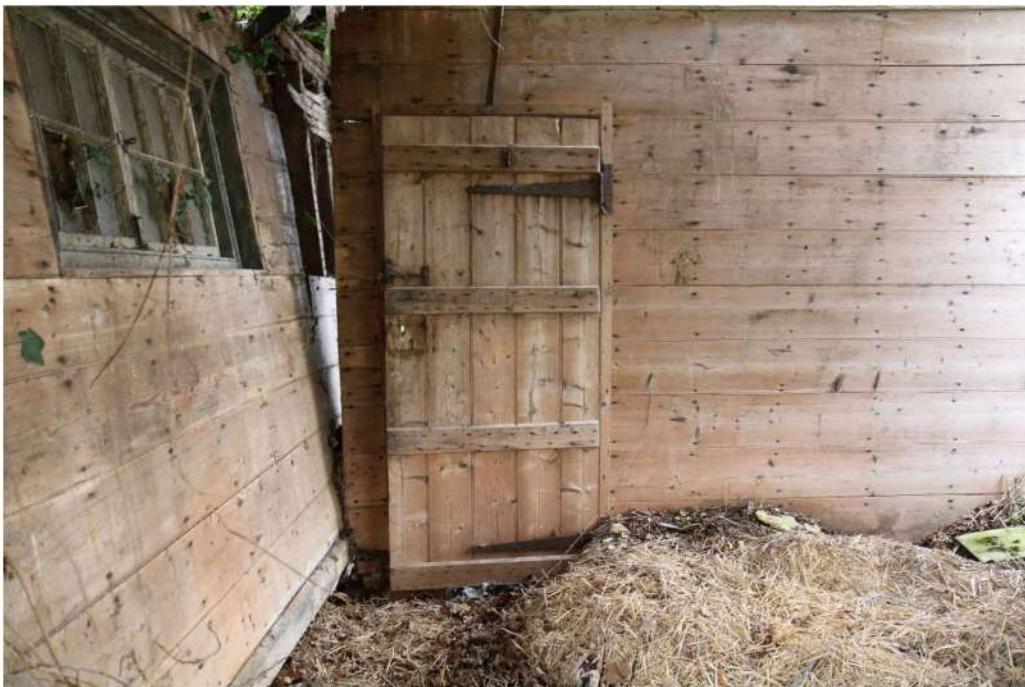
Two windows openings are present in the store, one in the south-eastern wall and the other in the south-western wall, both of which have been blocked on the exterior. A twelve-light timber-framed casement window is present in the south-western opening while the other is empty. A replacement door is situated in the north-eastern wall of the store, which leads through to the barn (Photograph 25).

Photograph 25 Detail of door in north-west wall of store. Photograph taken facing north-west.

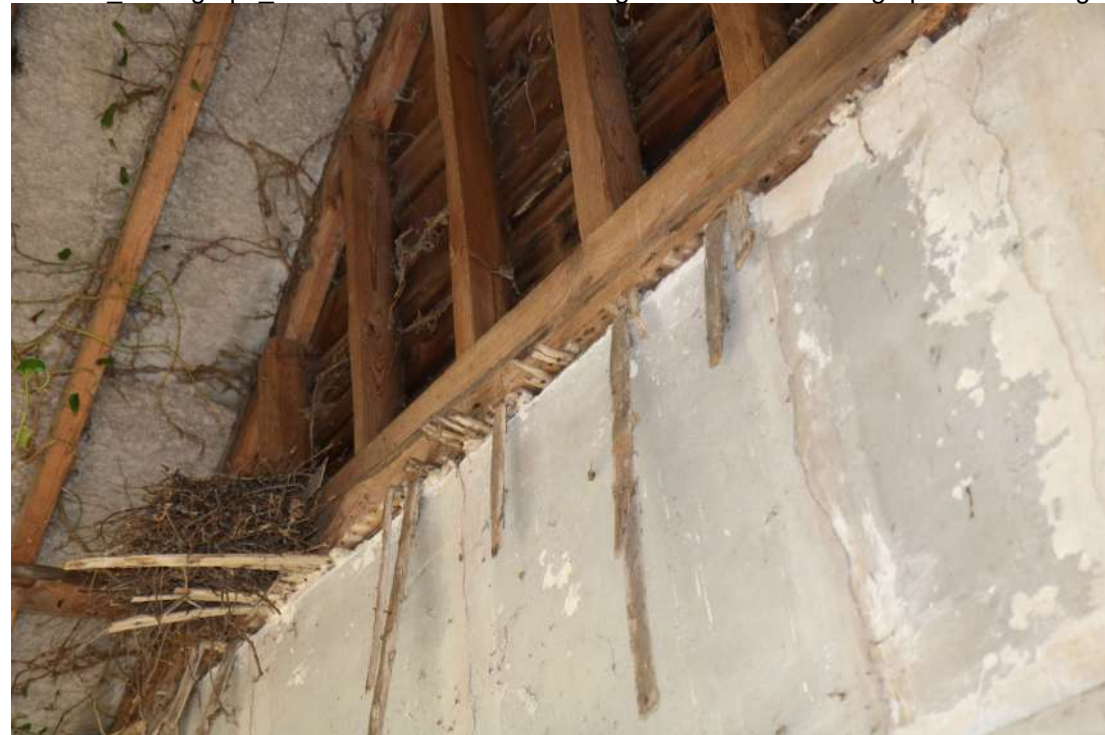
The north-eastern wall structure of the store has come away from the rest of the building, causing the roof structure to buckle.

SSGH24 Photograph 038Detail of collapsing roof of store. Photograph taken facing north.
