CAT Report 2095
Issued December 2024

**Historic building recording at 141 Thorpe Road,
Kirby Cross, Frinton On Sea, CO13 0NQ**

October 2024

**Planning district.: Tendring
Planning ref.: 23/01726/FUL**

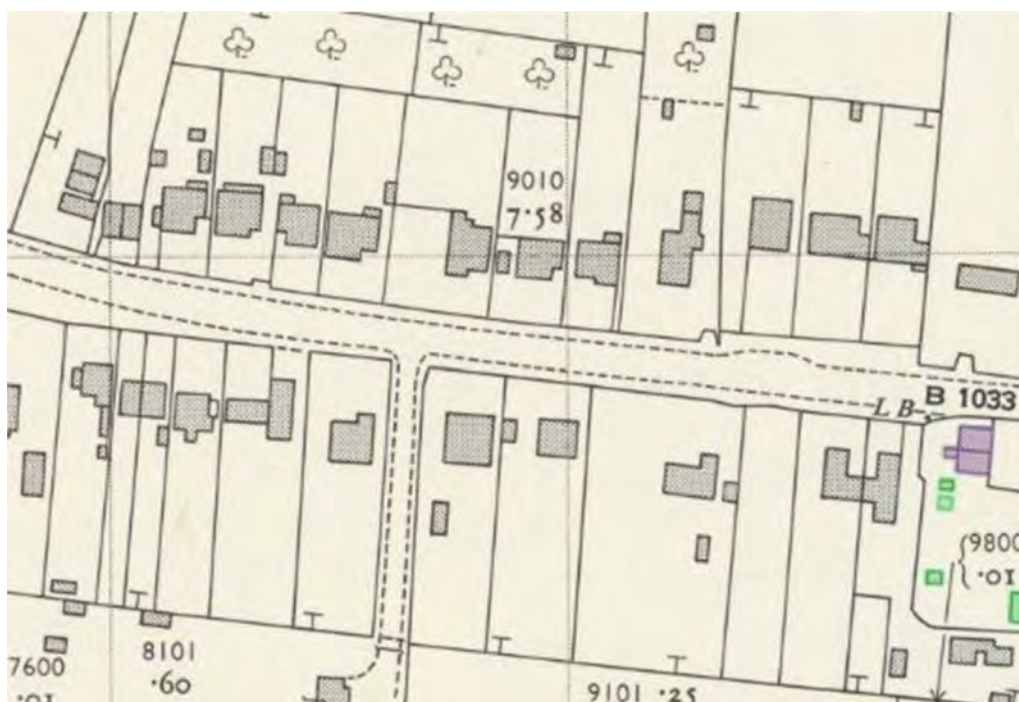
Map 6 Extract of the 1957 National Grid OS map. The buildings recorded highlighted in purple with associated, now demolished, outbuildings highlighted in green.

The National Grid OS map from 1957 (Map 6) presents the properties in a similar layout as the 25-inch OS map (Map 4) from 1923, with comparable detail. The buildings are presented as semi-detached cottages with associated gardens, along with four probable outbuildings to the south. These outbuildings were not found at the time of the recording.

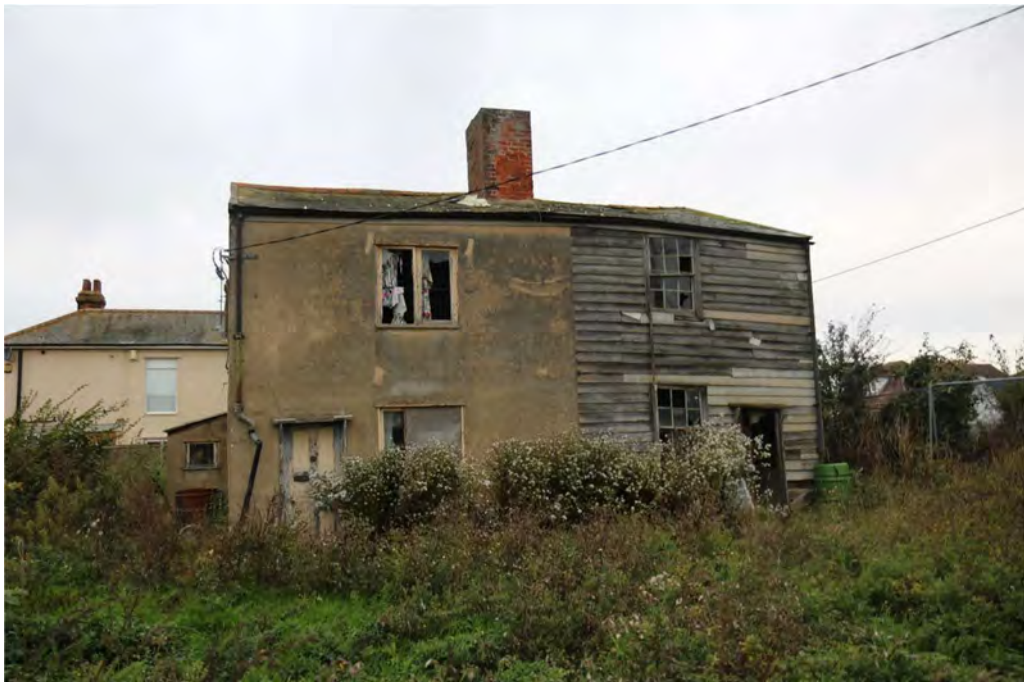
Photograph 1 Eastern elevation of semi-detached cottages with building A to the left. Photograph taken facing west.

On the eastern elevation (Photograph 1), each building has a single four-panel door (Photograph 3) along with two windows (Photograph 4) – one on each floor. The windows of building A are both timber-framed two-light casement windows while building B has twelve-light sash windows. A third window is present on building A – on a small extension projecting to the south.

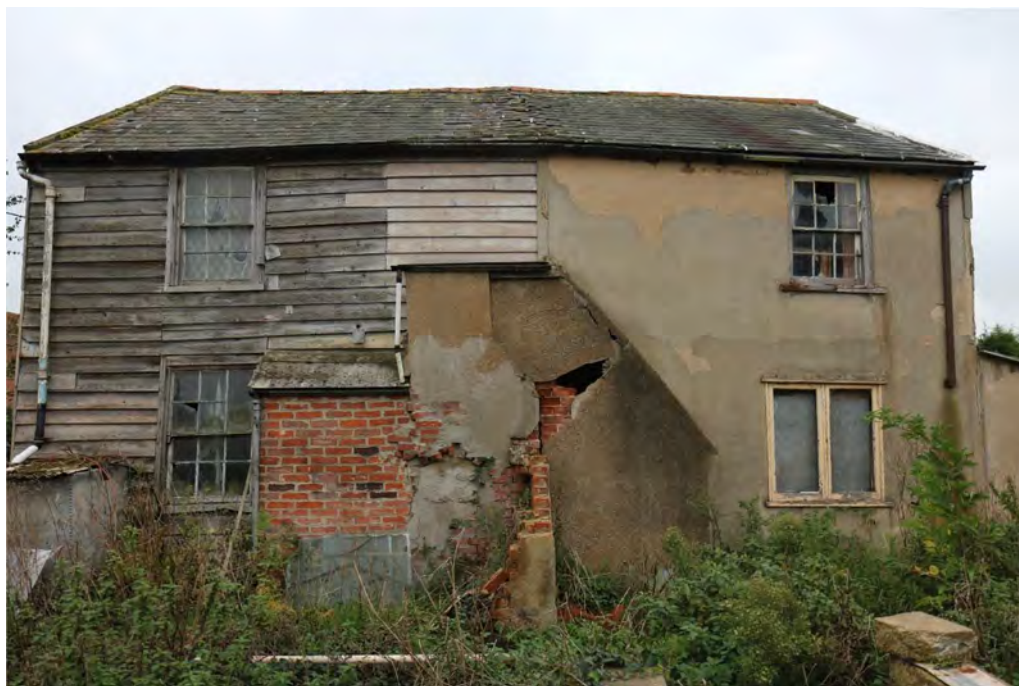
Similarly to the eastern elevation, the western elevation (Photograph 6) has four windows – two on each building. Building A has a two-light timber-framed casement window on the ground floor and a twelve-light timber-framed sash window on the first floor. Both windows on building B are twelve-light timber-framed sash windows. The western elevation showcases the remains of a dilapidated red brick structure, probably associated with an external chimney, the fireplace for which can be seen in room 1. The bricks are laid in Stretcher bond and measure 220mm x 110mm x 65mm. Directly

above this brick structure, it is noticeable that the weatherboarding has been repaired, probably caused by the removal of the chimney. The remains of the chimney have been incorporated into a small extension with a mono-pitched roof clad with roofing felt. The remains of outbuildings attached to the cottages are also present on this elevation, corresponding to the outbuildings depicted on Maps 3 and 4.

Photograph 6 Western elevation of semi-detached cottages. Photograph taken facing east.

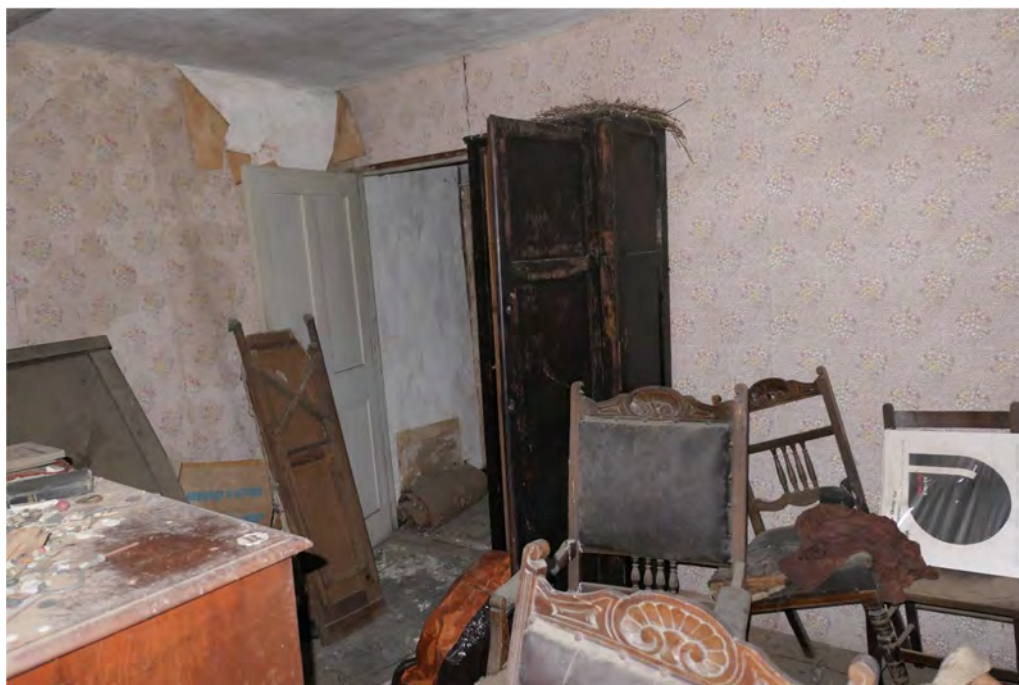
Rooms A3 and A4 are situated on the first floor of building A and were photographed from the outside using a pole-cam. Room A3 has a window on the western wall and a single four-panel wooden door in the eastern wall. The ceiling alongside the western wall slopes downwards (reflecting the differences in the roof pitch). Photograph 12 shows several chairs which may be original to the building.

Photograph 12 Interior shot of room A3 on the first floor in building A. Photograph taken facing north-east.

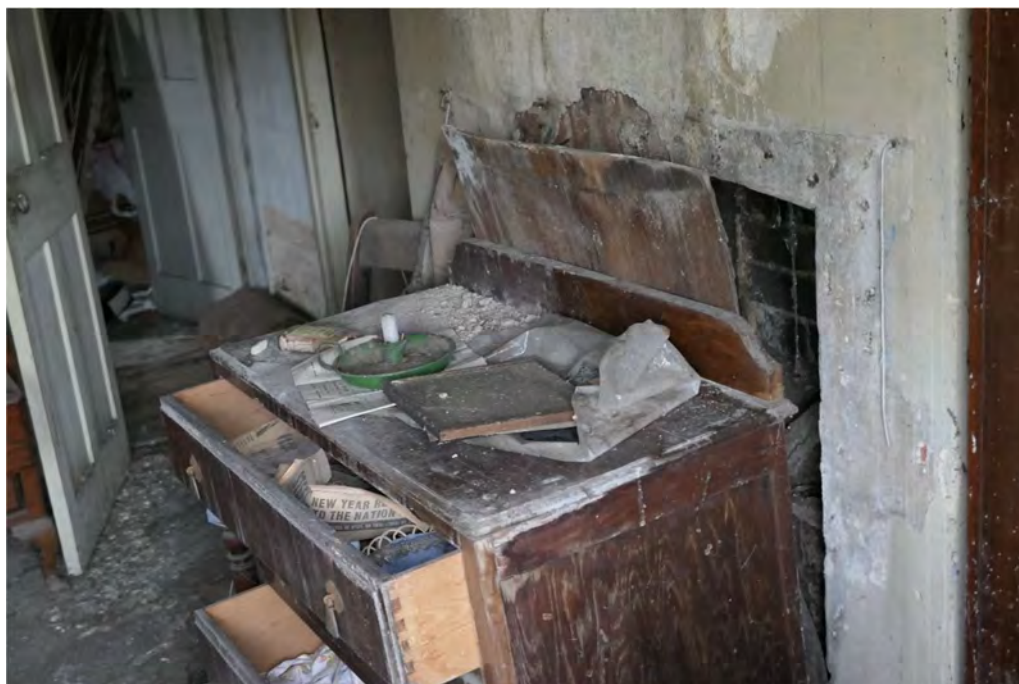
In room A4, there is a fireplace, central to the northern wall. Mostly blocked by piece of furniture, the only distinguishable features are damage to the wall from the removal of the surround and an exposed brick fire back (Photograph 13). A single four-panel wooden door, to enter the room, is in the western wall.

Photograph 13 Detail of fireplace in room A4, building A. Photograph taken facing north-west.
