**CAT Report 2149
Issued March 2025**

**Historic building recording at
Fairfields Farm, Mowden Hall Lane, Hatfield Peverel,
Essex CM3 2NT**

February 2025

**CAT project ref.: 2025/01h
ECC code: EEX61203**

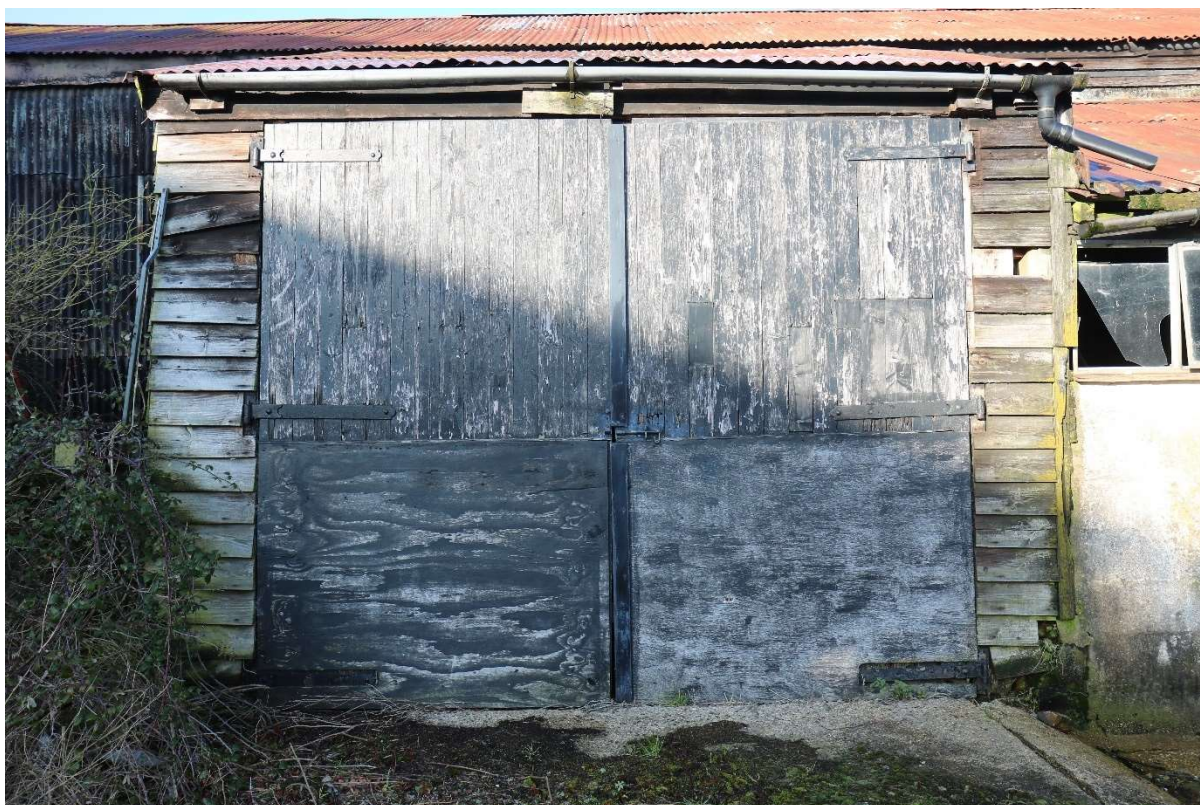
Photograph 6 Detail of barn doors on south-east elevation of threshing barn A. Photograph taken facing west north-west.

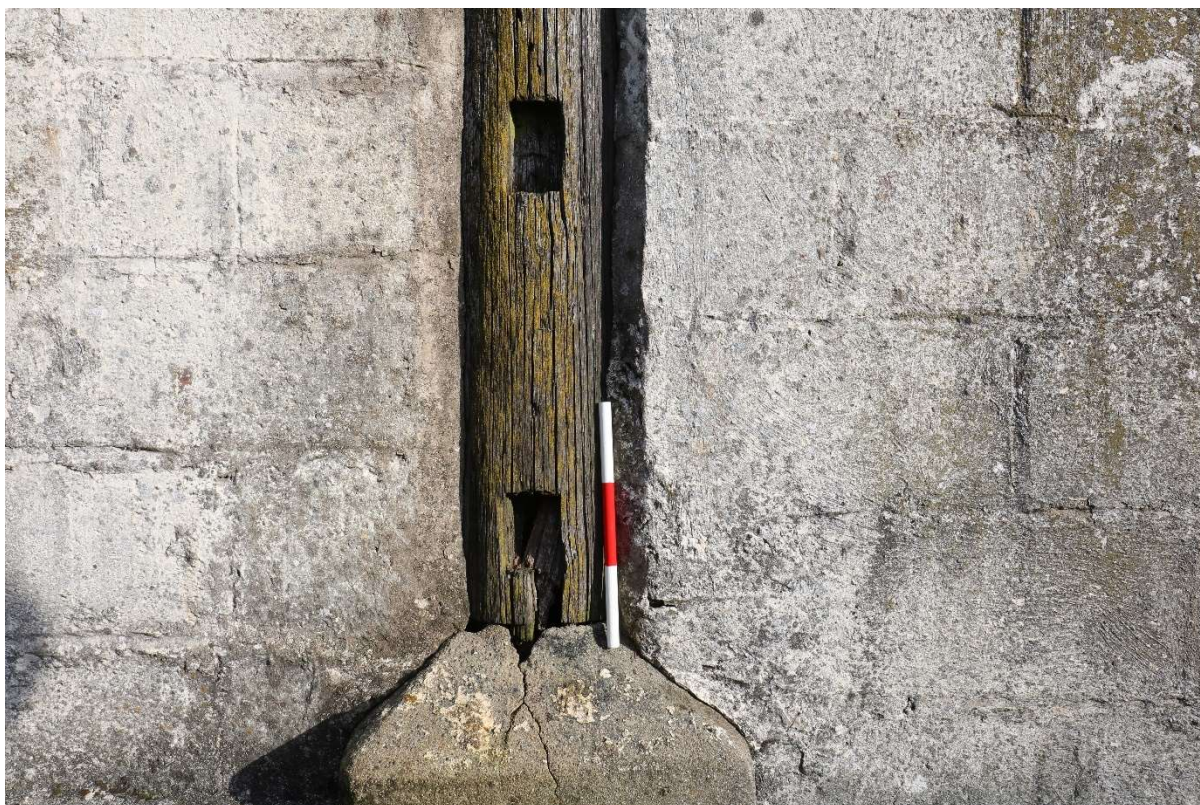
Photograph 10 Detail of reused timber post on south-west elevation of linking shed. Photograph taken facing north north-east.

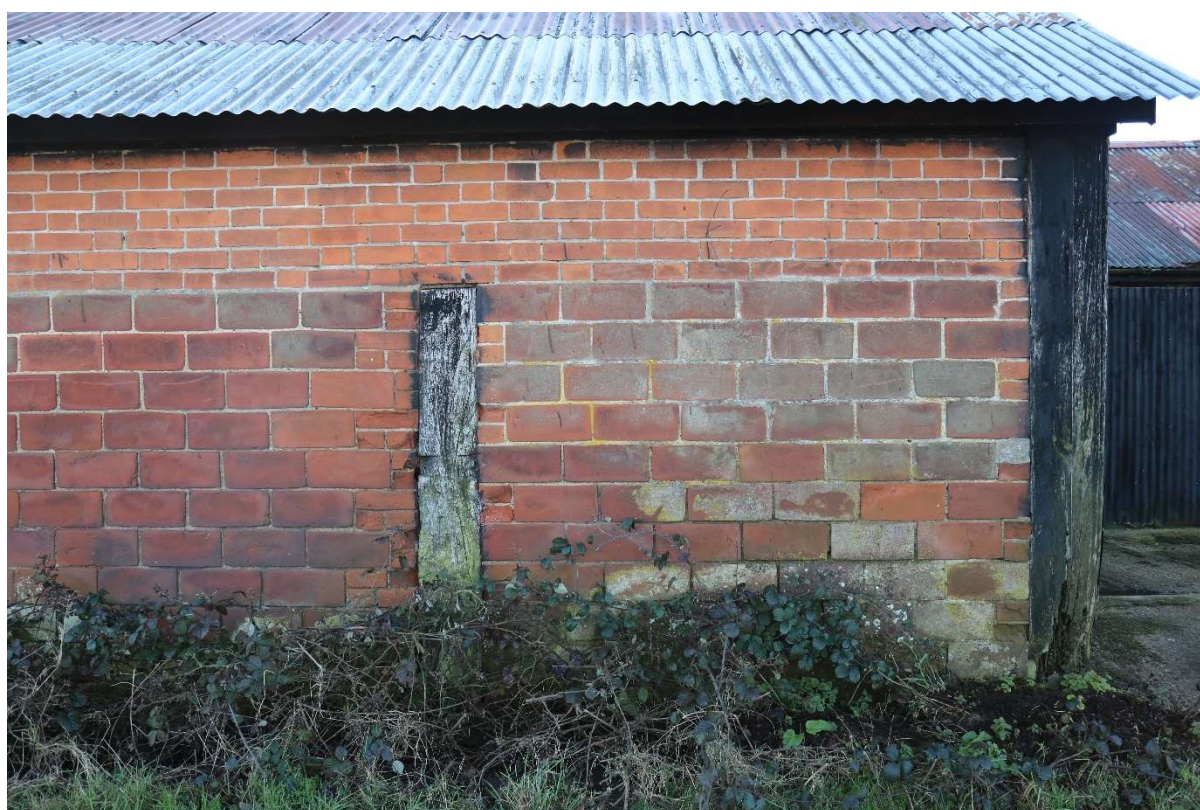
Photograph 11 Detail of reused timber post on north-east elevation of linking shed. Photograph taken facing south south-east.

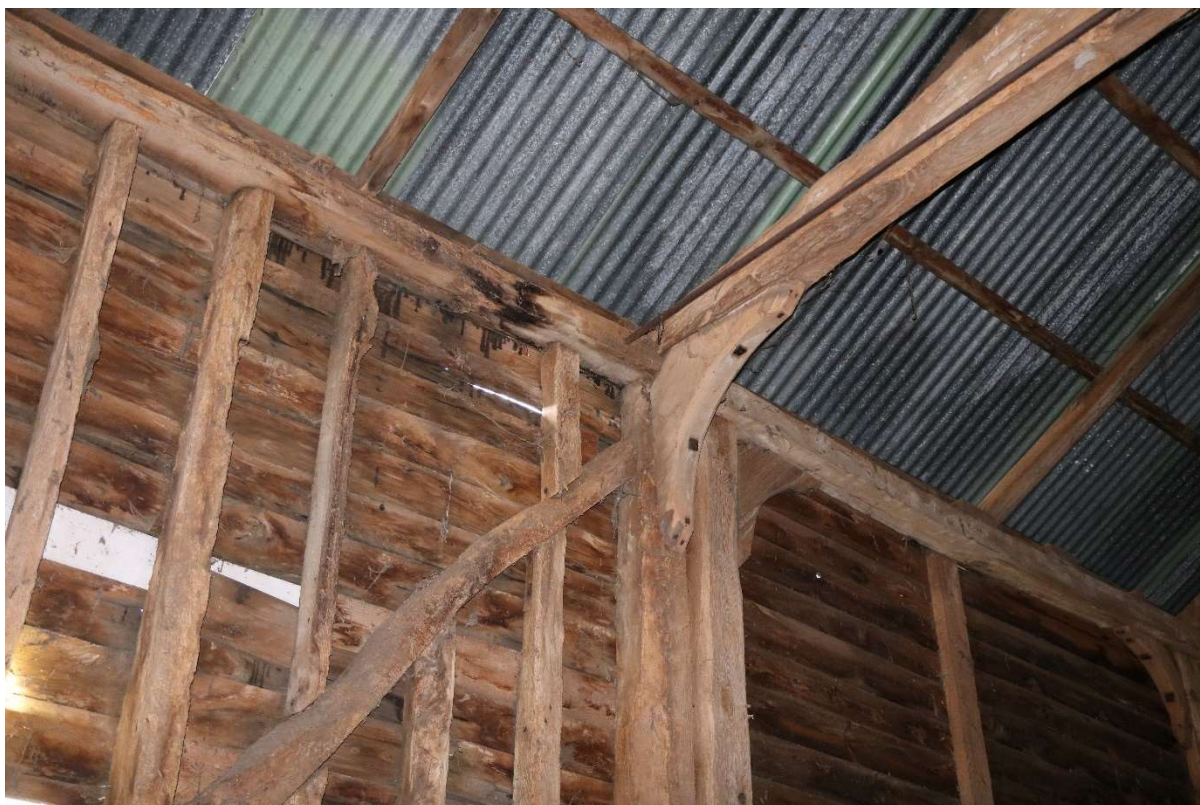
The tie-beams, which are quite sinuous, are supported on knee braces, which have been secured with iron bolts and nails (photograph 15). The wall-framing of the barn has girding beams, separating the upper and lower register. The girding beam is interrupted by the intermediate posts. The wall-framing is braced with diagonal-through-bracing, some bays have two braces per register while others only have one.

Photograph 15 Detail of knee brace and iron tie rod in north-western wall of bay 2 of threshing barn A. Photograph taken facing north-west.

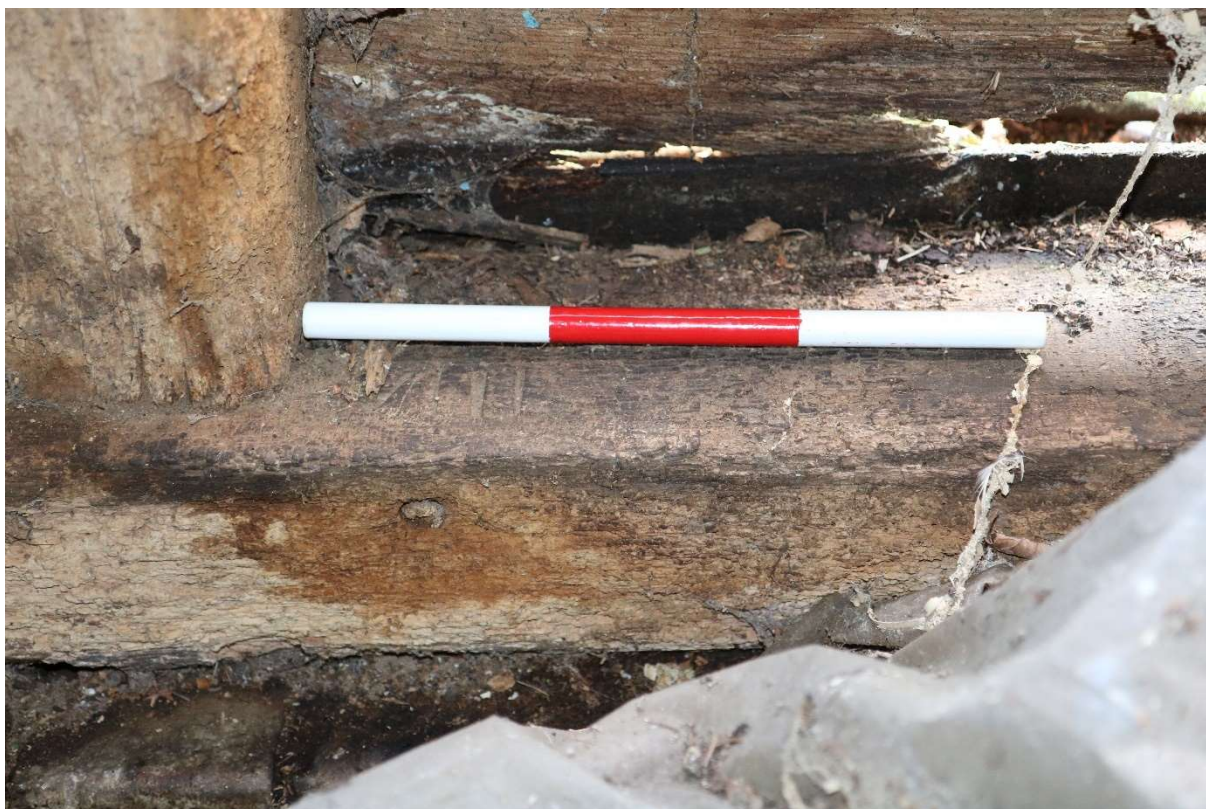
Photograph 17 Detail of carpenter's mark on sill-beam in north-western wall of bay 1 of threshing barn A. Photograph taken facing west north-west.

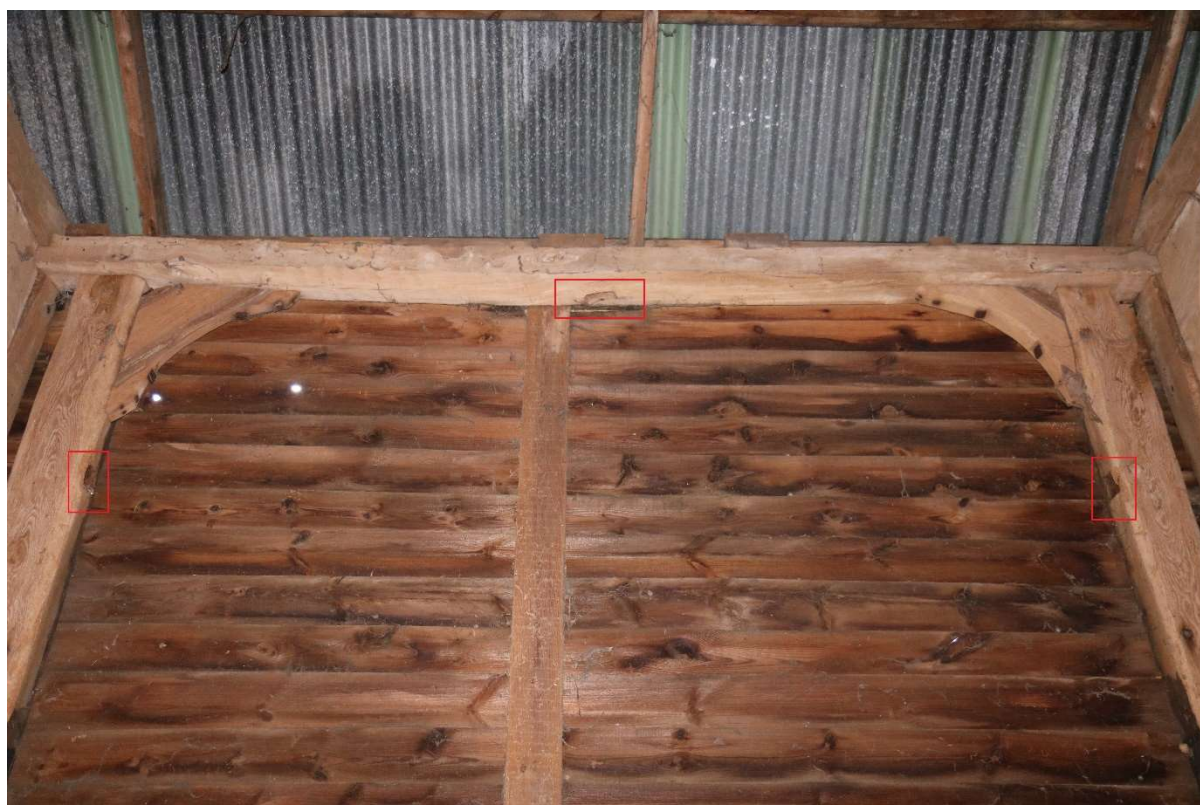
Photograph 21 Detail of empty mortices in tie-beam and door-posts in north-western wall of bay 3 of threshing barn A. Photograph taken facing west north-west.
(Empty mortices highlighted with red boxes)

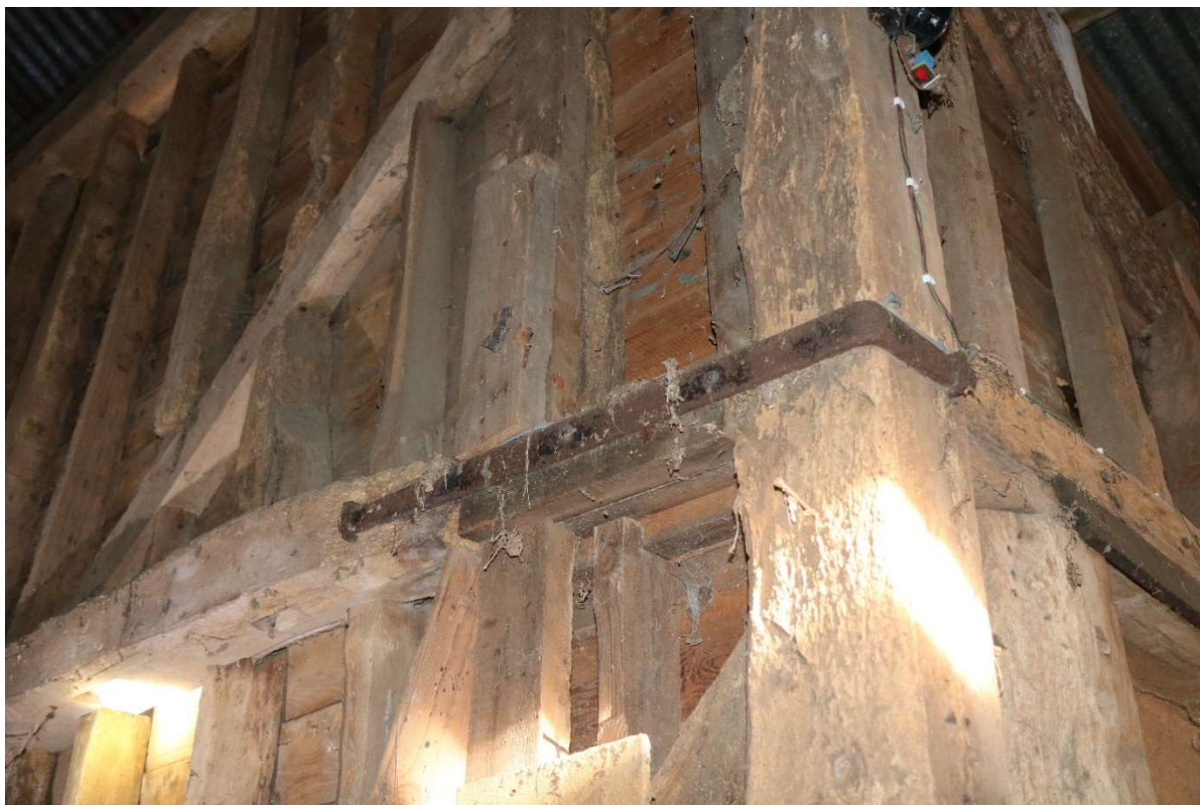
Photograph 24 Detail of iron strap on girding-beam and intermediate post of bay 4 of threshing barn A. Photograph taken facing east.

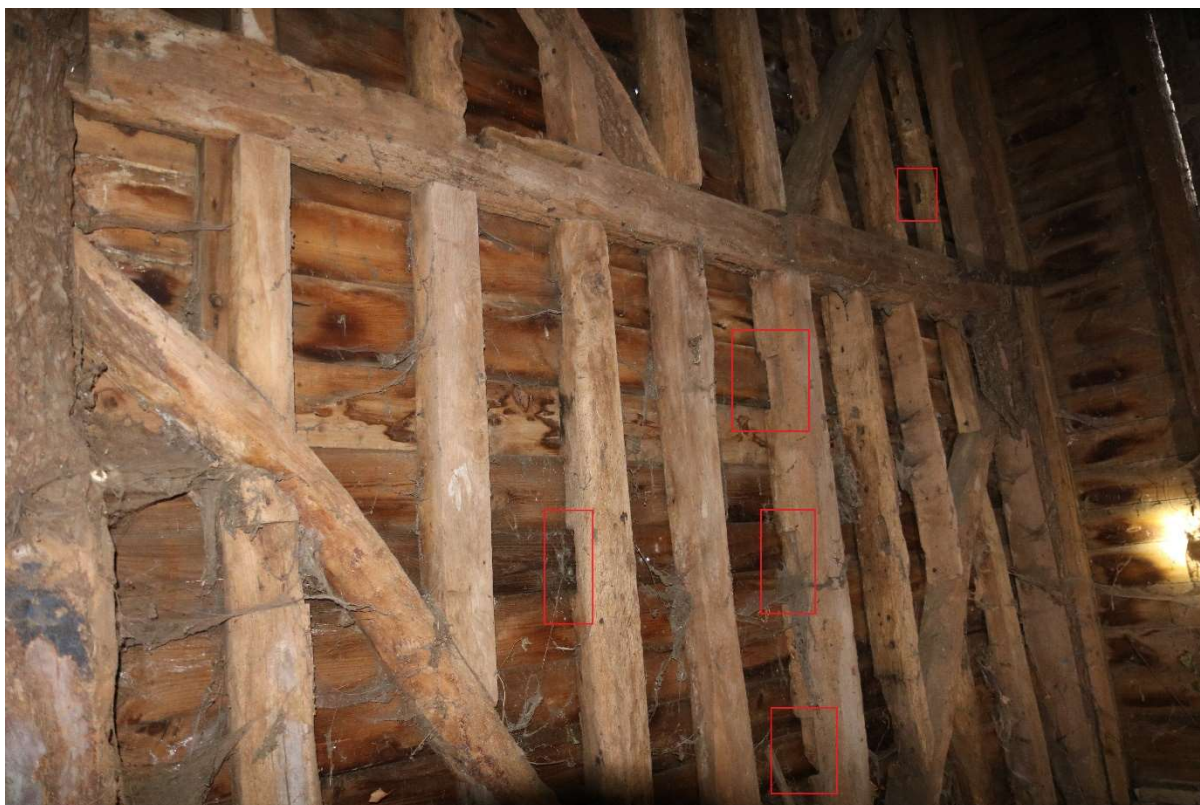
Photograph 28 Detail of reused studs in north-western wall of bay 5 of threshing barn A. Photograph taken facing north-west. (Empty mortices highlighted with red boxes)

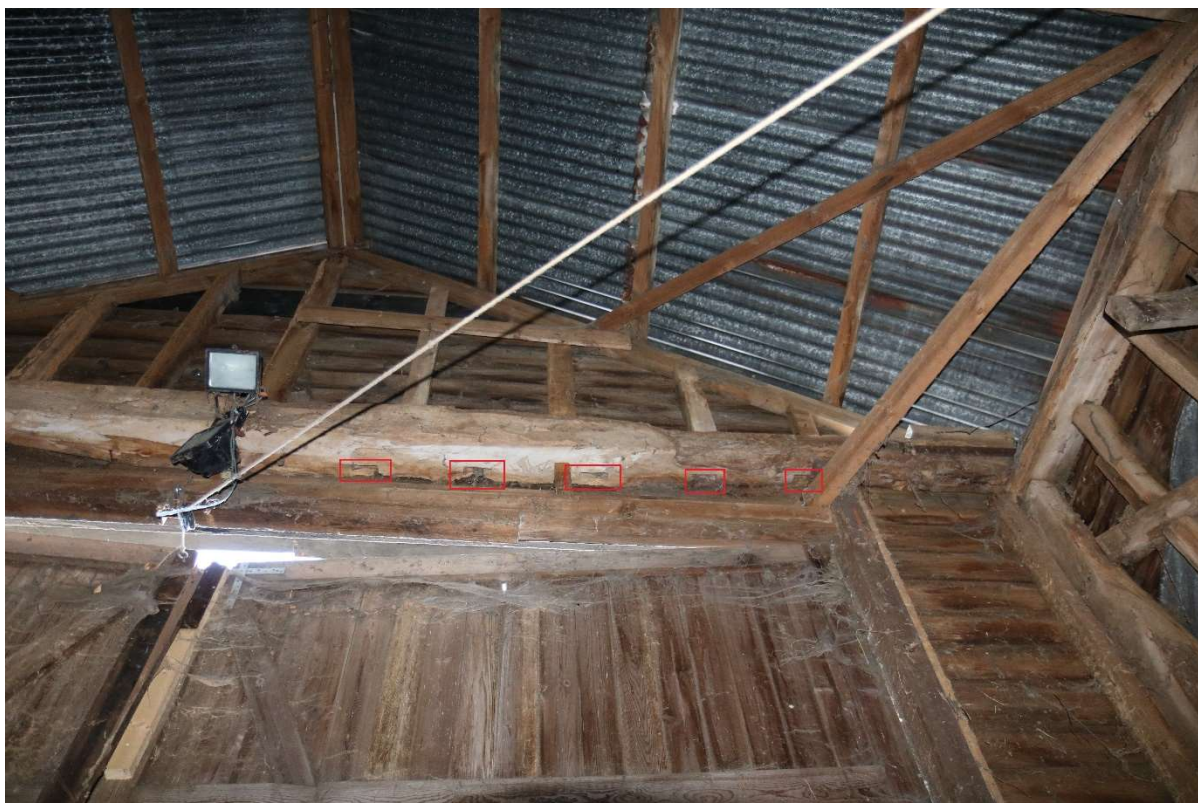
Photograph 29 Detail of empty mortices (highlighted with red boxes) in wall-plate in north-eastern wall of bay 5 of threshing barn A. Photograph taken facing north.

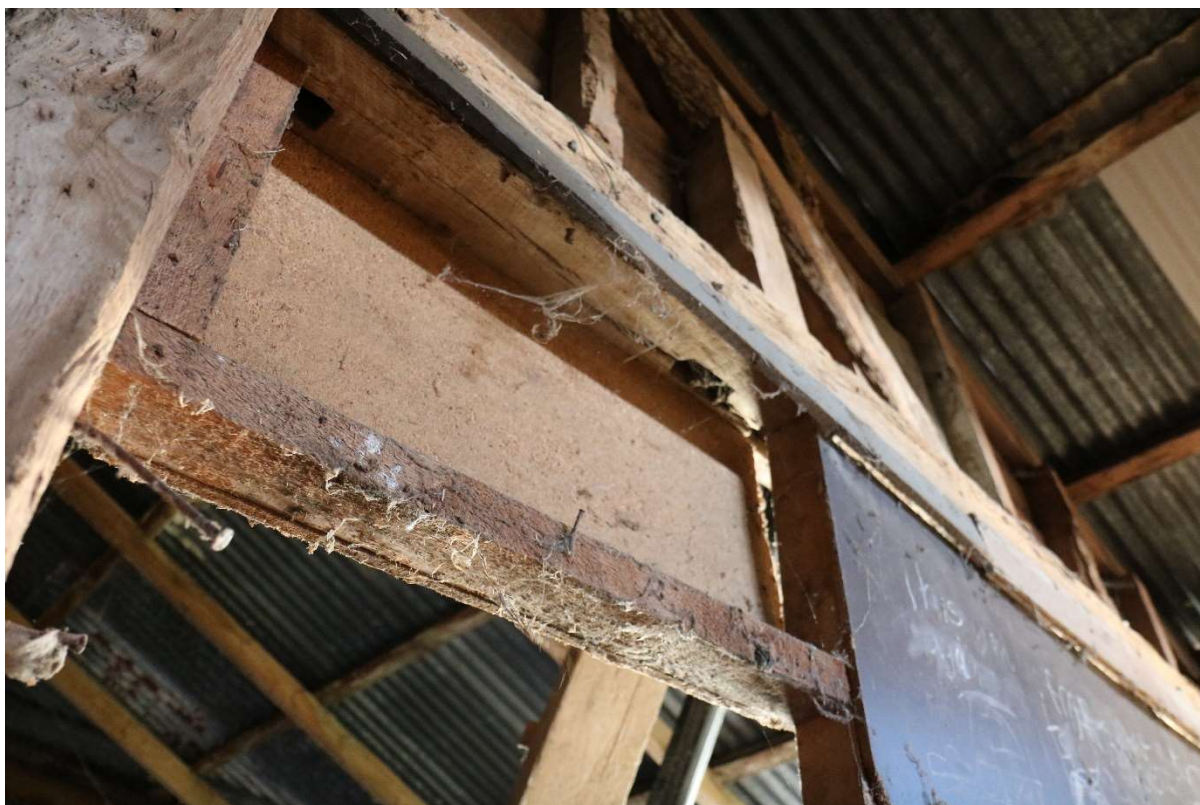
Photograph 31 Detail of empty mortices in girthing beam of north-western wall of midstrey of threshing barn A. Photograph taken facing north-east.

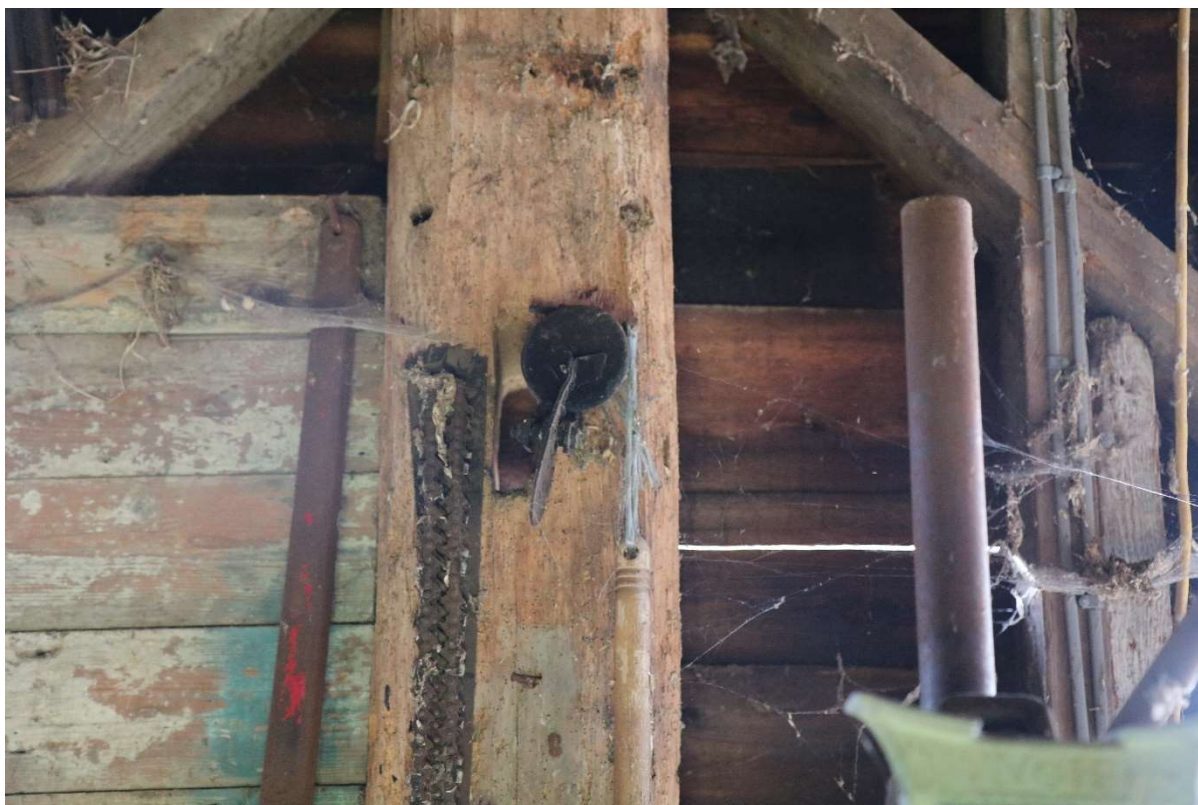
Photograph 34 Detail of reused intermediate post in south-western wall of bay 1 of threshing barn B. Photograph taken facing south-west.

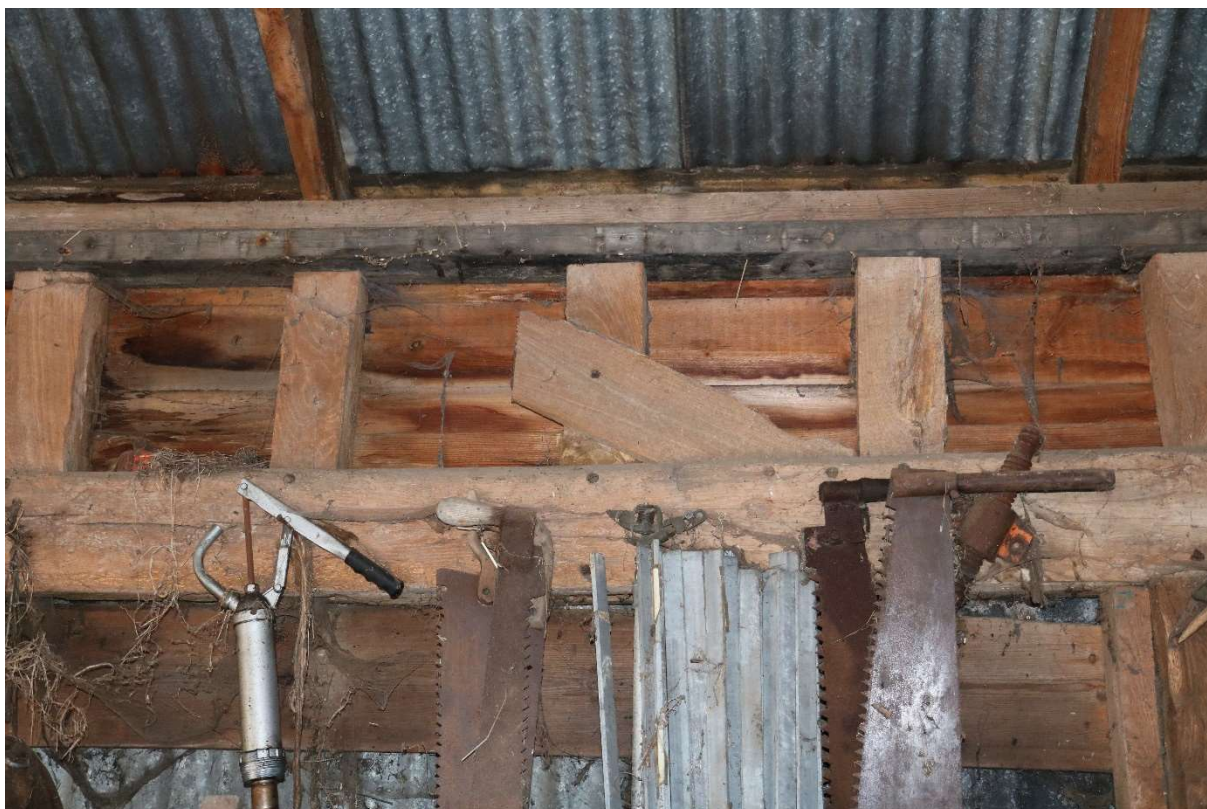
Photograph 37 Detail of reduced tension brace in bay 3 of threshing barn B. Photograph taken facing north-east.

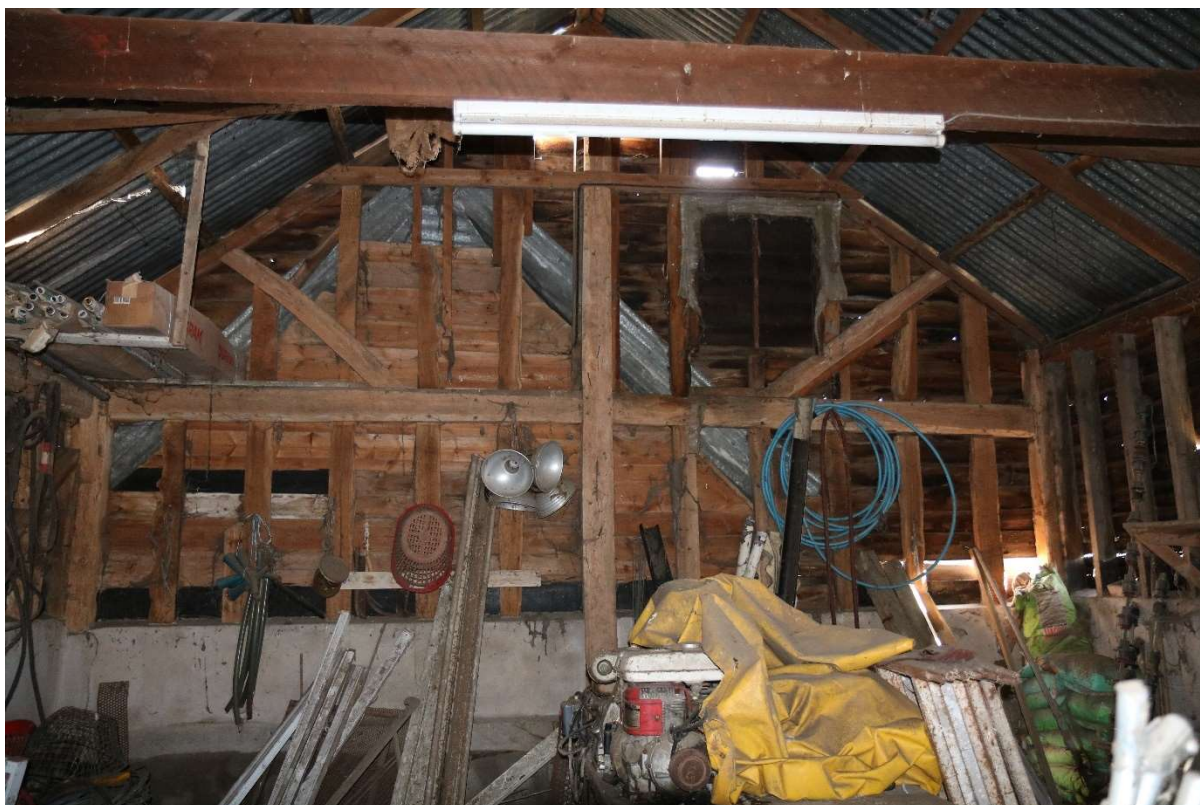
In bay 5, some of the studs in the south-eastern wall have been replaced with machine-cut timbers. A boarded-up pitching door is set into the upper register of this wall. The tension brace in the upper register of the north-eastern wall has been cut.

Photograph 40 South-eastern wall of bay 5 of threshing barn B. Photograph taken facing south-east.

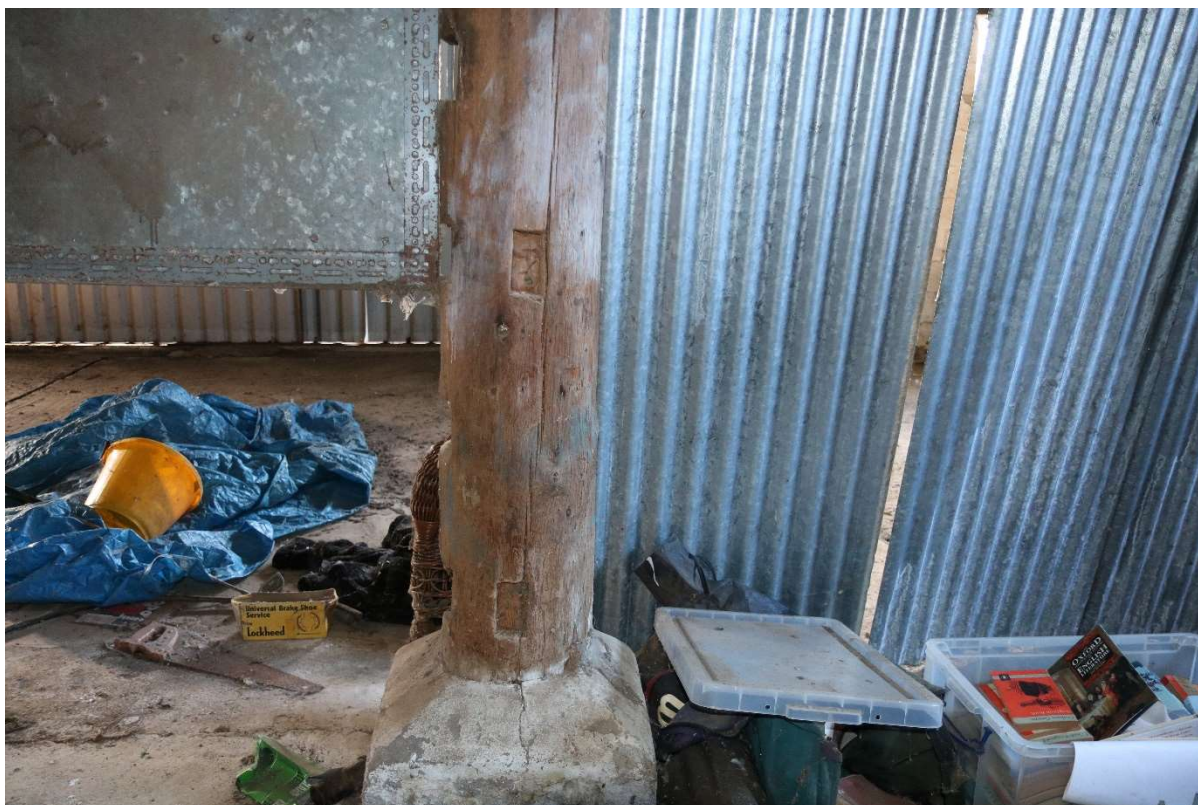
Photograph 46 Detail of reused centre-post of linking shed. Photograph taken facing west.

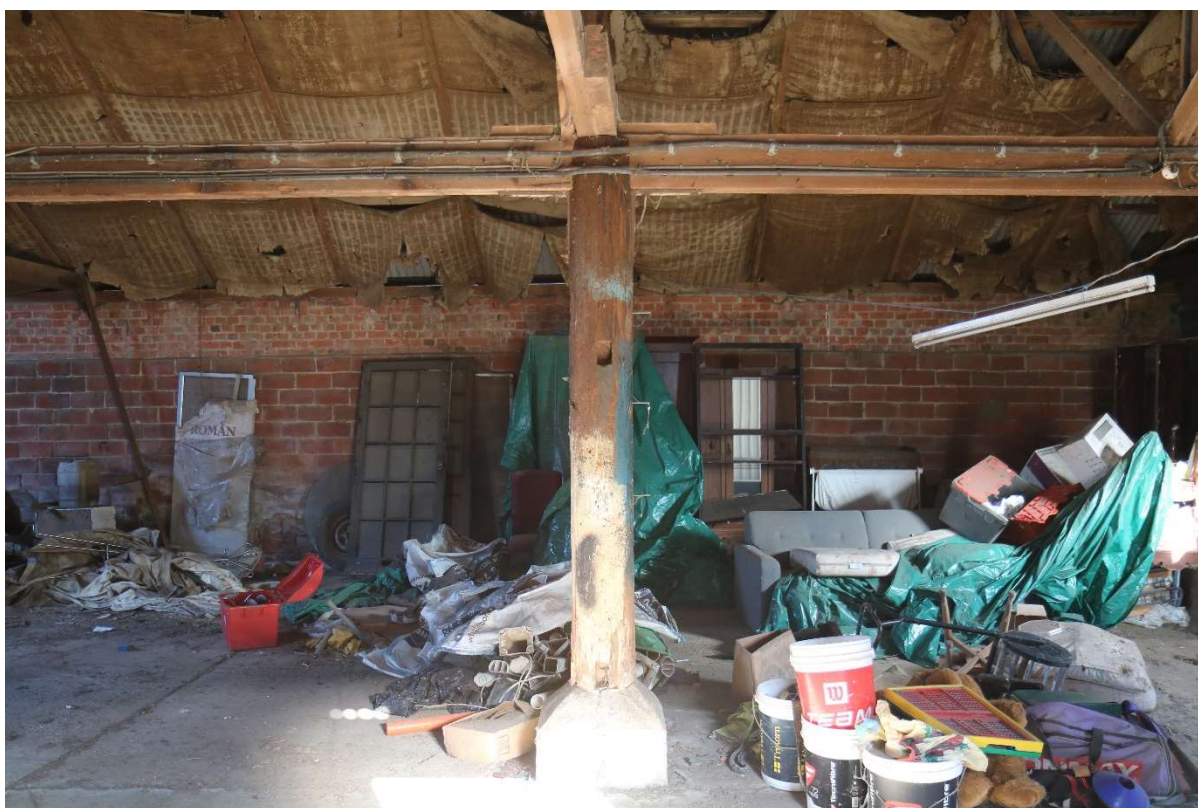
Photograph 47 Detail of reused centre-post of linking shed. Photograph taken facing north-east.

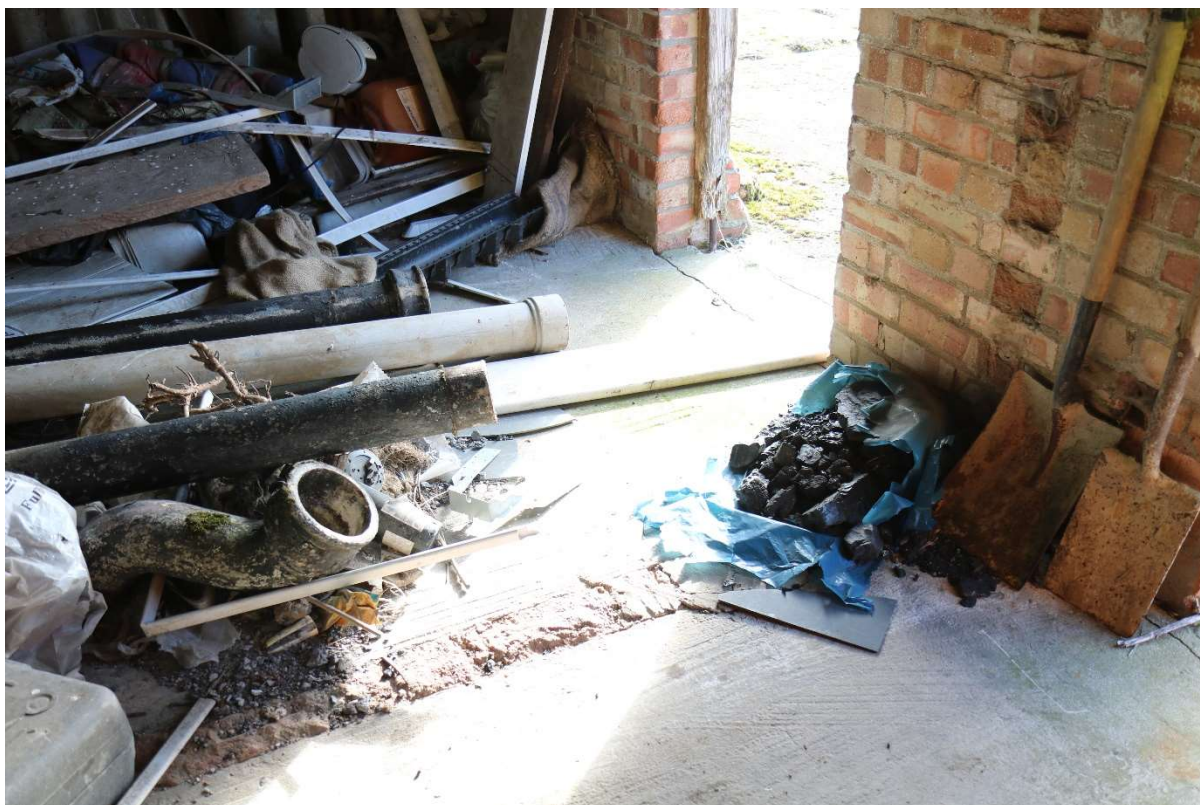
Photograph 49 Detail of removed brickwork in brick shed. Photograph taken facing south-west.

The remains of internal divisions, in the extant wall on the eastern end of the building and the missing divisions visible through the existing brickwork, suggest to us that brick shed may have formerly been a small stable block. It seems likely that as the usefulness of horses diminished, so too did the requirement for such a significant amount of space to be kept for them at Fairfield's.

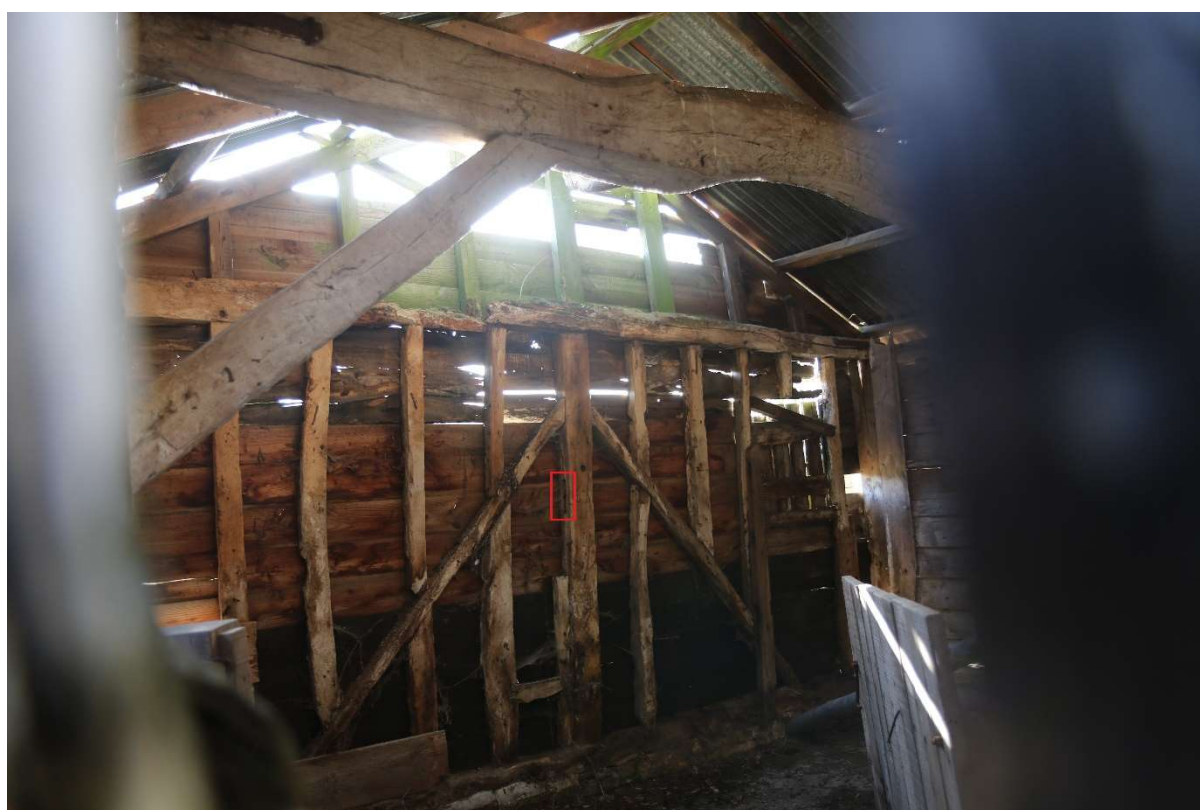
Photograph 51 Detail of reused centre-post of south-western wall of stable. Photograph taken facing south-west. (Empty mortice highlighted with red box)

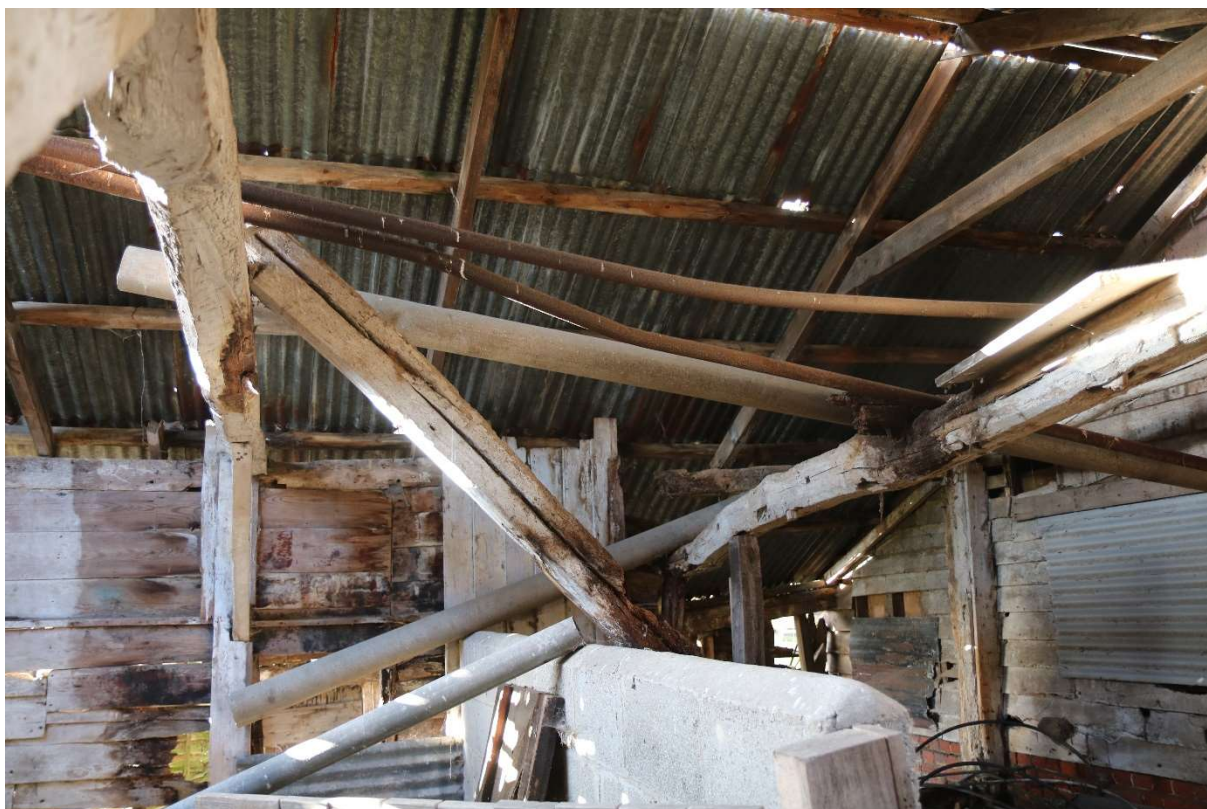
Photograph 52 Detail of reused tie-beam of stable. Photograph taken facing north-west.
