**CAT Report 2154
Issued April 2024**

**Historic building monitoring and recording at
Rye Cottage, Larks Lane, Great Waltham,
Essex, CM3 1DT**

**CAT project ref.: 2025/02L
ECC code: EEX61395**

**NGR: TL 6935412432
Planning district: Chelmsford
Planning ref.: 24/01361/FUL**

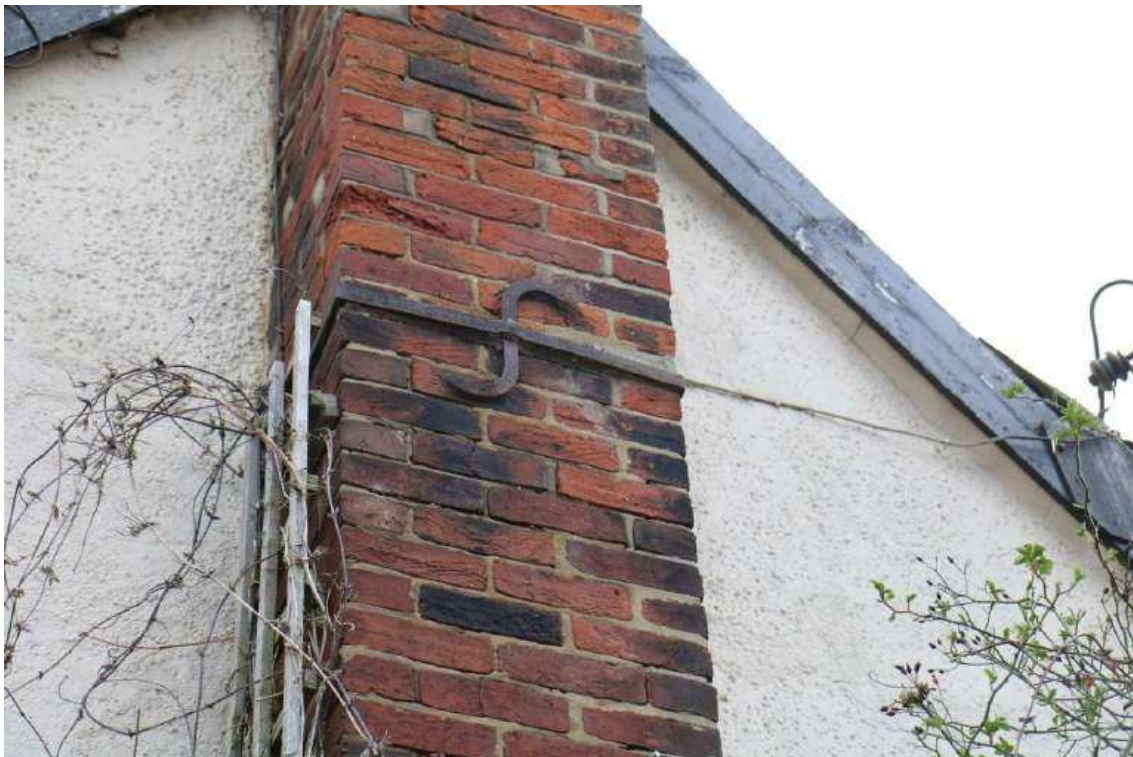
Photograph 6 Detail of iron strap and anchor plate on chimney breast on western elevation. Photograph taken facing south-east.

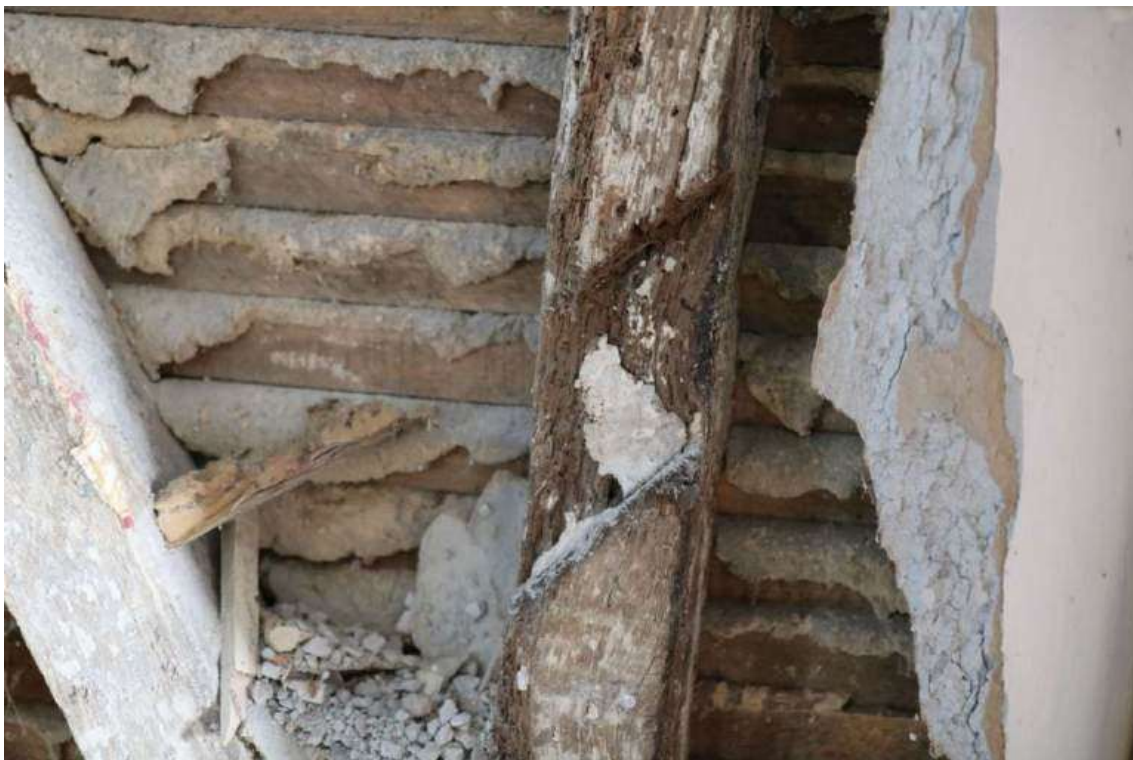
Photograph 17 Evidence of reuse on stud in northern wall of dining room. Photograph taken facing north.

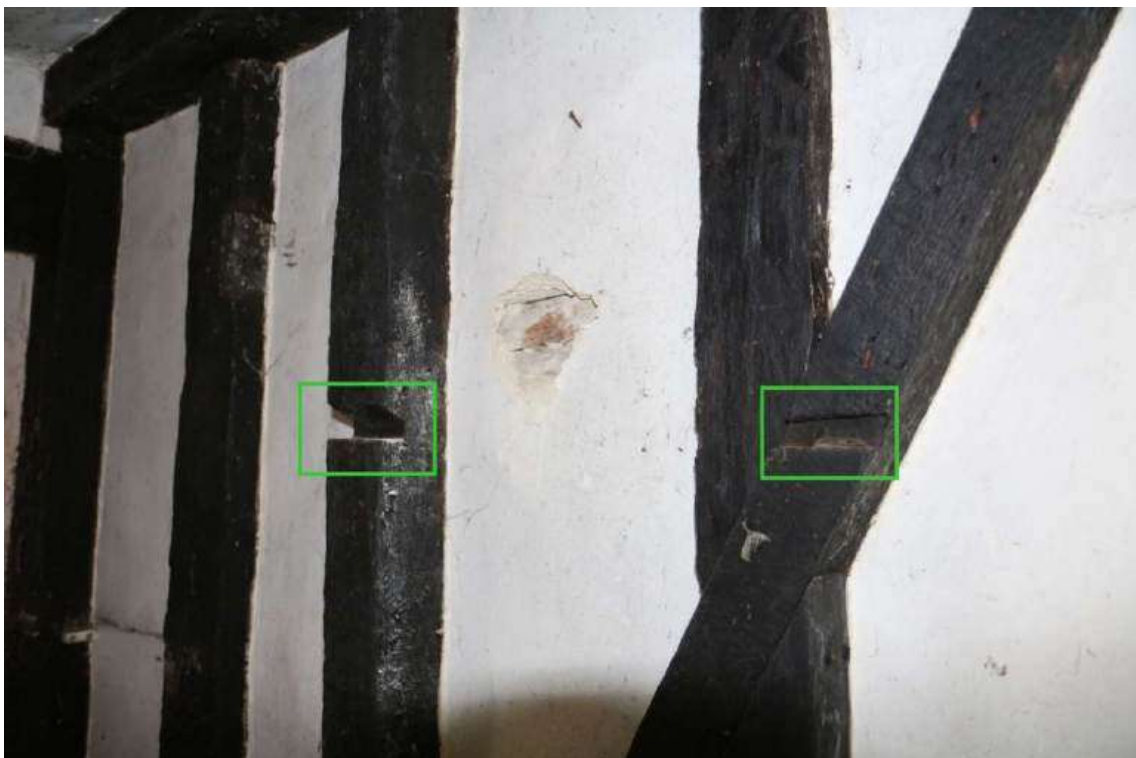
Photograph 20 Detail of possible evidence of reuse on stud and brace in northern wall of lounge. Photograph taken facing north-west.

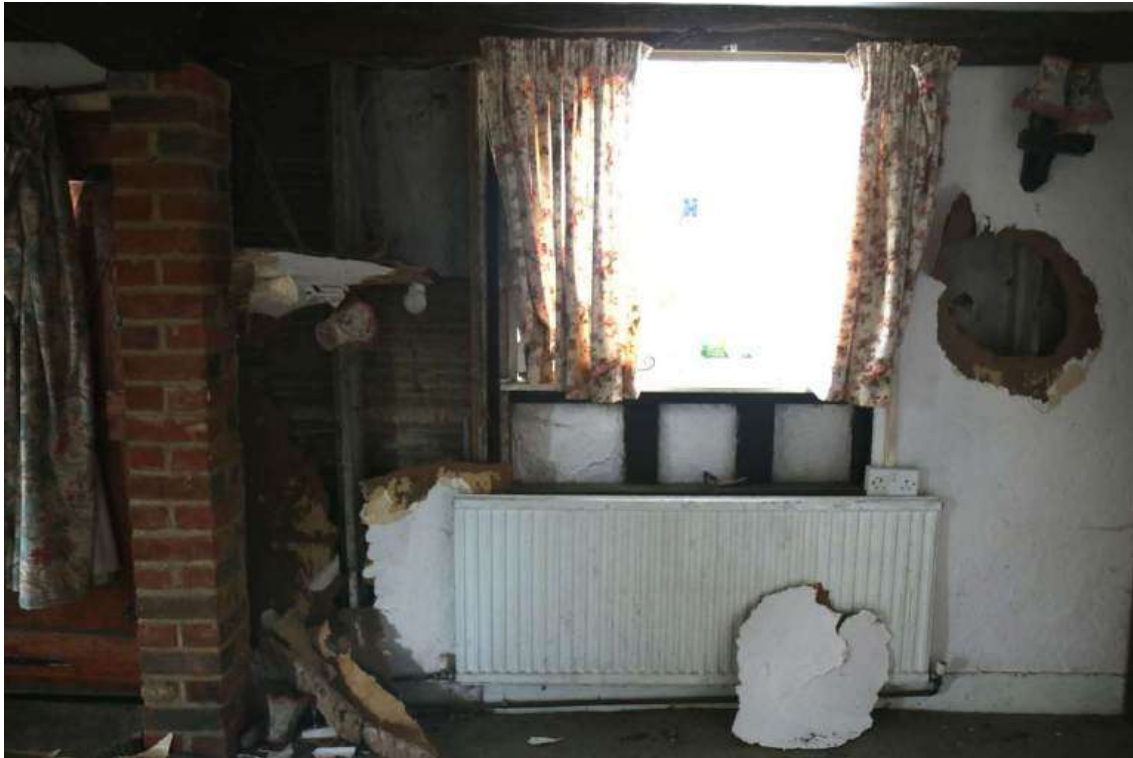
Photograph 21 Detail of replacement timber-framing in northern wall of lounge. Photograph taken facing north.

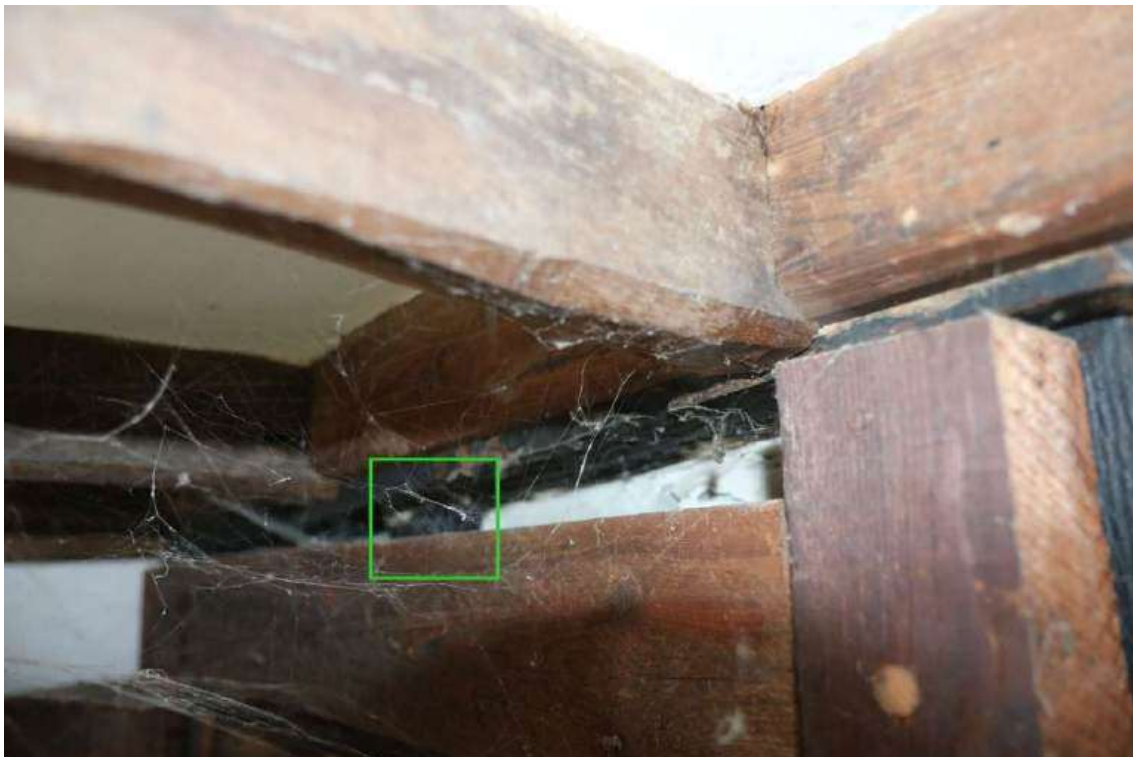
Photograph 22 Detail of possible remains of stud above doorway between dining room and lounge. Photograph taken facing north-east.

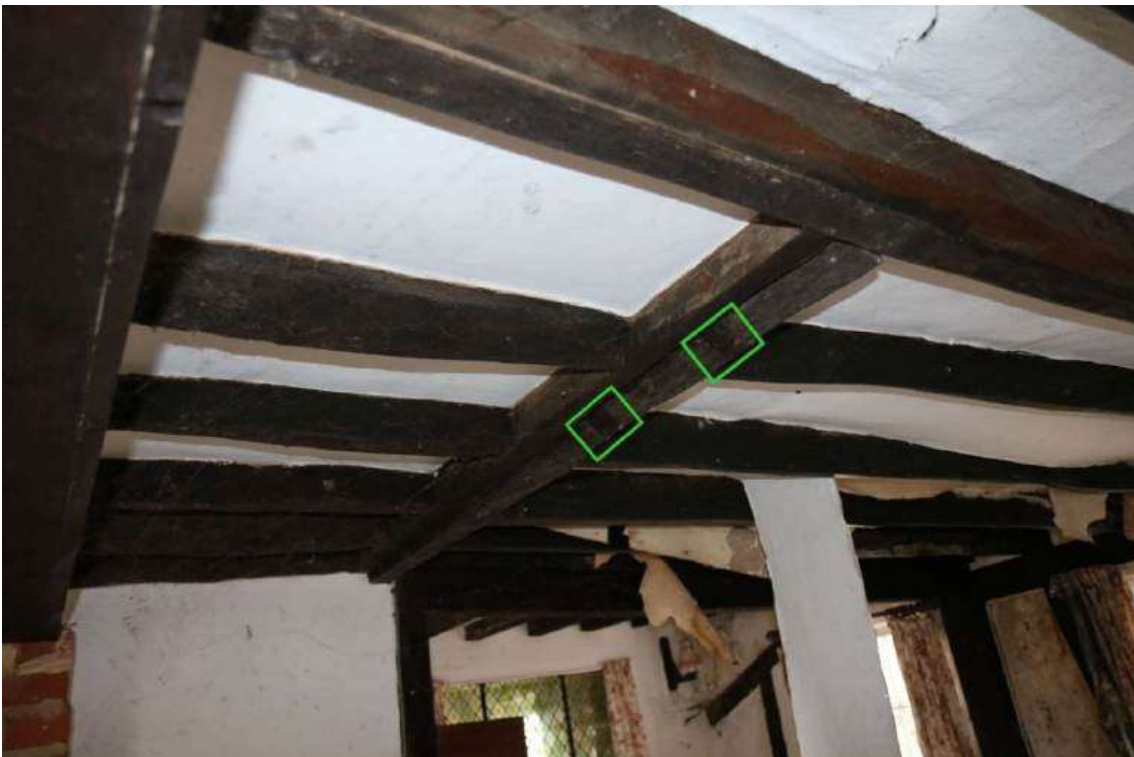
Photograph 24 Detail of floor joists and stair trimmer in ceiling of lounge. Evidence of reuse on the stair trimmer highlighted in green. Photograph taken facing south-west.

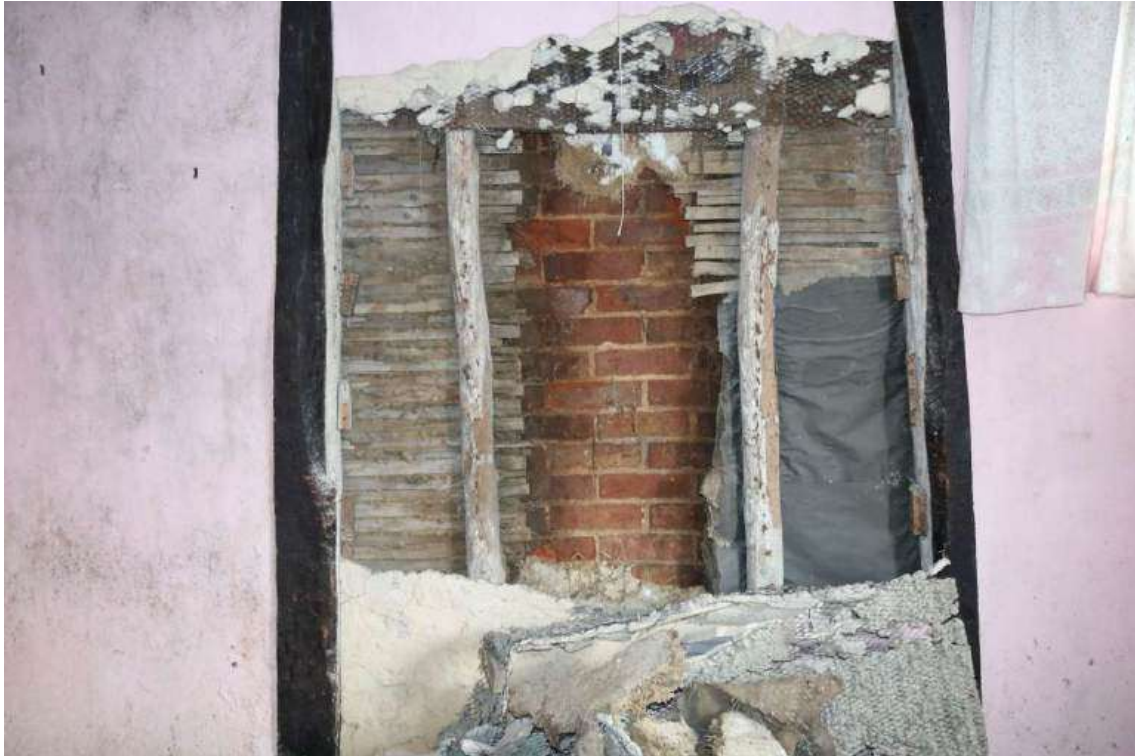
extents of the chimney. Removal of the plaster between these timbers has exposed a further two posts, both of which have been crudely hewn, as well as the brick work of the external chimney (Photograph 32). Cupboards are present along the eastern wall of bedroom 4, the southern of which has sheet timber flooring from the removal of the below staircase (Photograph 34). An inserted door is present in the southern wall, evidenced by a series of empty mortices in the above wall-plate (Photograph 35).

Photograph 32 Detail of plaster removal in western wall of bedroom 4, exposing brickwork of chimney. Photograph taken facing west.

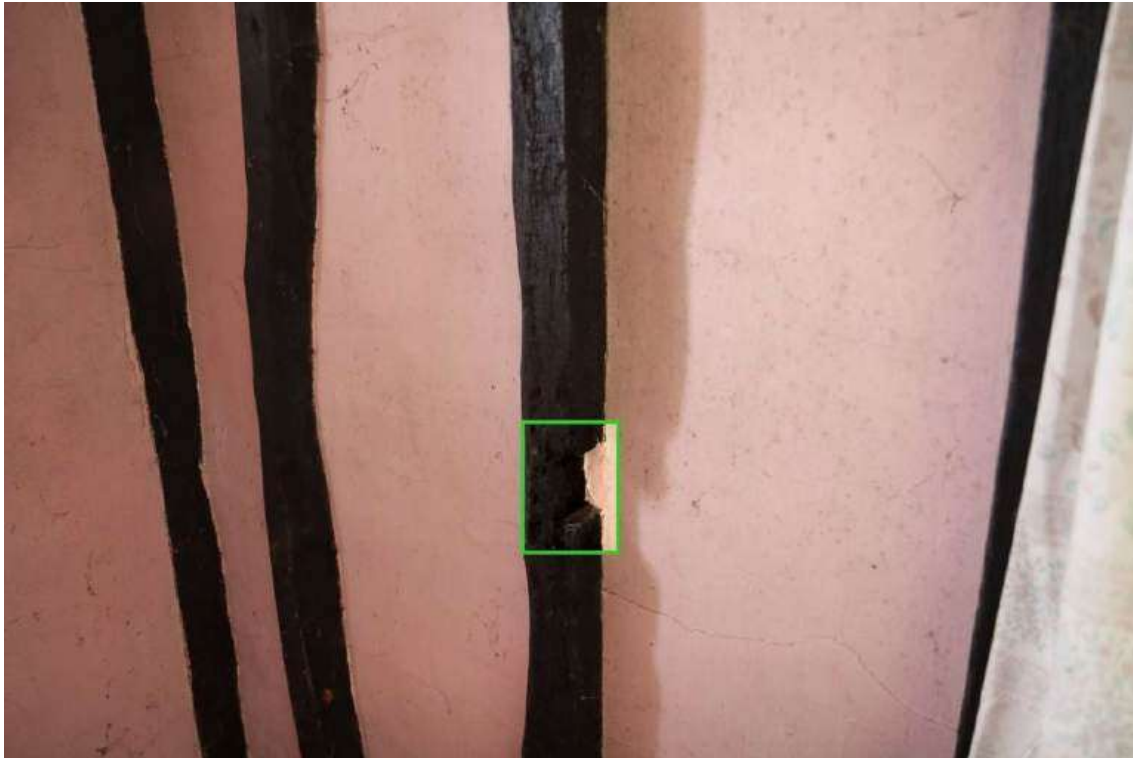
Photograph 33 Detail of reused stud in northern wall of bedroom 4. Photograph taken facing north-west.

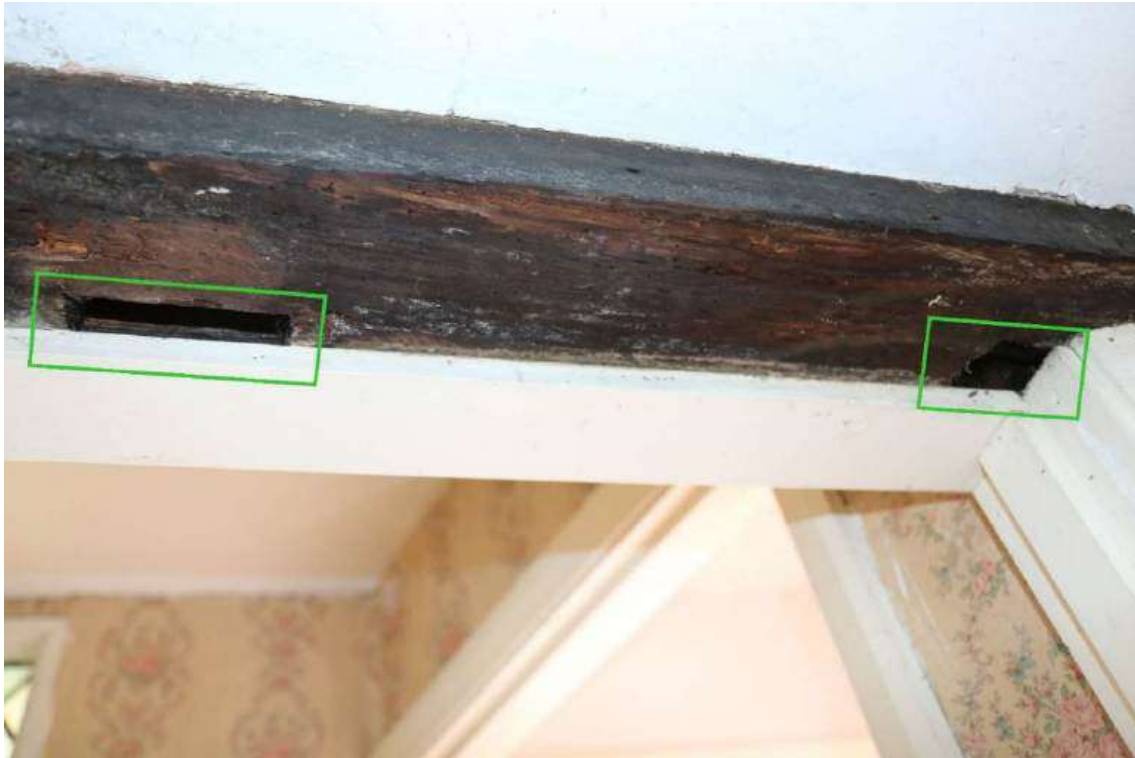
Photograph 35 Detail of empty mortices, highlighted in green, in southern wall-plate of bedroom 4. Photograph taken facing south-west.

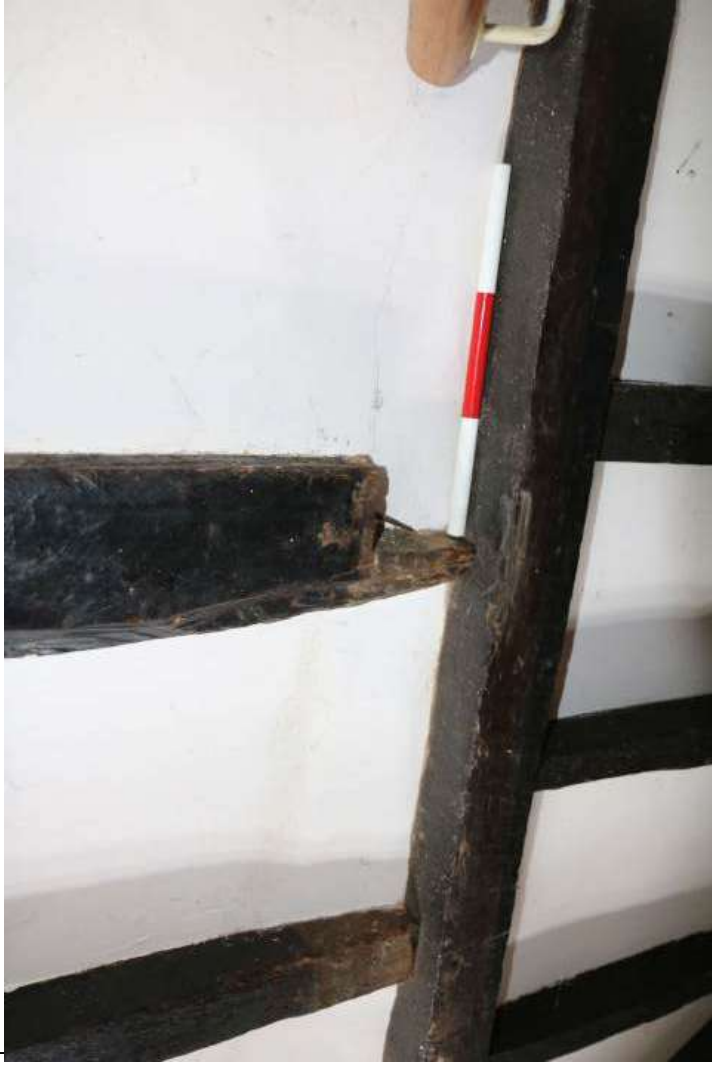
EEEX61395_PhotoGraph_0102
Detail of ?damaged timber in eastern wall of hall 1. Photograph taken facing east north-east.
