Archaeological observations
at
22-24 High Street, Colchester
(formerly John Menzies')

CAT Report 57

Archaeological observations at 22-24 High Street, Colchester, Essex (formerly John Menzies')

December 1999-January 2000

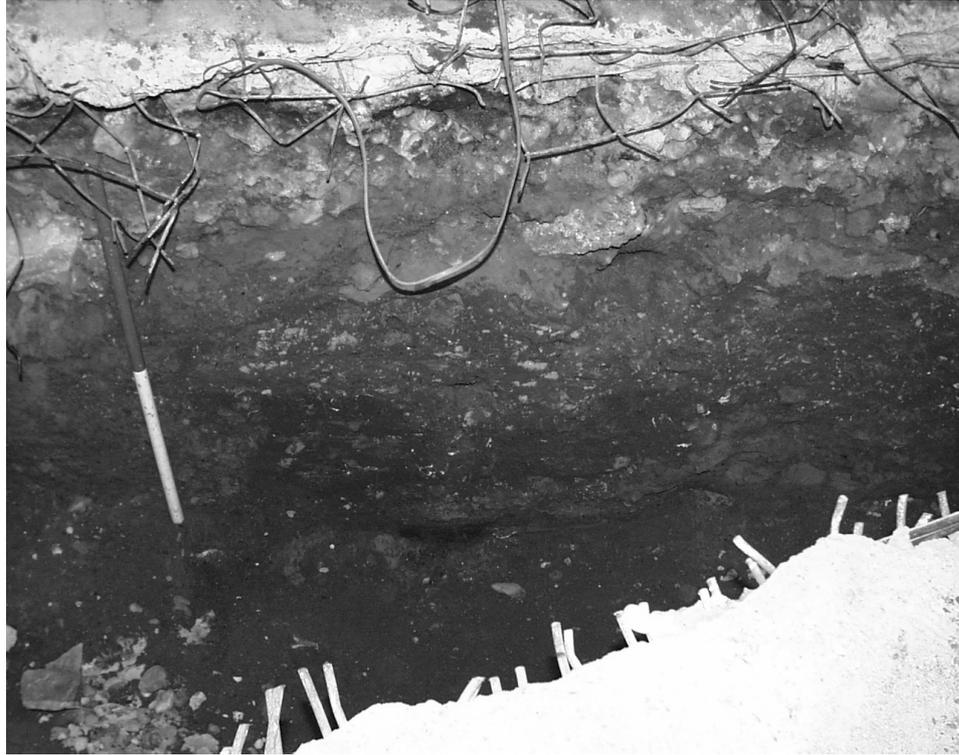
Fig a View of west side of Test pit 1 (section 1 here).

Context	Description	Interpretation	Date	Height of top (AOD)
L1	Concrete tiles	modern shop floor	20th century	30.60m
L2	Concrete slab with metal reinforcing	modern shop slab	20th century	30.55m
L3	Very mixed brick, concrete stone, sand rubble	make-up for modern floor	20th century	30.45m
L4	Sand brick, concrete rubble	demolition debris	20th century	30.10m
F1	N-S trench with cable in pipe	electric cable	20th century	30.10m
L5	Compacted loamy deposit with abundant mortar fragments & flecks, slate, brick fragments	demolition debris from previous buildings?	probably 20th century	29.95m
F2	Pit filled with dark grey brown silty loam, with medieval or later rubbish pit	highest surviving medieval deposit	medieval or later	29.70m
F6	Modern concrete base and fill of its cut. Slightly undercuts the strata around it	concrete stanchion and pit	20th century	29.60m
L6	Orange brown sandy deposit with Roman brick or tile. Looks burnt	Roman demolition debris. Highest Roman level	Roman	29.60m

L7	Dirty dark orange brown deposit, more mixed than L6, brick and tile fragments		Roman	29.60m
F3	Feature	uncertain feature	medieval or later?	29.50m
F4	A charcoal-filled cut	uncertain cut	Roman	29.30m
L8	Orange linear band	possible floor surface	early Roman	29.20m
L9	Orange brown sand and stones	redeposited natural?	Roman	29.35m
L10	Orange brown natural sand	natural sand	-	28.70m

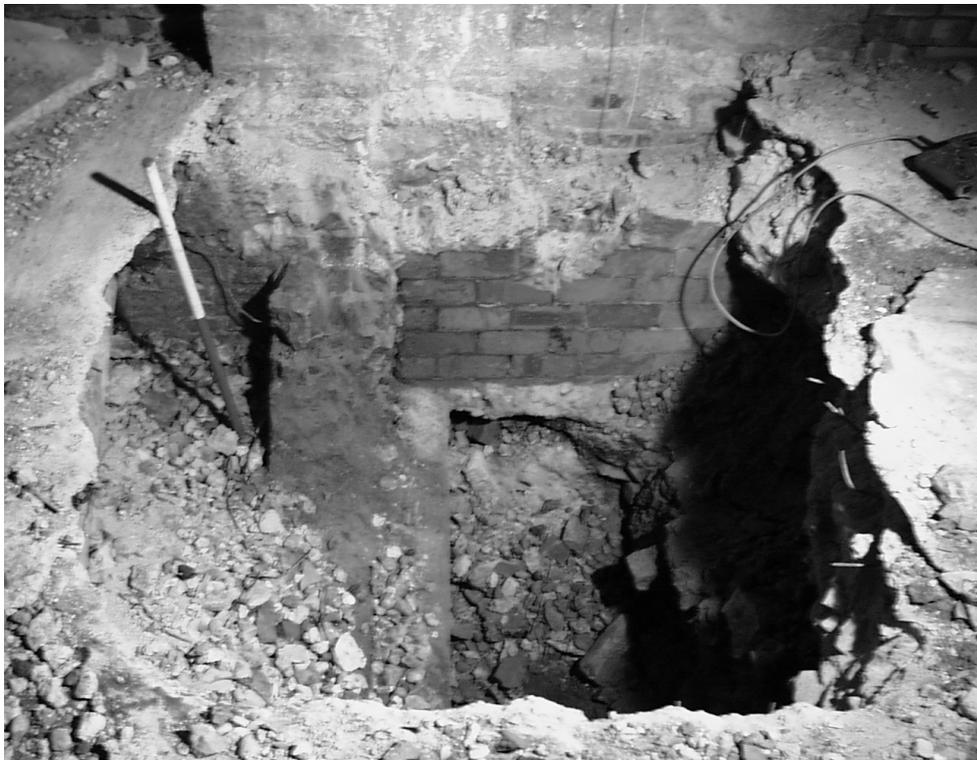
Fig b Cellar wall exposed in Test pit 2.

On the west side of the concrete beam, investigation was only down to approximately 29.80m. Here, an older wall was revealed. This was built of frogless red bricks measuring 45x100x??mm, of the type generally called 'Tudors'. In Essex, these are dated to the late

16th or 17th century.¹ A later date is probably ruled out by the thinness of these bricks. They are probably the face of a brick cellar (of unknown depth) belonging to a building pre-dating the present structure which is entirely 20th century in date.

- 4.1 Of the four test pits, only three were inspected (TP1, 2, 4). Test pit 3 had been infilled before it could be seen.
- 4.2 Test pit 2 revealed a 16th- or 17th-century brick wall, which is probably part of a cellar belonging to a previous property on this site. Test pit 4 revealed only modern deposits.

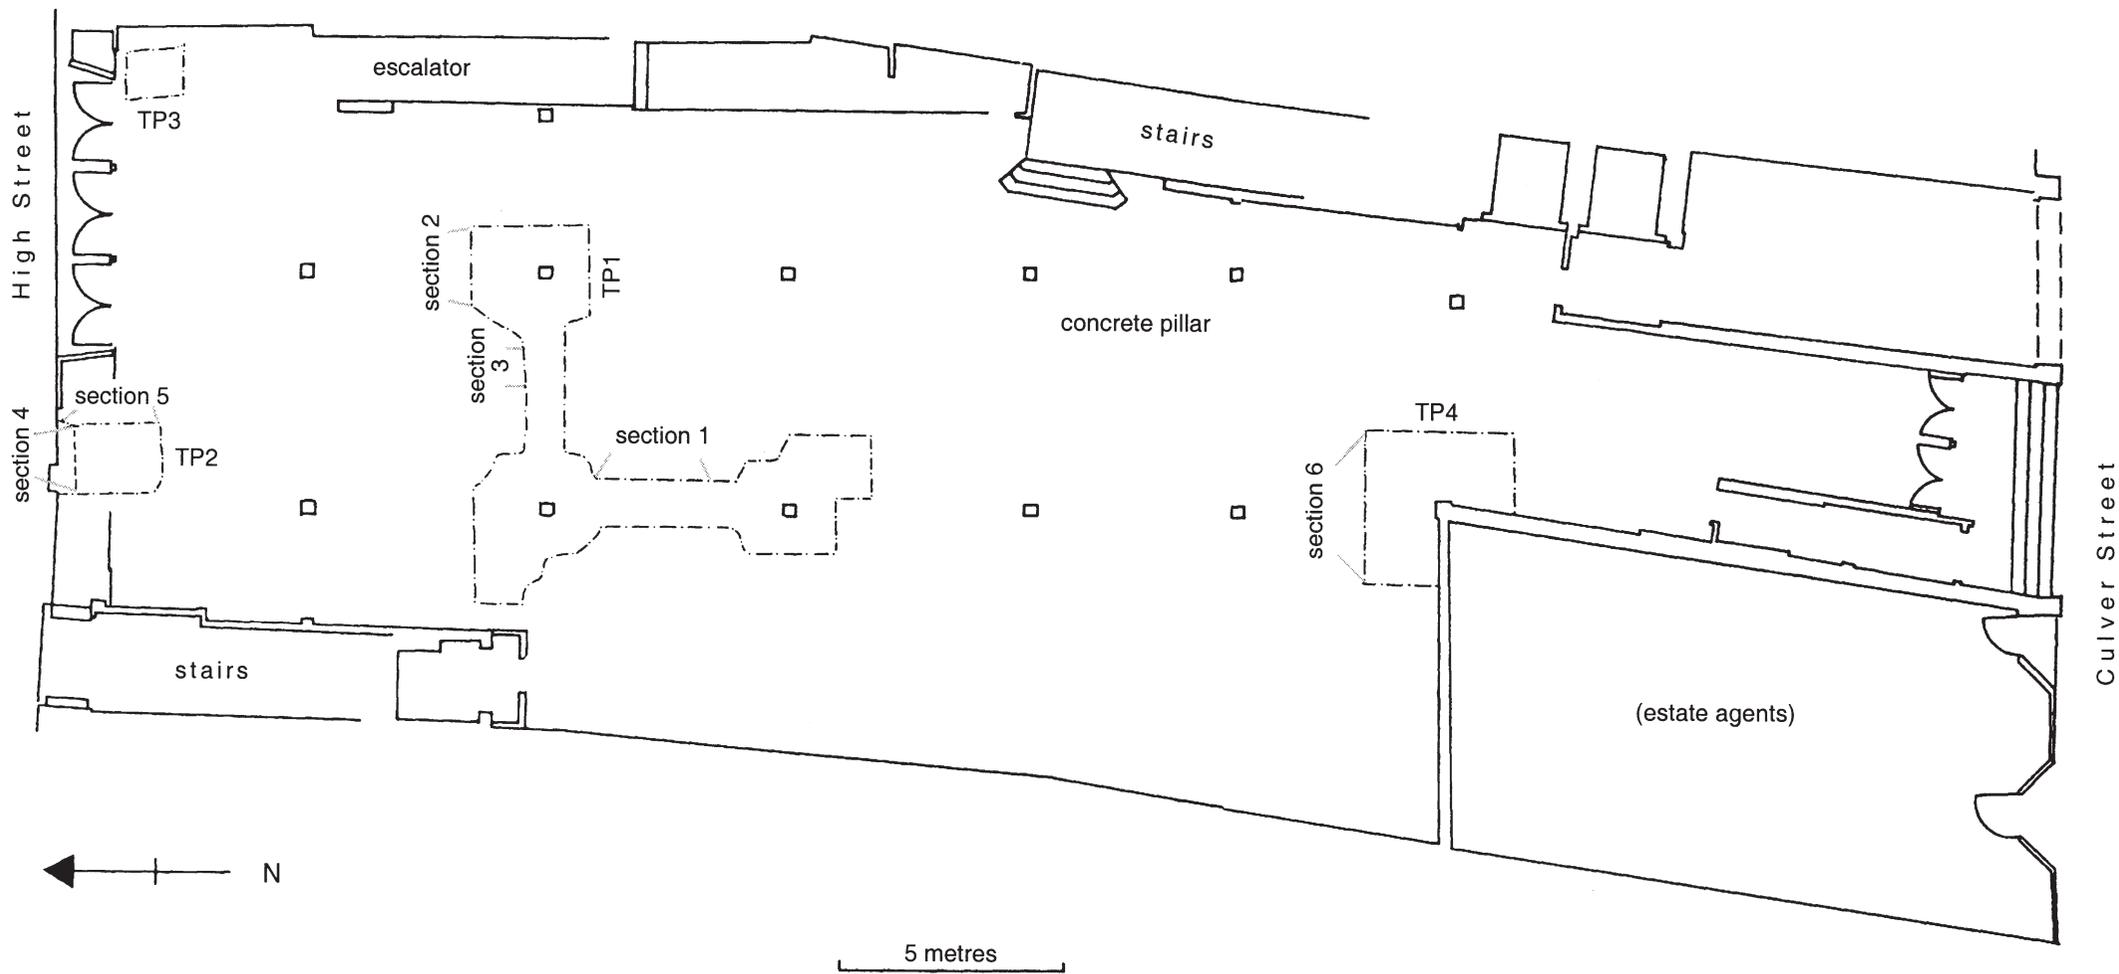
Fig 1 Site plan showing test pits and drawn sections.

This was an L-shaped trench slightly north of the centre of the old shop, and was the major below-ground geotechnical disturbance. Archaeological deposits were visible at four points located on Figure 1, and are given here as sections 1-4. Section 1 was drawn and described in more detail:

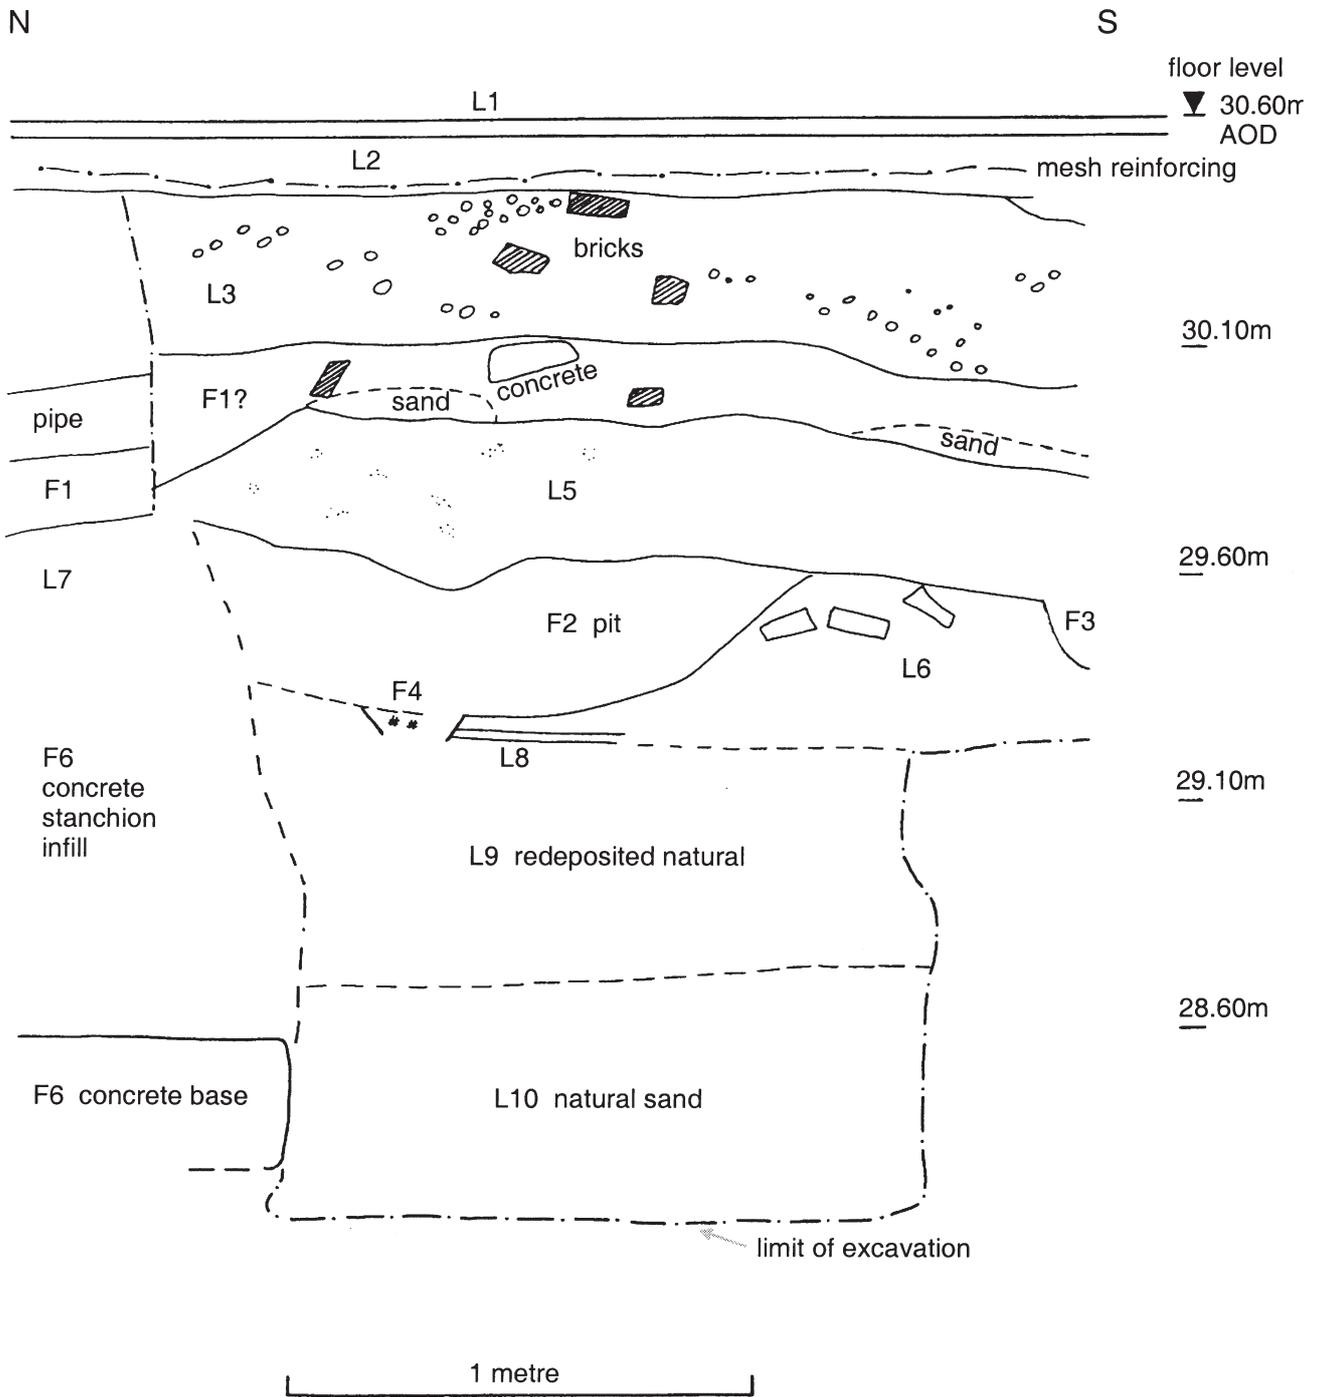
Fig 2 Section 1.

Test pit 1: section 1 (Figs a, 2)

- 4.3 Only Test pit 1 was helpful in establishing the depth and thickness of surviving archaeological deposits. In the three drawn sections a common pattern was seen. Below modern slab, there was a blanket of modern debris down to 29.60m AOD. In one section this contained concrete and was therefore definitely modern; in another (section 1) it contained slate and was certainly post-medieval.

- 4.5 The material which the pits cut was generally a thick layer of brown clay. Although this could not be differentiated in section 3, it was clear that it actually consisted of a number of distinct bands. In section 1, the top contained much brick and tile, and is therefore probably a Roman demolition deposit, or possibly Roman material disturbed in medieval times. Below this were several distinct bands of clay, in some instances with possible burnt clay surfaces. Judging by similar deposits excavated elsewhere in the town centre,² these must be successive Roman clay floors of buildings otherwise undetected (unless F4 in section 1 was a wall trench).

- 4.6 The natural subsoil was only reached in section 1, at 2m below modern floor (28.60m AOD).
- 4.7 Any development work which intrudes below 29.60m will have a detrimental effect on the archaeological strata described here.

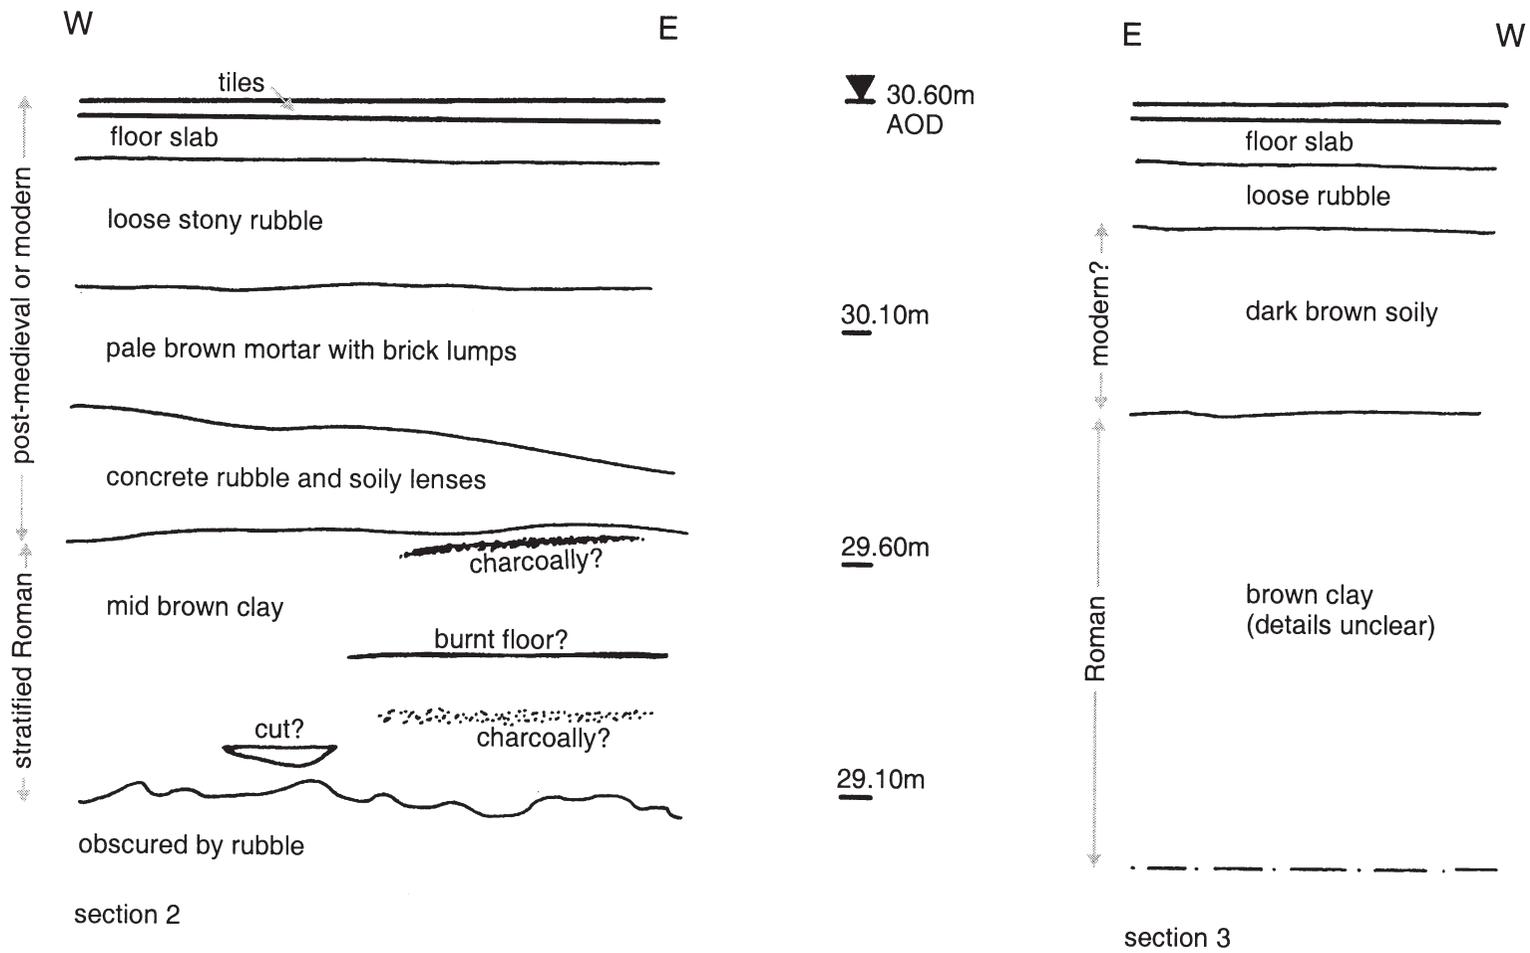
Fig 3 Sections 2, 3 (Test pit 1).

North face of north-east corner of Test pit 1. Strata revealed here were:

Description	Interpretation	Date	Height of top (AOD)
Modern concrete slabs with tiles on top	modern shop floor	20th century	30.60m
Loose stony rubble - make up for above	modern shop floor	20th century	30.45m
Pale brown mortar with brick lumps	demolition debris/make-up	20th century	30.20m
Concrete rubble with soily lenses	demolition debris	20th century	29.90m
Mid brown clay with several charcoally layers, one of which may be a floor level (at 8.75m). There was also one shallow possible cut visible in section	stratified Roman material with floor(s?)	Roman	29.65m
Lower levels obscured by rubble	(rubble at bottom of geotech trench)	21st century	29.10m

Central within main east west bar of Test pit 1. North face of trench.

Description	Interpretation	Date	Height of top (AOD)
Modern concrete slabs with tiles on top	modern shop floor	20th century	30.60m
Loose stony rubble - make-up for above	modern shop floor	20th century	30.45m
Dark brown soily deposit	this is different to sections 1 and 2; post-medieval pit fill	post-medieval	30.30m
Mid brown clay	stratified Roman material, no detail visible	Roman	29.90m
Limit of excavation	(bottom of geotech trench)	21st century	29.00m

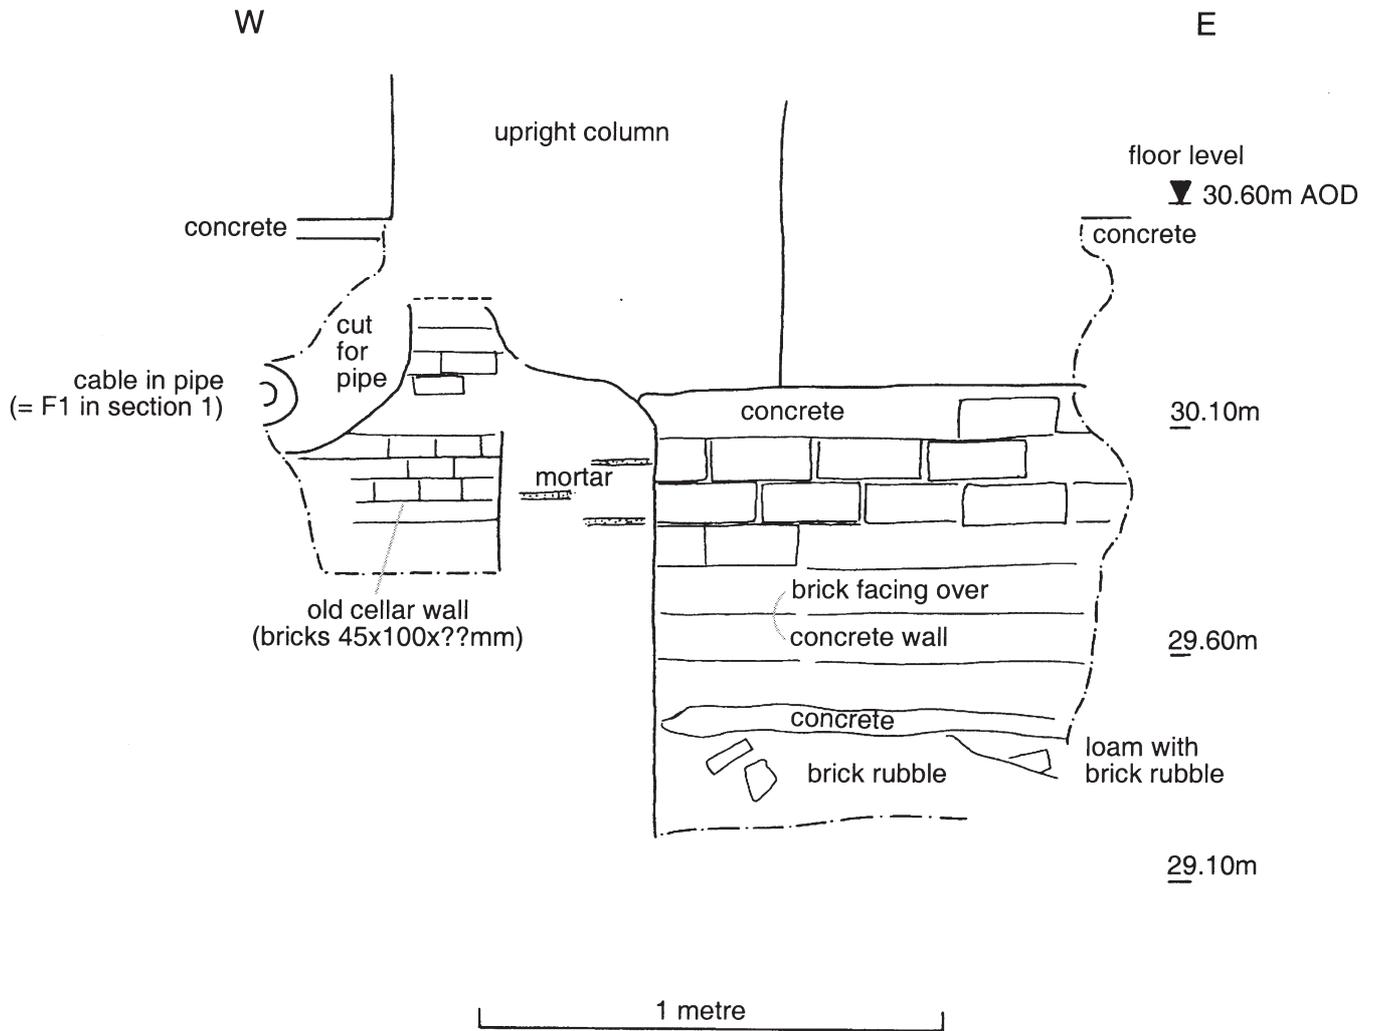
Fig 4 Section 4 (Test pit 2).

Test pit 2: section 4

This is not very informative. Modern concrete slab down to 30.1m, over a modern cut with concrete rubble (bottom at approximately 29.6m), cutting a brick rubble layer (top 30.1m, bottom 29.6m).

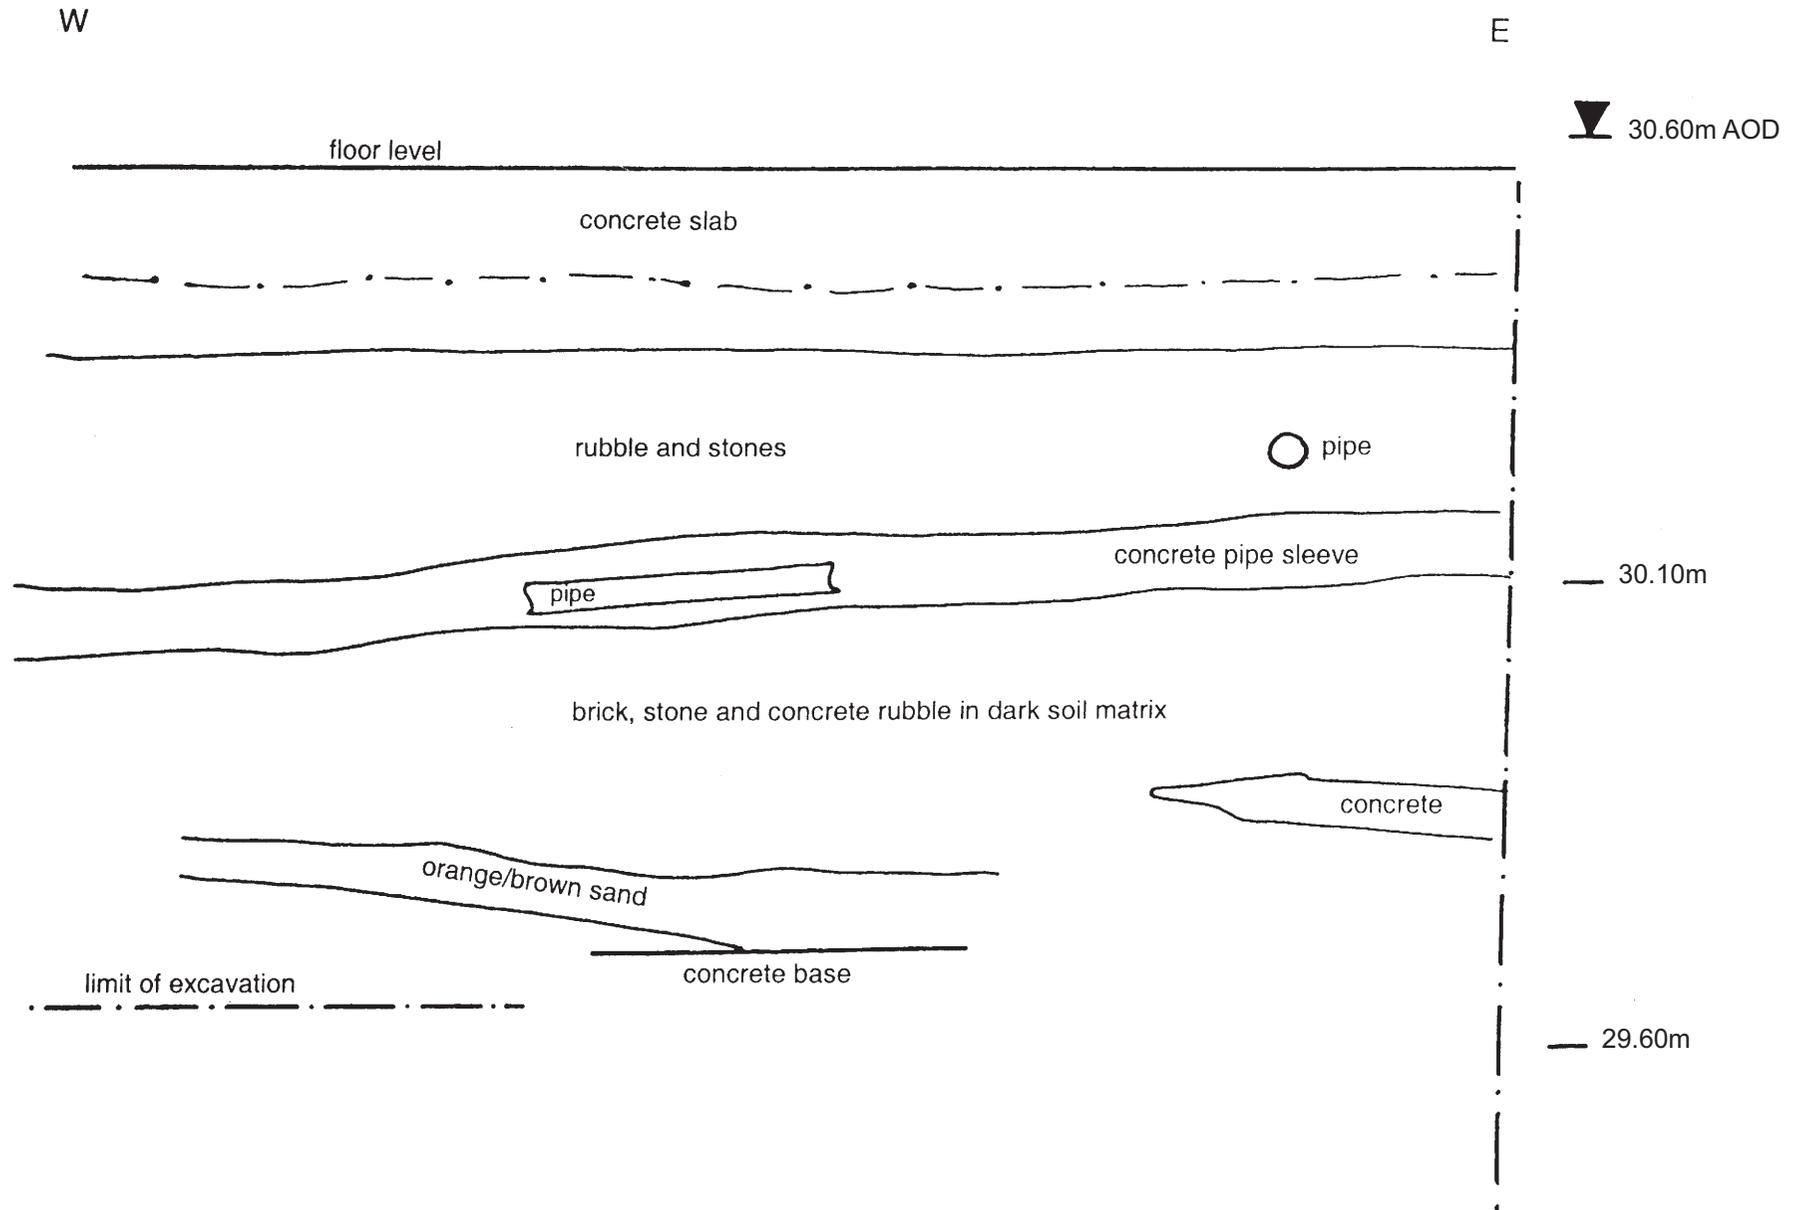
Fig 6 Section 6 (Test pit 4).

This was located on the Menzies' side of the north-west angle created inside Menzies' by the estate agent's on Culver Street. The entire pit was filled by concrete beams and slabs. The stanchion base was located at 1.8m below floor (28.80m). Various recent strata were seen in the north face of the trench, as follows:

Description	Interpretation	Date	Height of top (AOD)
Modern reinforced concrete slabs with tiles on top	modern shop floor	20th century	30.60m
Loose rubble and stones	make-up for modern shop floor	20th century	30.10m
Concrete sleeve with pipe	cable pipe?	20th century	29.5-29.7m
Brick stone and concrete rubble in dark soily matrix, and lenses of concrete and sand	a mixture of demolition debris from previous building and constructional debris from present building	20th century	29.4-29.6m
Concrete base	top of concrete stanchion base	20th century	28.80m
Limit of excavation	(bottom of geotech trench)		28.70m
