An archaeological evaluation at The old car park, The Tannery, Buntingford, Hertfordshire

March 2001

CAT Report 130

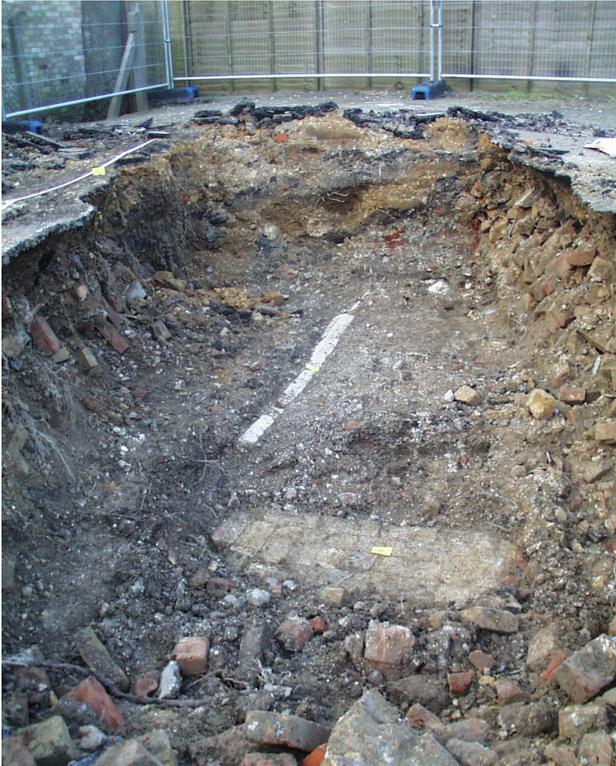
Feature 1 - a 3.3m length of electricity cable was exposed at the bottom of the north end of the trench, running in a north-north-east – south-south-westerly direction. The cable lay within L4 at 1.1m below ground-level and was covered with a concrete capping (Plate 1 and Fig 2).

Feature 2 - brick footings to a previous building were exposed at the bottom of the north end of the trench, running east-west. The footings were 470mm wide and the individual bricks were unfrogged and measured 235mm x 110mm x 70mm thickness. This feature lies within L4 at 1.25m below ground-level (Plate 1 and Fig 2).

Plate 1 Trench 1, looking north-west.

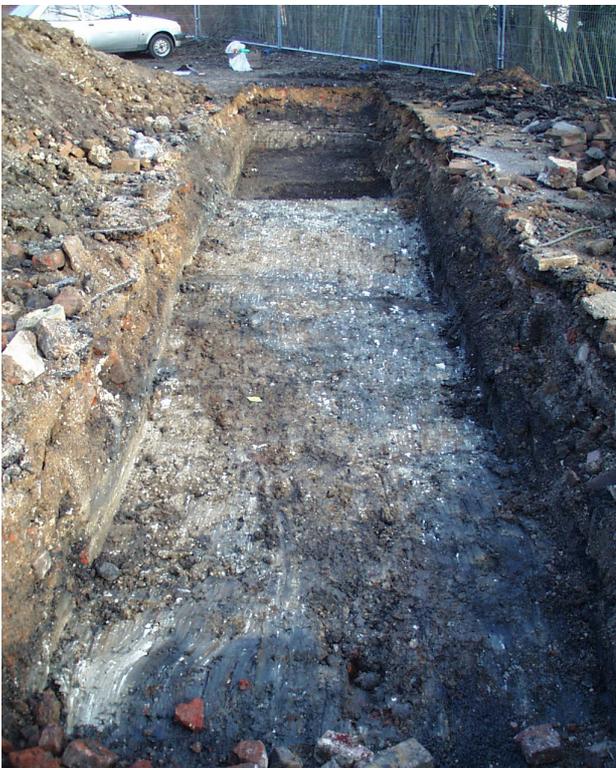
Feature 4 - The outline of a storm-drain trench was exposed running north-east to south-west in the western end of the trench. The feature was 600mm wide and was found in L8, 700mm below ground-level (Fig 2 and Plate 2).

Plate 2 Trench 2, looking south-east.

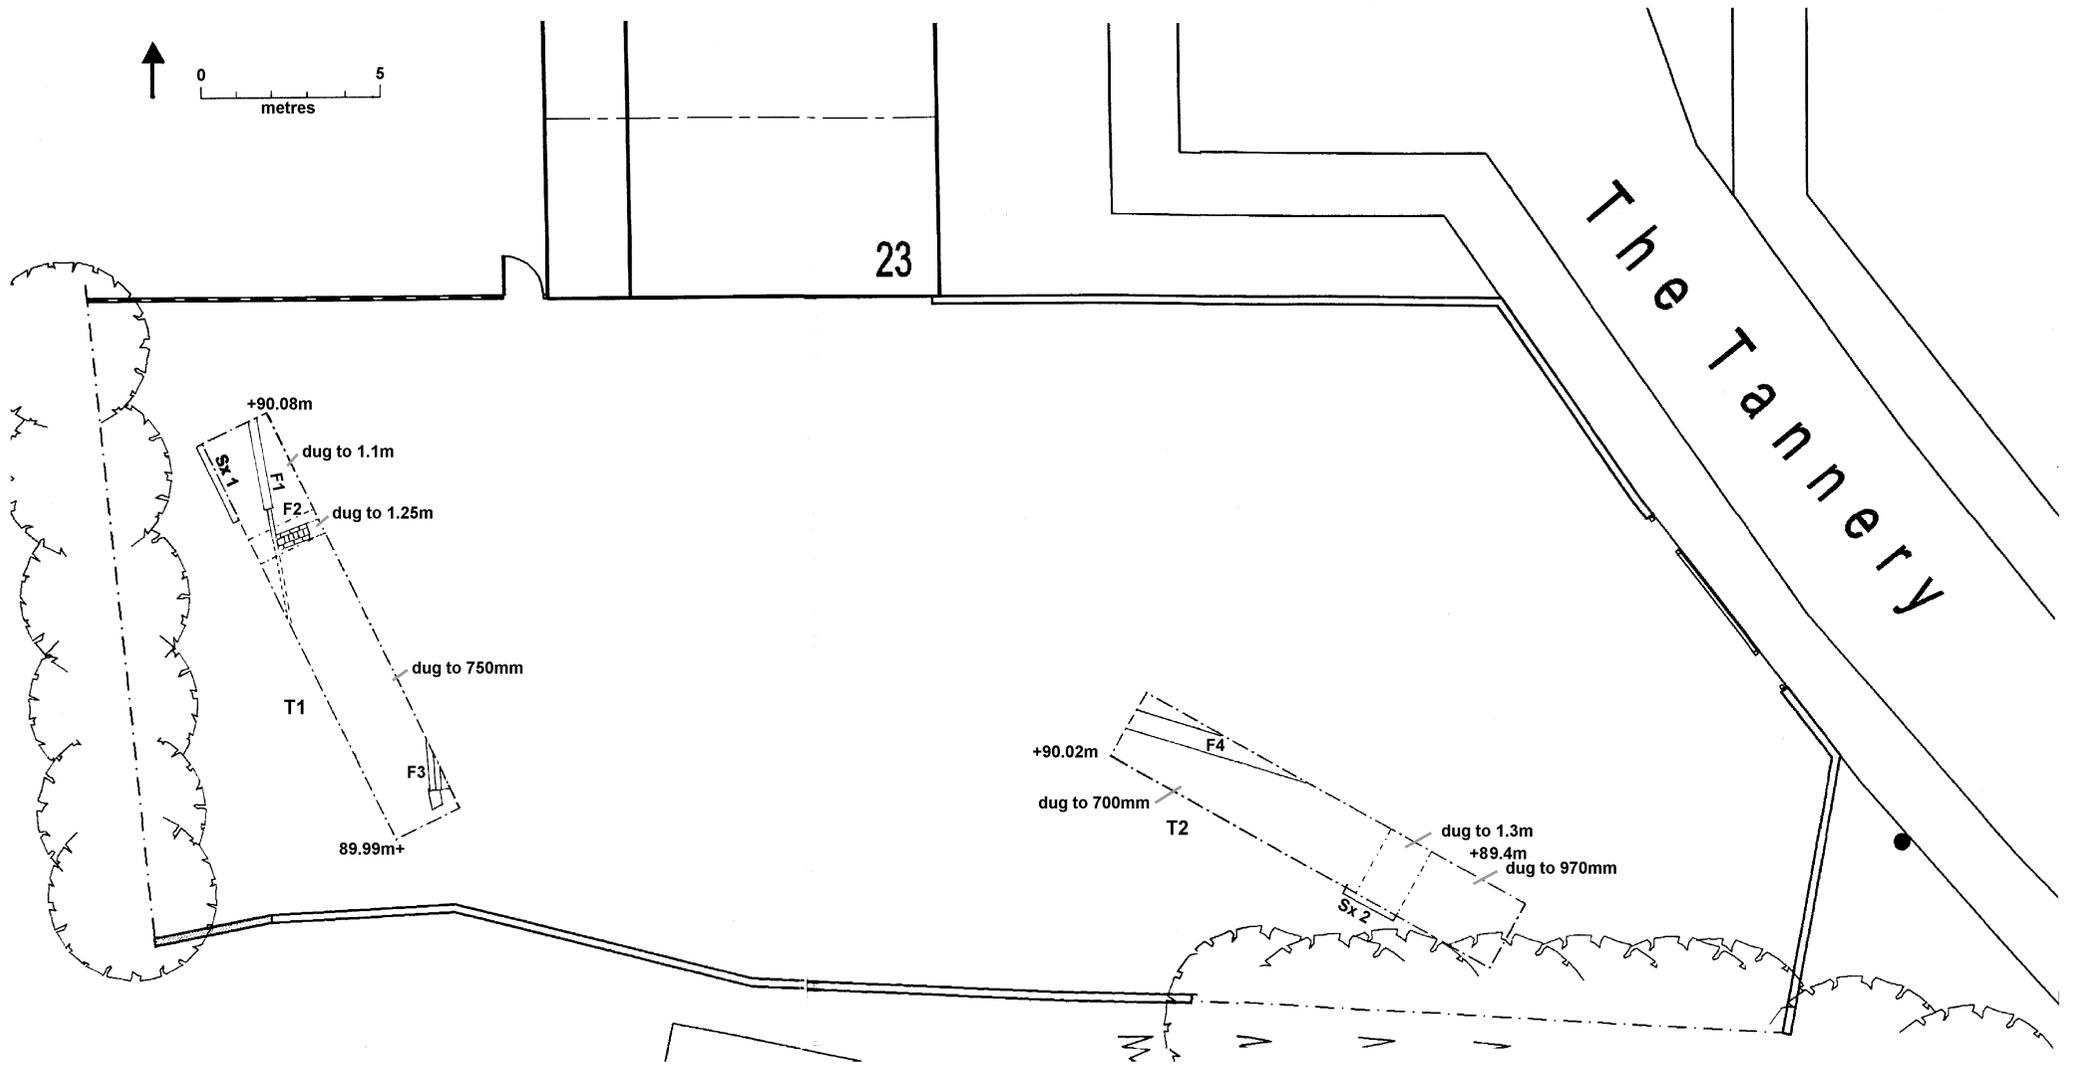
- 5.1 The work was undertaken by a professional archaeologist who carried out the fieldwork in one day. The total area excavated was 50m², ie just over 5% of the available area. The dimensions of the trenches were 2m x 12.5m each. Their locations and length were altered slightly from the Written Scheme of Investigation to avoid an unmarked stopcock and an electricity cable (Fig 2).

Feature 3 - three concrete slabs in a stepped arrangement protruded out 500mm from the eastern section at the southern end of the trench (Fig 2).

Fig 2 Plan of site, showing trial-trench positions and features: scale 1:150.

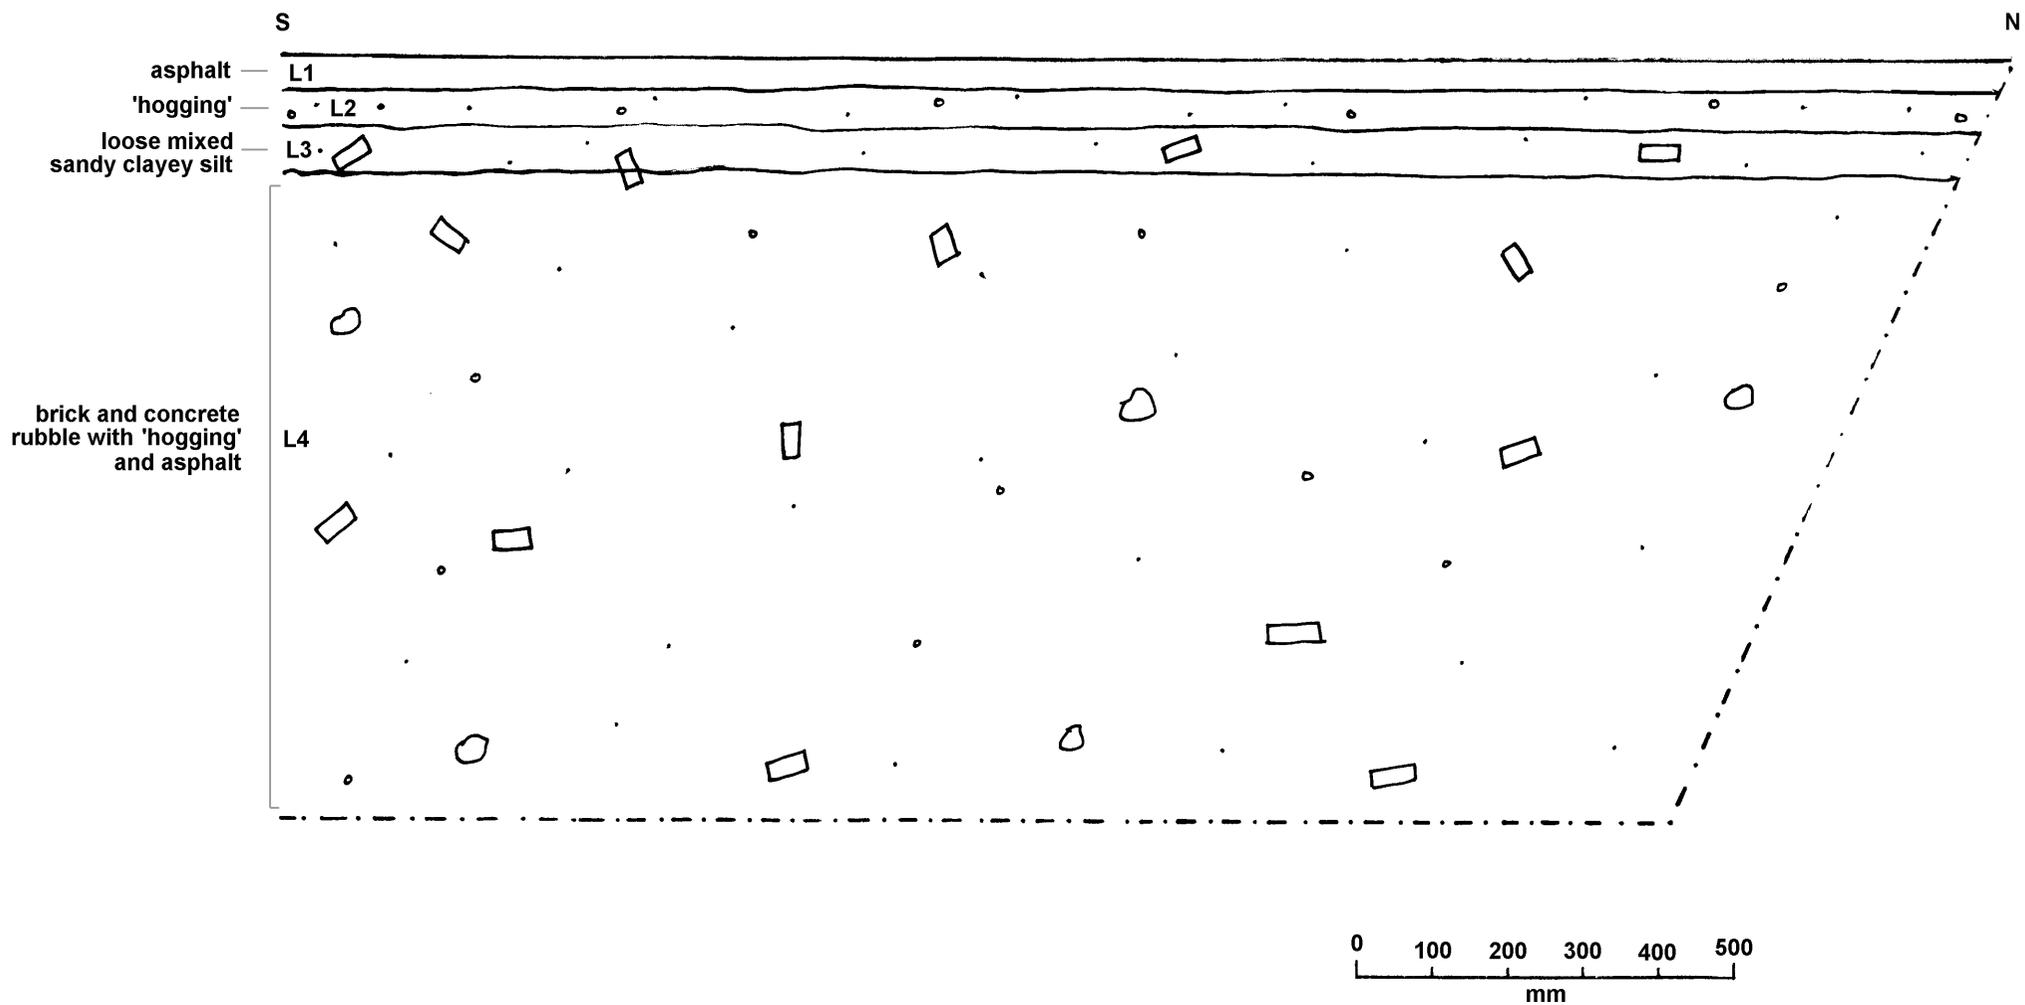
The northern third of the trench was dug to 1.1m. The southern two-thirds of the trench were dug to 750mm. An extra 150mm depth was dug out 3m south of the northern edge; this exposed brick footings of a previous building 1.25m below

ground-level (F2). Above this the northern third of the trench was filled with over 1m depth of 20th-century bricks mixed with concrete, asphalt, 'hogging', and slate (L2-L4). This rubble continued into the southern part of the trench, and for this reason it was not thought necessary to excavate the southern two-thirds of the trench to more than 750mm depth.

Layer 1 - 40mm-70mm of asphalt - surface of car park.

Layer 2 - 50mm of loose yellow/brown sand and gravel which includes whole unfrogged bricks (235mm x 100mm x 70mm thickness) and slate - sub-base ('hogging') for asphalt.

Layer 3 - 60mm of loose light brown coarse sandy clayey silt containing unfrogged bricks and asphalt - modern make-up.

Layer 4 - over 1m of rubble consisting of unfrogged bricks and concrete. These were mixed in with 'hogging' similar to L2 and asphalt. Modern china was also found at the bottom of this layer.

Fig 3 Part of Trench 1, Section 1: scale 1:10.

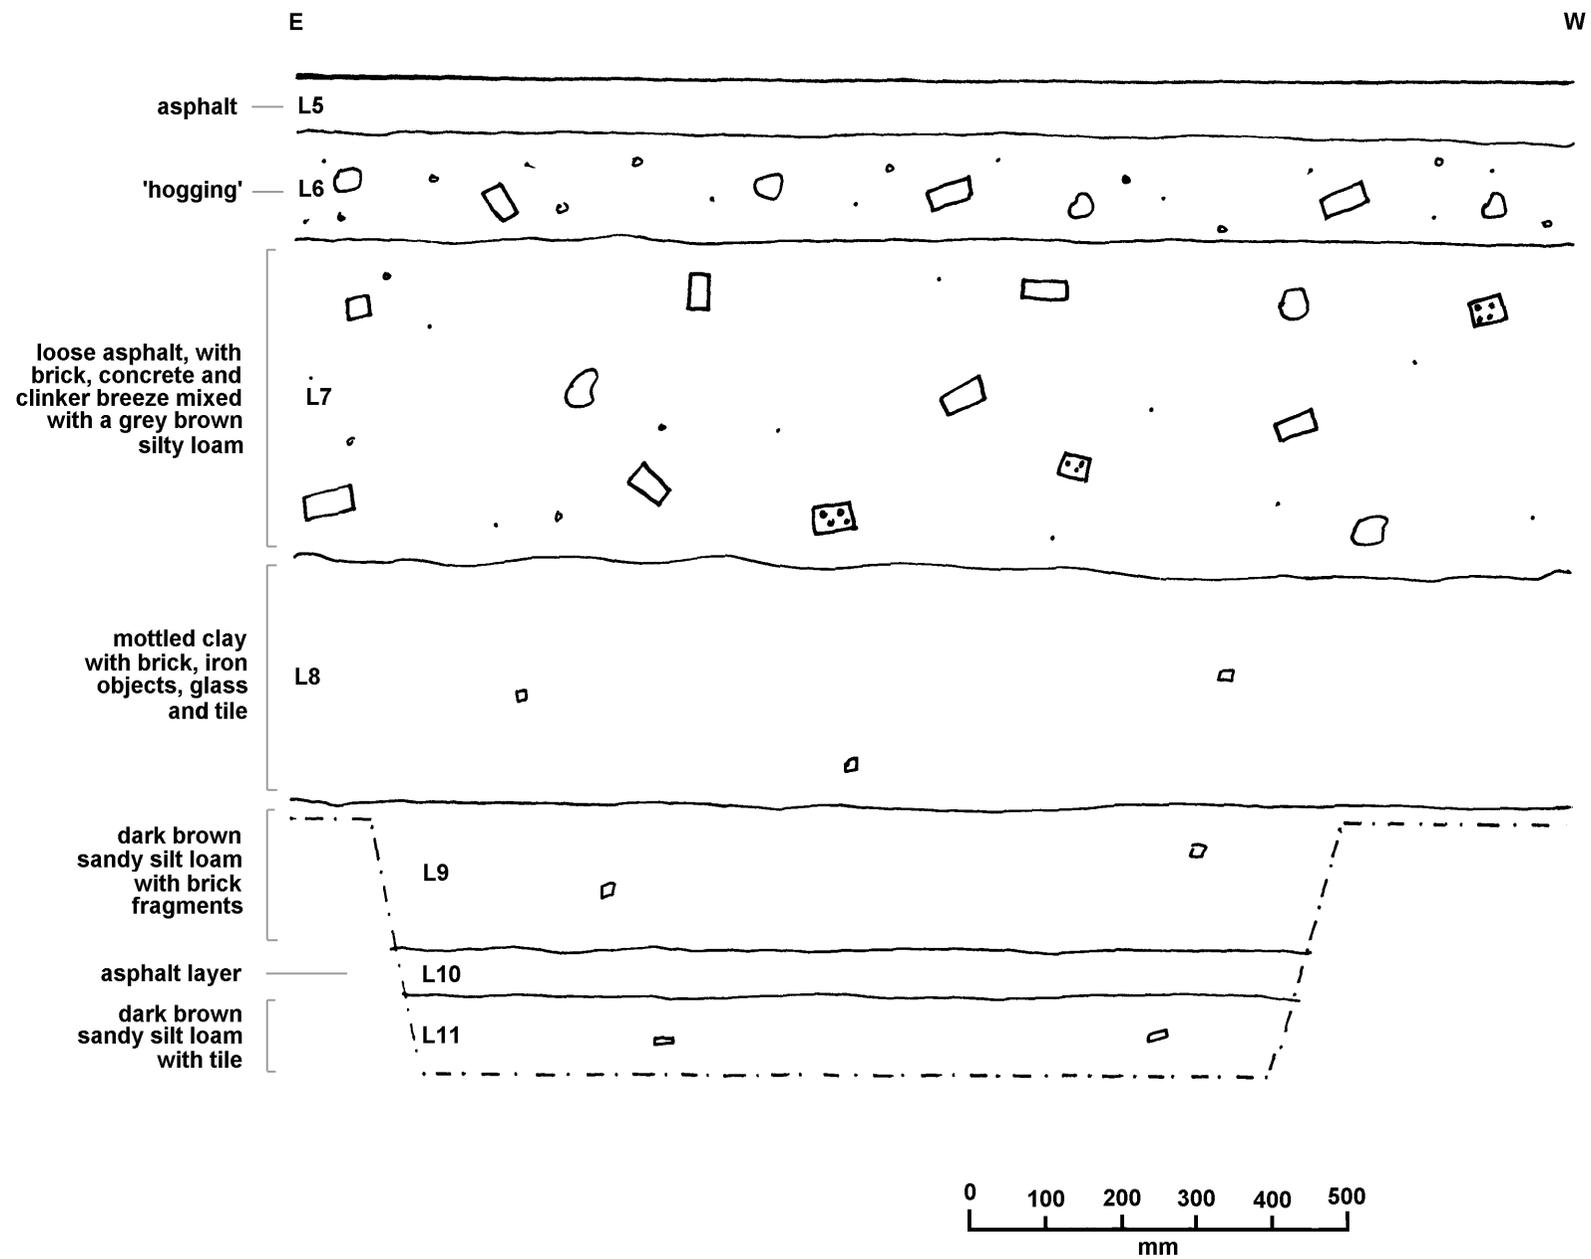
This trench by the river exposed many layers; however, all of them contained modern material. The eastern third of the trench was excavated to nearly 970mm depth. The western two-thirds of the trench were dug to 700mm.

An extra 330mm depth was dug out to 1.3m, 3m west of the eastern end of the trench (L9-L11).

Layer 5 - 70mm of asphalt for the car park (same layer as L1).

Layer 6 - 140mm of modern 'hogging' (same layer as L2). The bricks, however, appeared to be more modern than those in L2.

Layer 7 - approximately 420mm of loose asphalt, modern brick, concrete and clinker breeze mixed in with grey brown silty clay - modern make-up.

Layer 8 - 330mm of stiff mottled light brown and darker grey clay with chalky flecks containing modern brick fragments, roof-tile, and modern iron objects and glass - modern make-up.

Layer 9 - 180mm of more humic dark brown sandy silt loam containing modern iron objects, brick fragments, modern wall-tile, and one piece of horn core which may be connected with the tanning process. This layer goes down to 1.14m below ground-level.

Layer 10 - 60mm layer of reddish black asphalt. As this layer was only seen in a small section that was dug deeper by the machine, it is not known whether this is a previous surface that extends the whole length of the trench or not. This layer extends down to 1.2m below ground-level.

Layer 11 - 100mm of humic material similar to L9 containing modern tile and one cut animal bone.

Fig 4 Part of Trench 2, Section 2: scale 1:10.

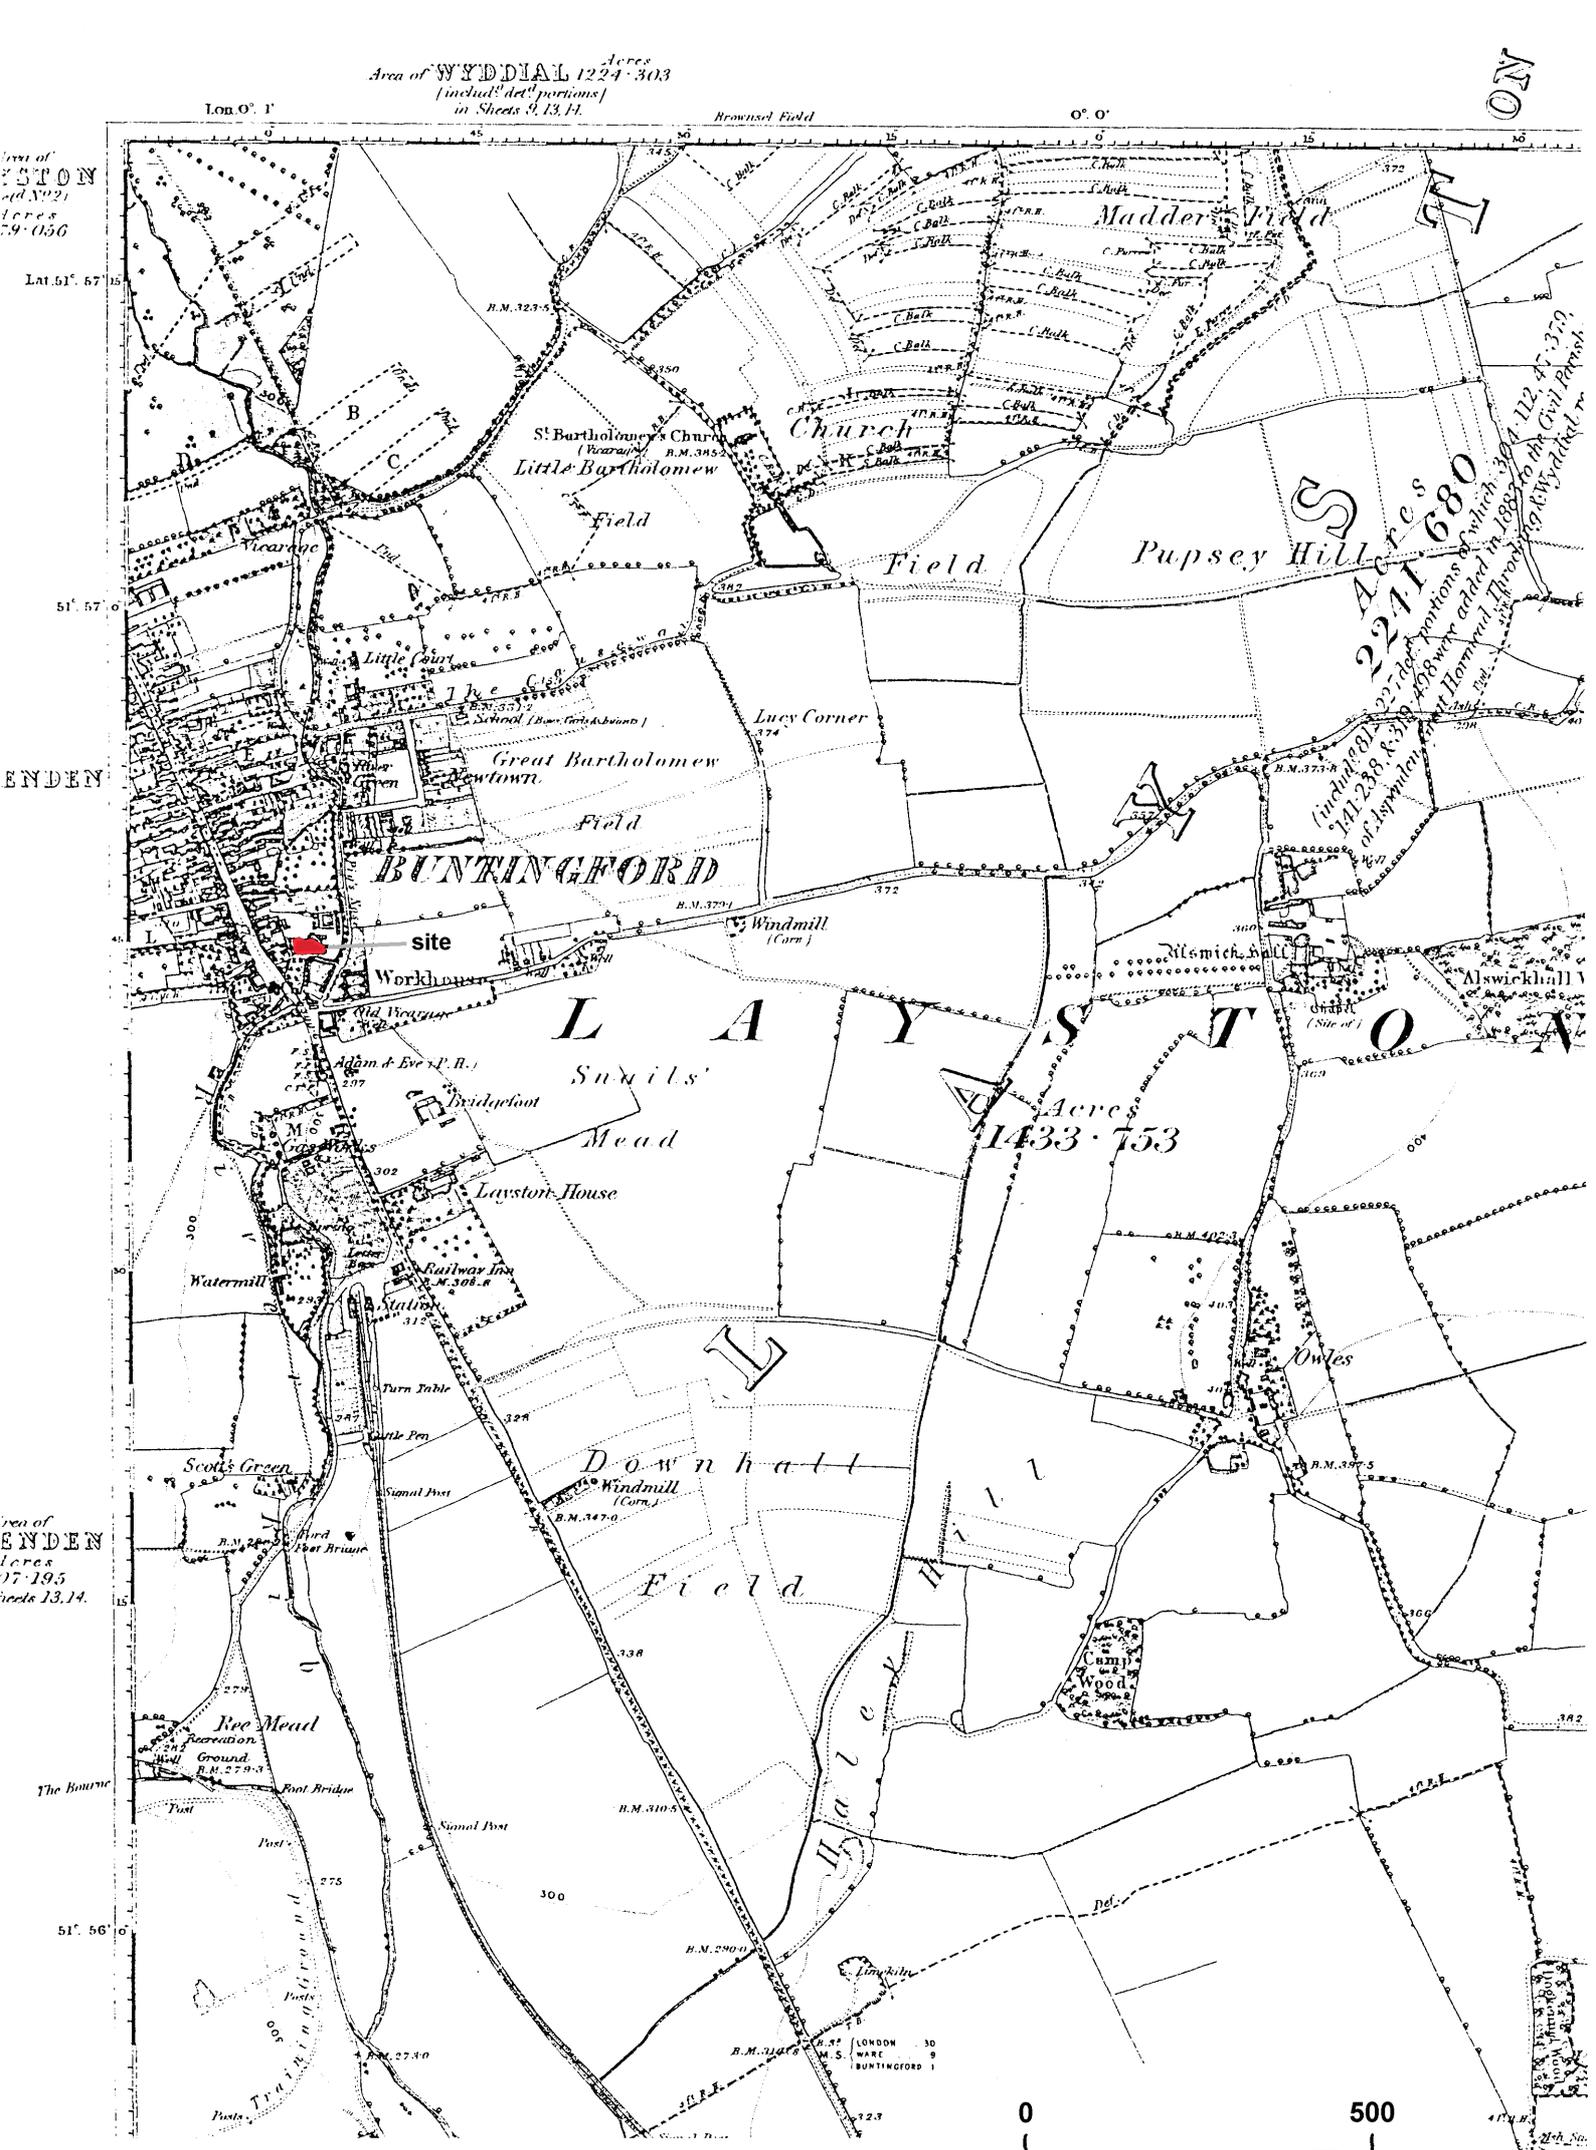
- 3.5** A tannery of 18th-century date is known to have been situated to the rear of 10 High Street. This comprised a two-storey building with basement and a timber-framed wing (Fig 6). The development site and the modern houses just to the north of it were built on the old tanyard which comprised a number of large old sheds with deep oakum pits for tanning leather (SMR 10380). These buildings show on the OS 1881 and 1897 maps (Figs 5 and 6).

Fig 5 OS 1st edition map 1881: scale 1:10560.

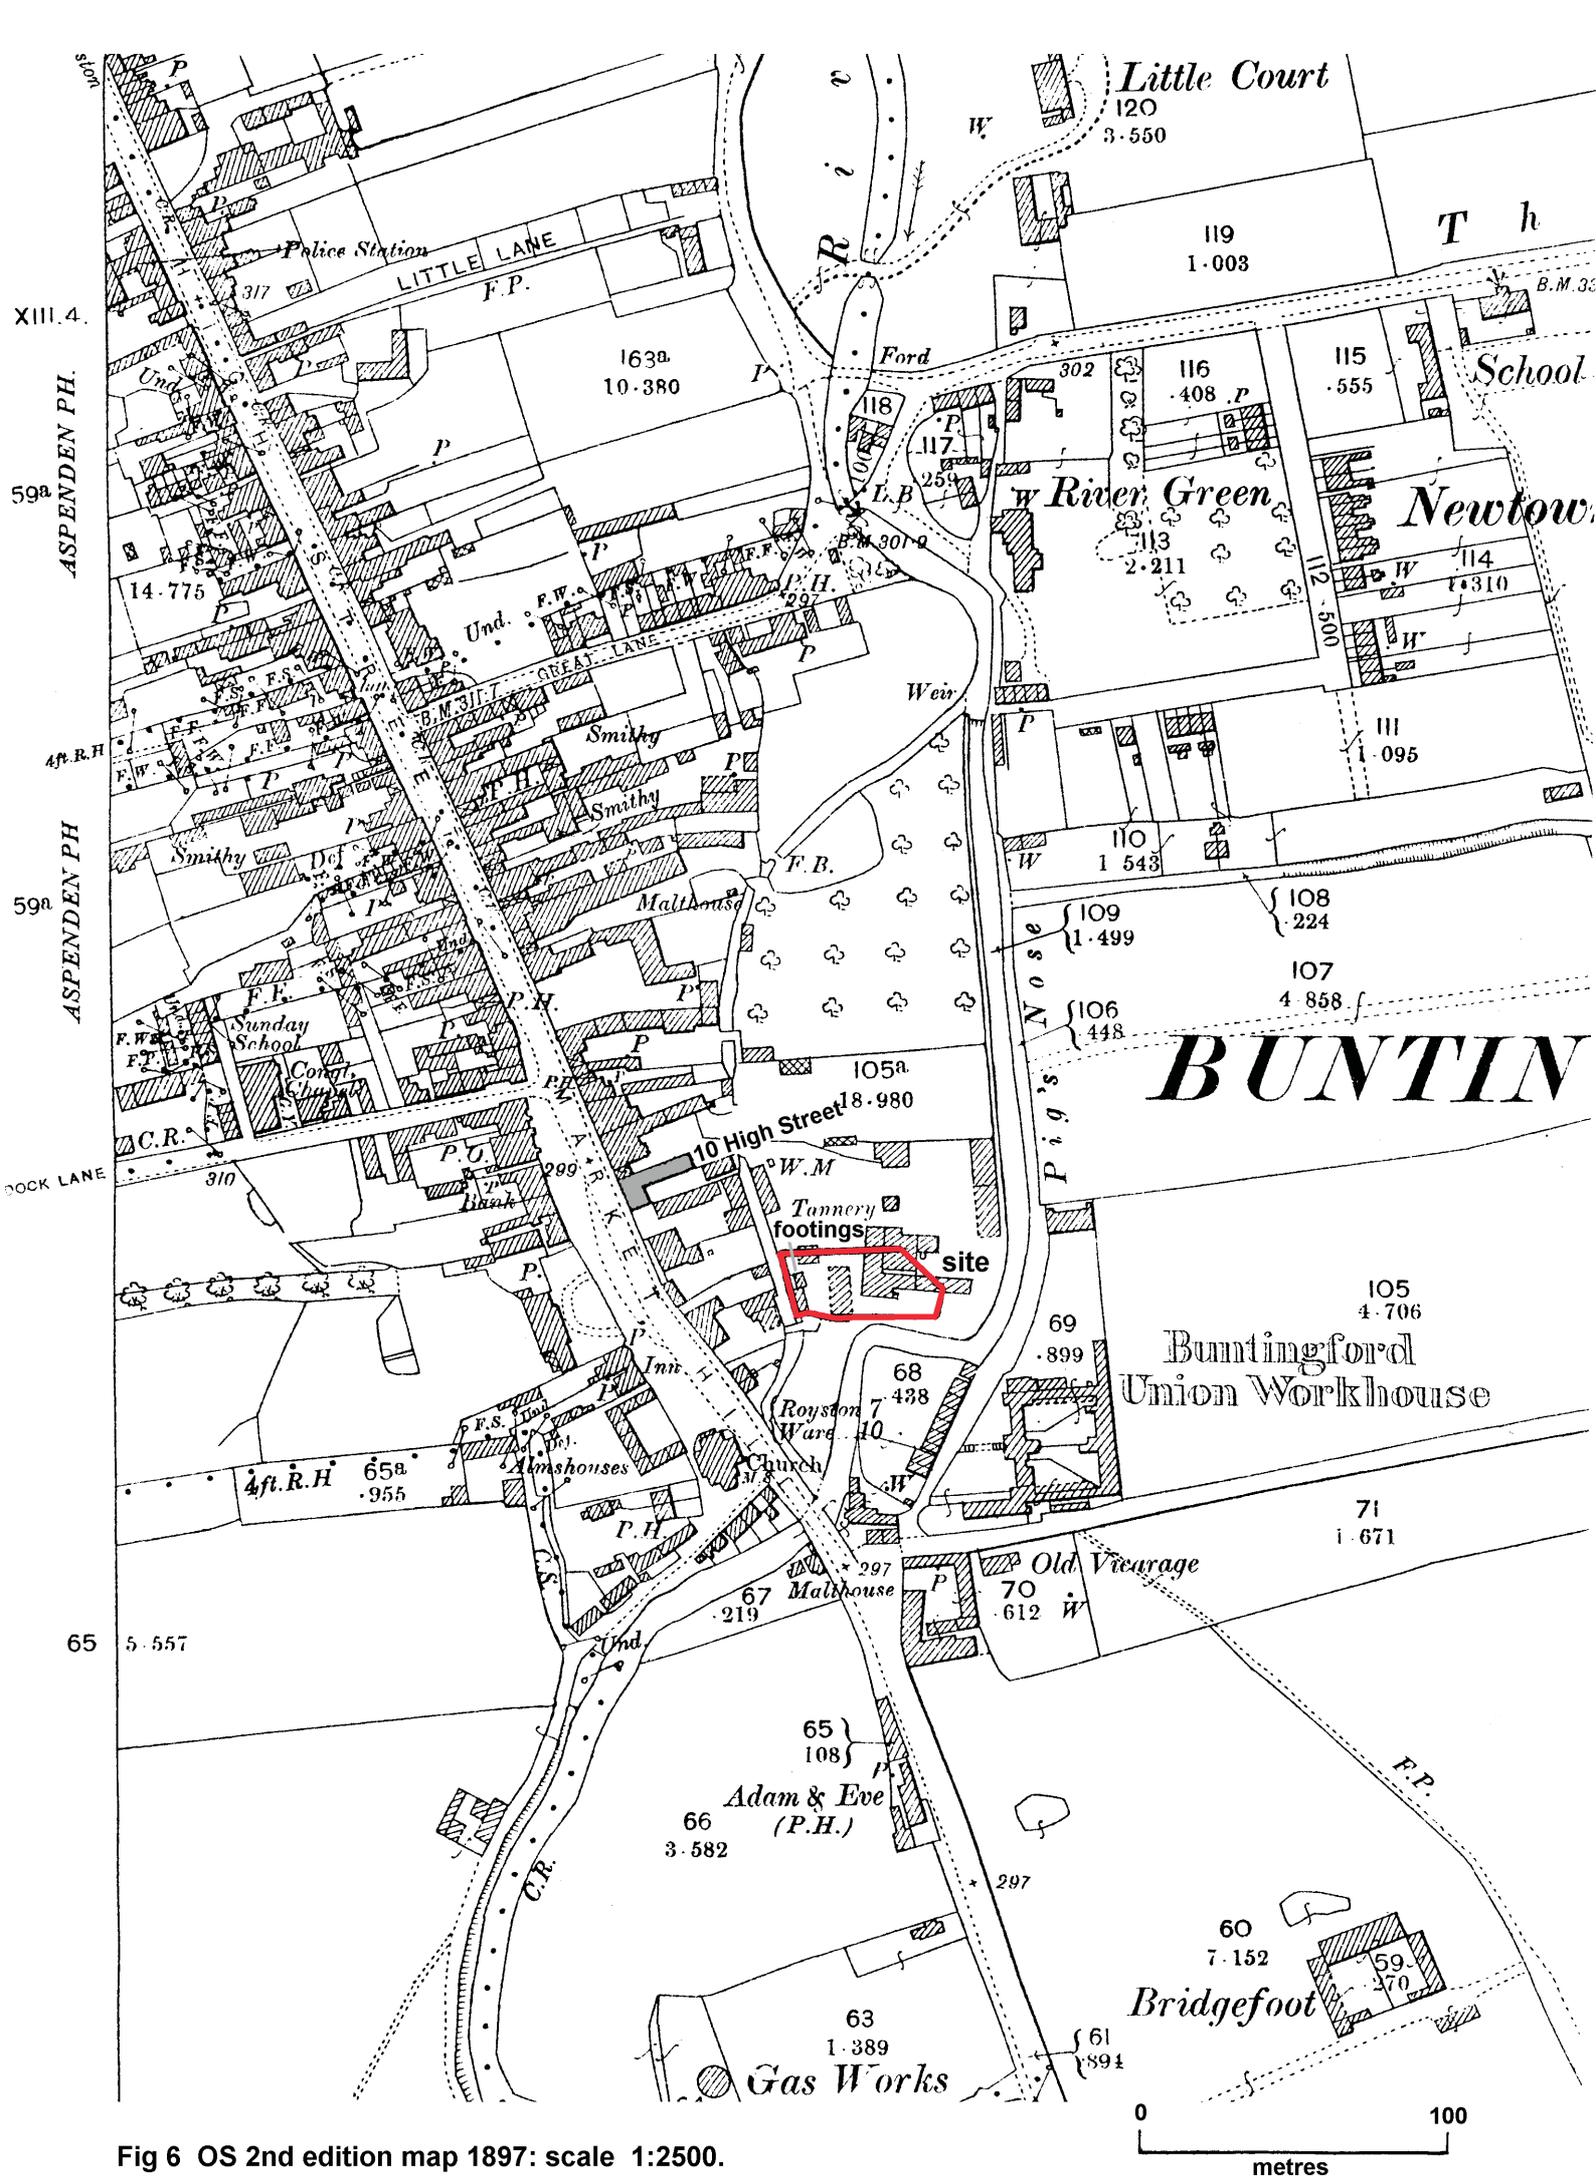
- 7.2 T1 exposed a short length of brick footings. SMR information shows that there was an 18th- or 19th-century tanyard on the development site (hence the name of the road). Nineteenth-century maps (Figs 5-6) show these buildings. The size and shape of the bricks give a late 18th- or 19th-century date for the footings so it seems likely that they belonged to a building which was part of the tanyard. If so, it is possible to pinpoint on the map the actual building to which the footings belong (Fig 6).

- 7.3 Figure 6 shows tanyard buildings covering most of the site and it is therefore likely that more foundations exist over the site. There were no foundations found in T2; however, this is probably because the trench at its western end was only dug to 700mm and therefore did not go deep enough to expose them. The remains of the foundations to the tannery buildings are considered to be of limited archaeological significance. The only value they are considered to have is in showing the location of the tannery buildings, but this is already known from 19th-century OS maps.

Fig 6 OS 2nd edition map 1897: scale 1:2500.
