**An archaeological evaluation at  
Bocking Hall, Bocking Churchstreet,  
Bocking, Essex  
August 2004**

**report prepared by  
Carl Crossan**

**CAT Report 278**  
November 2004

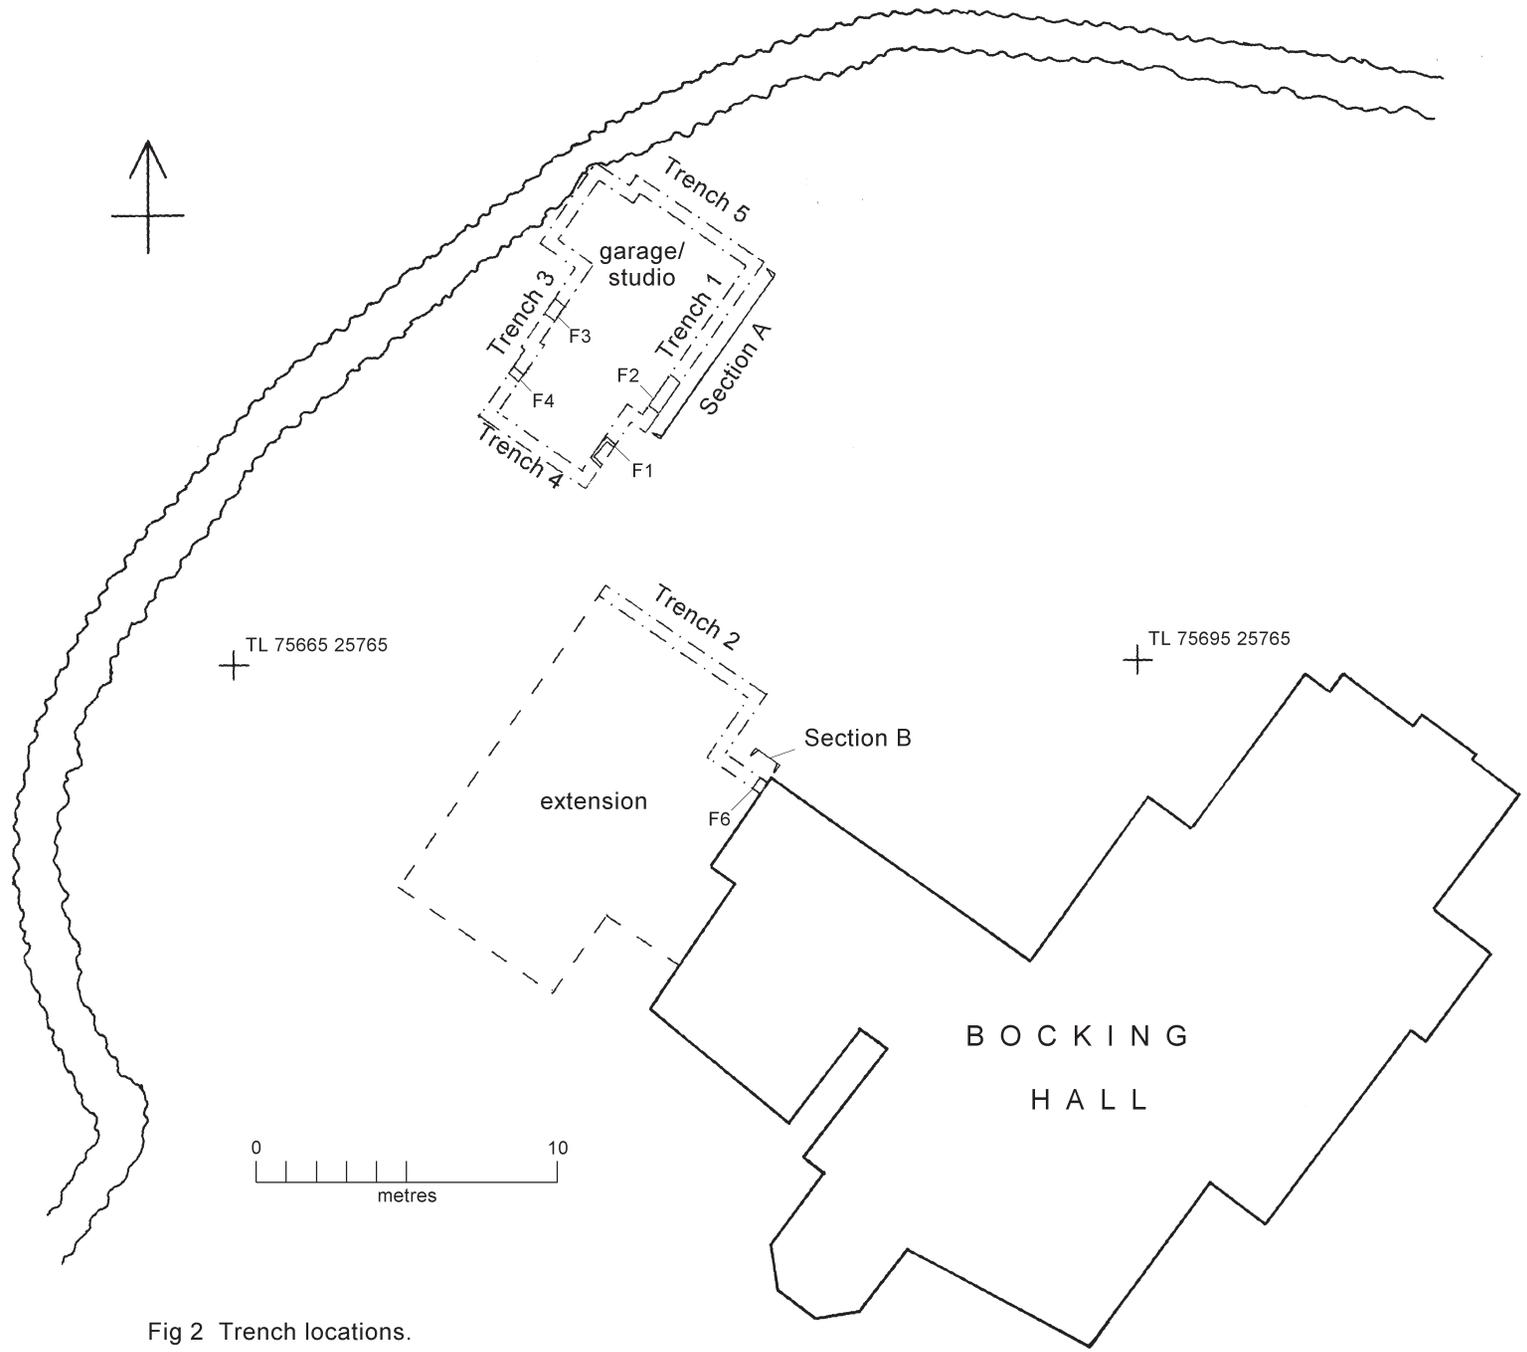
Fig 2 Trench locations.

6.1 Figure 2 shows the trench locations and the positions of the sections illustrated in Figure 3.

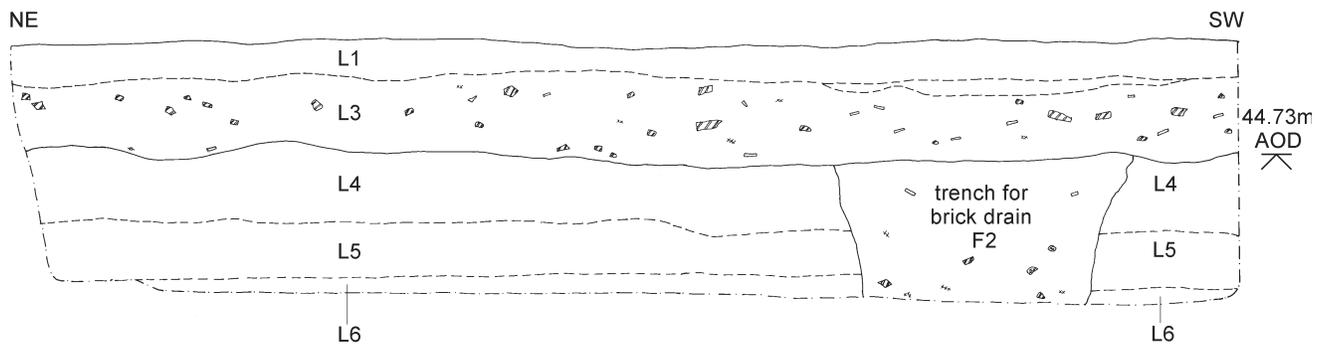
Section A Trench 1

This drain run was represented by a brick-lined square inspection pit (Feature or F1 in Trench 1) and a pipe trench (F4) which was cut by Trench 3. The inspection pit F1 was constructed of unfroged red brick typically measuring 22cm x 6cm x 11cm and was covered by a stone slab. The slab was laid at the level of the interface between Layer or L3 and L4 and appeared to be sealed by L3, although the continuity of this layer could not be established with certainty at this point due to heavy local root disturbance. The mortar adhering to the bricks varied from a lime-rich white to sandy yellowish brown, indicating either a very poor mix or possible re-use of the bricks. To the north-west, the associated pipe trench (F4 in Trench 3) contained a brown salt-glazed earthenware drainpipe of probable 19th- to 20th-century date.

The excavation of foundation Trench 1 revealed the cut for this drain (F2) which was more fully exposed by the deeper excavation in Trench 2 (F3). Here, the bottom of the trench contained a brick-floored drain with sides built from several courses of red brick laid lengthways in line with the course of the drain. The roof construction was not discernible as safety considerations prevented closer inspection of the drain, which lay at a depth of 2.1m. Bricks excavated from this feature were unfroged and measured 20cm x 5cm x 11cm. The trench was sealed by L3.

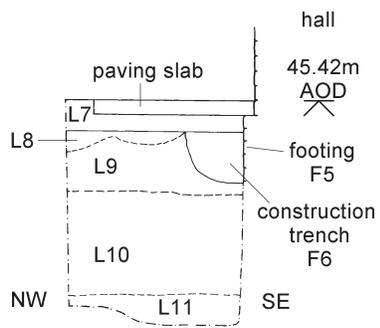
Section B Trench 2

Trench 2 butted against the north-west wall of the present hall, exposing its brick footing (F5) which is shown here in profile in Figure 3. The footing projected 5-6cm from the face of the standing wall and was constructed of red brick, typically 23cm x 6cm x 11cm, laid in five alternating courses of headers and stretchers (English bond).
