**An archaeological watching brief  
and limited excavation at  
60-66 East Street,  
Colchester, Essex  
May 2003-April 2004**

**report prepared by  
Kate Orr**

**commissioned by  
Roy Grimwade Architects Ltd  
on behalf of  
Harding Homes**

**CAT Report 283**  
July 2005

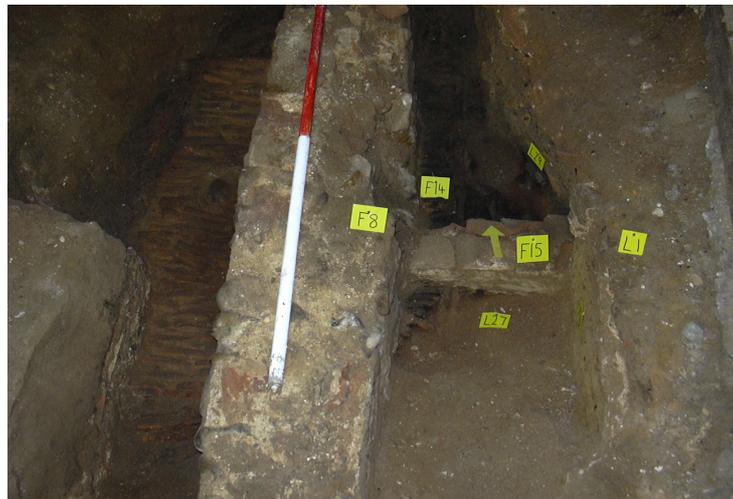
- L22 – compact buff clayey silt with a band of orange clayey silt and occasional daub – a late medieval or early post-medieval floor surface.
- F14 – a medieval hearth 900mm x 600mm wide, made of upturned peg-tiles set into light brown sandy silt. Walls F8 and F15 were constructed directly on top of the hearth. The hearth has a tile border around the eastern edge. The western side has no border and has a ragged edge as if some tiles have been removed. The tiles and the earth of the eastern part of the hearth had been burnt, as one would expect. Inexplicably, however, on the western side there is no evidence of burning apart from one small patch of reddening near the centre. The south-eastern edge of F14 has been cut away.

**Plate 2** Hearth F14 and wall F8.

In Rooms G6/G7 (no 62 East Street), a trench was dug by CAT within the oldest part of the building (T14). A hearth consisting of upturned peg-tiles with a border around the eastern edge was exposed (F14; Fig 3, Plate 2). Hearths of these types have been previously recorded at excavations of medieval houses in Colchester, for example at Middleborough, and have been found to date from the later 14th to the 16th centuries (Brooks & Crummy 1984, 190, 201). The open hall would have required a large central hearth to provide warmth for the residents, particularly as windows would have been unglazed at this time. However, hearth F14 being only 600mm x 900mm in size, would not have been able to hold a large enough fire to heat the main room. However, the ragged western edge may mean that some of the hearth has been removed.

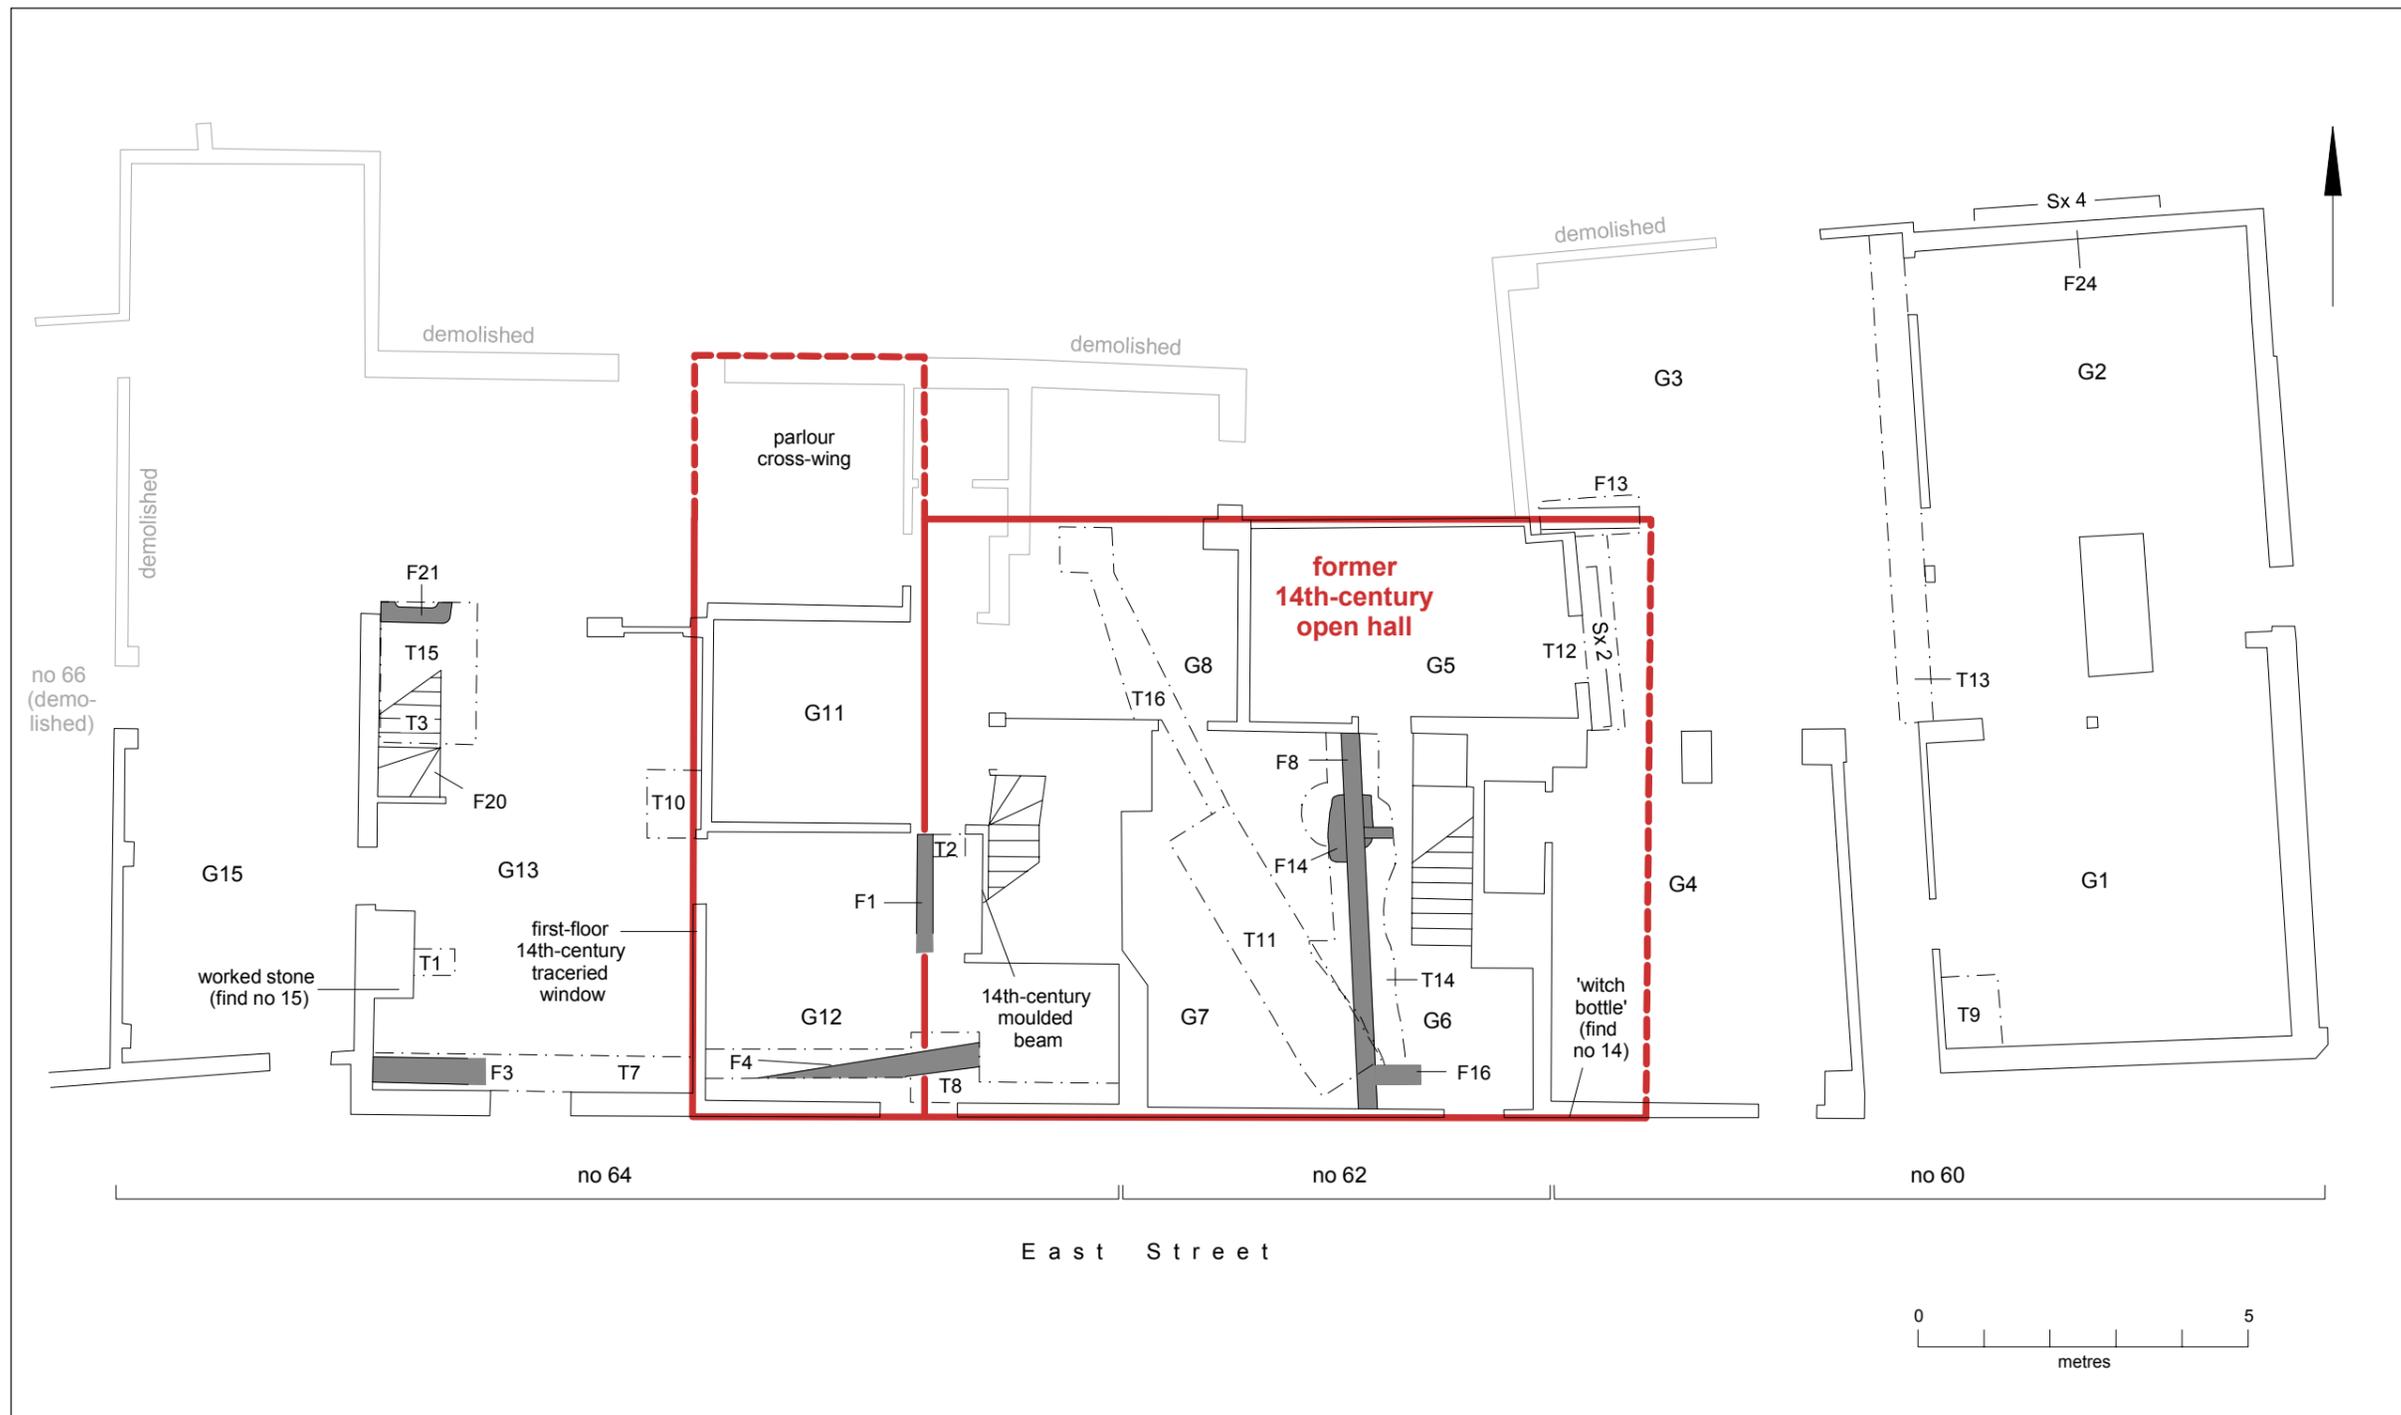
Fig 2 Plan of 60-66 East Street, showing the trenches and main archaeological features (shaded).

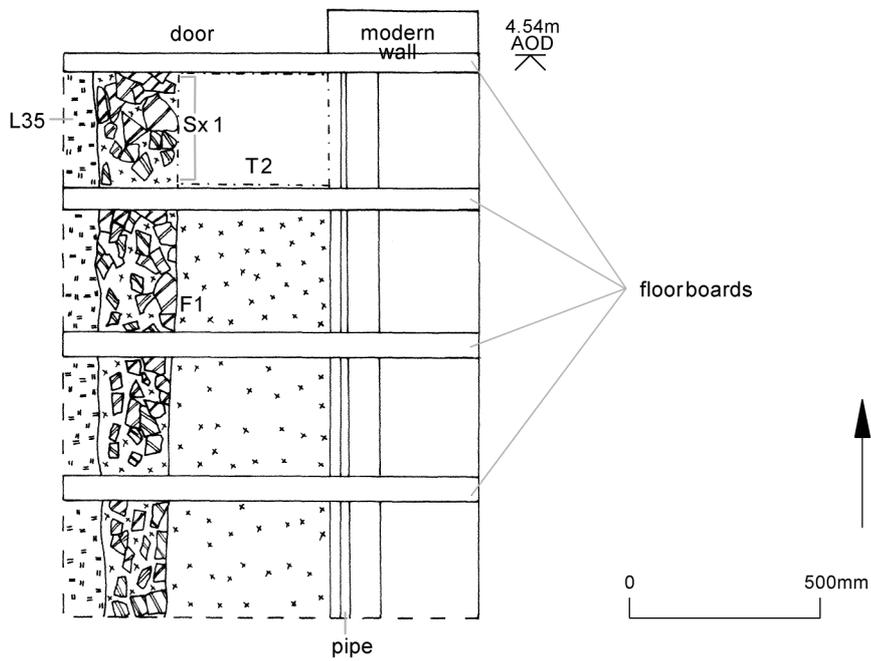
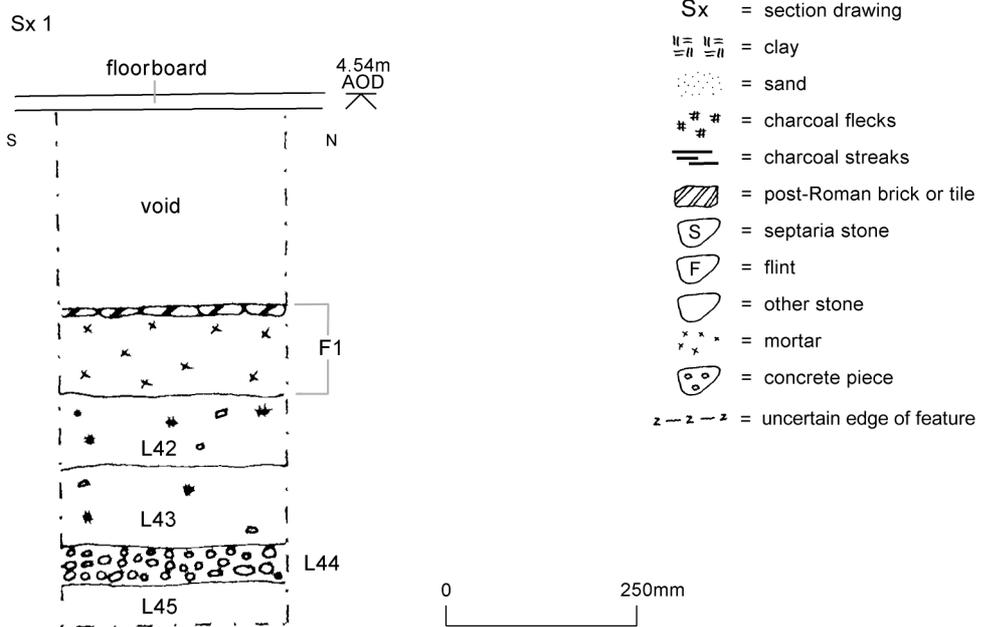
This trench was dug on the eastern side of wall F1 and is within the 14th-century open hall. It was dug to a depth of 700mm below the modern floorboards. The following profile was observed (Sx 1):

- F1 – this was seen to have a 100mm thick mortar sub-base (see section 6.2).
- L42 – F1 sealed a 100mm band of dark greyish black brown sandy loam containing flecks of tile and charcoal, possibly a previous medieval occupation layer. This layer contained modern sugar tongs (find no 11) and floor bricks but these may have come from L1 and been mis-assigned.
- L43 – underlying L42 was a 100mm-thick layer of light-mid brown yellowish sandy clay with occasional stones and charcoal flecks, a possible floor.
- L44 – a stone surface 40mm thick.
- L45 – mid brown sandy loam, possibly natural ground; this was reached at 650mm below modern ground-level.

Fig 3 T2: F1; plan and east-facing section.

In Room G12 (no 64 East Street), a shallow, 450mm-wide wall foundation was exposed (F1). This followed a north to south alignment and was constructed of peg-tile set flat into a 100mm-thick mortar sub-base. One piece of Roman wall-plaster had been used in the fabric. This room occupies what was the western end of the 14th-century open hall building. The feature is likely to have been a plinth of a medieval timber wall, which probably divided the high end of the open hall from a parlour cross-wing. The wing was jettied into the hall to create a projecting canopy of honour above the dais; the moulded beam being still visible. The top of this wall foundation was 280mm below the modern floorboards. A clay floor was recorded to the west of it. Other plinths of this type have been excavated in Colchester, in Building 76 at the Middleborough excavations of 1979, and dated to 1450-c 1600, although those with re-used Roman building materials and peg-tile were dated c 1350-1450 (Brooks & Crummy 1984, 199-200). The 14th-century open hall building may have featured a service cross-wing at its eastern end, but this cannot be proved. 60-66 East Street is not the first medieval open hall building to be excavated in Colchester. The New Market Tavern at Middleborough was recorded by CAT before being demolished in 1978 (Building 76 in Brooks & Crummy 1984, 198-203). Building 75 also included an open hall.

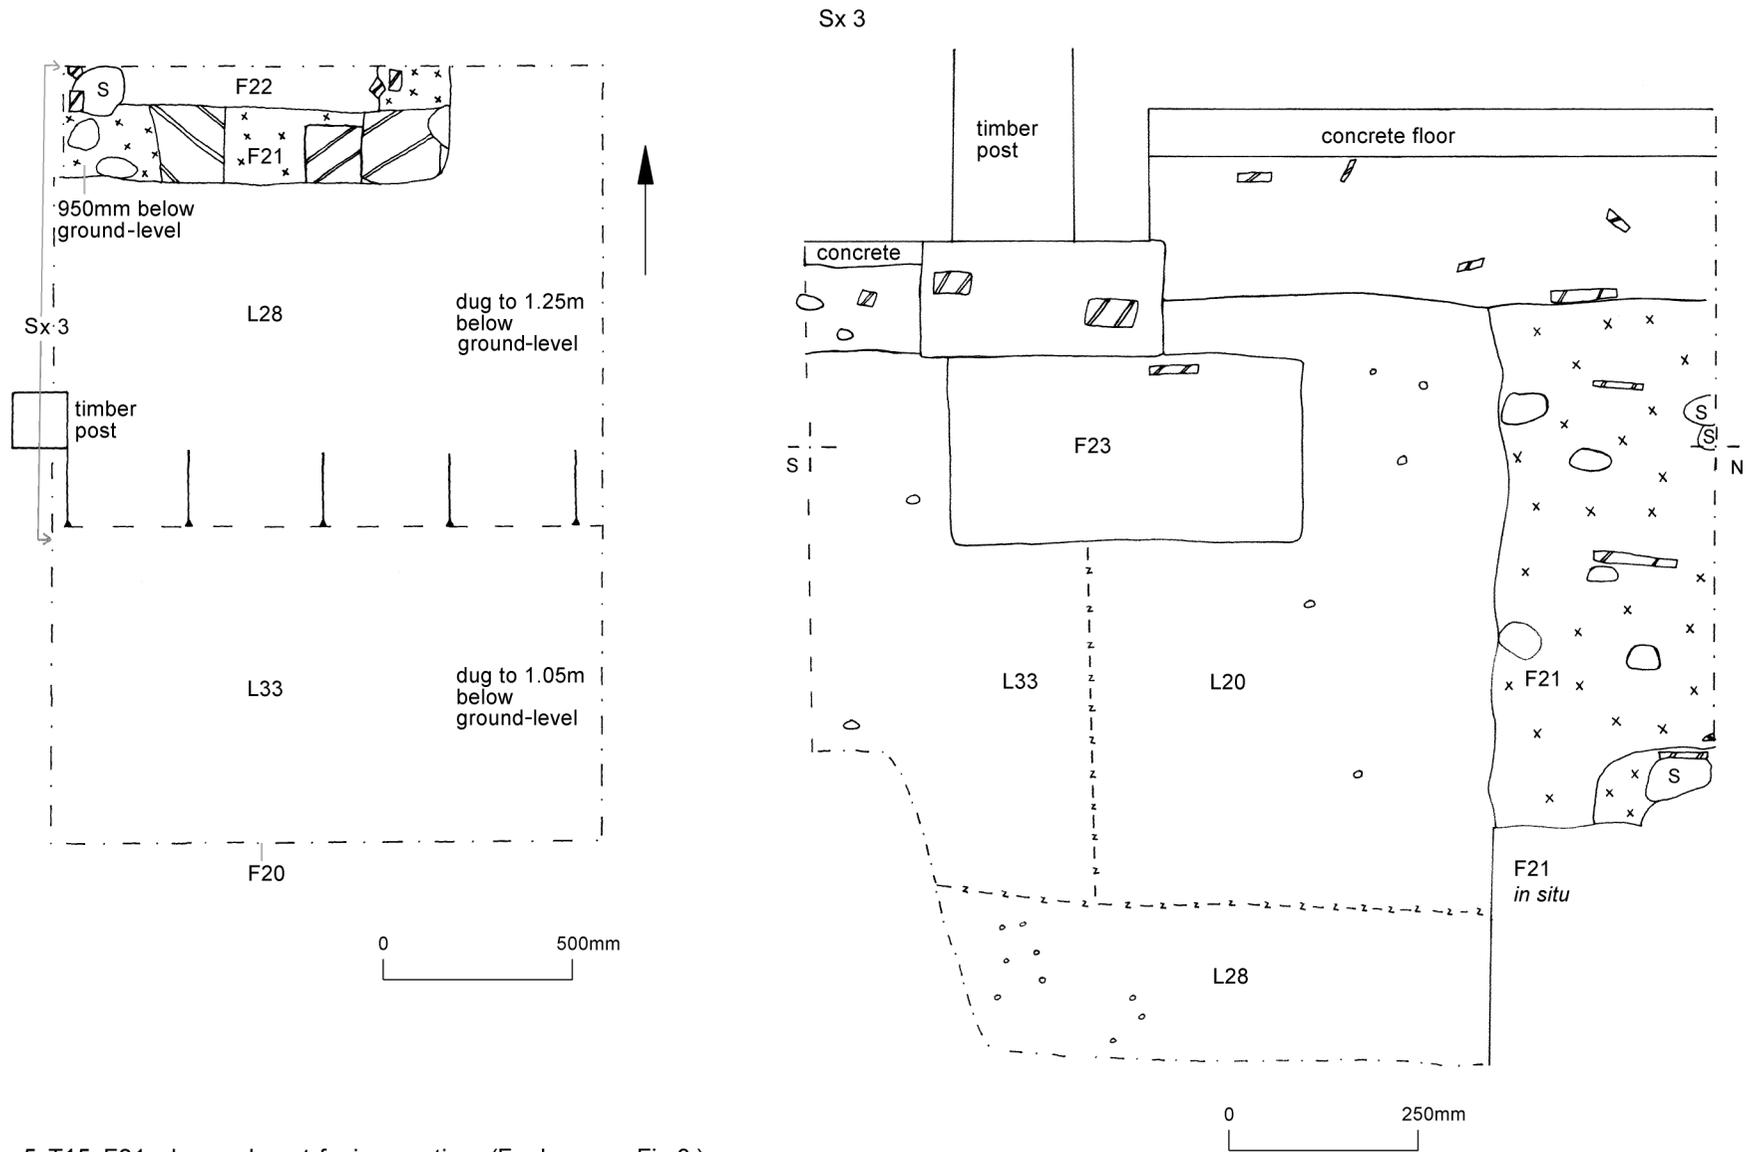
Underneath the modern concrete floor and brick rubble (L34) were the remains of a wall (F21) extending from east to west along the northern edge of the trench. The wall, which was between 170mm and 200mm wide, then returned to the north. This feature extended to a depth of 1.25m and was not bottomed. This was similar to F8 in T11 and T14 (see section 6.3), being made up of large nodules of flint and septaria, layered with peg-tile and bonded with mortar. However, it was less ornate and of much greater depth, and therefore it was not a plinth for a timber wall. The wall had been cut away by a large straight-sided ditch (F22) filled by mid brown silty clay with clay patches and containing peg-tile. To the south of F21 there were no occupation layers abutting the wall, merely garden soil L20.

In the east-facing section (Sx 3) and north-facing section, no evidence of medieval occupation layers was recorded, suggesting that this area did not lie within the footprint of the earliest building.

Fig 5 T15: F21; plan and east-facing section. (For key, see Fig 3.)

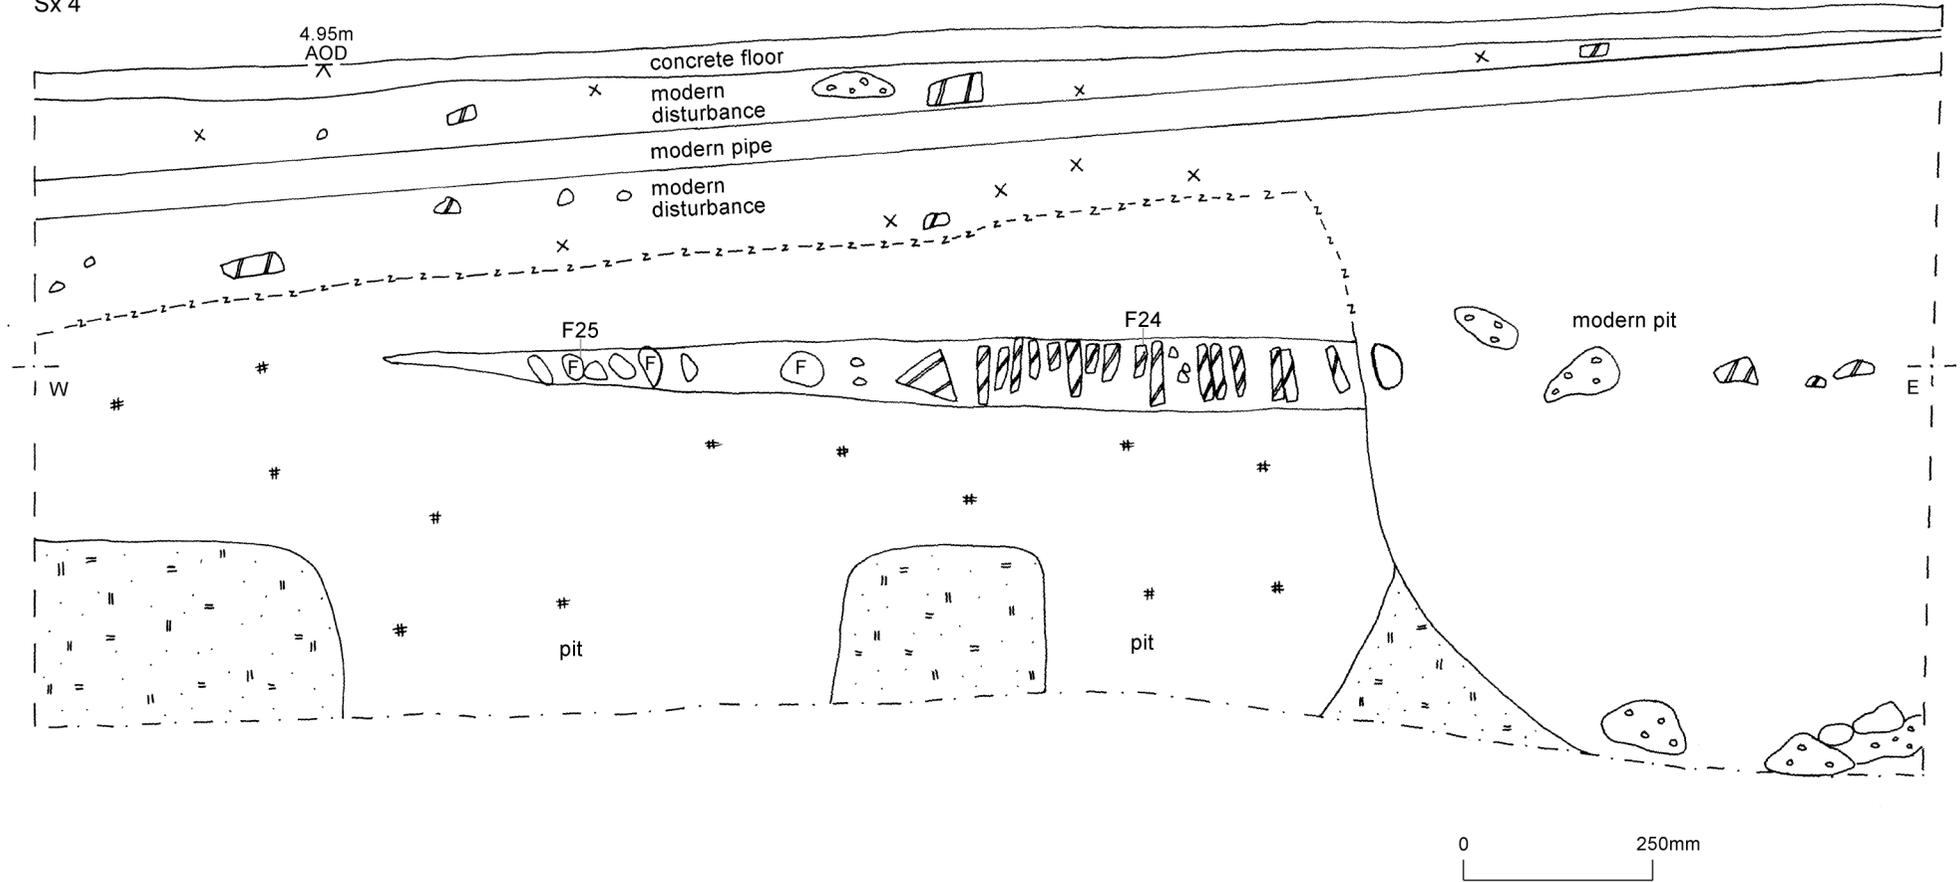
Sx 4

At the eastern end of the building (no 60 East Street), contractors replaced the rear foundation wall and exposed another hearth (F24). This feature was only seen in the south-facing section of the trench (Sx 4). It was made of upturned peg-tiles, similar to F14, and had been cut by a modern pit. To the west of the hearth was a surface consisting of small flint cobbles. This hearth was found within the later 17th-century part of the building but is not this late. Both F24 and F25 started 400mm below ground-level.

Fig 6 T17:F24; south-facing section. (For key, see Fig 3.)

In Room G2 (no 60 East Street), another hearth was exposed (F24). This feature was only seen in the south-facing section of the trench. It was made of upturned peg-tiles, similar to F14, and had been cut by a modern pit. To the west of the hearth was a surface consisting of small flint cobbles (F25). Although this hearth was found within the later, 17th-century part of the building, it is not this late. The similarity of F24 to F14 make it likely that they are of similar date (later 14th-16th century). By the 17th century, these types of open hearths had gone out of use as large central chimney stacks with fireplaces were inserted into medieval properties (Harris 1987, 18-19; Brooks & Crummy 1984, 195). This second hearth may well relate to a separate building, possibly contemporary with or one century later than the open hall building (Leigh Alston pers comm). The clay floors found in G3 (section 6.2) may relate to the same building as hearth F24.

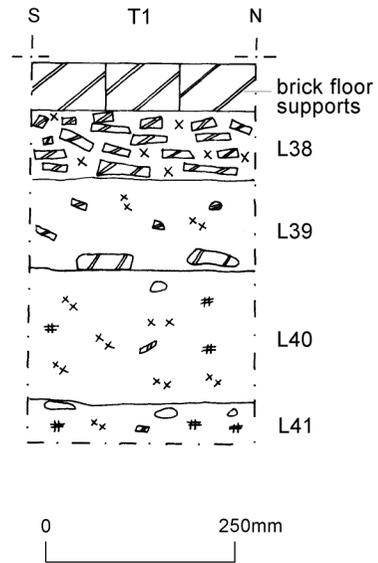
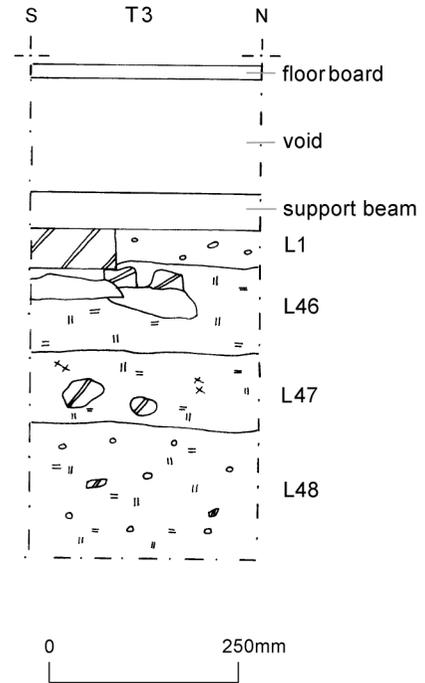
The following profile was recorded (Sx 5):

This trench was dug to a depth of 650mm below the floorboards. It was later dug through by T15 (see section 6.2). The following soil profile was recorded (Sx 6):

Fig 7 T1, east-facing section and T3, east-facing section.  
(For key, see Fig 3.)

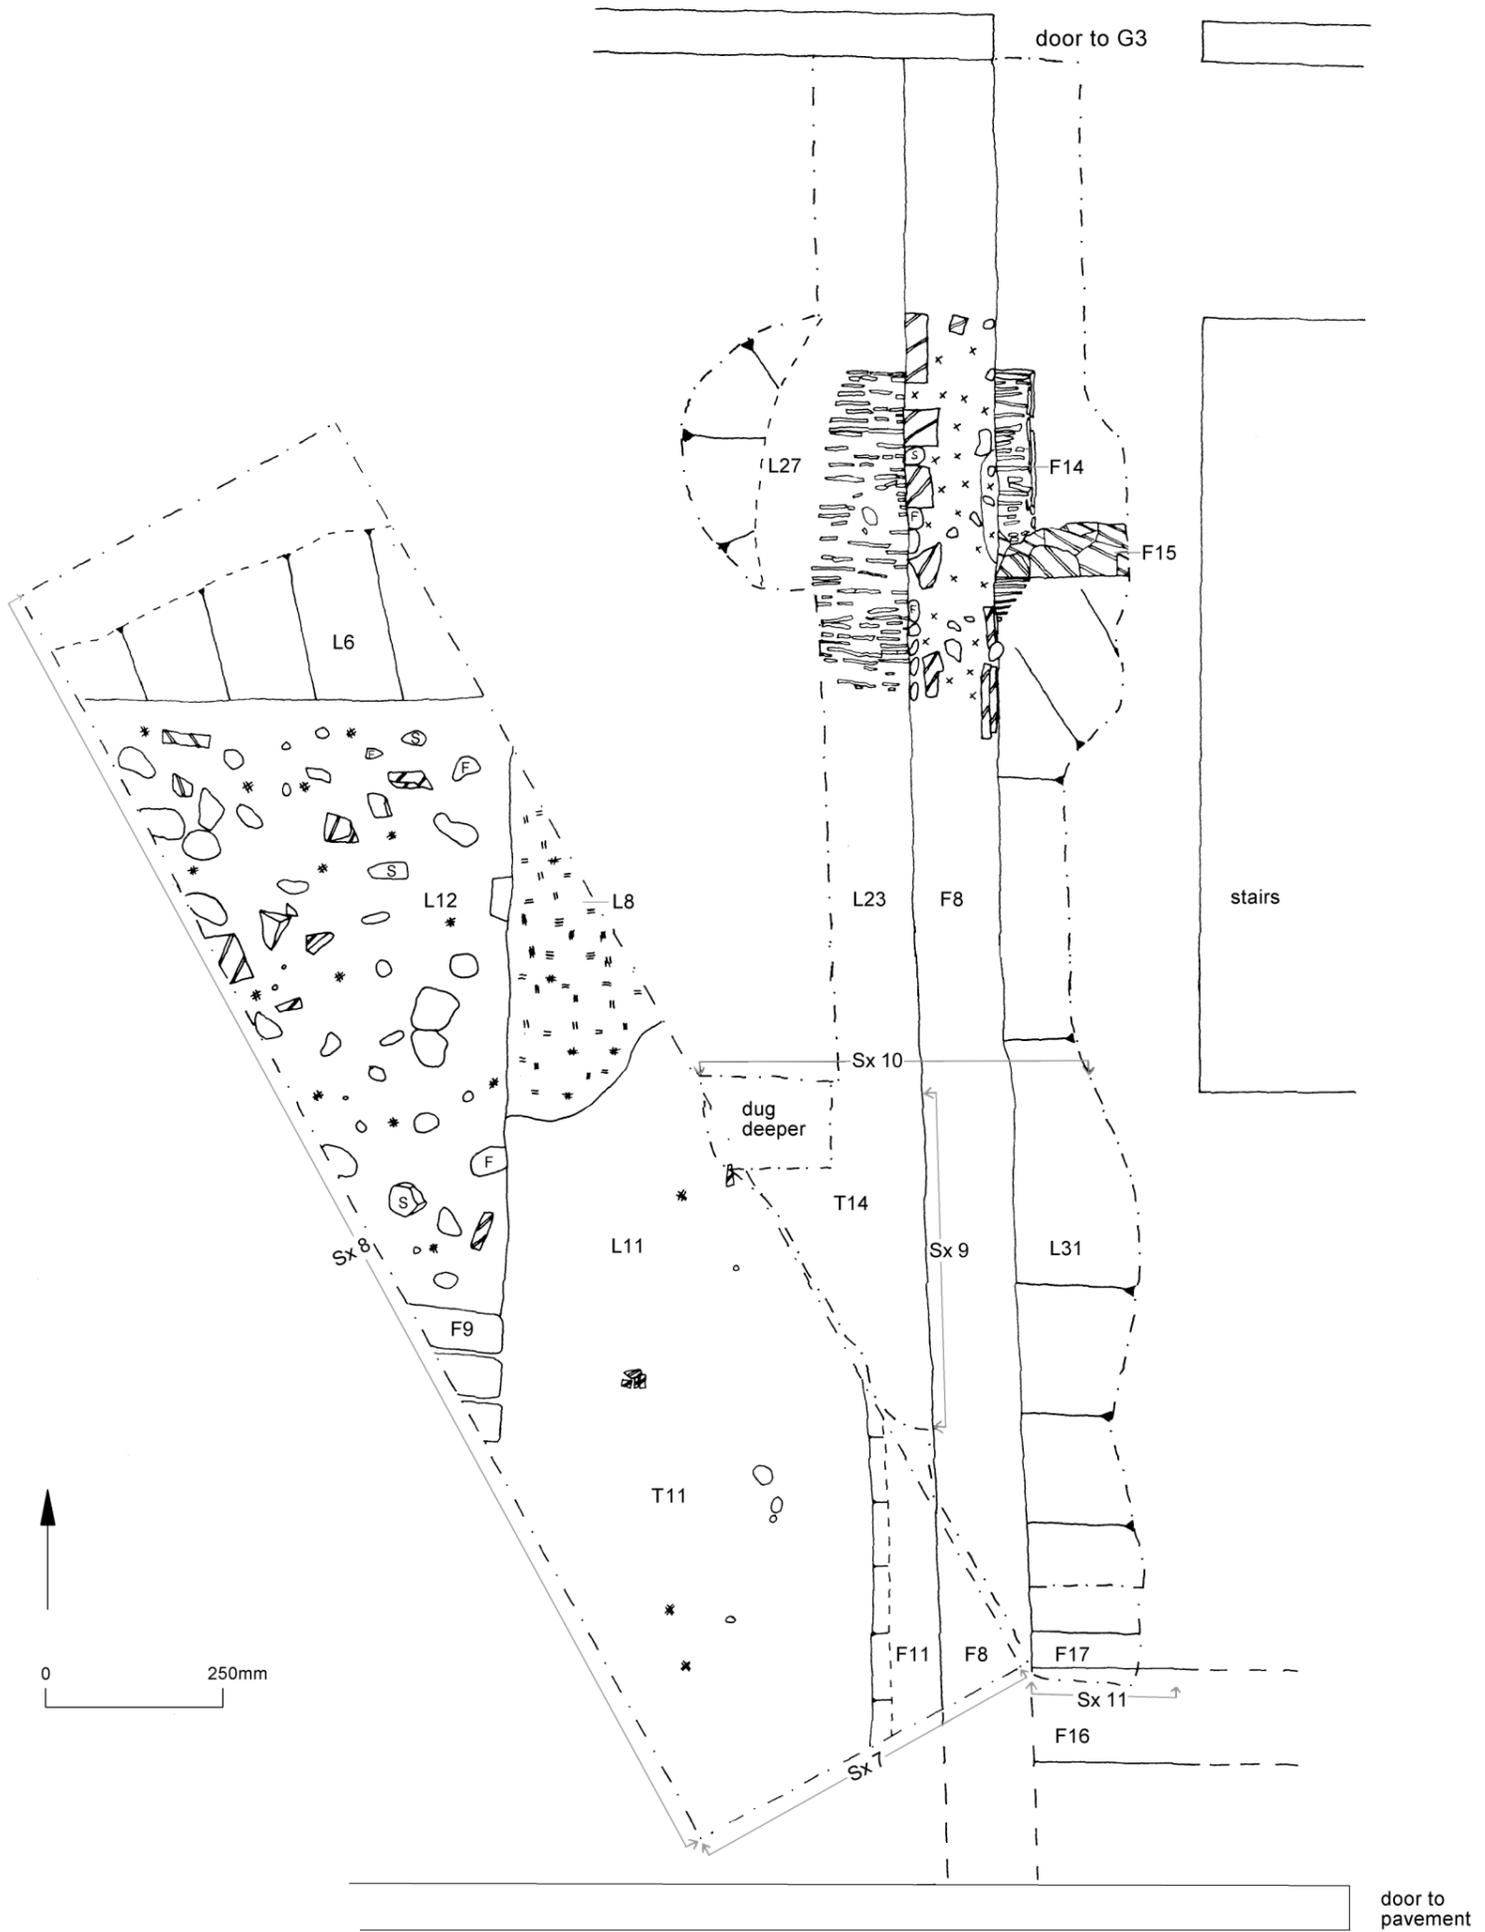
Fig 8 T11 and T14: plan showing hearth F14 and wall F8. (For key, see Fig 3.)

T11 in Rooms G6/G7 (no 62 East Street) was dug within the area of the 14th-century open hall. A flint and mortar foundation with courses of peg-tile was exposed (F8; Fig 3). A further trench was excavated by CAT in which more of this feature was recorded (T14). F8 is interpreted as having been a plinth for a timber wall which no longer survives. The plinth would have been partly above ground, thereby raising the wooden ground plate off the ground and preventing it from becoming rotten. There were only two bricks within the plinth's fabric, making it unlikely to be later than medieval or early post-medieval in date. Therefore a date of the 15th to mid 16th century is likely. It was built directly on top of the hearth (F14), and therefore post-dates it. Something similar was excavated in Building 75 at the Middleborough site, a 16th-century plinth built directly onto a 15th-century hearth (Brooks & Crummy 1984, 194).

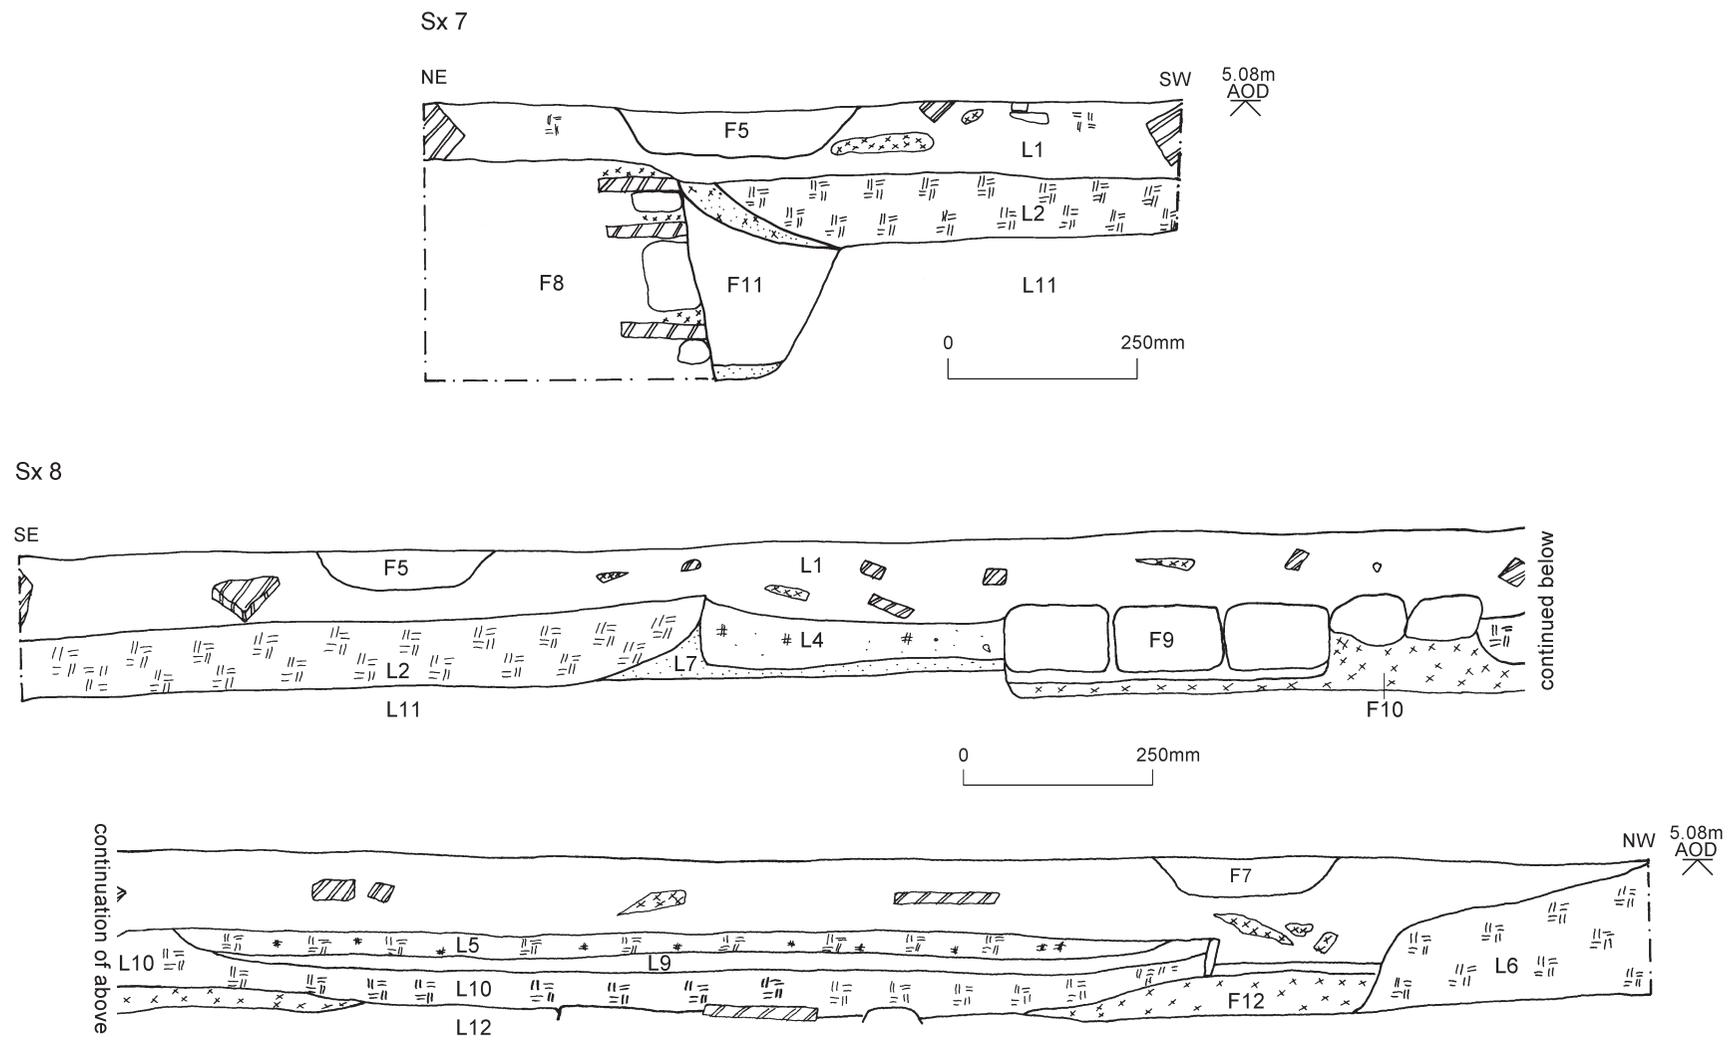
- L1 – 100mm of surface debris; mixed loose sandy silt, with burnt wood and charcoal.
- F5, F6 and F7 – three shallow modern slots for joist supports, filled by dark grey silty dust and cut into L1.

- F9 – a wall built of one course of red unfrosted bricks, probably post-medieval. The wall is aligned in a north to south direction. The cut for the wall (F10) returns to the west but the bricks do not survive here. This is not the base for the partition wall between Rooms G6 and G7 but it does follow the same alignment (Sx 8).

Fig 9 T11: top, north-west-facing section and bottom, north-east-facing section. (For key, see Fig 3.)

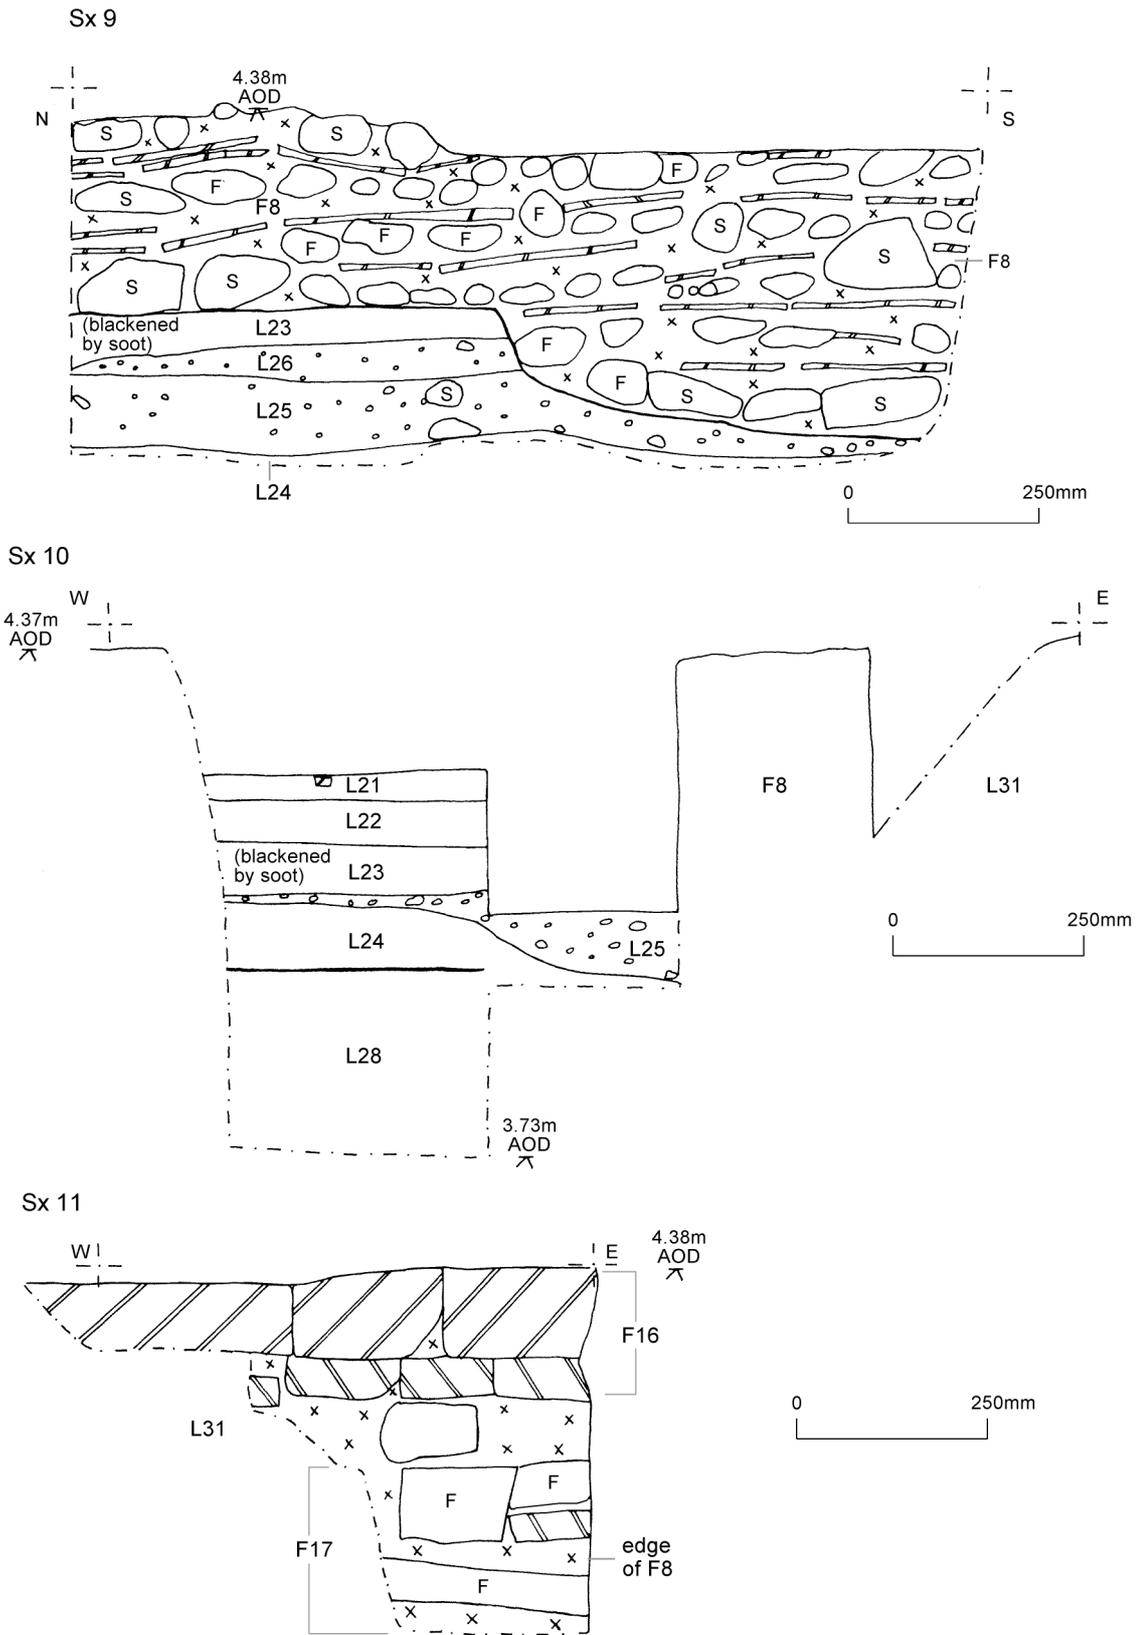
- F17 – a wall or foundation on an east to west alignment, partially below F16, made of large squared pieces of flint bonded with mortar; wall F8 was found to butt up against F17 and is probably part of the front wall to the same late medieval or early post-medieval building.

Fig 10 T14: F8, south- and west-facing sections and F16-F17, north-facing section. (For key, see Fig 3.)

On the south side of the room, the north-south plinth (F8) butted at right angles against a flint and mortar wall (F17) which could be the foundation for the frontage of the 15th- or 16th-century building.
