**An archaeological investigation  
of the Roman town wall at  
Roman Road, Colchester, Essex  
October 2004 and February 2006**

**survey and report prepared by  
Kate Orr, Mariusz I Górnjak, Chris Lister**

**CAT Report 356**  
April 2006

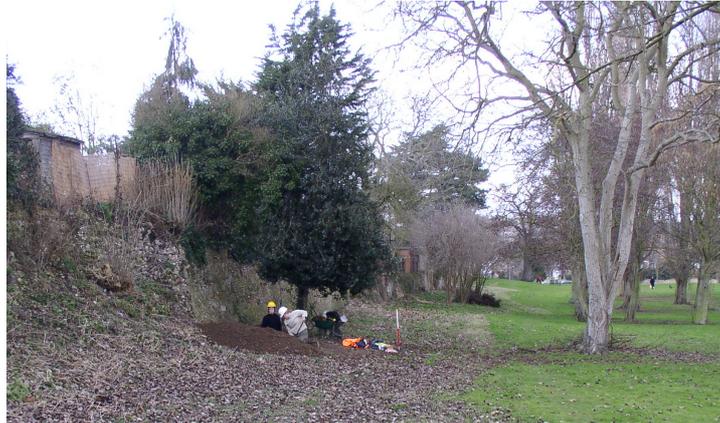
- Plate 1 Trench 2, looking north-west. front cover  
Plate 2 Foundations of wall in Trench 1, looking west. 3

The second trench was positioned to the north of Trench 1, 700mm away from the exterior face of the wall. The wall foundations were not encountered, necessitating a narrow slot to be dug on the western side of the trench to take it right up the wall face. This slot confirmed that the wall foundations do not survive here but have been robbed out. A robber trench (F3) running parallel to the wall was recorded cutting into redeposited natural ground (L6). This robber trench consisted of dark grey brown silt with mortar and a high stone content including some septaria. The presence of post-medieval brick and tile give a fairly late date for this robbing. The robber trench was sealed by a series of post-medieval to modern layers indicating recent digging and dumping in this area.

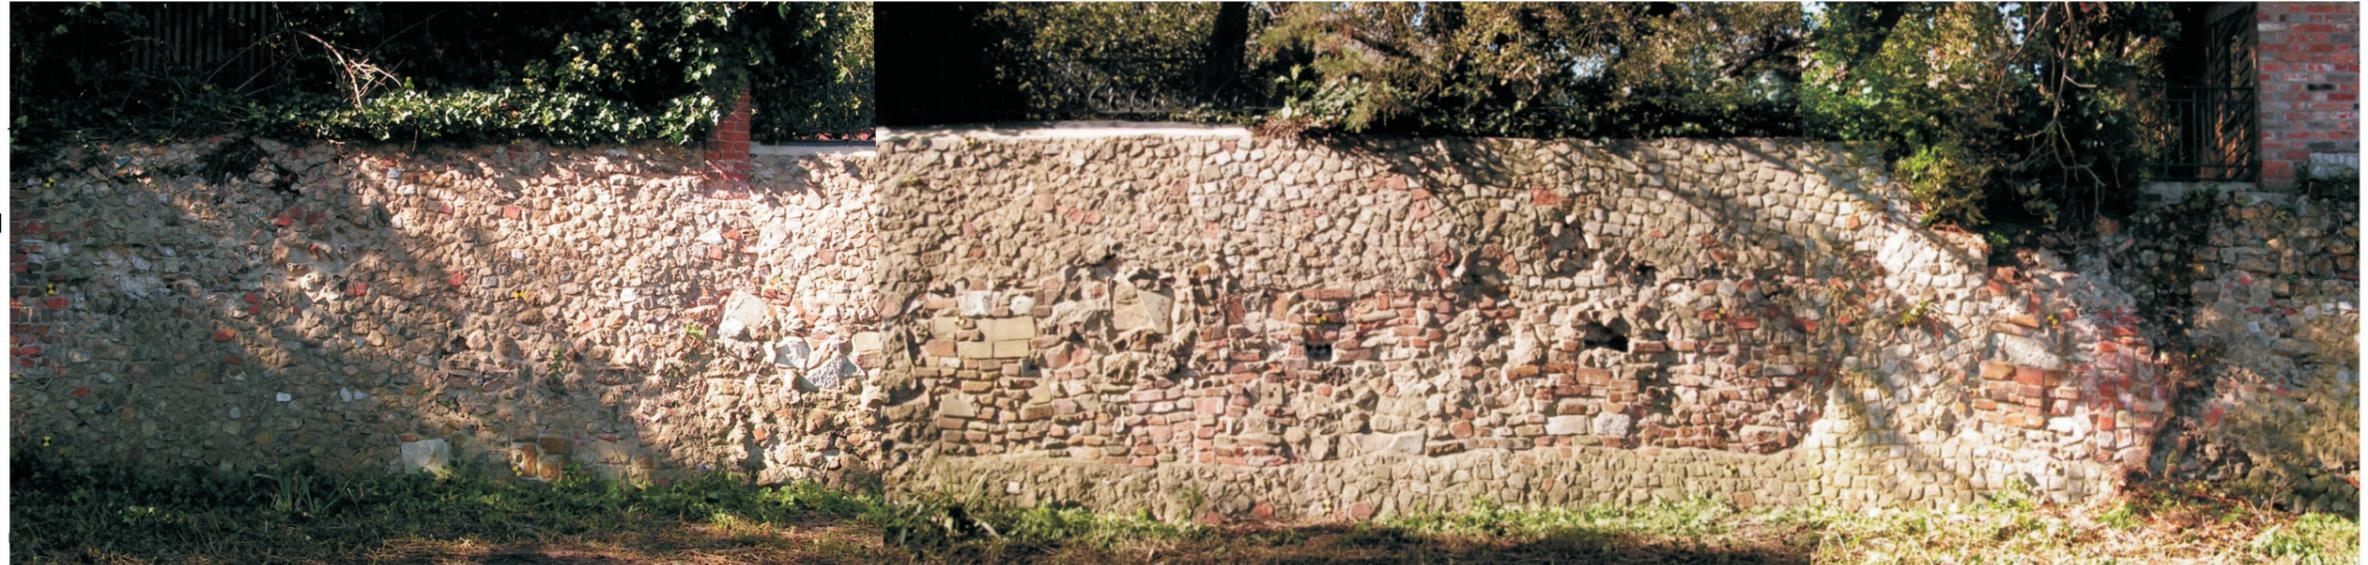
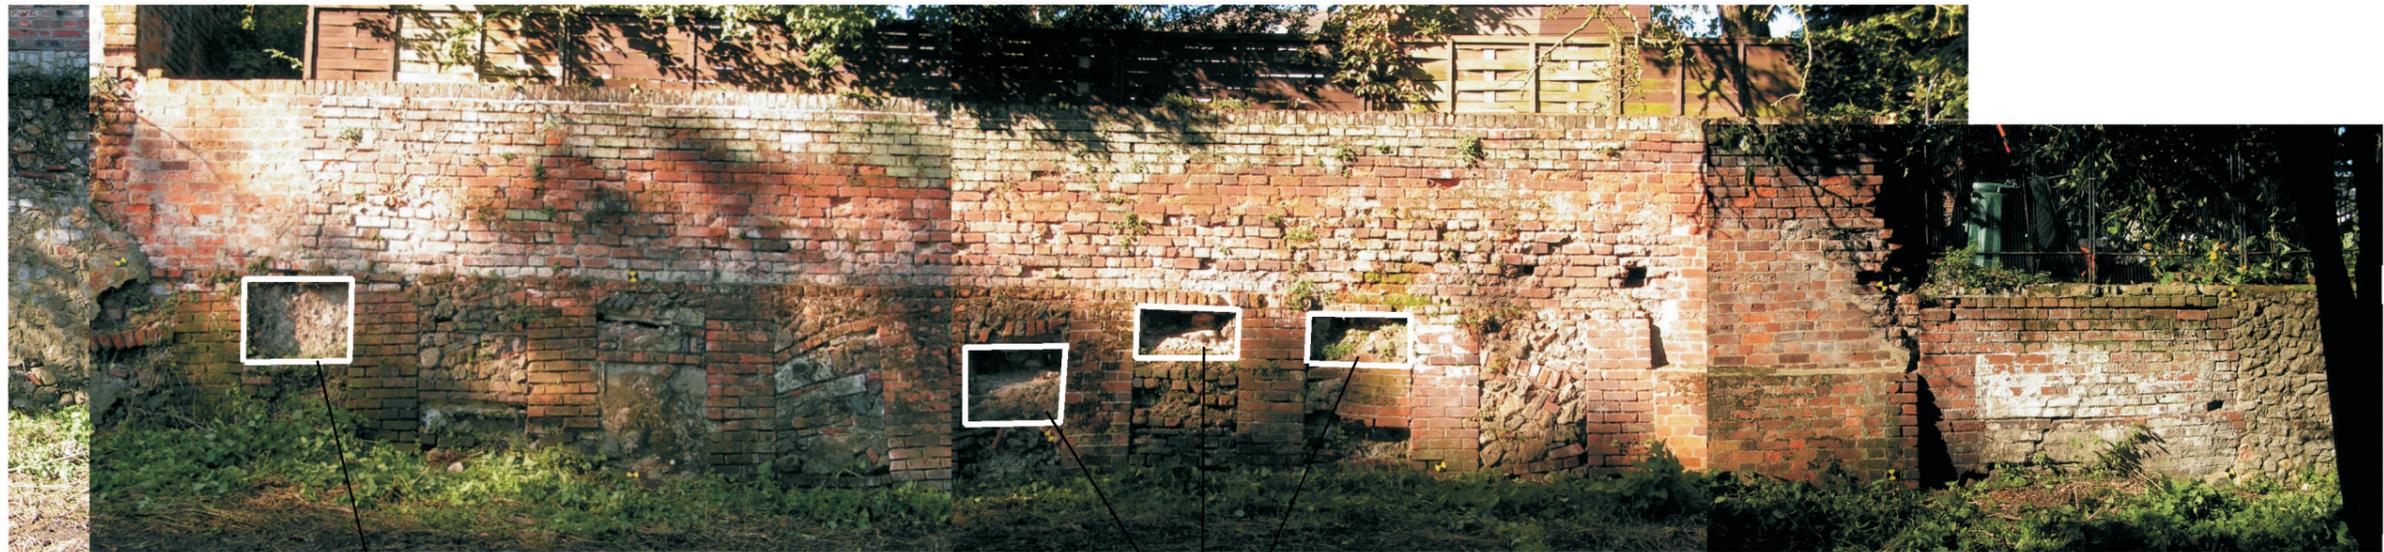
Fig 7 Wall elevation: sheet 3.

Roman wall

6	2 3	25 Roman Rd.	Septaria and occasional brick in dense polygonal bond, Red-bricks and stone	Second half of 19th century (1860s?) and early 20 <sup>th</sup> century (1930s?)	Modern repair of the wall. It completely obscures the remains of Roman wall. The <i>terminus ante quem</i> for this repair is the early 1950s. <i>Terminus post quem</i> is the turn of the 19th century. The most plausible date seems to be the 1930s. At the back of no 25 is a Victorian date (1860s) wall with the early 20th century (1930s) facing on its lower part.
7	3	27 Roman Rd.	Septaria and occasional brick in dense polygonal	Second half of the 19 <sup>th</sup> century (1860s?)	Very similar to Section 6 - a modern facing/repair (of the 1930s) on a 19th

pattern Red-bricks Red-bricks and stone	and early 20th century (1930s?)	century brick and stone wall (of probably 1860s date). In the central part of the section is a brick semicircular feature, which may mark the position of a Roman culvert.
<b>8</b>	3	29 Roman Rd.	Red brick and septaria blocks	Modern 19 <sup>th</sup> /20 <sup>th</sup> century	Of red-brick construction - a plain wall in the upper part, with segments of the core of the Roman wall visible in the lower part. It seems that the lower part of Section 8 marks the height of the Roman wall remains. The Roman wall is visible only in 4 segments - 'windows'. A further 5 'windows' are filled with a very peculiar and random pattern, presumably an artistic impression of the Roman wall.
<b>9</b>	3	31 Roman Rd.	Red-bricks, bricks and septaria	Modern 19 <sup>th</sup> /20 <sup>th</sup> century and early 20th century (1930?)	Brickwork, probably contemporaneous with the brick segment in Section 8. South from it there is modern facing - of 1930s date - which probably follows the height of the preserved Roman wall as it slopes down.

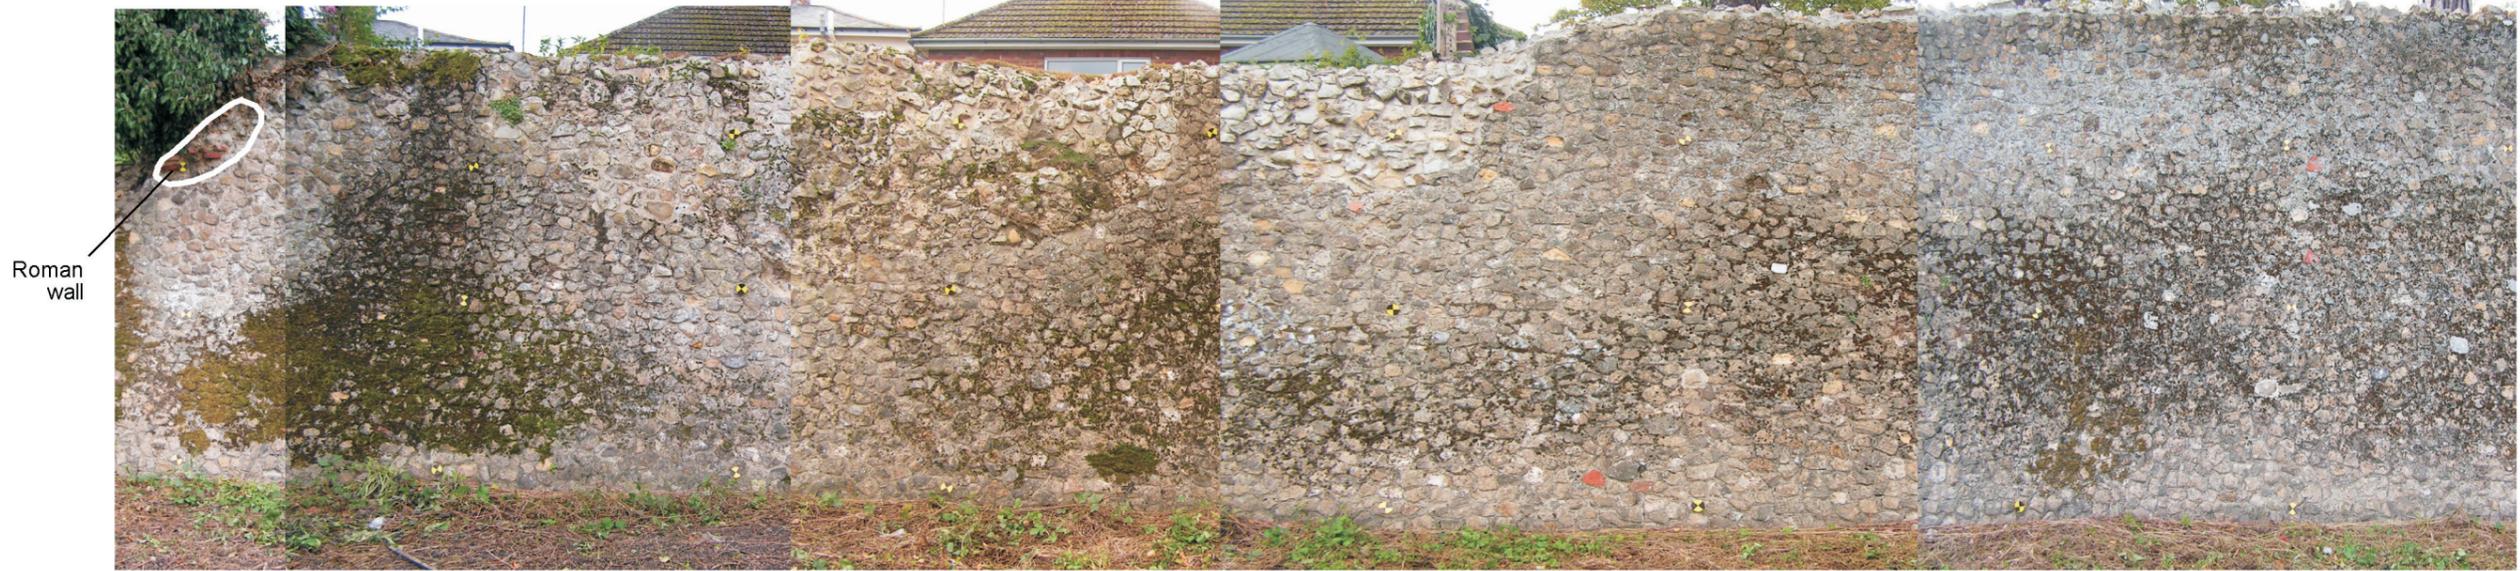
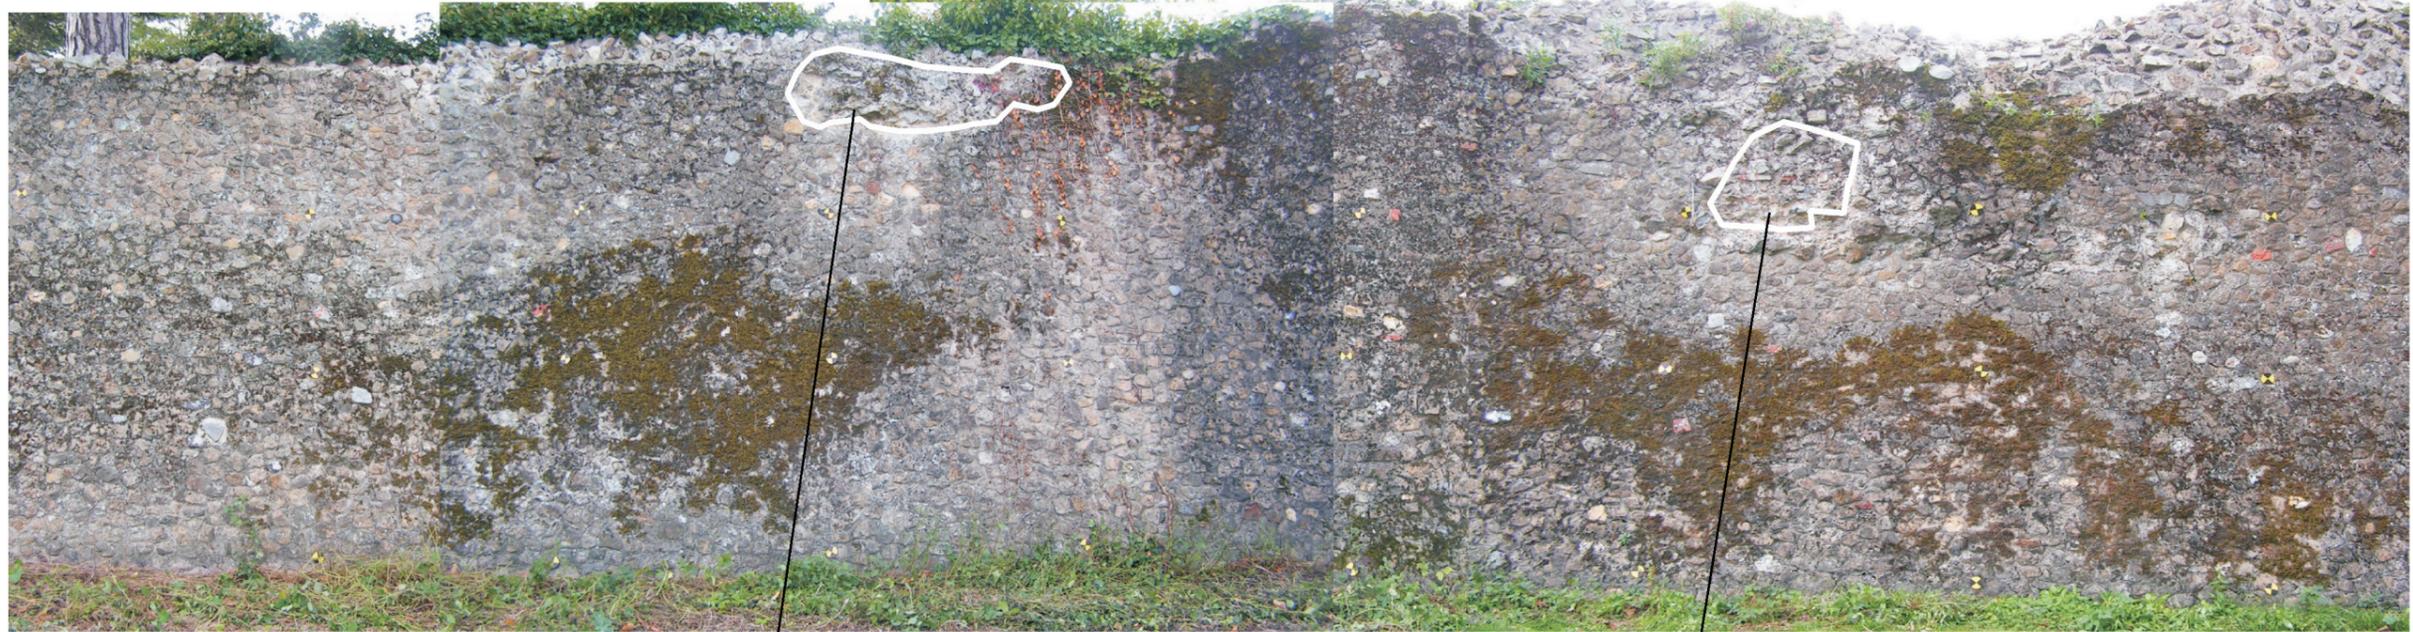
Fig 10 Wall elevation: sheet 5.

Roman wall

<b>15</b>	6 7	57 Roman Rd. and Society of Friends (Quakers) Burial Ground	Septaria and occasion other stone with occasional brick	Modern - early 20th century (1930s) and the 1990s	Facing made of septaria and other stone with occasional post-medieval and Victorian brick - polygonal pattern. Its early 20th-century date (the 1930s) is the most plausible. Fragments of Roman wall (core?) visible in northern part of the section. Recent (of the 1990s) repairs at the top of the section.
