**An archaeological watching brief at
St Michael's Church, Kirby-le-Soken, Essex
July and October 2007**

**report prepared by
Kate Orr**

**commissioned by
the Morton Partnership
on behalf of
St Michael's Church PCC**

CAT Report 441

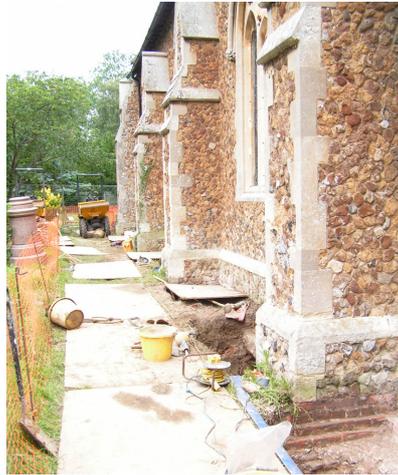
Plate 1 (front cover) the underpinning along the south aisle of St Michael's Church, view WNW.

- 5.1** The south aisle wall was underpinned by contractors hand-digging 21 rectangular pits (or 'pins') in a staggered fashion all the way along the exterior which were then filled with concrete. These pits were dug to a depth of 2.5m below ground-level and were wide enough to extend underneath the aisle foundations. By this method, a continuous strip foundation was achieved (see Fig 2).

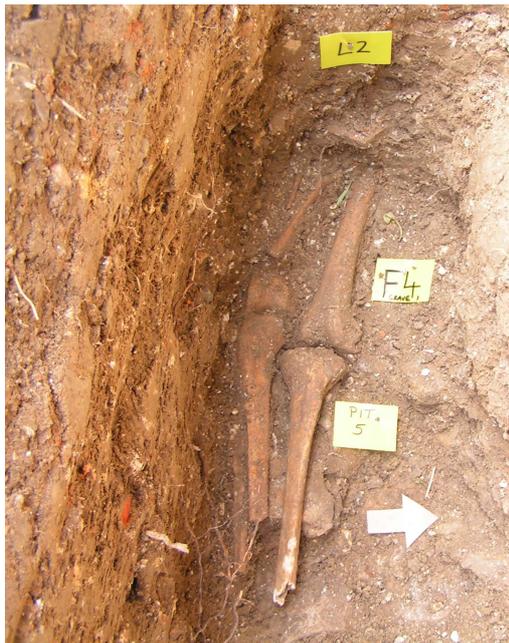
Plate 2: burial F4, view west.

One articulated skeleton was found here, consisting of leg bones (F4). The contractors had already picked up some of the foot bones. The head end would have been to the east and was outside the reach of the pit. The skull and another long bone were found while digging the adjacent pit to the west. Another piece of skull and an arm bone, probably of another individual, were found above the leg bones. The skeleton was encountered at 780mm below ground-level. It appeared to be lying on top of lumps of septaria which seemed to belong to the 19th-century rubble foundation F3. If so, then the burial post-dates the rubble foundation and therefore is post-1833. Peg-tile was the only datable find from the burial but this was in use from c AD 1200 to the present day.

Two articulated skeletons were exposed. The first burial (F4) was 780mm below ground-level and appeared to be cutting the rubble foundation (F3) which is 19th century. It is possible that F4 could be a post-1833 burial. The second skeleton (F8) was much lower down at 2m below ground-level and was overlaid by the rubble

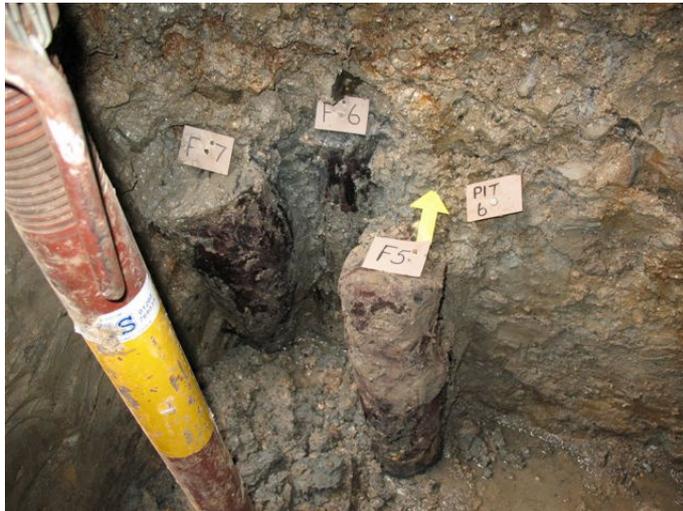
Plate 3: wooden piles F5, F6 and F7, view north-west.

The pit dug at the extreme western end of the south aisle, where it joins the tower, proved to be of interest. The pit was dug to a depth of 2.3m below ground-level and the rubble foundation (F3) was removed. Natural greyish clay had been reached and water was starting to seep up into the base of the pit. Two water-logged wooden piles (F5 and F6) were exposed and later inspection exposed a third (F7). All three were in the north-western corner of the pit and were upright. They were circular and had been cut flat on top. The only fully exposed pile (F5) had a diameter of 130mm, although F7 looked wider than F5 and F6. All three piles projected 470mm up from the base of the pit and were driven into the clay. They were underneath the rubble foundation (F3). No attempt was made to remove the piles; they were left *in situ*. A sample of F5 was taken for radiocarbon dating. A box was then made around the piles to protect them, and the pit was filled with concrete.

The pile was identified as elm (*Ulmus* sp.). The pile consisted of wide roundwood measuring 125mm in diameter. The wood was intact to the wood/bark interface but the bark was absent. About 14 annual growth rings were present. These were wide and indicated fast-growth, suggesting that the tree had grown in optimal conditions with little competition from other vegetation.

The radiocarbon date, when calibrated, indicates two probable date ranges. At 1 sigma (68.2%), the probable date lies at 1315-1350 or 1390-1420, and at 2 sigma (95.4%), the probable date ranges are 1300-1370 and 1380-1440. In other words, the felling of the tree used to make the pile can almost certainly be dated to the 14th to mid 15th century and probably c 1330 or c 1400.

Three water-logged wooden piles (F5, F6, F7) made of elm were exposed where the tower joins the south aisle. The piles were under the south wall of the tower. The radiocarbon date of one of the three wooden piles suggests that the tower was built in the 14th or first half of the 15th century. This accords with the date of the tower on stylistic grounds. Presumably all three piles are contemporary and were inserted by the medieval builders when constructing the foundations to the tower, the wet ground conditions as well as the massive proportions of the tower probably necessitating such piling. The stone foundation that the piles supported had presumably been removed by the substantial 19th-century foundations.

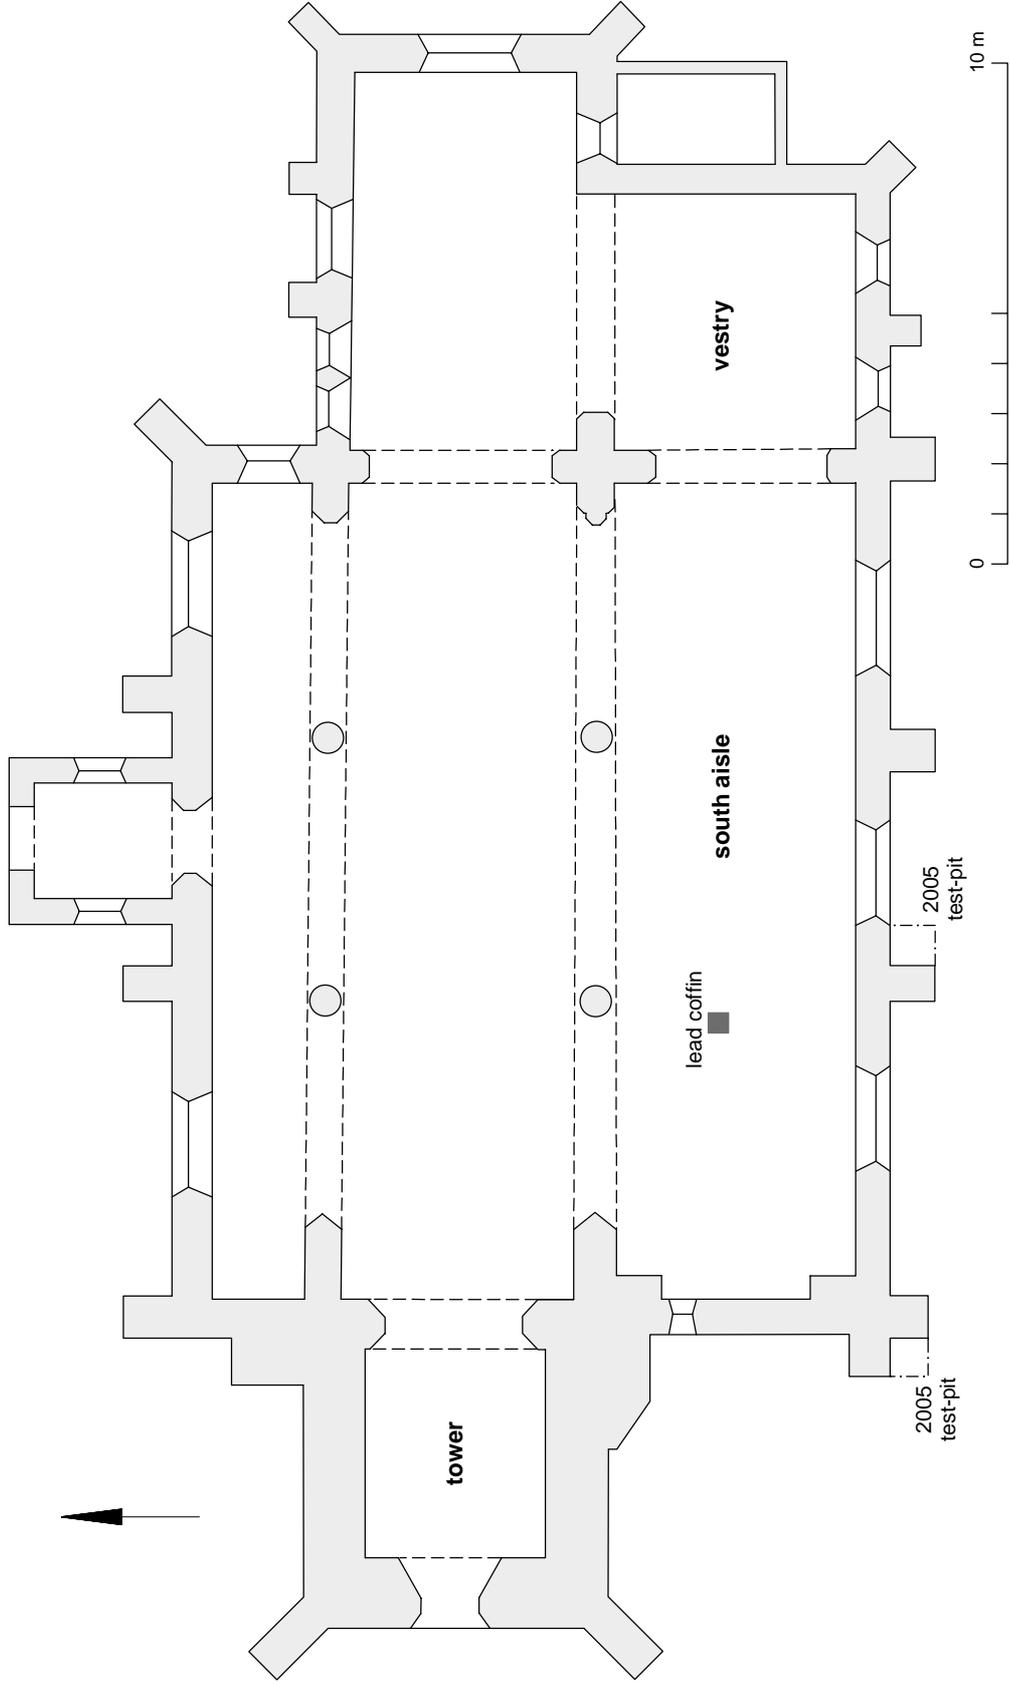
Fig 1 Church ground-plan (after RCHME 1922).

- 4.1 Only the 14th-century chancel and north aisle and the apparently 15th-century west tower survive from the medieval church (Essex Historic Environment Record or EHER no 3572). The tower is 'surprisingly big and important looking' (Bettley & Pevsner 2007, 514). The church is now, essentially, a 19th-century building following the complete rebuilding of the nave, south aisle and chapel. Rodwell and Rodwell (1977, 111) state that the south aisle, nave and chapel were completely rebuilt in 1833 and restored in 1870-73. However, Pevsner and Bettley (2007, 515) state that the chancel was rebuilt in 1870 and the nave restored in 1872, including new arcades, new south aisle and organ chamber on south side the chancel.

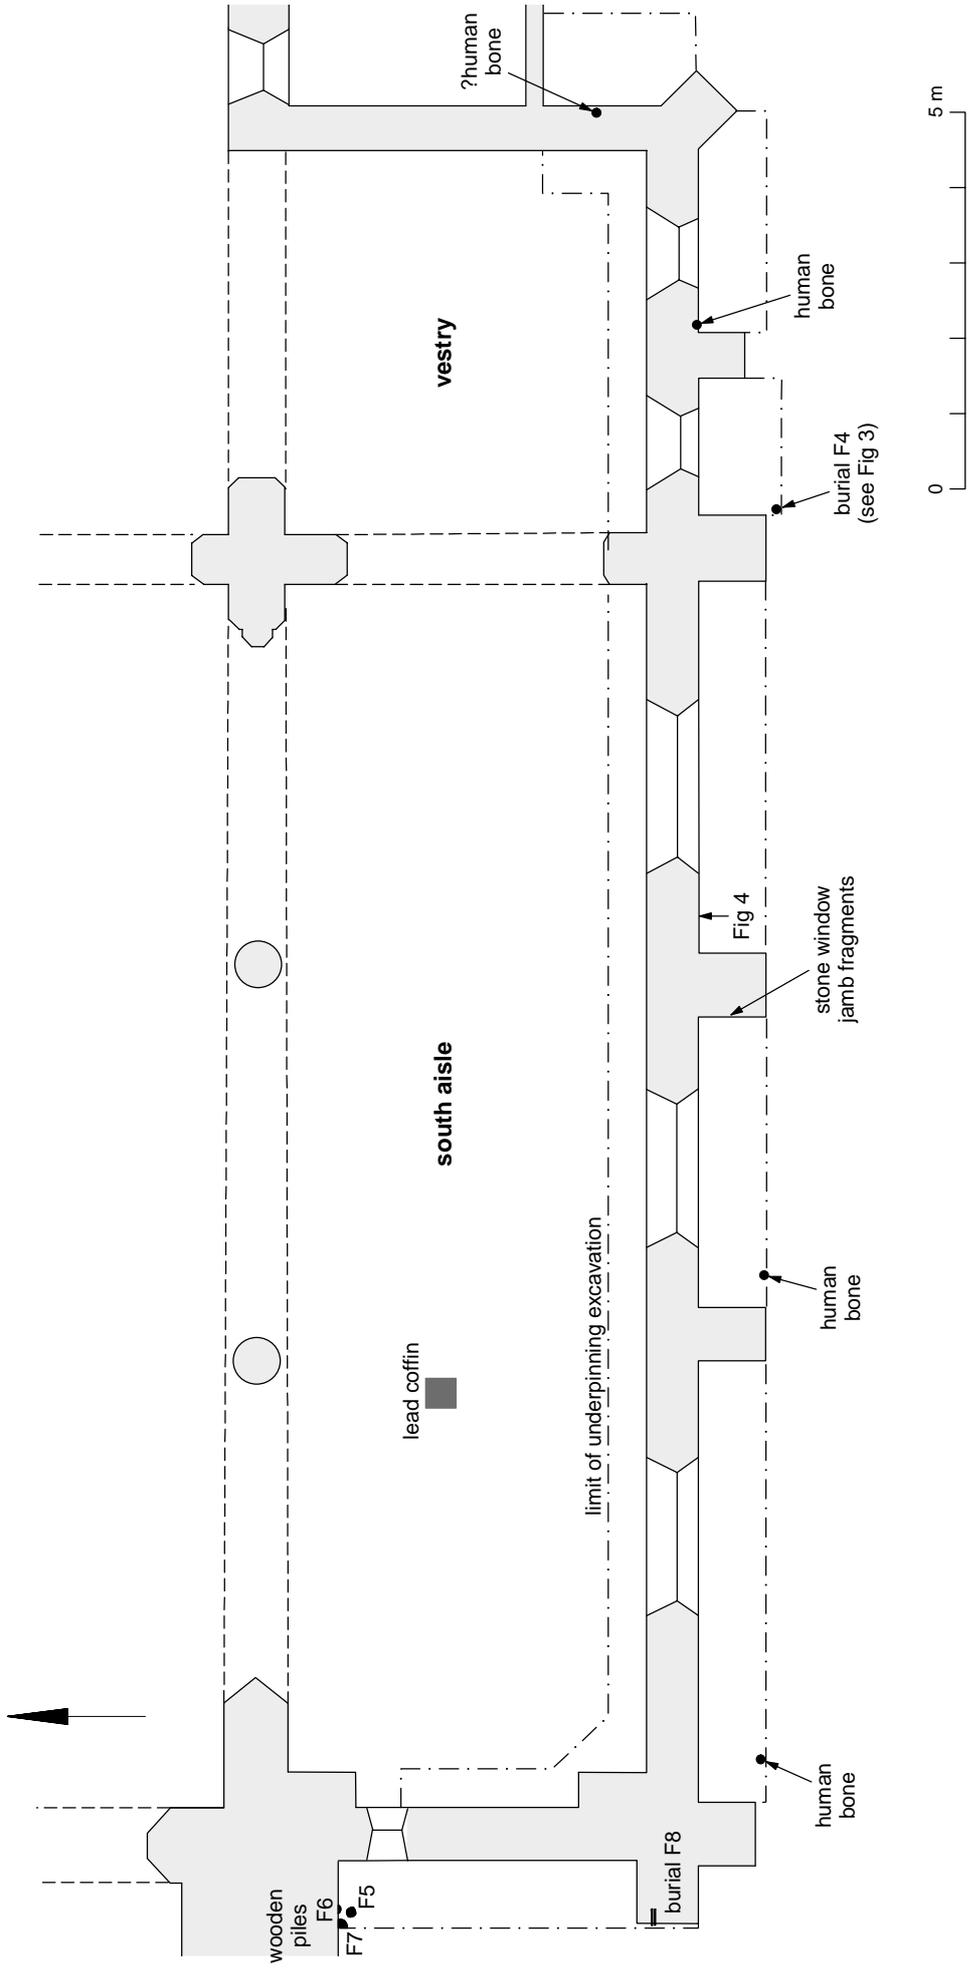
Fig 2 Plan of south aisle, showing finds and features.

Disarticulated human bone was found in two other places (see Fig 2), at least 1m below ground-level. The bone came from within the clay layer (L3) and no grave cuts could be discerned. As the clay at this level contained fragments of bone, this indicates that it is not natural after all.

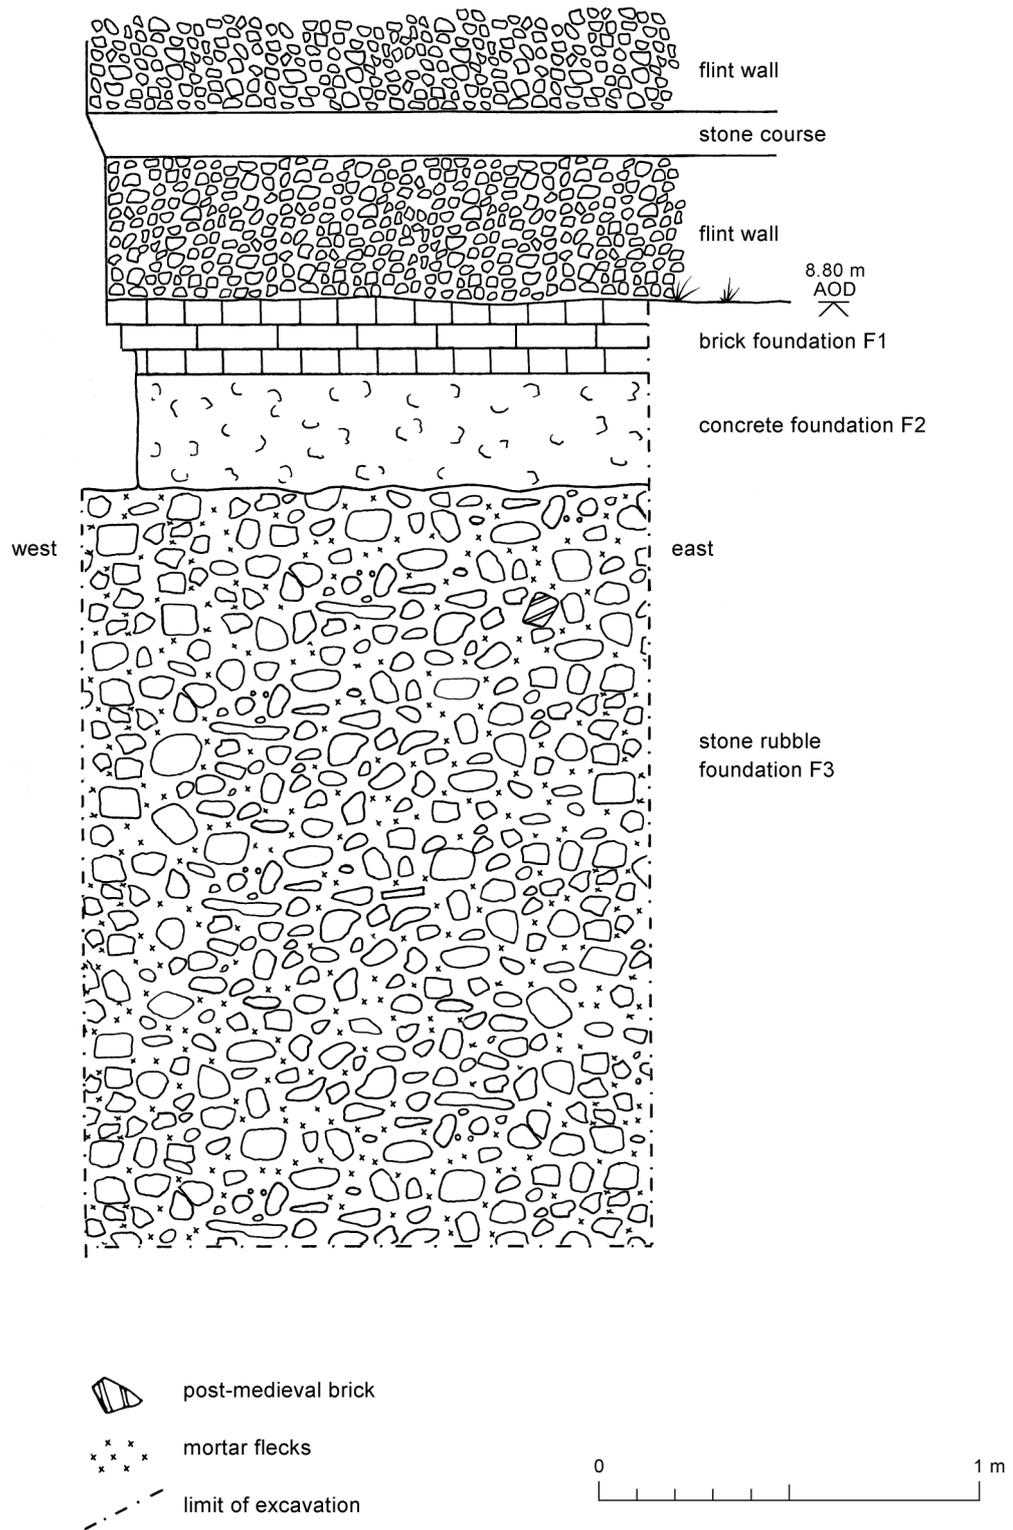
Fig 4 South-facing elevation of south aisle and section within pit dug for underpinning.

The pits dug along the central and western end of the south aisle encountered approximately 150mm of topsoil (L1) overlying between 550mm and 750mm of mortar-rich brown clayey loam containing brick and tile fragments (L2). At between 700mm and 900mm below ground-level, L2 gave way to a mottled greyish brown clay, assumed to be natural (L3). This clay continued to the base of the pits. On the church side of the pits, the foundations to the south aisle were exposed. These were fairly uniform, consisting of two or three brick courses (F1) overlying a concrete foundation 200-300mm thick (F2). The concrete foundation extended out 220-300mm from the exterior wall face. Judging from the previous test-pits that had been dug (see section 4.4), it was not expected that the foundations would be any deeper. However, the concrete foundations had been laid on top of a wide deep rubble foundation

which extended at least to the base of the pits (F3). This consisted mainly of rough nodules of flint but included some blocks of chalk, and some chunks of greensand and septaria, plus occasional brick. The rubble was loosely packed with earth which contained flecks of mortar. Kango hammers had to be used to remove it.

The rubble foundation (F3) was not a uniform width, but was 1.1m wide at its narrowest. It generally only extended out as far as the concrete foundation above it. This is probably why the rubble foundation was not encountered in the first test-pit that was dug in 2005. However, in some places it extended out further than the concrete, almost as far as the end of the buttresses. Under the eastern end of the south aisle it did not exist at all (see section 6.2). In the central section of the south aisle, four large pieces of dressed stone were picked out from this rubble foundation by the contractors. These are pieces of window jambs from the medieval church. The presence of brick argues against this foundation being medieval. It is thought to consist of rubble from the demolition of the medieval south wall in 1833 which was then re-used as a foundation by the 19th-century builders.
