**An archaeological watching brief,  
survey and building recording at  
Great Greenfields,  
Gransmore Green, Felsted, Essex  
September-October 2009**

**report prepared by  
Adam Wightman and Christopher Lister**

**on behalf of  
Foxley Builders**

**CAT Report 531**  
December 2009

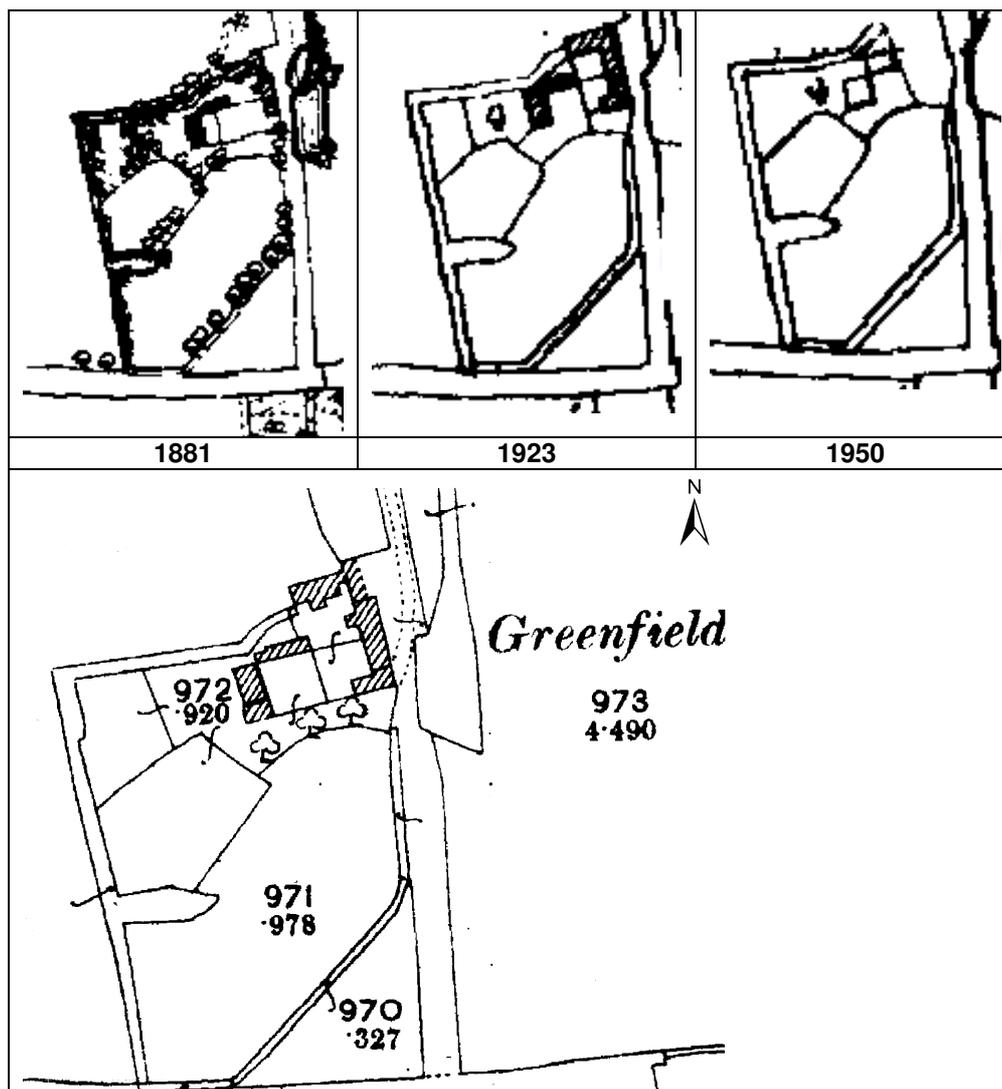
**Plate 1: extract from OS 1897 map (with thumbnails above of OS maps 1881, 1923, 1950).**

Comparison of the current site layout with the OS maps of 1881 and 1897 shows three principal changes (Plate 1). First, a causeway now crosses the south-eastern part of the moat, providing access to a small grass-covered field. Second, a 28m-long stretch of the northern part of the moat has been infilled, probably recently; certainly after 1950. Third, although the only buildings within the moated enclosure on the 1881 OS map are the house and a rectangular outbuilding to the north-east (on the site of the annexe which was being renovated during the works on the site), a range of buildings had been constructed over the north-eastern corner of the moated enclosure at a date after 1881, and had been demolished at a date between 1923 and 1950. This part of the moated enclosure is now clear of buildings, and the moat is infilled.

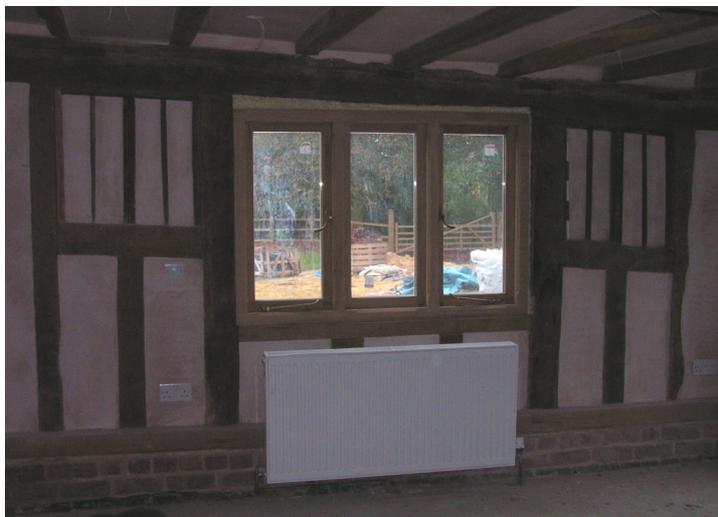
**Plate 2: ground-floor original windows flanking modern replacement, view east.**

During renovation works, which included the replacement of the windows and front door and the addition of a gabled porch above the front door, four original windows were uncovered (Plates 2-3). These originally flanked the windows which were replaced by the diamond-leaded casement windows. Each of the newly-discovered windows contained a central ovolo-moulded mullion flanked by two narrow diamond-shaped ones (Fig 6). The diamond mullions blocked the opening which itself would have been closed with either sliding or folding shutters; oiled cloth or thin sheets of horn may also have been used. No evidence of shutters was observed around any of the windows. The central mullion was twice the width of the diamond mullions and was ovolo-moulded, a style which became prevalent in the 16th century.

Both windows on the ground floor were intact, but with some damage, and only one mullion survived. The first-floor south window was also intact. The first-floor north window has been repaired.

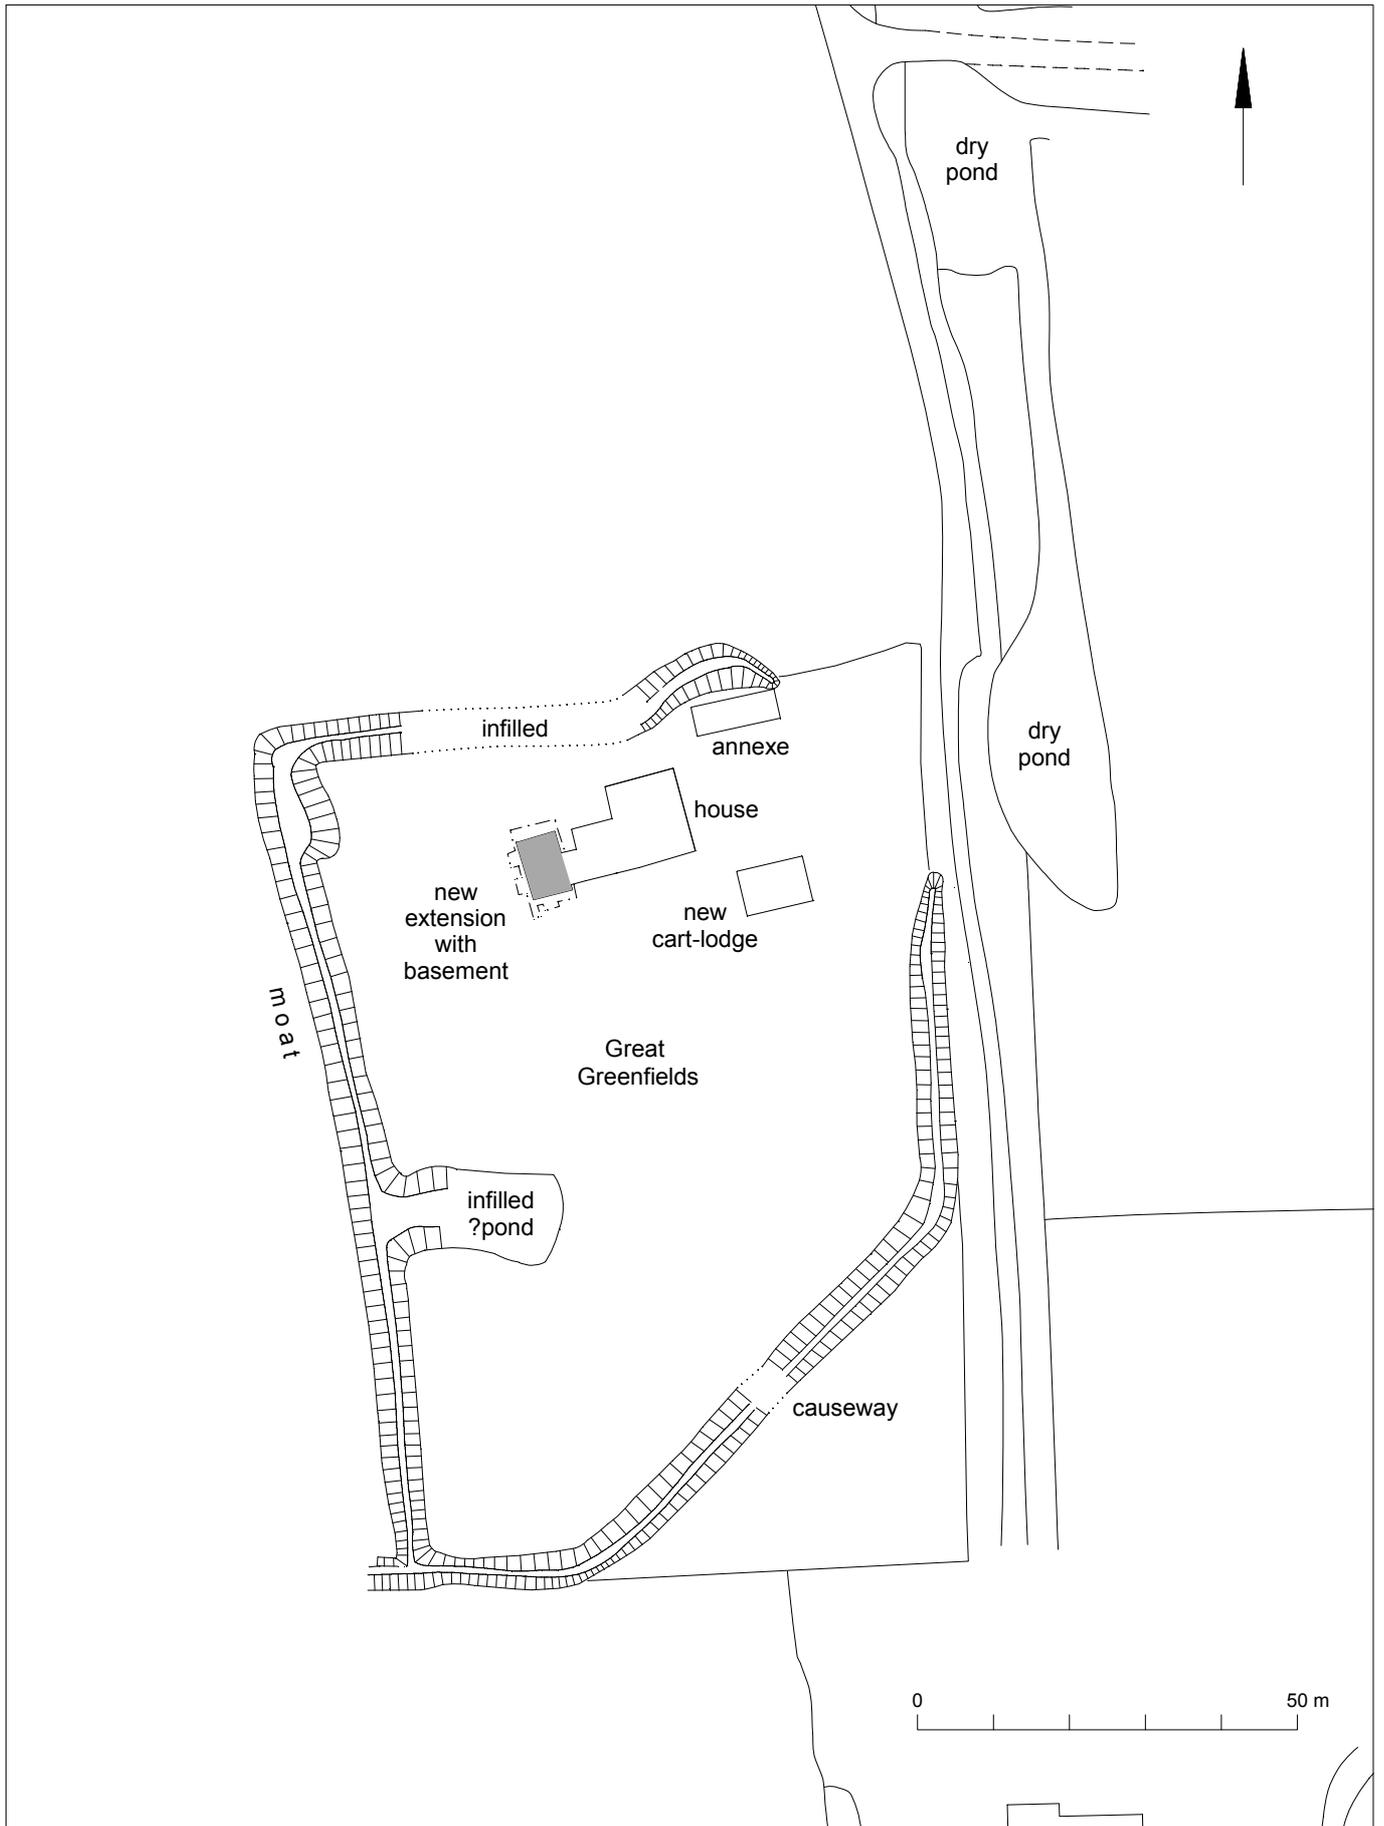
Fig 2 Surveyed moat, and existing and new buildings.

The moat survey was conducted using a total station, and plotted in CAD onto an OS base map. A combined length of 278m of the various parts of the moat were surveyed.

In plan, the moat is essentially an irregular rectangle with its south-eastern corner cut off. The reason for its irregular form, as indicated by the EHER (EHER no 1272) may be that it originally formed one half of a double moat with the moat at Poplars, the property which lies to the south-east. That moat, to the south of the Poplars house, is V-shaped, irregular and incomplete, and has a maximum width of 3m. Its eastern part diminishes in size as it heads north-east, where it connects with a pond.

On average, the Greenfields moat was between 5m and 6m wide, and between 1.1m and 1.5m deep. Although soft underfoot (in September), there was no water in the moat, which is partially water-filled at certain times of the year.

Near the middle of the western side of the moat there is a small internal inlet or pond. The pond, which is shown on the 1881 and 1897 OS maps, has been mostly infilled, probably recently. Where it isn't infilled, it is comparable in depth to the rest of the moat.

An east-west ditch connects to the moat at the point where its southern part turns to the north-east. At this point, the moat is noticeably narrower than elsewhere on the site being between 0.8m and 1.2m wide, and V-shaped in profile. There is no cartographic evidence that this ditch was ever a part of the moat system.

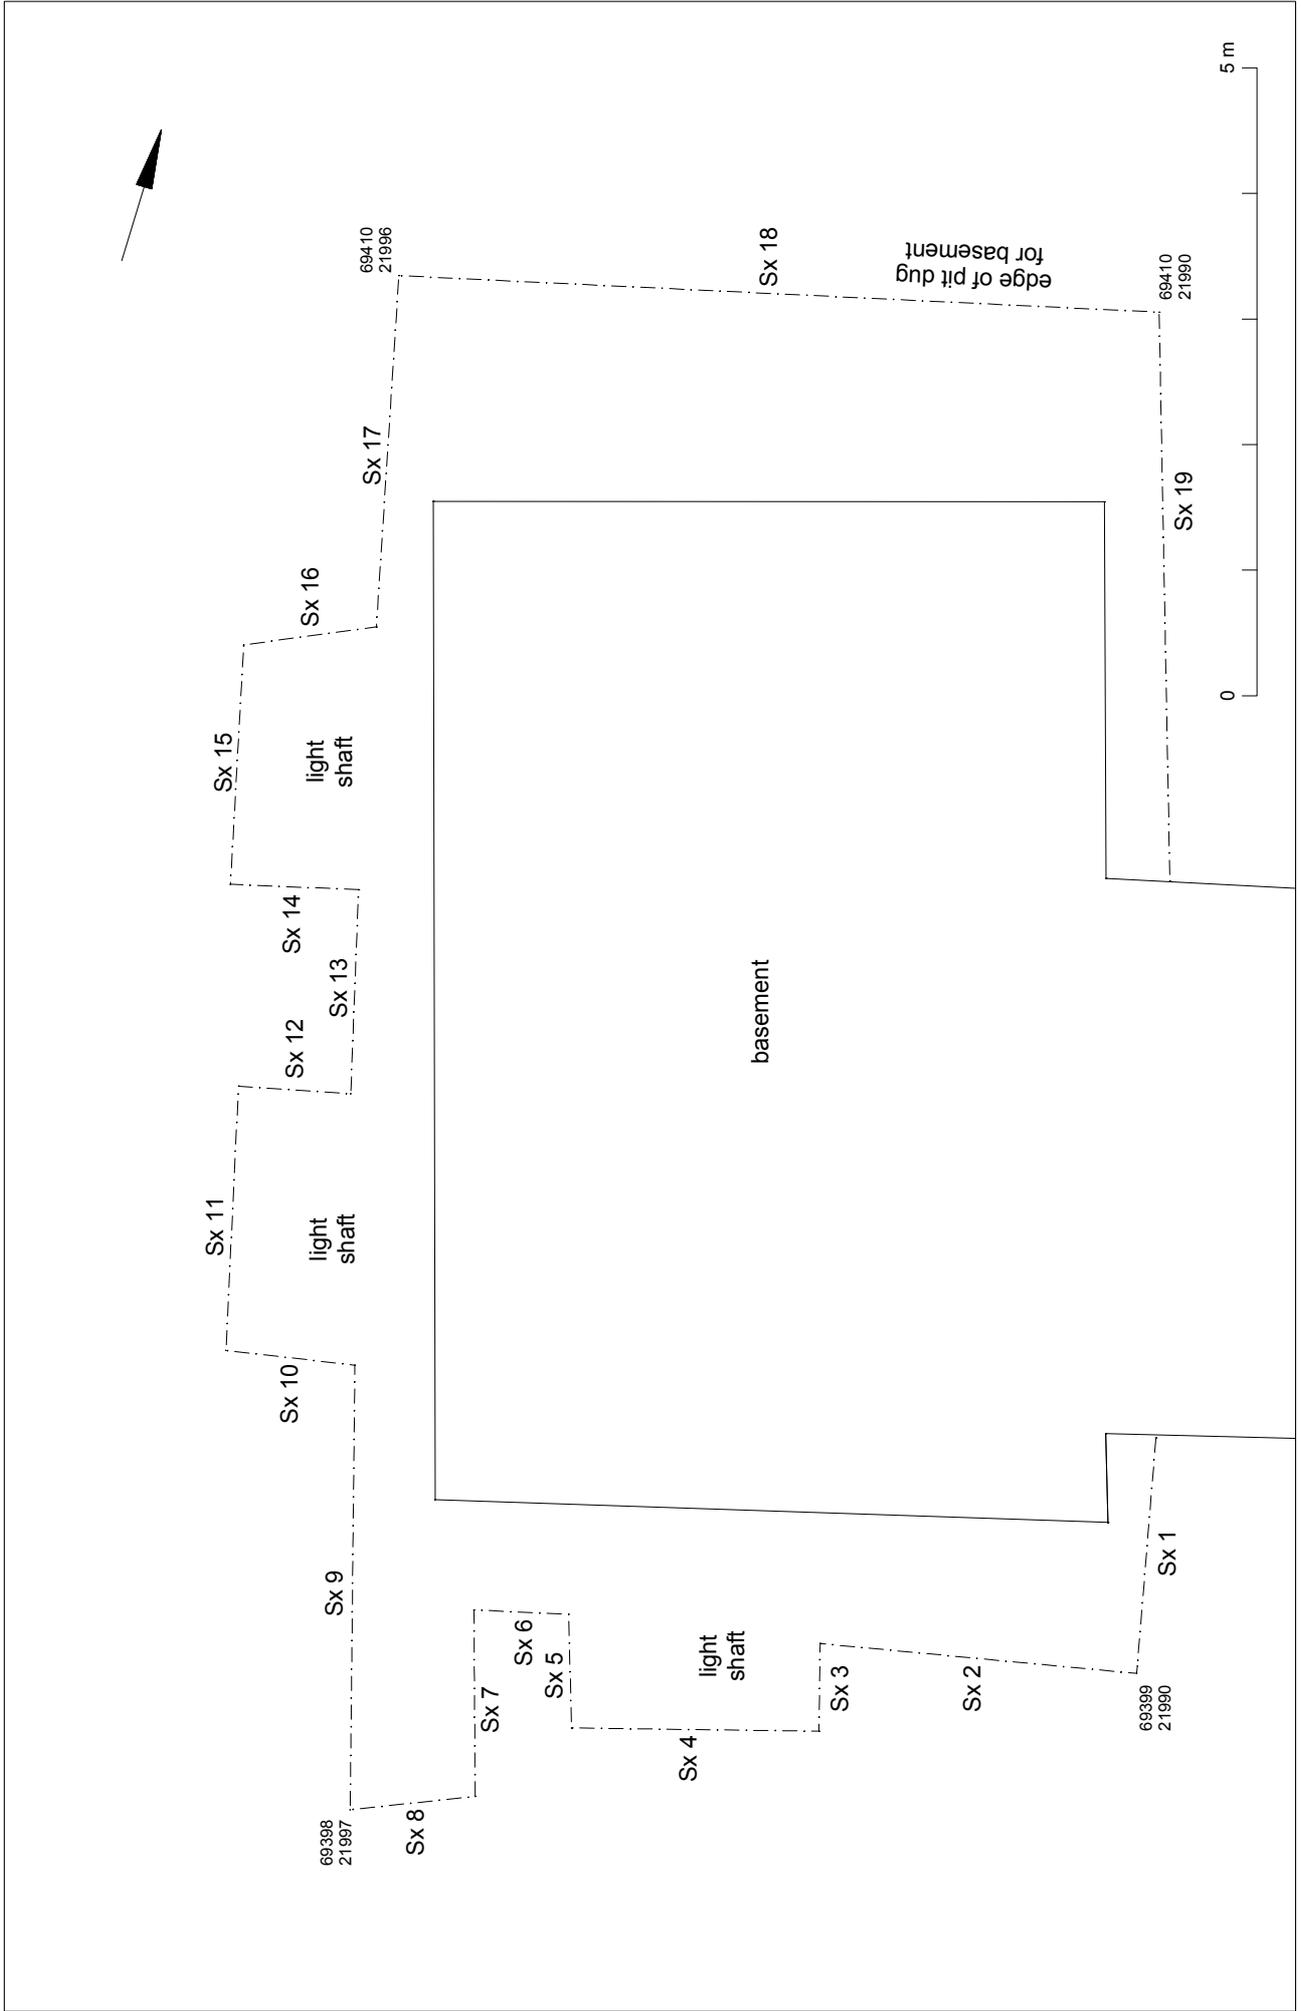
Fig 3 Sx 1-Sx 19: locations in relation to the basement to the extension.

- 2.5** Archaeological recording on the 5th and the 6th October involved the examination and recording of the sides of the 8 x 5m pit dug out for the basement of the extension. Most of the sides of the pit were still visible. However, the pit had been backfilled on the northern side, so a mechanical excavator equipped with a toothless bucket was used to remove the hardcore infill. The edge of the pit was cleaned and examined and all archaeological features identified were recorded in a combined section (Sx 1-Sx 19; Figs 3-4).

The pit dug out for the basement of the extension was excavated by contractors. The sides were subsequently cleaned by hand by CAT staff, and photographed and drawn (the latter at a scale of 1:10; Figs 3-4). Work on the sections was conducted from above due to the depth of the pit and the confined nature of the space between the edge of the pit and the newly-constructed basement.

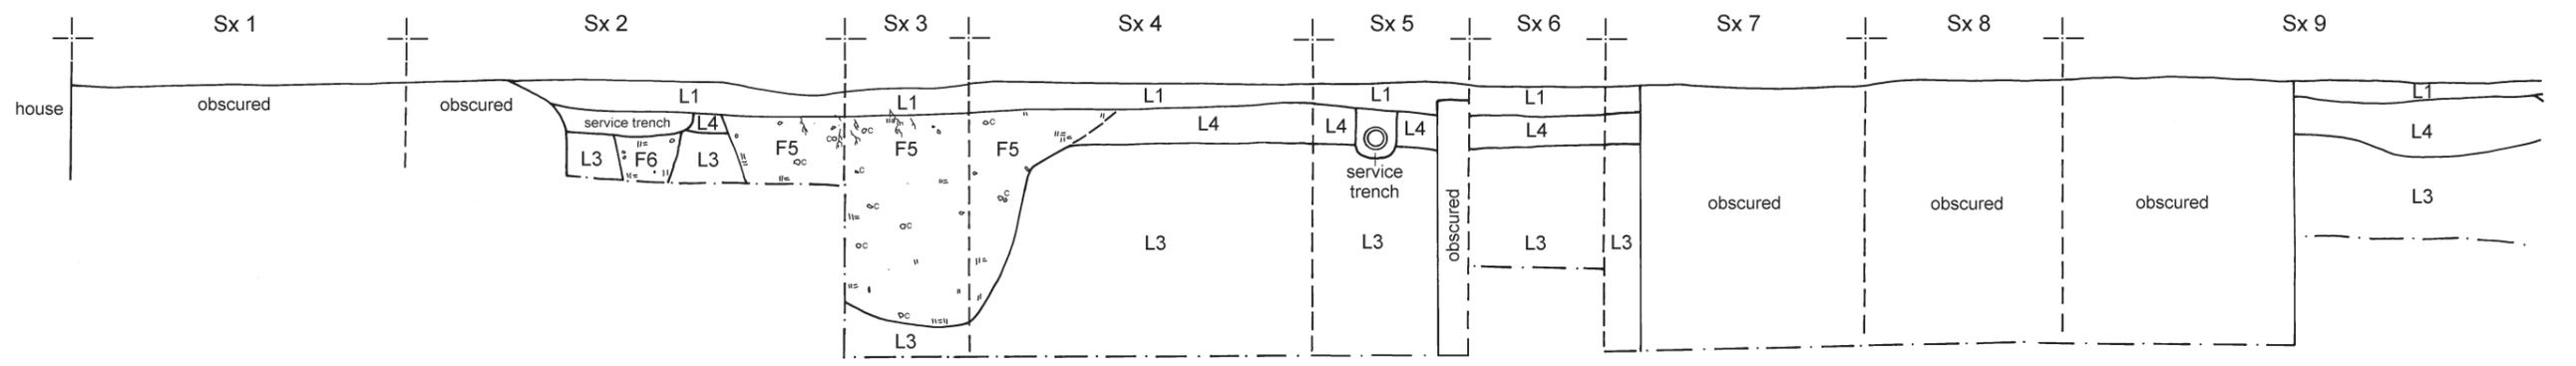
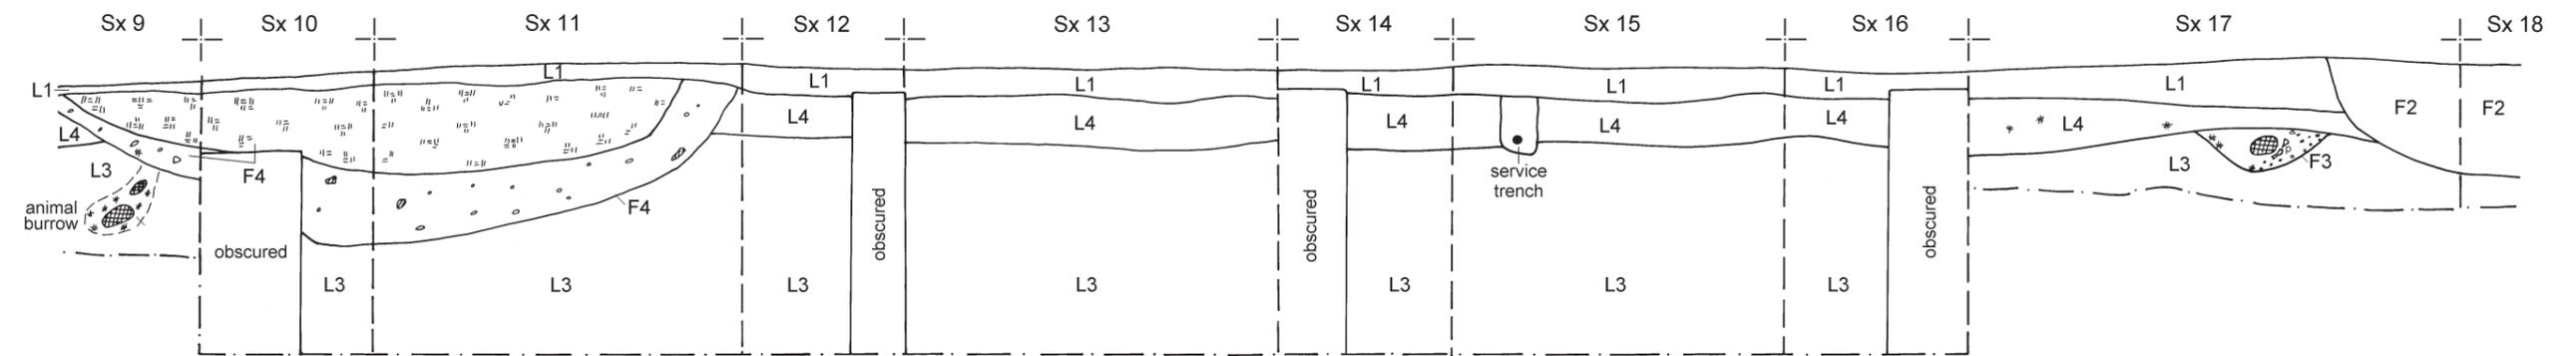
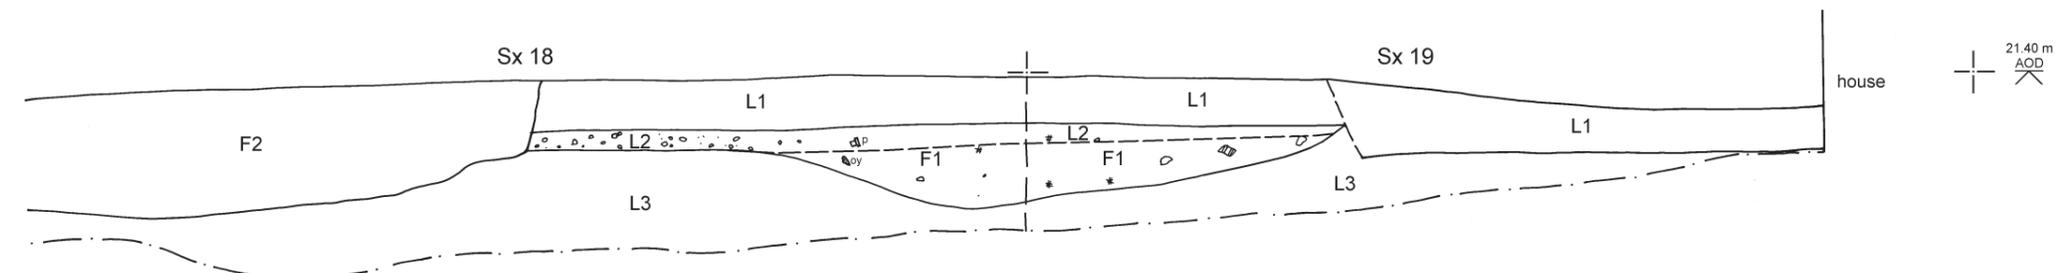
Fig 4 Combined section (Sx 1-Sx 19).

A layer of dark-brown clayey topsoil (L1) covered the site. It sealed L2, which had abundant inclusions of chalk, peg-tile and daub, and rare charcoal and oyster shell, and contained ten sherds of pottery ranging in date from prehistoric (probably

Bronze Age), to Roman and medieval. This layer was only seen in sections 18-19 (Sx 18-Sx 19). The date-range of the finds in L2 may indicate that this layer has been redeposited. L2 was not present in the sections along the western or southern sides of the pit dug out for the basement. Here, L1 sealed a medium brown silty-clay (L4) with few inclusions and no observable finds.

The pit dug out for the basement had removed L1-L2 (where present) and the natural layer (L3) to a maximum depth of 1.6m below modern ground-level. L3 was a hard, orange/brown clay with frequent chalk flecks and nodules increasing in frequency as depth increased (they were very common at 700mm below ground-level).

Six archaeological features were identified around the edges of the pit dug out for the basement. Two of them were modern (F2, F4). F2 was a large modern rubbish-pit. Finds included residual prehistoric (probably Bronze Age) and early medieval pottery sherds, along with modern building materials and plastic. F4 was a large area of modern construction disturbance. It had two distinct lenses, ie a dark silty clay layer overlaid by redeposited natural clay. The profile and edges of the feature indicate that it was excavated using a mechanical excavator.

Three features contained medieval pot sherds, ie F1, F5, F6, and they all had brown silty-clay fills with frequent inclusions of charcoal and daub. F1 was a medieval pit. F5 was a relatively deep, straight-sided pit, the base of which was 1.35m below ground-level and over 1m into the natural chalky clay. A feature this deep may originally have been dug as a well and subsequently infilled. Six fragments of pottery recovered from its upper fill date to the medieval period. Only a small part of F6 survived, so it is difficult to determine if it had been a small pit or a ditch.

The remaining feature was F3. As with F6, only a small part of this feature survived. It included a large lump of daub (seen in section), and a rim of either prehistoric or Roman date. The feature could be prehistoric or Roman, or it could be medieval with residual material. The fill of F3 was the same as the fills of the medieval features.

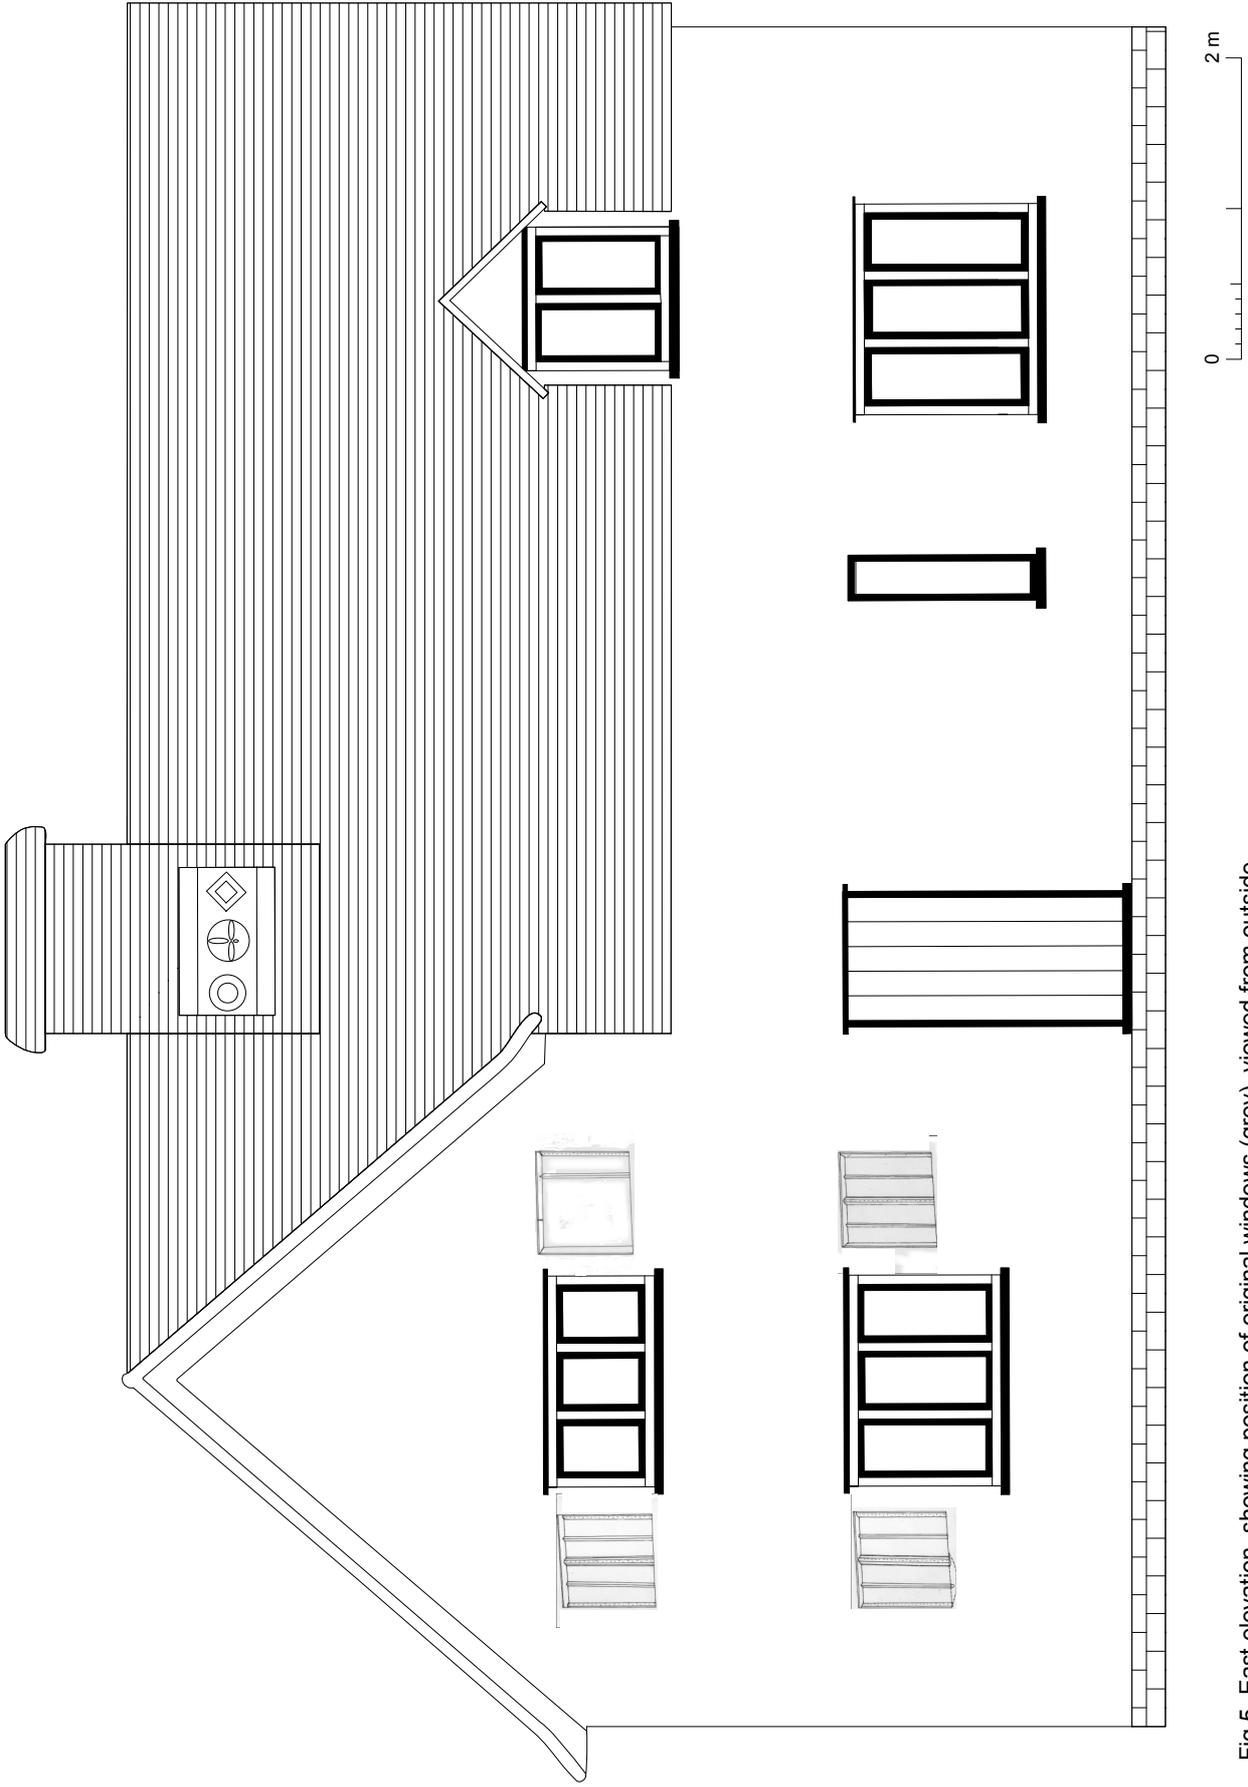
Fig 5 East elevation, showing position of original windows (grey), viewed from outside.

Recording within the house was focused on the four mullion windows which had been covered over externally but were still visible internally. They formed the side elements of two pairs of windows each consisting of two small mullions flanking a central larger window (later replaced).
