Survey of buildings behind the North Hill Hotel, 51 North Hill, Colchester, Essex June 2010

report prepared by Philip Crummy and Richard Shackle

CAT Report 522 June 2010

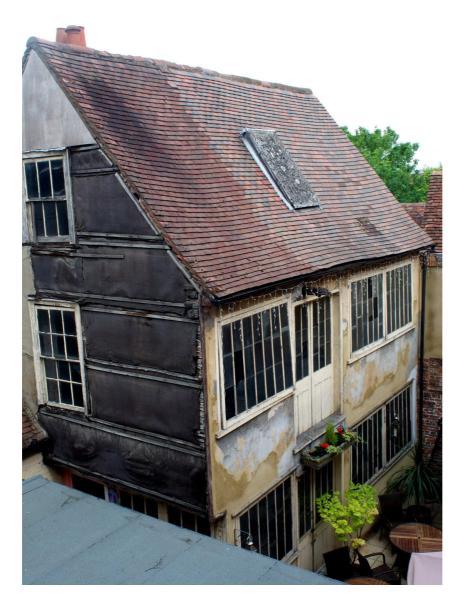
30 View of the east elevation of Day's Warehouse from the roof of the North Hill Hotel, taken with the kind permission of the manager.

The focus of Day's modifications was on the east wall of the crosswing, ie the one which overlooked the yard and rear of the hotel. The whole wall was stripped out to leave the corner and central storey posts (ie the main structural frame) fully exposed. Six large windows and two pairs of double doors were then inserted into the wall and the rest of it made good with lath and plaster finished off with a cement render. The double doors were glazed in the same way and to the same depth as the windows. Each window had five vertical glazing bars to form six lights, each of which contained three panes of thin, rather fragile glass. There were no horizontal glazing bars but, instead, the panes were simply overlapped to prevent the ingress of water. Plainly these are low-cost, functional windows of a sort appropriate to an industrial or agricultural context. Each window had a large iron hinge at each upper corner to allow the bottoms of the windows to open outwards, and there is a projecting beam with hook over the upper double-doors showing how heavy goods and materials could be moved around the building.

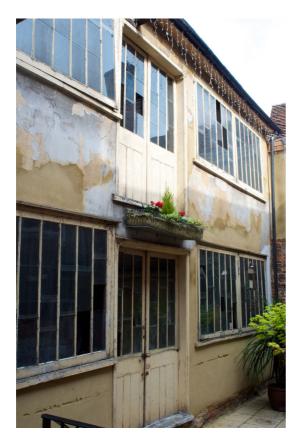
31 East elevation of Day's Warehouse.

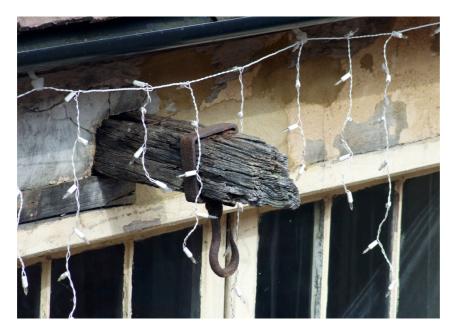
32 Surviving part of the lifting gear on the east elevation of Day's Warehouse.

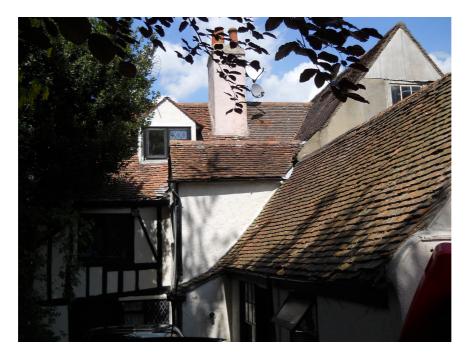
33 Hall-house and extensions, viewed from the south.

A small two-storeyed extension was built in the angle between the new crosswing and the former open hall. This extension is timber-framed and has its own tiled roof. Partly covering the jettied south front of the new crosswing is a single-storeyed brick extension, which was probably a stable as it has two half-round windows; these are often found in stables. Attached to the south end of this building was another extension of which there only remains one wall.

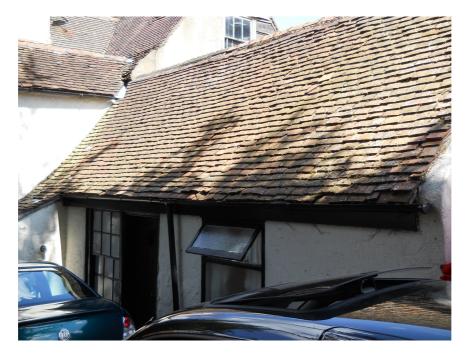
34 Hall-house and extensions, viewed from the south.

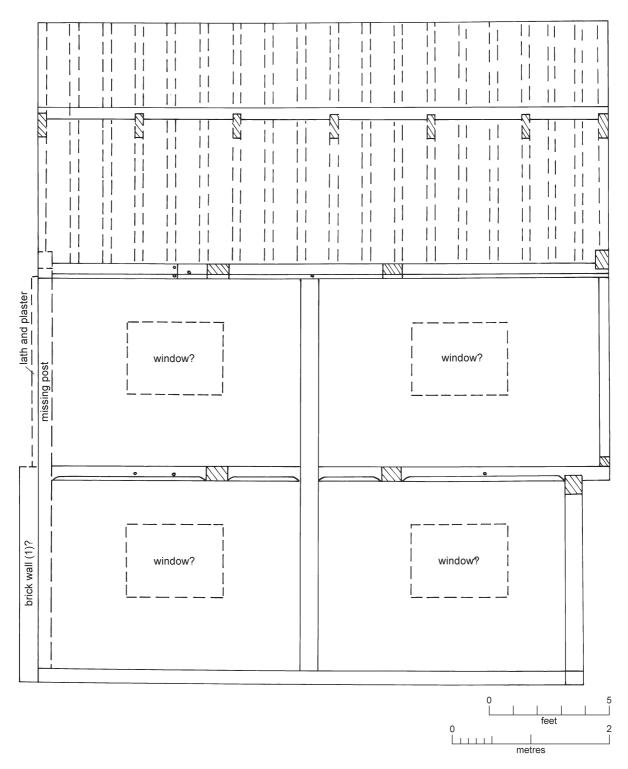
Fig 3 17th-century crosswing: east wall, internal view.

The framing of this crosswing had a storey-post in the middle of the east and west walls. The ground floor and attic floors are supported by two large bridging joists with lambs tongue chamfers. The top-plates of the east and west walls have face halved and bladed joints which are thought to date either from 1525-1575 or 1575-1850. There is a side purlin roof with clasped purlins. Most of the collars are slightly cambered. When the former open hall had an inserted floor put in, a new window was put in upper floor of the rear wall. This window is now fragmentary, but it was probably 38 inches wide with a central mullion having two beads on the inside and almost certainly rebates for glass on the outside. This type of window may date to *circa* 1570-1600. The roof of the former open hall is of the side purlin type; this is unlikely to be the original roof which was probably a crown post roof. The side purlin roof could have been put in when the 17th-century crosswing was added or at any time after 1600.

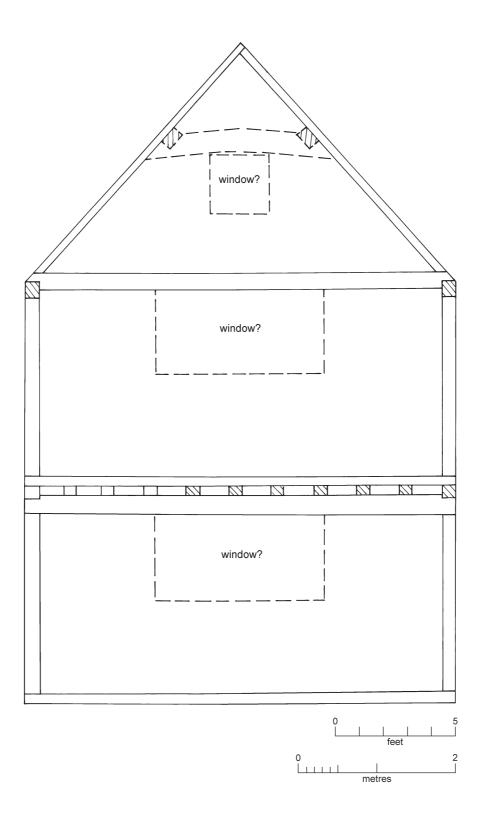
Fig 5 17th-century crosswing: south wall, internal view.

The south gable wall was also modified, but not to the same extent as the east wall. Another one of the large windows was inserted into the gable wall at ground-floor level. There is a double-hung six-pane sash window at first-floor level and a similar one, but with three-pane sashes, lighting the attic. The frames of these windows are flush with the outer face of the wall, which suggests that both are earlier (perhaps 1800-50) than the windows installed in the building by Charles Day.

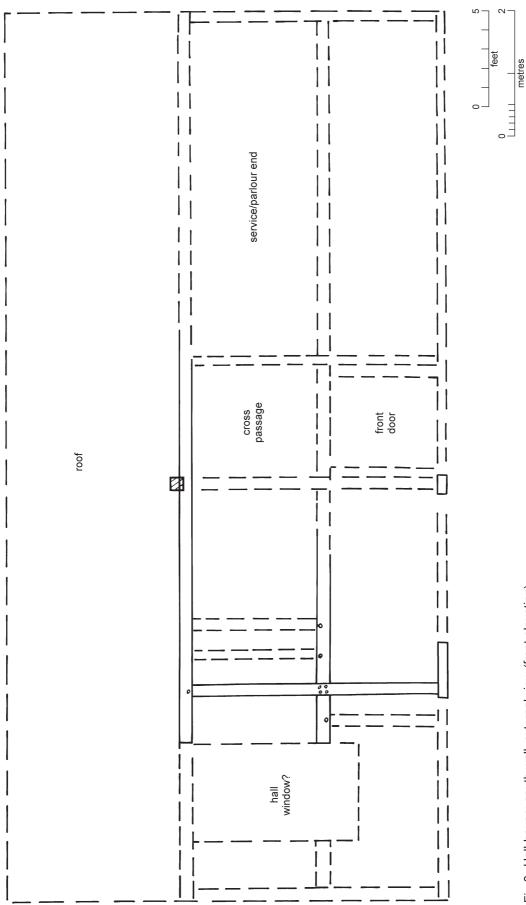
Fig 8 Hall-house: south wall, external view (front elevation).

The open hall now consists of a cross-passage, the lower end bay of the hall and part of the upper end bay of the hall. The front wall of the hall facing south consists of a storey-post pegged into the top-plate and two middle girts double pegged into the flanks of the storey-post. The tie beam, which one would expect to be over the storey-post, is now 29 inches to the west. The rear wall consists of a truncated storey-post, and parts of two middle girts with studs pegged into them. Part of the other hall bay can be seen in a cupboard which is now a flying freehold over the adjacent property. The tie beam separating the hall from the cross-passage is dovetailed into the rear top-plate. It is thought that the original hall-house consisted of a two bay hall, a cross-passage and service end which has now been replaced by the 17th-century crosswing.

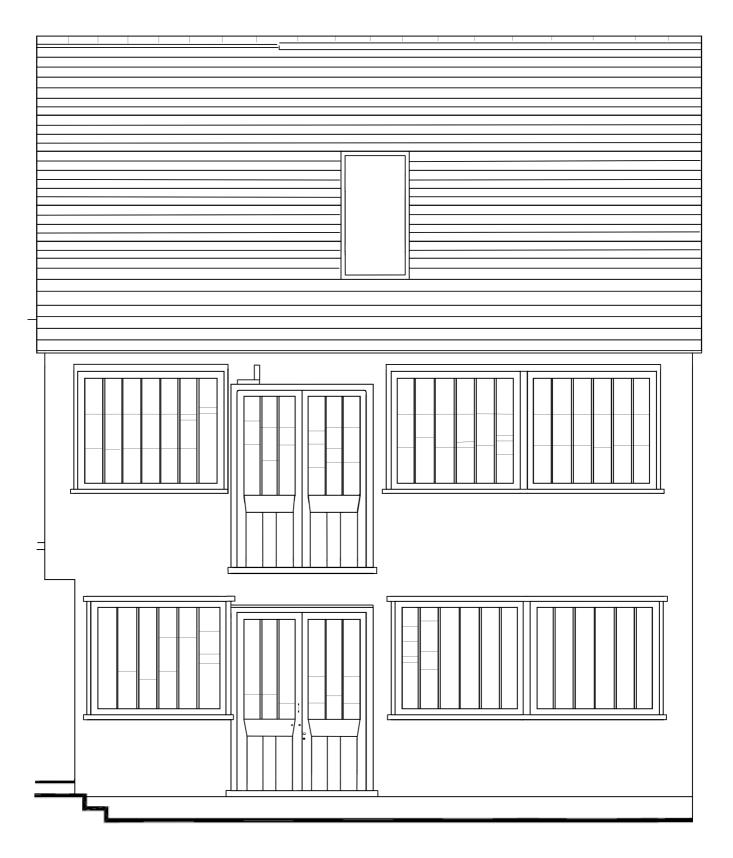
Fig 10 East elevation of Day's Warehouse: sketch plan (based on a plan provided by Hurley Porte and Duell Ltd).
