**Building recording at 1-3 The Potteries,
Pottery Lane,
Chelmsford, Essex
June 2011**

**report prepared by
Chris Lister**

**on behalf of
Marden Homes**

CAT Report 609

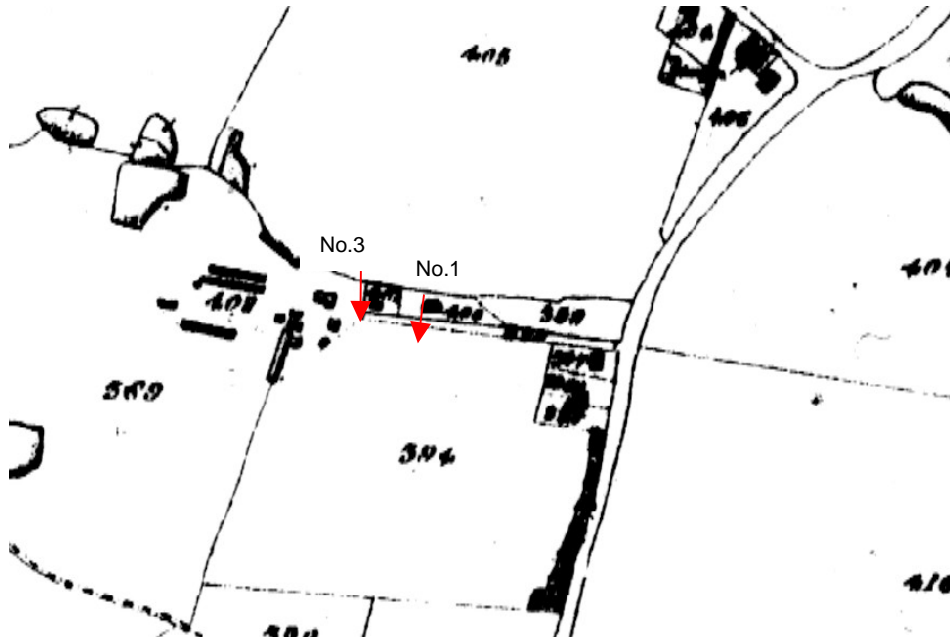
Illustration 1 1848 tithe map of Broomfield parish (D/CT 54).

This shows the cottages to the east of the brickworks with the award listing two cottages with gardens as being owned by James Christy. This is good evidence for the evolution of the properties as it clearly shows there were originally only two buildings and that the third cottage must be a later addition. Such additions appear to have occurred at several points in the cottages' history. An 1854 map of James Christy's estate (Illust 2) shows the eastern cottage as having an extension to the north.

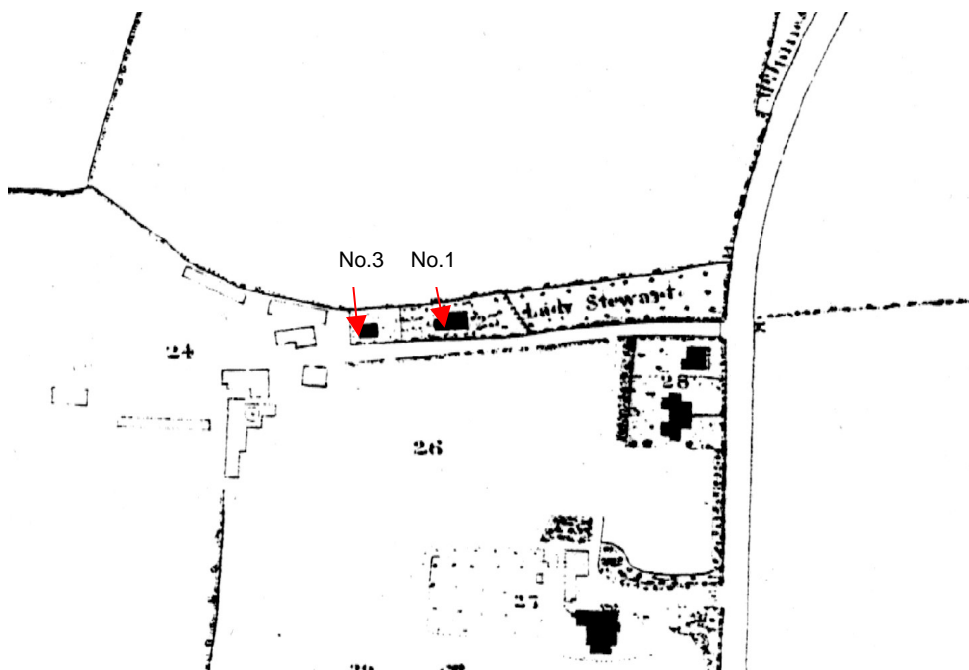
Illustration 2 1854 Map of an estate belonging to Mr James Christy (TS/M 62/2).

The estate map shows that the eastern cottage is almost twice as long as that to the west and the northern extension makes it even bigger. Because of this increased size and its location away from the brick kilns, it is possible that the brickworks' manager or foreman occupied the east cottage.

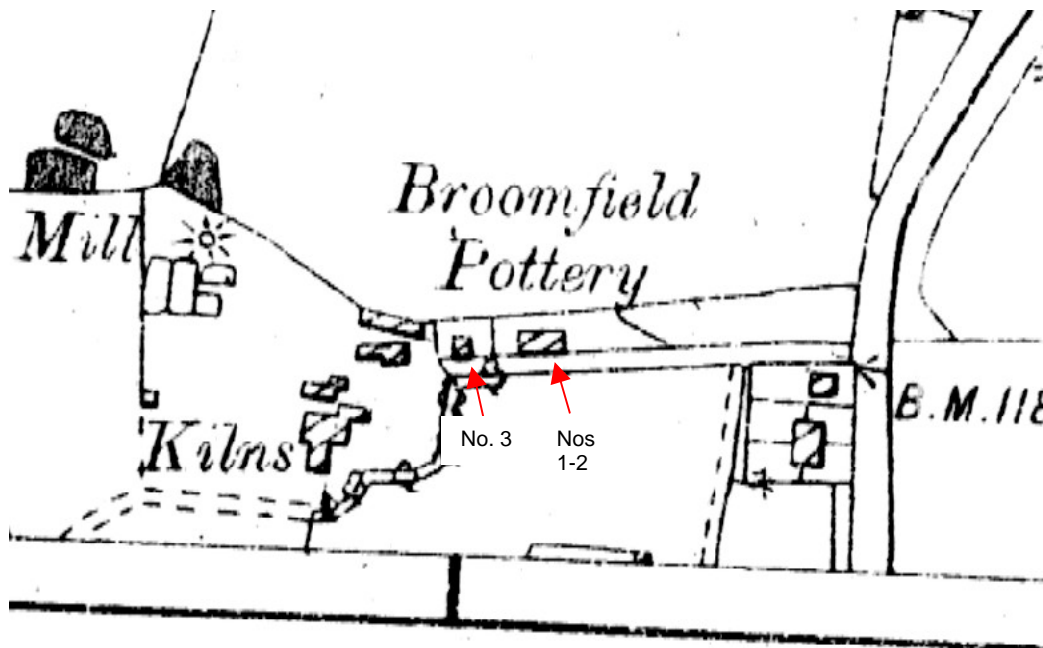
However, by the time of the 1897 6" edition Ordnance Survey (Illust 4) significant change had taken place. The east cottage appears longer than previously and the one to the west has an extension to the north.

Illustration 4 1897 6" edition Ordnance Survey (Sheet 43 SE).

These changes altered the layout of the east cottage considerably. The western third of the cottage was transformed into an independent dwelling, with space for a kitchen and three additional rooms. It was probably at this time that the cottages were numbered 1-3, although this may have happened when the brickworks closed and were sold off in 1912.

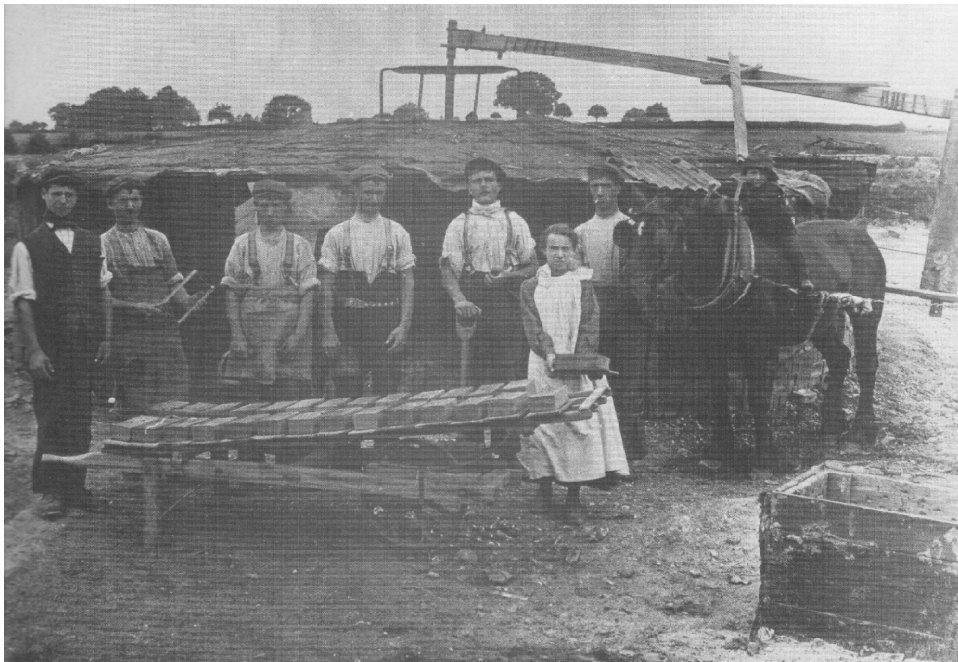
Plate 1 Victorian brick production in Chelmsford (from Marriage 1982).

Plate 1 shows workers (predominantly young men) standing in front of a horse-powered clay pug mill. This was for mixing the clay to a consistency ready to be slapped into the mould (held by the worker second from the left). The bricks were then loaded onto the barrow and taken to a drying area. After about three weeks of good dry weather, the bricks were taken to the kiln or, as in Plate 2, stacked in a clamp ready for firing.

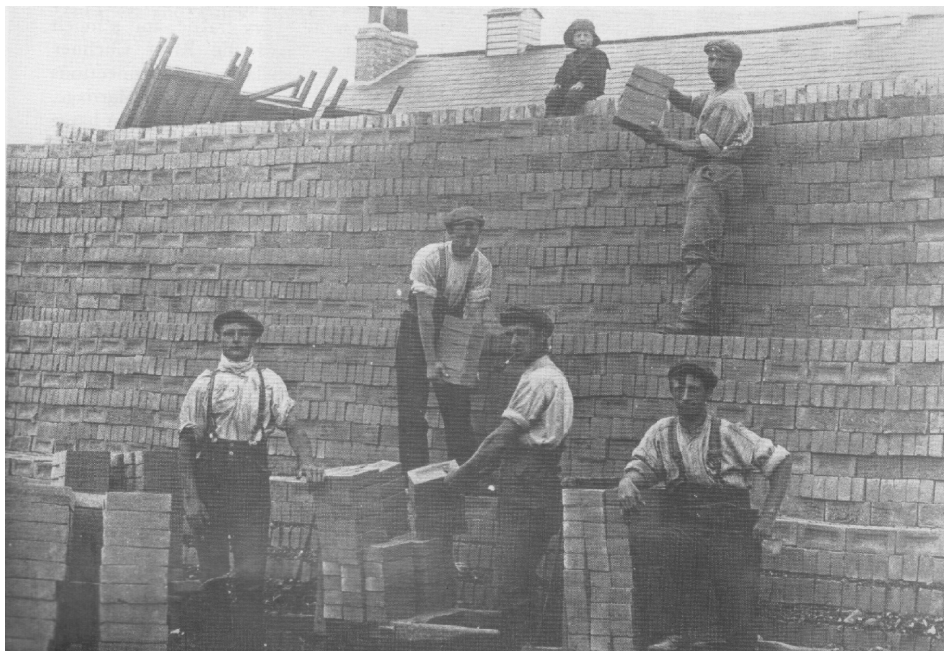
Plate 2 Victorian brick production in Chelmsford (from Marriage 1982).

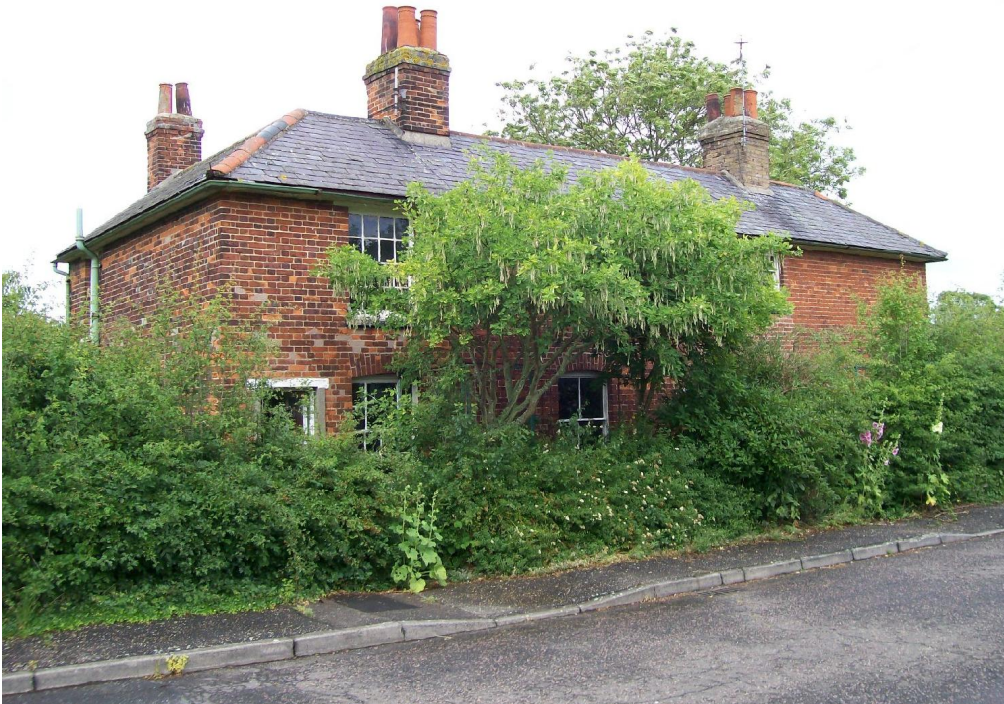
The south elevation has two entrances and three windows on the ground floor with three windows to the first floor. The windows are recessed from the brickwork and were originally concealed box sashes. Those on the upper floor are tucked under the eaves. The entrance to No.2 has been altered and has a plain concrete lintel. Scarring in the brickwork above this lintel indicates the original door head was either a segmental brick arch or that there was a structural fault above the door that had to be repaired. The entrance to No.1 is off-centre to the original range and the door itself is probably original. The windows flanking this original entrance are two-over-two hornless sashes with segmental brick arches above, whilst that in the extension is a hornless sash of five-over-eight (Plate 5). This unusual combination of lights probably results from damage to both the glass and the glazing bars holding them in place and a repair that was adequate but not aesthetically pleasing. The fenestration of the first floor is also quite interesting. The window of the extension is another eight-over-eight sash, identical to the one below it, but those in the original range have been altered significantly. The window in bedroom 2 of No.2 is a sliding horizontal sash that has been inserted into the original opening (the pulleys of which can be seen in the sides of the frame), whilst that in bedroom 1 of No.1 is a hybrid four-over-one horned sash (Plate 6). This may represent an early example of an Arts and Crafts movement window.

Plate 3 The south elevation of Nos.1-2 with the later extension ('Albany') to the left.

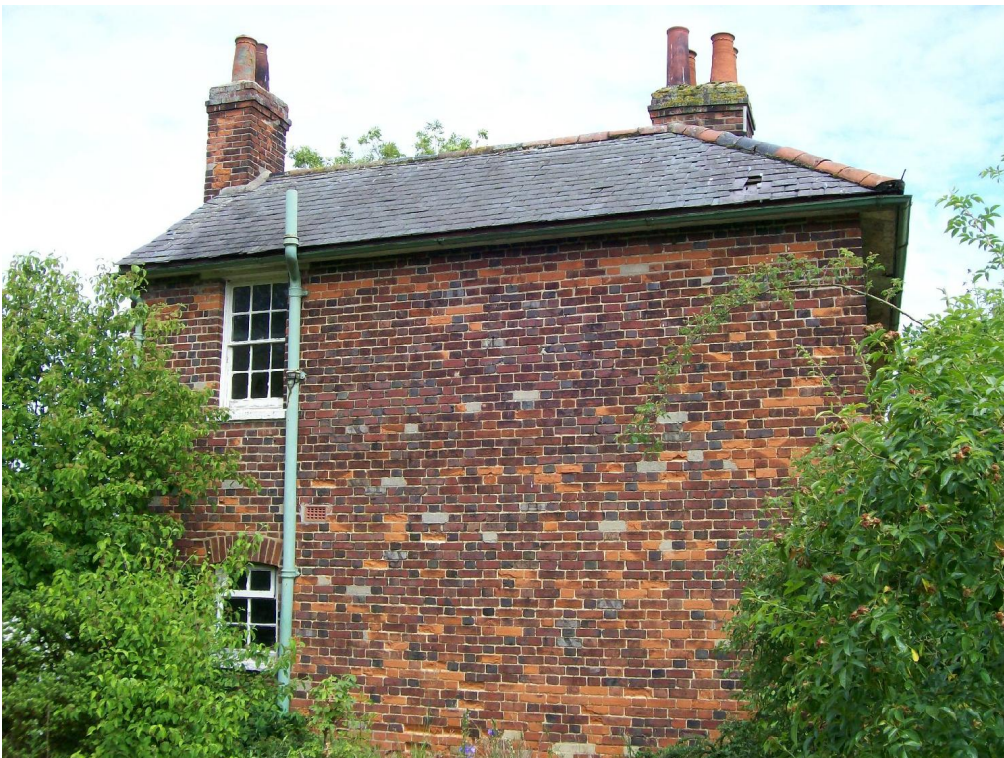
Plate 4 The west elevation of No.2 showing the lower quality brickwork.

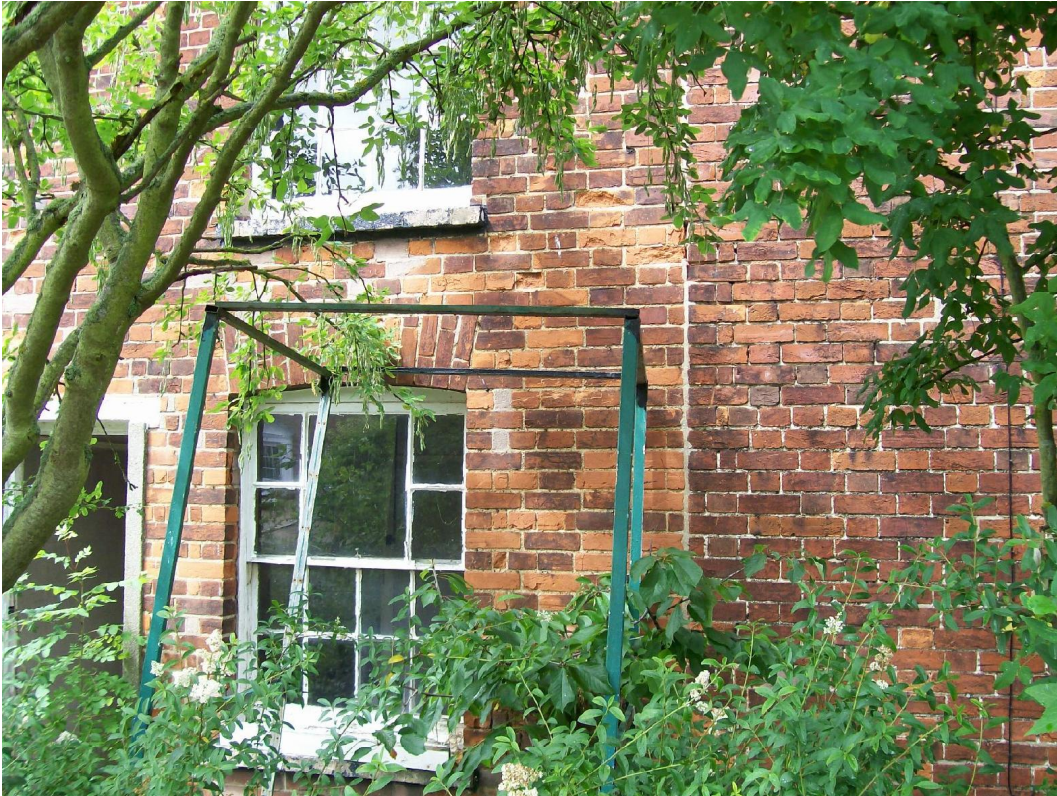
Plate 5 The join between Nos.1 and 2 and the repaired sash window.

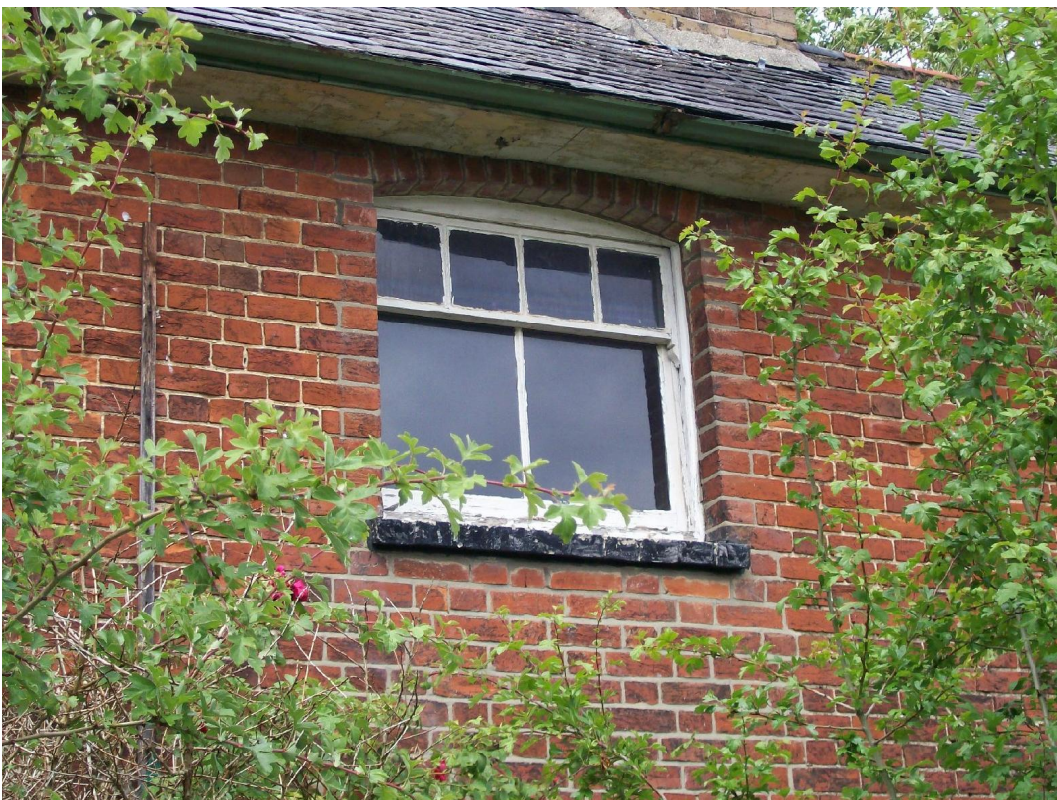
Plate 6 No.1 Arts and Crafts style window.

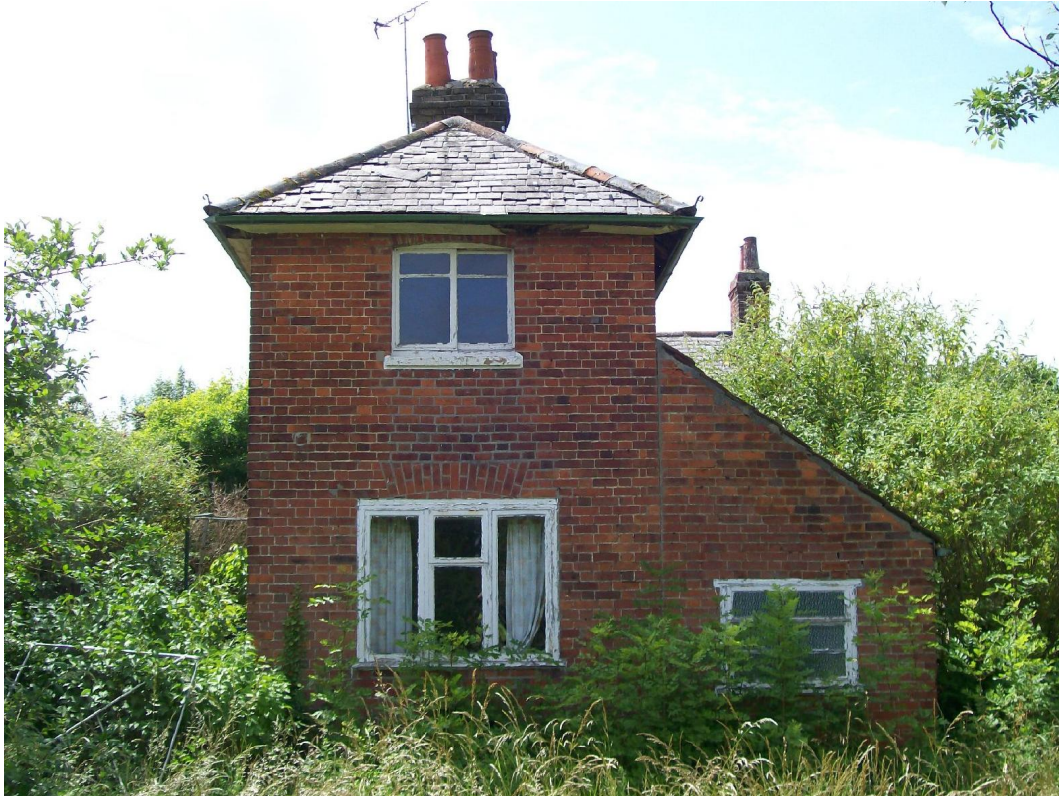
The east elevation of No.1 presents evidence of both ground- and first-floor windows being altered (Plate 7). The ground-floor window has been replaced with a much wider casement, although the original window head can clearly be seen. The first-floor window has been replaced with another sliding horizontal sash. Plate 7 also shows the earliest phase of extension to the building, the 1854 or earlier extension that contains the bathroom and kitchen. This has a single pitch roof of clay

Plate 7 No.1 east elevation showing altered windows and the earliest phase of extension.

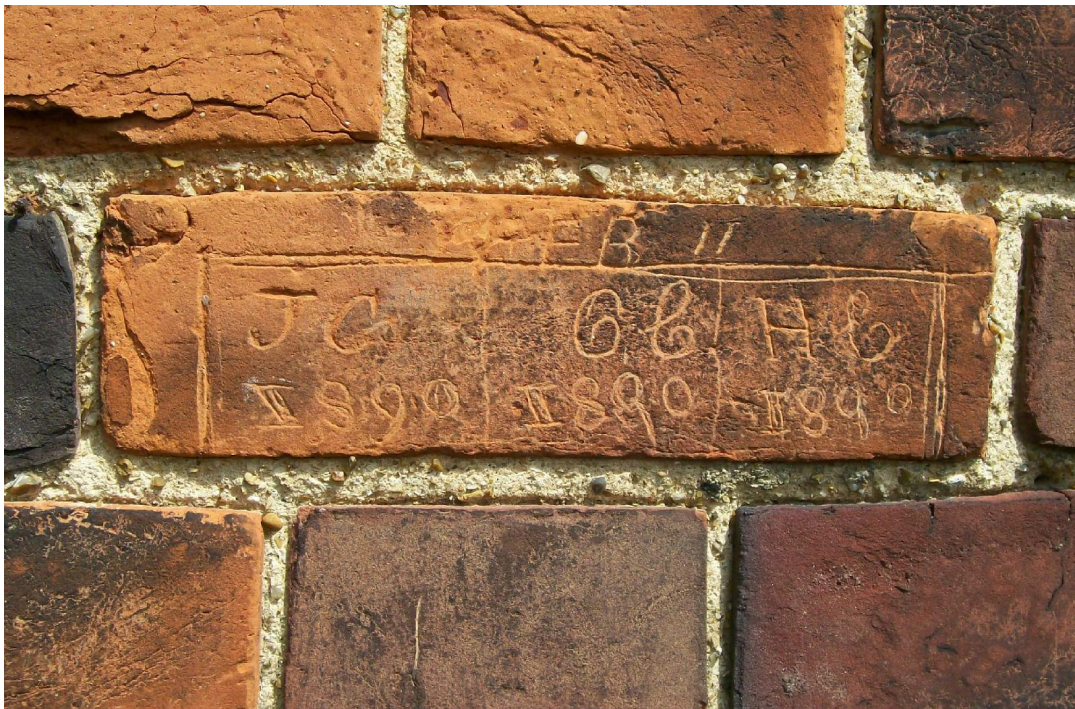
The west elevation is predominantly blank apart from a small window of six lights in the ground floor, opening onto the kitchen of No.2 and a six-over-six unhorned sash window above this in the first floor. There are also graffiti scratched into the brickwork of this elevation. One brick is inscribed with three sets of initials (J.C.; ?C.L.; H.B.) and the date 1890 and another brick has an illegible inscription with a date that might be 1890 (Plate 8).

Plate 8 Graffiti dated 1890 on west wall of No.2.

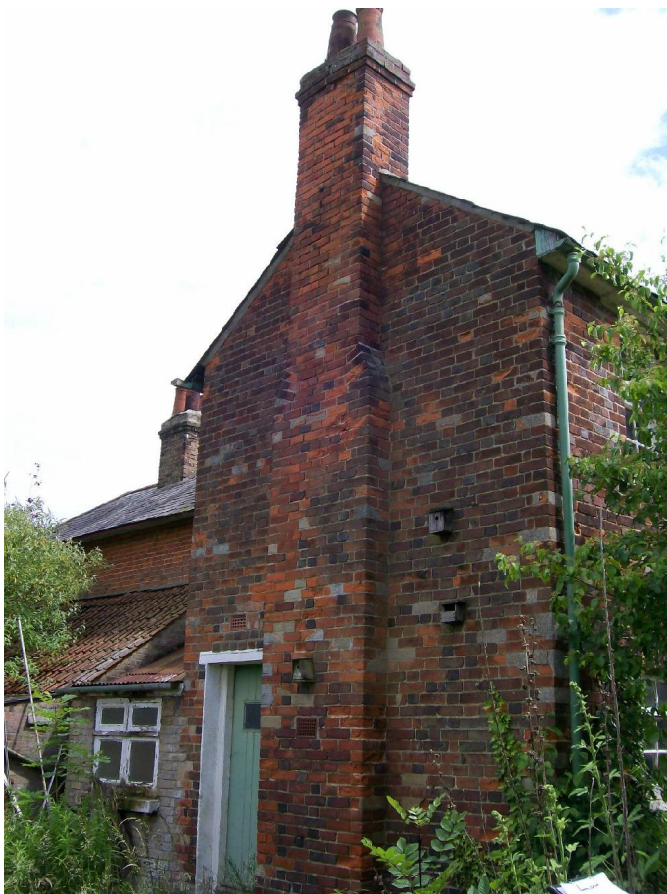
The north elevation of the original structure appears to have been solid brickwork with no fenestration and only one entrance (directly opposite that in the south wall). The pre-1854 extension to No.1 has a window illuminating the kitchen. This is the same design as the one in the bathroom, three horizontal lights with the upper being a top-hung casement. These windows are later in date than the extension and the brickwork around the openings suggests that they were inserted into the walls rather than replacing earlier fenestration. Projecting from this extension is a small, probably C20th, single-storey brick-built lavatory. The north elevation of the extension to No.2 has a chimney stack projecting from it and an entrance into the kitchen (Plate 9). The wooden plank door in this entrance appears to be original. A further extension for a bathroom has been added to the side of the cross-wing.

Plate 9 No.2 north elevation showing later extensions

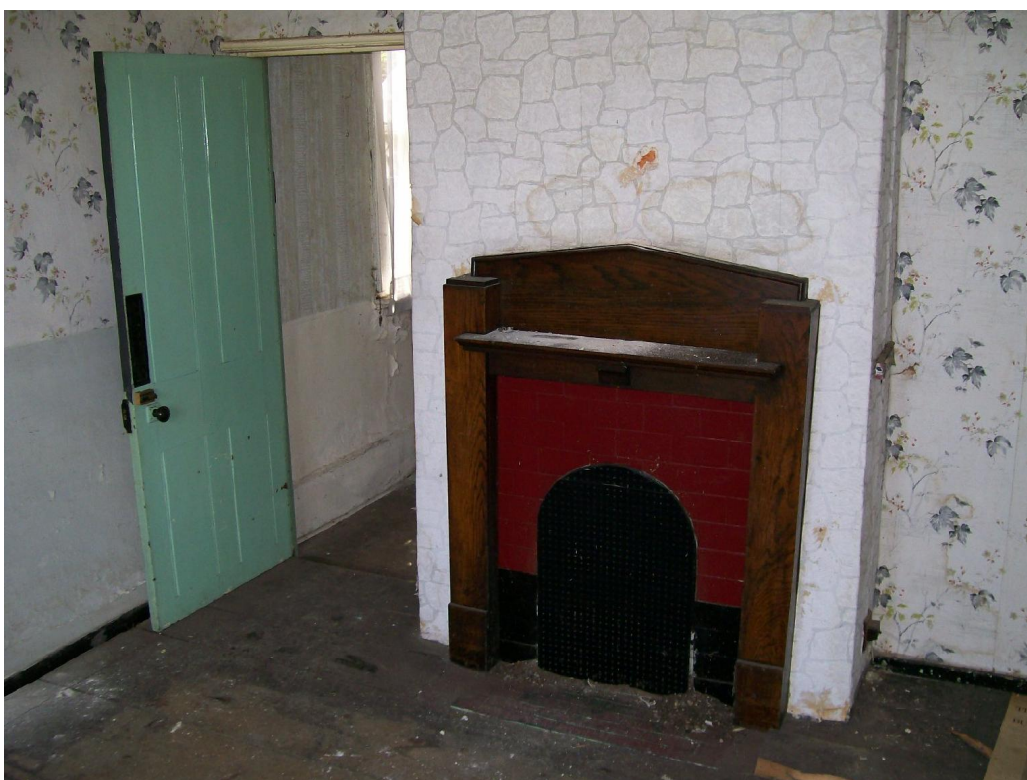
The interior of the original cottage was very simple in plan: three rooms downstairs and three rooms upstairs. The downstairs rooms all had fireplaces and hardwood floors, with the two rooms to the east linked to the western room by a passage under the stairs. The first floor was accessed by a quarter-turn flight of stairs located on the west side of the central room. The landing at the top of the stairs led to three bedrooms, each with a fireplace and hardwood floors. The subsequent extensions increased the number of rooms to nine on the ground floor and five on the first floor. However, the division of the structure into two dwellings altered the floor plan. No.1 to the east has five rooms (two of which are original) on the ground floor and two above (both original). The central room of the original cottage (room 1 on Fig 2) still has the original stairs and flooring but the Victorian fireplace has been replaced with a later Art Deco version with decorative glazed tiles. This has subsequently been converted to accommodate a gas fire. The alcove to the north of the chimney has a floor to ceiling cupboard. Room 2 has a fireplace with an arched grate, geometric-styled wooden mantel and surround, and glazed tiles (Plate 10). Although the surround is late Victorian/early Edwardian, the arched grate is indicative of a mid-Victorian style that would be contemporary to the construction date of the cottage. Both rooms have a picture rail. The extension to the north of No. 1 contains the kitchen, bathroom and lavatory, although all fixtures and fittings have been removed from the kitchen. All of these rooms are floored with red ceramic tile and the bathroom has upright pine tongue and groove cladding to two walls. The stairs (which have a door at the base closing them off from room 1) lead to a small landing that originally branched east and west to bedrooms either side of the stairs. Access to the west has been blocked. Bedroom 1 has a square, late Victorian fireplace with a cast-iron surround and rectangular cast-iron grate with angled tile panels. Directly above the fireplace is a wooden tie beam aligned north to south, anchored to the walls with large iron staples (Plate 11). This may represent an attempt to prevent bowing of the outer walls. Bedroom 2 has a fireplace with a simple wooden mantel and surround. The cast-iron grate has been removed.

Plate 10 No.1 room 2 fireplace with possible contemporary grate.

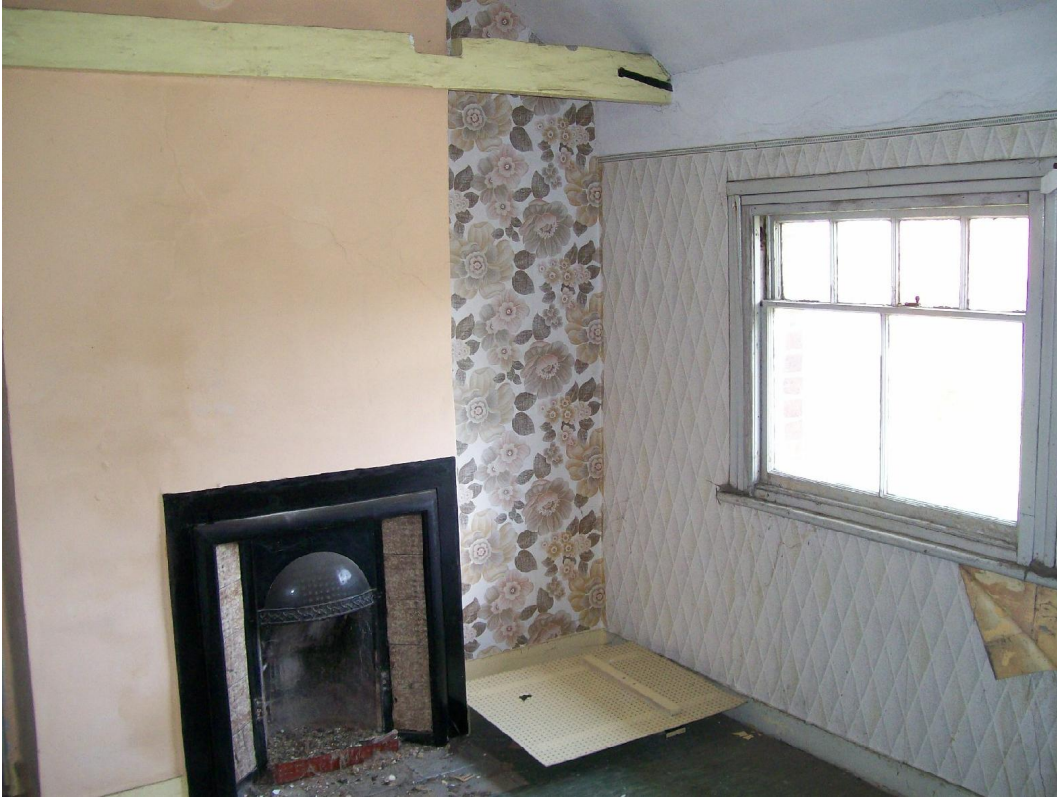
Plate 11 No.1, bedroom 1 showing the wooden tie beam, Victorian fireplace and the four-over-two hybrid sash window.

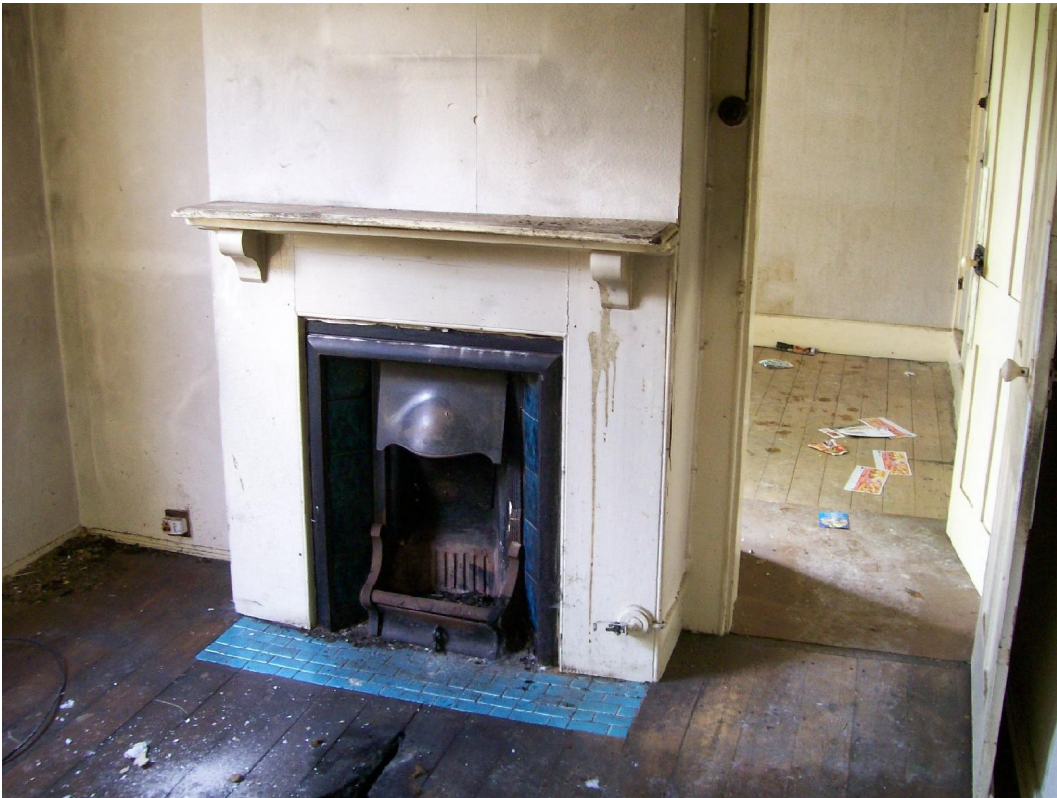
The front door to No.2 Pottery Lane opens into a room (room 1 on Fig 2) with a softwood floor and a square, late Victorian fireplace with cast-iron surround and a rectangular cast-iron grate with angled tile panels. This is surmounted by a large but plain wooden surround and mantel. Room 2 has an identical mantel and surround (Plate 12). The fireplace is similar in style to that in room 1 and shows that both are contemporary with the extension. Both rooms have a picture rail and room 2 has a gaslight fitting on the chimneybreast (Plate 13). This fitting may be contemporary with the original cottage but is more likely to be of later date. Room 1 has Bakelite electric switches by the front door and the stairs. These are obviously not original to the building but do nonetheless date to the early C20th. The kitchen has a linoleum-

Plate 12 The fireplace in ground floor room 2 of No.2 with the original hardwood flooring to the foreground and the later softwood flooring of the extension to the rear.

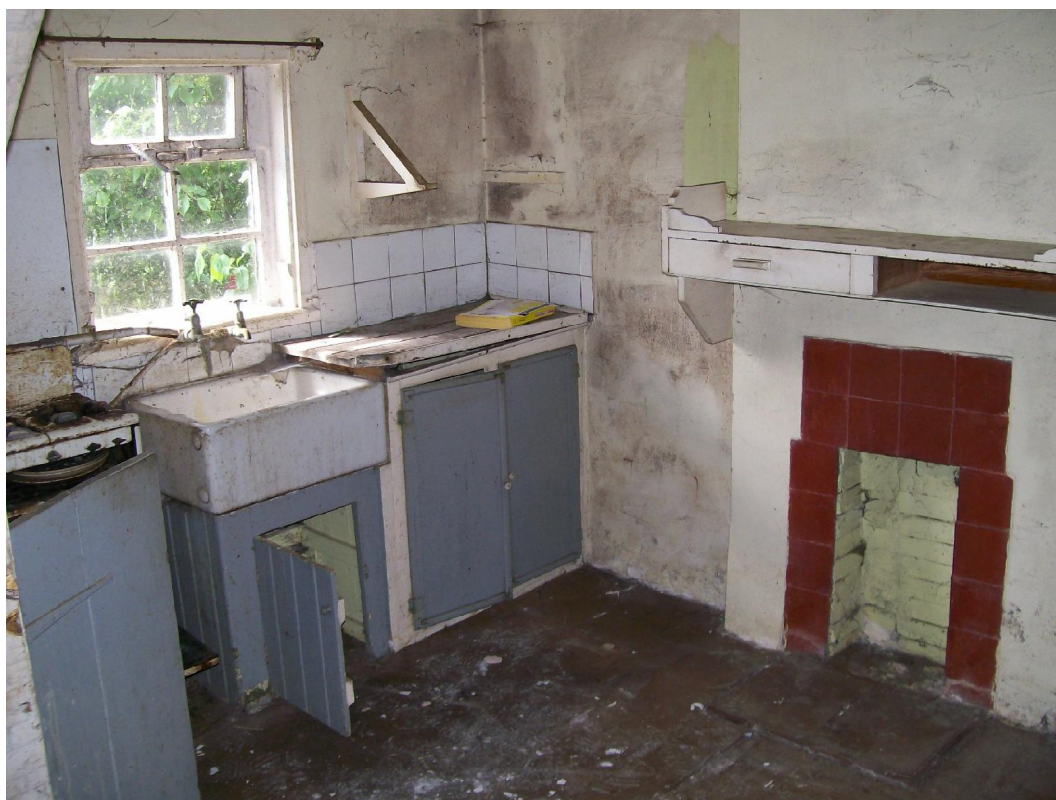
covered concrete floor and an opening for a fireplace, although the grate has been removed. Wooden worktops and a Belfast sink are ranged along the west wall (Plate 14). A small bathroom with lavatory is accessed from the kitchen. The first floor of No.2 is reached by a quarter-turn flight of stairs off room 1, which leads to a small landing. Three bedrooms open off of this landing. Bedrooms 1 and 3 both have softwood flooring whilst bedroom 2 has the original hardwood floorboards. Although all three bedrooms originally had fireplaces, the one in bedroom 3 has been blocked off and the others replaced with gas fires. Bedroom 2 has two built-in cupboards.

Plate 14 No.2 kitchen.

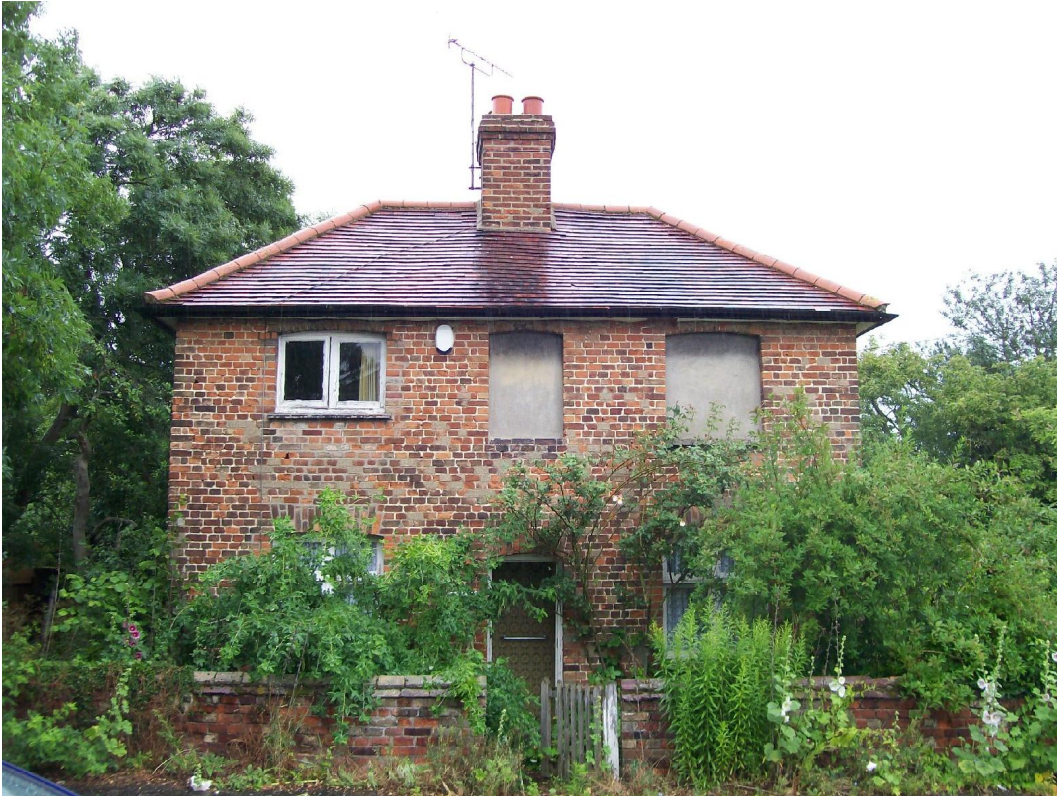
This is a detached rectangular two-storey brick-built structure with a single-storey extension to the north (Plate 15). There is no discernible bonding to the brickwork, which is of many different colours and includes many that have been over-fired. The hipped roof was originally slate but has been recovered with ceramic tiles. As with Nos 1-2 there is no attic space. A centrally located chimney stack projects through the roof. The cottage originally had a line of symmetry through its south elevation but this has been lost due to the blocking up of the central and east windows on the first floor, and the shortening and widening of the window to the west. On the ground floor, the centrally-located entrance, surmounted by a door head of arched brick, appears to be original but the openings flanking this entrance have been widened and replaced with wooden casements. A window in the first floor of the east elevation has been altered in the same fashion. The west elevation has a small window in the first floor but this has also been altered and made smaller. These windows would have been recessed concealed box sashes like those in Nos 1-2, with those in the upper floor being tucked under the eaves. There appear to be no openings on the north elevation apart from those in the later extension. This has two windows, one of three horizontal lights for the kitchen, the other of hammered glass for the bathroom. The extension is of light coloured brick laid in English bond and has a single pitch roof of ceramic tiles.

Plate 15 No.3 showing blocked windows and alterations to remaining fenestration.

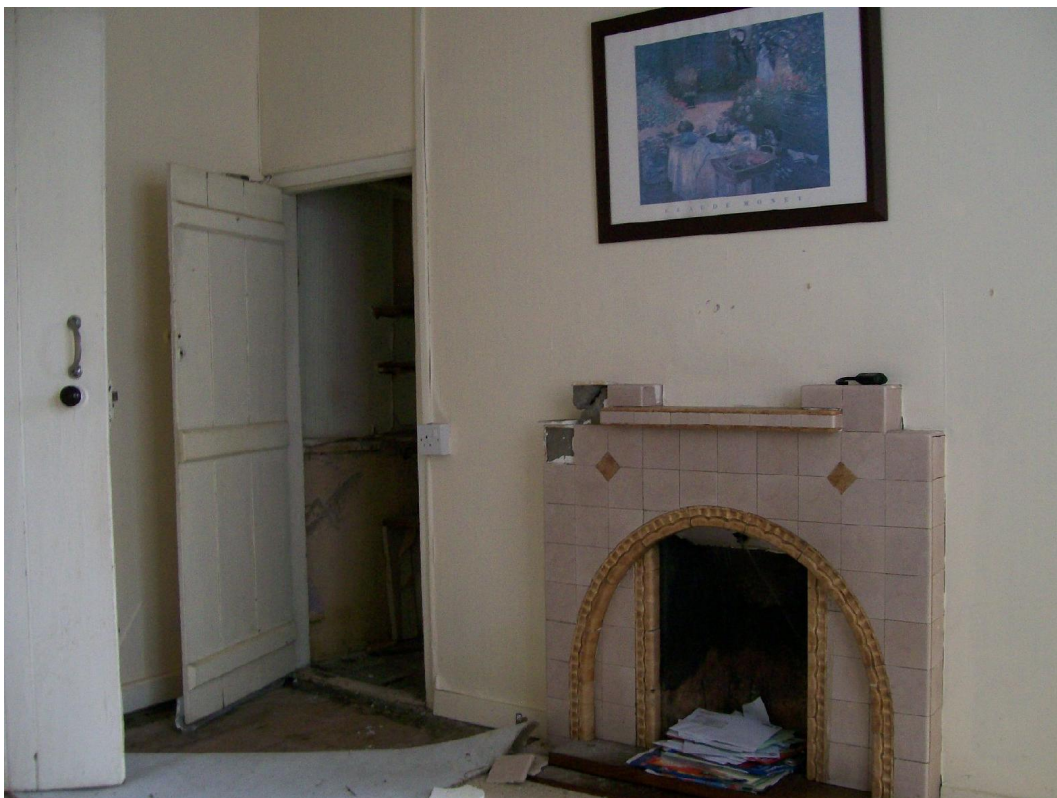
The interior of the cottage has a single room either side of the chimney stack on both floors with two additional rooms in the ground floor extension. Room 1 to the west has an Art Deco fireplace of geometric ceramic tiles (Plate 16). To the north of this is a cupboard. Although the cottage is carpeted throughout, the floors beneath are of hardwood. Aligned east-west across the centre of the room is a wooden tie beam: this may be purely decorative. A door in the north wall grants access to the kitchen and bathroom extension. Room 2 on the other side of the chimney stack is very similar to room 1. A fireplace with a geometric wood mantel and surround is attached to an earlier, larger blocked-in opening. Along the north wall is an enclosed staircase to the first floor. This has a door at its base and a cupboard beneath it. The extension does not appear to display any original fixtures or fittings, instead it appears that the extension was modernised in the mid to late C20th.

Plate 16 No.3, room 1 showing Art Deco fireplace and cupboard.

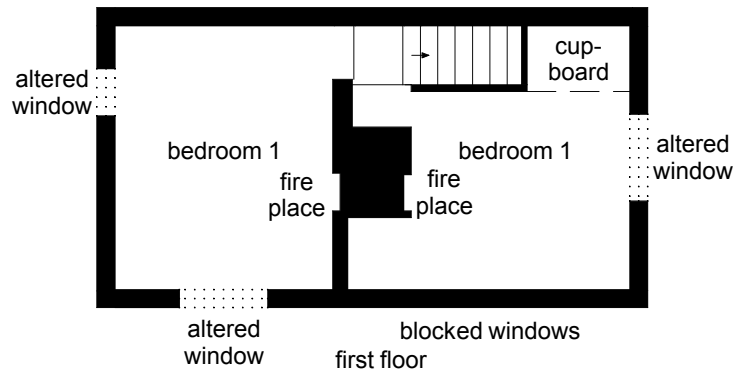
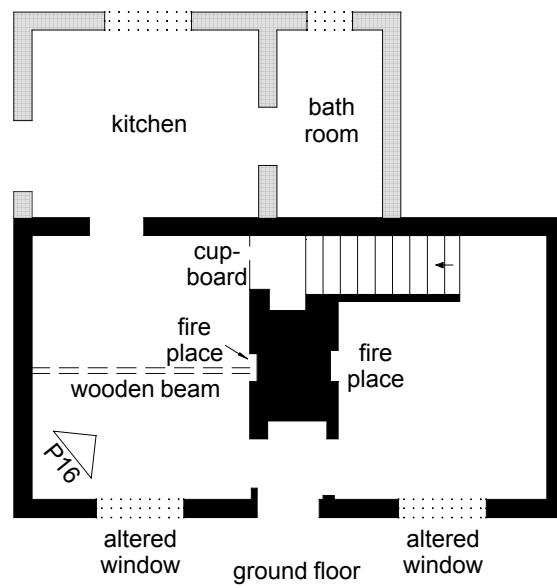
Fig 4 No 3 Pottery Lane: plan.

The west cottage, No. 3 Pottery Lane (Fig 4)

The first floor has two rooms, both very straightforward in layout. Bedroom 1, which is smaller than the other room, has no chimney breast but does have an airbrick indicating the location of an earlier fireplace. Bedroom 2 has the full width of the chimney projecting into the room, with a fireplace in the centre of this. A cupboard is located above the stairs.
