**Historic building recording
of an air-raid shelter
at Birch School,
Colchester, Essex
February 2012**

CAT project ref: 12/02b
NGR: TL 9423 1989 (c)
Colchester and Ipswich Museum
accession code: 2012.9

CAT Report 635
February 2012

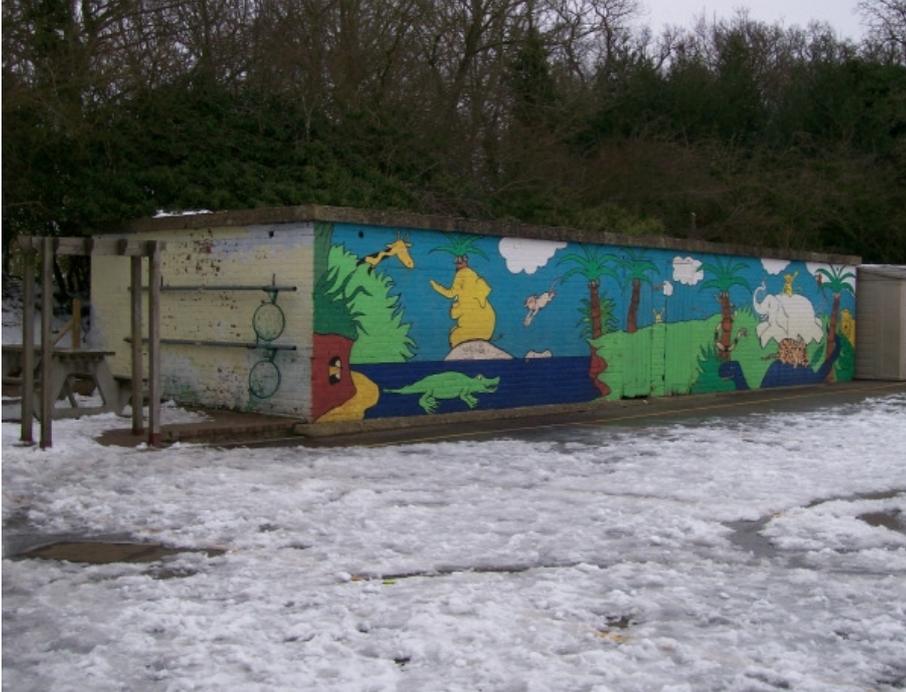
Plate 1 Air-raid shelter - view north-east.

The air-raid shelter is a rectangular structure, 13m by 4.5m, orientated north-east to south-west in the north-west corner of the school playground (Plate 1). It stands on a concrete plinth 15cm high at the west end and is brick-built of red stock bricks (dimensions 22cm by 6cm by 10.5cm) laid in twenty-eight courses of English bond. The roof is formed from a slab of reinforced concrete 15.5cm thick that overhangs the walls. The height of the shelter, from slab to bottom of the roof, is 2.15m.

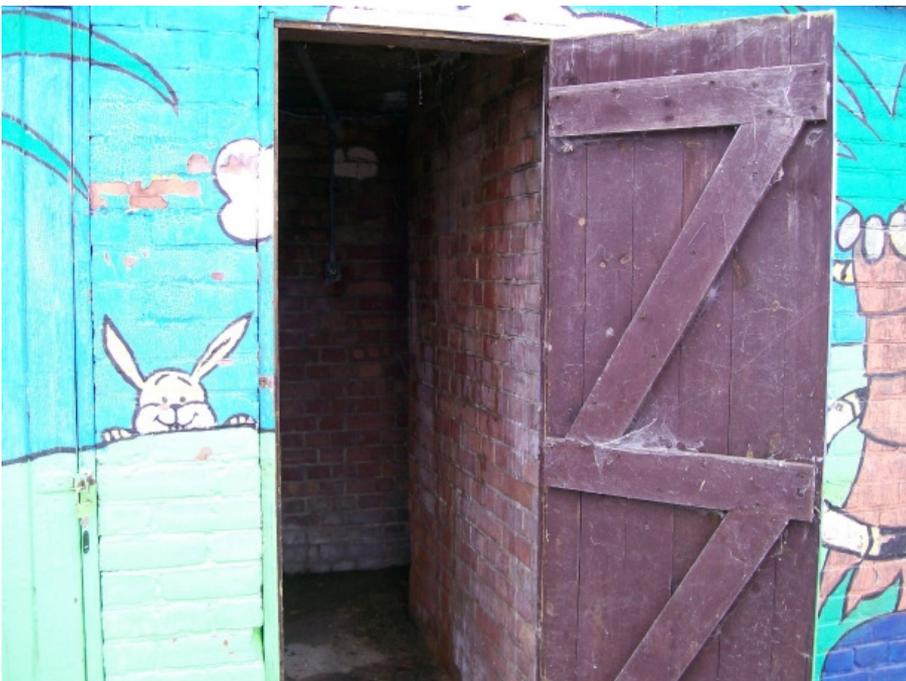
Plate 2 East shelter entrance with blast wall to the right - view north.

The building is symmetrically divided into two separate shelters through a central brick wall. Flanking this wall are two entrances, one to each shelter, which share a concrete lintel. Each entrance opens onto a 2.27m long corridor formed by the dividing wall and a blast wall, terminating in a second blast wall creating a right-angled turn into the main chamber of the shelter (Plate 2). These blast walls are the same thickness (34cm) as the main walls of the shelter. The main chamber of the

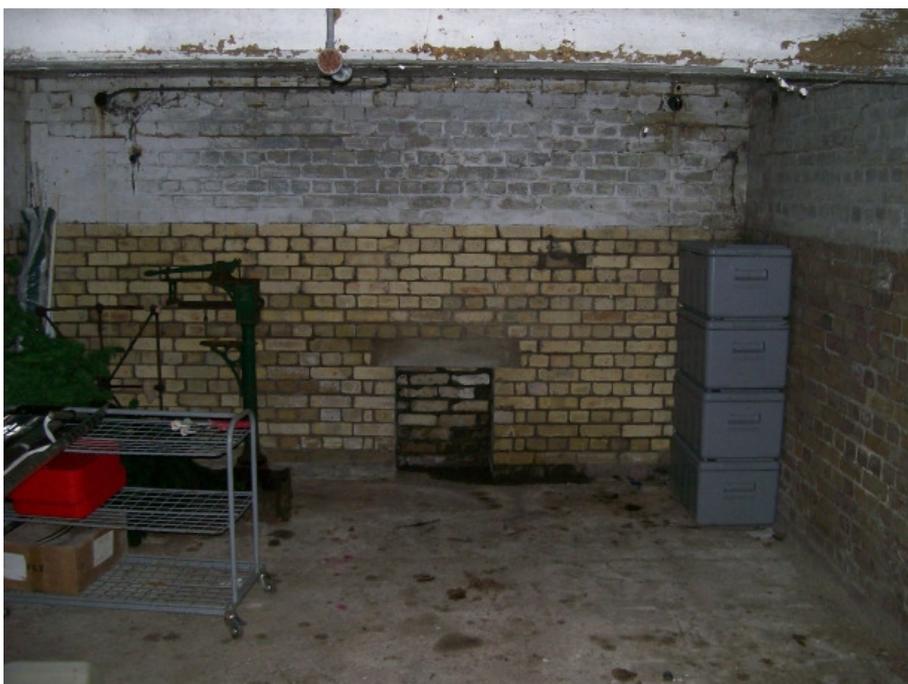
Plate 3 East shelter interior - view north-east.

shelter is a rectangular open space with a recess to the north of the entrance corridor (Plates 3-4). The interior brickwork is finished in yellow stock bricks rather than red, although the upper third of the walls are white-painted. Ventilation holes formed from sections of cast iron pipe are placed around the shelter in the second course of bricks down from the roof (Plate 5). These are 7cm in diameter and located at the corners of the building, 69cm from the corners on the short sides and 65cm from the corners on the long sides. Each of the short sides has a low, off-centre opening with a concrete lintel (Plate 6). These are 60cm high by 53cm wide and are in line with the opening from the corridor. Both openings have been blocked in by one brick thick walls (Plate 7).
