**Historic building recording at
the barn, Greys Cottage,
Maldon Road, Kelvedon, Essex
June 2012**

**report prepared by
Chris Lister**

CAT Report 653
November 2012

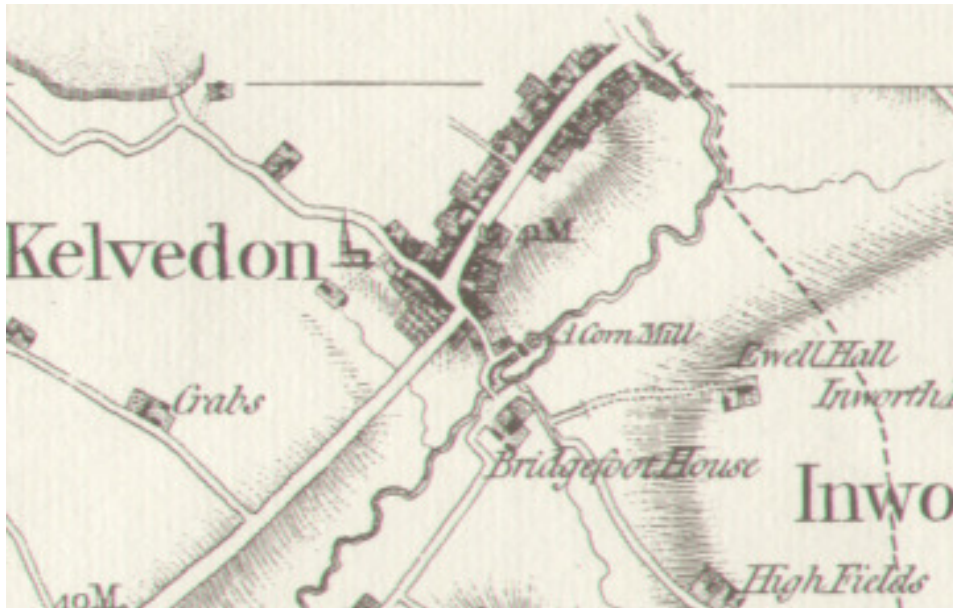
Fig 1 Chapman and André map of Essex, 1777 (Plate XIII)

The 1777 Chapman and André map of Essex (Fig 1) shows the 17th-century mill with some associated buildings but is too indistinct to distinguish the barn.

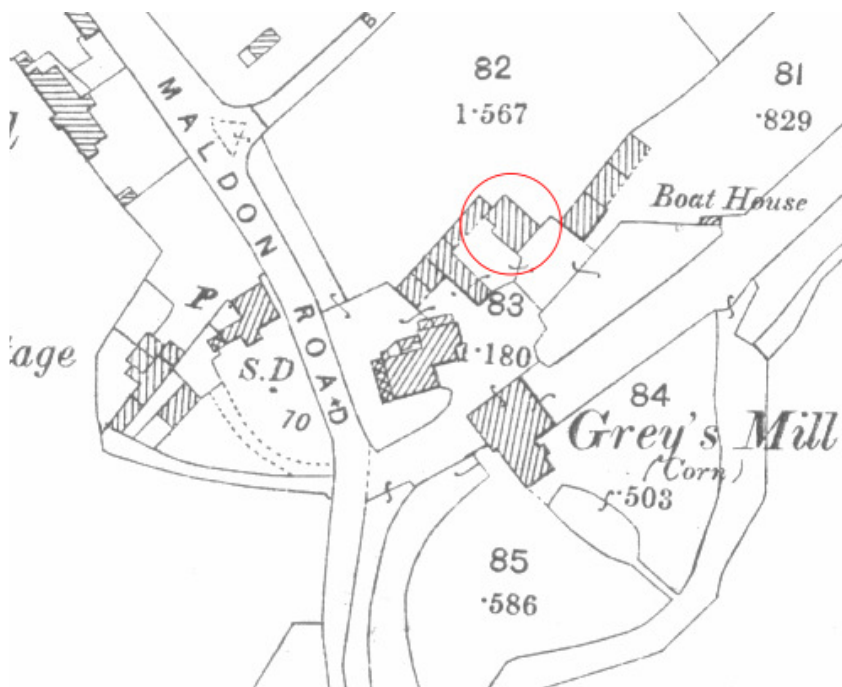
Fig 4 Second edition 25" OS map, 1897 (sheet 35).

The second edition 25" Ordnance Survey map of 1897 (Fig 4) confirms that no further alterations were made to the barn after 1875.

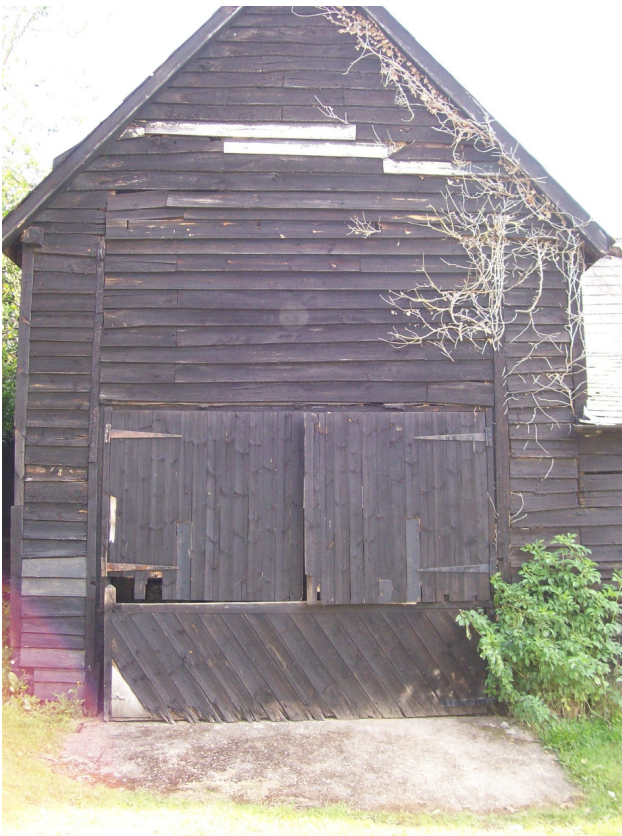
Plate 2 Midstrey showing the modern cart doors below the original opening

The midstrey on its south-west elevation has two modern cart doors held on modern strap hinges with a modern side-hinged threshold leap below (Plate 2). The north-west wall of the midstrey has an outward opening, vertical plank door held on pintels and round-ended strap hinges.

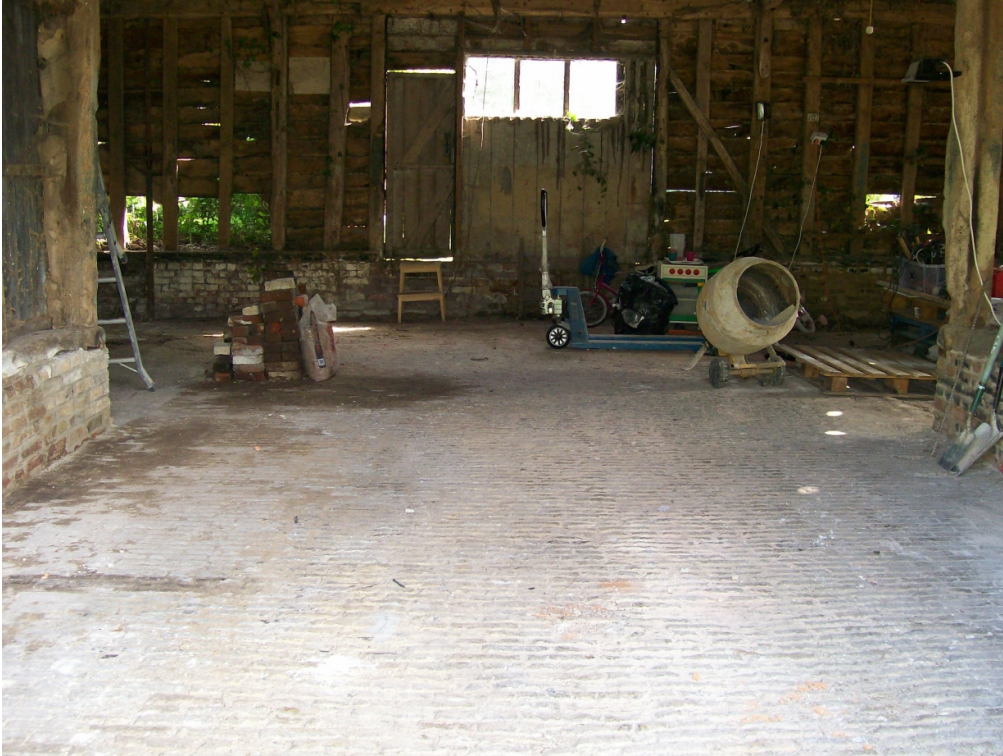
Plate 3 Interior of the barn viewed from the midstrey

The interior of the barn was relatively clear, apart from some clutter and building materials covering parts of the floor and lower parts of the walls (Plate 3). By the time of the survey the internal wall fabric and floorboards of the lean-to had been stripped out but the remainder of the barn was still intact.

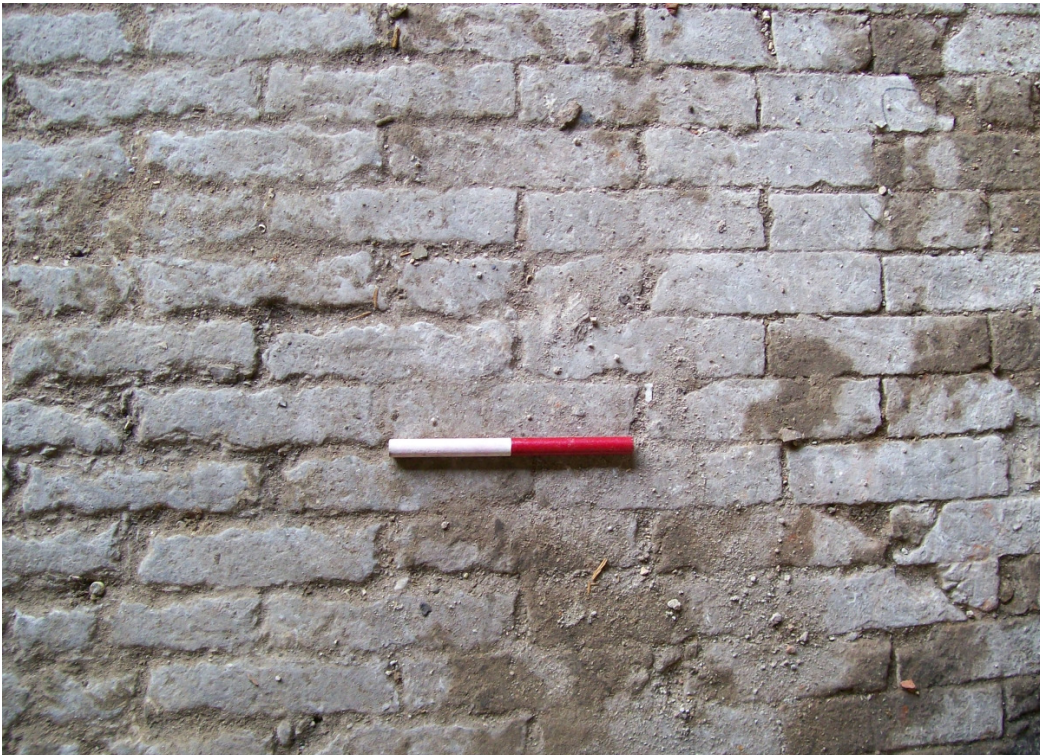
Plate 4 Brick threshing floor showing worn bricks to the left

The barn is of three bays of differing width. Bay 1 (at the north-west end) is 3.9m wide, bay 2 (centrally located) is 4.7m wide and bay 3 (at the south-east end) is 3.6m wide. The floor of the barn, from the midstre entrance to the rear of bay 2, is formed of pale yellow bricks with dimensions of 200 x 55mm laid on edge in a stretcher bond. These are particularly worn in the centre but are in very good condition to the sides of the floor (Plate 4). Bays 1 and 3 have earth floors which have been covered with bitumen, although much of this has worn away.

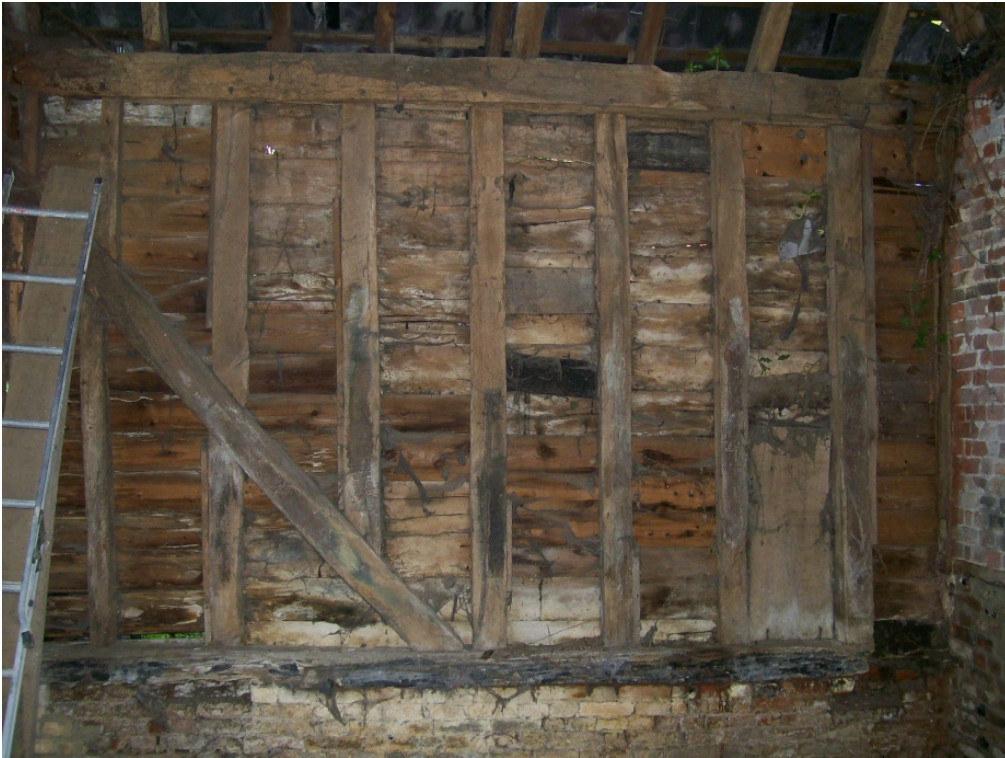
Plate 5 Bay 1, south-west wall frame with internal plank brace - view south-west

The outer bays each have seven studs single-pegged to the wall-plate (Plate 5), although one of these is missing from the south-west wall of bay 3. The south-west wall of bay 1 and the north-east wall of bay 3 are reinforced by lightly-curved internal plank bracing falling from the corner posts. There is similar bracing on the north-west wall of bay 1 although this is external to the wall frame. As is noted above, the north-west wall is of solid brick up to the wall-plate and the south-east wall has an inserted window. This window has partially truncated two of the studs but enough of the original timbers survive to indicate that lightly-curved internal plank braces rise from the corner posts at the sill beam (Plate 6). Typical stud dimensions are between 9-14cm wide and 6-12cm deep, with gaps of 37-44cm.

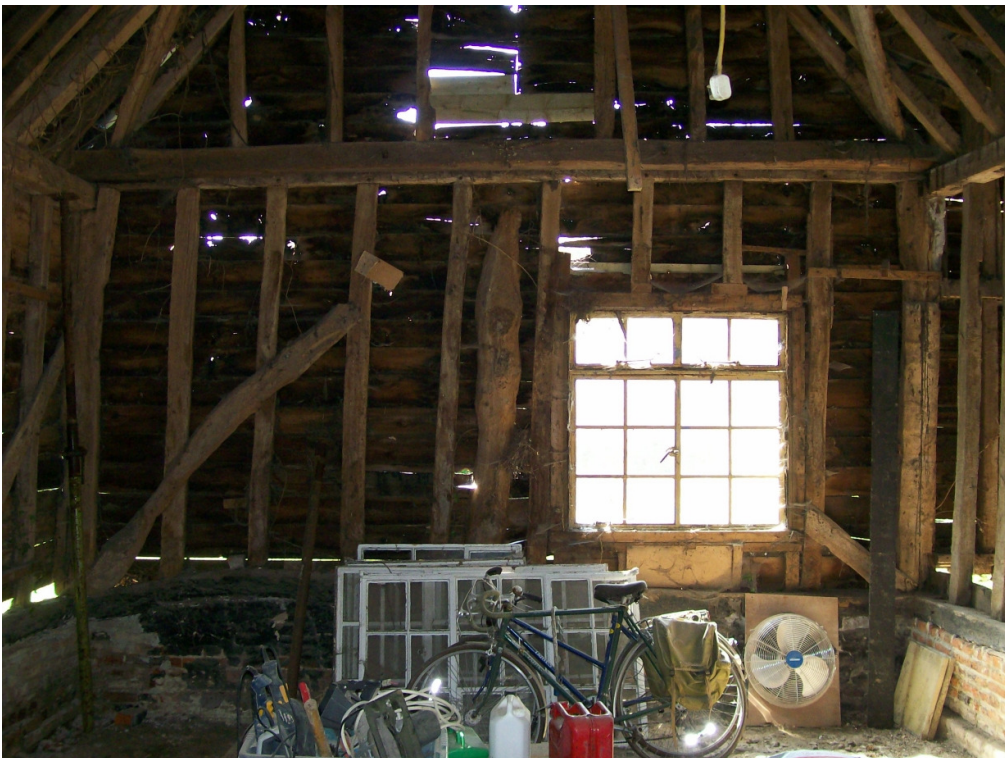
Plate 6 South-east wall frame showing curved sill beam and inserted Crittall window - view south-east

There is an edge-halved scarf joint on the north-west wall sill beam of bay 1. The sill beam of south-east wall is significantly curved at one end and the plinth has extra partial brick courses to compensate for this (Plate 6). Where the sill beam is level, below the inserted window, there is an edge-halved scarf joint. The sill beam of the south-west wall of bay 3 has been cut 80cm from the midstre corner post but has not been scarfed. The longer section of the sill beam, the studs and the wall-plate are all replacement timbers. The gable wall-plate of the south-east wall is obscured by a strengthening beam that is bolted to the frame. The wall-plate of bay 2 has been cut either side of the principal posts and replaced with a larger section beam jointed to the ends of the wall-plate with edge-halved scarfs each secured by two untrimmed pegs (Plates 7,8). The sill beam of bay 2 ends either side of the blocked opening.

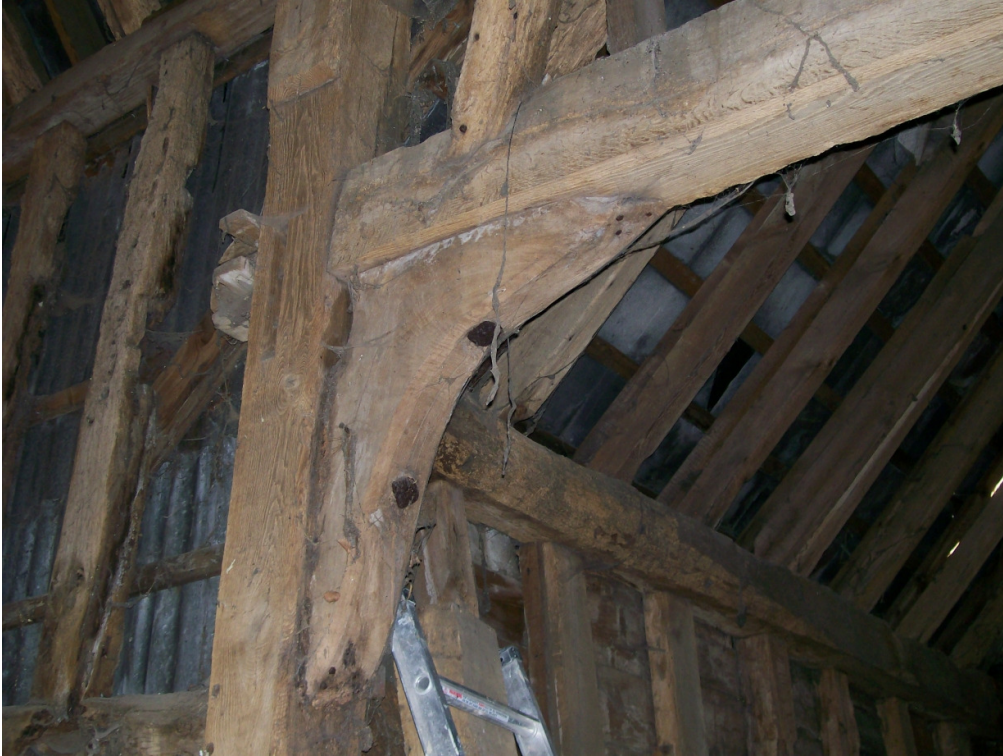
Plate 9 Elbow brace at south-west end of truss A with midstrey to the left

The tie-beam of truss A is a straight timber 17cm wide x 28cm deep with chamfered edges. At the north-east wall this sits on the wall-plate in normal assembly and is given additional support by an elbow brace of slender proportions. This is secured to the principal post by two large bolts, with the ends of the elbow nailed to the timbers. At the midstre the tie-beam is supported by an elbow brace of much thicker proportions, although it is bolted and nailed in the same manner (Plate 9). The tie-beam itself does not rest on the wall-plate at this end but rather passes through the corner post of the midstre and is held in place by a double tusk tenon (Plate 10). The north-east post of truss A has an exposed mortice (double-pegged) below the elbow brace which suggests an earlier arched brace has been removed. There is a similar mortice on the midstre side post of truss A and there are also exposed double-pegged mortices on the tie-beam. The north-east post of truss B is formed from two separate full length timbers pegged together to make one thick post. Apart from this, the composition of truss B is the same as that of truss A, although there is only a single tusk tenon at the midstre corner post.

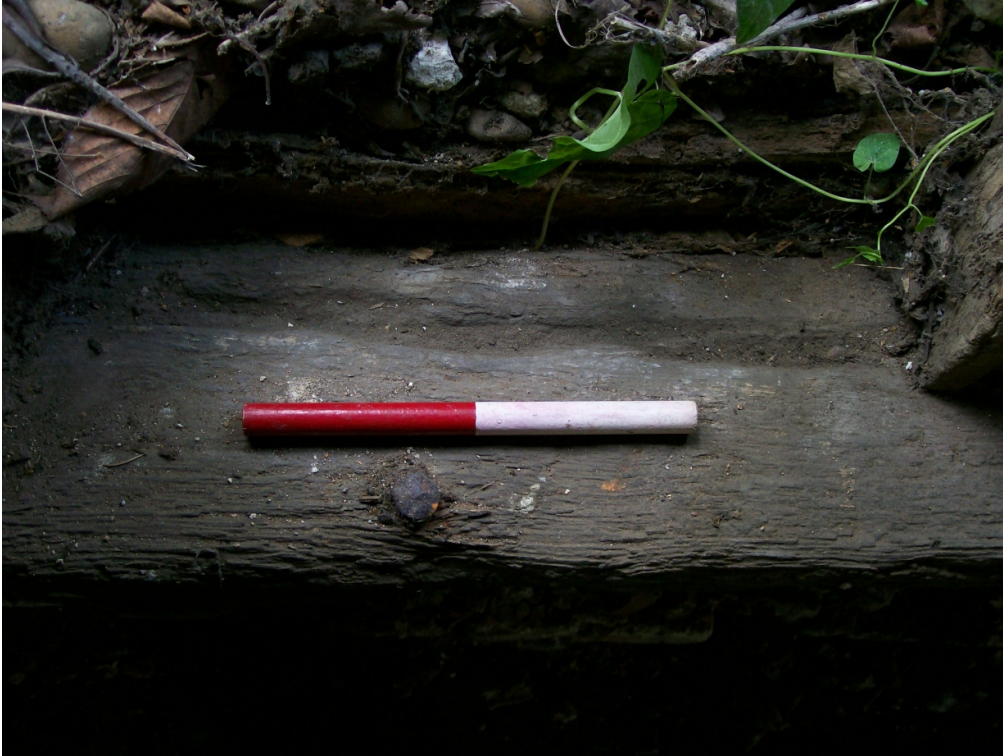
Plate 11 Bay 1, evidence for original wattle and daub stave groove in north-east sill beam

There appear to be the remains of stave grooves on the sill beams which suggest the panels were infilled with wattle and daub (Plate 11). However there are no indications of corresponding stave holes on the underside of the wall-plates.

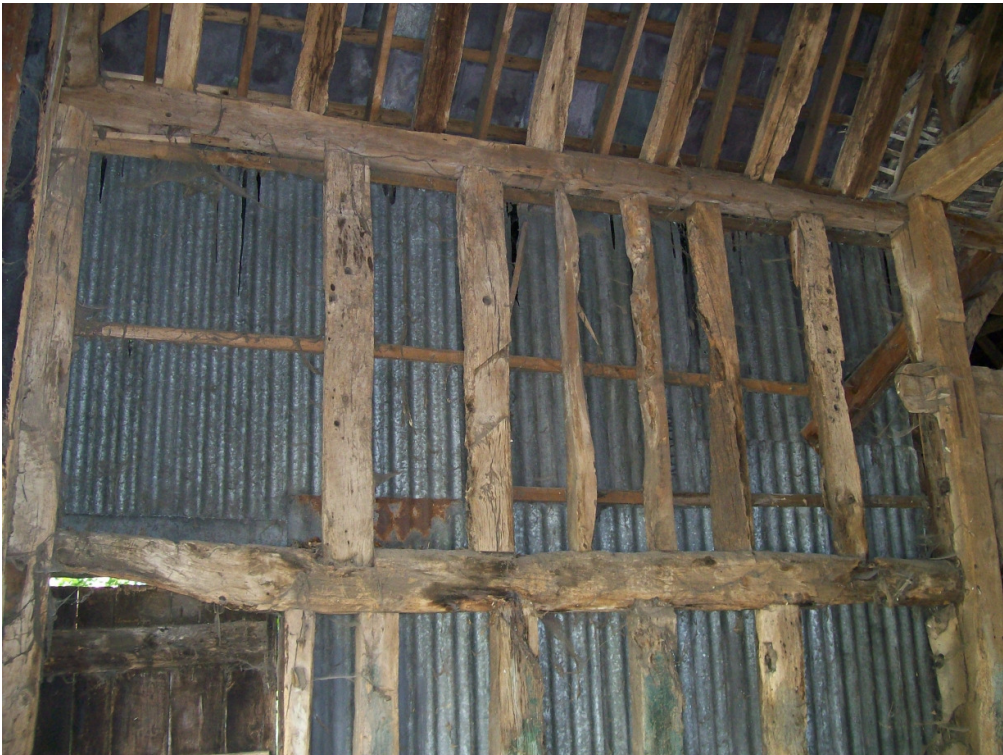
Plate 12 Midstrete, north-west wall frame, showing greater height of corner posts

The side walls of the midstrey each comprise two large section posts rising from the sill beam to the wall plate with a double-pegged girding beam between them. At the main barn end of the midstrey the corner posts act as the principal posts for the trusses (Plate 12). These posts are significantly higher than those at the other ends of the trusses and rise to heads with square-cut jowls supporting the wall-plates and a lightly cambered tie-beam. The wall-plates extend 80cm into bay 2 through the heads of the corner posts. Both of these are re-used beams and the projections carry the end rafters of the midstrey that form the valley between the midstrey and the main barn. The corner posts by the cart doors are straight posts without jowls and the gable tie-beam rests directly on the wall-plate. The lower register of the north-west wall has four surviving studs single-pegged to the girding beam and displays mortices for two more in the sill beam and girding beam. An outward-opening door of vertical planks has been inserted where one of these studs has been removed. The upper register has six surviving studs and a mortice in the wall-plate that suggests there was a seventh.

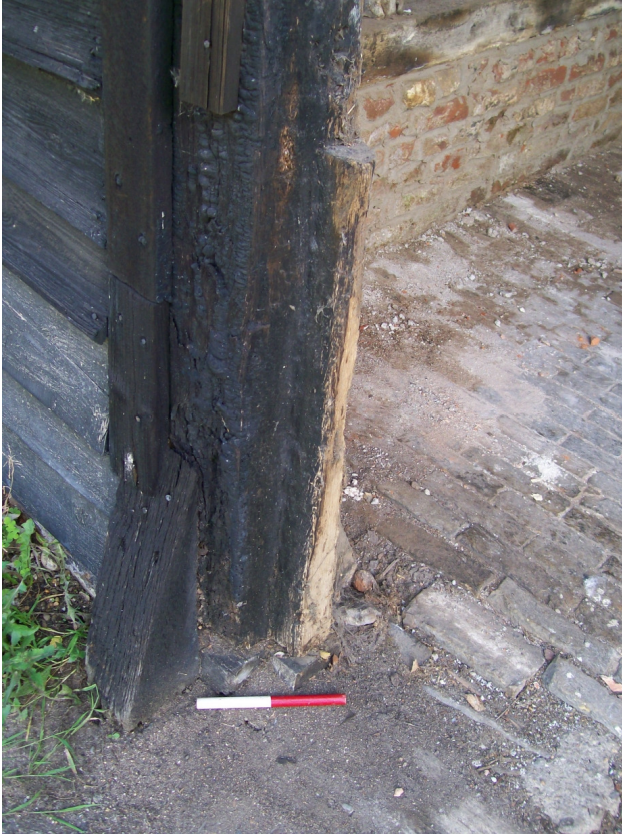
Plate 13 Recess for the original threshold leap

The posts for the cart doors are straight timbers set in from the corner posts and stand on timber piles set into the ground. These posts are single-pegged to the gable tie-beam and have a short rail single-pegged to the corner posts. Large elbow braces provide additional support to the doorposts and tie-beam. These are each held in position by two bolts with the ends of the brace nailed to post and beam in the same manner as the braces for the trusses. The gable tie-beam is strapped to the wall-plates. A recess for the original threshold leap can be seen on the north post of the cart doors (Plate 13) but the original doors and threshold leap have been

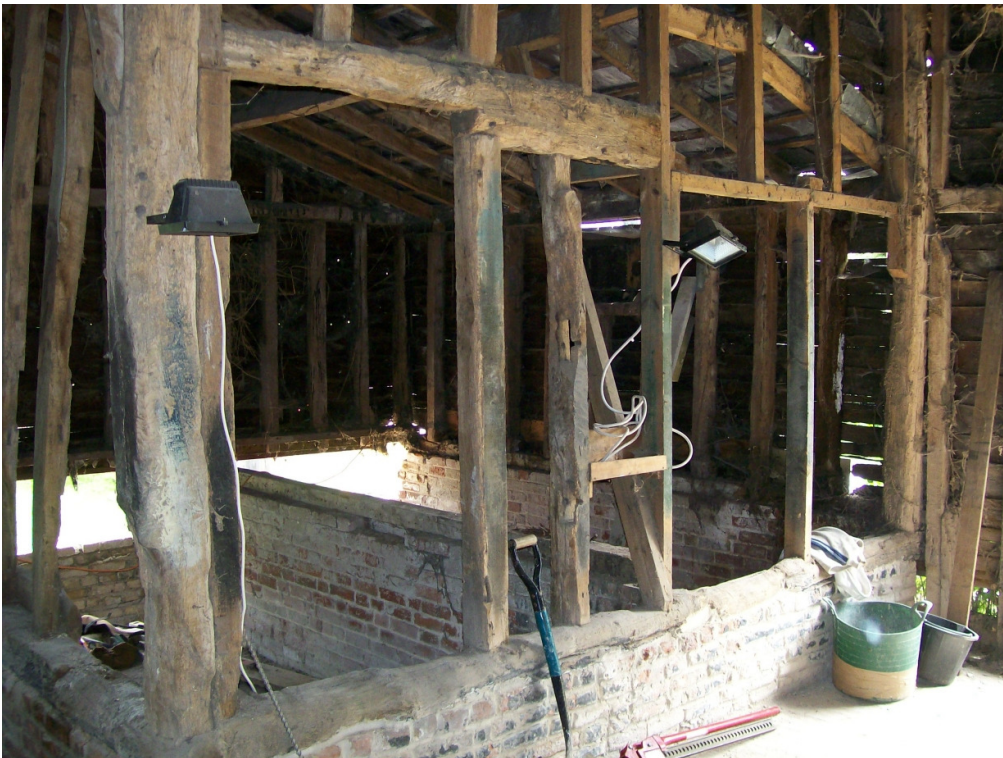
Plate 14 View into the lean-to from the midstrey

This structure is a mono-pitched timber-framed lean-to attached to the south side of bay 3. It has a raised timber floor which is level with the sill beams of the main barn and the midstrey (Plate 14). This floor is supported on two walls of 13 courses of soft red brick with dimensions of 220 x 100 x 60mm, laid perpendicular to the midstrey. The space beneath the floor is a void open to the exterior. The frame of the lean-to is completely constructed from machine-cut timbers and the sill beam of the south-east wall is supported only by the brick walls which project slightly from the lean-to. There is an edge-halved scarf joint on the sill beam of the south-west wall and a centrally located hatch in the top part of the same wall.

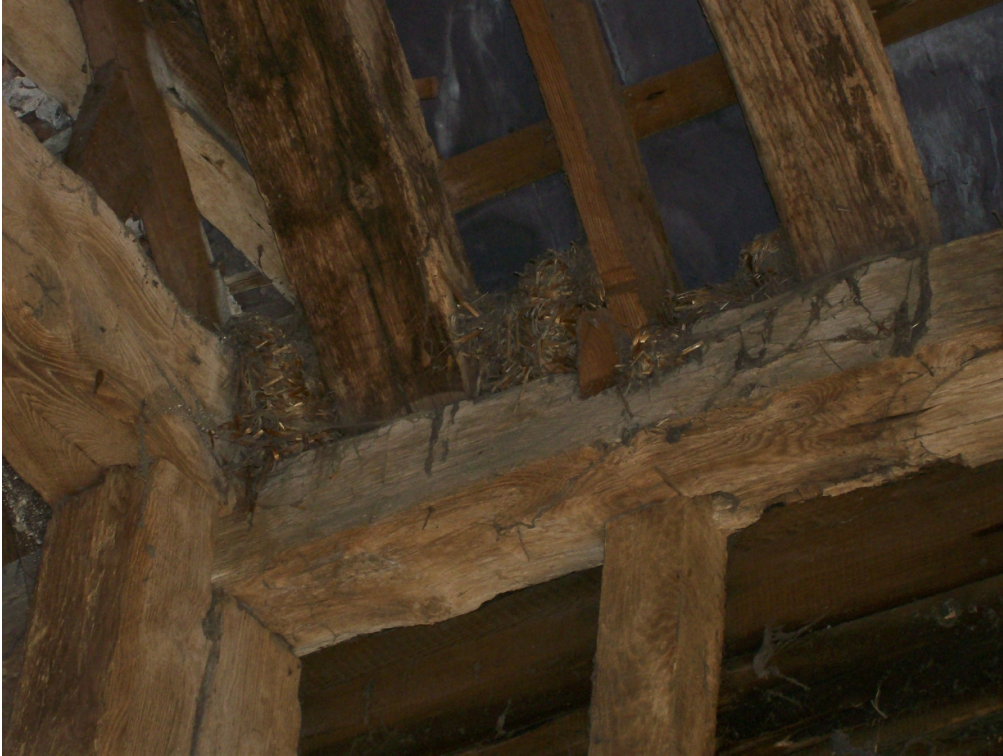
Plate 15 Remains of thatch on midstrey south-east wall plate

The roof is predominantly covered in slate with peg-tiles used for the valleys. This replaced original thatch, possible remnants of which can be seen on top of the wall plates (Plate 15).

The re-roofing of the barn is interesting because of the mix of materials used. There is evidence that the barn was originally thatched (Plate 15) but the surviving peg-tile valleys indicate the thatch was removed and that the barn was completely re-roofed by peg-tiles. The subsequent use of slate as a roof covering may be linked to the 1858 fire and the re-building that occurred in its aftermath. This date coincides with a rise in the popularity of slate as a roof covering as the development of the rail network allowed greater distribution of this material. However, slate roofs require lead valleys and those of the barn at Greys Cottage retained the peg-tiles with the slates of the roof overlapping the edges of the valleys. The reasons for this can only

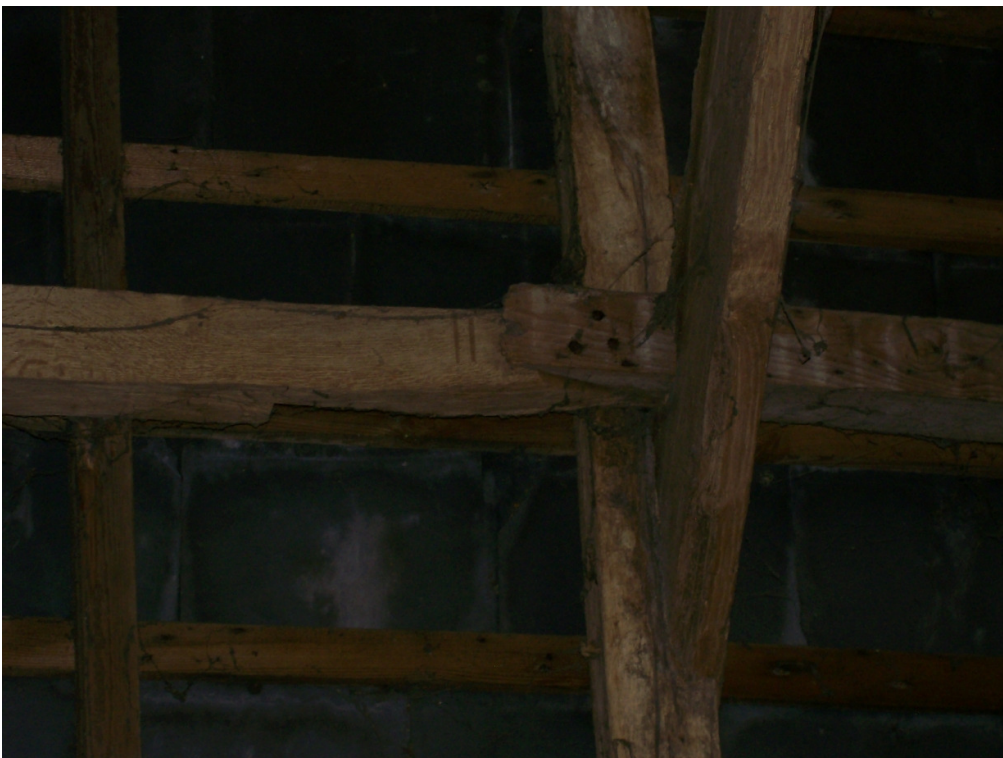
Plate 16 Bay 1, carpenters' mark (II) on purlin of north-east roof pitch and splayed scarf joint

The purlin carried on the collars of the trusses in bay 2 is scarfed to the purlins of the outer bays with a splayed and nailed joint. The three collars of bay 2 are joined to the purlins with a nailed birdsmouth joint rather than trenched to the rafters. The purlin in bay 1 is formed from two timbers and has an incised carpenter's mark (II) where it is scarfed to the machine-cut purlin (Plate 16). The purlin in bay 3 is formed from one long timber. Both ends of the roof have angled wind braces rising from the gable wall-plate passing beneath the rafters to the outermost collar of each bay.

The paucity of carpenters' marks on the structure is interesting and may reflect the number of replaced timbers in the structure. Another reason for this may be that the midstrey and the alterations were not carried out by a 'professional' carpenter but were conducted by less experienced labour. This may explain why the tie-beams are tusk-tenoned to the posts of the midstrey rather than jointed in a more complicated manner.

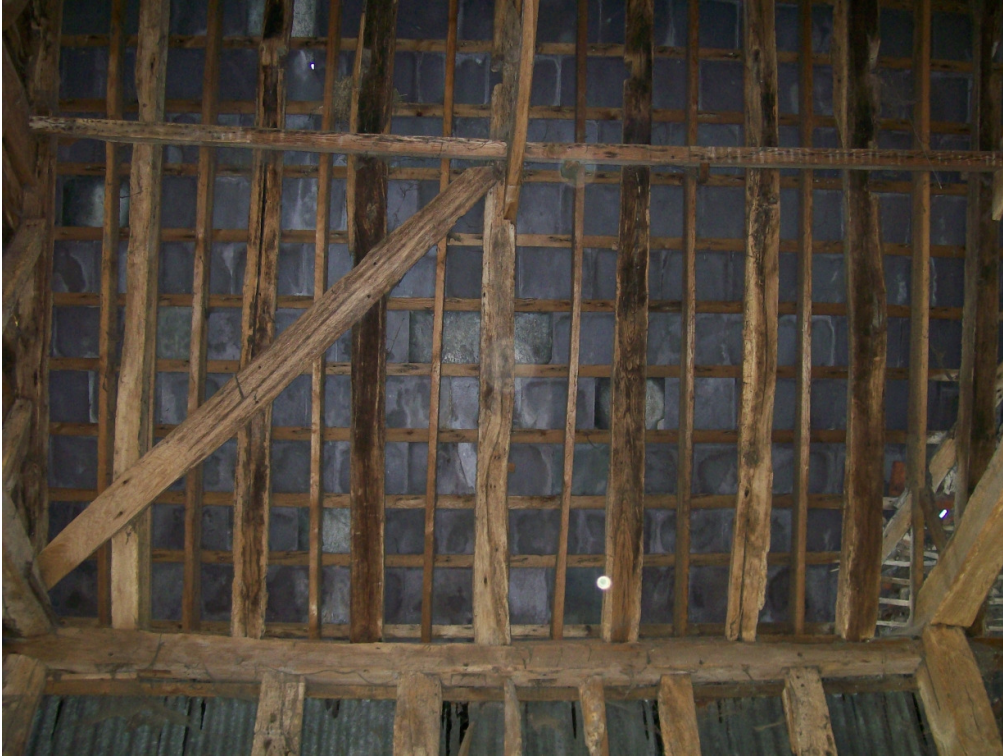
Plate 17 Midstrey roof with smoke-blackened re-used timbers

The roof of the midstrey has seven rafters to each pitch, the majority of which are re-used timbers displaying signs of smoke damage (Plate 17). Machine-cut timbers have been inserted between each of these rafters which carry laths supporting the roof covering of slates. As with the roof of the main barn the original rafters have furring boards behind them. Each pitch has a single through purlin extending from the gable collar to the penultimate rafter of the midstrey. This is supported on a triple-pegged trenched collar located at the central rafter of the midstrey. On both roof pitches inclined plank braces rise from the gable tie-beam to the underside of the junction of the midstrey collar and purlin.
