**A report on the monitoring of ground
investigations within the precinct of St John's
Abbey and on the site of the Roman circus.
Alienated Land Area B1b (Flagstaff
Compound), Colchester Garrison, Essex
September 2013**

CAT Report 730
October 2013

Introduction (Fig 1)

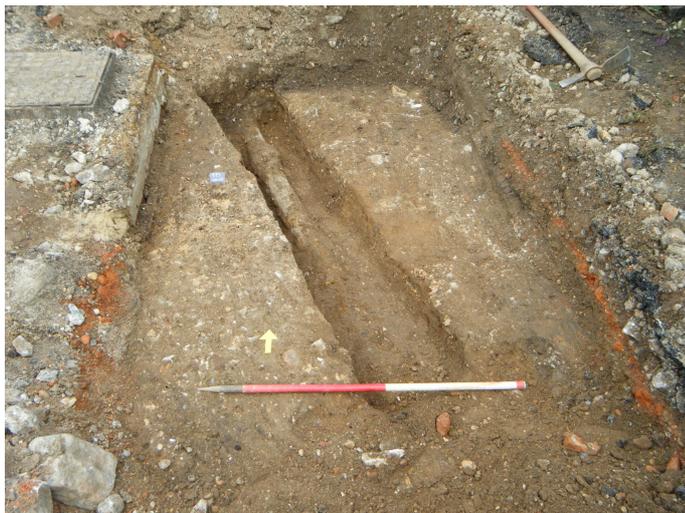
Plate 1 TP1 southern end (F14 & F15), facing north.

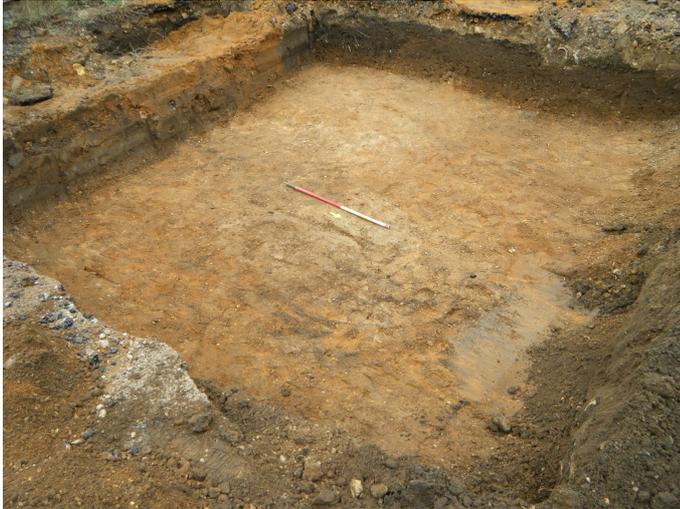
TP11 was excavated to a depth of c 4m to facilitate a water soakage test. The test-pit was then backfilled before the excavation area was extended to ascertain whether any archaeological features or deposits survived in the area of a proposed soakaway (Fig 13a). A sherd from a Roman storage jar (82g) and a sherd of medieval pottery (Fabric 20, 6g) were recovered from the accumulated soil (L2) in the area of the soakaway. However, no archaeological features or deposits were identified (Plate 2).

Plate 2 The area of the proposed soakaway, facing south-west.

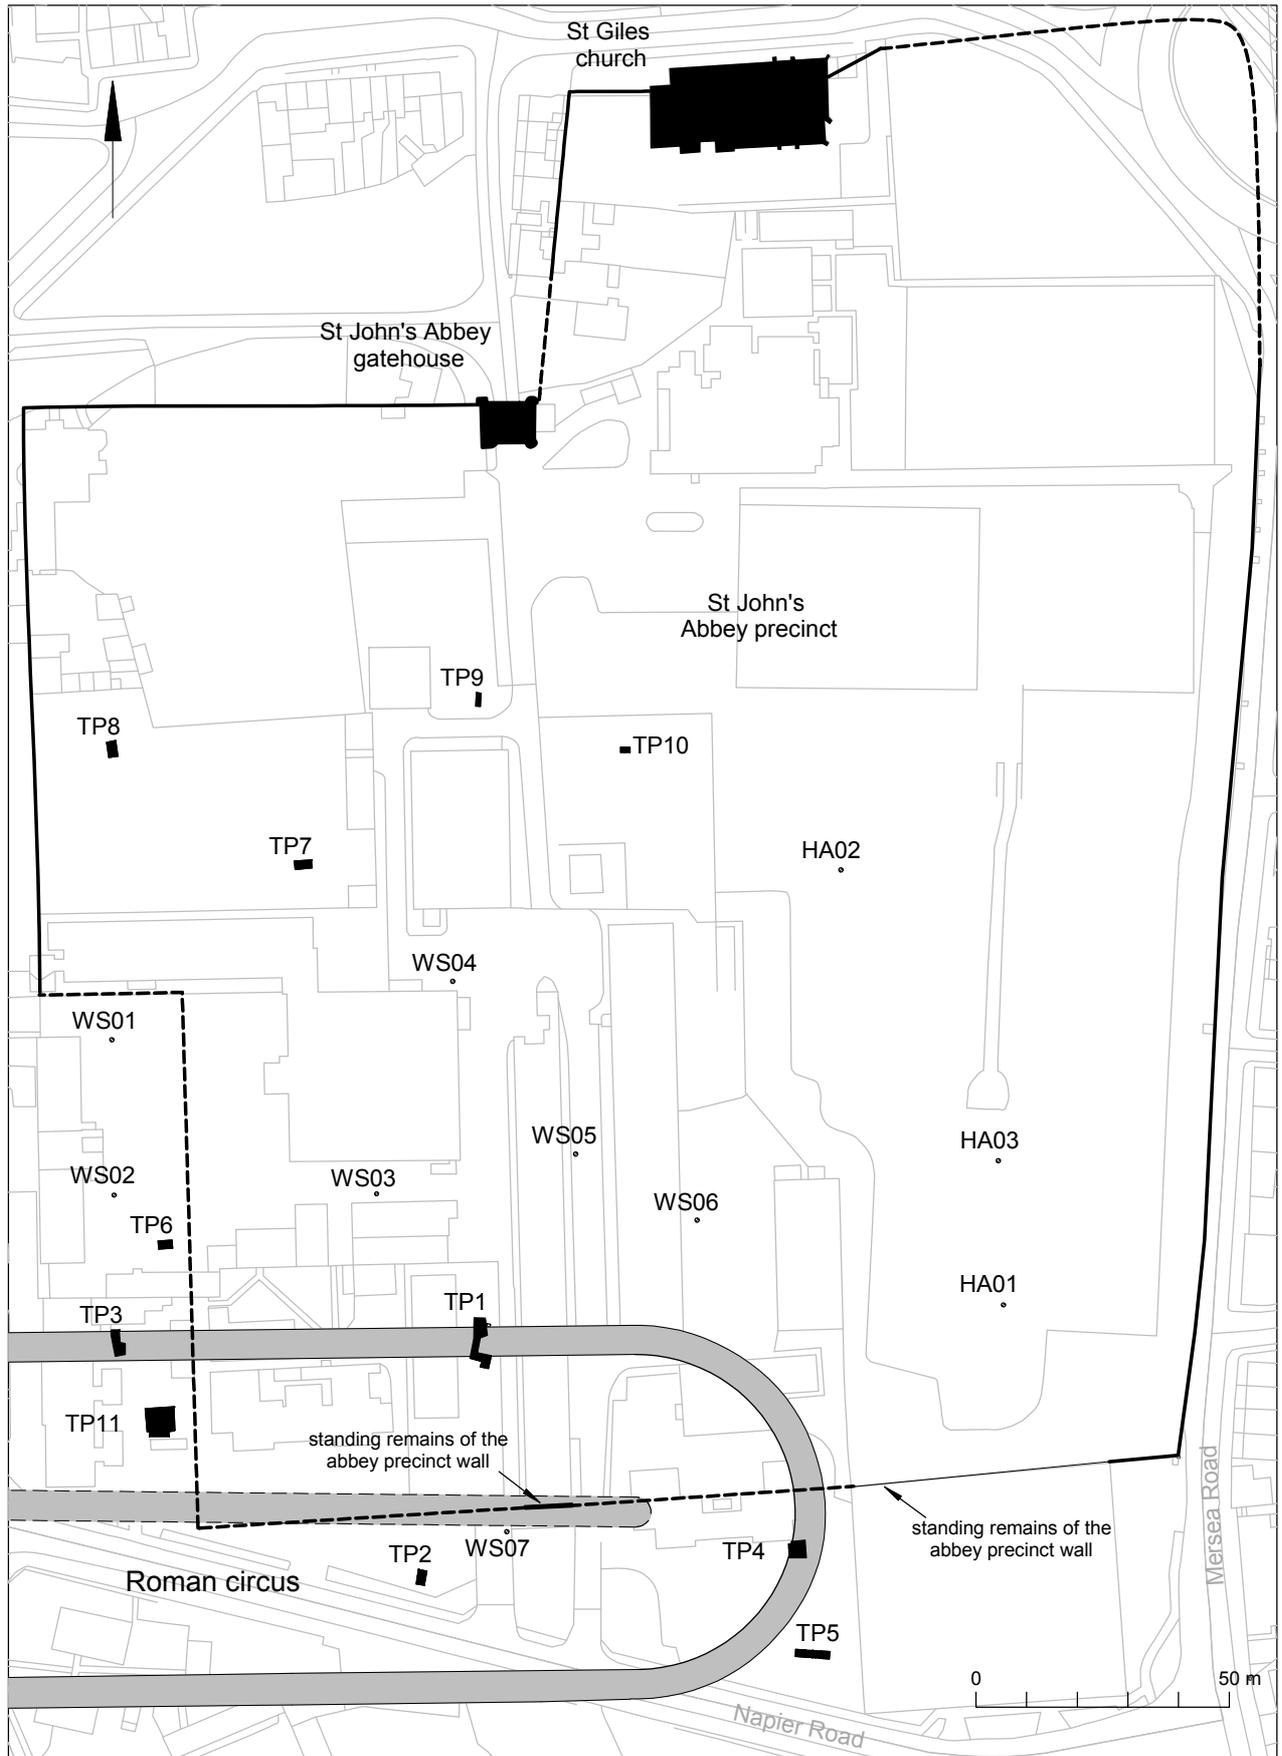
Fig 1 Location of the test-pits TP1-TP11, the windowless samples WS01-WS07 and the hand-auger pits HA01-HA03.

In addition, seven windowless sample holes (WS01- WS07) and three hand-auger pits (HA01-HA03) were excavated by geotechnical engineers to assess shallow ground conditions and obtain soil samples (Fig 1). All ten of these holes were hand-excavated to a depth of 1m below modern ground level under archaeological supervision.

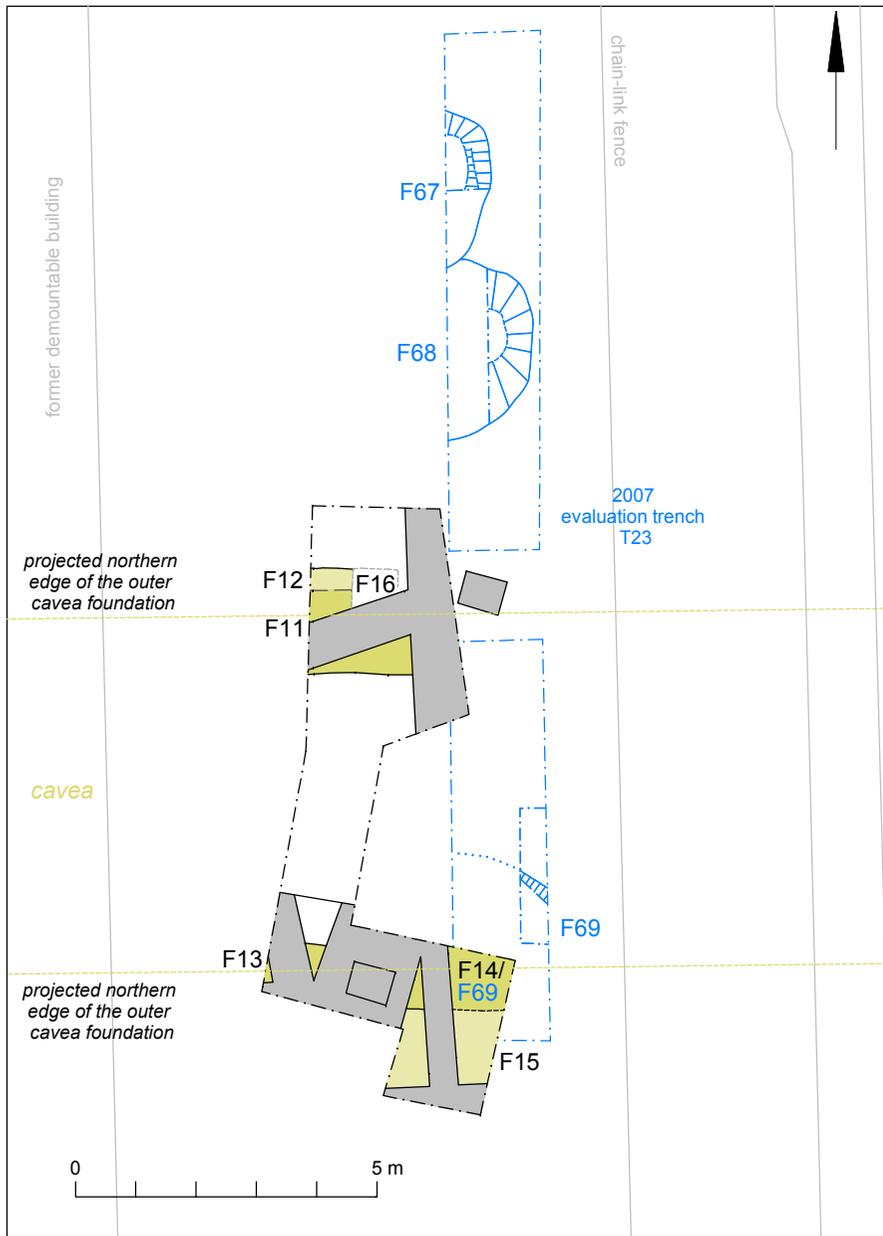
In the northern half of TP1, fragments of Roman mortar and greensand stone were encountered at a depth of c 500mm below modern ground level in line with the projected position of the outer *cavea* wall (Fig 2a). Three modern service trenches cut the mortar and greensand deposit in this location (two deep drainage pipes and an electricity cable) (Fig 2b). There appeared to be a fourth service trench in this location, but no service could be located. It is probable that a modern pit (F16) similar to those identified to the north during an evaluation by CAT in 2007 (Trench 23, F67 and F68; CAT Report 438), existed in this location (Fig 2a). By examining the section through the mortar and greensand deposit where it was cut by F16, it was possible to ascertain that the foundation of the outer wall of the *cavea* had been completely robbed-out in this location (F11), probably sometime in the 12th or early 13th centuries (Cat Report 412, 1345). The robber trench measured 1.35m in width, indicating that this part of the foundation must have incorporated an external buttress. A thin spread of circus-derived debris from the robbing of the foundation was identified to the north of the robber trench (F12).

Roughly 4.4m south of the southern edge of the outer *cavea* foundation, two small triangular patches of mortar and greensand (F13) were identified. F13 was 470mm below modern ground level (Fig 3: Sx2) in line with the projected position of the inner *cavea* foundation (Fig 2a). The remains of the inner *cavea* foundation were truncated by two service trenches and a concrete inspection chamber (Fig 2b). The modern backfill along the western side of the inspection chamber was hand-excavated to allow the easternmost part of F13 to be examined in section (Fig 3: Sx3). This revealed that the foundation of the inner *cavea* wall had also been completely robbed-out in this location.

The excavation of TP1 did not continue to the south as it was assumed that the service trenches would have destroyed the southern edge of the robber trench (F13). Instead, an area to the west of the inspection chamber was excavated to try to locate the southern edge of the robber trench (Fig 2a). A large spread of mortar and greensand over 2m in width was identified in this area at a depth of 375mm-500mm below modern ground level (Fig 2a & Plate 1). By excavating the modern backfill from a service trench (Plate 1), it was possible to distinguish the southern edge of a deep feature (F14) as well as a shallow spread of circus-derived debris (F15) immediately to the south (Fig 3: Sx4). The southern edge of F14 was located 0.8m to the south of the northern edge of robber trench F13, within the parameters for the width of the inner *cavea* foundation robber trench seen elsewhere around the circus (0.6m-0.9m; CAT Report 412, 1345). However, F14 was considerably deeper than the robber trench immediately to the west (F13) and would have been unusually deep for the inner *cavea* foundation. A more likely explanation is that F14 is the southern edge of a large post-medieval pit which contained circus-derived debris and was identified during the 2007 evaluation (F69; CAT Report 438) (Fig 2a).

Fig 2a Plan of TP1 showing the areas of Roman circus-derived debris (possible robber trench remains are shaded dark yellow and circus rubble spreads are light yellow) and the 2007 evaluation trench (shown in blue).

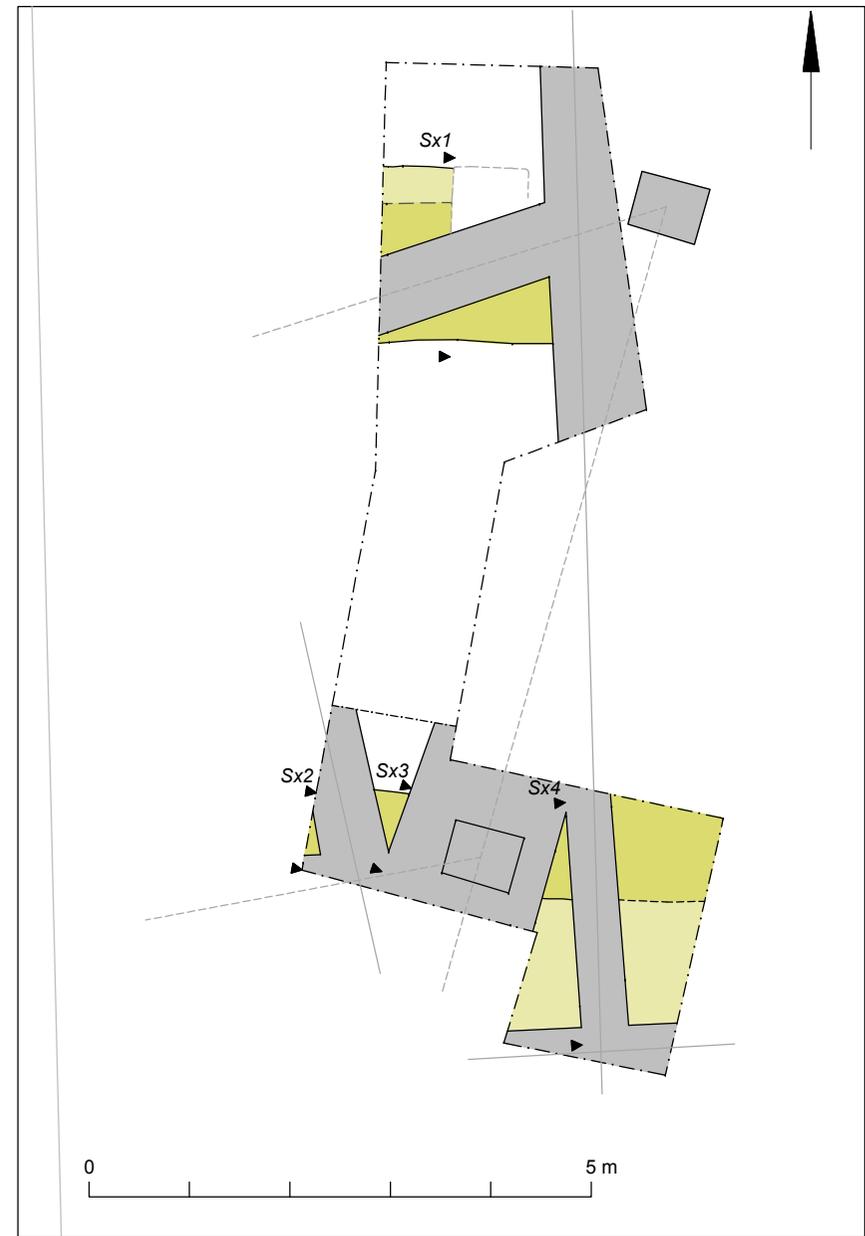
Fig 2b Plan of TP1 showing the modern service trenches (shaded grey) and the locations of the section drawings (Fig 3).

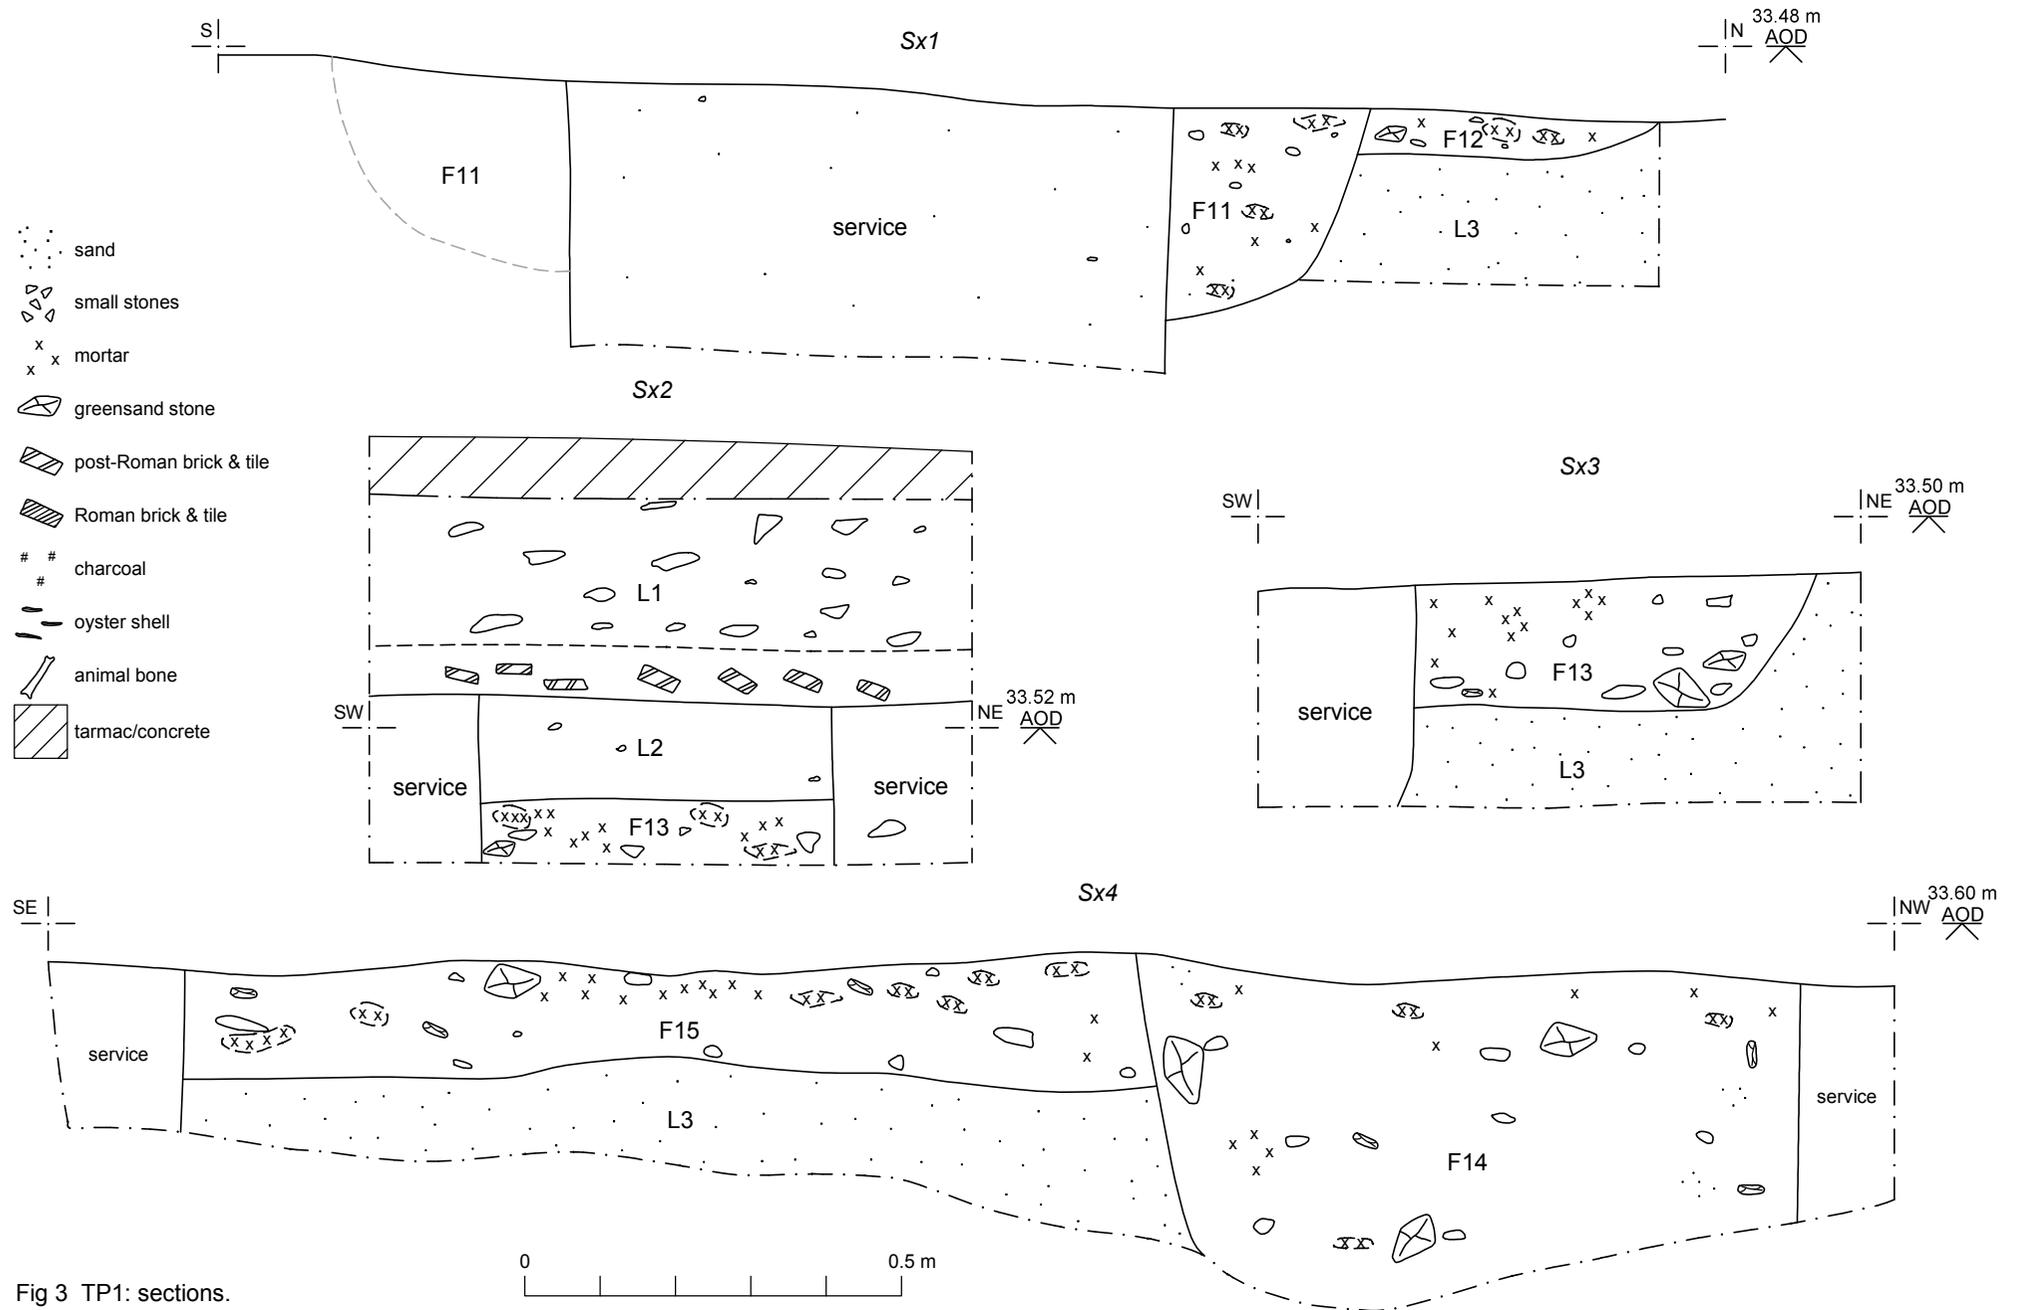
Fig 3 TP1: sections.

Test-pit 1 was excavated to determine the condition of the Roman circus remains beneath a roadway and to examine the possibility of laying new services along the lines of old ones since the archaeological remains in these places are likely to have been destroyed. The Roman circus remains were expected to take the form of two parallel, east-west orientated foundations which supported the outer and inner walls of the seating area known as the *cavea* (CAT report 412, 1345). Throughout TP1, modern tarmac, stone and crushed brick (L1) overlaid a thin layer of buried topsoil (L2) (Fig 3: Sx4).

A section of the service trench to the south of F16 was hand-excavated to allow a hypothetical section across the robber trench (F11) to be recorded (Figs 2 & 3: Sx1).

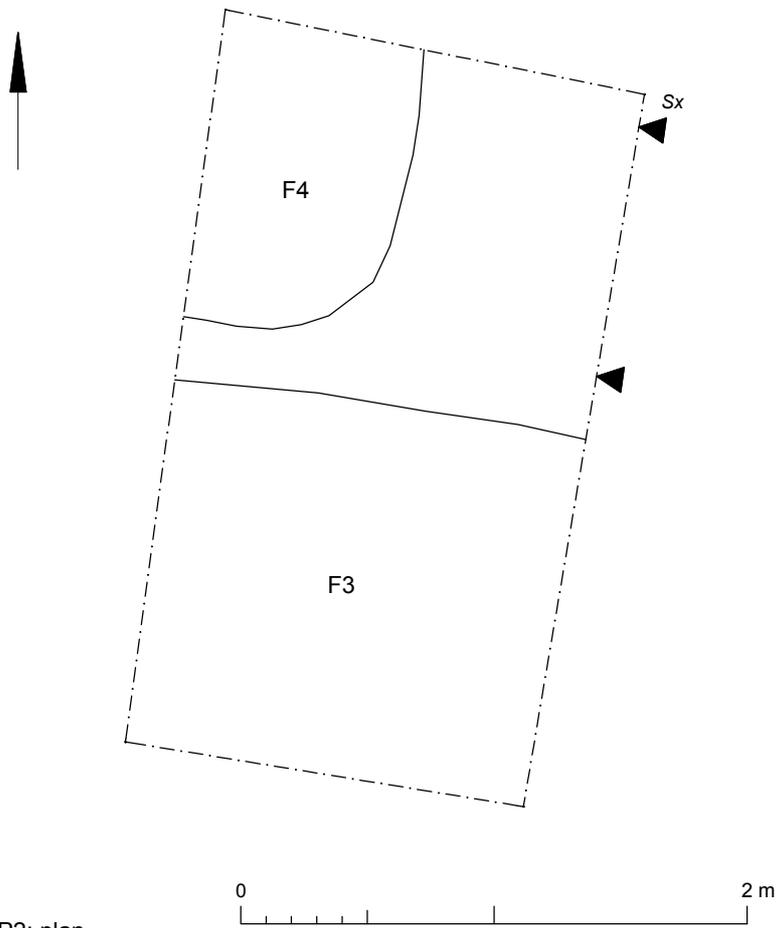
Fig 4a TP2: plan.

Two features were identified in TP2 cut into the natural sand (L3), a large post-medieval/modern ?pit (F3) and a modern sub-circular pit (F4) (Fig 4a). F3 had a mid-grey/brown sandy-silt fill identical to the overlying topsoil. Peg-tile fragments (3@91.6g), clay pipe stems (2@11g) and an iron nail (22g) were recovered from F3 (but were not retained). F4 had a dark grey fill and contained modern bottles and brick fragments.

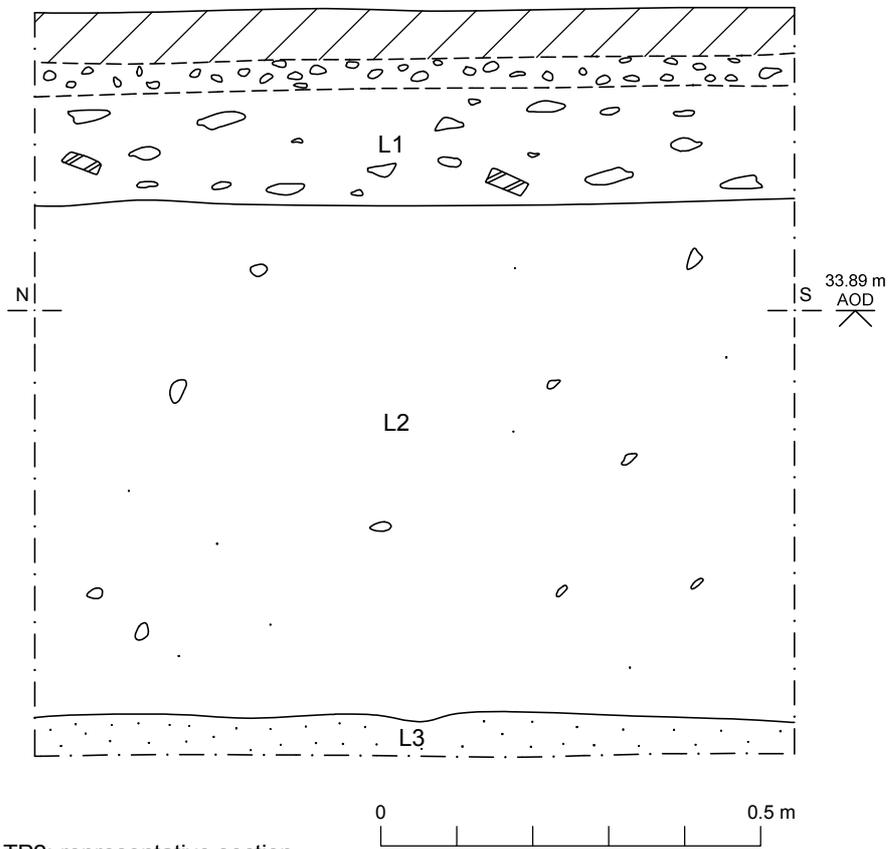
Fig 4b TP2: representative section.

TP2 was located within the track of the Roman circus and to the south of the St John's Abbey precinct wall (Fig 1). Modern hardstanding (L1) overlaid a deep deposit of buried topsoil (L2) (Fig 4b). The natural orange sand (L3) was uncovered at a depth of c 950mm below modern ground level (Fig 4b).

Where the buried topsoil remained seemingly undisturbed by post-medieval/modern truncations, no evidence of the arena surface of the Roman circus was distinguishable (Fig 4b).

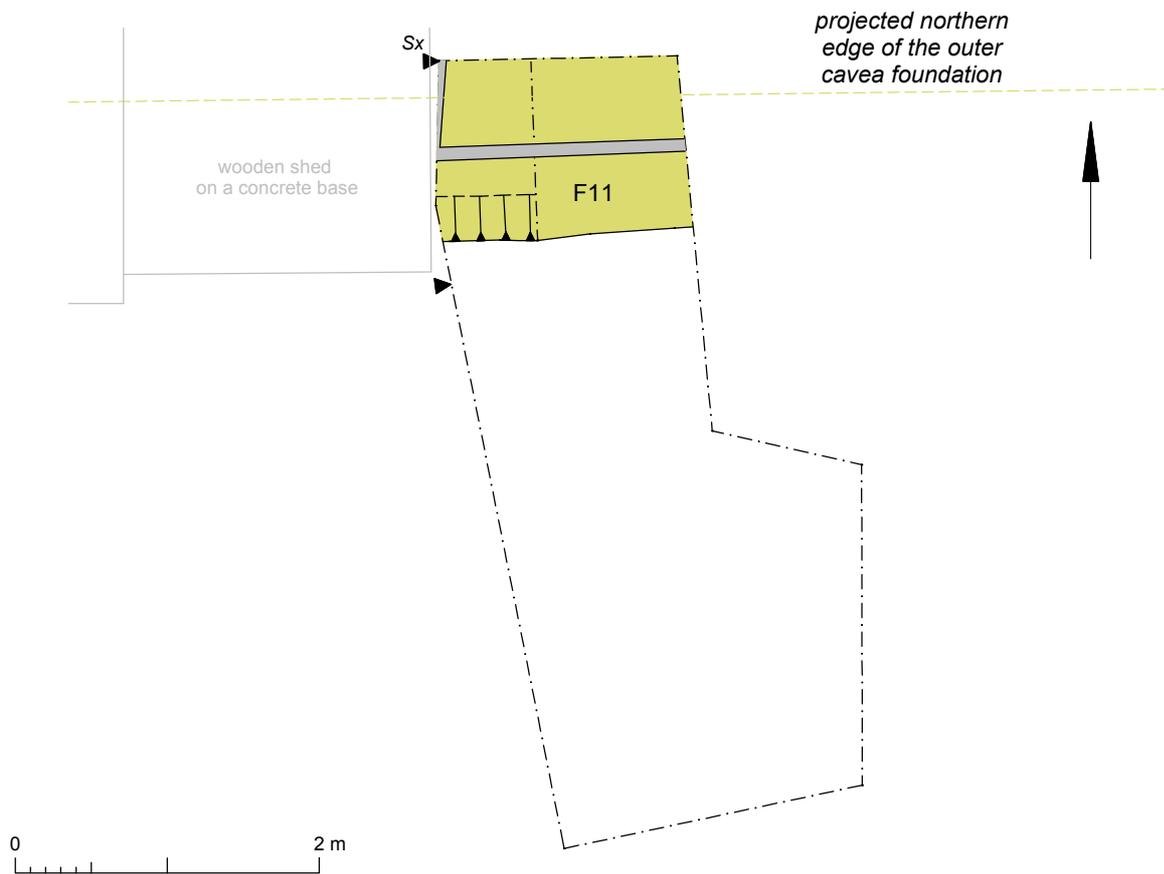
In the northern end of TP3, fragments of Roman mortar, greensand stone and Roman brick (F11) were encountered at a depth of between 700mm and 800mm below modern ground level in line with the projected position of the outer *cavea* wall (Fig 5a). One modern service was situated above F11 and another crossed the edge of the trench obliquely and truncated the uppermost 150mm of F11 (Figs 5a & 5b). A small section of F11 was hand-excavated (Fig 5a). This confirmed that the foundation of the outer *cavea* wall had been completely robbed-out in this location (Fig 5b). Three fragments of Roman brick (211g) were recovered from the excavated section. The northern edge of the robber trench was not uncovered in TP3, but the exposed section was already 1.15m in width suggesting that this part of the foundation may have also incorporated an external buttress. The natural sand (L3) was uncovered at a depth of 790mm below modern ground level.

As the excavation of TP3 continued to the south, it became apparent that the modern drain that was believed to cross the line of the circus foundations in this location was actually located further to the west. As it was not possible to ascertain whether the drain crossed the line of the outer *cavea* wall in this location, the excavation of TP3 ceased before the remains of the inner *cavea* wall were exposed (Fig 5a).

Fig 5a Plan of TP3 showing the robbed out remains of the outer wall foundation (shaded yellow) and the modern services (shaded grey).

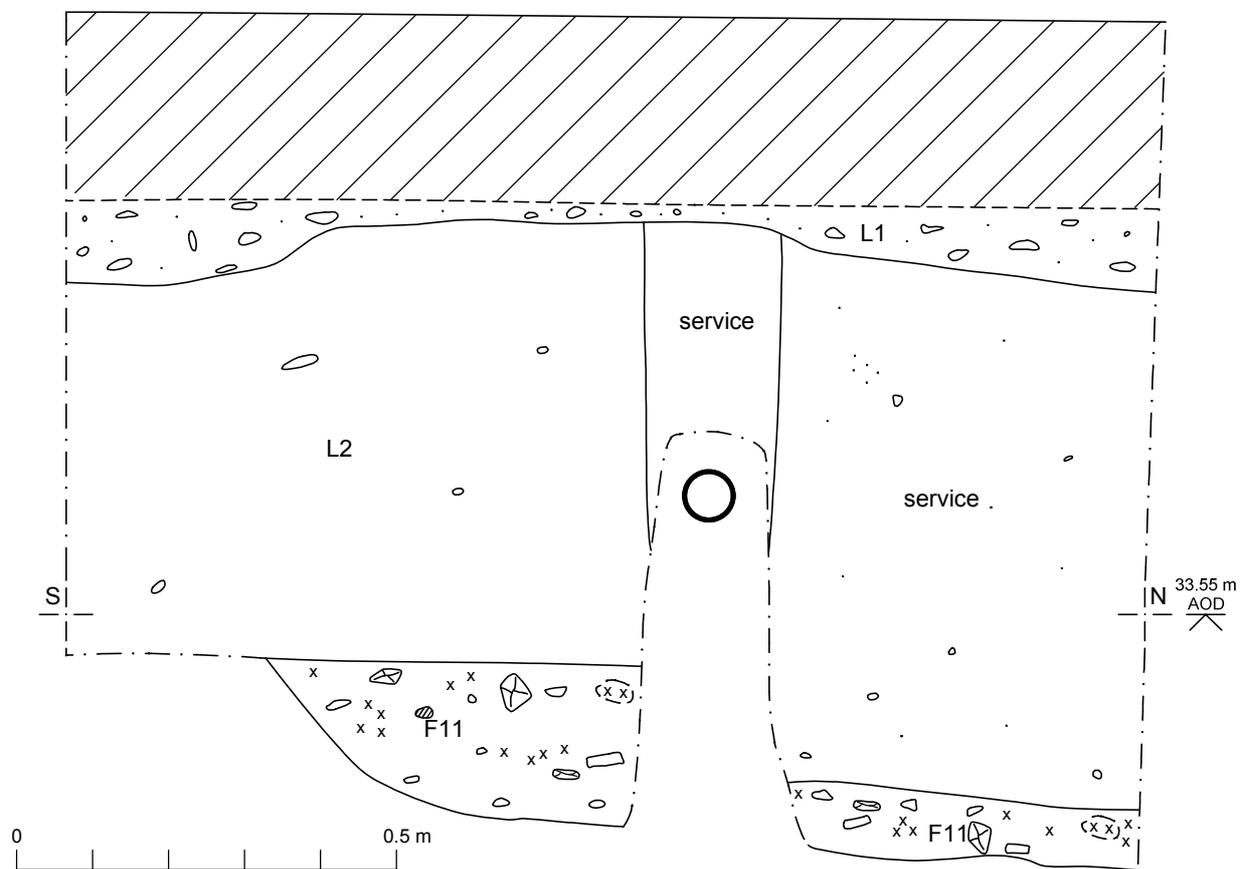
Fig 5b TP3: representative section.

As with Test-pit 1, Test-pit 3 was excavated to determine the condition of the Roman circus remains in this area and to examine the possibility of following service lines during the installation of new services. Modern hardstanding (L1) overlaid a buried topsoil (L2) which, in turn, overlaid the natural orange sand (L3) (Fig 5b).

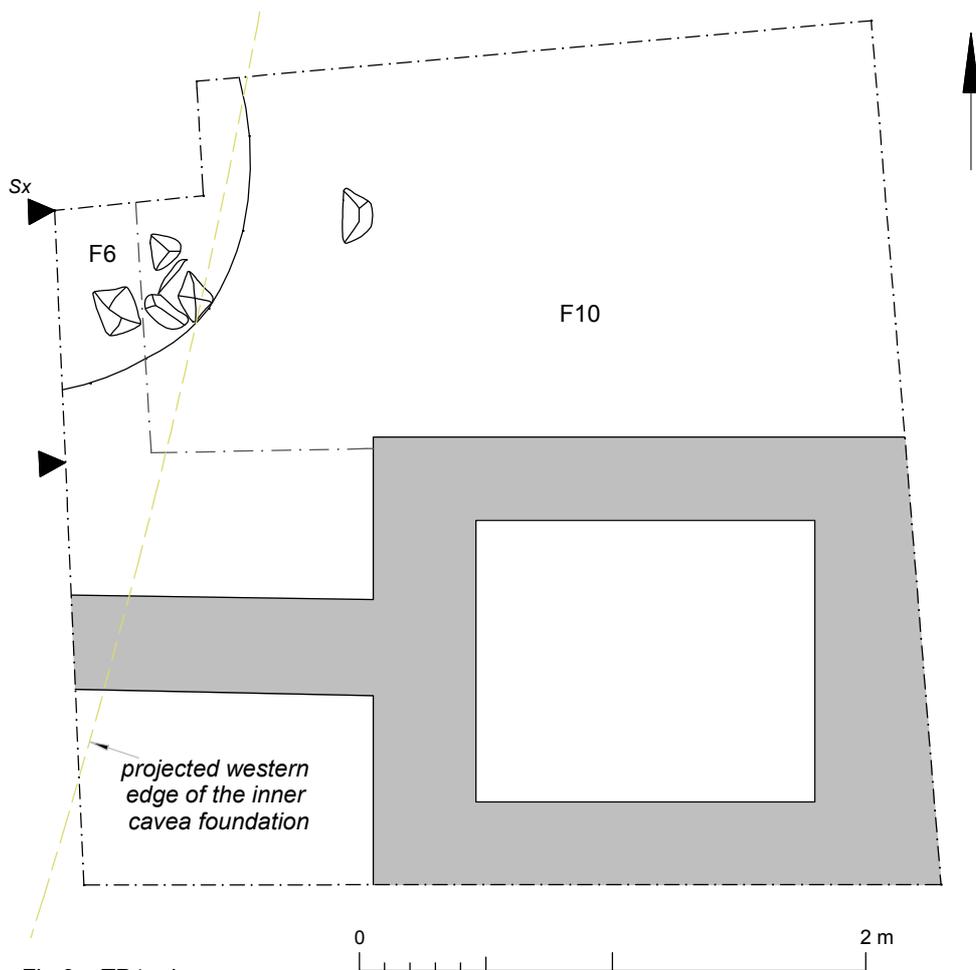
Fig 6a TP4: plan.

Beneath a layer of modern topsoil 260mm thick (L4), a spread of large greensand pieces was identified in the location where the inner wall of the *cavea* was expected to cross TP4 (Fig 6a). To try to ascertain the context of the greensand pieces, an existing service trench to the south was hand-excavated and this section was subsequently extended northwards (Fig 6a). This revealed that the concentration of greensand pieces was located within a shallow pit (F6) which also contained modern brick fragments (Fig 6b). Furthermore, it was apparent that F6 cut a deep soil deposit containing residual circus-derived debris which is likely to be a large post-medieval quarry (F10) which was identified during the 2007 evaluation (CAT Report 438). Hand excavation into the quarry ceased at a depth of 650mm below modern ground level.

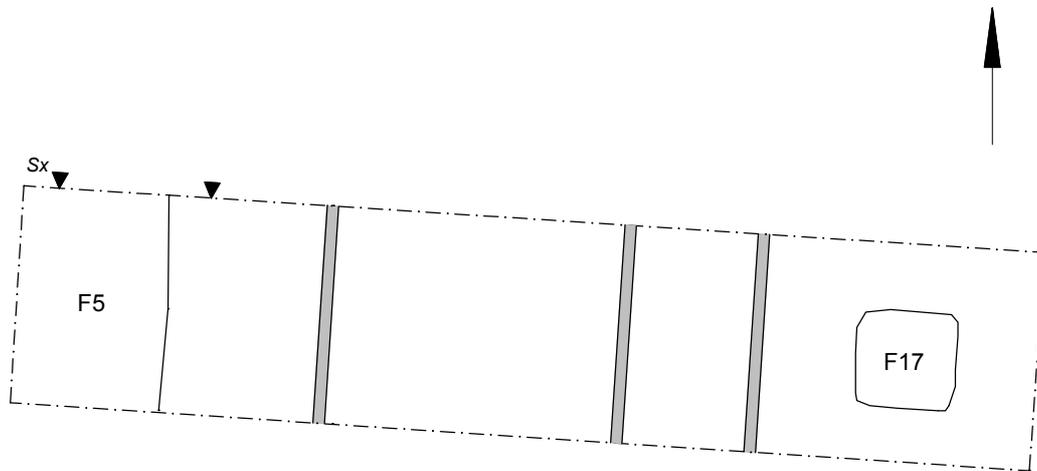
Fig 7a TP5: plan.

The excavation of TP5 began at the eastern end (Fig 7a), where a modern pit (F17) and two electricity cables were encountered beneath a modern topsoil layer c 300mm thick (L4). As a result, the excavation of TP5 was continued to the west where a third electricity cable and a deposit of building materials in loose mortar (F5) were uncovered 400mm below the modern ground level (Fig 7a). As well as modern brick and peg-tile fragments, F5 also contained pieces of greensand, septaria and Roman brick (Fig 7b). It is possible that F5 may be associated with the modern repairs to the standing remains of the abbey precinct wall to the north-east and north-west (Fig 1).

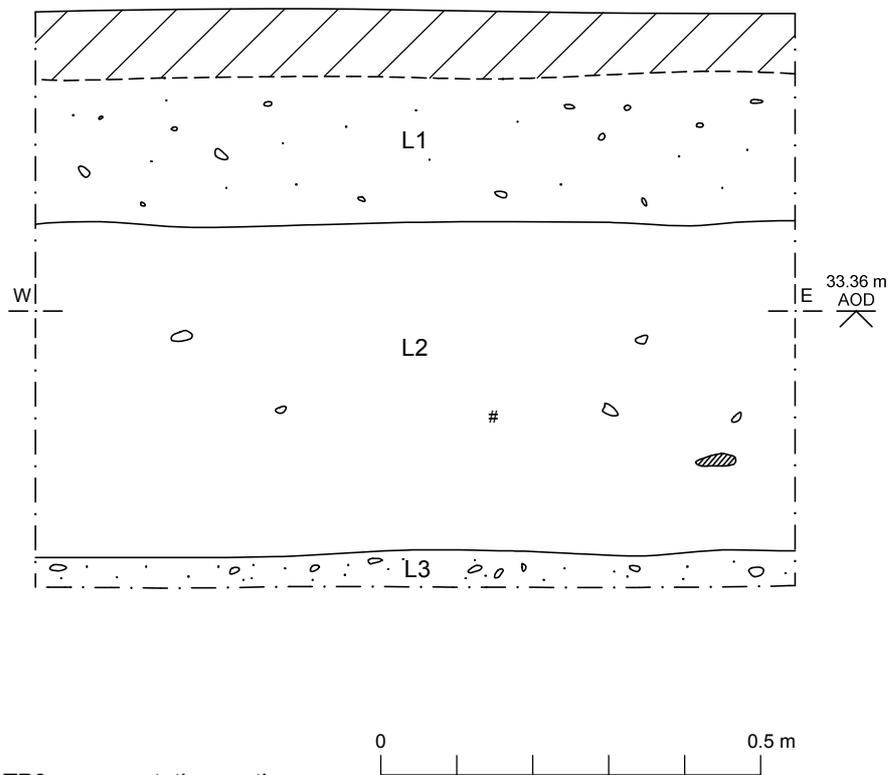
Fig 8b TP6: representative section.

Modern hardstanding (L1) overlaid a buried topsoil (L2) which, in turn, overlaid the natural orange sand (L3) (Fig 8b). Two features were identified in TP6 at a depth of c 550mm below modern ground level. F1 was circular in shape and was either a pit or a well (F1) and F2 was either a large pit or a linear feature (Fig 8a). Both F1 and F2 had mid grey/brown sandy-silt fills which contained fragments of peg-tile and oyster shell. A sherd of post-medieval stoneware (early 18th century or later) was recovered from the upper fill of F1.

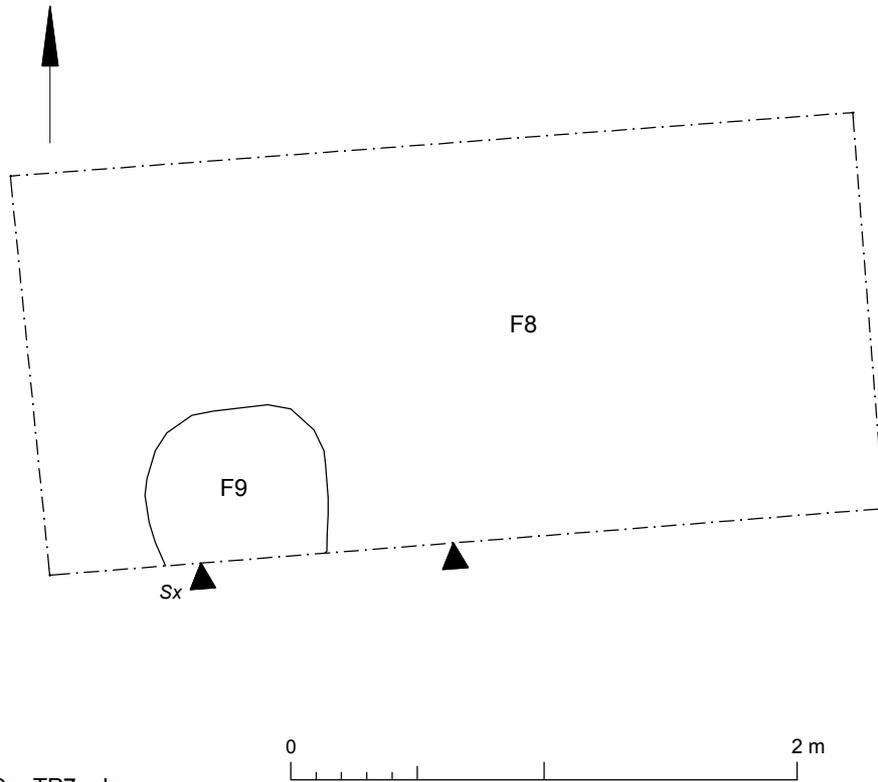
Fig 9a TP7: plan.

midden were not visible in the trench which indicates that it extended beyond the test-pit in all directions (Fig 9a). F8 is probably part of the same medieval/post-medieval midden identified 7m to the north during the 2007 evaluation (Trench 11, F126; CAT Report 428). F8 was cut by a small pit (F9) which had a dark grey sandy-silt fill and contained sherds of modern pottery and peg-tile (Figs 9a & 9b).

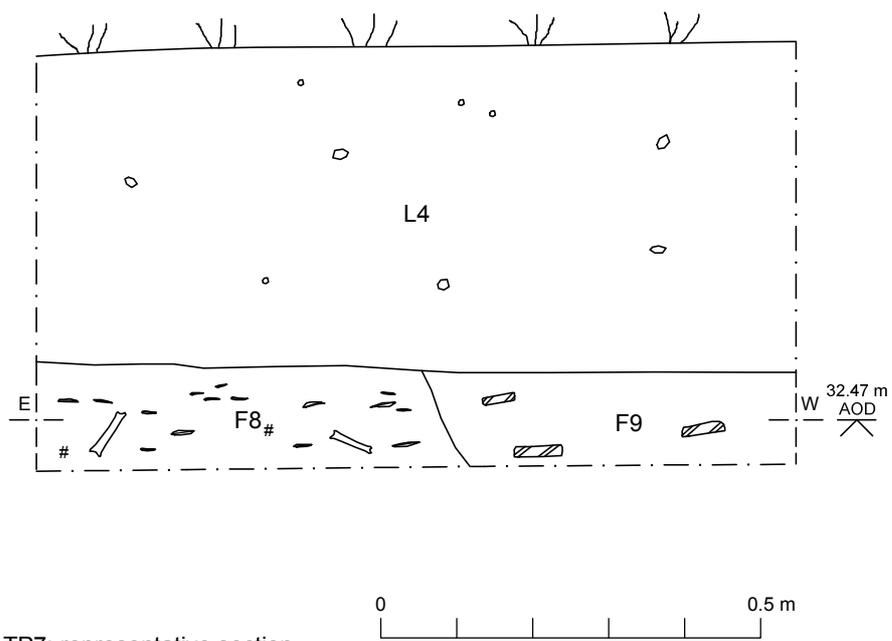
Fig 9b TP7: representative section.

Just over 400mm of topsoil (L4) overlaid an extensive midden deposit (F8) containing a high density of oyster shells in a brown/grey sandy-silt fill (Fig 9b). The edges of the

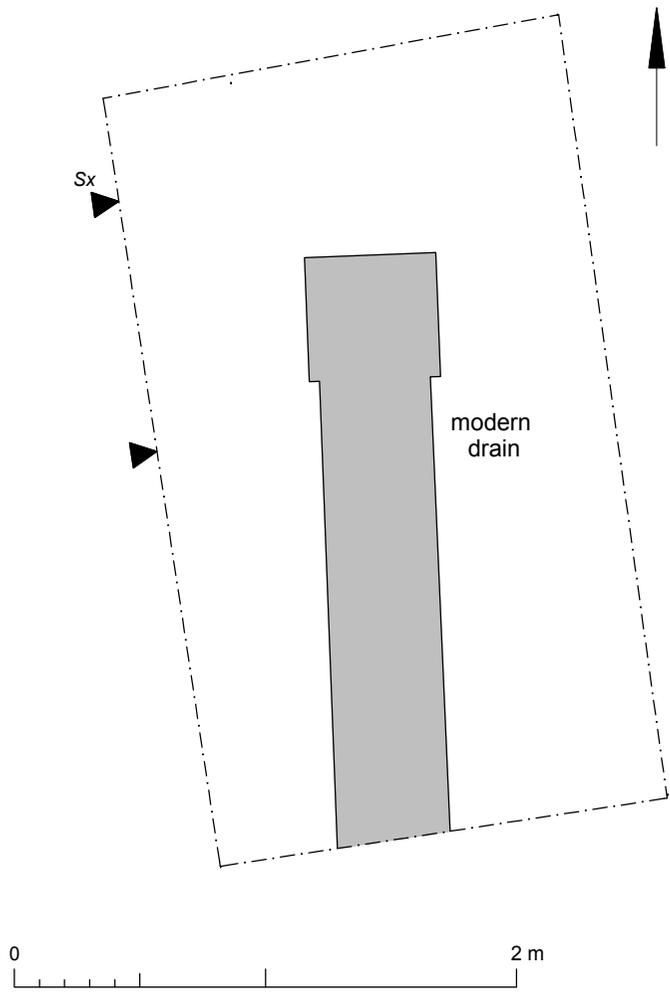
Fig 10a TP8: plan.

Roughly 400mm of modern topsoil (L4) overlaid a deep deposit of modern made-ground consisting of large pieces of stone, brick and a layer of compressed tarmac pieces (L6) (Fig 10b). At a depth of 1.2m below modern ground level, a brick drainage gully with a metal grill was encountered (Fig 10a). The drain is probably associated with the Victorian and later barracks and road layout and is probably the same drain that was identified 12m to the south in the 2007 evaluation (Trench 9, F120; CAT Report 438).

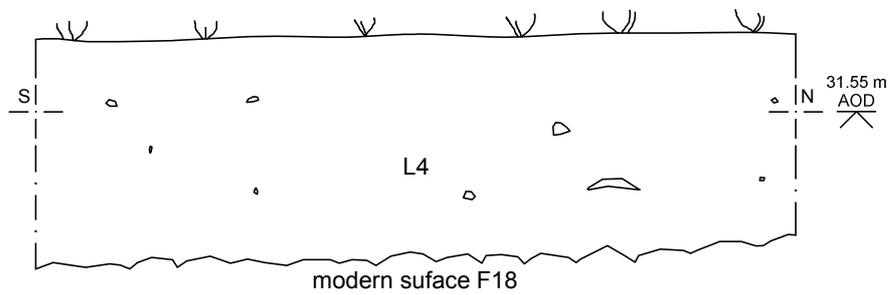
Fig 11b TP9: representative section.

In TP9, 300mm of modern topsoil overlaid a modern surface (F18) made of stone and brick pressed into tarmac (Fig 11b). Due to the solidity of the surface, the excavation of TP9 ceased at this depth.

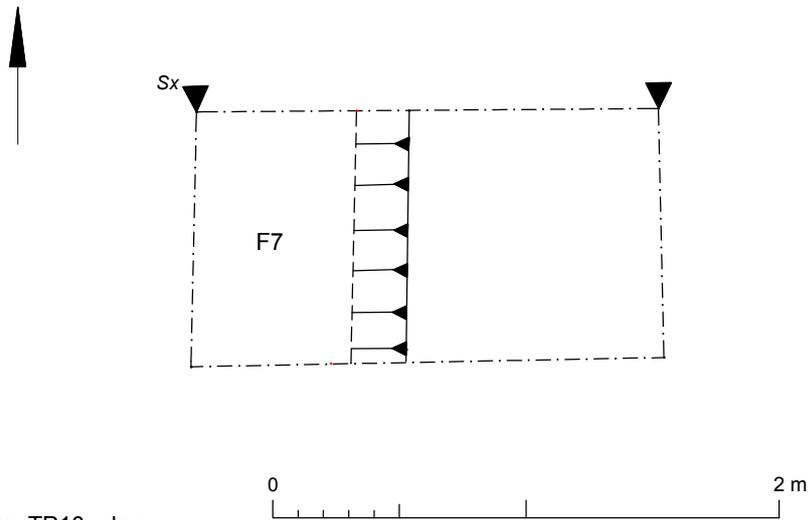
Fig 12a TP10: plan.

Between 500mm and 650mm of modern topsoil (L4) overlaid a buried topsoil layer (L5) and a large pit or linear feature (F7) (Fig 12a). F7 had a loose grey/brown sandy-silt fill which contained many oyster shell inclusions (Fig 12b). F7 cut the natural sand (L3), but it was uncertain whether it cut the buried topsoil (L5) or whether it was overlain by it (Fig 12b). A rim sherd from a medieval pot (Fabric 20, 28g) indicates that F7 is probably associated with activity within St John's Abbey in the 12th or 13th century. Other finds from F7 included mammal bones/teeth from pig, sheep and cattle (13@140g), bird bones (4@1g), fish bones (5@5g), a re-used Roman brick (208g) and a re-used flue tile fragment from a Roman hypocaust (253.3g). A piece of greensand (258g) and an oyster shell (5g) were also collected but were not retained.

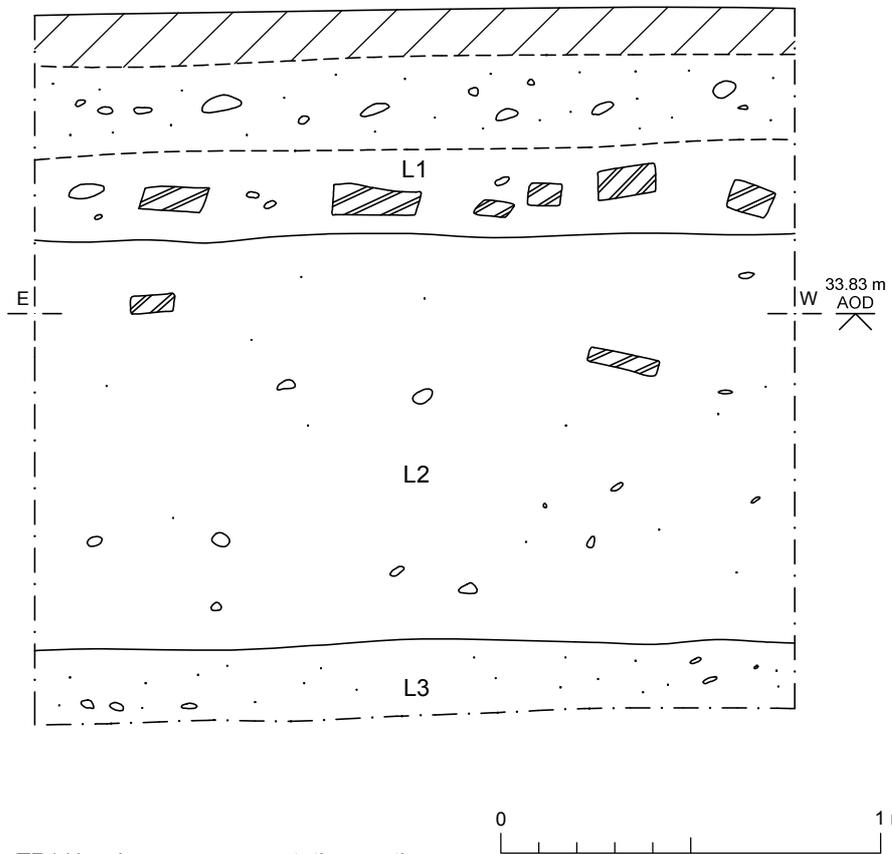
Fig 13b TP11/soakaway: representative section.

TP11 was located within the arena of the Roman circus (Fig 1). Modern hardstanding (L1) overlaid a buried topsoil (L2) which, in turn, overlaid the natural orange sand (L3) (Fig 13b). The natural sand was uncovered at a depth of between 750mm and 850mm below modern ground level. No surviving surface of the arena was discernible during the excavation of TP11. This supports the theory that the arena was a dirt track which is now indistinguishable from the soil accumulation which overlies it (CAT Report 412, 1348).
