**An archaeological watching brief during the  
construction of the Williams & Griffin  
temporary trading store in the Colchester  
Borough Council car park, St Runwald Street,  
Colchester, Essex.**

**July-August 2013**

**CAT Report 742**  
November 2013

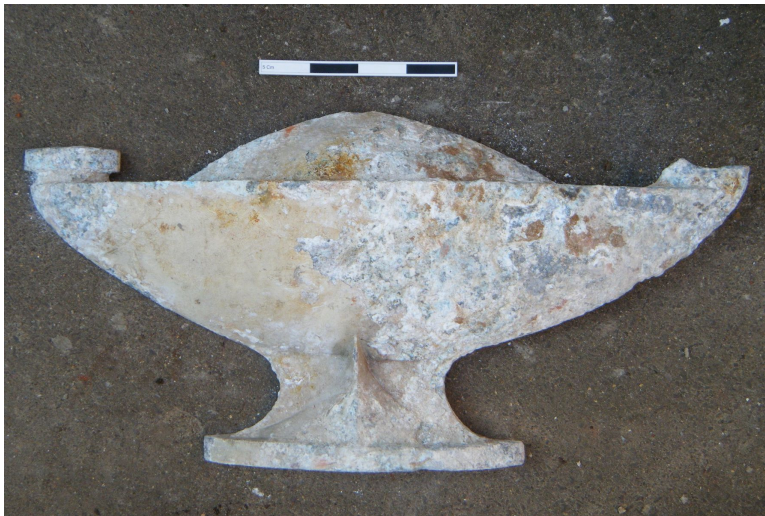
**Plate 1 Cast iron object (20cm-long scale).**

The only find retained during the watching brief was a large cast-iron object 740mm long by 370mm high (Plate 1). It is presumed that it was once displayed somewhere, perhaps outside a shop. It is relatively flat, has a large bolt protruding from its reverse side and is partially painted on its front surface. It is possible that the object represents an oil lamp. A circular protrusion from the top of the object on the right hand side has been broken off and may have been the handle of the lamp (Plate 1).

The object was recovered by the contractors during the excavation of the cable trench in the north-western corner of the CBC car park. It is probably Victorian or early 20th century in date and could have been made in the iron foundry which once occupied the plot where the existing department store now stands (CAT Report 622).
