**Historic building recording
at the Stag Inn, Hatfield Heath,
Essex
December 2013**

CAT project ref: 13/12a
NGR: TL 5243 1500 (c)
ECC HE code: HSF113
Saffron Walden Museum
accession code: 2013.88

CAT Report 761
March 2014

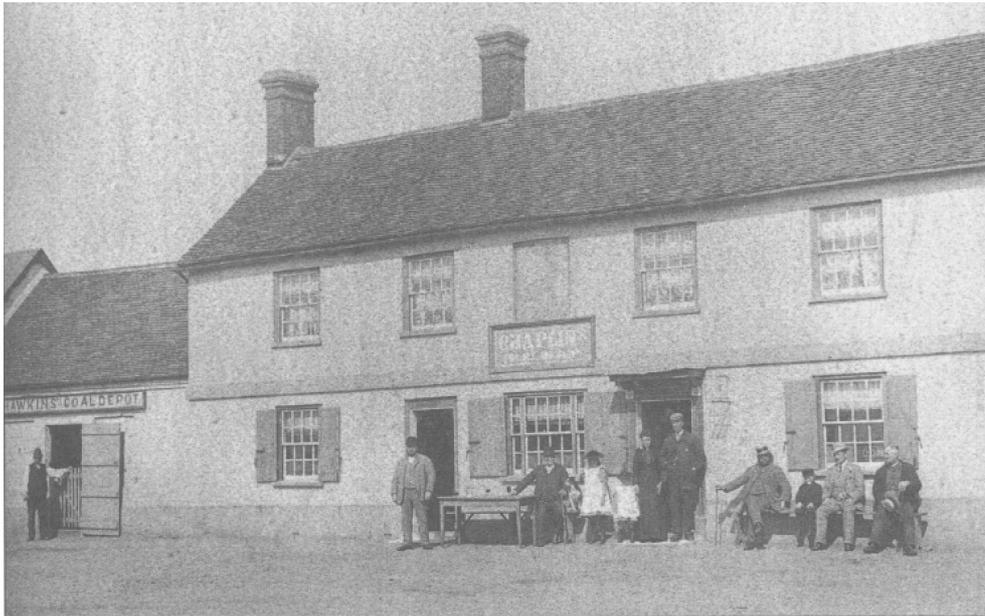
Illustration 1 The Stag Inn c 1881-1900, showing the main range and the extension to the west, used as a coal depot by Aaron Hawkins (A History of Hatfield Heath)

In addition to the extension, this photograph shows what are probably the original windows of the Georgian façade, unhorned sash windows of eight-over-eight lights, with those on the ground floor having wooden shutters. The façade has a great deal of symmetry: the outer windows of the ground floor are directly below those of the first floor, the two doorways are directly below the inner windows of the first floor and the tripartite window on the ground floor is directly below a centrally-located blind window.

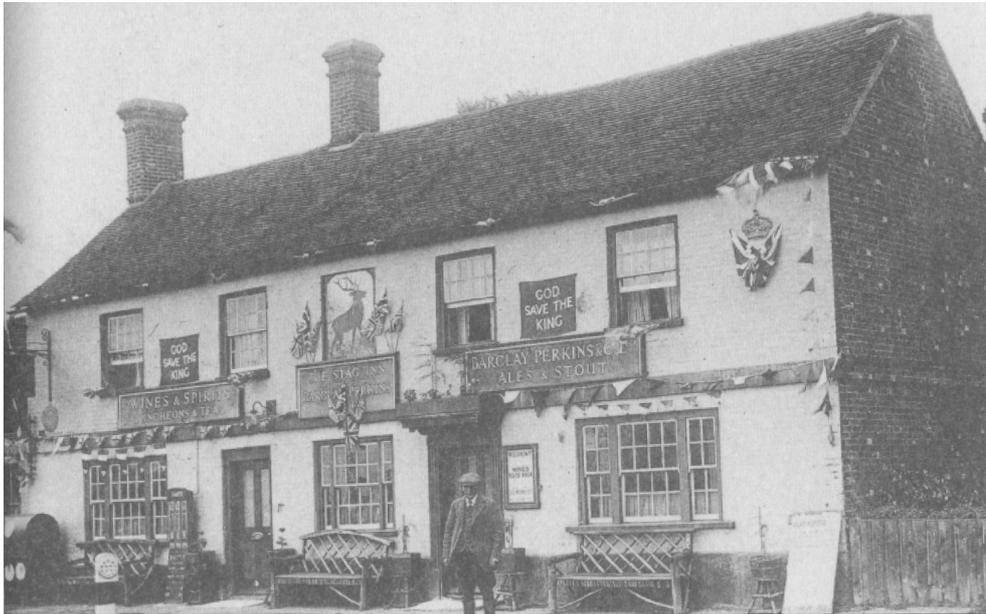
A second photograph dated to 1911 shows some significant change to the Inn's façade (Illustration 2). A painted sign, depicting a stag, has been inserted to the blind window on

the first floor and the outer windows of the ground floor have been replaced with horned tripartite sashes of eight-over-eight lights, flanked by margins of four-over-four lights.

Illustration 2 The Stag Inn in 1911, with remodelled ground floor windows (A History of Hatfield Heath)

At the extreme left-hand side of the photograph it can be see that a window has been inserted to the front wall of the extension used as a coal depot in the 1880s. The reason for this insertion is explained by a third photograph (Illustration 3).

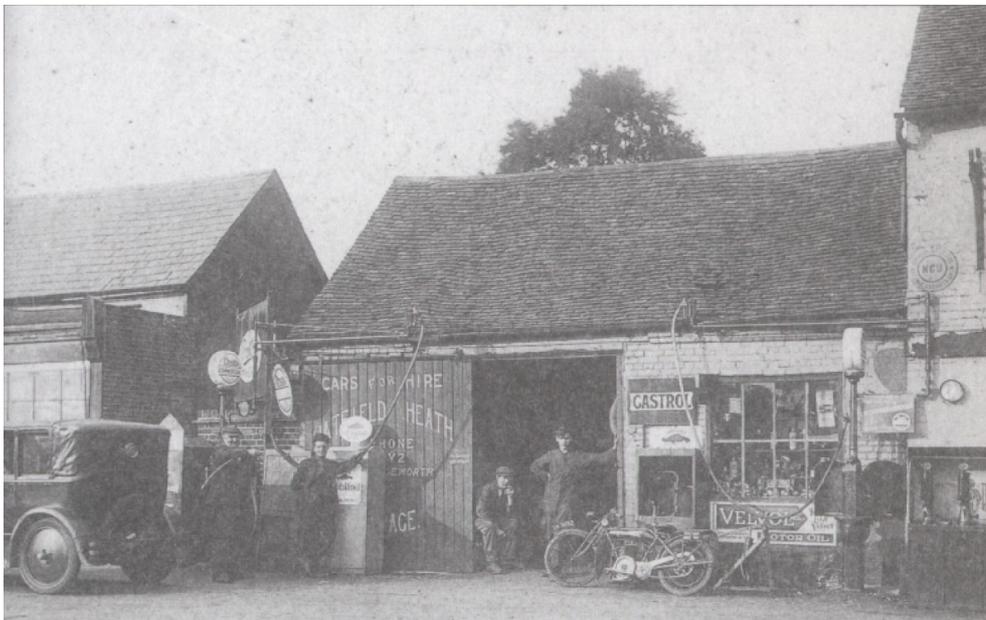
Illustration 3 Halls' garage converted from Aaron Hawkins' Coal Depot (A History of Hatfield Heath)

At some point prior to 1911 (possibly after 1906, when Kelly's Directory ceases to refer to Henry Hawkins as a coal merchant) the extension utilised as a coal depot was converted

to a garage. Kelly's Directories throughout the 1920s record Charlie Halls as running a garage on the premises, whilst his wife administered the Stag Inn. The front of the extension has been extensively altered; in addition to the inserted window the doorway has been replaced by a much larger sliding door.

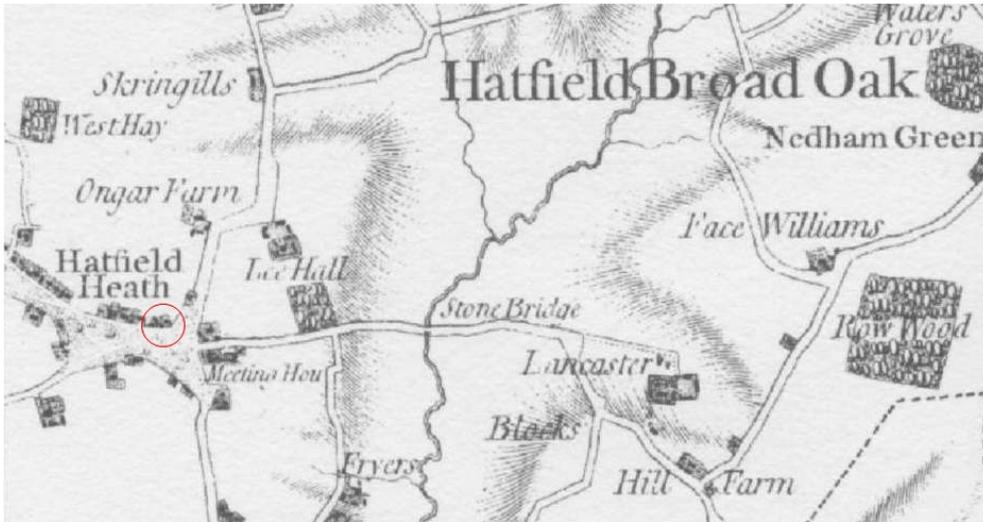
Map 1 Chapman and André map of Essex, 1777 (Plate XII) with the location of the Stag Inn circled

The earliest cartographic evidence depicting the Inn is the Chapman and André map of Essex, 1777 (Map 1). However, this is too indistinct to make out individual detail of the Inn and its outbuildings.

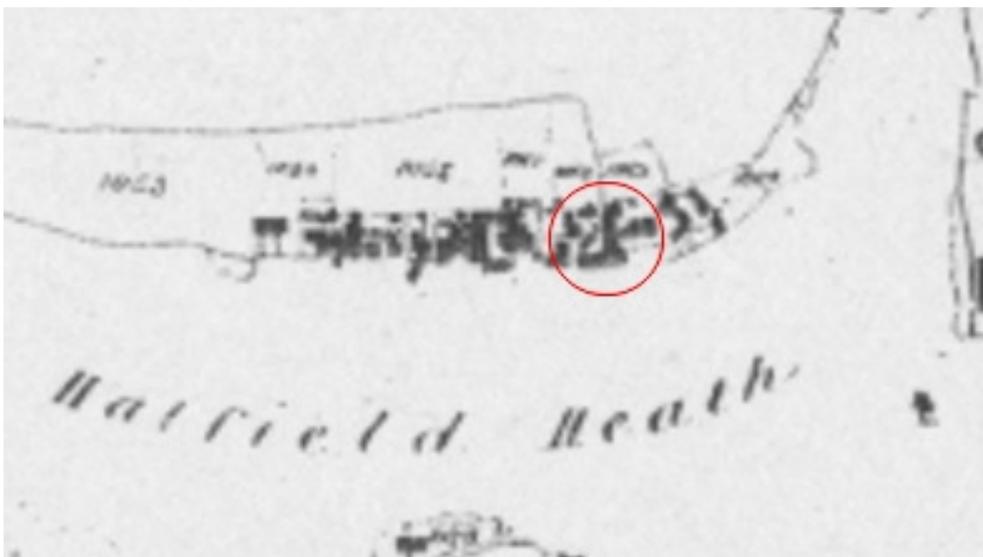
The 1838 tithe map for Hatfield Broad Oak (ERO D/CT 166) shows greater detail (Map 2). The Inn is shown as a rectangular building parallel to the street, with a perpendicular structure extending north from the east end of the main range and several smaller structures to the rear. These additional structures are probably associated with the forge, although the perpendicular structure may be stables associated with the Inn.

Map 2 1838 tithe map (ERO D/CT 166) showing the Stag Inn.

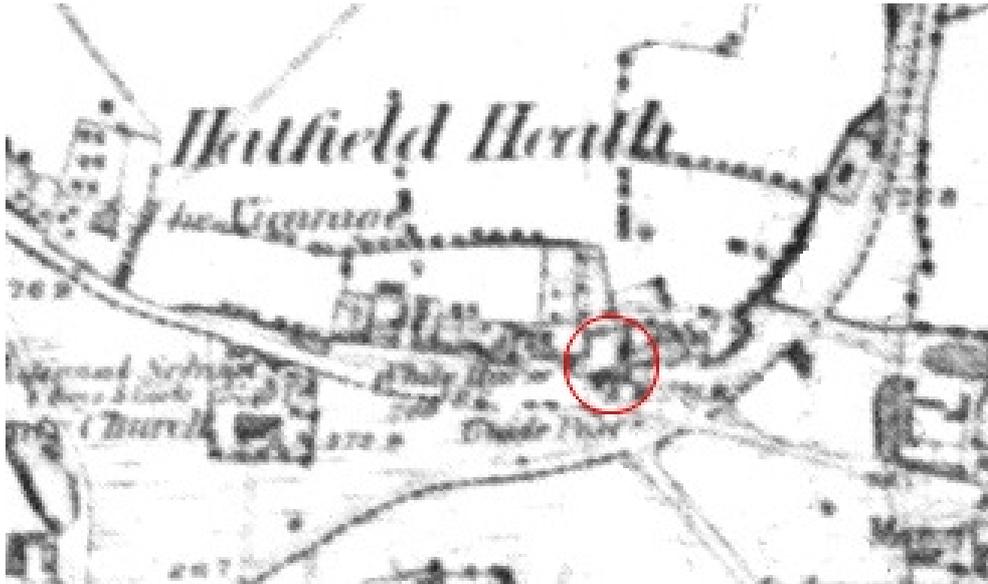
Map 3 1st edition 6" OS map, 1875 (sheet XXXI).

Unfortunately, the 1st edition 6" Ordnance Survey map of 1875 (Map 3) is quite indistinct, with only vague features able to be discerned. The clearest mapping is the 2nd edition 25" Ordnance Survey map of 1897 (Map 4). This shows the Stag Inn as a rectangular structure parallel to the road, incorporating the historic range and a brick extension to the rear. There is a smaller rectangular extension to the west of the main range (the coal depot/garage) and there are linear extensions shown extending north at an angle from the main range.

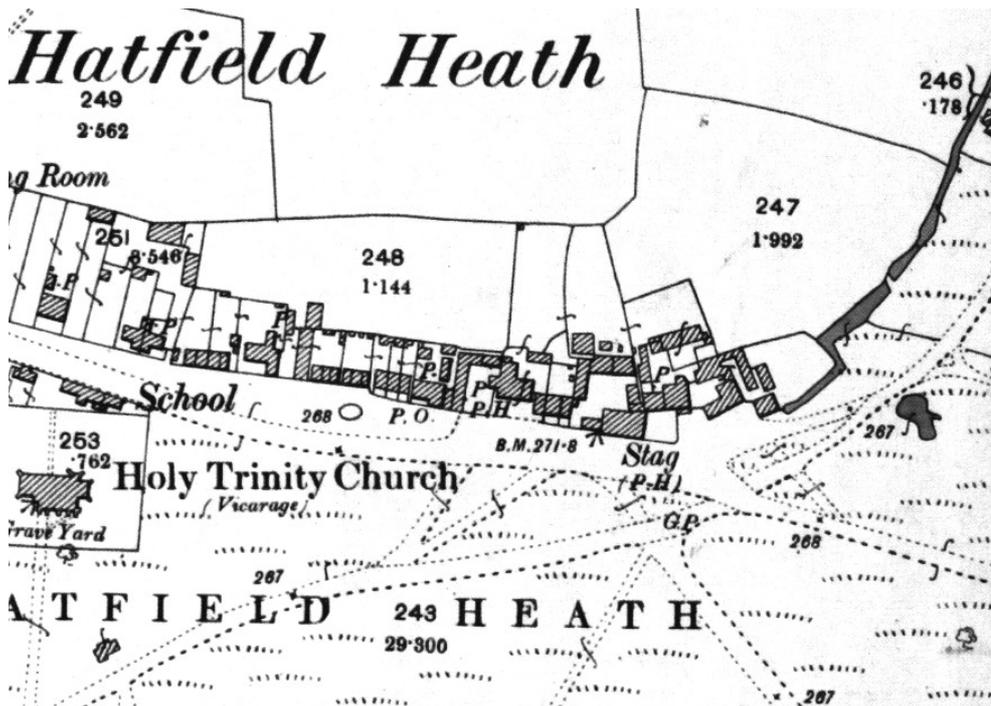
Map 4 2nd edition 25" OS map, 1897 (sheet XXXI.16).

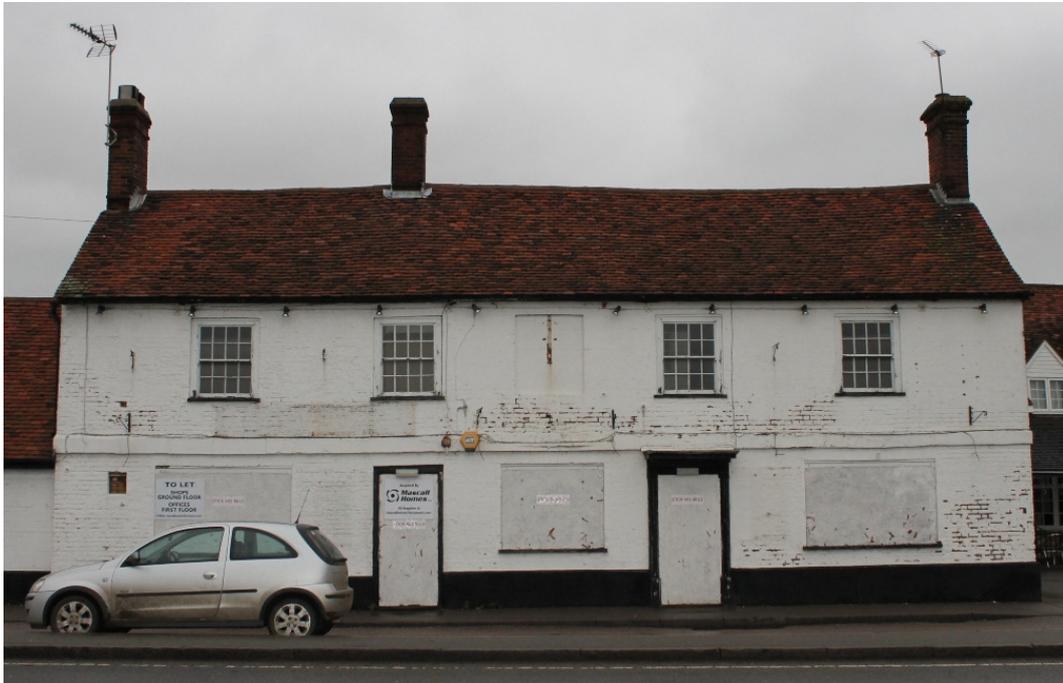
Plate 1 South elevation of the Stag Inn - view north

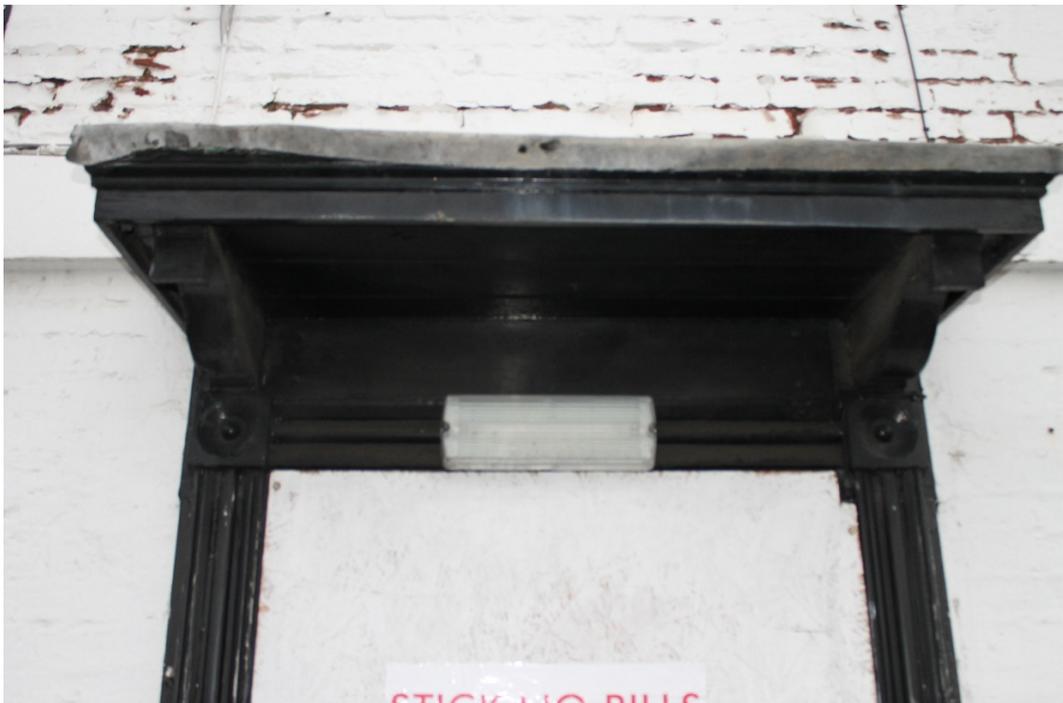
Plate 2 Detail of original Georgian hood and fluted door surround with bull's eye corner decoration – view north

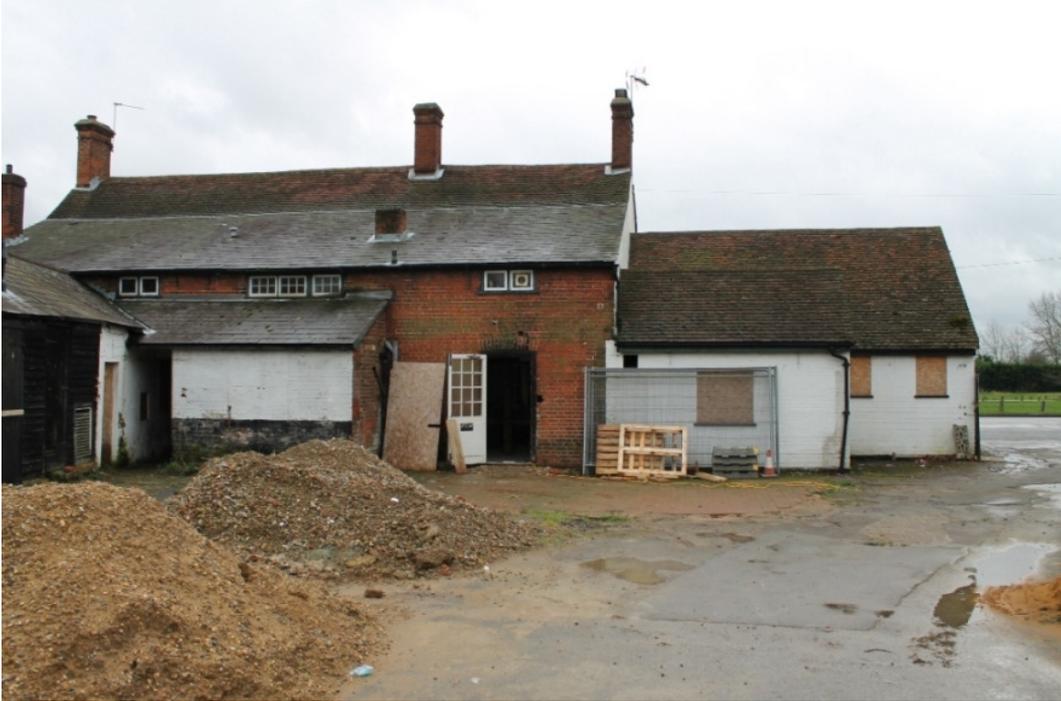
Plate 3 North elevation of the Stag Inn, with the main range in the background and the various extensions in the foreground and to the right – view south

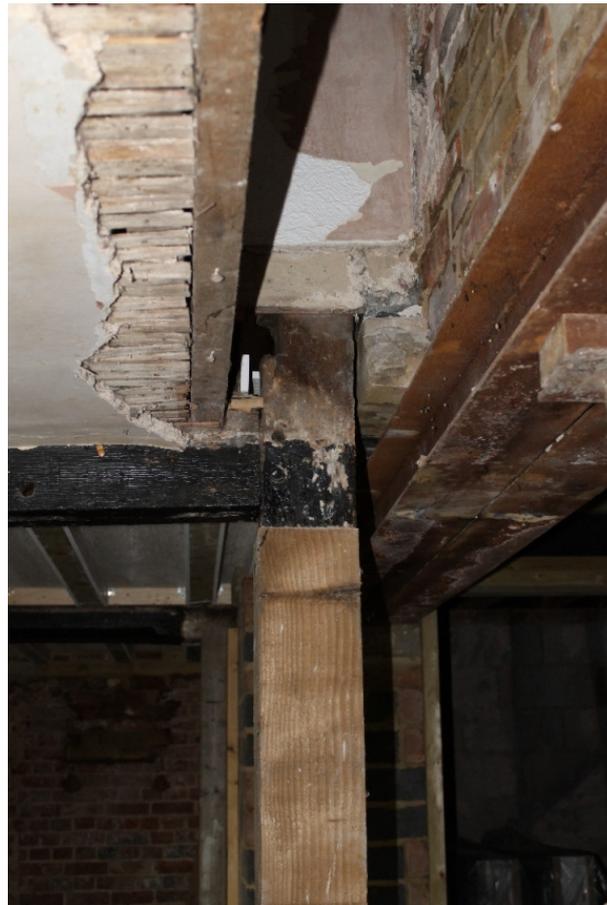
Plate 4 The west wall of the main range, showing the surviving timber frame of Phase 1 inside the brick skin of Phase 2 - view north

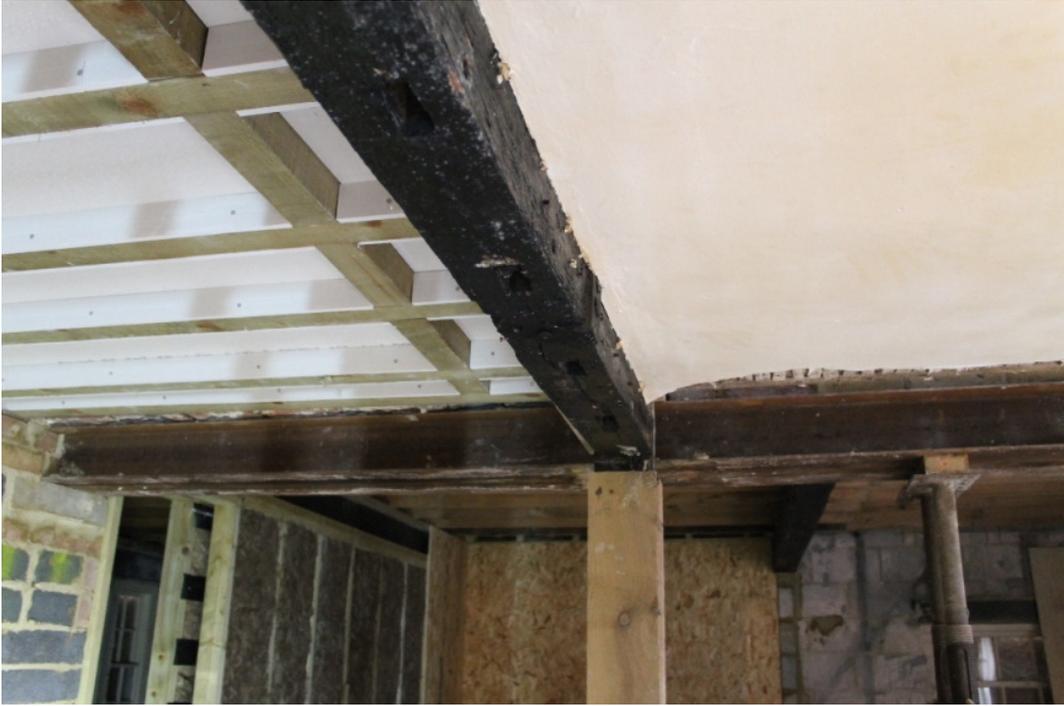
Plate 5 Girding beam at the rear of the Phase 1 structure, with exposed mortices in underside of beam and single peg holes - view west

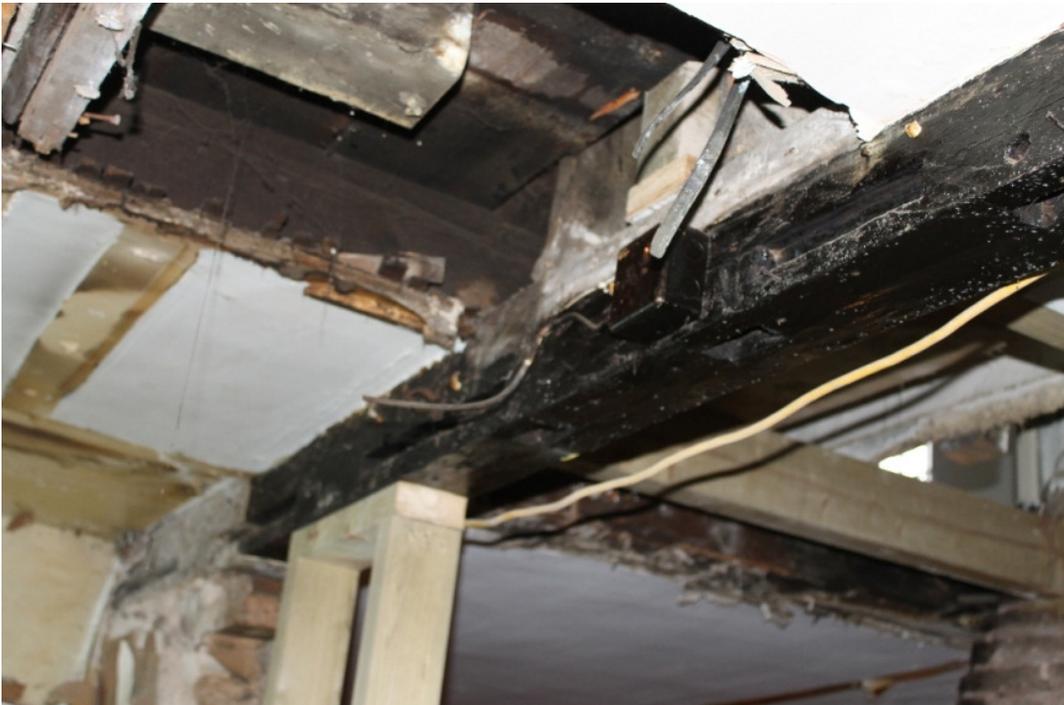
Viewed from the outside, the Stag Inn appears to be a brick-built Georgian structure and a casual survey of the interior reinforces this perception. However, the renovations have revealed traces of an earlier hardwood timber-framed structure, hidden behind the brick façade, belonging to Phase 1. A storey post at the north-west corner of the structure is double-pegged to a girding beam at the rear of the main range (Plate 4). The corner post has dimensions of 140mm x 150mm, whilst the girding beam is 150mm high by 115mm wide. The underside of the girding beam has exposed mortices for studs which were single-pegged to the beam, with divisions of approximately 350mm (Plate 5). Mortices in the external face of the girding beam indicate there was a projecting structure to the rear of the main range, although all other trace of this has been removed (Plate 6). The White

Plate 6 Mortices in the external face of the Phase 1 girding beam, indicative of a structure that once projected from the rear of the main range - view south-east

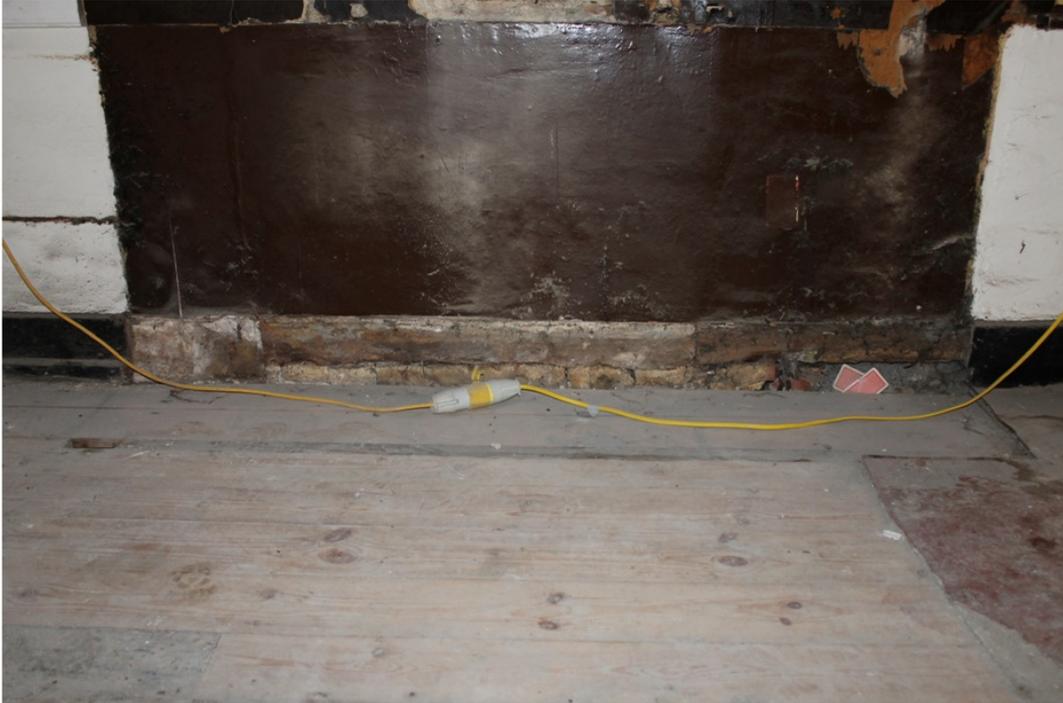
Plate 7 Phase 1 sill beam and brick plinth exposed in rear wall of bar - view north

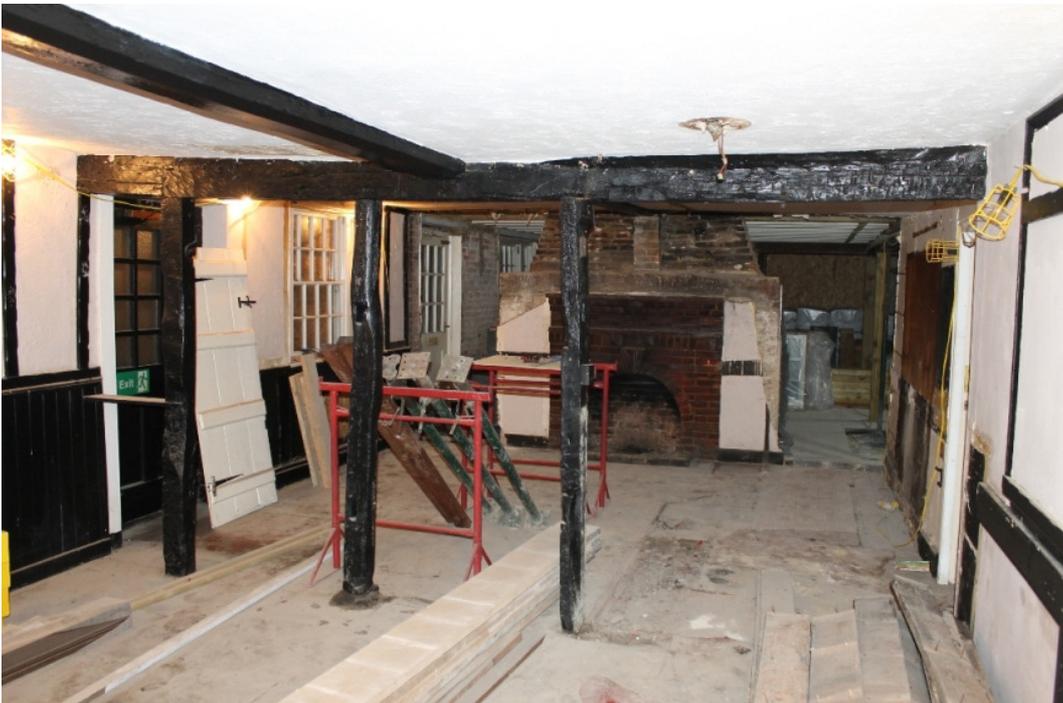
Plate 8 The bar viewed from the lounge, showing the large-section lateral bridging beam with re-used posts and one of the chamfered longitudinal bridging beams – view north-east

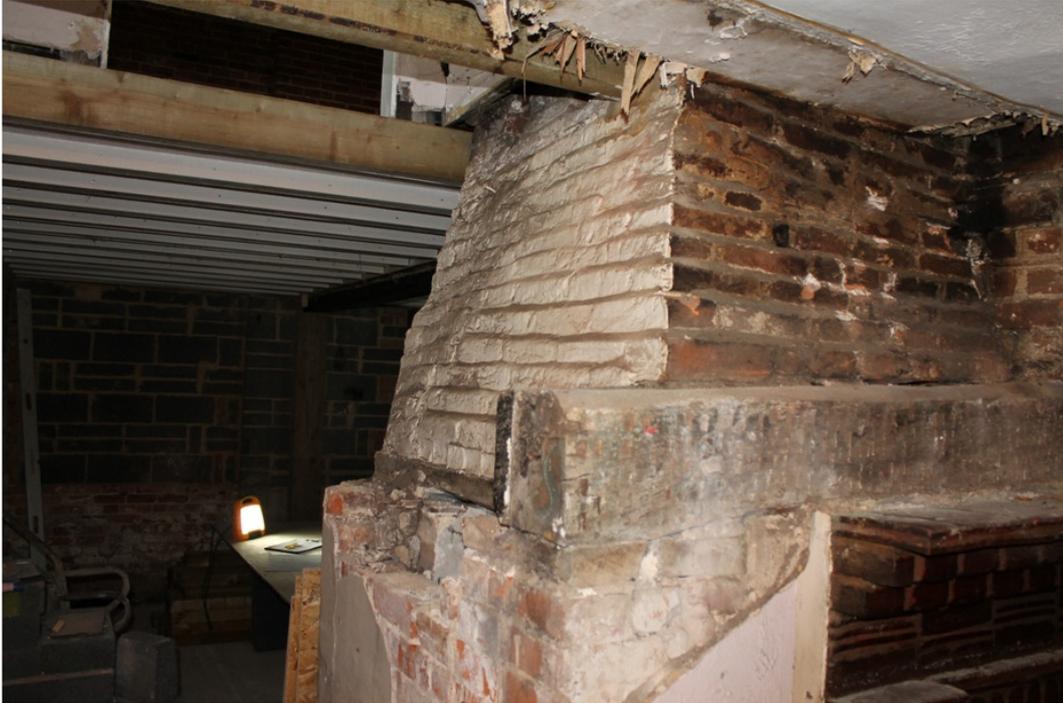
Plate 9 The original Phase 1 chimney between the dining area and the bar, with the stepped brickwork of the stack and the cambered timber mantel - view north-west.

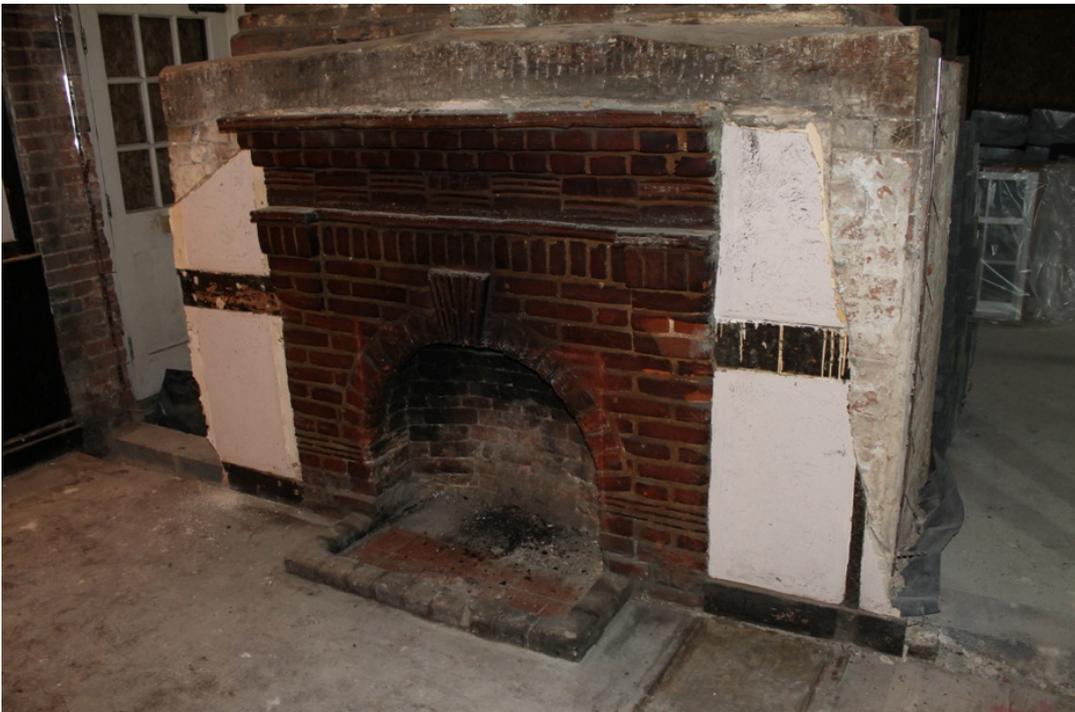
An additional surviving feature from the Phase 1 structure is the brick chimney stack between the dining area and the bar (Fig 4). Although it is square-built at the base, the stack is gently stepped towards the ceiling and is constructed from red brick with dimensions of 230 x 115 x 60mm laid in irregular bond (Plate 9). This originally had openings on both sides but the one to the west has been blocked. The original fire surround facing the bar is surmounted by a large-section, cambered timber mantel, keyed to accept a modern render. A 20th-century Art Deco fireplace has been built on the front of the stack (Plate 10).

Plate 10 Art Deco fireplace inserted to the Phase 1 chimney, with Phase 5 render and mock timber framing – view south-west

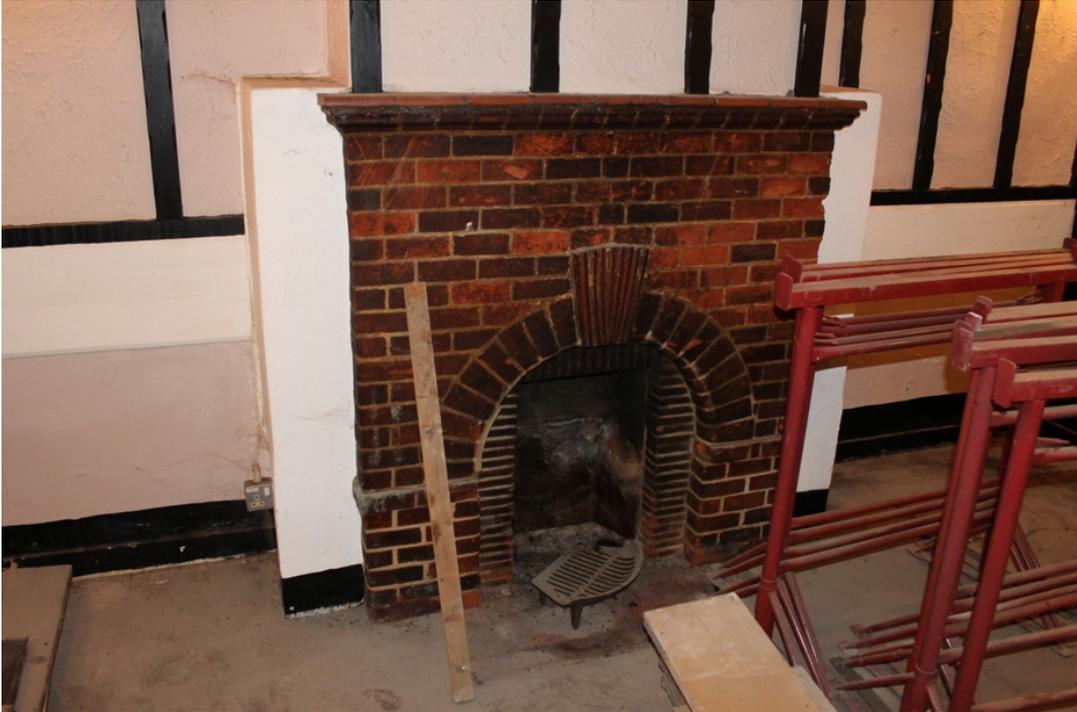
Plate 11 Art Deco fireplace on Phase 2 chimney breast at east end of the lounge – view south-east

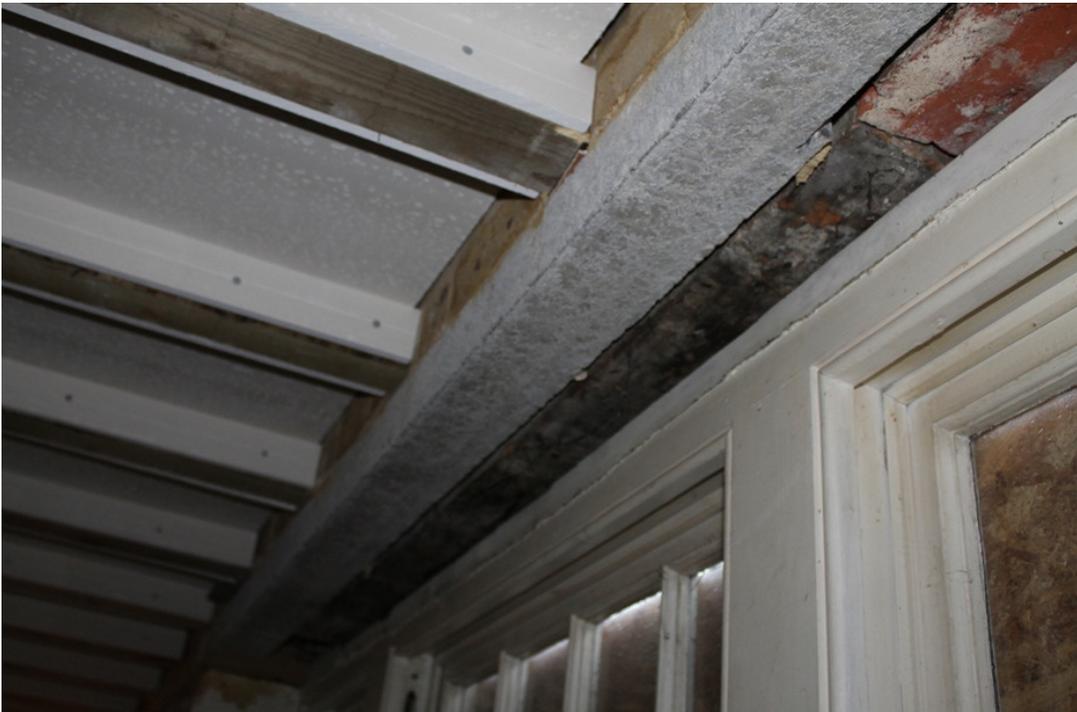
Plate 12 Phase 2 timber window lintel above 20th-century window in dining area - view south-east

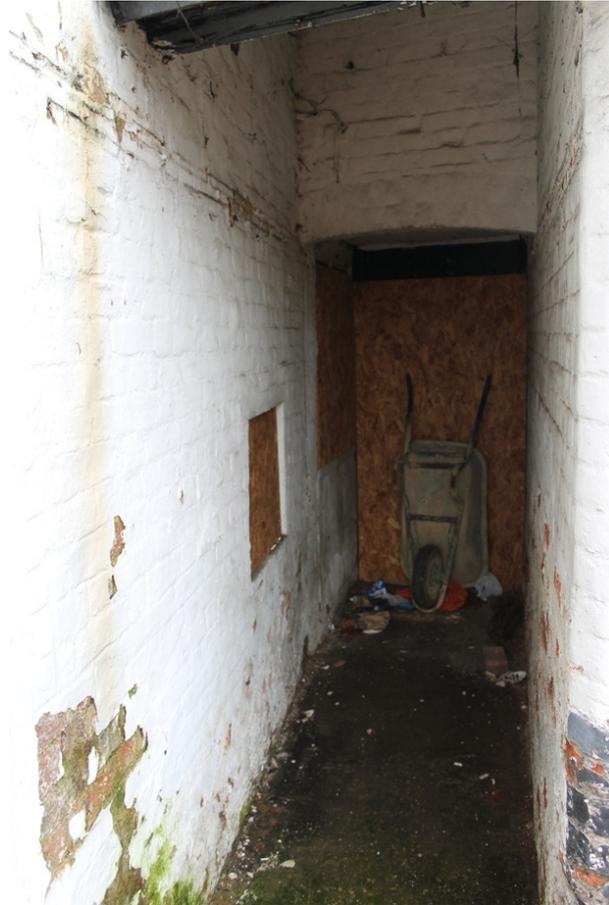
The Phase 3 extension extends the length of the main range and appears to have originally comprised at least two, but probably three rooms. At the west end a room to the north of the dining area was intended as additional space for the public area of the Inn, complete with its own external doorway, whilst the remainder of the extension was given over to service areas. Later alterations divided these areas, with an inserted passage way providing access to the yard behind the Inn, but the position of the staircase and an arch in the external wall denoting an original doorway (Plate 13) suggests they were originally two

Plate 13 Phase 4 passage way leading from yard into Phase 3 extension, showing the arch for the original doorway to the extension – view south-east

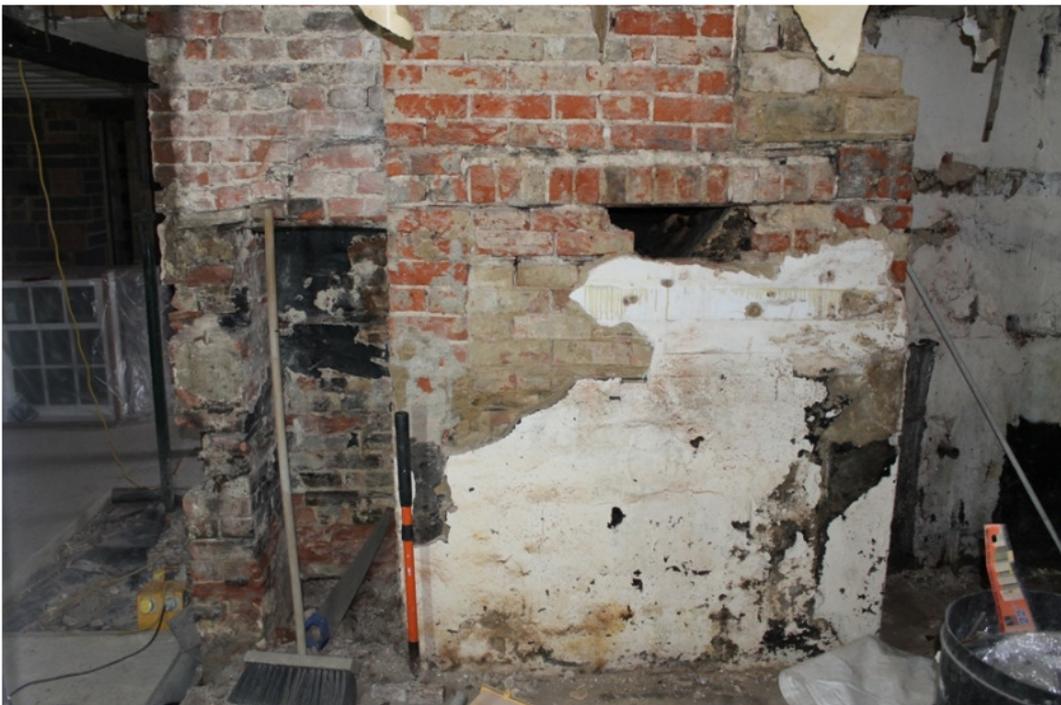
Plate 14 Phase 3 kitchen, showing blocked fireplace with warming oven to the left - view west

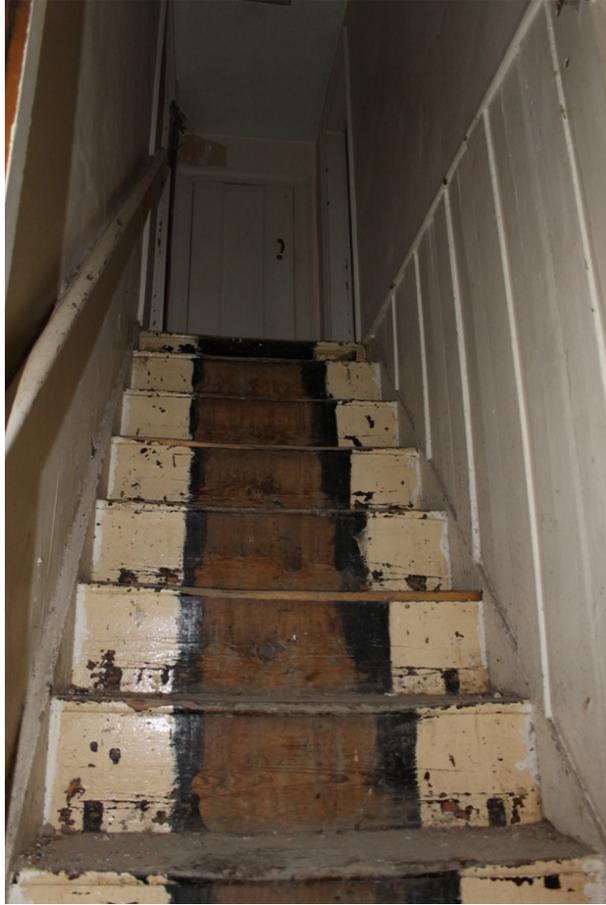
The first floor of the Inn is accessed by a staircase in the Phase 3 extension (Plate 15) which enters the original range through the rear wall (Fig 3). No trace of a staircase contemporary to the Phase 1 structure was observed and it may be that there was an external access, perhaps associated with the mortices noted in the external face of the rear girding beam. However, a significant portion of the Phase 1 structure survives on the first floor, including most of the rear wall frame and the dividing walls between the

Plate 15 Phase 3 staircase to first floor - view west

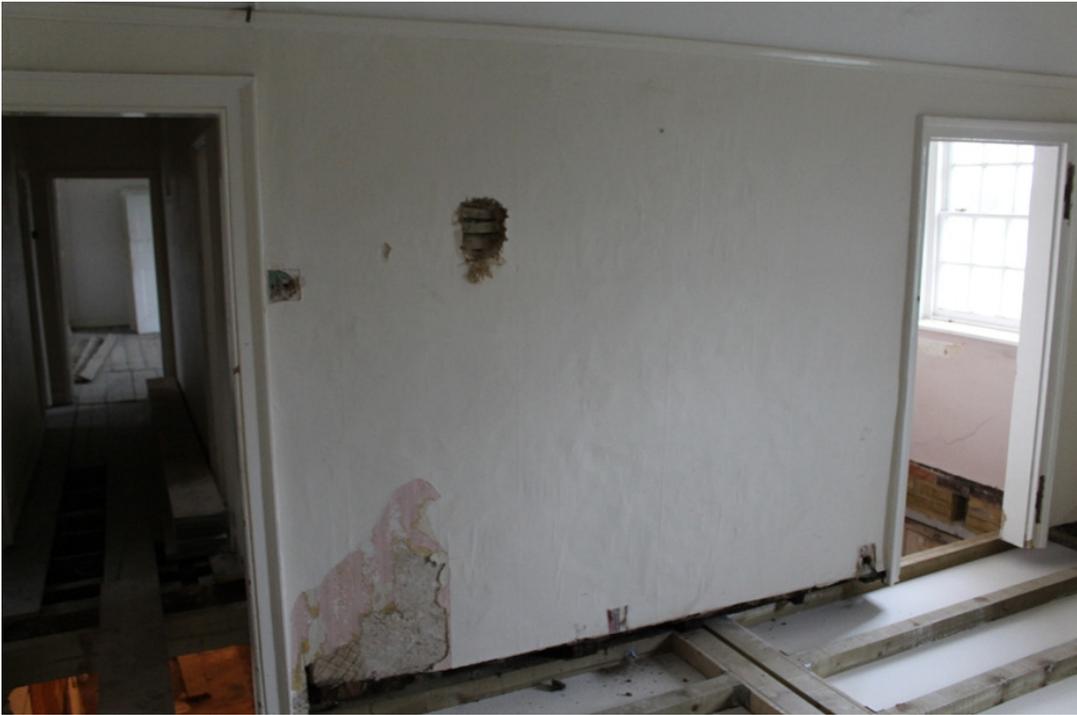
bedrooms. These walls are covered with lath and plaster, with a later render on top (Plate 16). The internal walls divide the first floor into three rooms, with a corridor linking the outer rooms. The original chimney is hidden between the walls to bedrooms 1 and 2 (Fig 4) but later cupboards, constructed either side of the stack, have exposed the original wall framing (Plate 17).

Plate 16 Bedroom 1, showing dividing wall to chimney stack, with lath and plaster over original Phase 1 timber framing - view south-east

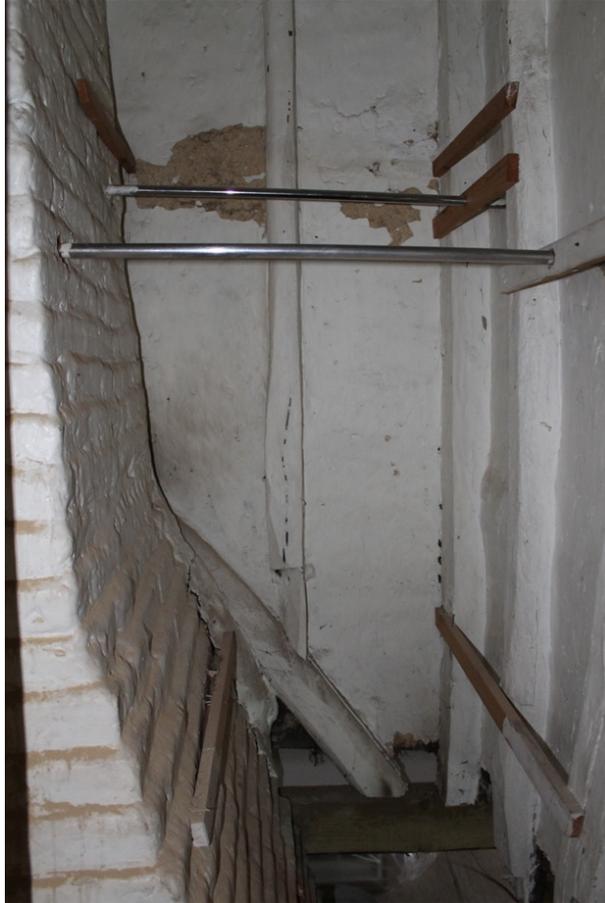
Plate 17 Cupboard formed from the space besides the Phase 1 chimney stack, exposing the original framing – view west

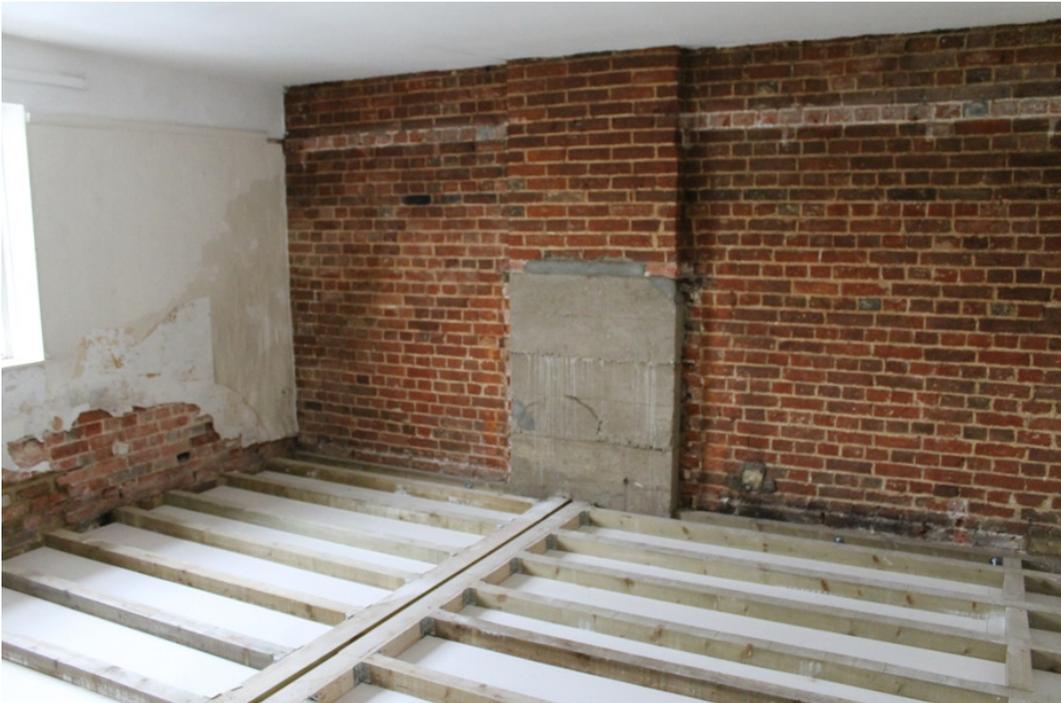
As with the ground floor, all trace of the front and side wall framing was removed by the construction of the Phase 2 Georgian brick façade (Plate 18). Bedrooms 1 and 3 had fireplaces (since blocked) but the central bedroom was unheated.

Plate 18 Bedroom 1, showing the blocked fireplace in the Phase 2 brickwork – view south-west

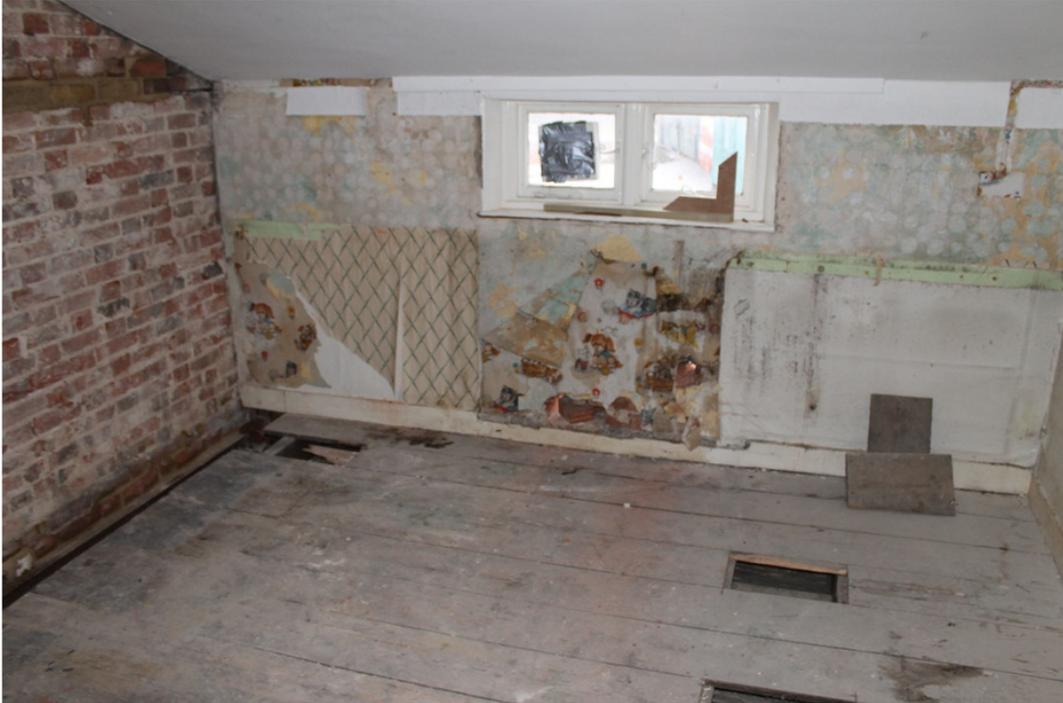
Plate 19 Bedroom 4, possibly intended as a nursery or child's room, with sloped ceiling and narrow wooden-framed casement windows – view north

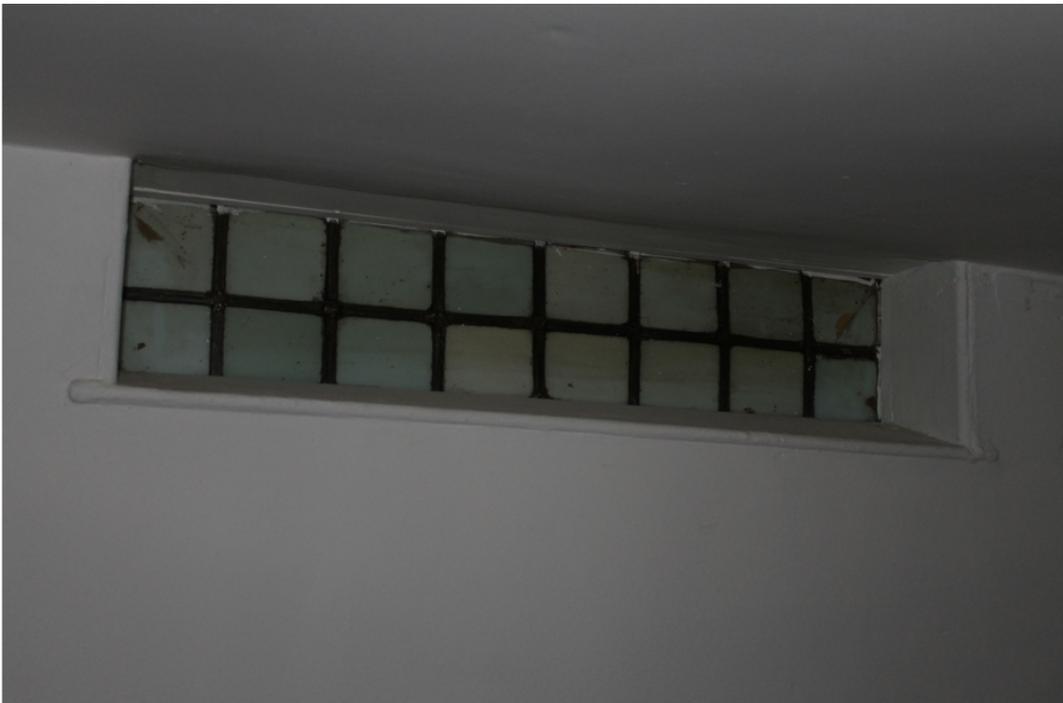
Plate 20 Leaded light window in dividing wall between bedrooms 3 and 5 – view south-west

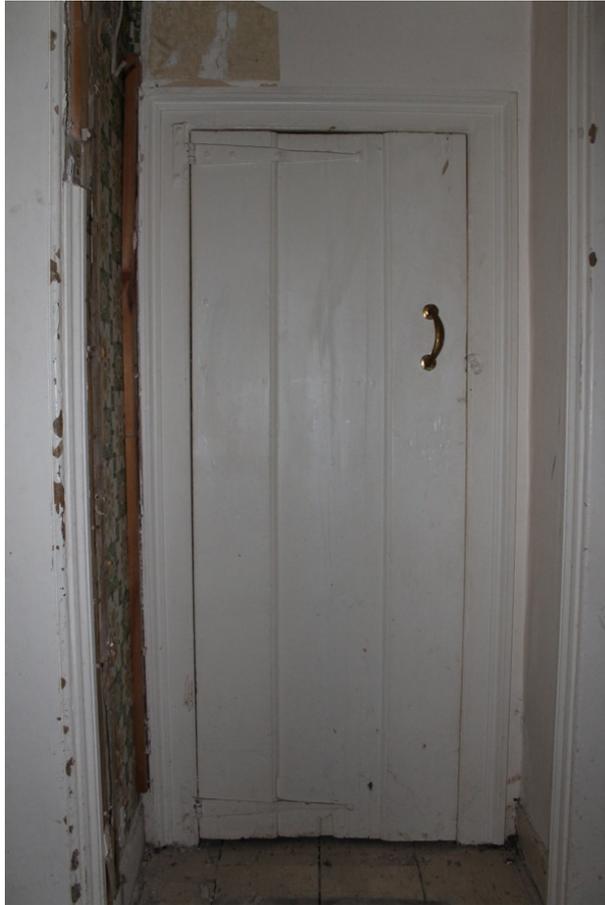
At the head of the stairs there is a cupboard with the original plank door (Plate 21). There are similar doors to the bathroom and bedroom 3. The cramped conditions and lack of heat in the bathroom and bedroom 5 suggests these rooms may have been used by the lodgers mentioned in the 1861 and 1871 censuses, rather than by family members.

Plate 21 Cupboard at head of Phase 3 staircase with original plank door – view west

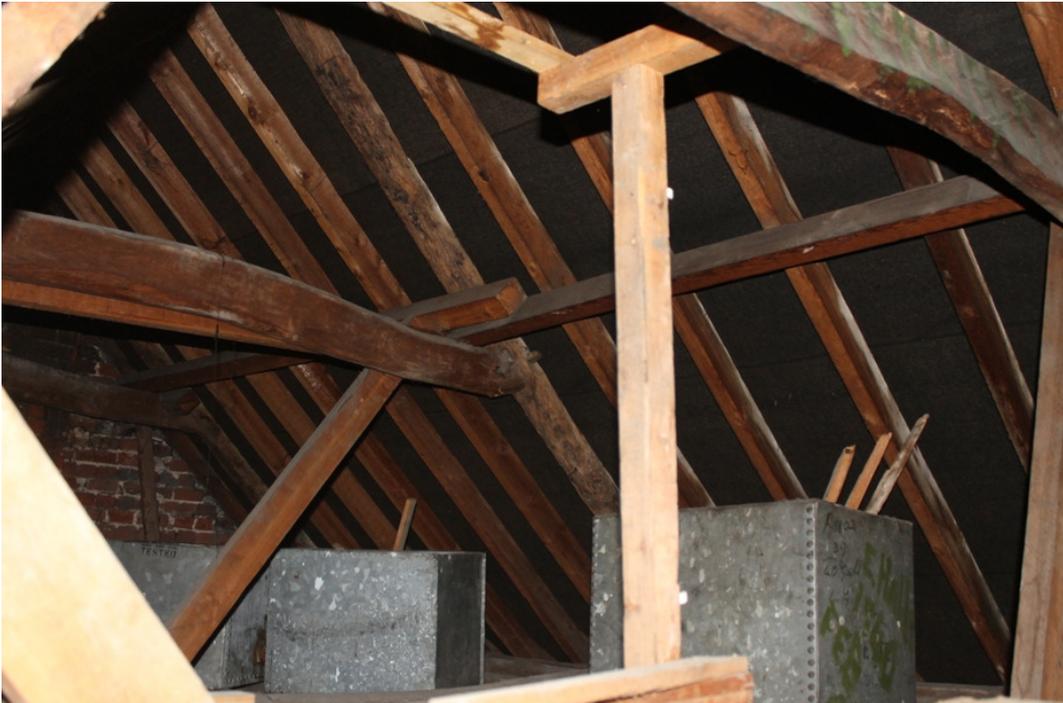
Plate 22 Detail of the roof timbers, showing original Phase 1 principal rafter and collar and modern inclined queen post, purlin and common rafters – view south-east
