**Historic building recording
at the Stag Inn, Hatfield Heath,
Essex
December 2013**

CAT project ref: 13/12a
NGR: TL 5243 1500 (c)
ECC HE code: HSF113
Saffron Walden Museum
accession code: 2013.88

CAT Report 761
March 2014

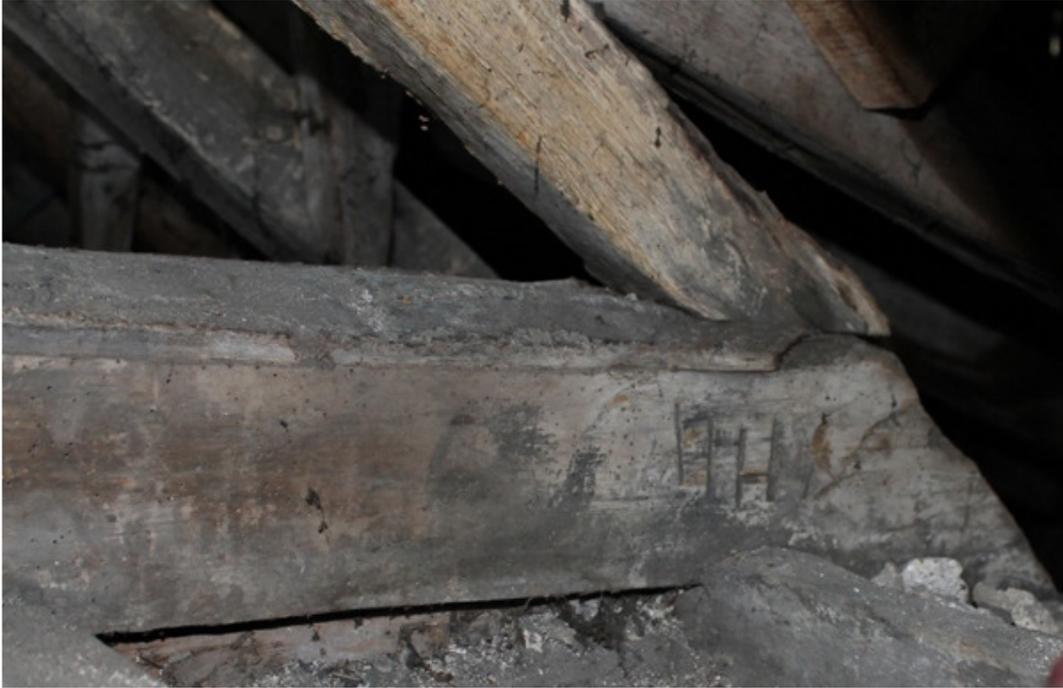
The majority of the common rafters are modern machine-cut timbers, carried on replacement purlins and inclined queen posts, indicating that the roof was rebuilt in the 20th century. There are, however, six original trusses dating to Phase 1 (Fig 4). These comprise a tie beam with dimensions of 200mm x 150mm and principal rafters joined by a single-pegged collar (Fig 5, Plate 22). The collars originally held clasped purlins with splayed scarf joints but nearly all of these have been replaced with machine-cut timbers. Several of the principal rafters have exposed mortices, indicating they are re-used timbers. The ends of the tie beams have chiselled carpenters' marks at the joint with the feet of the principal rafters (Plate 23).

Plate 23 Chiselled carpenter's mark on the end of an attic tie beam – view north-west.

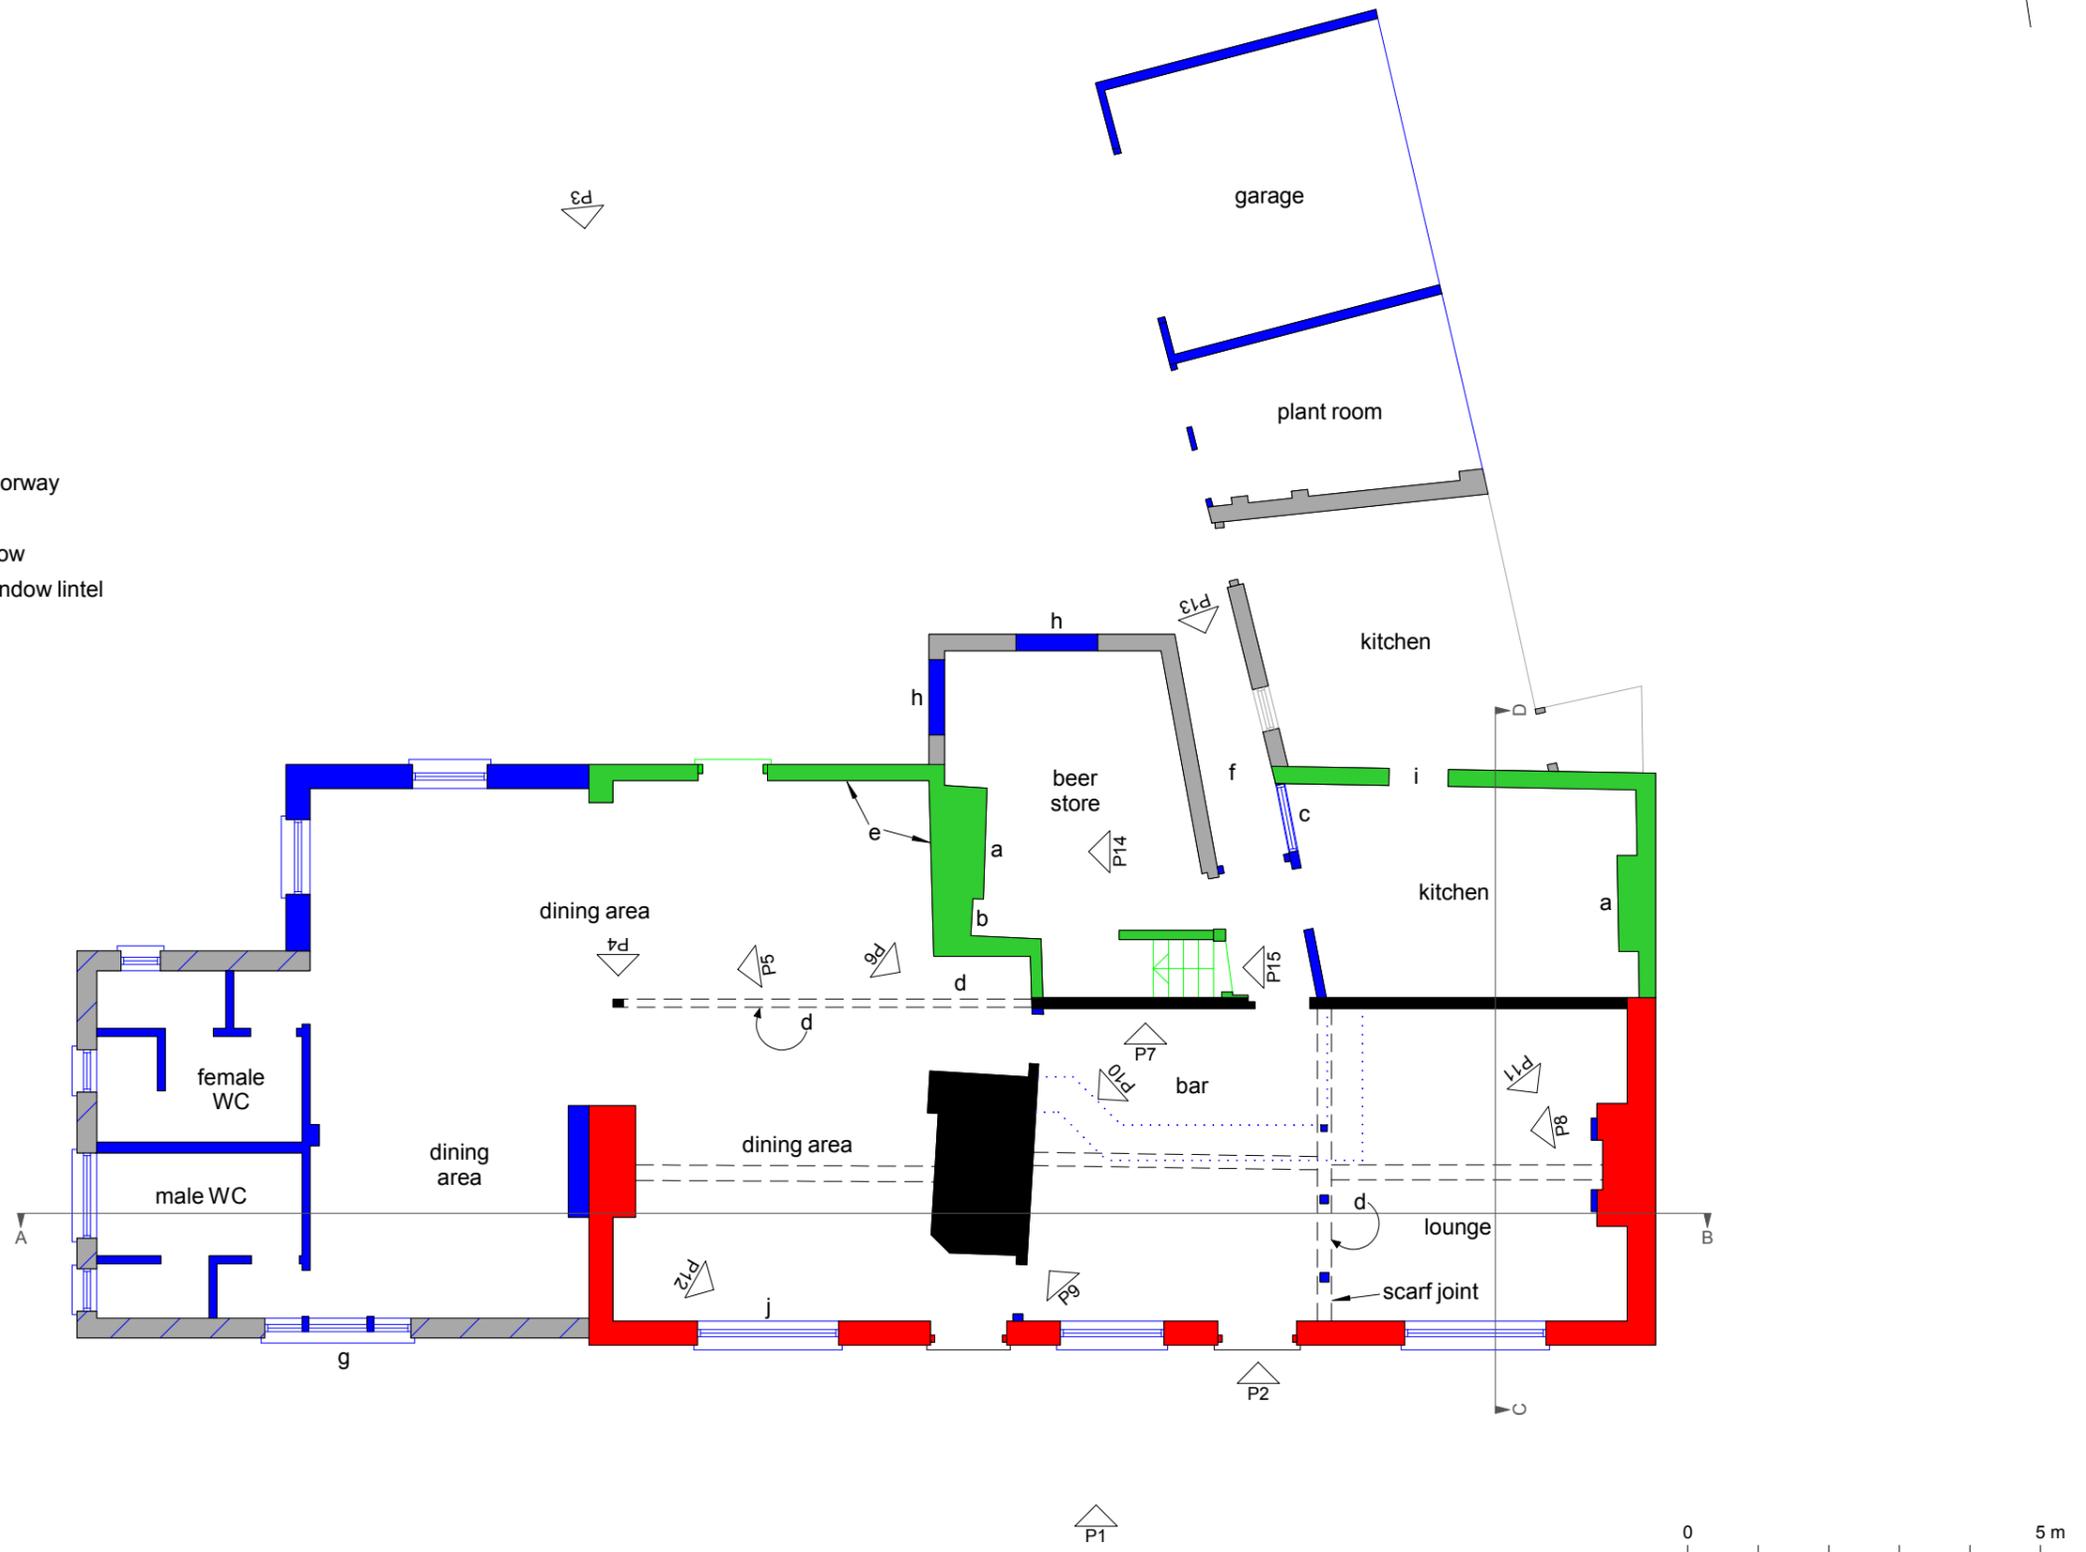
Fig 2 Ground floor plan of the Stag Inn, showing phases and alterations. The location and orientation of photographs included in this report are indicated by the numbered arrows.

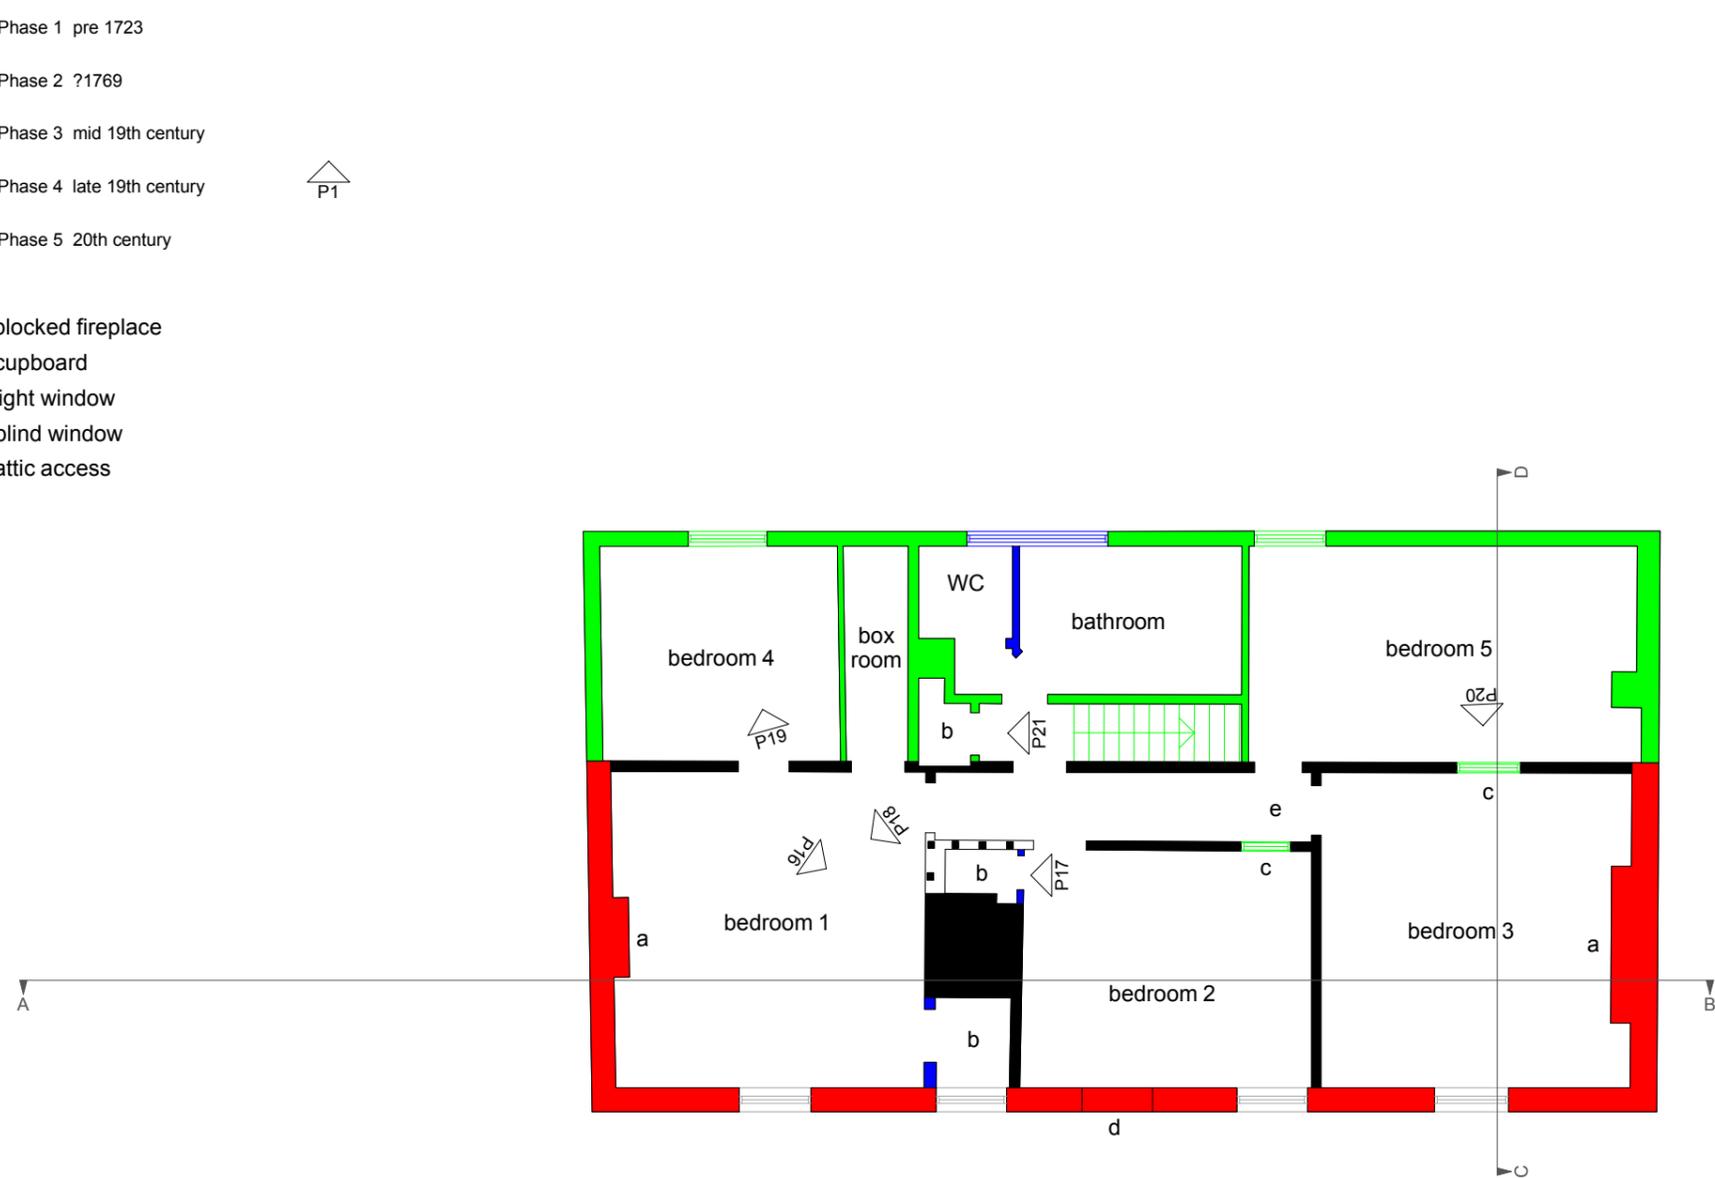
Fig 3 First floor plan of the Stag Inn, showing phases and alterations. The location and orientation of photographs included in this report are indicated by the numbered arrows.

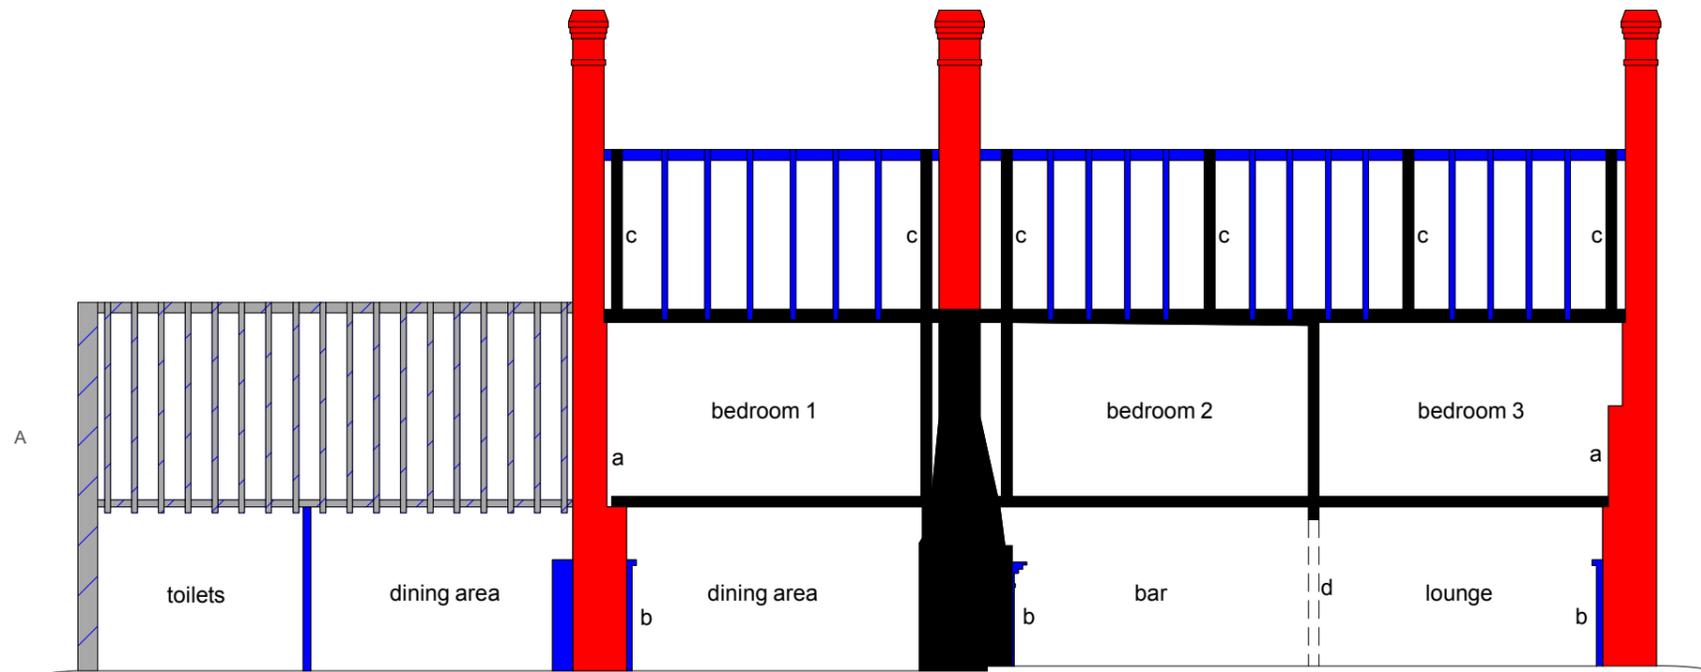
Fig 4 Longitudinal section of the Stag Inn, showing phases and alterations.

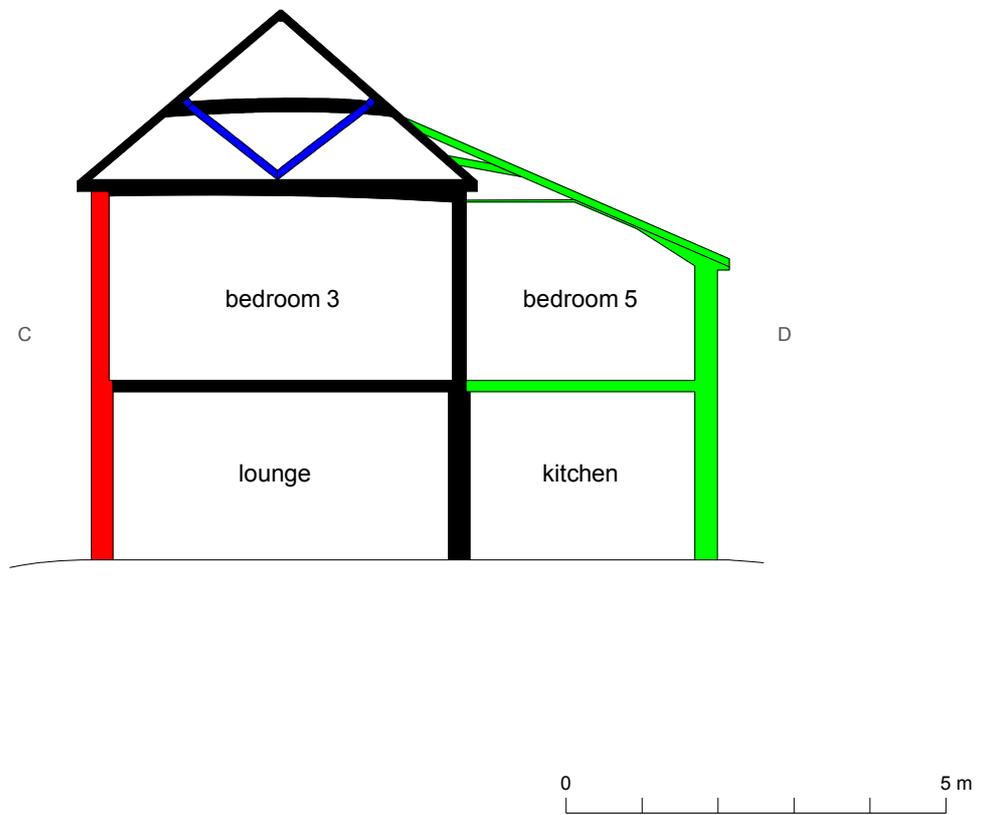
Fig 5 Cross-section of the Stag Inn, showing phases and alterations.
