**Historic building recording  
at the Flagstaff complex  
of Colchester Garrison  
November 2014**

**report prepared by  
Chris Lister  
on behalf of  
Taylor Wimpey**

CAT project ref: 14/10g  
NGR: TL 9976 2458 (c)  
Colchester and Ipswich Museum  
accession code: COLEM 2014.110

**CAT Report 819**  
May 2015

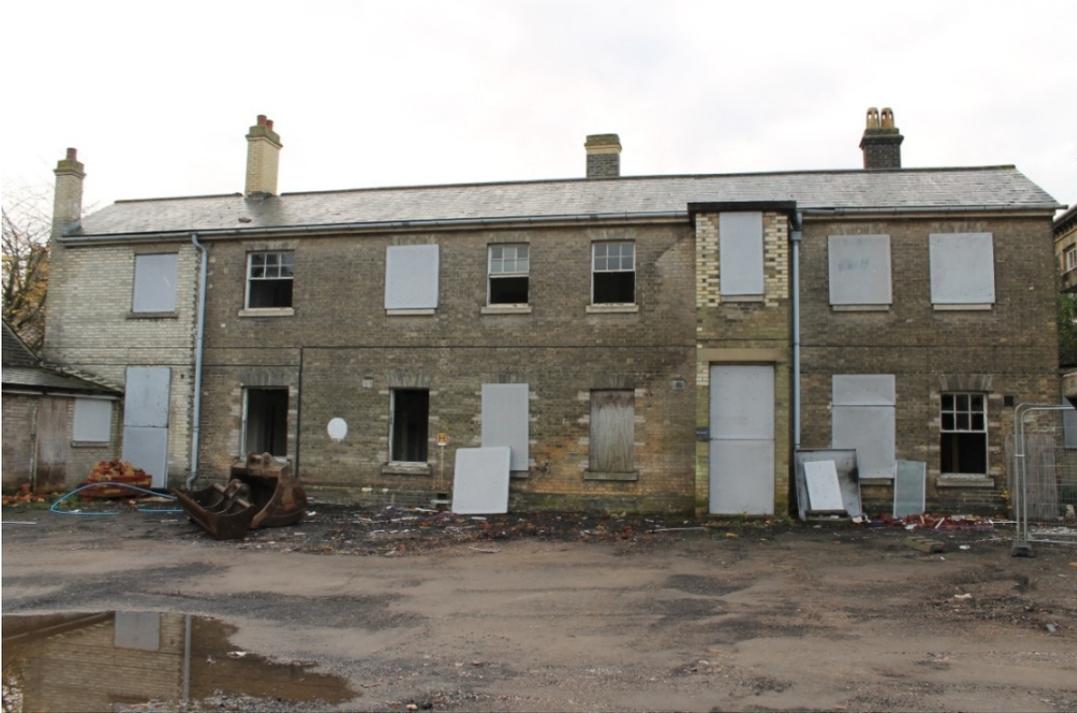
**Plate 1** North elevation of the Annexe - view south

The Annexe is a two-storey building constructed from yellow stock bricks with dimensions of 230 x 114 x 65mm laid in Flemish bond (Fig 2, Plate 1). It is aligned east to west and has evolved to become an extension to FLG1 although, originally, it was a free-standing structure as indicated on the 1897 second edition Ordnance Survey (Map 3). The map evidence suggests a construction date for the first phase of the building of 1876-97. The roof is gabled with a slate covering and the main façade faces north onto an open square, latterly used as a car park but originally a parade ground. The building was constructed as offices for the Garrison Headquarters company.

The north elevation originally comprised six sash windows of six-over-six lights to both floors, two to the west of a projecting entrance and four to the east (Fig 4). The entrance was originally a single-storey structure but has since been built up to the full height of the façade. A two-storey extension has been constructed at the east end of the range partly on top of what appears to be an earlier wall (Figs 5 and 6, Plate 2). Apart from the colour difference of the brickwork these additions have been executed in identical style to the original building and appear to have been the last major alterations made to the building (Phase 4). The east elevation is plain brickwork apart from where a doorway has been inserted to the ground floor, providing a covered walkway to FLG 1. There is a painted sign on the brickwork indicating that the C.O.O<sup>S.S</sup> office is downstairs and the Ordnance office is upstairs (Plate 3).

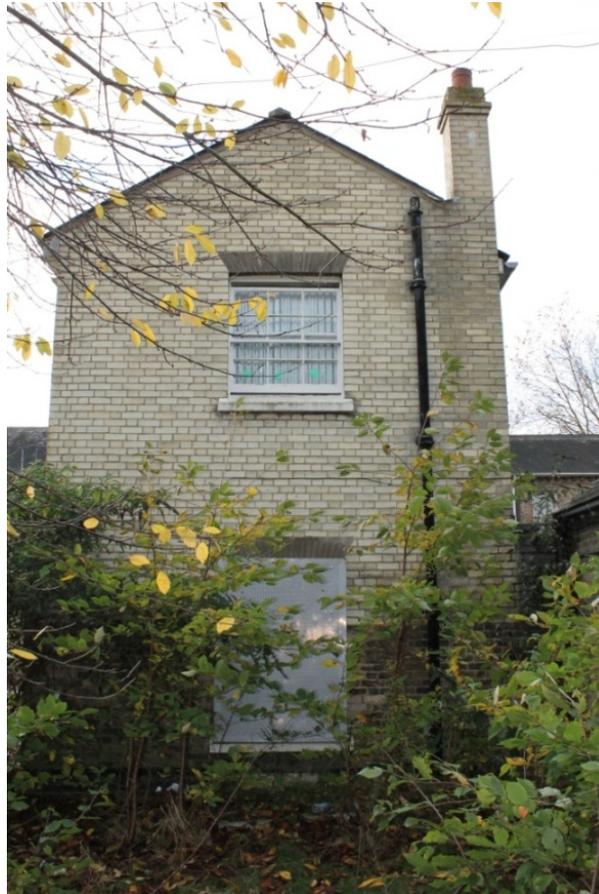
**Plate 2** East elevation of the Annexe showing the Phase 4 extension constructed on top of an earlier wall – view west

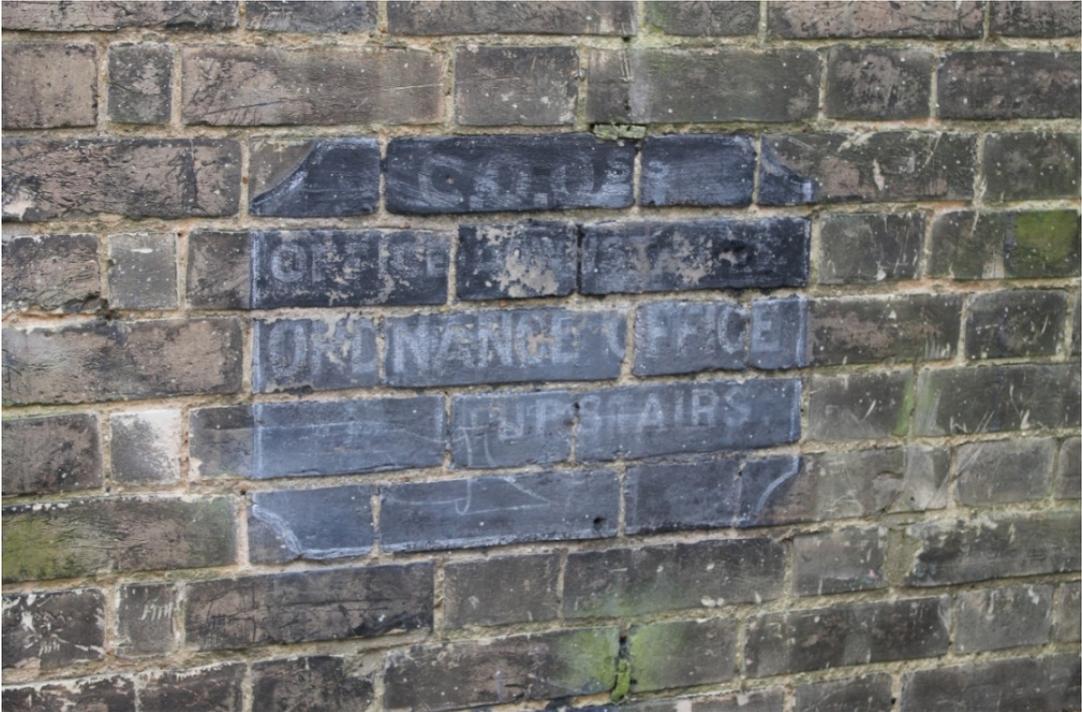
**Plate 3** Painted sign on the east elevation of the Annexe

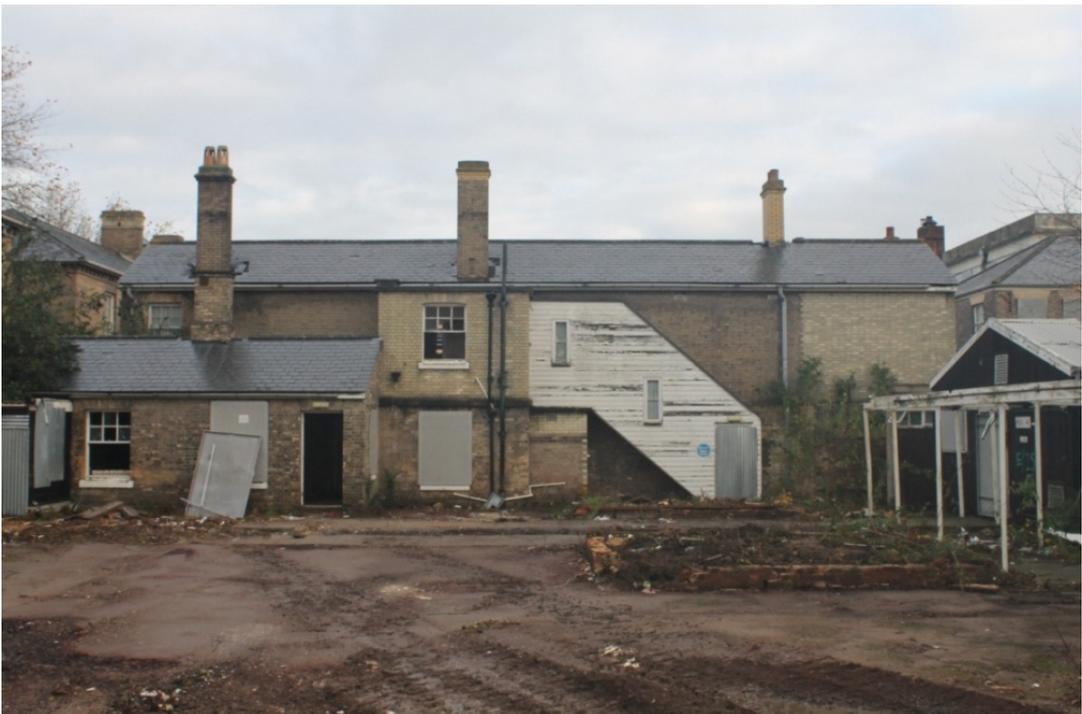
**Plate 4** South elevation of the Annexe showing the extensions to the rear of the range - view north

The south elevation has been much altered with the original façade virtually obscured by later extensions (Fig 5, Plate 4). A single window has been inserted to the first floor at the west end of the range but apart from this the rear elevation appears to have been unadorned brickwork. The oldest of the extensions is a single-storey structure at the west end (labelled Phase 2 on Fig 2) and is indicated on the 1921 edition of the Ordnance Survey. This second phase of building has a gabled slate roof and is constructed from yellow stock bricks with dimensions of 230 x 113 x 67mm laid in Flemish bond. Its south elevation has a doorway at the east corner and two six-over-six sash windows. Part of the south elevation is obscured by a later timber-constructed covered walkway to FLG 4. This covers a doorway that may be original but appears to have been inserted. There is a narrow sash window of two-over-two lights in the west elevation (Fig 6). To the east of the Phase 2 extension there is a small single-storey brick-built structure with a flat roof that has subsequently been built on creating a second storey, also with a flat roof. This third phase of building has a single six-over-six sash window in its south elevation and is constructed

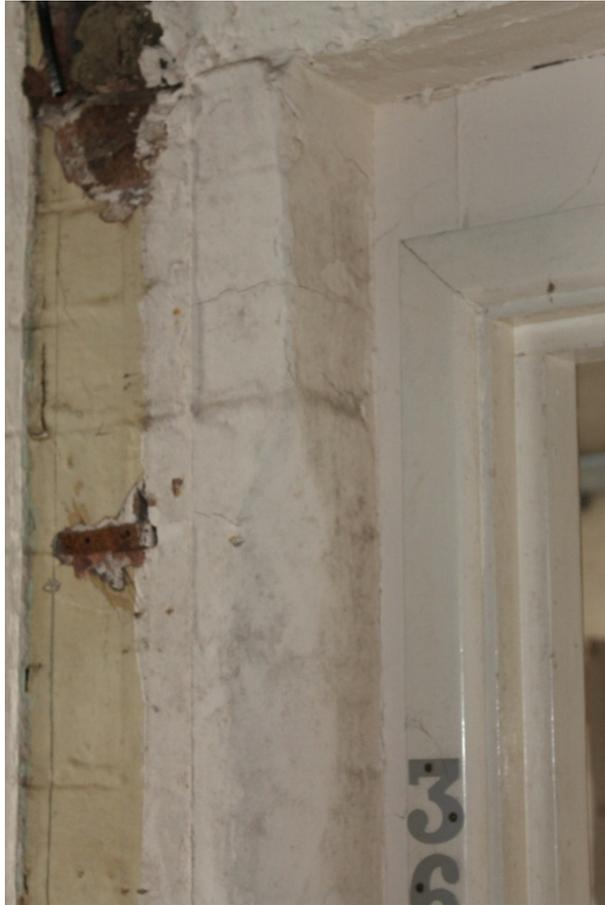
**Plate 5** Chamfered brick door jamb in dividing wall of the ground floor to the Annexe - view north-west

As with Room 1, Room 2 originally had a large fireplace in the south wall, which has subsequently been blocked, and has three doorways which have been inserted into its south wall, granting access to Rooms 7, 8 and 9. None of these doorways appear to have been inserted through window openings. At the east end of Room 2 an original doorway granting access to Room 3 has been widened. The door jamb on the north side of this has chamfered brickwork (Plate 5).

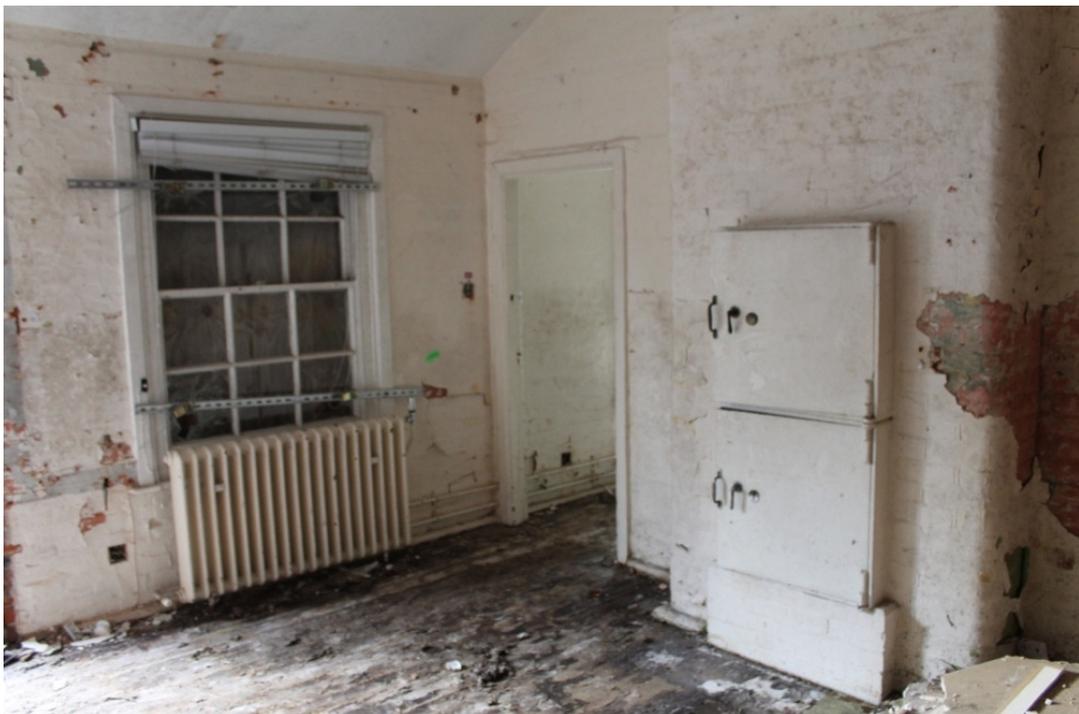
**Plate 6** The interior of Room 7 of the Annexe showing the fireplace converted to a double safe – view south-west

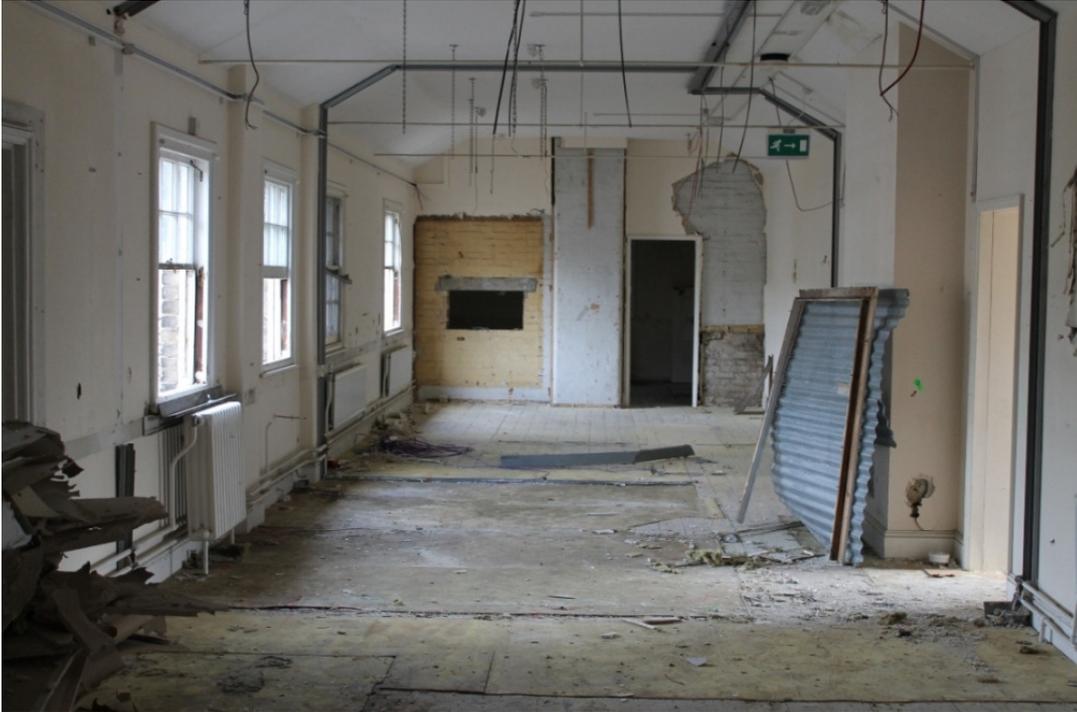
**Plate 7** First floor of the Annexe with the Phase 4 extension to the rear - view east

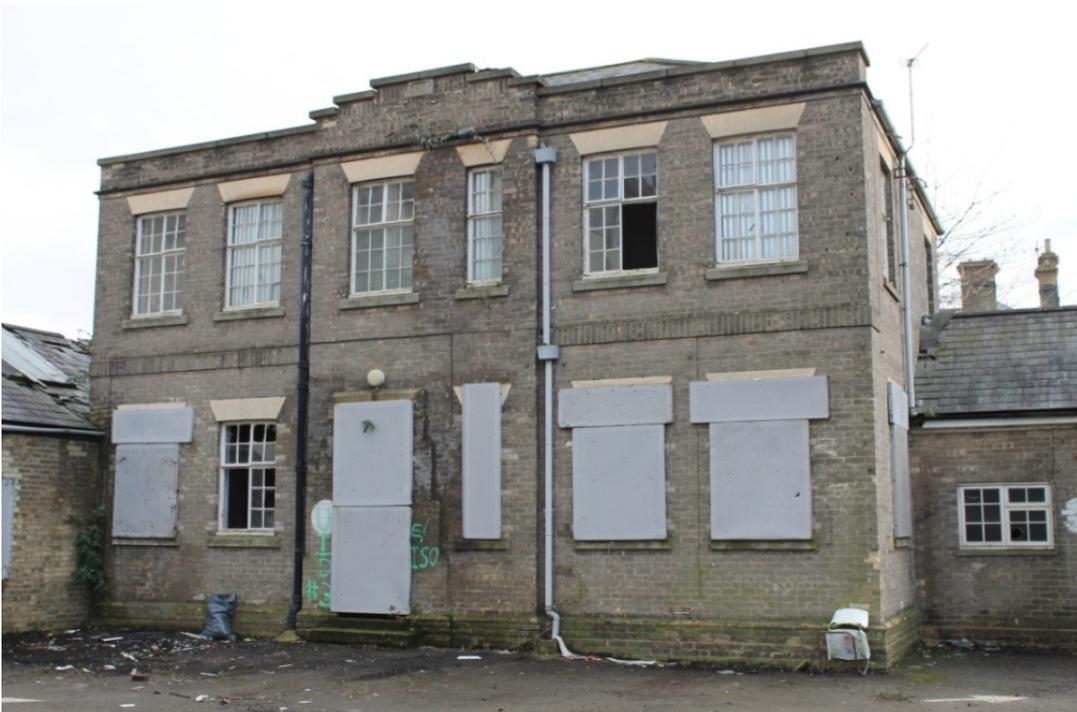
**Plate 8** North elevation of FLG 2 showing the metal-framed windows, stepped door surround and pediment – view south-east

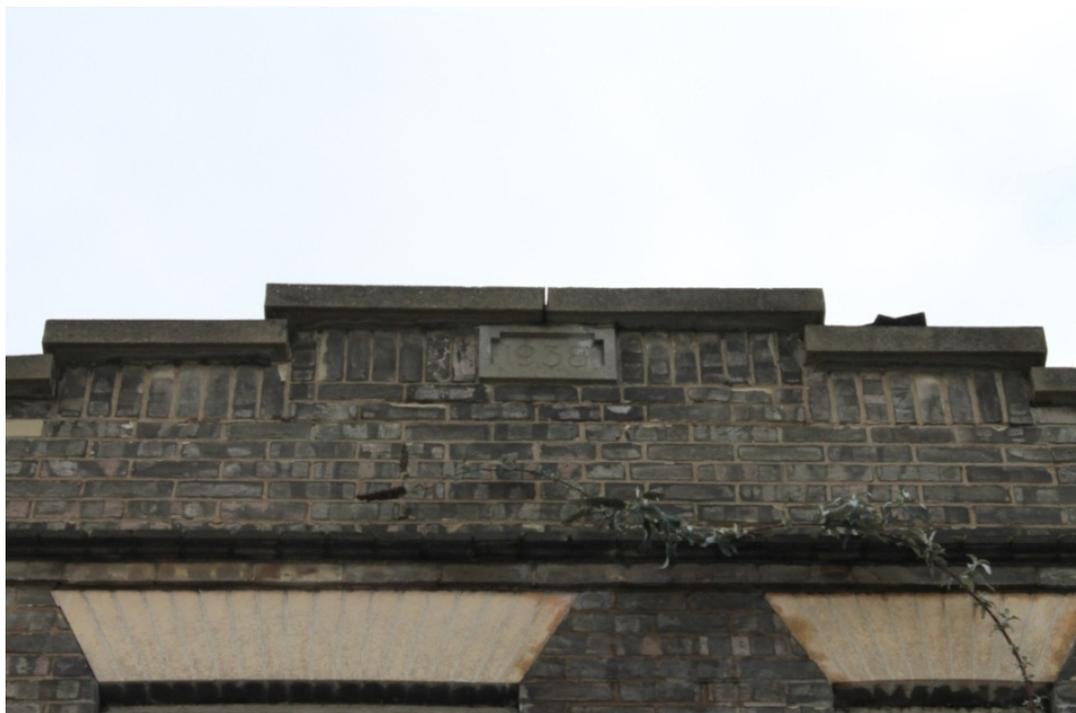
**Plate 9** North elevation of FLG 2 showing the date stone marked 1938 below the stepped section of the parapet - view south

low parapet at roof level with a stepped centre, below which is a date stone marked 1938 (Plate 9).

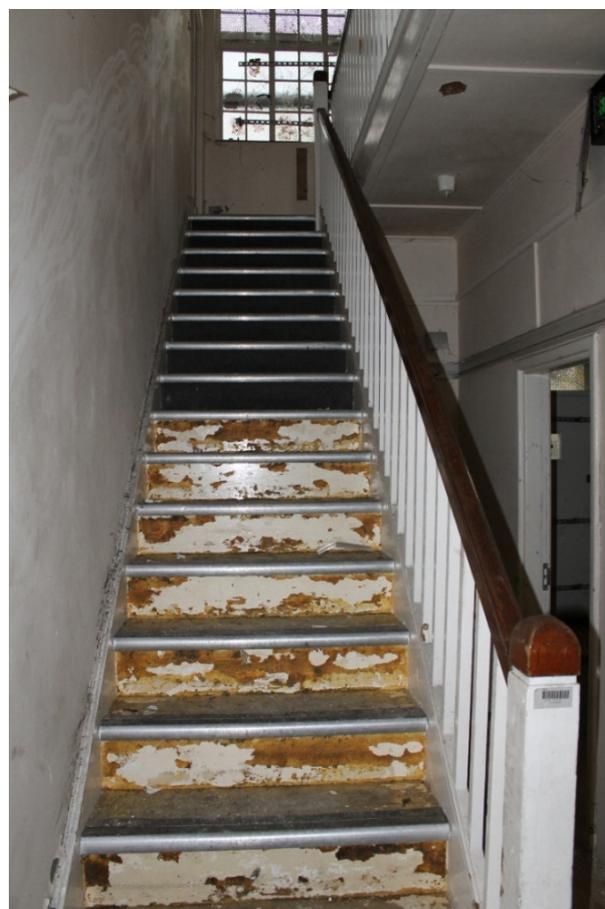
**Plate 10** FLG 2 stairs to the first floor – view south

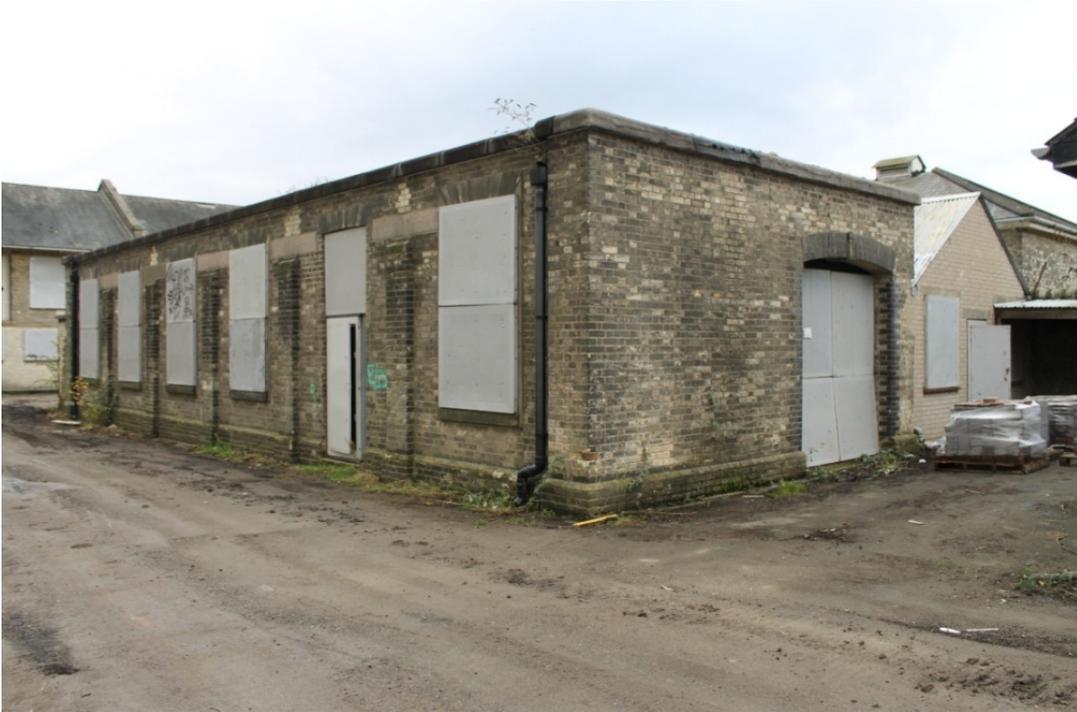
**Plate 11** Building 3, flat-roofed brick shed with building 3a to the right – view south-east

Building 3a has been created by roofing over the space between the south wall of Building 3 and a boundary wall and FLG 17 to the south (Fig 12, Plate 11). The building is shown on the 1921 Ordnance Survey, so it must have been constructed only a short time after Building 3 was completed, probably for use as a store room. Gabled walls of pale yellow brick with dimensions of 230 x 110 x 67mm laid in Flemish bond have been inserted at the west and east ends and it has a roof of corrugated metal sheeting, although this is likely a modern replacement for slate. The east elevation has a centrally-positioned double doorway flanked by two metal-framed windows (Fig 14), whilst the west elevation has a single doorway flanked by two metal-framed windows (Fig 15).

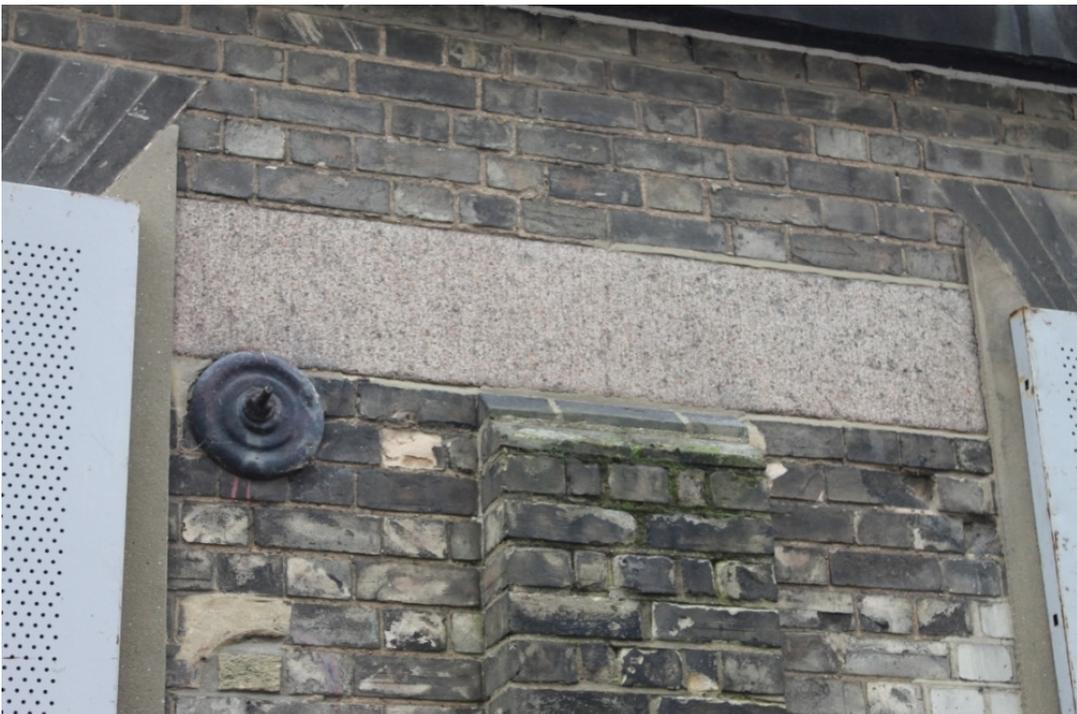
**Plate 12** North elevation of Building 3 showing one of the granite pads above a brick buttress which carry the I-beams of the flat roof – view south

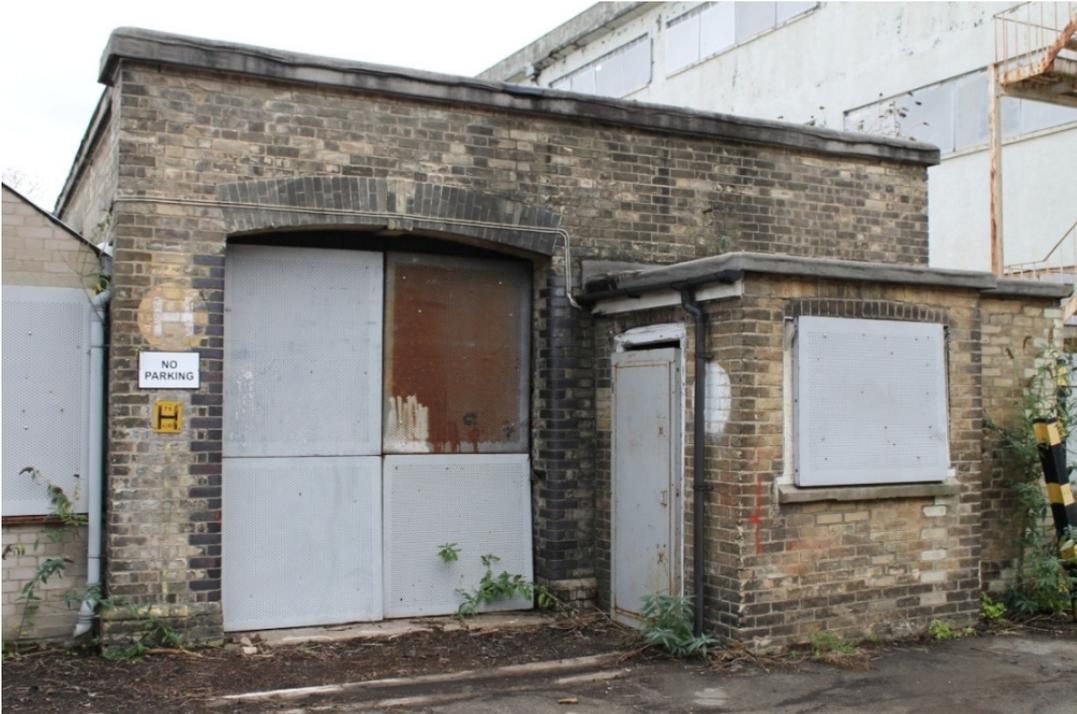
**Plate 13** East elevation of Building 3 showing the wagon doors with jambs constructed from blue bricks with rounded edges - view west

The short elevations to the east and west each have a large pair of timber sliding doors, the openings for which have jambs constructed from blue brick with rounded edges (Figs 14 and 15, Plate 13). This is the sort of architectural detail observed elsewhere on the buildings of Colchester Garrison usually employed where horses were using the openings. The west elevation has a small brick-built extension next to the sliding doors, visible on the 1922 edition Ordnance Survey (Fig 14).

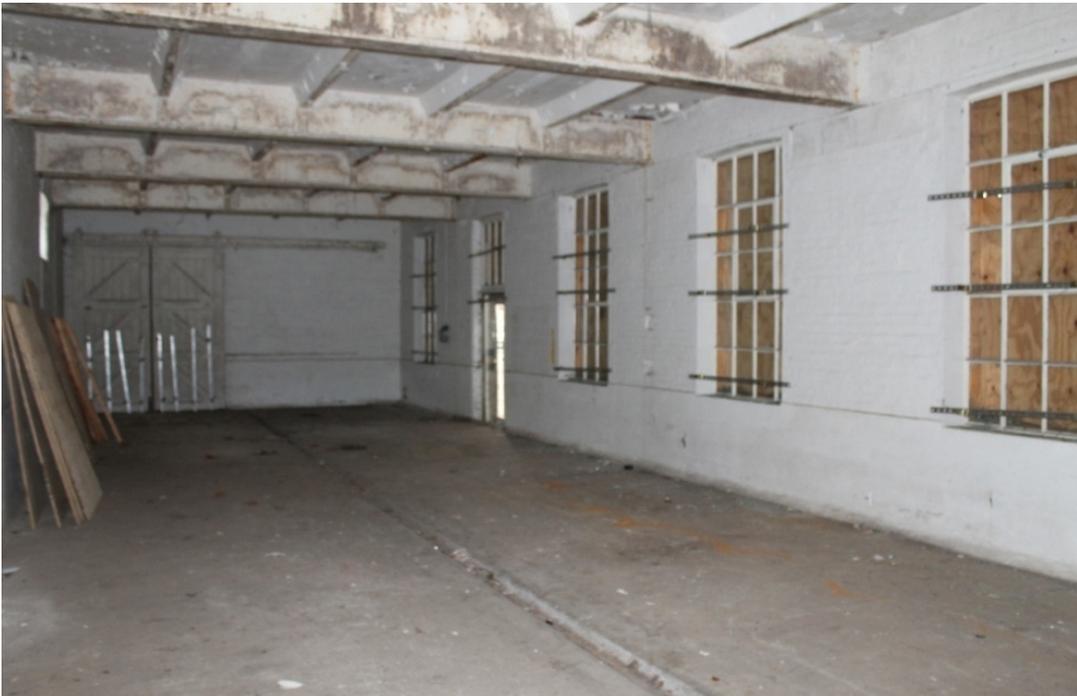
**Plate 14** Interior of Building 3 showing the sliding wagon doors, the metal-framed windows, the I-beams carrying the flat roof and the drainage gully in the floor – view north-west

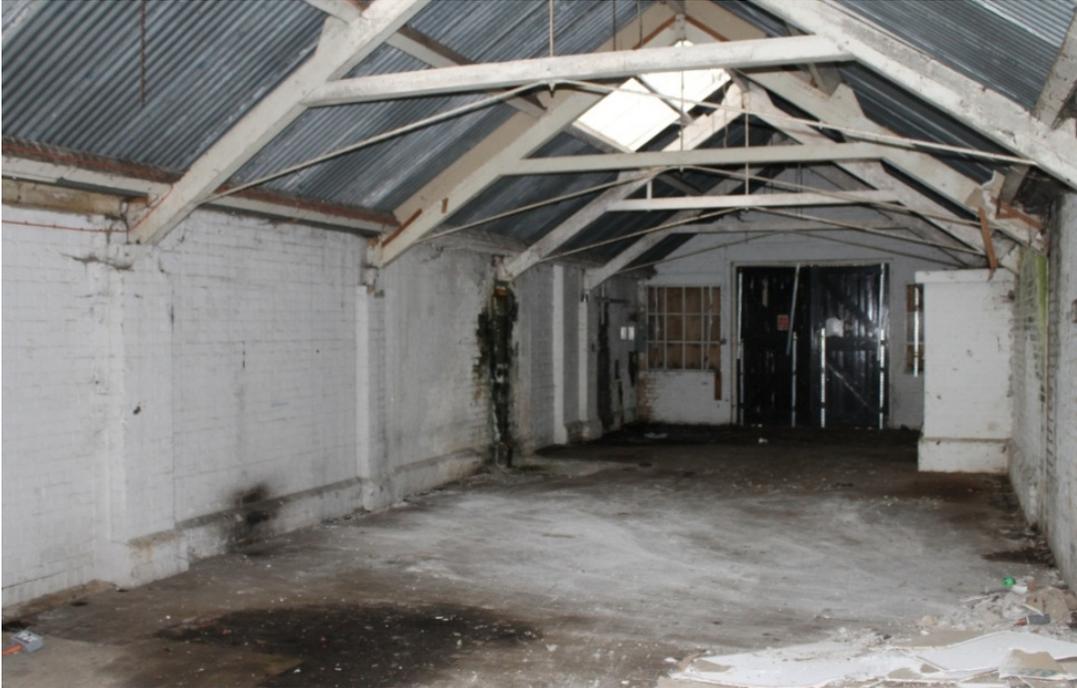
**Plate 15** Interior of Building 3a showing the timber roof trusses supported on the south wall of Building 3 and the boundary wall to the right – view north-east

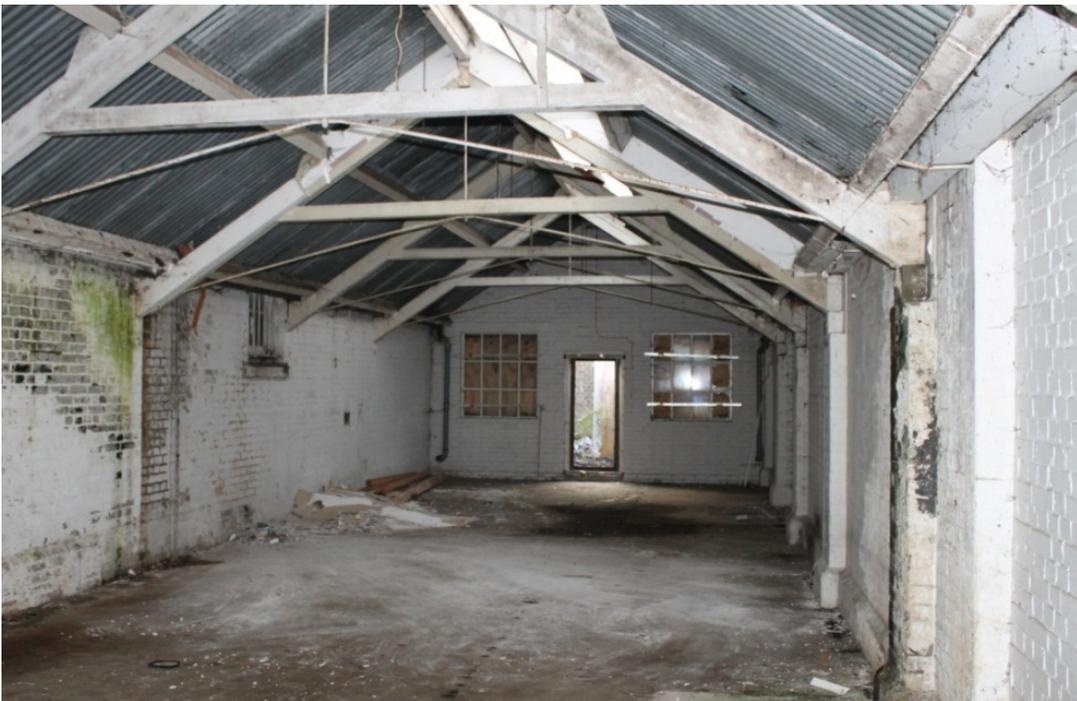
**Plate 16** Interior of Building 3a showing the timber roof trusses and the blocked window to FLG 17 on the left – view south-west

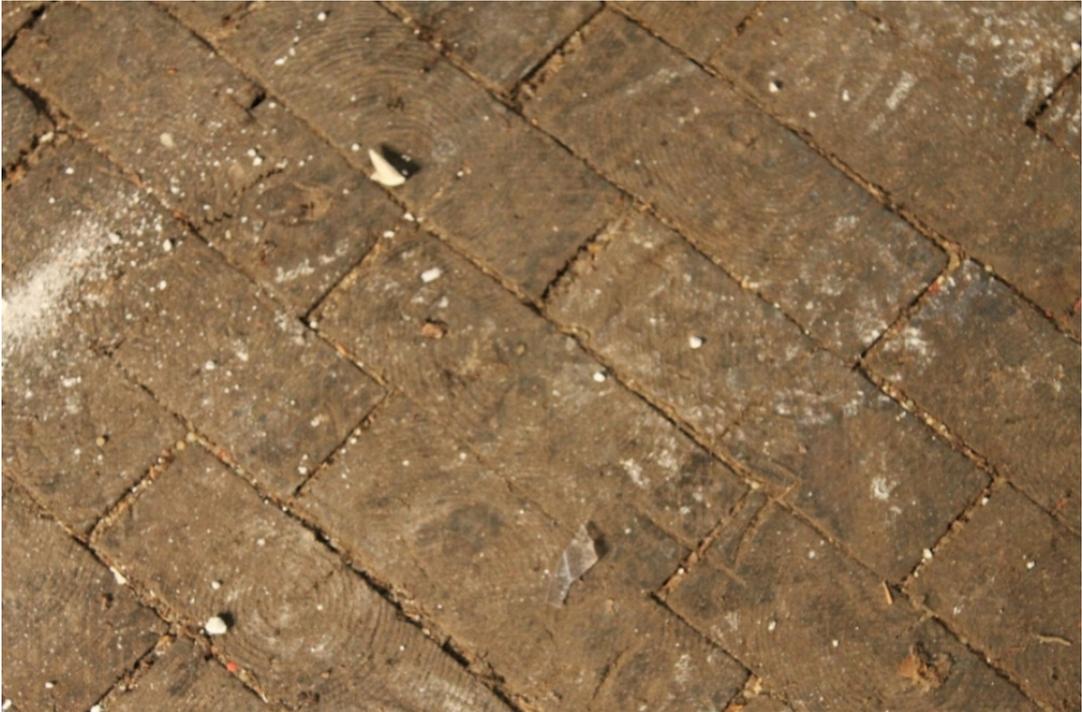
**Plate 17** Detail of wooden parquet floor to Building 3a

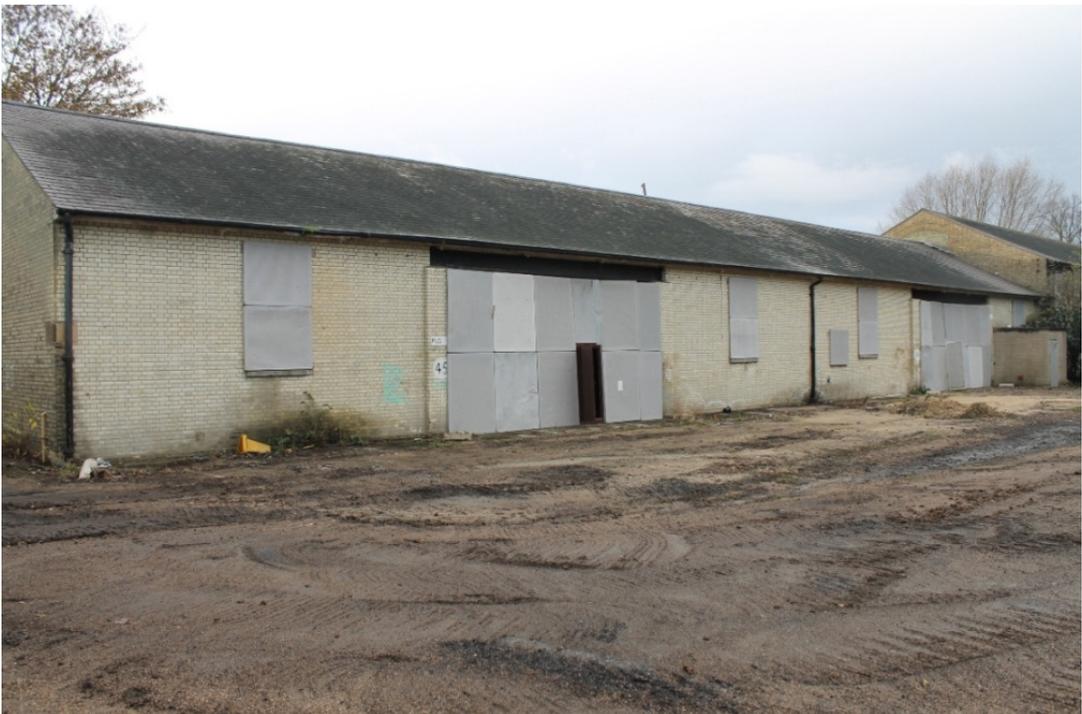
**Plate 18** East elevation of FLG 10/11 showing the infilled front and raised roofline - view north-west

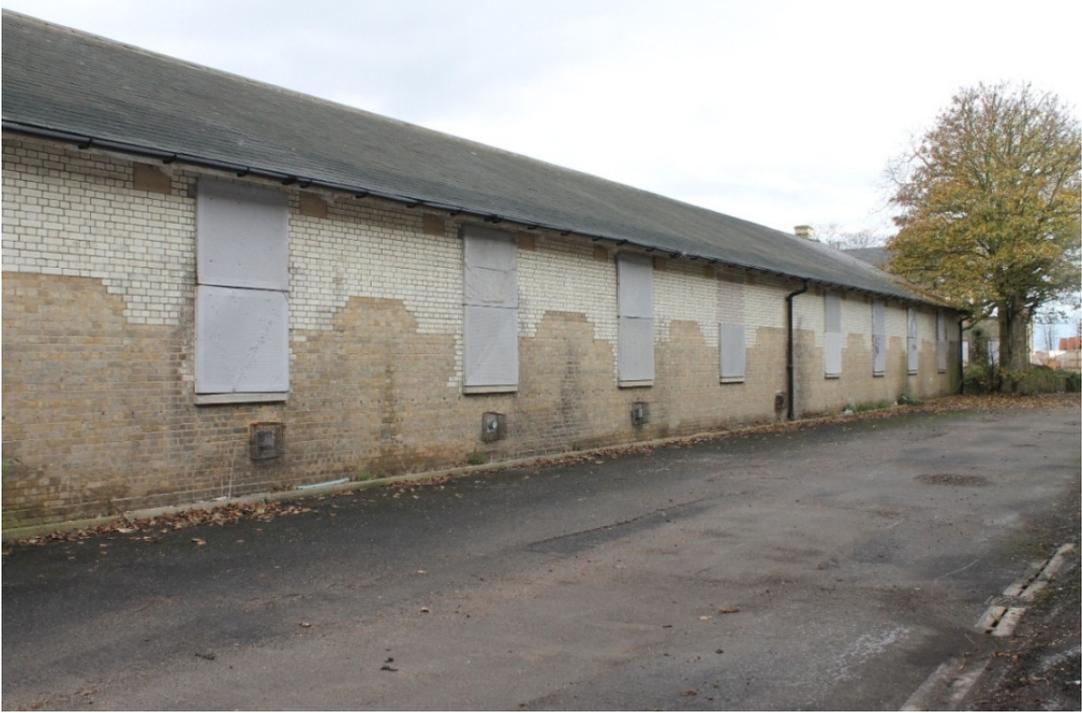
**Plate 19** West elevation of FLG 10/11 showing the increased height of the brickwork and the windows which were inserted to the elevation at the same time - view south-east

The west elevation clearly shows the new brickwork where the height of the building has been increased (Fig 18, Plate 19). At the same time as the building's height was increased large windows were inserted along the length of the building. These are metal-framed and identical to those found in Building 3, suggesting they were re-used from another building on the complex. One of these windows has subsequently been reduced in height. On either side of the windows there are York stone pads which carry the roof trusses. These have been raised from their original positions. The south elevation clearly shows the increase in the gable height (Fig 19, Plate 20) and also has York stone blocks at the south-east corner that originally held the timber doors of the wagon shed. A window has been inserted into the south elevation near to the south-west corner.

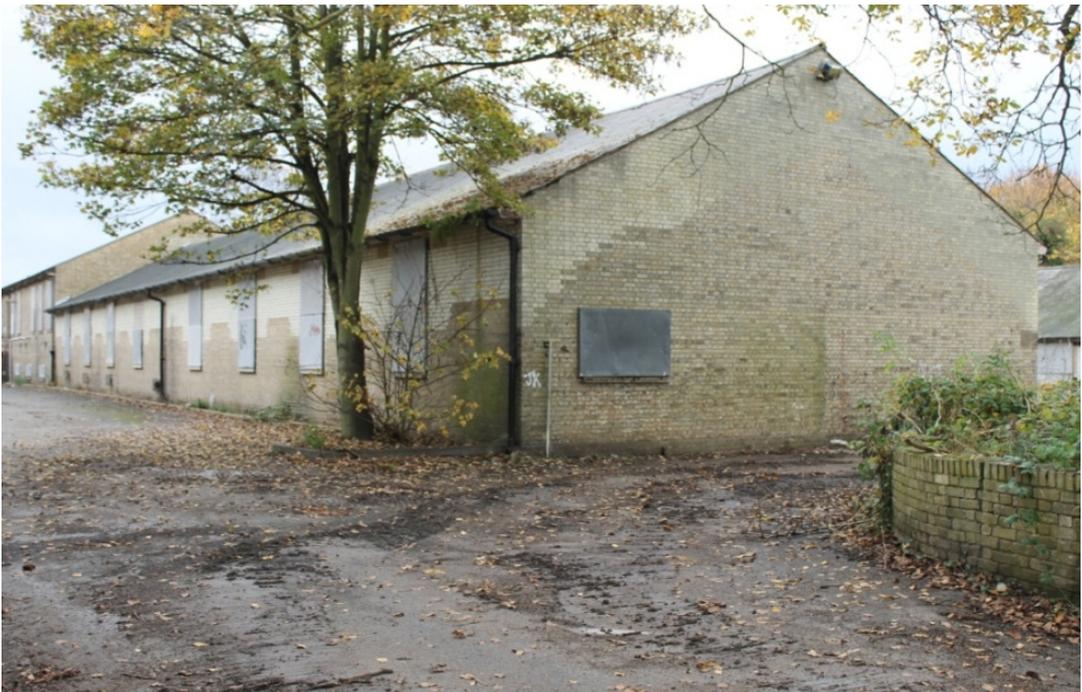
**Plate 20** South elevation of FLG 10/11 showing the increased height of the brickwork and a later inserted window - view north-east

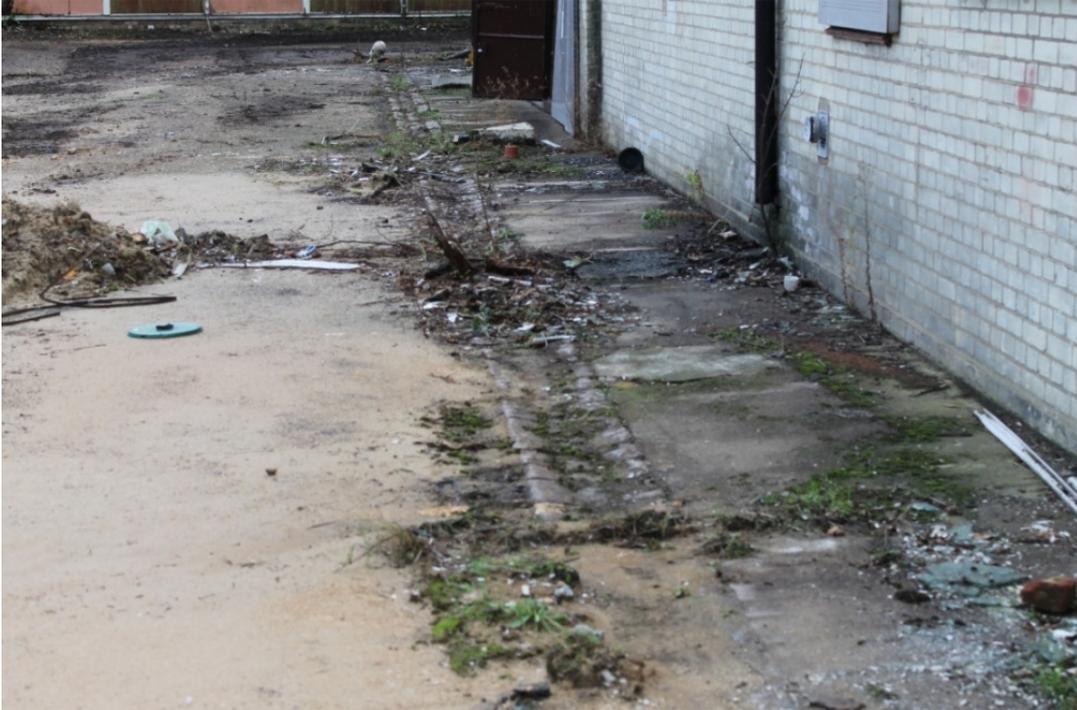
**Plate 21** Original granite-lined drainage gully extending the full length of FLG 10/11 - view south

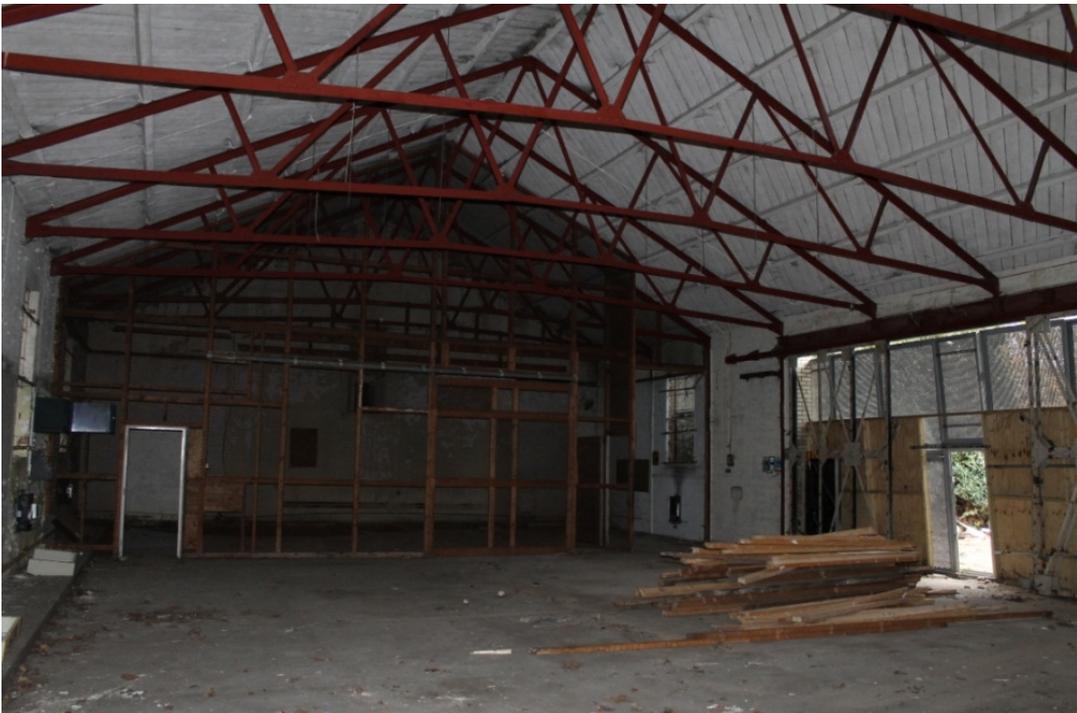
**Plate 22** The interior of FLG 10 showing the later caged area to the north and the sliding doors of the modified east elevation. The steel roof trusses supporting the diagonal sarking boards are part of the original building and have been raised to the modified height - view north

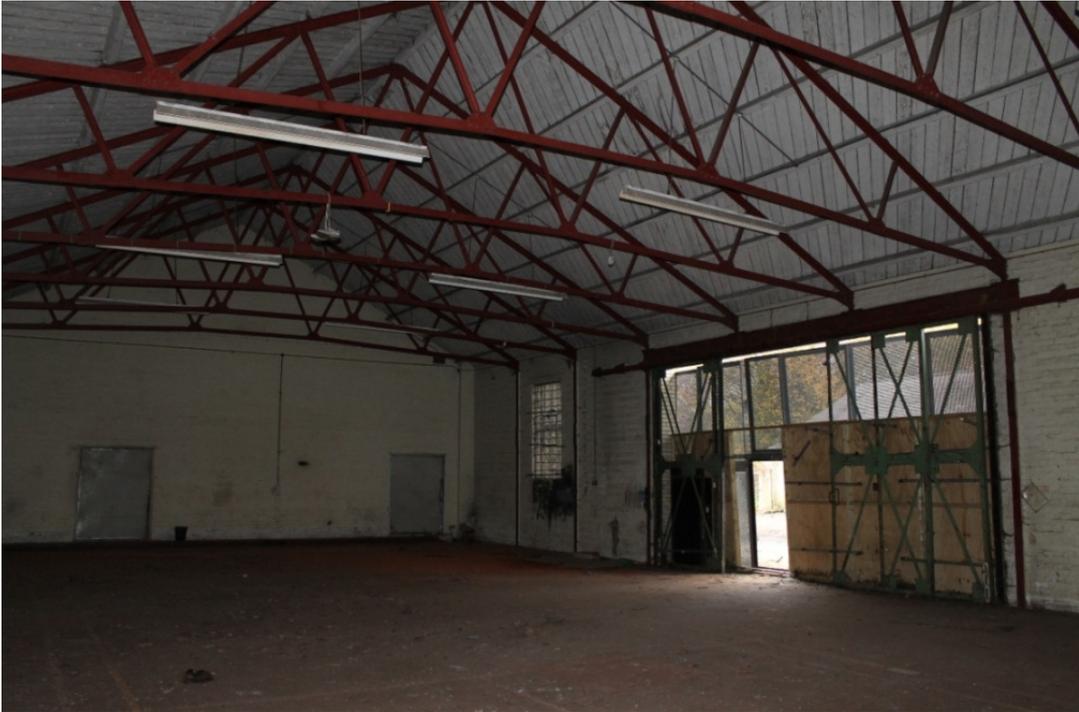
**Plate 23** The interior of FLG 11 showing the original steel roof trusses supporting the diagonal sarking boards of the roof and the badminton court painted on the floor - view north-east

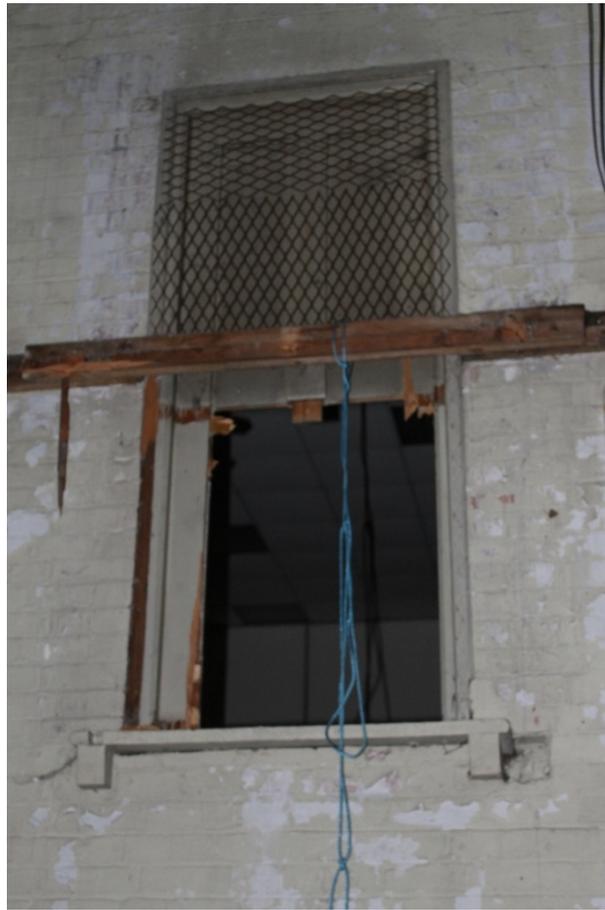
**Plate 24** Doorway in the dividing wall between FLG 10 and the building to the north - view north

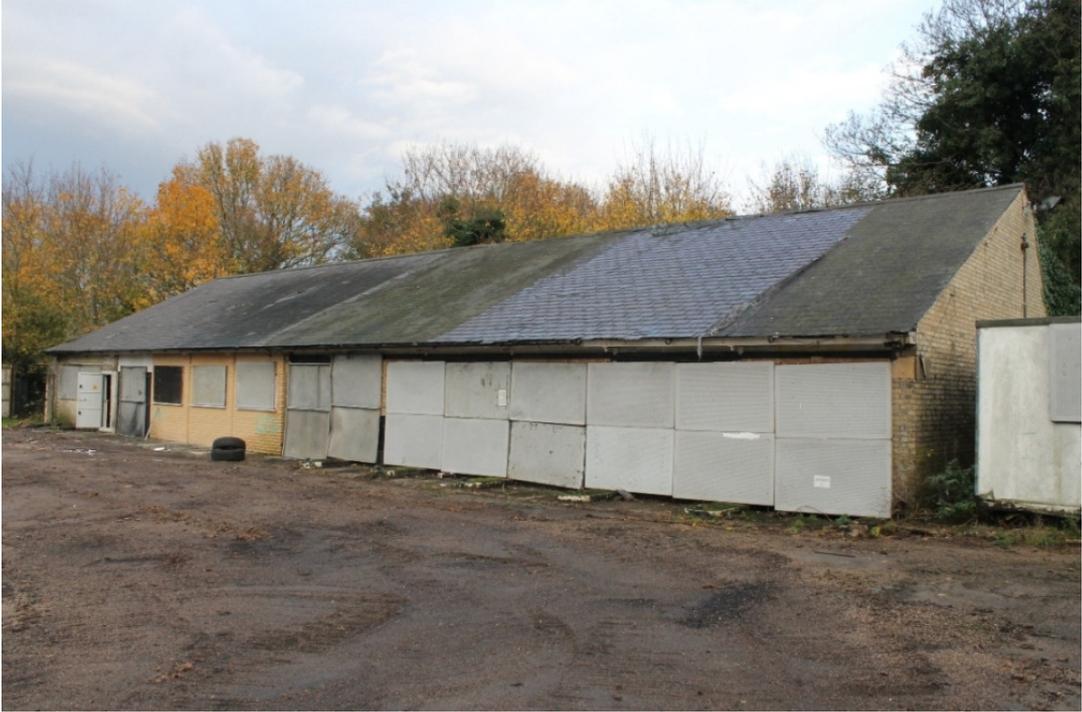
**Plate 25** West elevation of FLG 12/13 showing the alterations to the wagon doors - view north-east

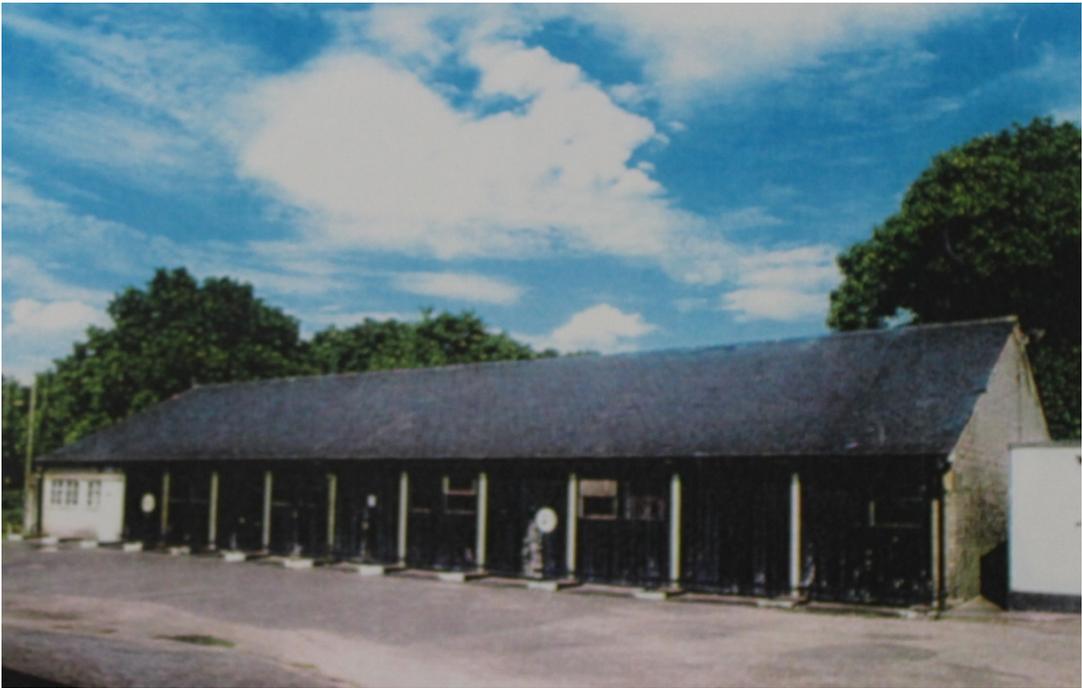
**Plate 26** West elevation of FLG 12/13 photographed in 2000 showing the original wagon doors extending along the length of the façade - view north-east (copyright Ingrams, 2000)

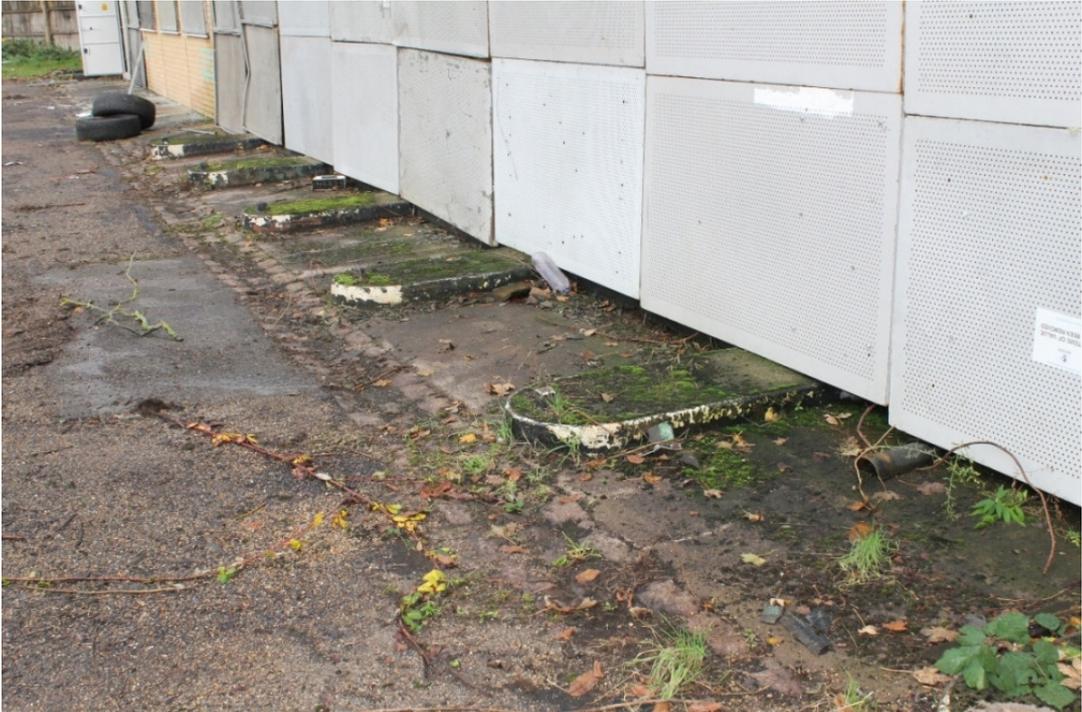
**Plate 27** West elevation of FLG 12/13 showing the original granite-lined drainage gully in front of the wagon doors - view north-east

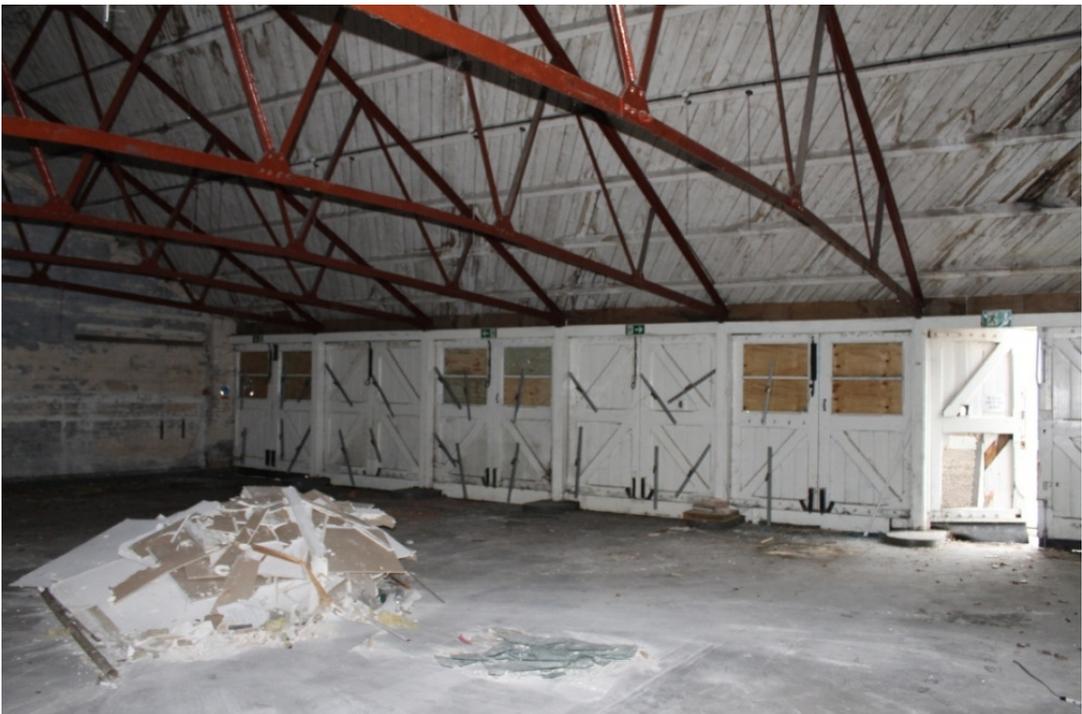
**Plate 28** Interior of FLG 13 showing original wagon doors, steel roof trusses and diagonal sarking boards - view south-west
