**Historic building recording  
at the Flagstaff complex  
of Colchester Garrison  
November 2014**

**report prepared by  
Chris Lister  
on behalf of  
Taylor Wimpey**

CAT project ref: 14/10g  
NGR: TL 9976 2458 (c)  
Colchester and Ipswich Museum  
accession code: COLEM 2014.110

**CAT Report 819**  
May 2015

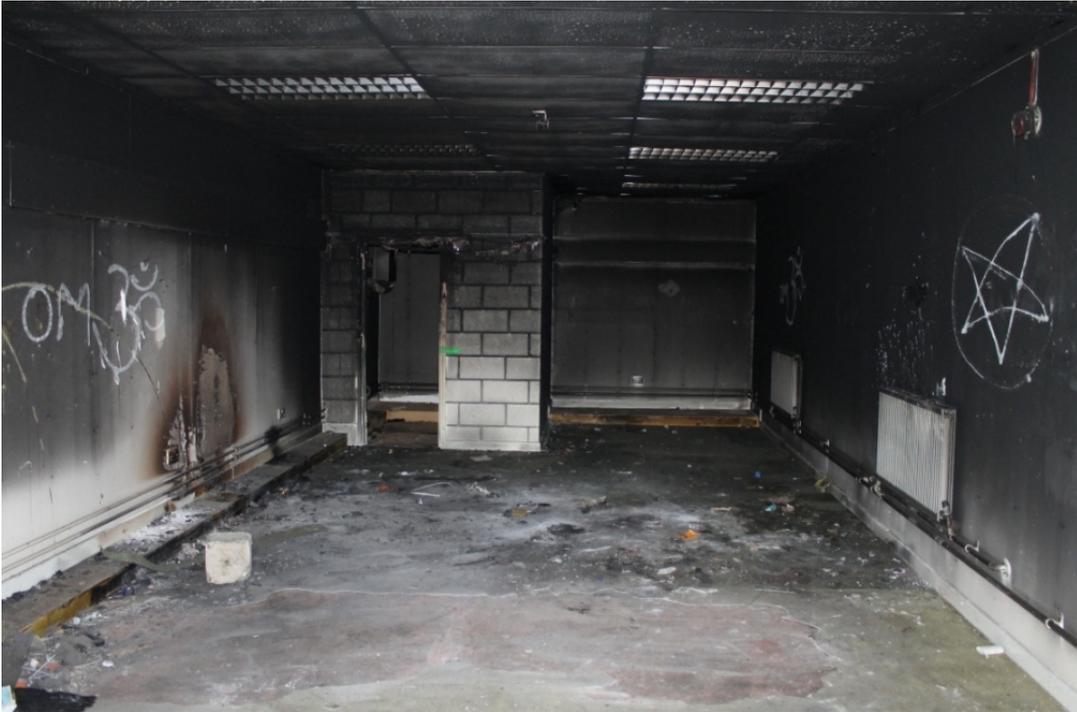
**Plate 29** Interior of FLG 12 Room 1, possibly used as a foyer for the cinema next door - view east

FLG 12 to the north has been substantially altered. An inserted wall has divided the original open space into two unequally-sized chambers (labelled 1 and 2 on Fig 20). Room 1 was gutted by fire in an arson attack after the complex was formally closed and the resulting damage has made it difficult to interpret what this room was used for (Plate 29). It was probably used as a foyer for the room next door. Room 2 is clad in sound proofing material (both walls and ceiling) and was used for a short time as a cinema (Plate 30).

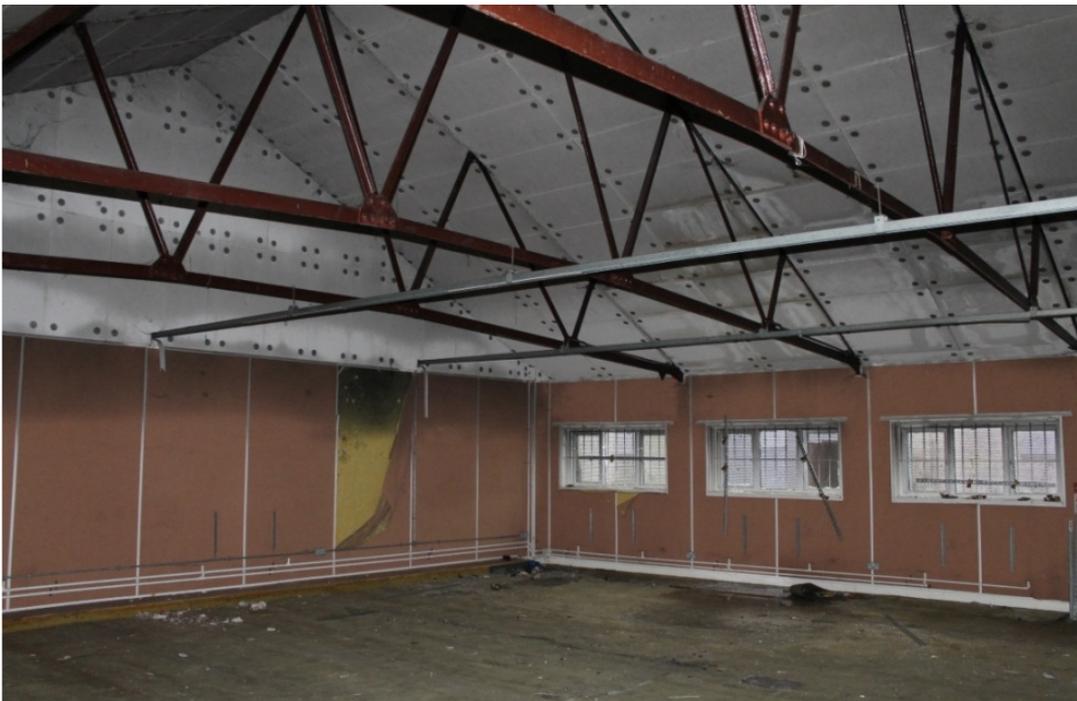
**Plate 30** Interior of FLG 12 Room 2, fitted out with sound-proofing for use as a cinema - view south-east

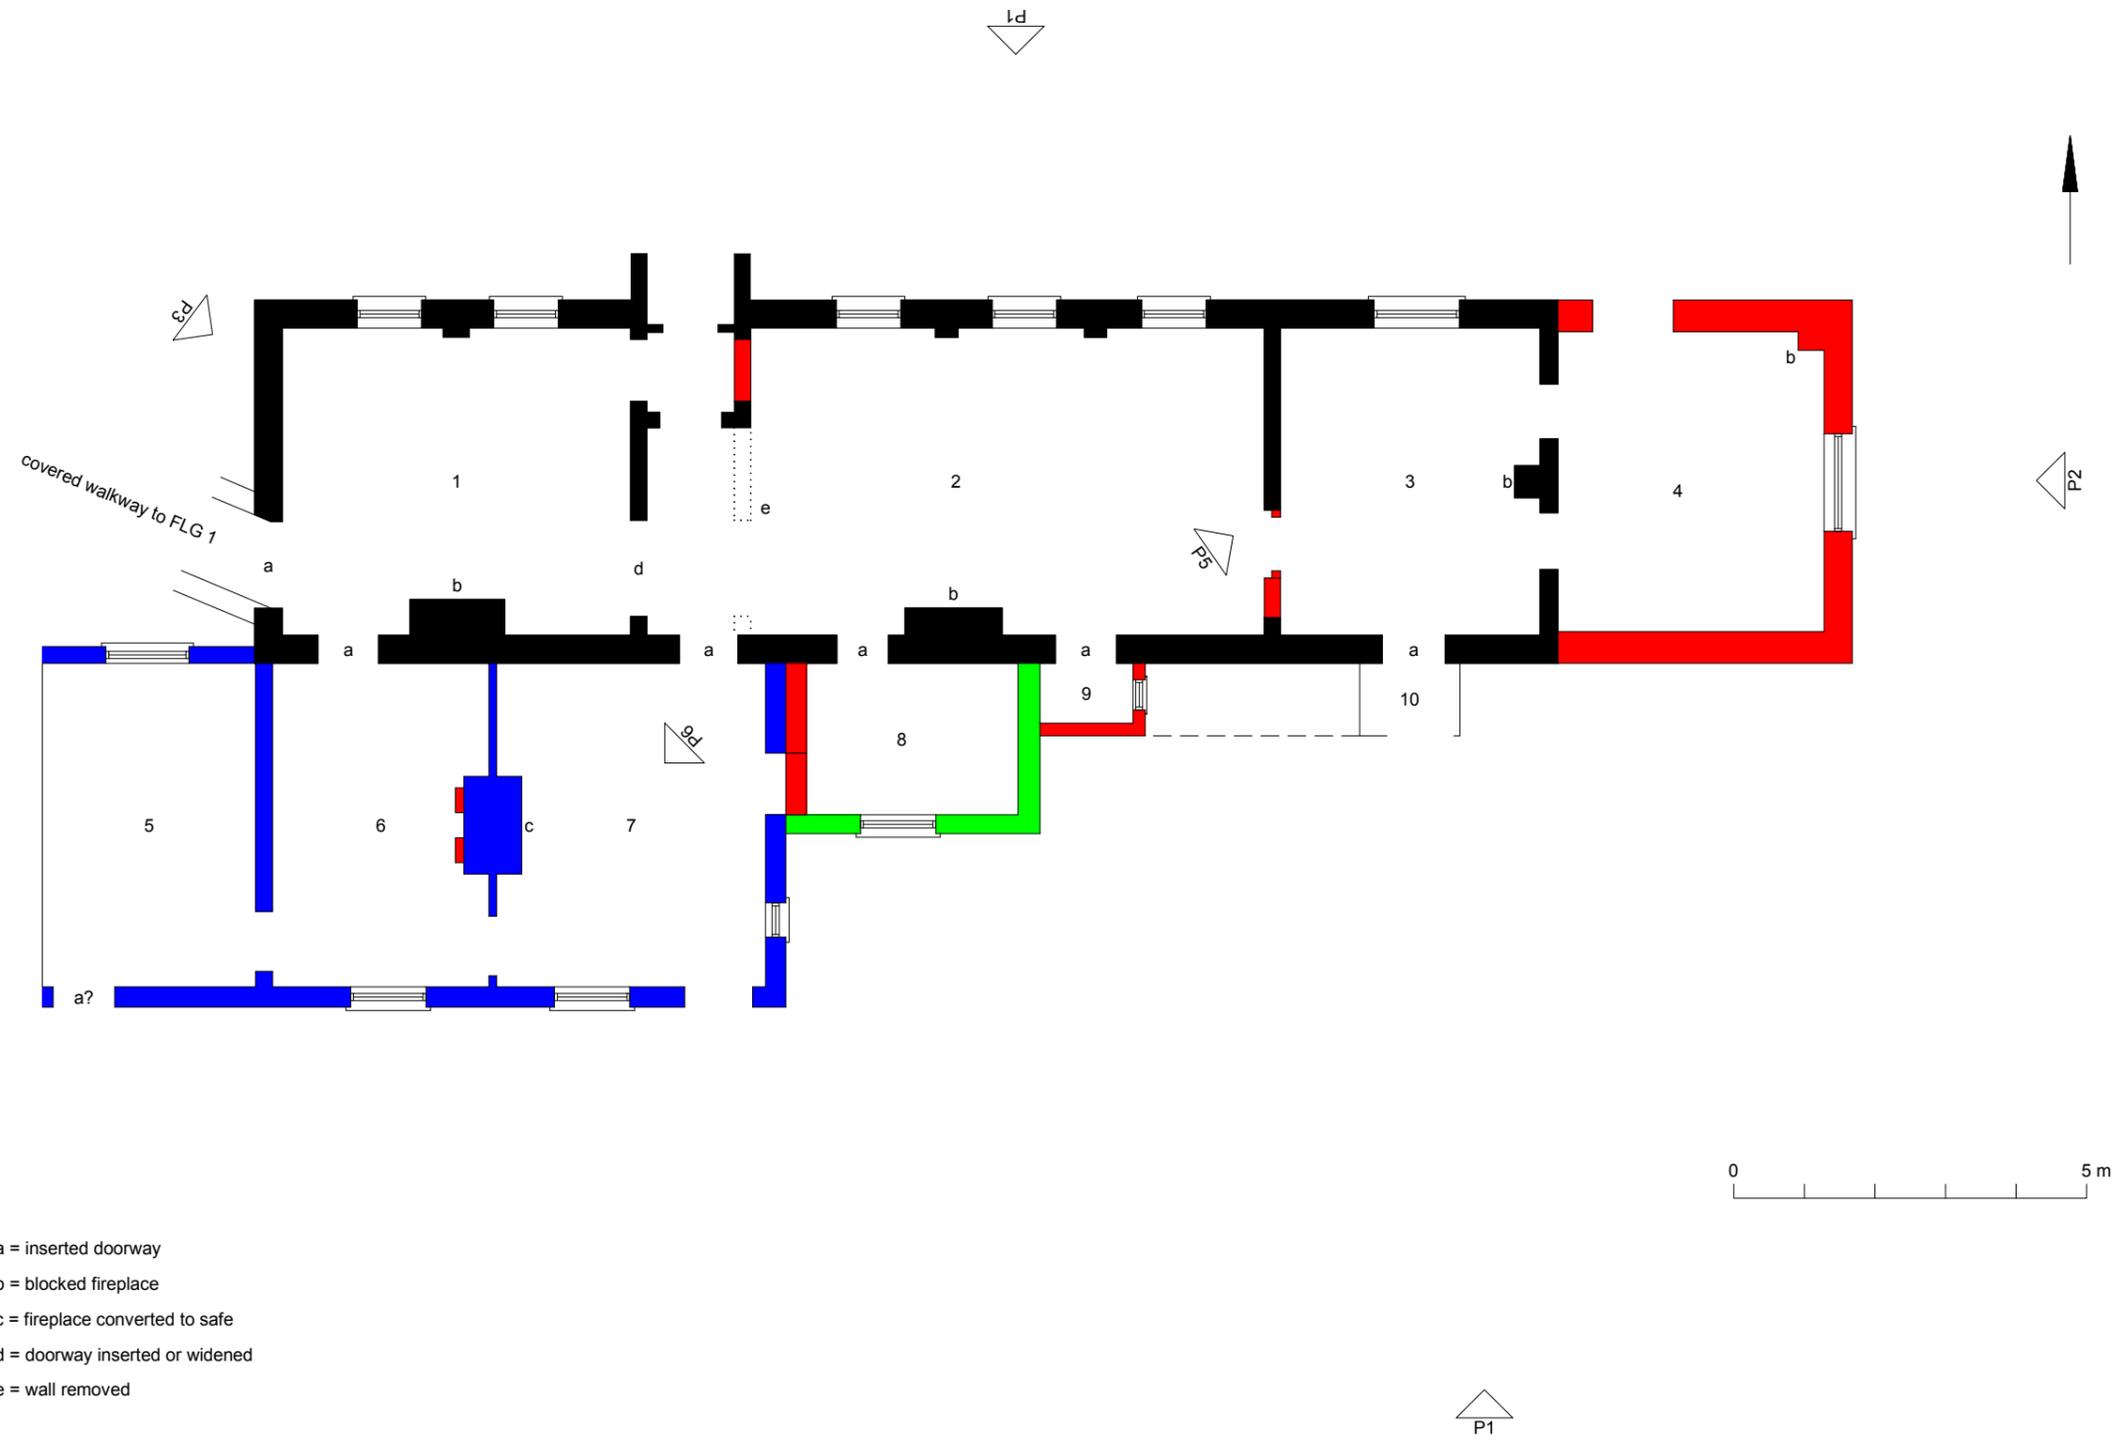
Fig 2 Ground floor plan of the Annexe, with the original fabric shown black and subsequent phases coloured. The location and orientation of photographs included in this report are indicated by the numbered arrows.

The ground floor interior of the Annexe is divided into four unequally-sized rooms (labelled 1-4 on Fig 2) accessed from a small lobby behind the main entrance. The lobby has a doorway in its west wall granting access to Room 1 at the west end of the range. Room 1 originally had a large fireplace in the south wall, which has subsequently been blocked, and doorways inserted through the west and south walls. A second doorway in the dividing wall, which has either been inserted or widened, opens onto Room 2. The area directly behind the lobby appears to have been where the original staircase was located; this has subsequently been removed, as has the east wall of the stairwell. It is unclear if there was a connecting passage beneath the stairs between Rooms 1 and 2. The east wall of the lobby has a blocked doorway in the surviving section of the dividing wall, which would have been the original entrance to Room 2.

The Phase 2 extension has three rooms (labelled 5, 6 and 7 on Fig 2). Room 5 at the west end of the structure is built up against FLG 1 and has a doorway in the south-west corner that may have been inserted to provide access to FLG 1. The dividing wall has a doorway granting access to Room 6 which has entrances to Room 7 to the east and to the main range to the north. Rooms 6 and 7 are built around a back-to-back chimney stack: in Room 6 the hearth has survived although there is a later brick surround; in Room 7 the fireplace has been converted to hold a double safe (Plate 6). In the east wall of Room 7 a doorway has been inserted, probably through an original window opening to provide access to the Room 8 (Phase 3). This doorway was subsequently blocked by the load-bearing wall that was required to support the later second storey (part of Phase 4). This necessitated cutting a new doorway through the rear of the main range. Room 9 is a small room accessed via an inserted doorway in the rear wall of Room 2. It serves no real purpose other than to support the upper landing of the external staircase 10. Room 9 and staircase 10 are part of the final phase of alterations carried out on the Annexe.

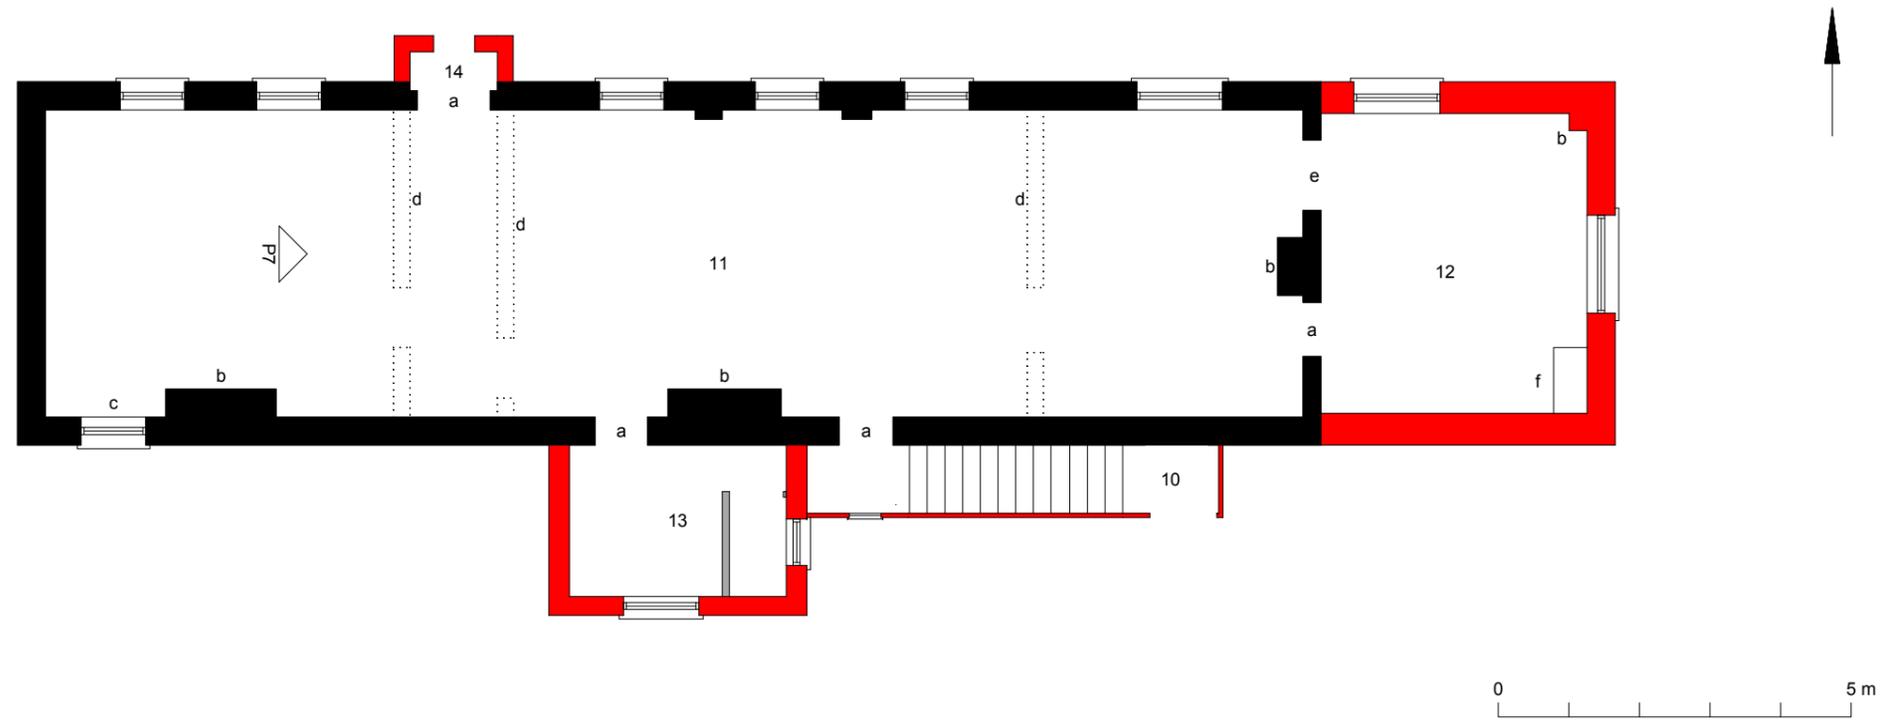
Fig 3 First floor plan of the Annex, with the original fabric shown black and subsequent phases coloured. The location and orientation of photographs included in this report are indicated by the numbered arrows.

The first floor is accessed via the external staircase at the rear of the building, although originally the staircase appears to have been in line with the entrance way. The removal of that staircase has resulted in the original first floor becoming one long space, with a smaller room to the east formed by the Phase 4 extension (labelled 11 and 12 on Fig 3, Plate 7). Scars on the floorboards in Room 11 indicate where walls have been removed suggesting there were originally three rooms on the first floor, one to the west of the staircase, two to the east. This theory is supported by the presence of three blocked chimney breasts, one for each original room.

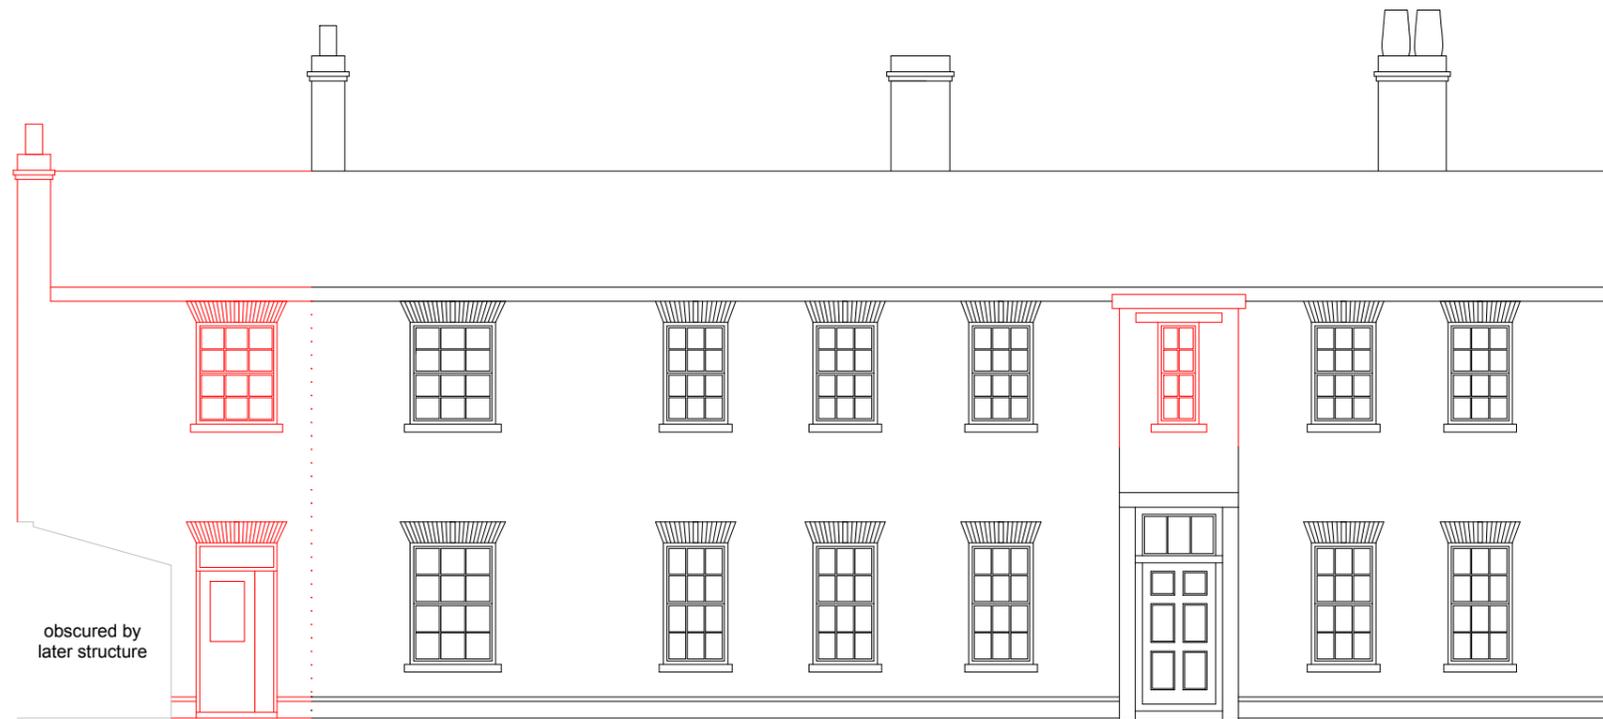
Fig 4 North elevation of the Annexe, with the original fabric shown black and subsequent phases coloured.

The north elevation originally comprised six sash windows of six-over-six lights to both floors, two to the west of a projecting entrance and four to the east (Fig 4). The entrance was originally a single-storey structure but has since been built up to the full height of the façade. A two-storey extension has been constructed at the east end of the range partly on top of what appears to be an earlier wall (Figs 5 and 6, Plate 2). Apart from the colour difference of the brickwork these additions have been executed in identical style to the original building and appear to have been the last major alterations made to the building (Phase 4). The east elevation is plain brickwork apart from where a doorway has been inserted to the ground floor, providing a covered walkway to FLG 1. There is a painted sign on the brickwork indicating that the C.O.O<sup>S.S</sup> office is downstairs and the Ordnance office is upstairs (Plate 3).

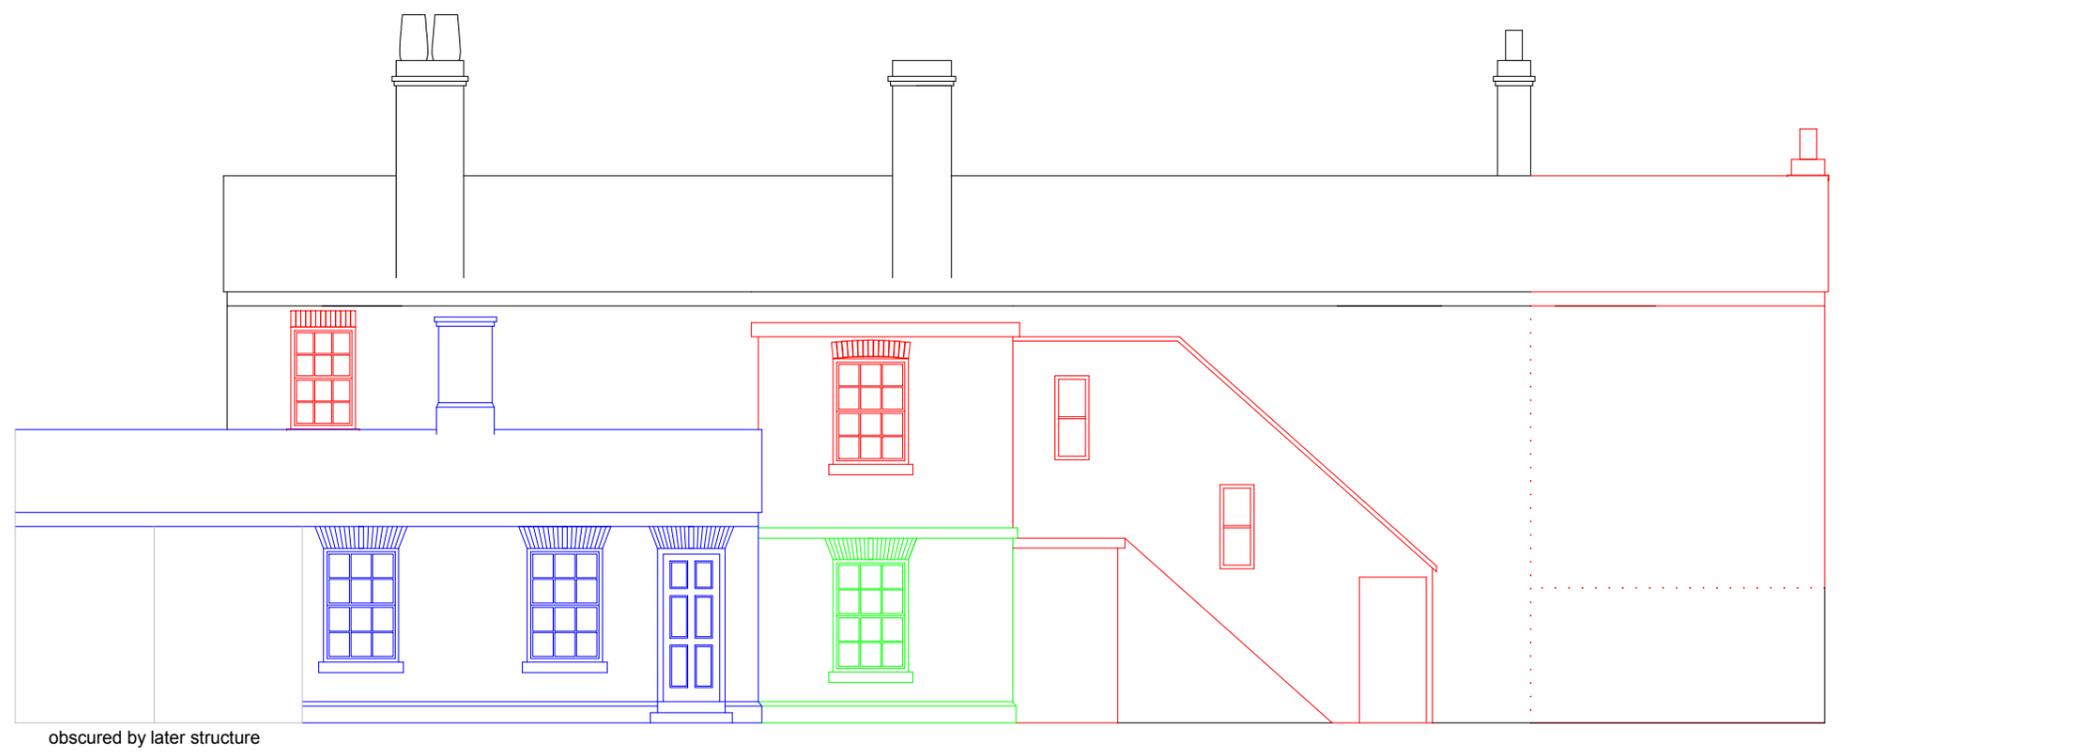
Fig 5 South elevation of the Annexe, with the original fabric shown black and subsequent phases coloured.

The south elevation has been much altered with the original façade virtually obscured by later extensions (Fig 5, Plate 4). A single window has been inserted to the first floor at the west end of the range but apart from this the rear elevation appears to have been unadorned brickwork. The oldest of the extensions is a single-storey structure at the west end (labelled Phase 2 on Fig 2) and is indicated on the 1921 edition of the Ordnance Survey. This second phase of building has a gabled slate roof and is constructed from yellow stock bricks with dimensions of 230 x 113 x 67mm laid in Flemish bond. Its south elevation has a doorway at the east corner and two six-over-six sash windows. Part of the south elevation is obscured by a later timber-constructed covered walkway to FLG 4. This covers a doorway that may be original but appears to have been inserted. There is a narrow sash window of two-over-two lights in the west elevation (Fig 6). To the east of the Phase 2 extension there is a small single-storey brick-built structure with a flat roof that has subsequently been built on creating a second storey, also with a flat roof. This third phase of building has a single six-over-six sash window in its south elevation and is constructed

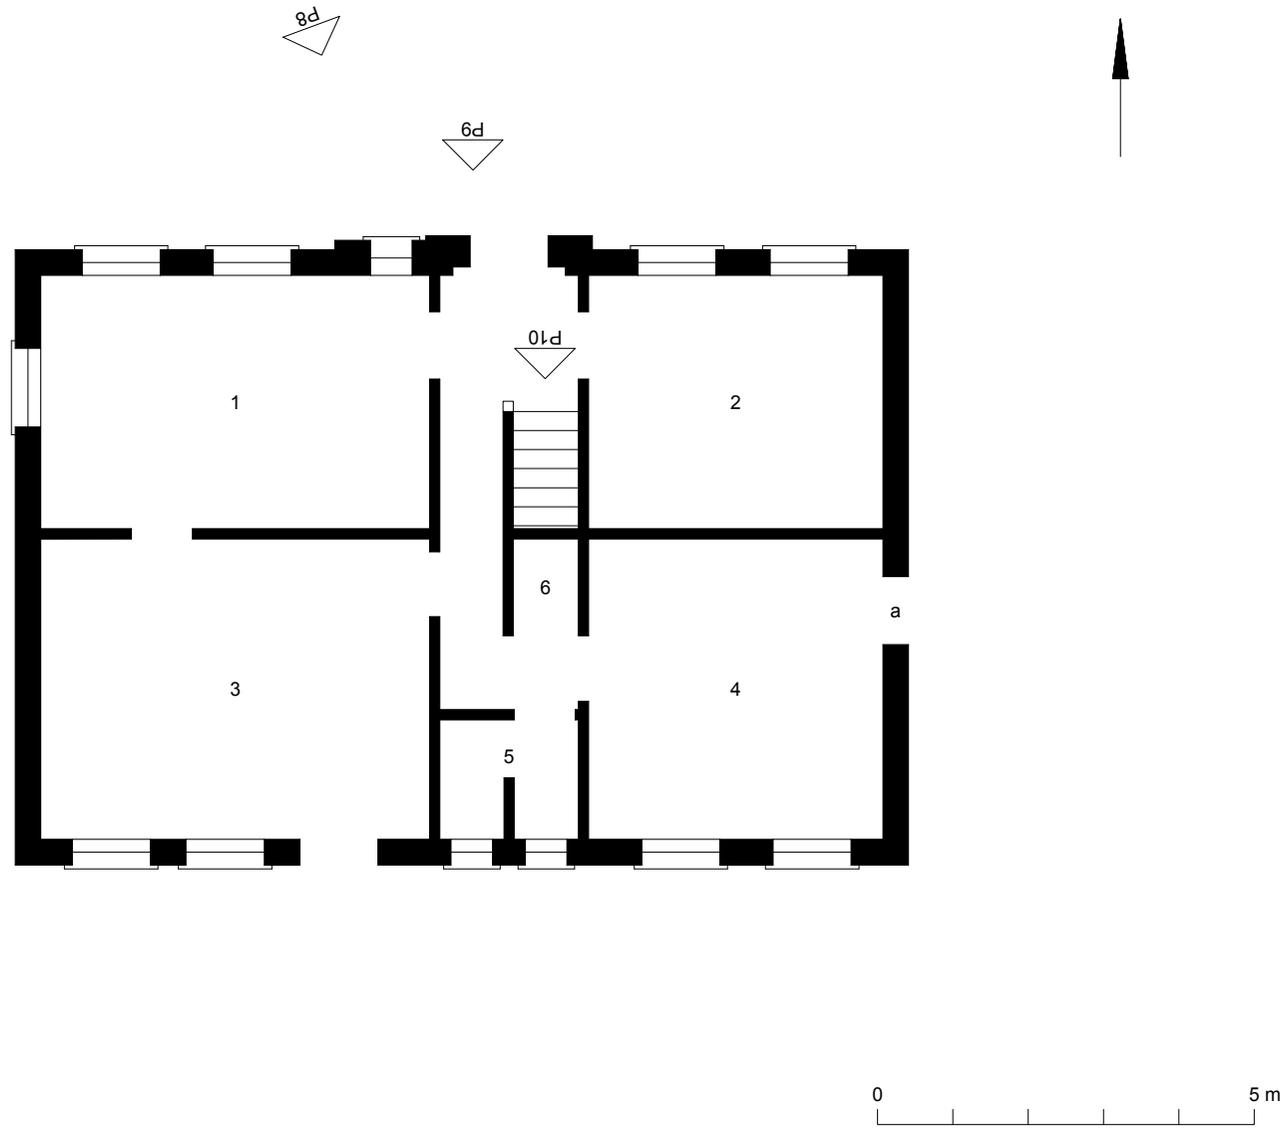
Fig 7 Ground floor plan of FLG 2, with the original fabric shown black.  
 The location and orientation of photographs included in this report are indicated by the numbered arrows.

The ground floor of FLG 2 is divided into four rooms (labelled 1-4 on Fig 7) two either side of an off-centre corridor and staircase, with Rooms 1 and 3 on the west side slightly larger than Rooms 2 and 4 on the east side. Room 1 has a connecting doorway with Room 3 which has a doorway onto the corridor and also an external doorway in the south wall. Room 2 can only be accessed from the lobby and originally Room 4 could only be accessed by a doorway at the end of the corridor although a doorway has subsequently been inserted to the east wall. At the end of the corridor Room 5 comprises a toilet and a wash basin, which appear original to the building. An under stairs cupboard (labelled 6 on Fig 7) was probably used for storage.

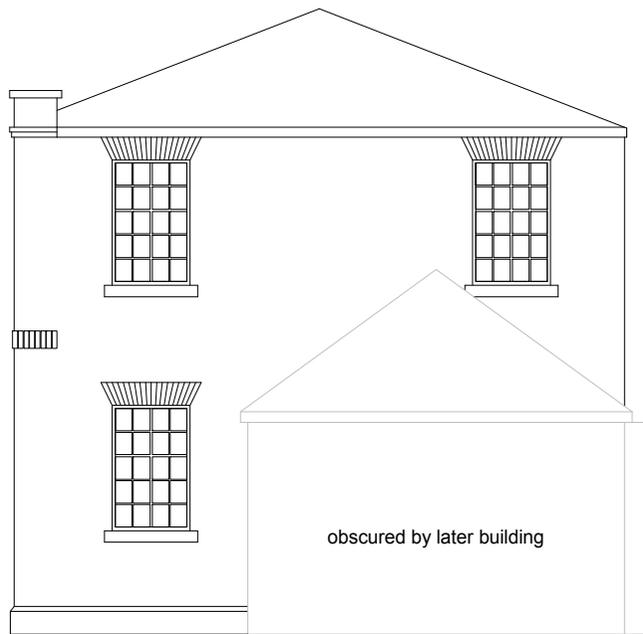
Fig 11 West elevation of FLG 2.

The east elevation is obscured by a single-storey brick warehouse/workshop and the west elevation is partially obscured by a single-storey brick outbuilding (Fig 11). The visible part of the west elevation has two of the metal-framed windows on the first floor and one on the ground floor. It is feasible that there is a second window on the ground floor hidden by the outbuilding but no trace of this was found during the internal survey.

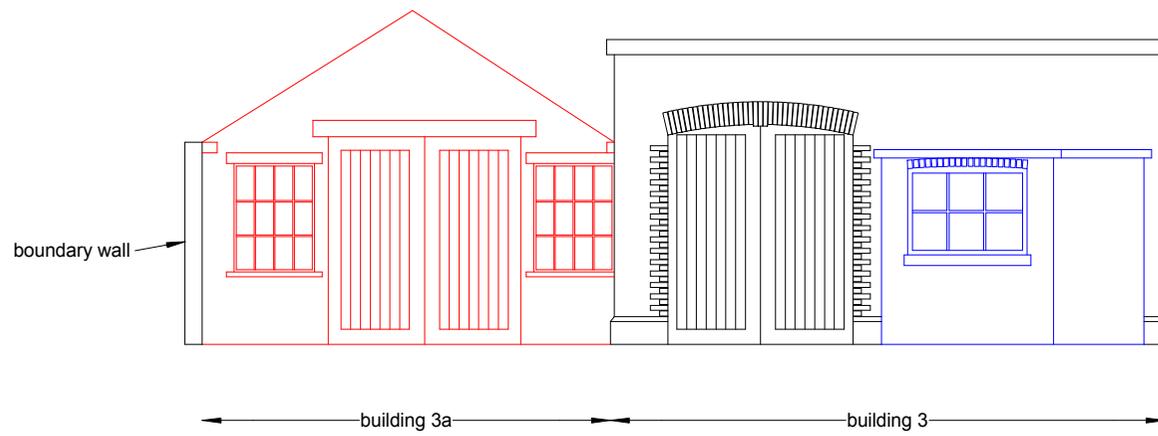
Fig 14 East elevation of building 3 and 3a.

The short elevations to the east and west each have a large pair of timber sliding doors, the openings for which have jambs constructed from blue brick with rounded edges (Figs 14 and 15, Plate 13). This is the sort of architectural detail observed elsewhere on the buildings of Colchester Garrison usually employed where horses were using the openings. The west elevation has a small brick-built extension next to the sliding doors, visible on the 1922 edition Ordnance Survey (Fig 14).

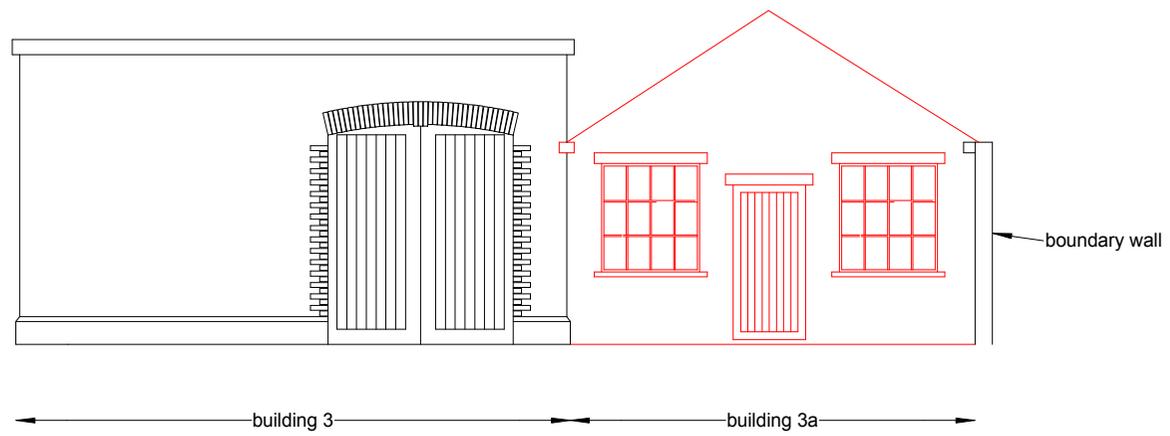
Fig 15 West elevation of building 3 and 3a.

Building 3a has been created by roofing over the space between the south wall of Building 3 and a boundary wall and FLG 17 to the south (Fig 12, Plate 11). The building is shown on the 1921 Ordnance Survey, so it must have been constructed only a short time after Building 3 was completed, probably for use as a store room. Gabled walls of pale yellow brick with dimensions of 230 x 110 x 67mm laid in Flemish bond have been inserted at the west and east ends and it has a roof of corrugated metal sheeting, although this is likely a modern replacement for slate. The east elevation has a centrally-positioned double doorway flanked by two metal-framed windows (Fig 14), whilst the west elevation has a single doorway flanked by two metal-framed windows (Fig 15).

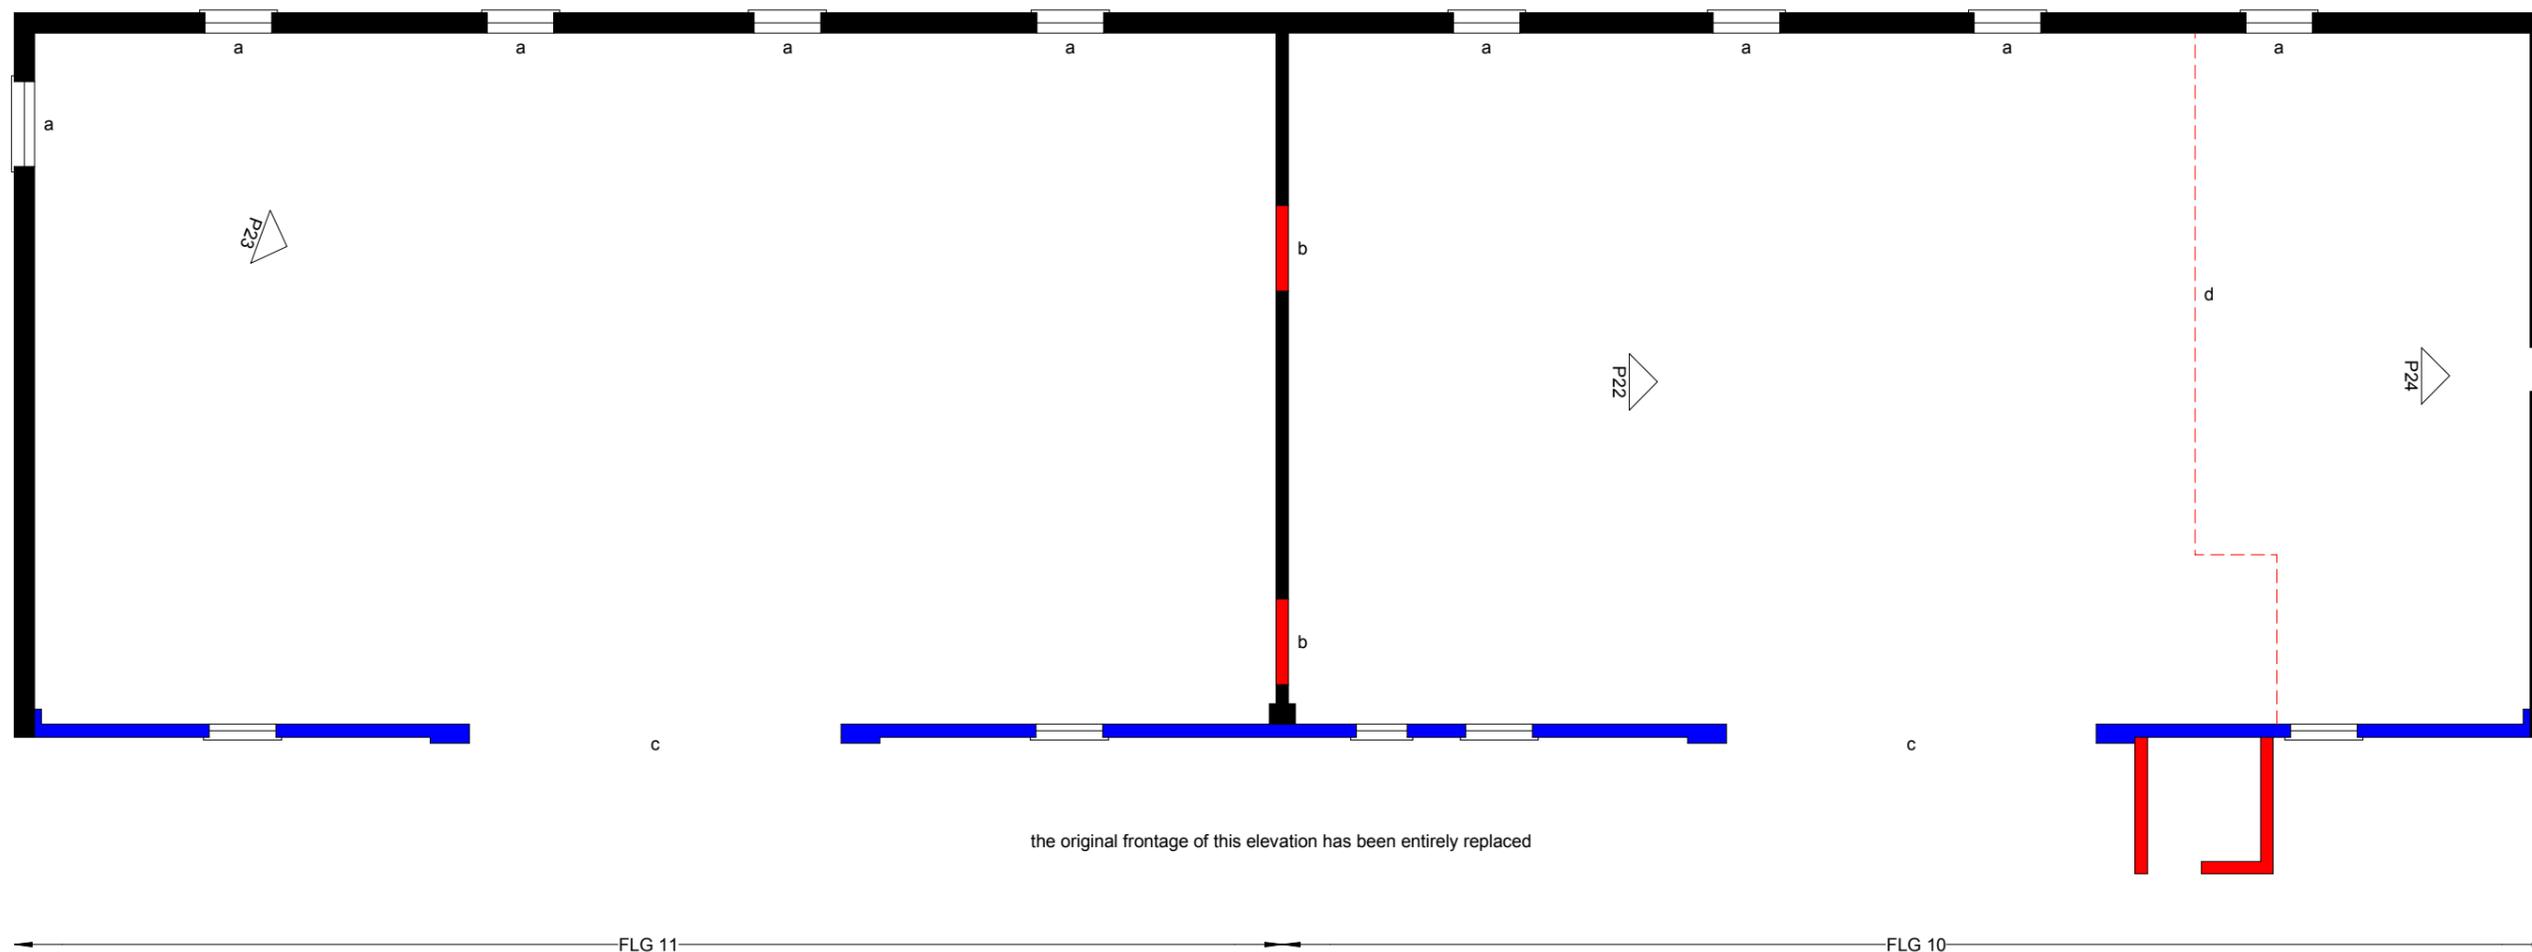
the original frontage of this elevation has been entirely replaced

Fig 16 Plan of FLG 10 and 11, with the original fabric shown black and subsequent phases coloured.  
The location and orientation of photographs included in this report are indicated by the numbered arrows.

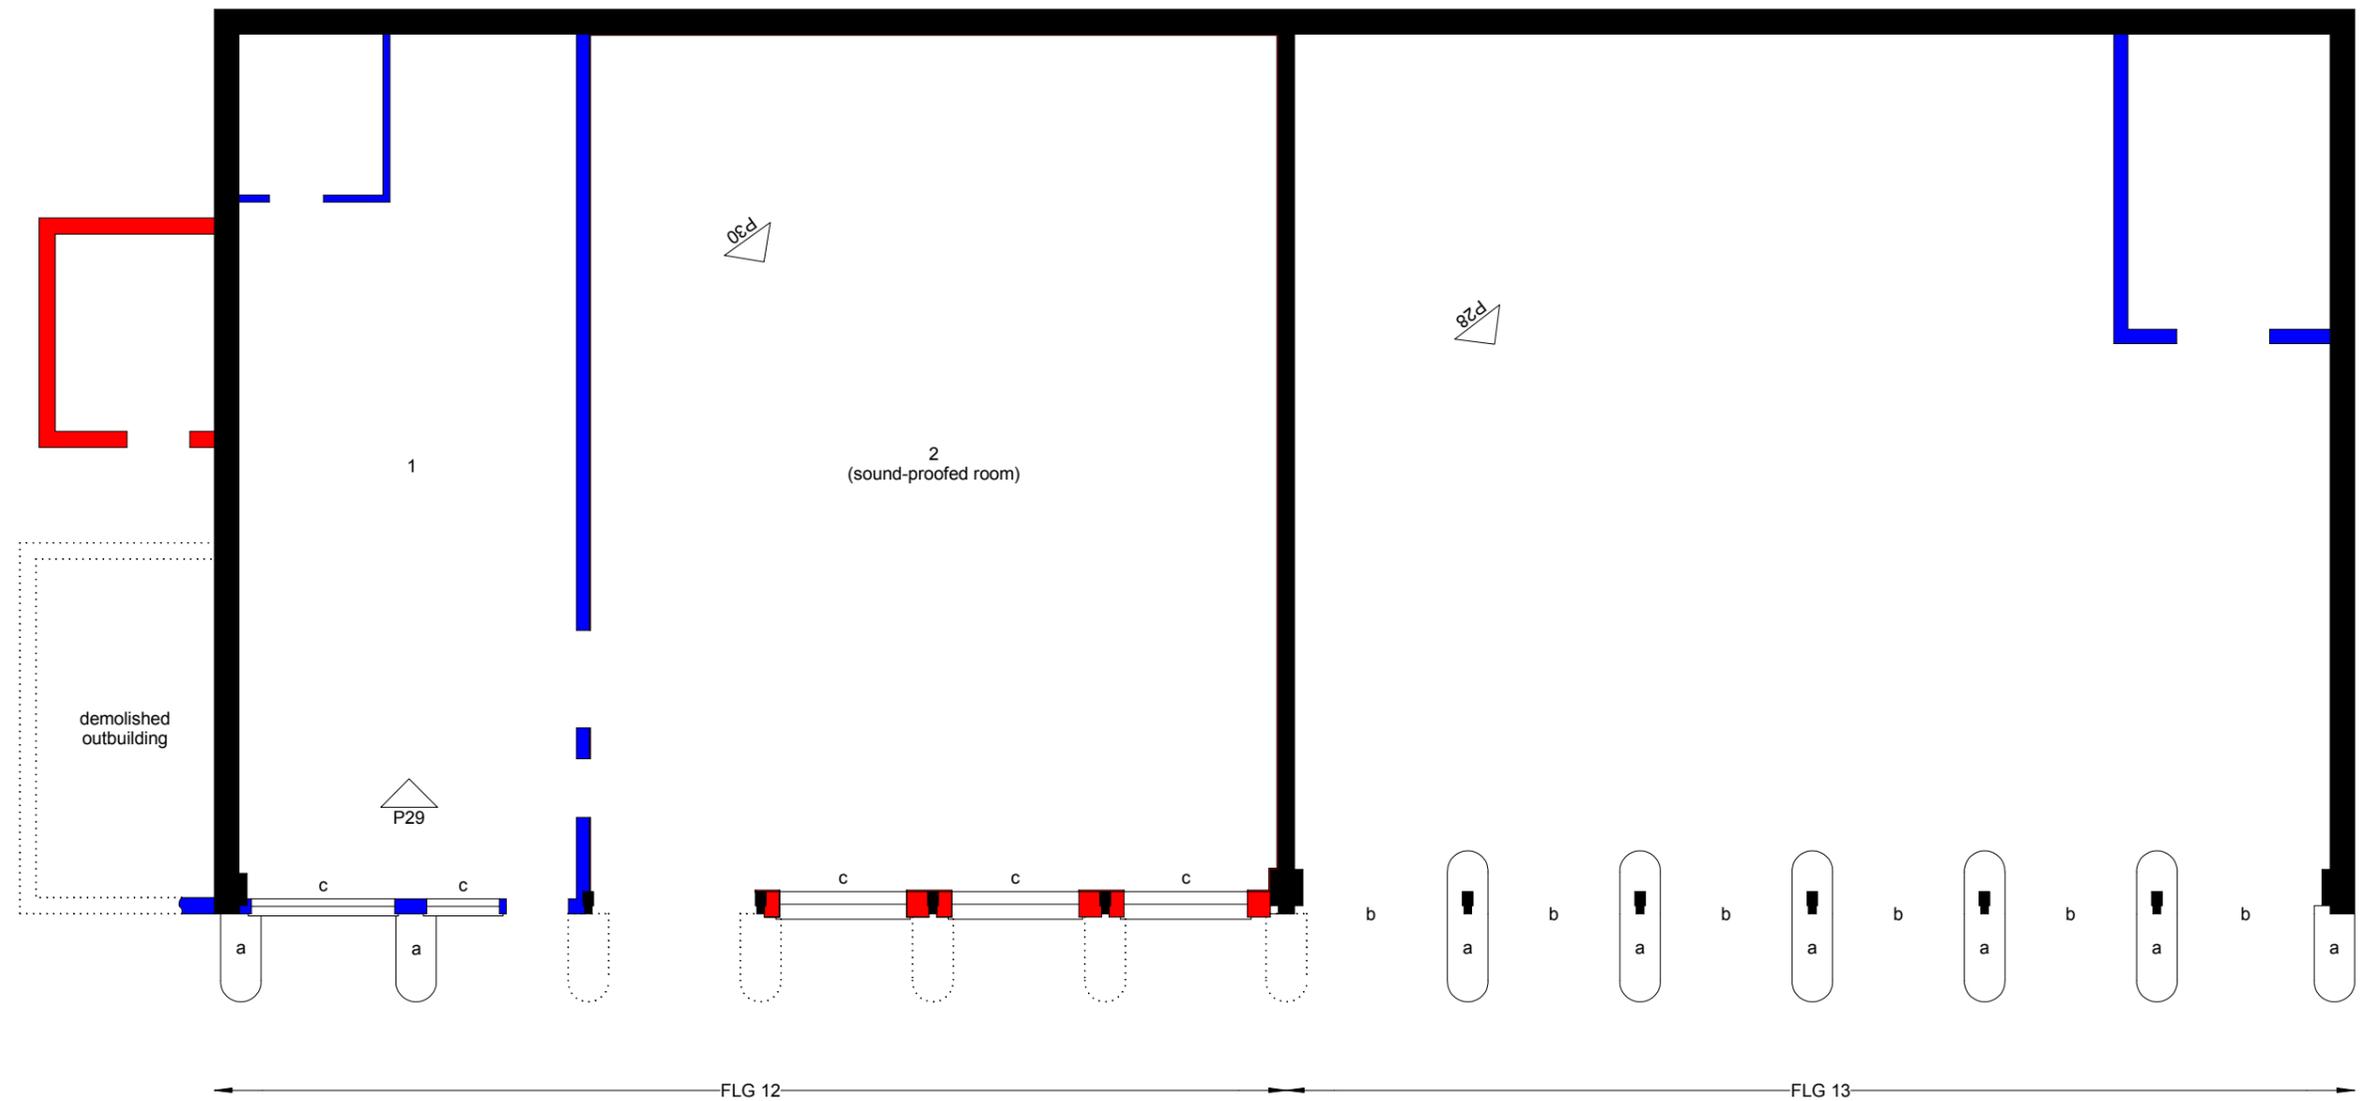
- Phase 1
  - Phase 2
  - Phase 3
- a = iron-bound concrete fender
  - b = original wagon doors
  - c = original wagon door openings replaced by brick infill

Fig 20 Plan of FLG 12 and 13, with the original fabric shown black and subsequent phases coloured.  
 The location and orientation of photographs included in this report are indicated by the numbered arrows.
