# Archaeological building assessment and monitoring at land to the rear of 11 Market Place, Great Dunmow, Essex

April 2015

CAT project ref: 15/03q  
NGR: TL 62661 22070  
HEA code: GD39

**CAT Report 844**  
June 2015

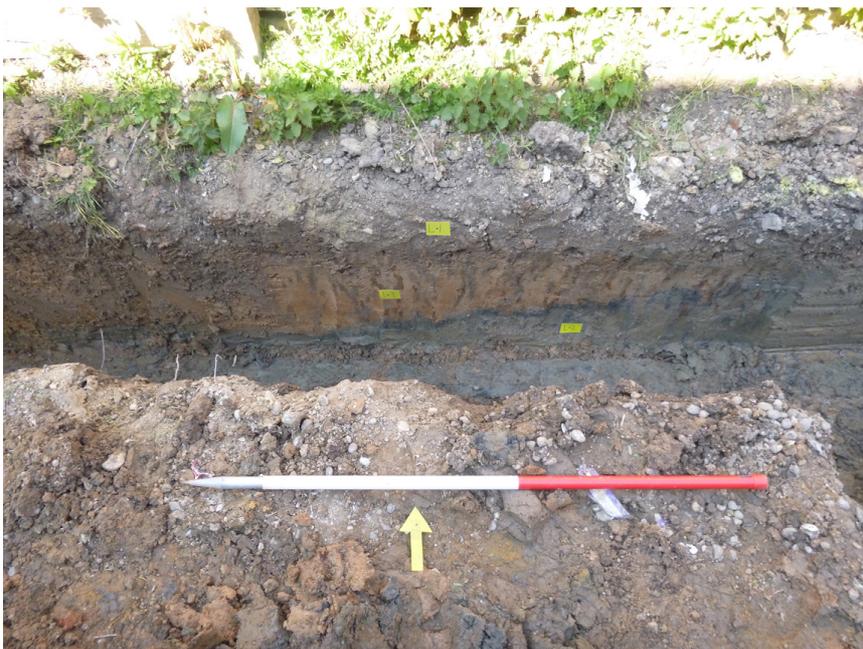
**Plate I** Representative section of foundation trench. Shows redeposited natural L3 sealing contaminated L2. Shot taken facing north.

These layers all suggest that the site has been heavily landscaped. The difference in ground level between this site and the adjacent plot is 1.9m, so at least one terracing event has occurred in the recent past.

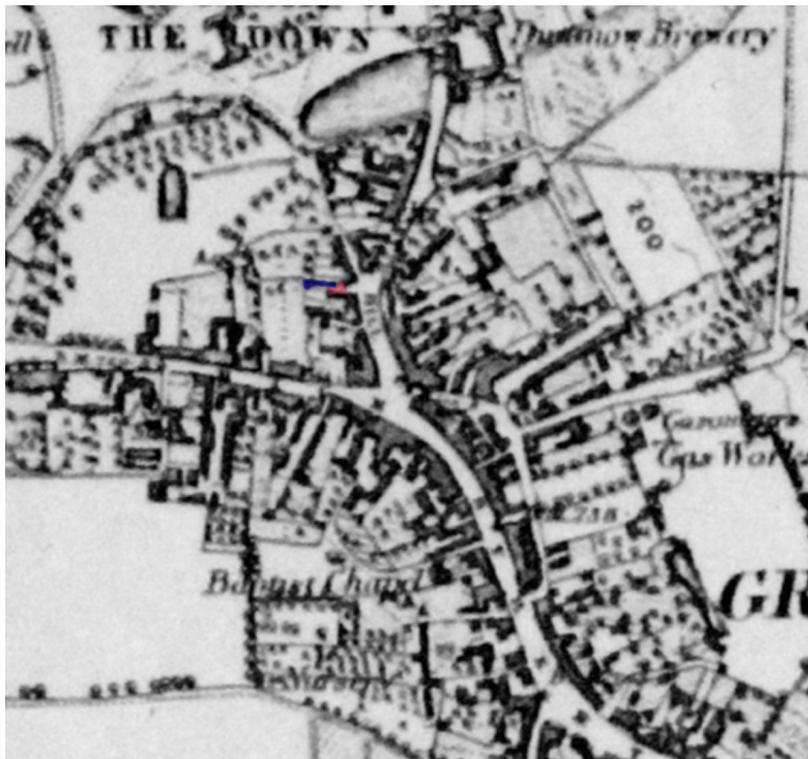
**Plate II** 1st edition OS map (1875). Site shown in red, building shown in blue.

The first edition OS map (1875 – Plate II) shows a building occupying this site. However, later cartographic evidence seems to suggest that this was not the building demolished prior to this investigation.

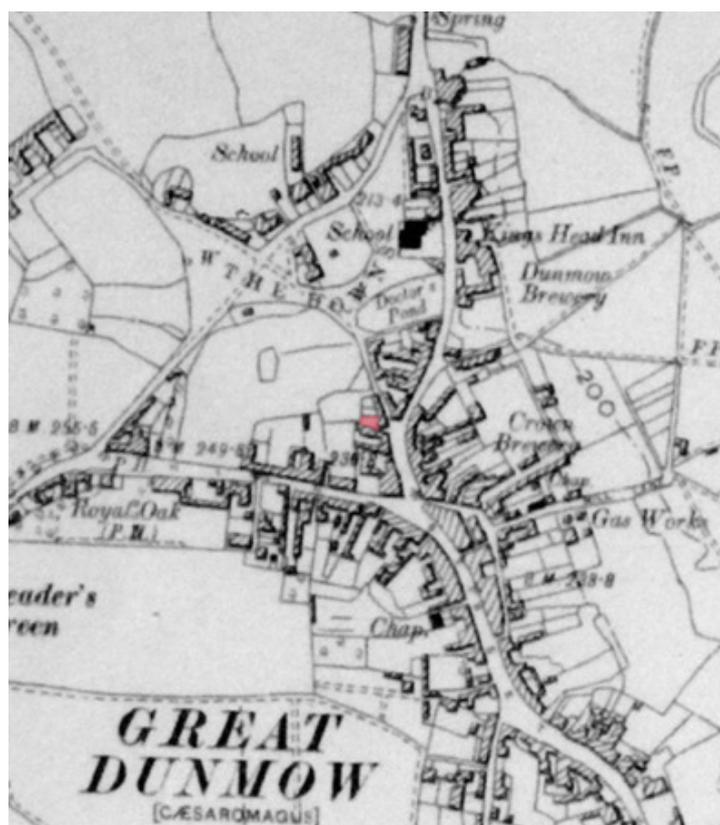
**Plate III** 2nd edition OS map (1898). Site shown in red, no building present. Change in plot boundaries visible.

The second edition OS map (1898 – Plate III) shows no building present on the site and a restructuring of plot boundaries. It would appear that between the 1st and 2nd edition OS maps the historic barn noted in the brief (Havis, R, 2015) had been demolished.

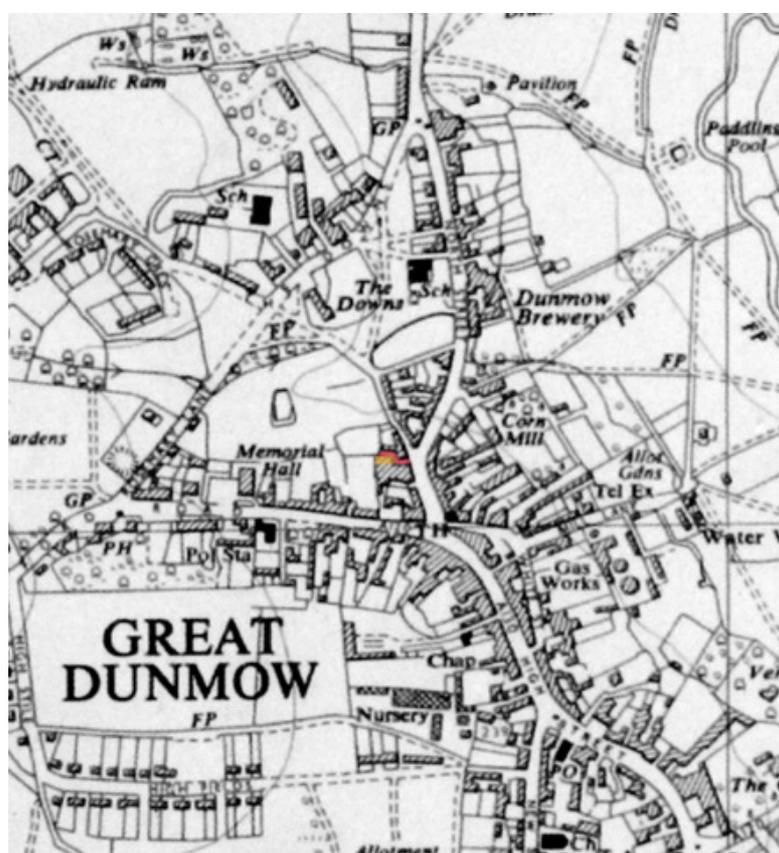
**Plate IV** 1955 OS map. Site shown in red, new building shown in yellow.

A building does not appear again on the site until the 1955 OS map (Plate IV) – it is likely this is the (much more recent) building that was the subject of demolition prior to the investigation. This is corroborated both by the stratigraphy encountered during the monitoring and by a conversation with the client (suggesting the demolished building had been constructed within the lifetime of the previous landowner).
