# **Archaeological monitoring, test pits and building recording at Hedingham Castle, Castle Hedingham, Essex**

**June 2014 - December 2015**

**CAT Report 849**  
December 2015

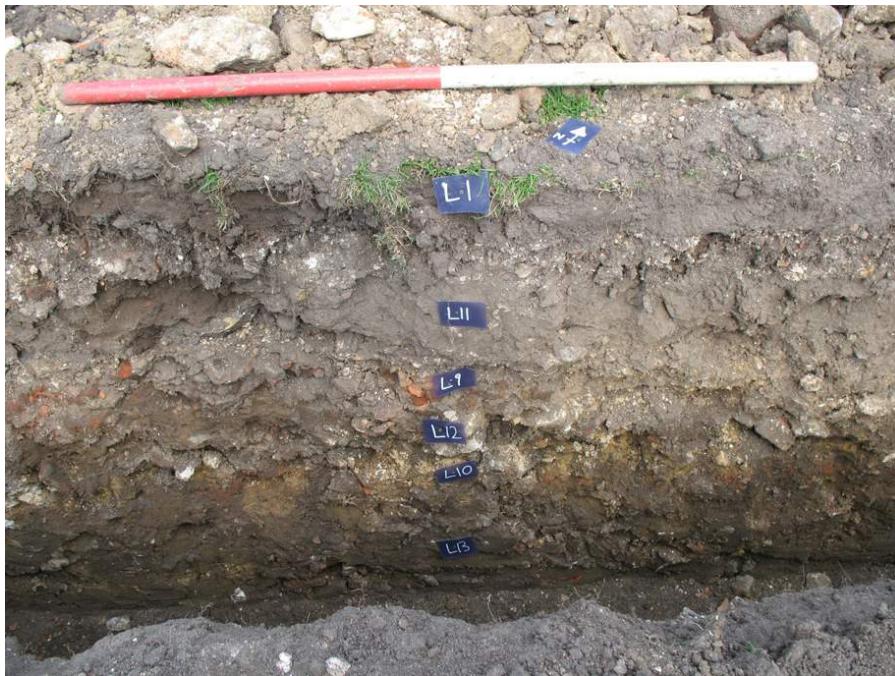
**Plate I** Build-up of post-medieval layers on top of the motte in T1. View facing north-west.

Between L5 and L7 lies a successive build-up of Tudor and later post-medieval layers (Plate I). The earliest of which is L13, which abuts both the rampart (L5) to the east and L7 to the west, before itself being covered by the later post-medieval layer sequence of L10, L12 and L9. Covering these post-medieval layers is the modern placed topsoil of L11, which itself is covered (as is the whole motte) by modern turf (L1).

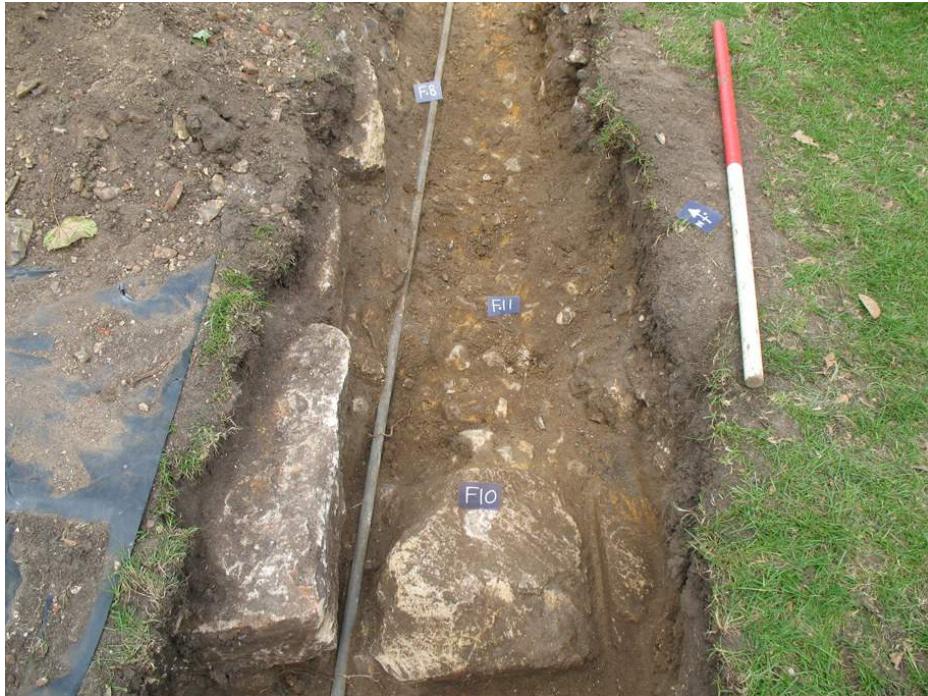
**Plate II** F10 and F11 in T2. View facing north-east. Modern steel waterpipe (F8), running through the foundation.

The most prominent remains of a Norman building in the service trenches are the facing stones and foundation (F10 and F11, respectively) found in T2 on top of the motte (Plate II). These match the location of the 'rubble foundations' associated with the gatehouse uncovered in the 1868 excavation (Fig 2), as well as the broad location of the gatehouse from the 1592 survey (Plate XVI). Assuming that the facing stones are the western limit of the structure, and extrapolating from the 1868 excavations, it would have extended c13m from the location of the current bridge and would have had a width of at least c8m. If this is the gatehouse, and it seems likely from the substantial size of the foundations, it suggests that the primary entrance to the motte has always been in the location it is today, ie. the Tudor bridge is a direct replacement for an earlier Norman bridge (or drawbridge).

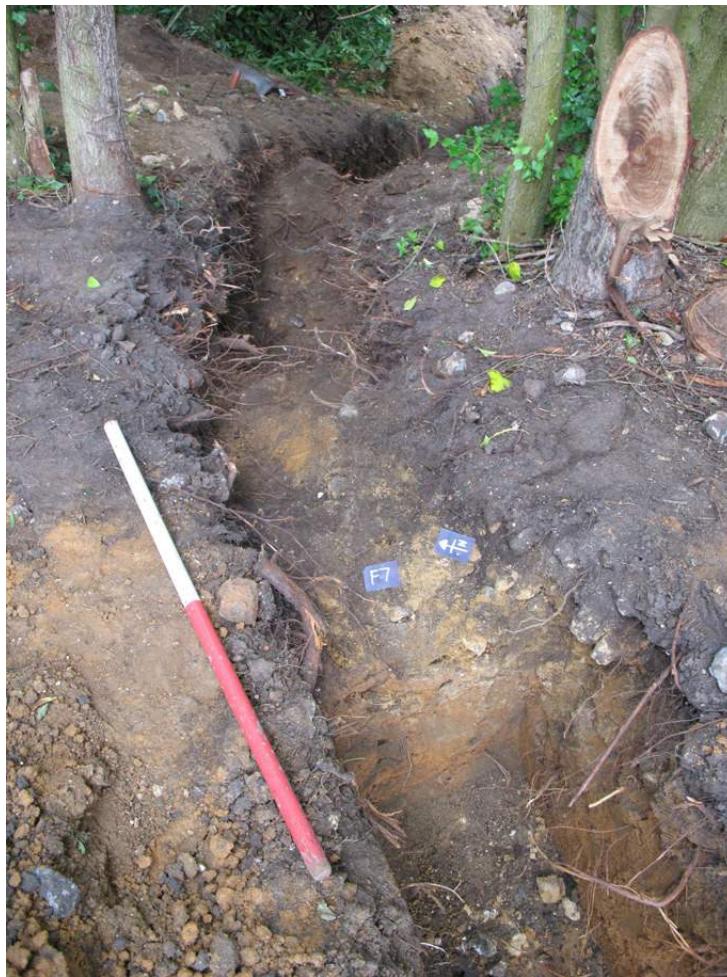
**Plate III** F7 in T1. View facing north-east.

At the very edge of the motte is a solid lime mortar and flint foundation (F7) that is visible for 4m in T1 before ending as the trench makes its way down the slope (Plate III). This foundation is likely to be the remains of the curtain wall encircling the top of the motte – the remains of which were found on the other side of the motte during the excavations of 1868 (Fig 2). Although a stone wall surrounding the motte is not a common adaptation to motte-and-bailey castles, neither is it unheard of, as the castles at Sandal, Beckhamstead and Windsor all attest (Brown, 2004). With the width of this foundation being so great, it is possible that T1 may have coincided with the location of a buttress, in which case the actual width of wall would have been narrower elsewhere.

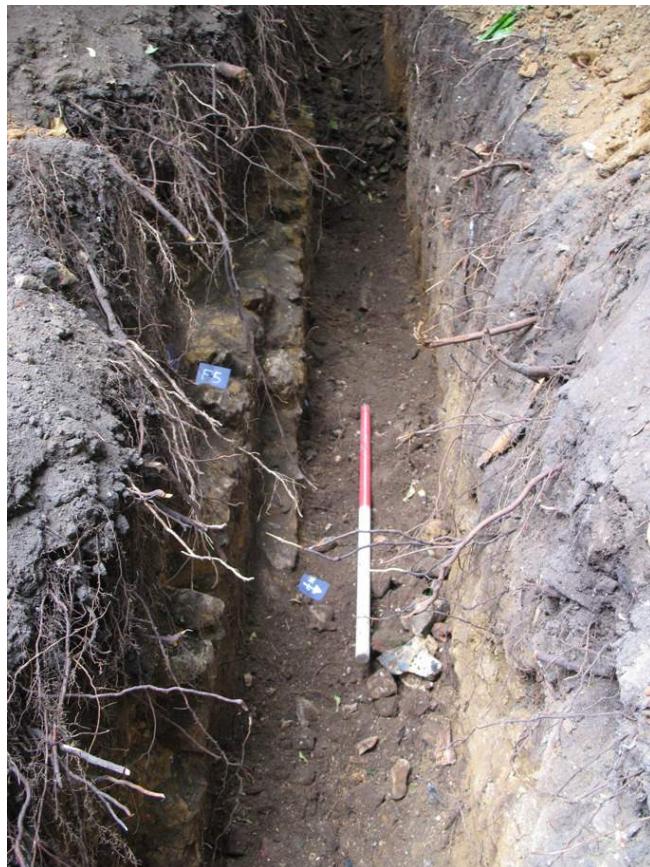
**Plate IV F5 in T1. View facing south-west.**

Going further down the sides of the motte, T1 exposed the substantial foundations of F5 (Plate IV). This differed from the other Norman foundations encountered. Instead of irregular nodules of flint mixed with lime mortar, F5 consisted of large worked rectangular blocks of flint placed atop of one another and bound with lime mortar. Although the flint blocks were not faced in any fashion, F5 could be described as less of a foundation and more of a buried wall. It runs up the side of the motte before vanishing into the side of T1 as the trench turns (Fig 4). An exploratory slot was dug to ascertain the width of the wall. The other side was not encountered, but it has a width of at least 1.3m. Given its location, this wall presumably connected the curtain wall of the motte with a curtain wall around the inner bailey (Fig 9).

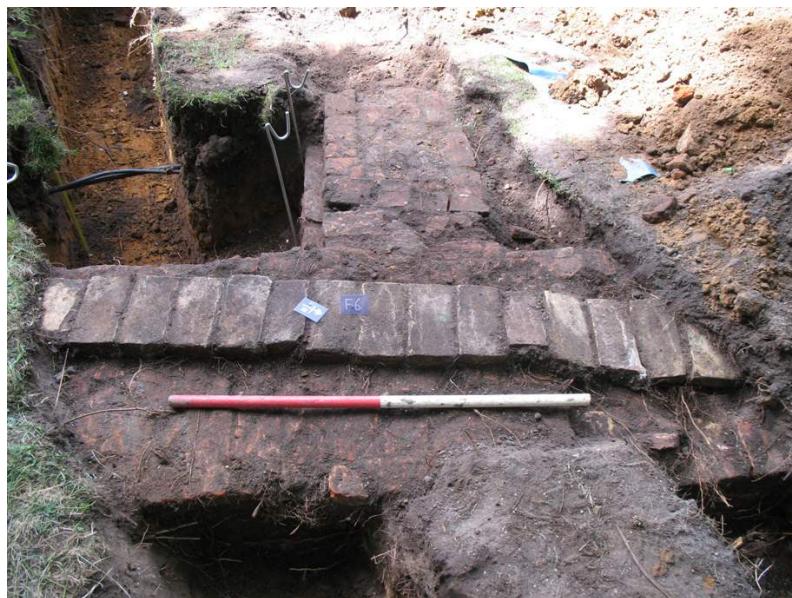
**Plate V** F6 in T1. View facing south-west. Note the course of lighter pavior bricks.

Of the Tudor foundations observed, by far the most substantial is F6, uncovered on top of the motte (Plate V). This foundation is aligned north-west to south-east across T1, with a smaller section aligned south-west to north-east, both at 6 courses deep. Like the foundations uncovered in 1868 (Fig 2), this is likely part of a Tudor building erected in the motte before being subsequently demolished in the late post-medieval to early modern period. Alternatively, there is some possibility of this being the remains of a Tudor wall surrounding the top of the motte, intended to replace the Norman curtain wall. But as no 'Tudor curtain wall' was uncovered in the 1868 excavation this seems less likely.

One curious thing to note is the course of yellow pavior bricks present across the top of the foundation F6 (Fig 4). These are of a later date (c 18th century), and likely re-used from another structure. Why they've been placed onto this Tudor foundation is open to debate, but the most likely scenario seems to have been the marking out of known foundations by an earlier owner of the castle – they certainly don't appear to have ever had a structural purpose.

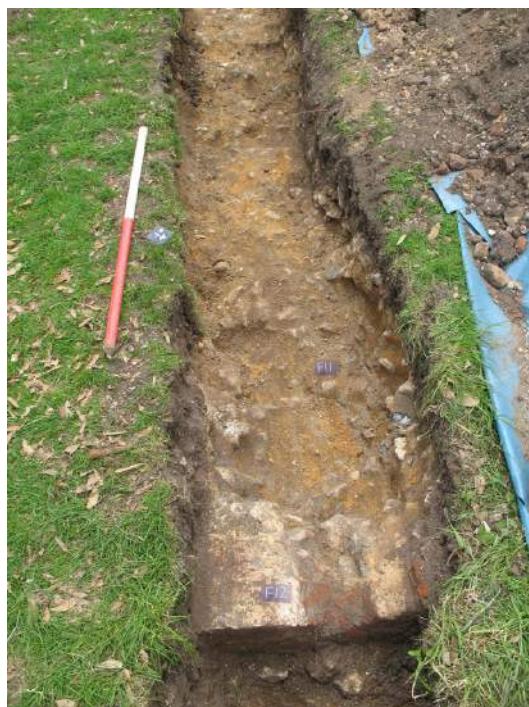
**Plate VI** F11 and F12 set into it in foreground in T2. View facing south-west.

One much smaller example of Tudor foundations is F12, observed in T2 (Plate VI). It consists of a segment of brick wall set into the Norman foundation of the gatehouse (F10). While not architecturally impressive, this does show very clearly the re-use of Norman materials, and even foundations, in later periods of the castle's development. As for the foundation itself, given its location, it could be the remains of a Tudor gatehouse – although on the 1592 survey the gatehouse is clearly labelled as stone, not brick (Plate XVI). It seems more likely that it is merely a repair to the existing structure, instead of a complete replacement.

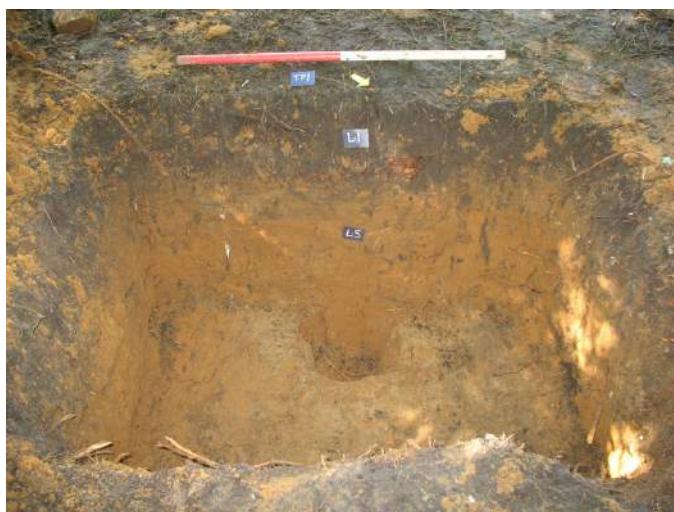
**Plate VII** Test Pit 1. View facing south-west.

TP1 was located at the top of the motte on the north-eastern side, and was intended to identify traces of a curtain wall or outbuilding prior to the digging of T1. It was 800mm deep and its stratigraphy consisted of 300mm of topsoil (L1) before encountering rampart bank material (L5). No features were observed or finds recovered.

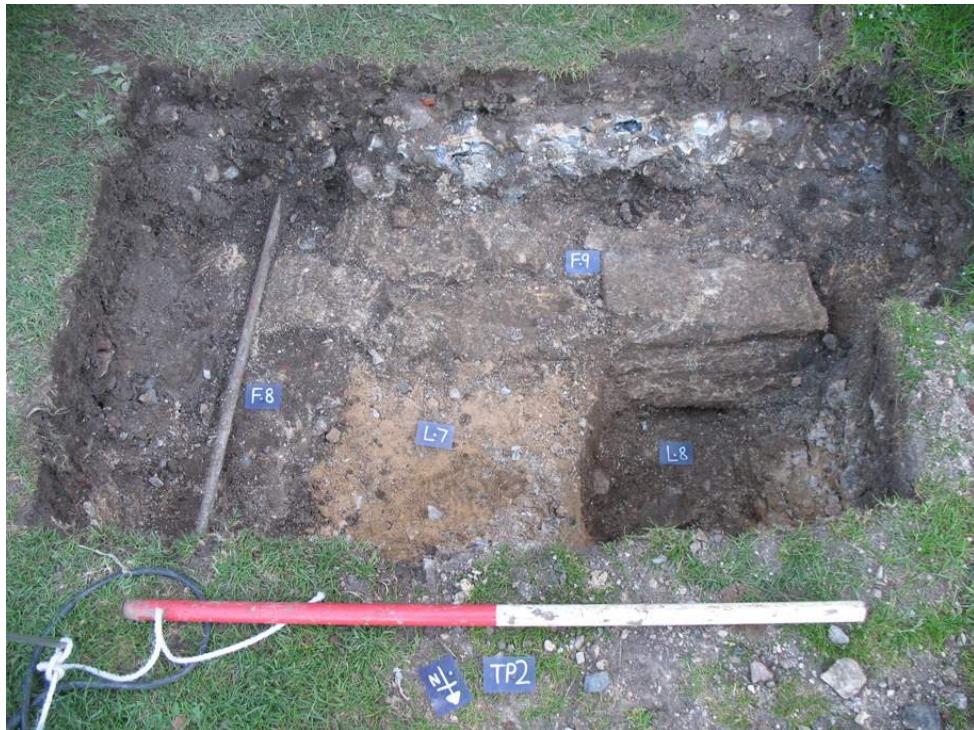
**Plate VIII** Test Pit 2. View facing south-west.

It encountered the battered sides of the keep (F9) continuing downwards, cut by a modern steel waterpipe coming out of the basement door (F8). Also encountered were L7 and L8, two mortar rich layers that abut the side of the keep. The date of these layers is unclear. They cover the keep walls

F9, which would have originally been visible (judging by the worked stone) so they are unlikely to be associated with the keeps construction. However, no finds were recovered from either, and the mortar in both (and nodules of flint in L7) are all Norman building materials. These layers could be Tudor or later post-medieval dumps of Norman building material, possibly from the demolition of the fore-building (see below). Alternatively, they could be earlier depositions of material in order to support the keep (the could even be late Norman in date). Without dating evidence it is difficult to be certain. L7 seals L8.

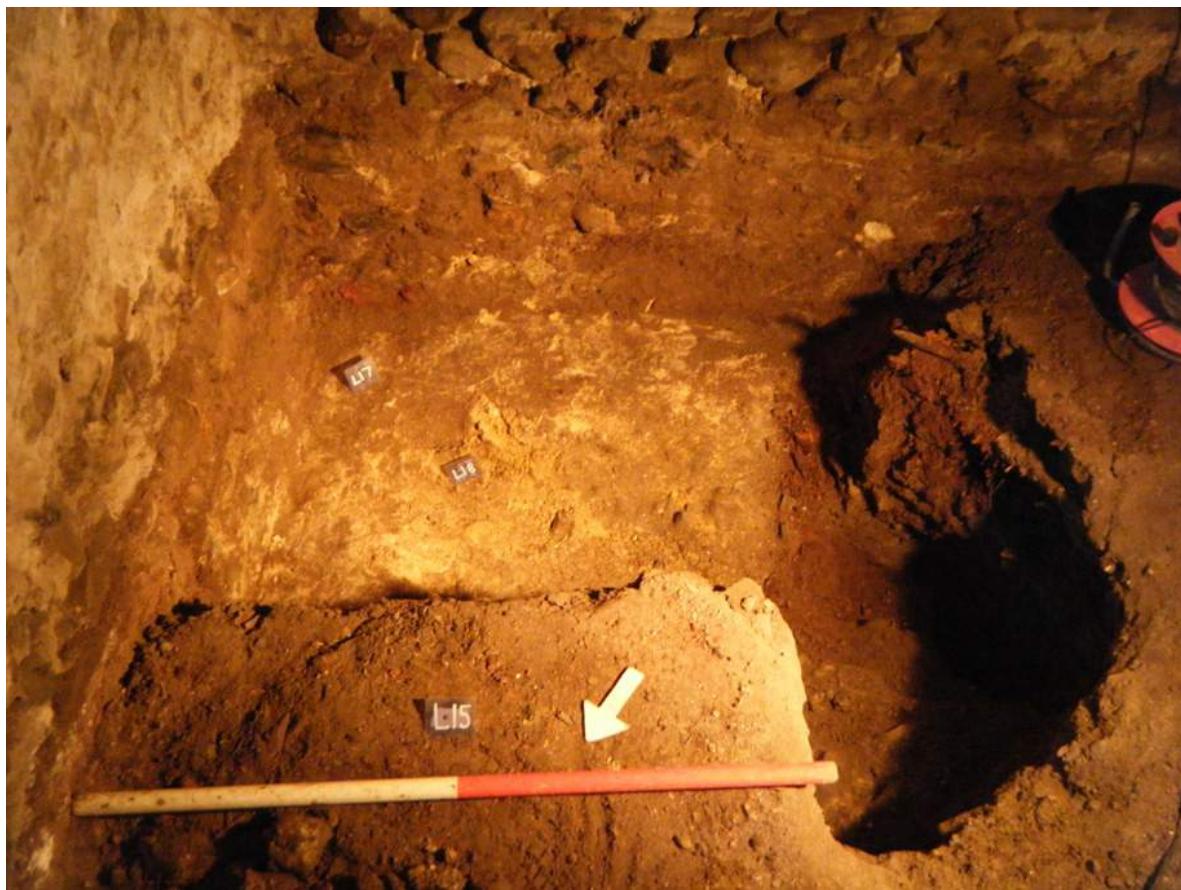
**Plate IX** Test Pit 3, fully excavated. View facing south-east.

The test pit was 600mm deep. The first layer encountered after cleaning away the dust and debris within the alcove was L15, a compact surface that was 70mm thick. Immediately beneath this was a 400mm thick dump of material, including bottles and rotted wood (L16). Directly sealed by this dump of material was the patchy remains of the original keep floor surface (L17), and beneath that, the keep foundations (L18).

Two features were observed in TP3, the small pits F14 and F15. Both of these features were dug into L15 and L16, with F14 slightly impacting the keep foundations (L18). These pits were already pre-existing hollows in the floor of the alcove prior to excavation, and only partially backfilled. This suggests they were dug in the very recent past.

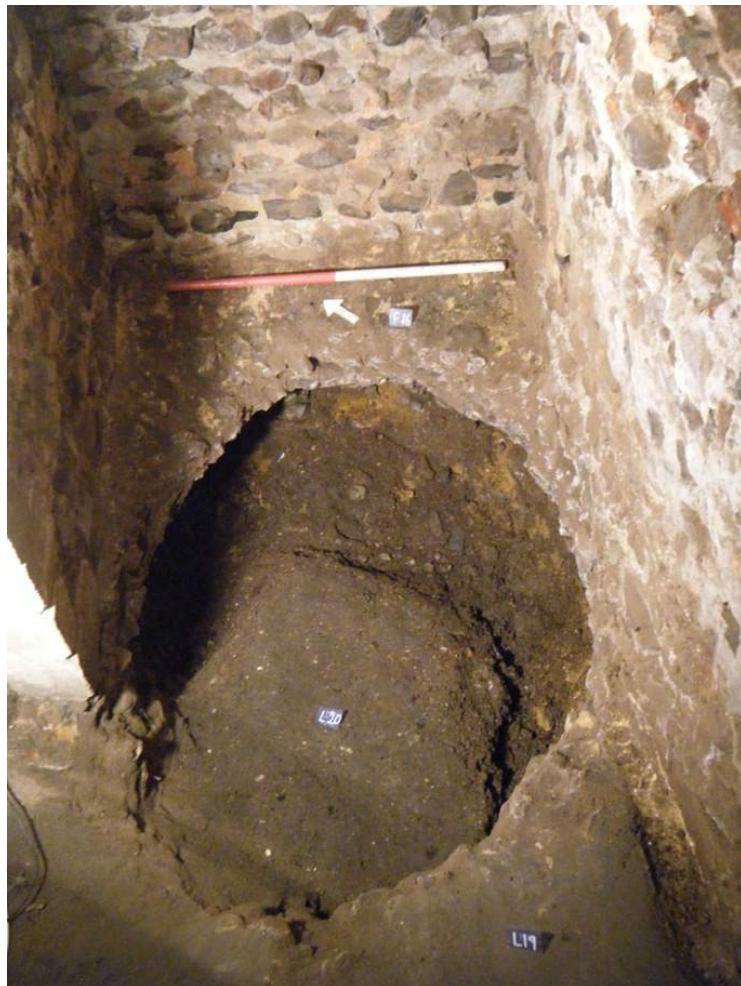
**Plate X** Test Pit 4. View facing north-east.

The test pit was dominated by a large pit cut into the foundations (F16). The pit was 1.1m in diameter and 850mm deep with plastic, glass bottles, foil wrappers and other modern rubbish observed in its fill. The fill itself was generally loose, but there was a much more compacted segment which was identified as a possible 'ramp' into the pit (L20). Even though the feature reached a significant depth, the foundations of the keep still continue beneath it. The pit has clearly been in use as a rubbish dump in the modern period, and L20, L19 and the cleared area around the pit (presumably for access) are all testament to this. Although all the finds recovered from the pit are modern in origin, the date of its initial excavation is uncertain.

Clearly digging a large hole into the foundations of the keep would have been a time consuming and difficult task, as well as causing potential structural issues (the pit has caused collapse and undermined the nearby walls – Fig 7). Digging such a hole just for the purpose of depositing rubbish would make little sense, so there must be another reason for its excavation. A potential explanation is that the pit was dug in order to remove an object set into the floor of the alcove. Given the size of the hole, such an object would have been quite large in size, and removing it would not have been an easy task. What the object could have been is difficult to say, although it is likely to have been related to the storage of goods, given the use of the basement as a whole.

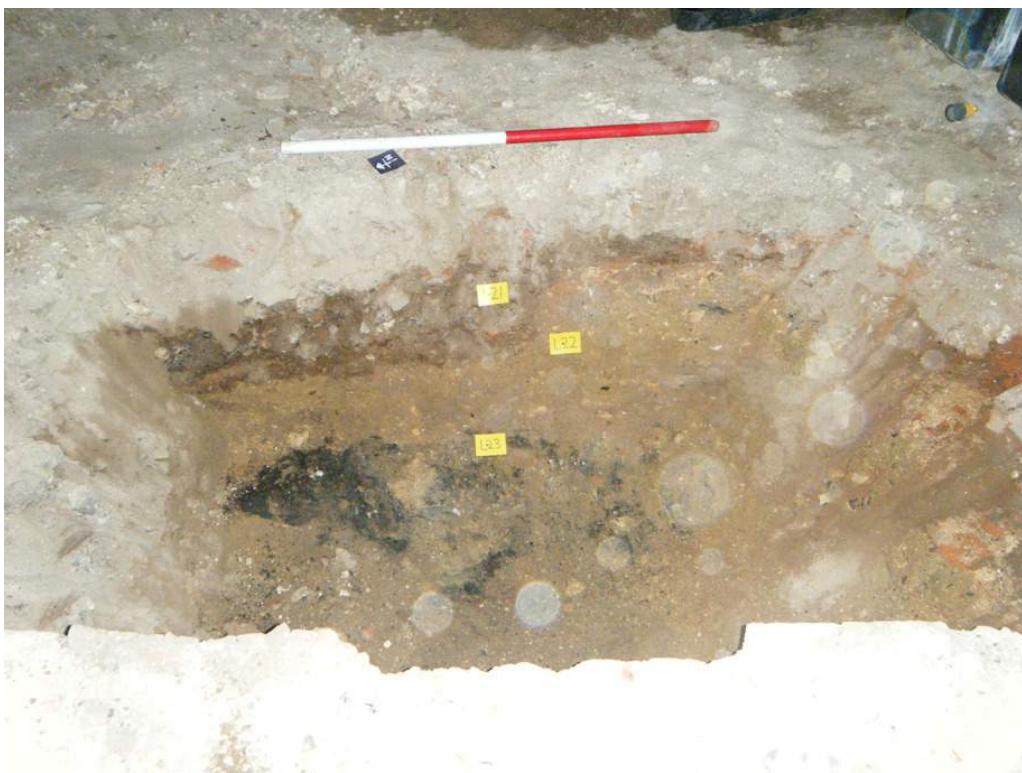
**Plate XI** Test Pit 5. View facing south-east. Poor image quality due to lack of lighting and large amount of dust in air.

Below this layer was a 130-400mm thick layer of loose sandy silt with mortar flecks (L22), which directly sealed a heavily burnt clay floor with large patches of charcoal (L23). The burning of this layer almost certainly originates from the fire in 1918. Aside from the burning, L23 is very similar to the other clay surface uncovered in TP4 (L19). The possibility these are the same surface seems likely. Presumably the clay surface in TP4 would have been protected from the fire due to its location in the alcove.

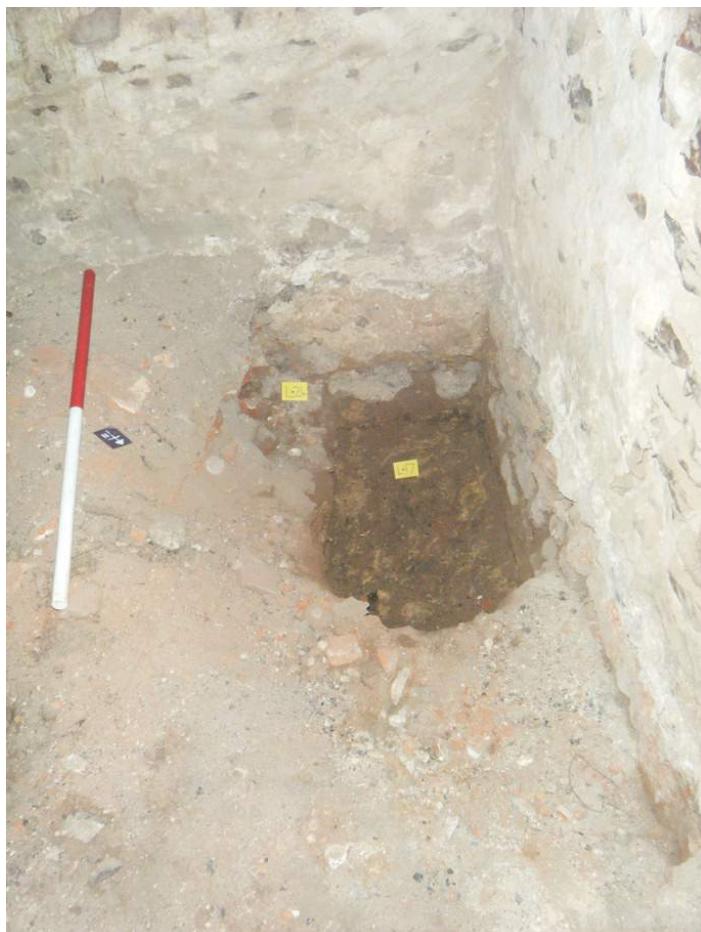
**Plate XII** Test Pit 6. View facing south-west.

Directly sealed by this layer is L17, the original keep surface. No evidence of a later clay surface was encountered (L19 in TP4 and L23 in TP5). Unlike other examples of the original mortar surface observed in TP3 and TP4, L17 in TP6 is stained with charcoal and has evidence of burning across it. As with the clay floor in TP5, this can be attributed to the fire of 1918.

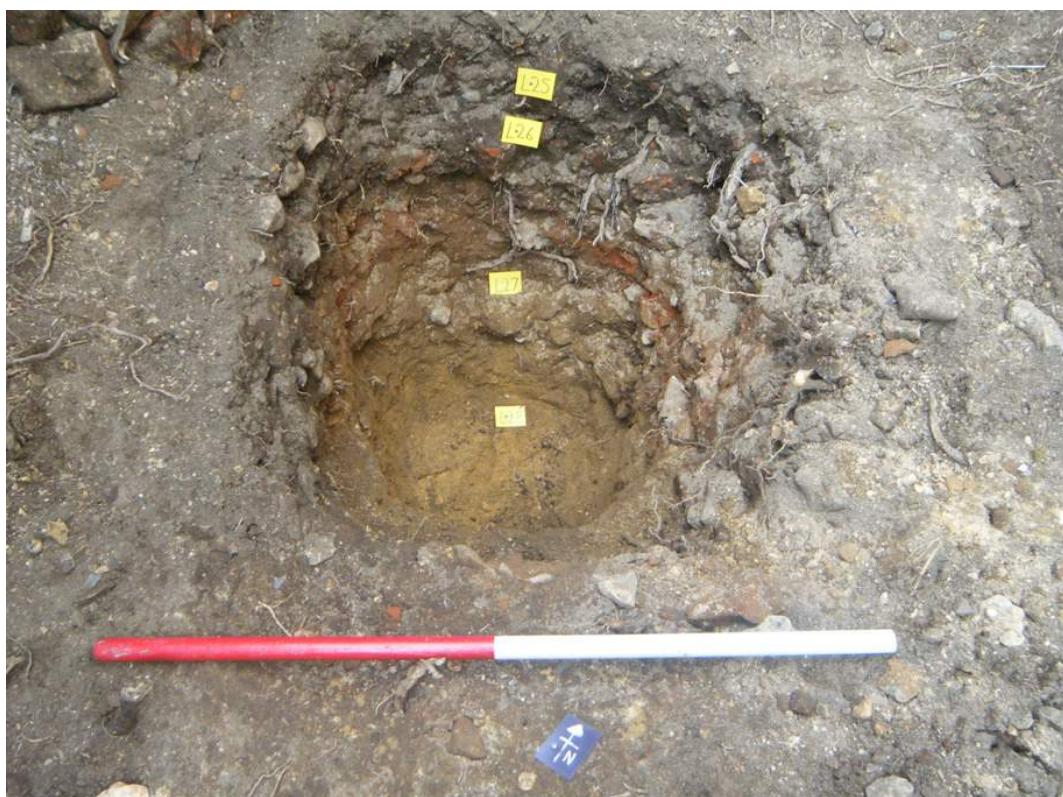
**Plate XIII** Test Pit 7. View facing north-west.

As with L8, the dating of this layer is uncertain. It had no finds present and the only indicator as to its age are the mortar flecks.

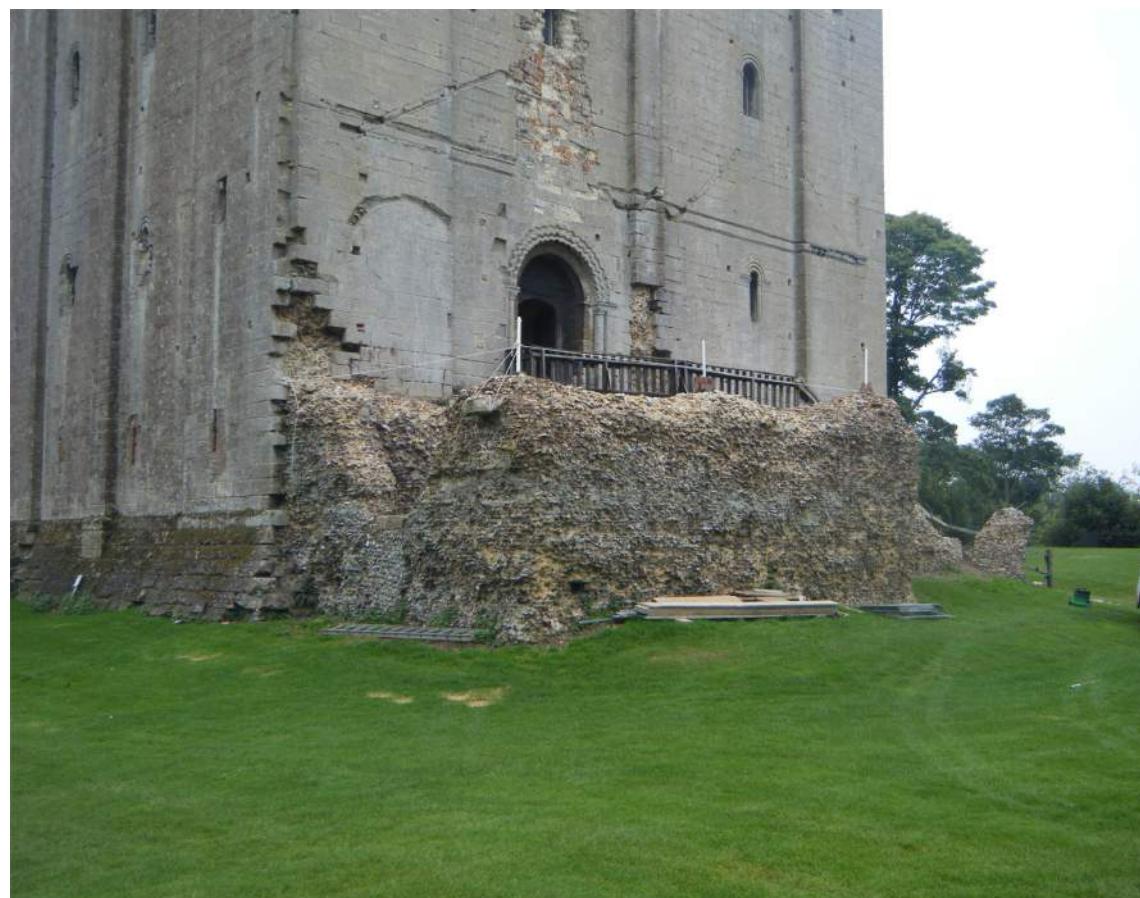
**Plate XXXV** Fore-building viewed from west. Scars on keep wall show likely height of fore-building when intact.

The apparent smaller size of the fore-building at Hedingham suggests that there was never a chapel above the entranceway (as is the case at Rochester). It appears to be a more basic affair, with just the entranceway above and the large vaulted room below. The scars present on the south-eastern side of the keep seem to bear this out (Plate XXXV).

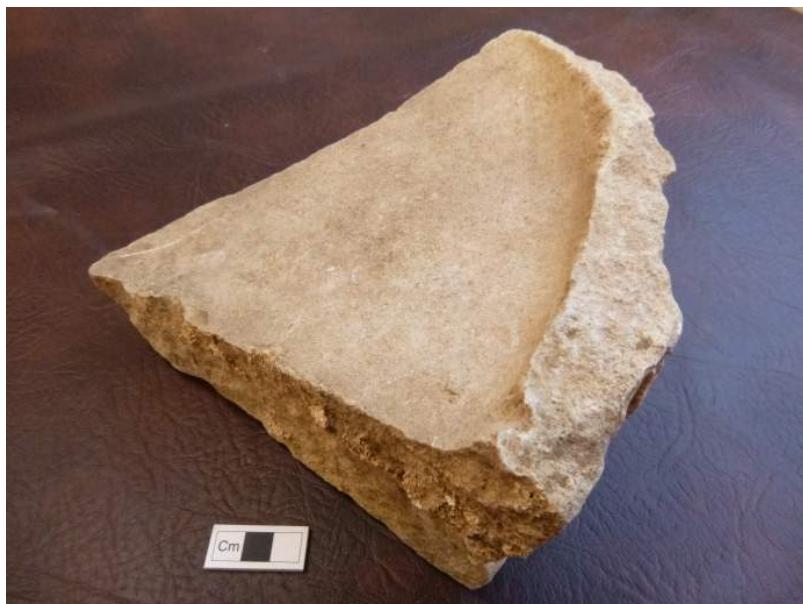
**Plate XXXVI** Medieval stone mortar (SF1) interior.

**SF 1** Limestone mortar L10(1) (Plates XXXVI & XXXVII). Section from the base of a large medieval limestone mortar. Triangular in shape and representing approximately 20% of the base. Diameter of base at foot approximately 350 mm. Rounded foot to base edge and scar where a rib (approximately 50 mm broad) has been removed. Smoothed base foot surface, outer body surface roughly finished with fine pecking, underside with smoothed areas and coarse pecking. Some mortar on broken edge extending onto internal surface indicating it has been reused as building material; the rib may have been trimmed away at that time and possibly the coarse pecking made to the base. (provisionally dated 13th-14th century).

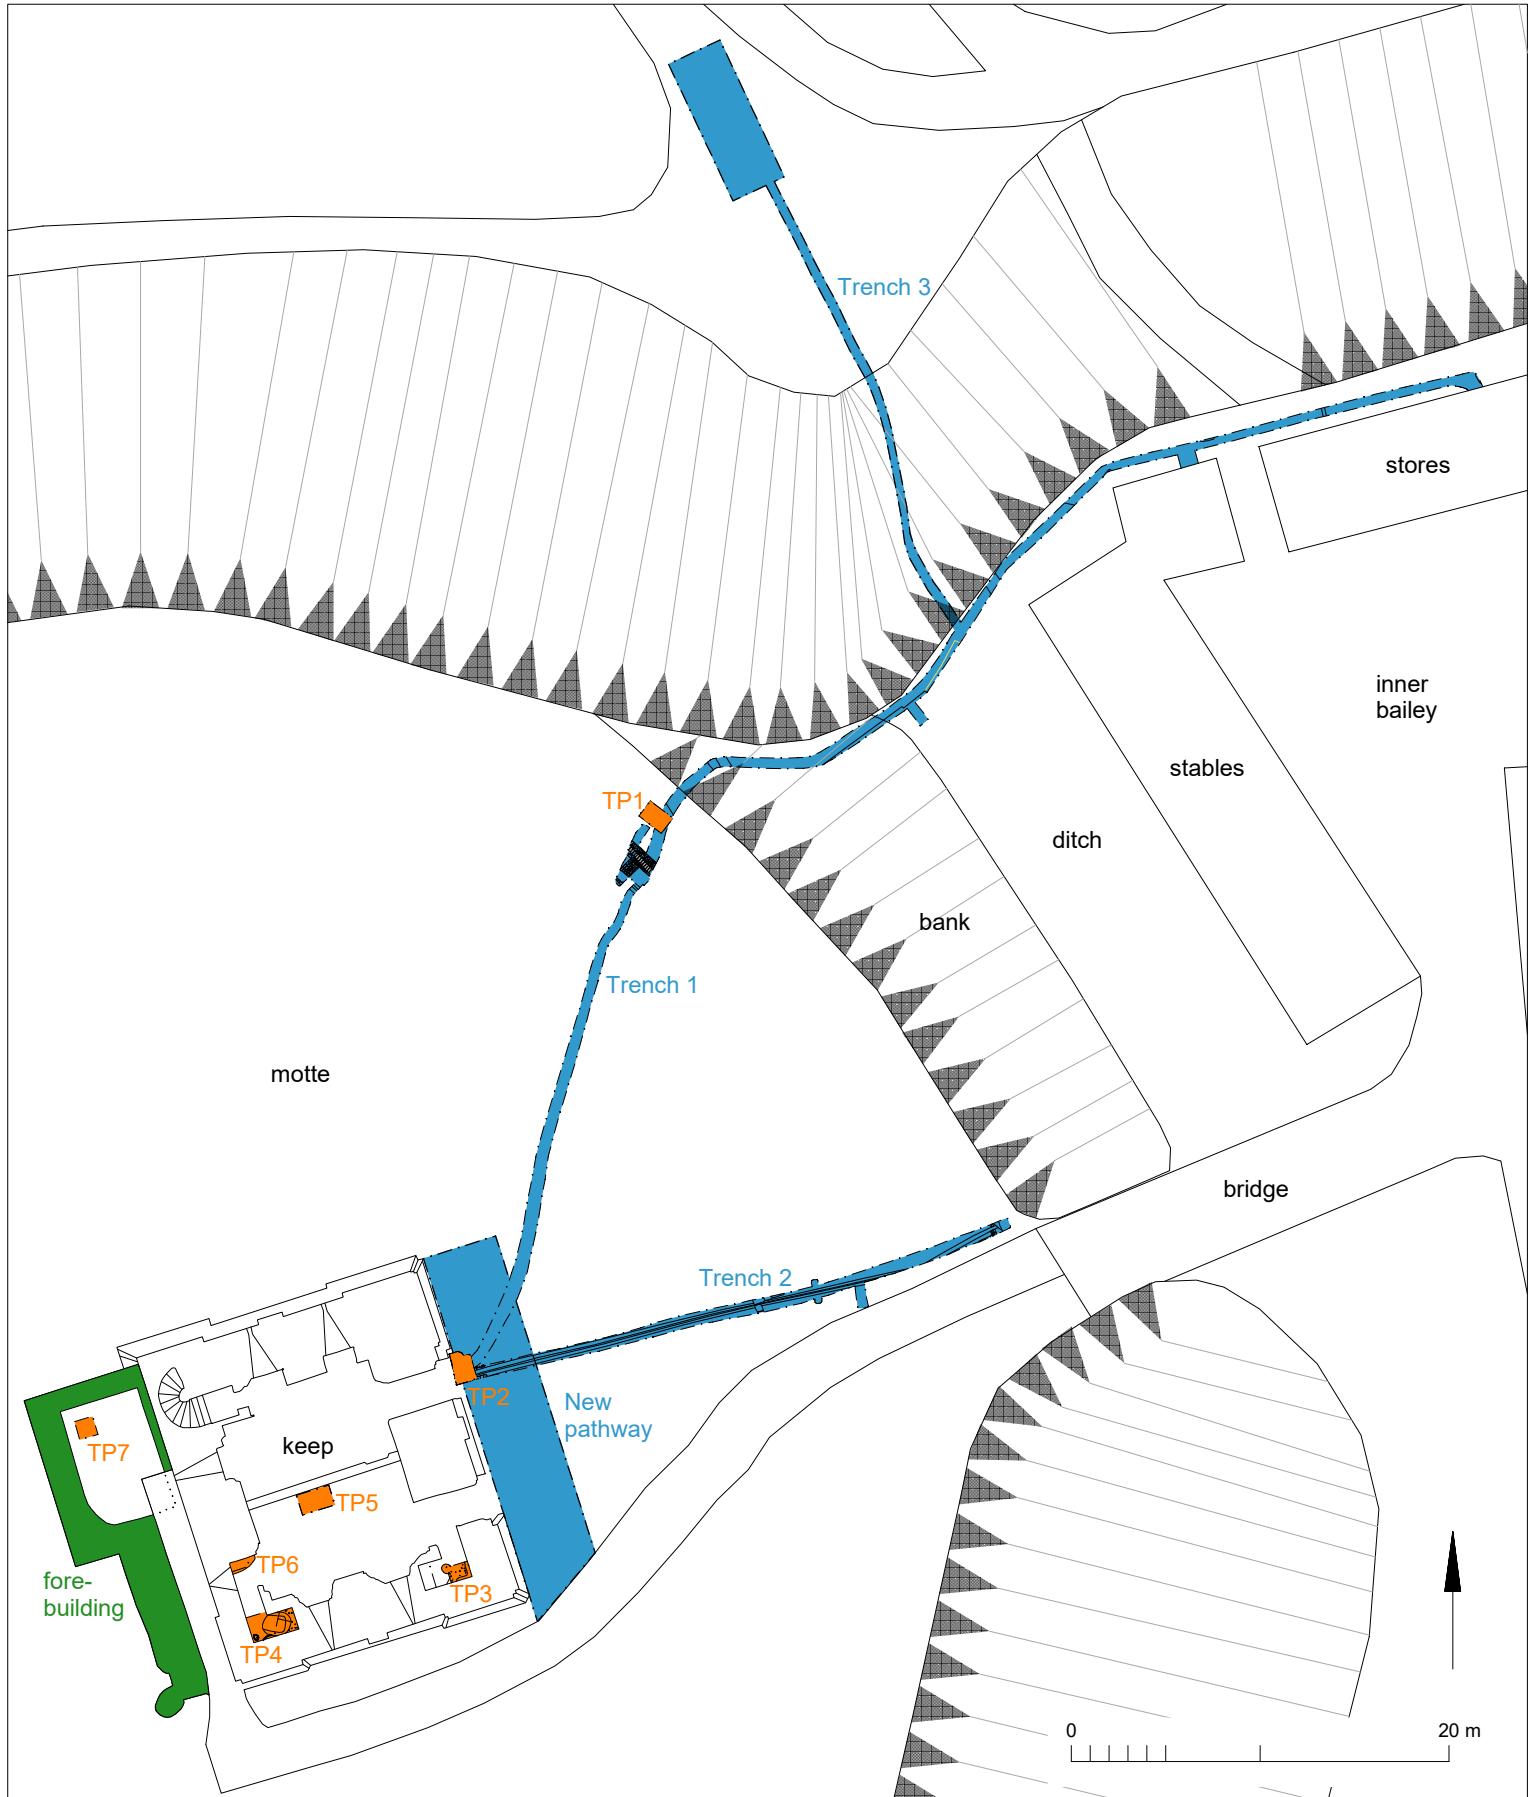
Fig 3 Overview of archaeological investigation.

In total during this investigation, three service trenches and one new pathway were monitored, seven test pits were excavated and the fore-building of the keep was surveyed (Fig 3).

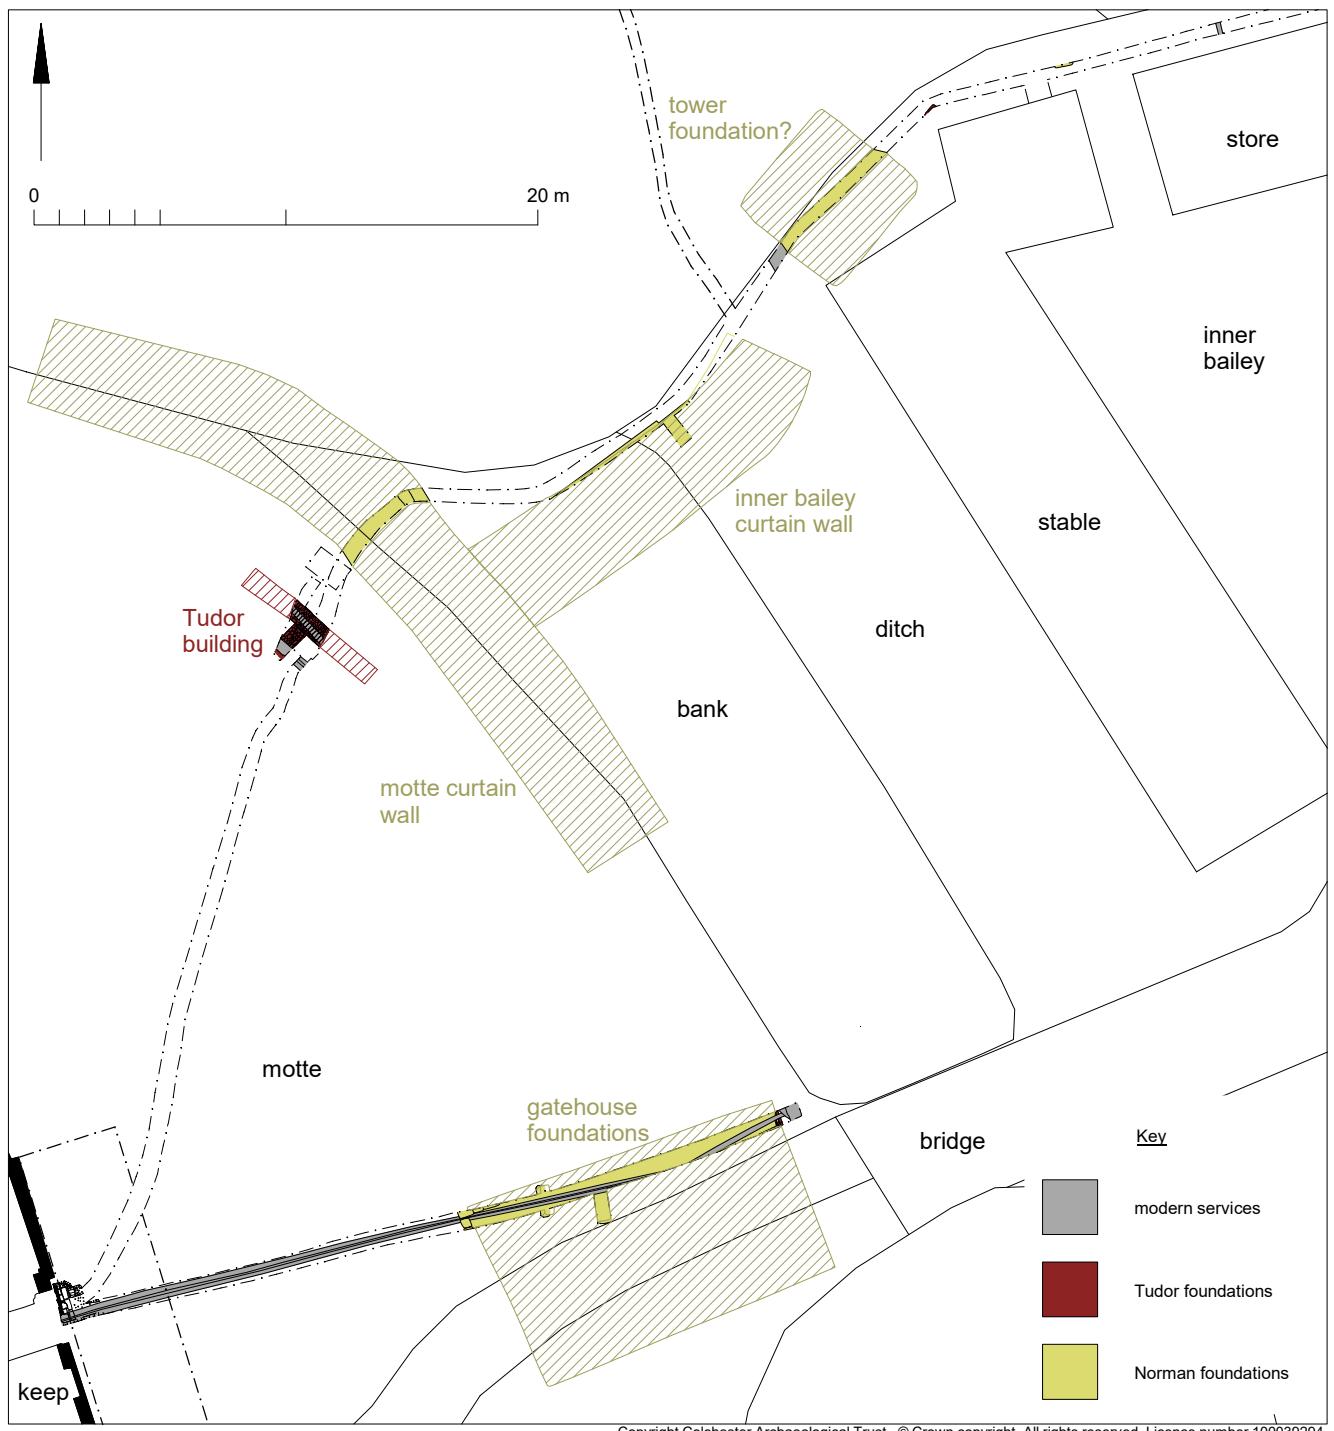
Fig 9 Norman and Tudor foundations with extrapolations.

On the corner of the inner bailey in T1 a large area of Norman foundation was dug through (F2). This is likely related to a curtain wall around the inner bailey, although it does not appear to continue to the east. It could possibly be the foundation of a tower, overlooking the earthworks to the north (Fig 9).
