# Historic building recording at 11 Trinity Street, Colchester, Essex, CO1 1JN

May-June 2016

**CAT Report 990**

A programme of historic building recording was carried out by Colchester Archaeological Trust at 11 Trinity Street, Colchester in May-June 2016. The work was restricted to a survey of the roof timbers, exposed during the replacement of the ceiling in one of the first floor rooms. The building dates from the 16th century and the survey showed the roof to be a side-purlin construction.

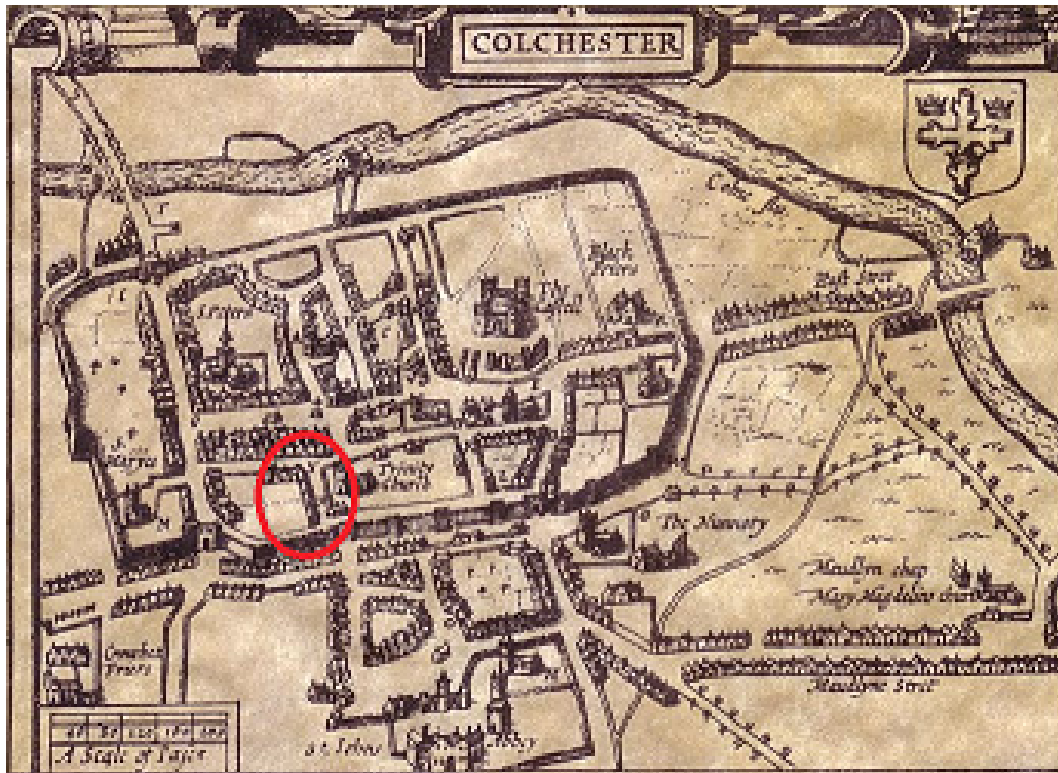
**Map 1** Extract from John Speed's c.1610 map of Essex, clearly showing buildings on the west side of Trinity Street.

The building is believed to date to the 16th century and this is supported by John Speed's map of Essex, c.1610 (Map 1) which has a cartouche showing Colchester at that time. Buildings can clearly be seen along the west side of Trinity Street (or Schere Gate Street as it was alternatively known at the time) opposite the church and the inn on the south-west corner. The listing text states that an inscription on No. 13 dates the buildings to c.1500, but the inscription as it exists today actually reads 1550 (see Photograph 3).

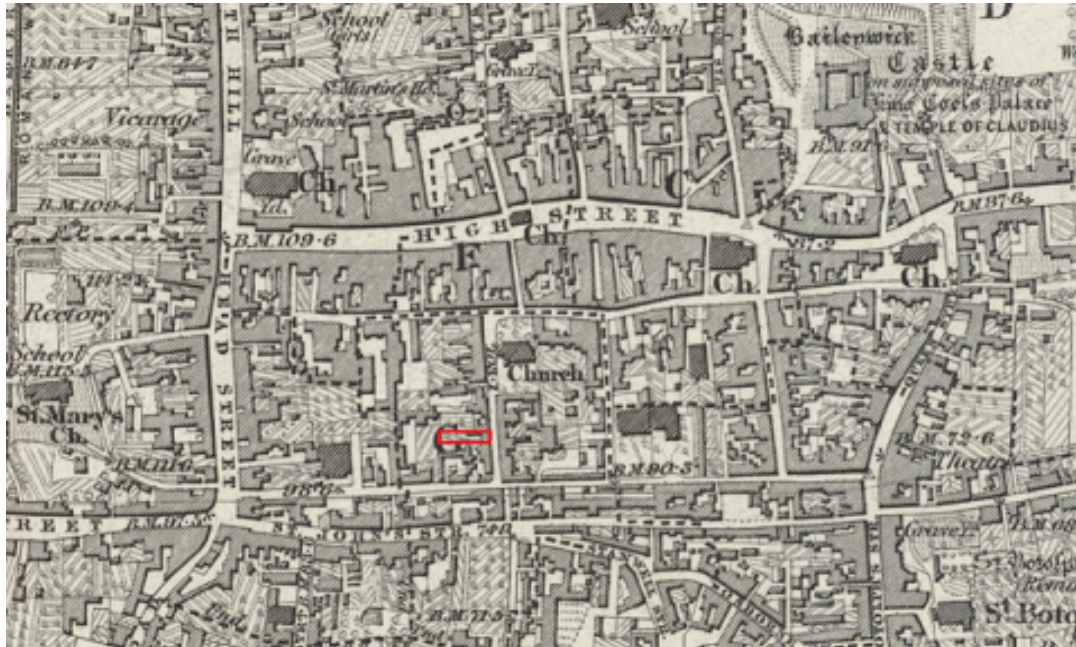
**Map 4** Ordnance Survey 6" edition (Essex XXVII) 1875.

The scale of the Ordnance Survey maps of Colchester from the 19th century and the size of the building in question make it difficult to pinpoint the age of the extension to No. 11. The 1875 edition (Map 4) appears to show no extension, whilst the 1896 edition (Map 5) appears to be more blocked in, suggesting the extension was built sometime between these two dates.

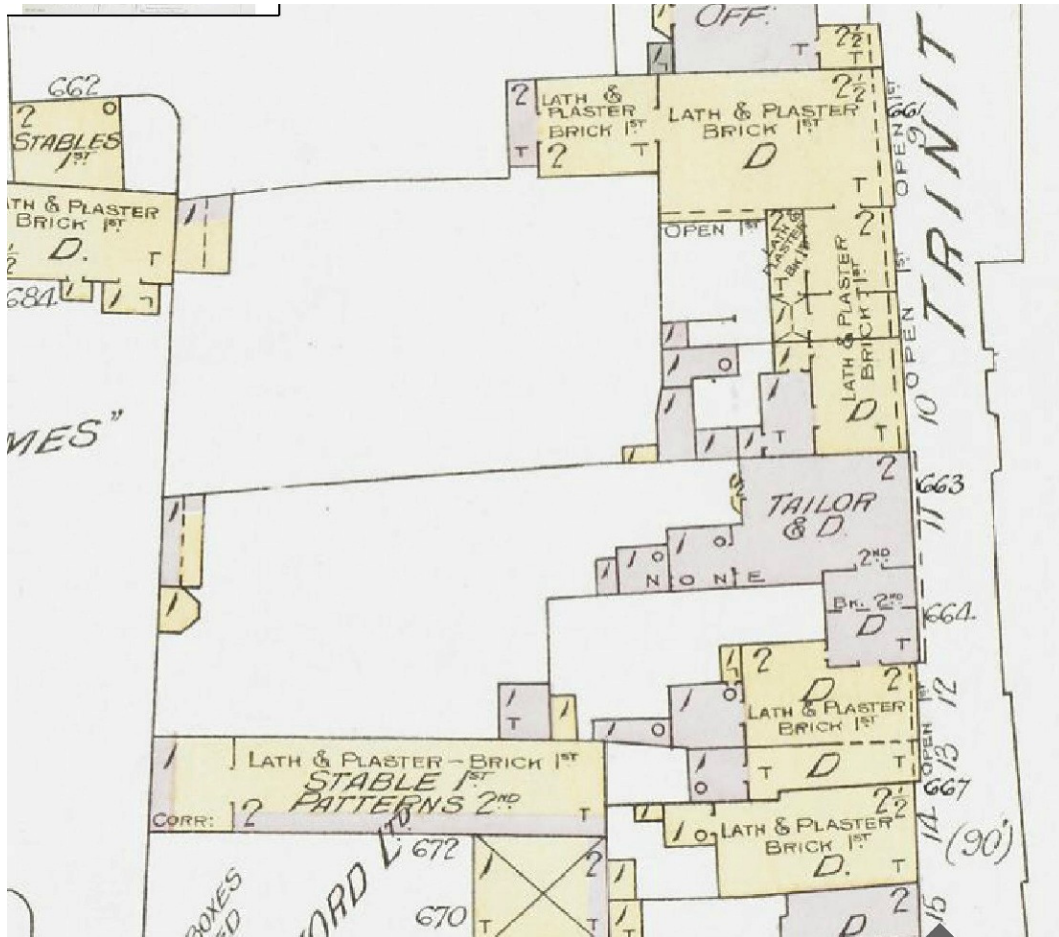
The extension to No. 11 is, however, shown on the 1909 Goad Fire Insurance map of Colchester (Map 6). The original range is shown with the extension (and subsequent extensions) projecting westwards from the north end of the building and it is even possible to discern the brick facing to No. 11 that projects into Trinity Street. The map notes that No. 11 was used as a tailor's and dressmaker's premises.

**Map 6** 1909 Goad Fire Insurance map of Colchester showing 11 Trinity Street in use as tailor's and dressmaker's shop but making no differentiation between the original timber-framed range and the later extensions to the rear.

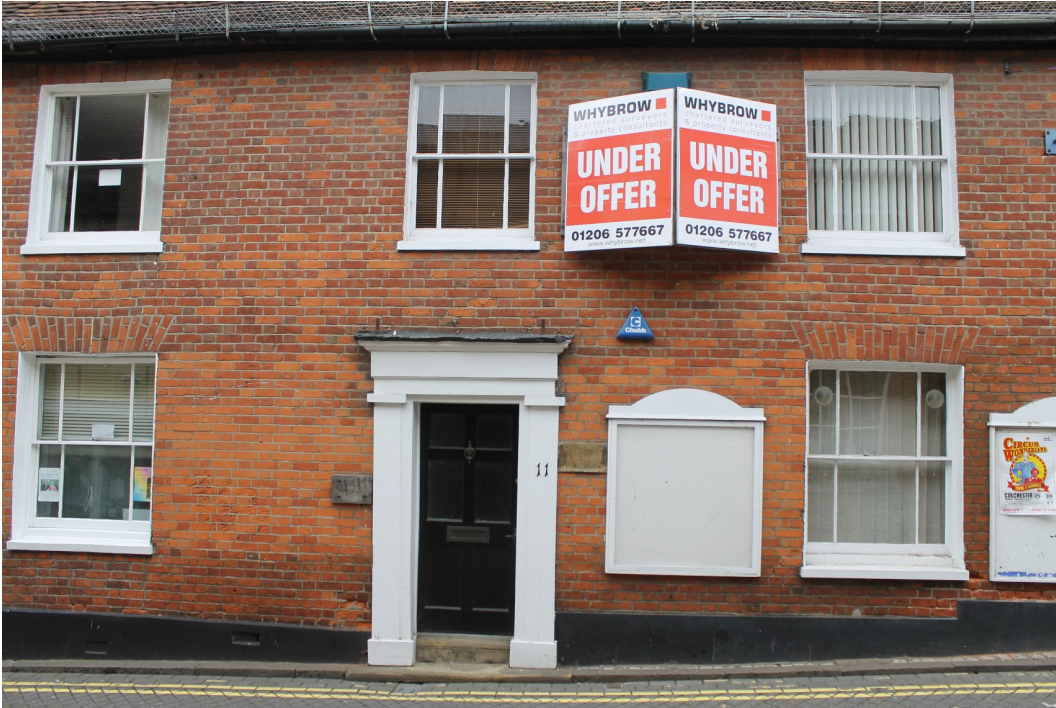
**Photograph 1** Street frontage of No. 11 showing the symmetry of the probable 19th-century brick facing – view west

No. 11 Trinity Street, together with Nos. 12-13, forms a north-south aligned range fronting directly onto the Street (Fig 1). No. 11 has a brick facing of soft red brick laid in Flemish bond and presents a symmetrical elevation with a central doorway flanked by sash windows (Photograph 1). Although this is believed to be 19th-century in date the windows are unhorned but contain large panes of glass. This is curious as the lack of horns suggests the sash windows are earlier in date but the large window panes suggest a later date.

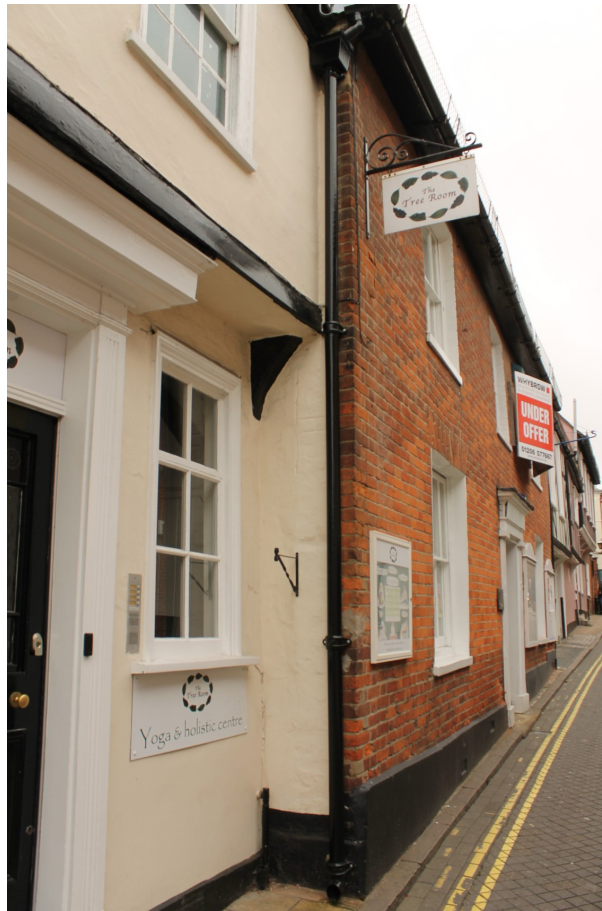
**Photograph 2** Brick facing to No. 11 with the jettied first floor of No. 12 showing what is concealed by the brick facing – view north-west

The brick facing conceals the jettied first floor to No. 11. However, this is still present behind the brickwork as shown by Photograph 2, which also shows the exposed jetty of No. 12.

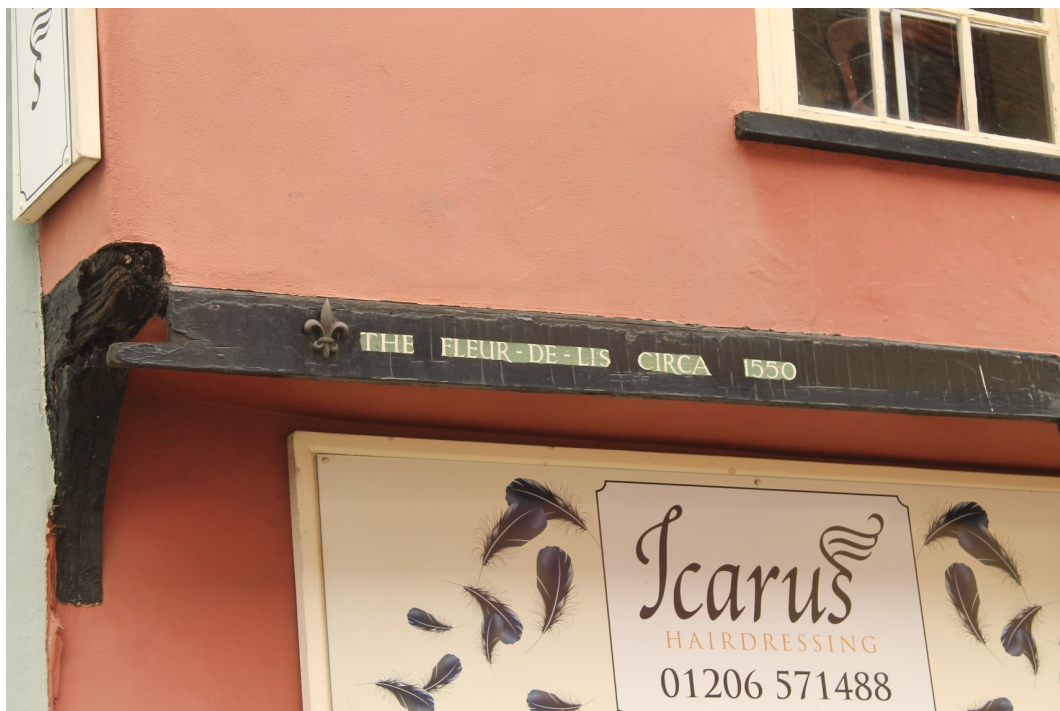
**Photograph 3** Inscription on jetty of No. 13 – view west

No. 13 has an inscription on the jetty recording “THE FLEUR DE LIS CIRCA 1550” (Photograph 3). Although this inscription probably dates to the 20th century it is presumed to be an accurate date for the building group.

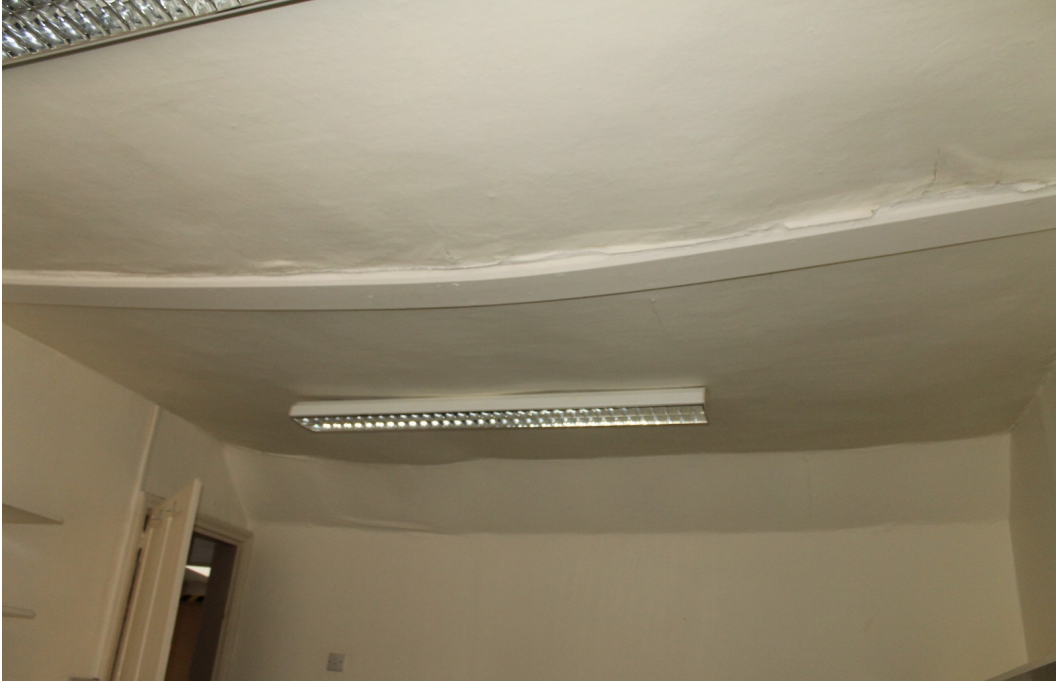
**Photograph 4** Sagging ceiling, with bowed bridging beam in first floor room – view west

Photograph 4 shows the sagging ceiling in the first floor room prior to any repair works being undertaken. The bridging beam is clearly bowed and the ceiling has a pronounced central bulge. Access into the roof space showed this to be caused by the weight of debris lying on the surface of the ceiling, deriving from an earlier ceiling's gradual collapse, as shown in Photograph 5.

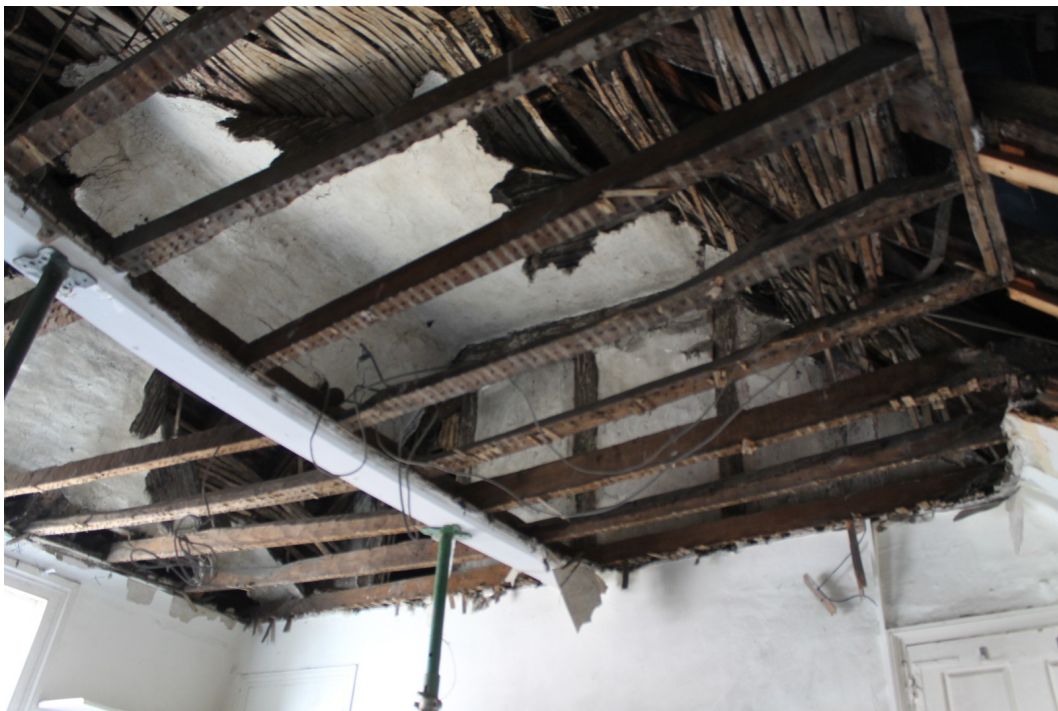
**Photograph 6** Exposed ceiling joists with earlier lath and plaster ceiling above – view south-east

After contractors had stripped away the modern plasterboard ceiling, exposing the joists, an inspection of the roof space was undertaken. The joists were a mixture of machine-cut and hand-sawn timbers, aligned east-west across the original building and jointed at the centrally-located bridging beam (Photograph 6, Fig 2). The joists were jointed to the bridging beam with staggered mortises (Photograph 7). Although modern plasterboard was removed from the ceiling this had been covering lath and plaster, the ghost of which can be seen on the underside of the joists. Despite this lath and plaster covering it is clear that the sagging ceiling was a 19th or early 20th-century insertion to the building as the machine-cut timbers of the joists were contemporary to the ceiling and not later repairs.

Visible above the inserted ceiling were the remains of an earlier lath and plaster ceiling, the deterioration of which had caused the later ceiling to sag and bulge. This was constructed from horsehair plaster applied to laths nailed to the rafters and the undersides of collars. These collars were scarfed to the purlins with birdsmouth joints but were formed from machine cut-timbers (Photograph 8), which suggests that this earlier lath and plaster ceiling dates to the late 18th or early 19th century (machine cut-timbers appear with the advent of the circular saw blade during the Industrial Revolution towards the end of the 18th century).

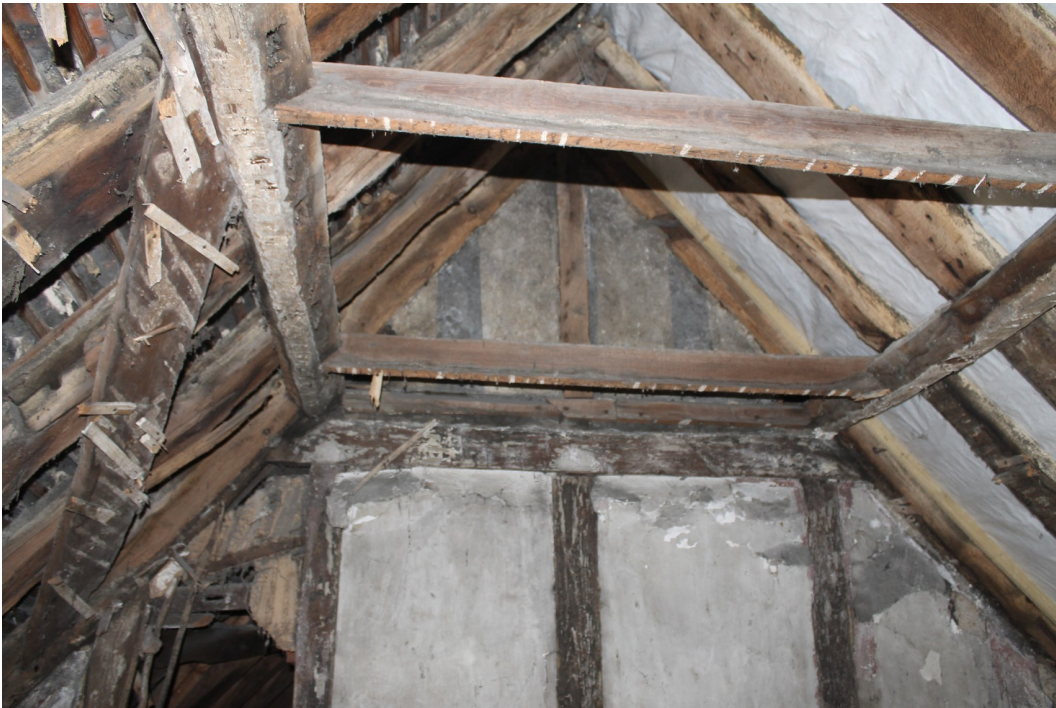
A third inspection was undertaken after the remains of the earlier lath and horsehair plaster ceiling was removed and the roof space fully exposed. This showed that the roof timbers are predominantly re-used oak timbers with common rafters of varying dimensions carried on a single purlin to each pitch (Photographs 9, 10 & 11, Figures 3 & 4). The purlins are lightly trenched into the collars at the north gable frame and at the central cross frame and are single-pegged to the principal rafters. The studs of the gable frame and the cross frame are single-pegged to original collar beams.

There is a wind brace to the street side pitch (Photograph 13) and the purlin on that side displays both toolmarks and empty mortises, indicating it is a re-used timber.

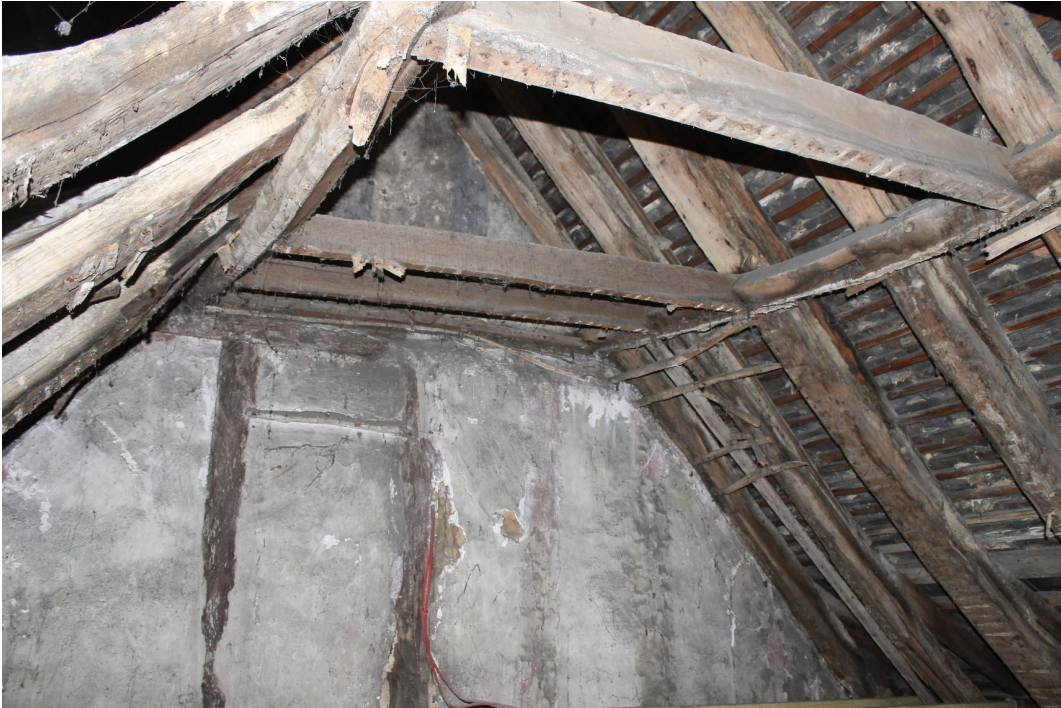
**Photograph 10** Interior of the roof space looking towards the gable frame with the original wattle and daub infill panels – view north

The gable frame and the cross frame have widely-spaced studs with wattle and daub infill panels. This can particularly be seen in Photograph 12.

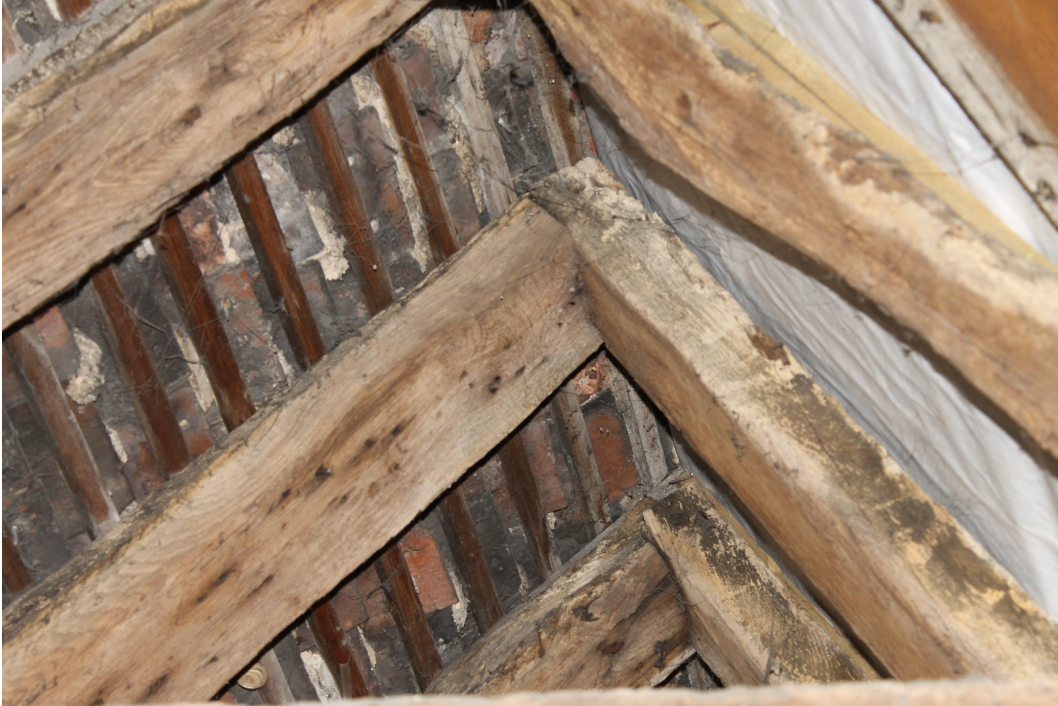
**Photograph 14** Heads of the common rafters, single-pegged to each other

There is no ridge board; instead the heads of the rafters rise to meet each other and are single-pegged (Photograph 14).

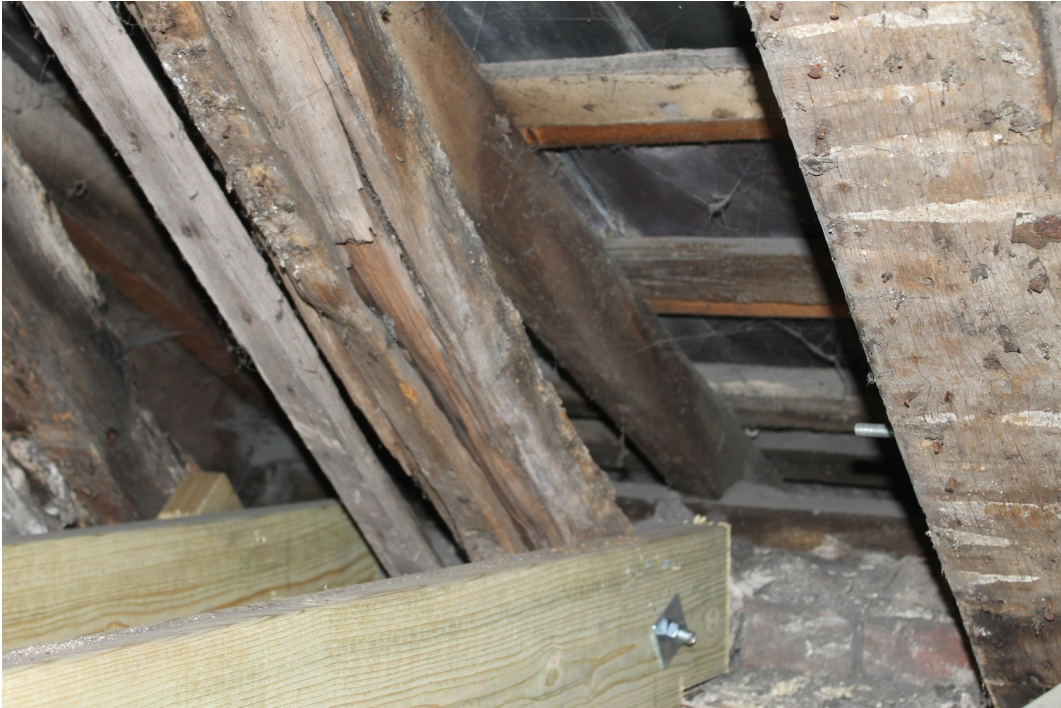
**Photograph 15** Sprockets at the feet of the street side rafters, allowing the roof to flare out over the brick facing – note the slate roof covering above the battens – view north-east

Where the roof covering flares out on the street side to cover the increased width caused by the brick facing this has been achieved by the insertion of sprockets to the feet of the rafters (Photographs 15 & 16). Why this has been undertaken at the rear of the original building is unclear unless there is a brick skin to the rear of the building, subsequently covered by the 19th-century extension. The sprockets to the rear of the building extend further than those to the front, so it is more likely that the rear had a small extension built at the same time as the brick facing and prior to the construction of the 19th-century extension.

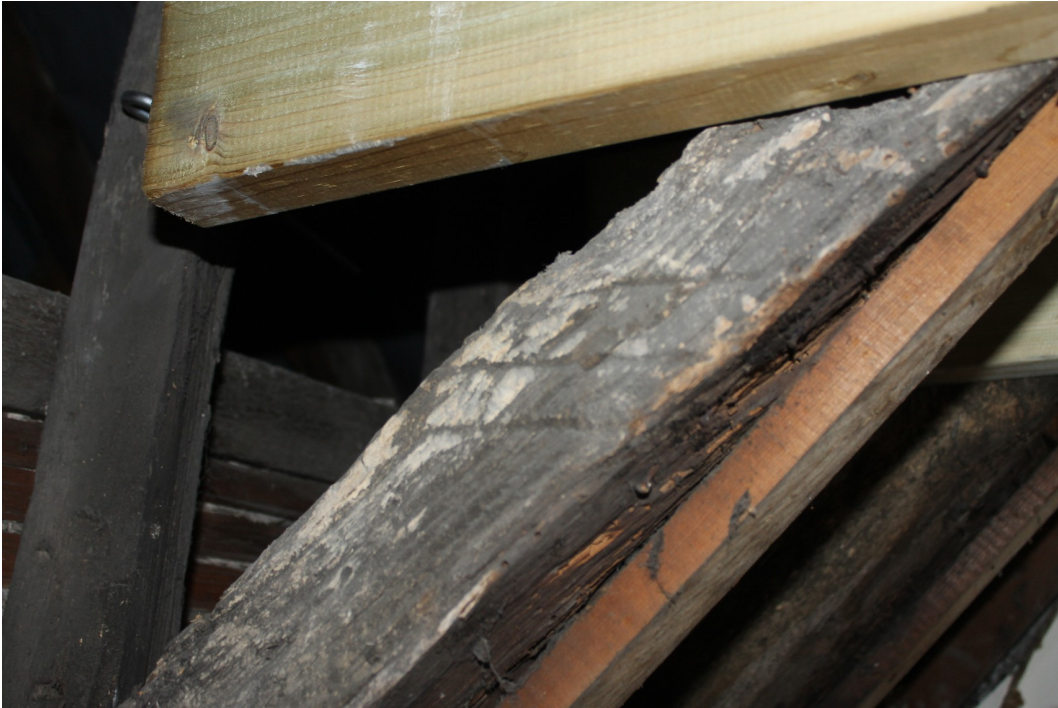
**Photograph 17** Possible carpenter's mark on the foot of one of the rear side rafters - view north-west

Despite the large number of re-used timbers in the framing of the roof only one set of potential carpenter's marks were observed. Three horizontal lines were scratched into the foot of one of the rafters of the rear pitch (Photograph 17), although these may not be original to either the building or the beam.
